**FIVE-YEAR REVIEW REPORT FOR
GENERAL MILLS/HENKEL CORP SUPERFUND SITE
MINNEAPOLIS, MINNESOTA**

June 2021

**Minnesota Pollution Control Agency
Site Remediation and Redevelopment Section**

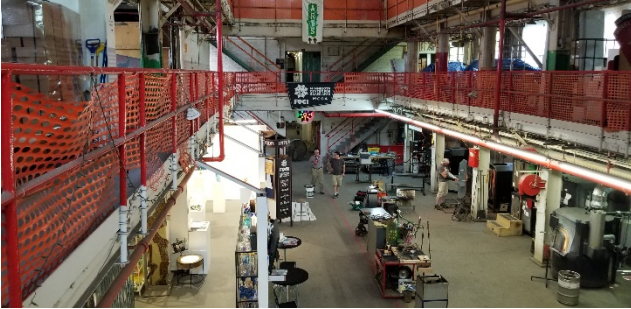
Photo 1 Glass blowing area in Building 10. Looked for vapor points. Inspected floor. No evidence of cracks.

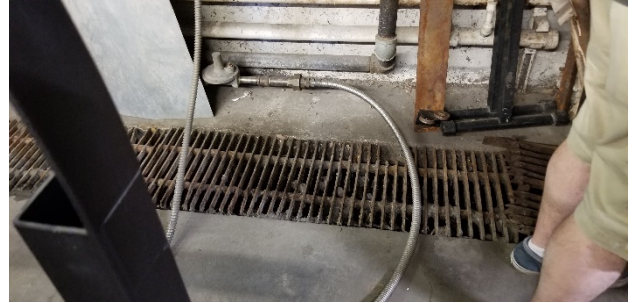
Photo 2 Floor drain in basement of Building 10.

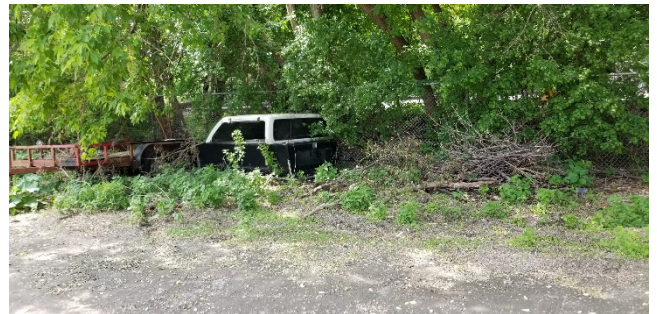
Photo 10 Trailer and topper noted in 2014 Site Walk.

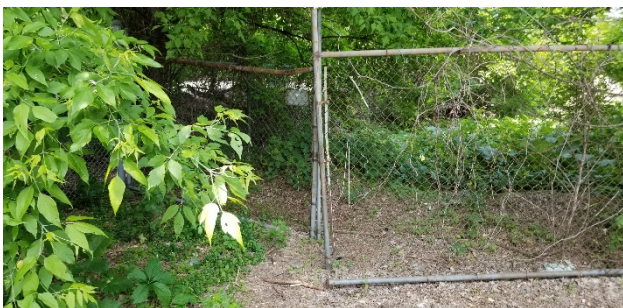
On June 3, 2019, a FYR site visit was conducted. During the FYR site visit the groundwater pump-out control building was overgrown with vegetation and the fence around the system was in disrepair. Repair of the fence, vegetation control, and posting the area with a “No Trespassing” sign is needed.

Photo 11 Breach in fence near former water treatment system.

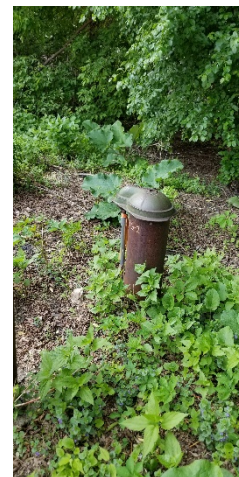
Photo 12- Well MG-2. No damage noted.

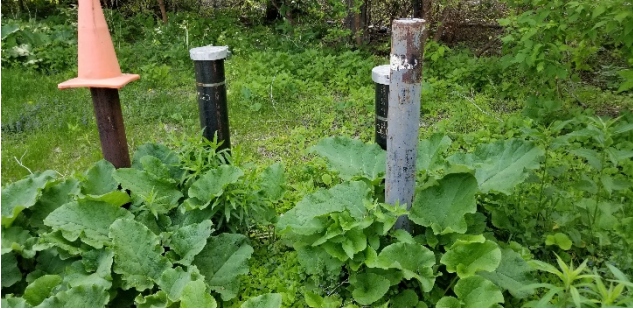
Photo 13- Well 311 GD and 311 GS. No damage noted.

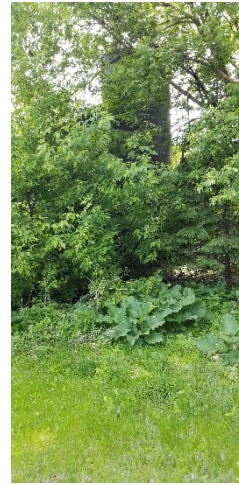
Photo 14 Bushes and trees growing into power lines.

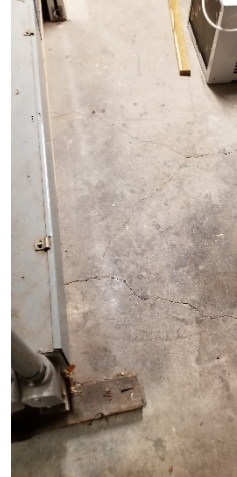
Photo 32- Cracks in floor at Varsity Apartments.

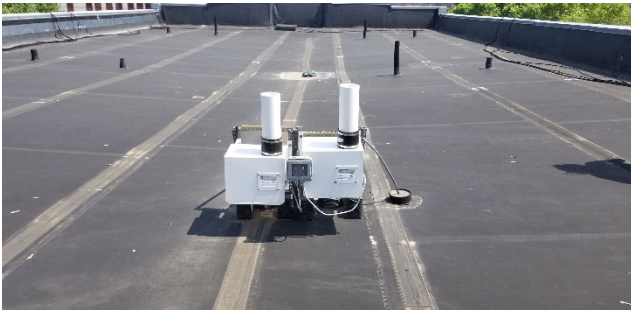
Photo 33- Blower at Varsity Apartments.

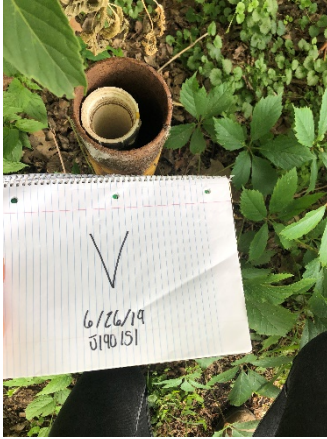
Photo 7 Well V. 2" PVC well casing, no well plug, one bollard, appears to have old/abandoned well or broken bollard behind it.

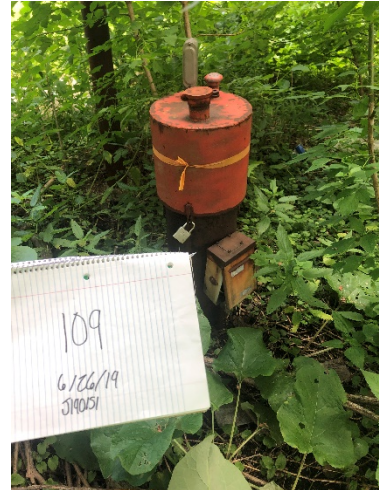
Photo 2- Well 109 In wooded area. Damaged electrical box attached to outside of well.

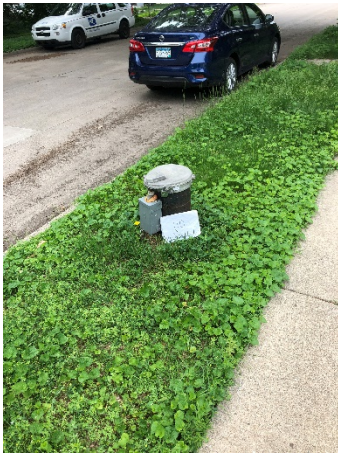
Photo 3 Well 110. No damage noted.

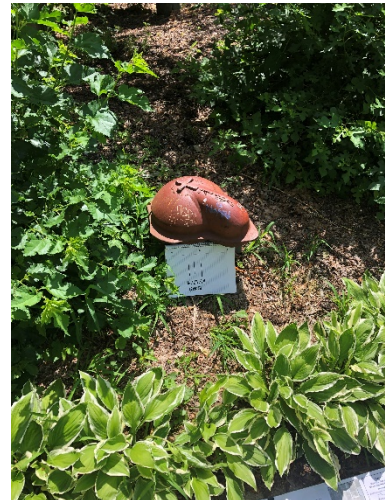
Photo 4. Well 111, 8-10" steel outer casing, electrical box attached to outside of well. Cap bolted on, did not open. No bollards.

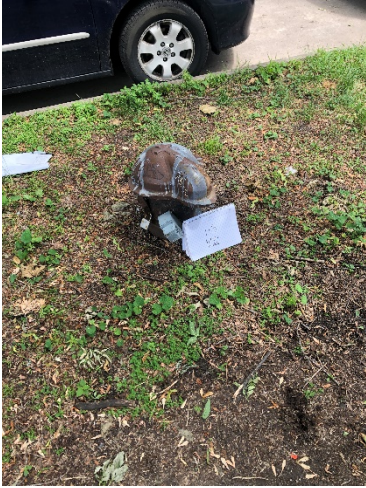
Photo 7 8-10" steel outer casing, electrical box attached to outside of well, appears slightly damaged. Cap bolted on, did not open, No bollards.

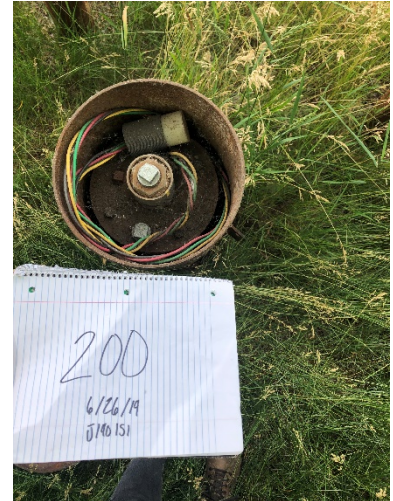
Photo 8 Well 200. 8-10" steel outer casing, two bollards on road side, pumping housing and electrical plug inside well. No damage noted.

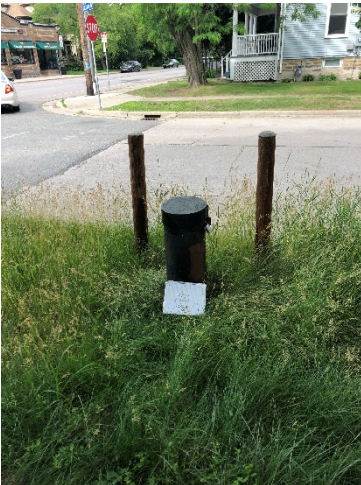
Photo 9. Well 200. 8-10" steel outer casing, two bollards on road side, pumping housing and electrical plug inside well. No damage noted.

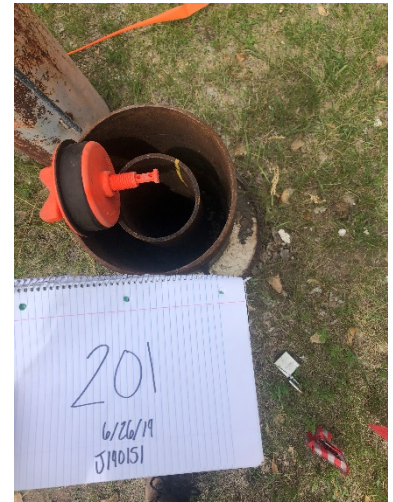
Photo 10 Well 201. 4" steel well casing, plug present, no bollards. Area under construction at time of inspection. No damage noted.

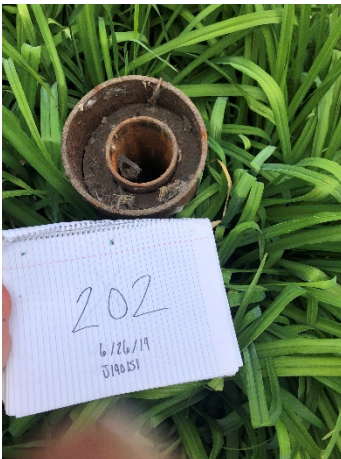
Photo 11 Well 202. 4" steel well casing, surrounded by vegetation, no plug/cap, no bollards.

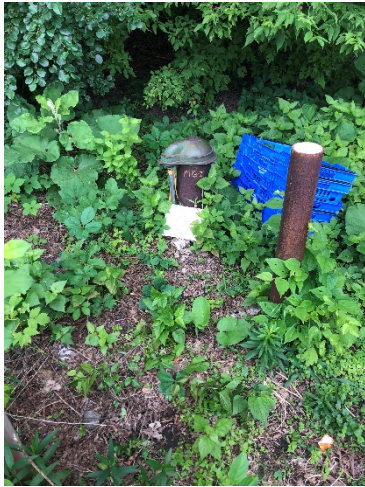
Photo 19 MG-2. 8-10" steel outer casing, Two bollards one with electrical box attached, don't appear damaged.

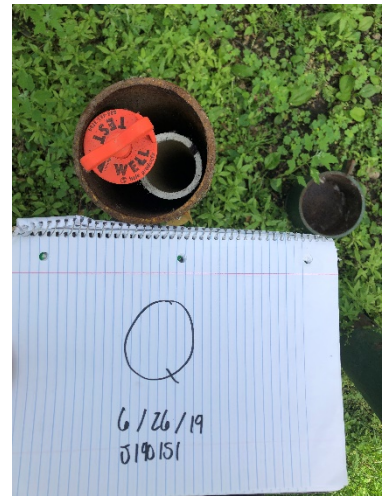
Photo 20- Well Q. 2" PVC well casing, plug present, three bollards. No apparent damage.

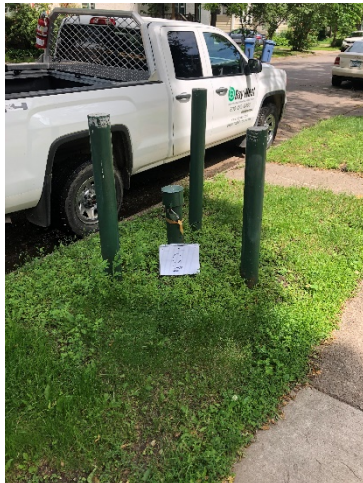
Photo 21- Well Q. 2" PVC well casing, plug present, three bollards. No apparent damage.

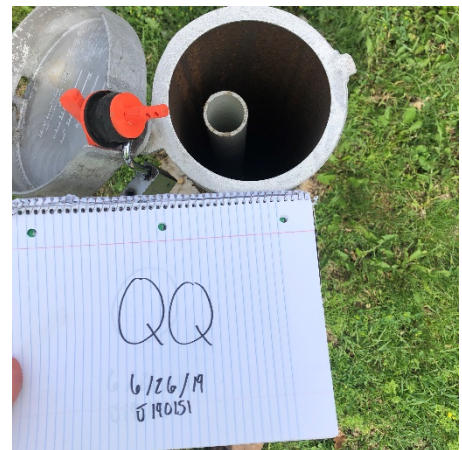
Photo 22- Well QQ. ~1 1/2" well casing, plug present, no bollards.

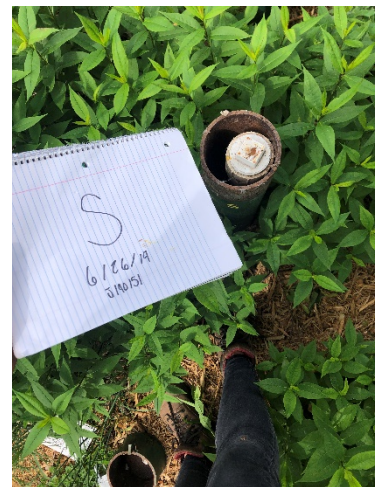
Photo 24- ~2" PVC well casing, plug/cap present, three bollards. No apparent damage.

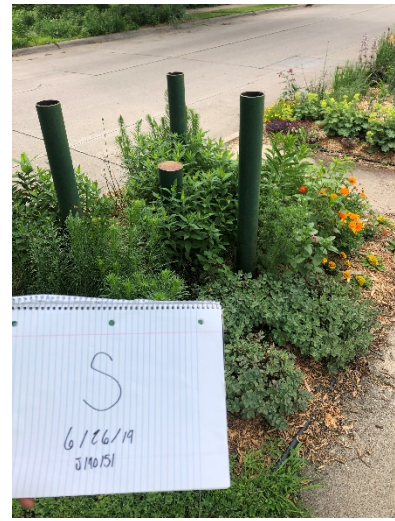
Photo 26- Photo 24- ~2" PVC well casing, plug/cap present, three bollards. No apparent damage.

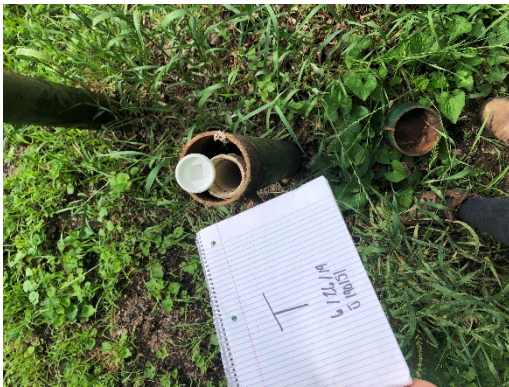
Photo 27- Well T. ~2" PVC well casing, plug/cap present, three bollards. No apparent damage.

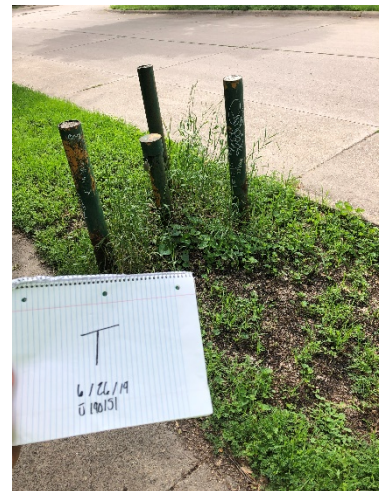
Photo 28- Well T. ~2" PVC well casing, plug/cap present, three bollards. No apparent damage.

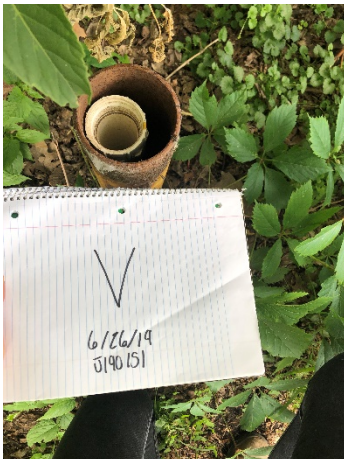
Photo 29- Well V. 2" PVC well casing, no well plug, one bollard, appears to have old/abandoned well or broken bollard behind it.

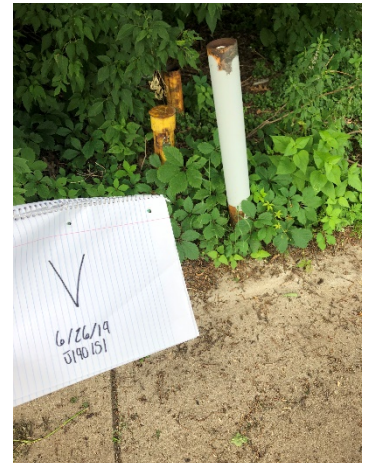
Photo 30- 2" PVC well casing, no well plug, one bollard, appears to have old/abandoned well or broken bollard behind it.
