Swan River Channel Stability and Geomorphic Assessment

Technical Memo

Submitted to the MPCA

South St. Louis County Soil and Water Conservation District

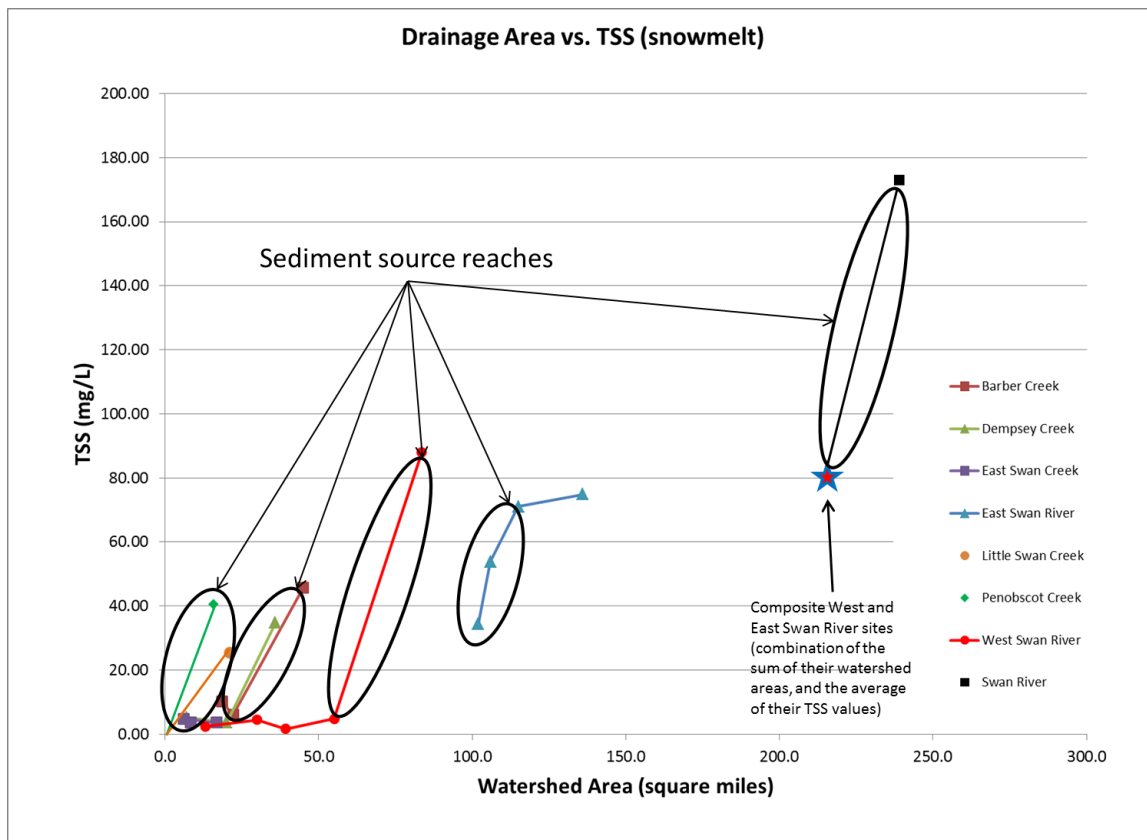
Figure 4: TSS vs. Drainage Area. High gradients suggest that sediment is being sourced in those reaches.

From Figure 4 it is immediately clear that there are high TSS contributions in several specific areas. The smaller watersheds of Penobscot and Little Swan Creek are contributing a large amount of suspended sediment relative to their drainage areas. Similarly, the reach of Barber Creek near its confluence with Penobscot Creek has a dramatic increase in suspended sediment. Just east of Barber Creek, there is a large increase in suspended sediment in Dempsey Creek downstream of Antonelli Road. The lower reaches of the West Swan River also appear to be contributing a good deal of suspended sediment; increasing from 1.6 mg/L at CR 442 to 88 mg/L at Hingely Road. Finally, almost the entire East Swan River (aside from the reach between Zim Road and CR 442) is contributing considerable sediment to the system. A spatial view of the possible sediment-source reaches in the watershed is shown in Figure 5, which assumes that the majority of the suspended sediment is coming from the channel bed and banks as opposed to overland sources.

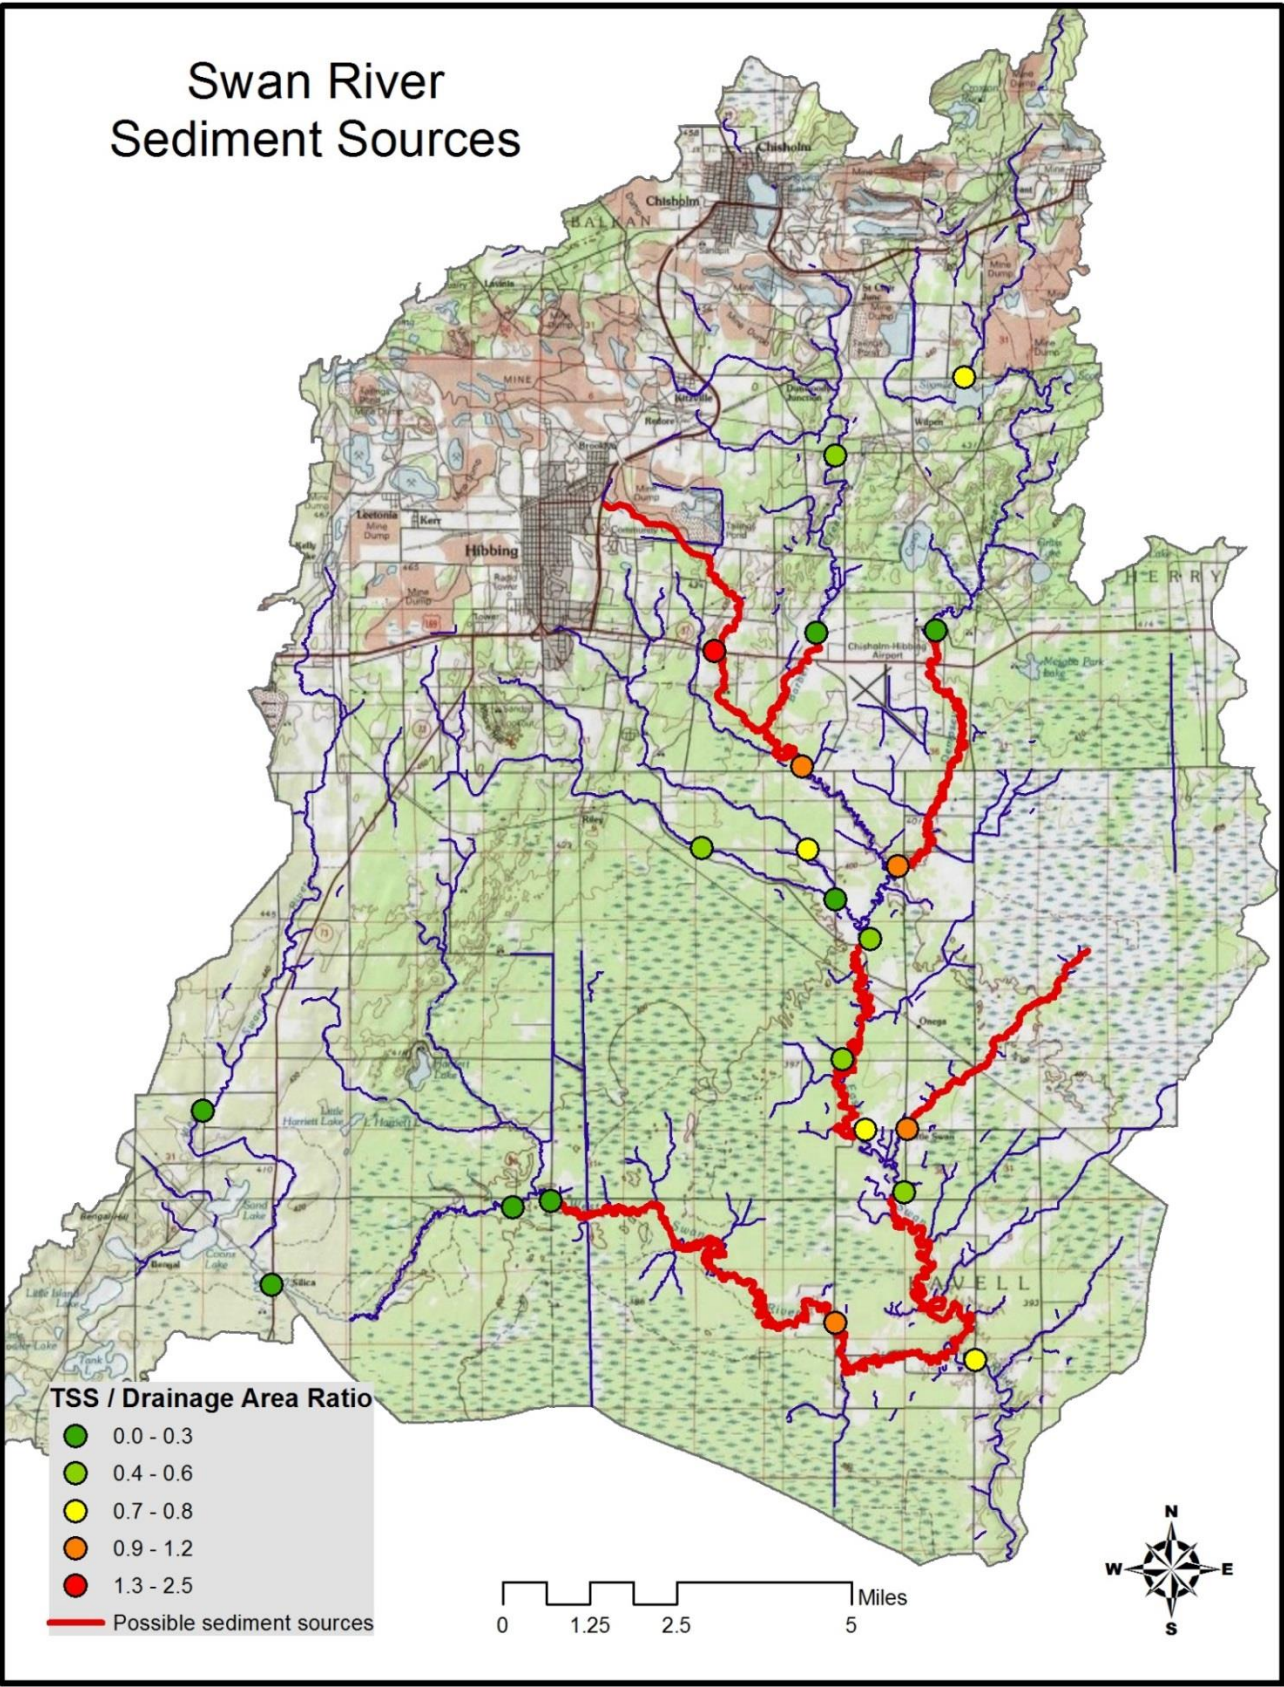
Figure 5: Spatial view of the possible sediment sources in the Swan River watershed (based on longitudinal TSS sampling during snowmelt)

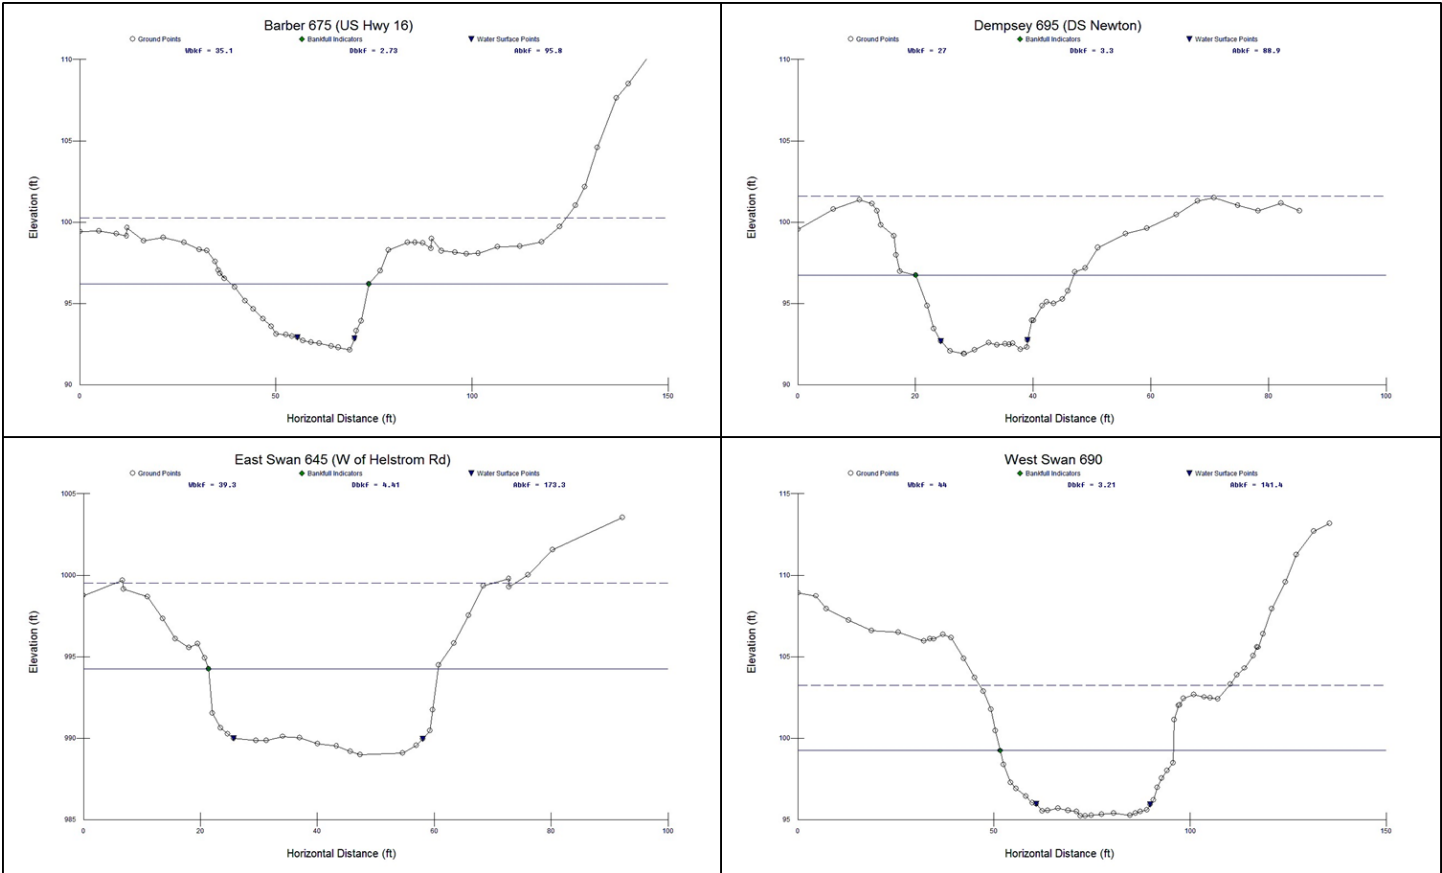
The empirically-derived relationship between DA and cross-sectional area in the Swan River watershed is $Y=5.1501X^{0.7336}$, where X is the drainage area and Y is bankfull cross-sectional area at any particular site. This formula was used to approximate the bankfull elevation at incised sites and to determine the degree of incision (i.e. incision ratio). The following several images are some examples of incised cross-sections where the mini regional curve was used to estimate the bankfull elevation. In almost all of them there was no bankfull bench, but there was a slope inflection that indicates that the stream is trying to recreate its floodplain at the lower elevation.

Figure 12: Examples of incised cross-sections where a mini regional curve was needed to approximate bankfull elevation

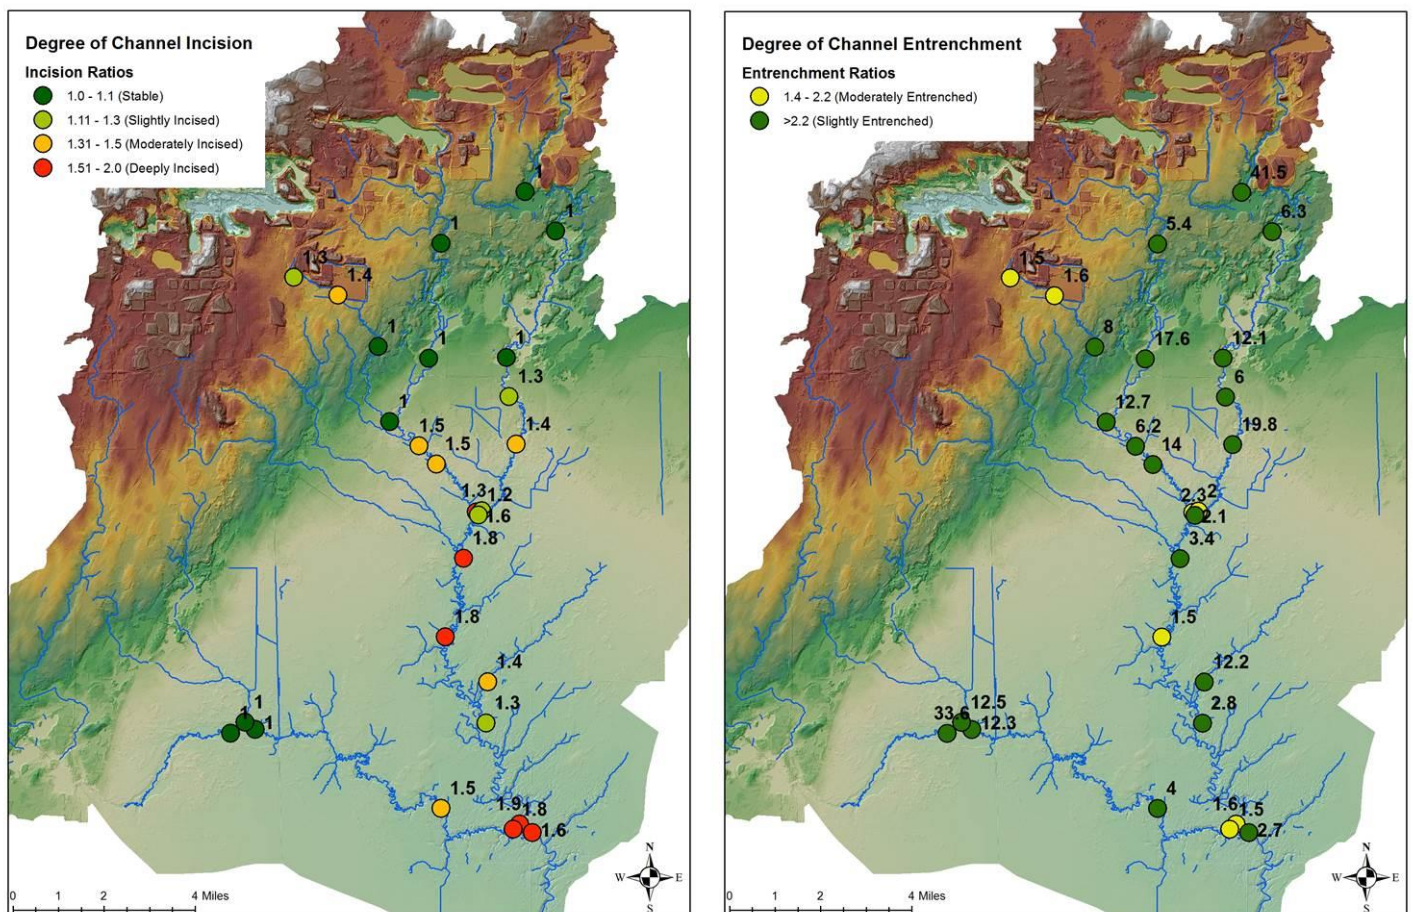
In the upper reaches of the watershed, channels generally have well-developed bankfull depositional surfaces and are connected to their floodplains. In the Dempsey and Barber systems, channel incision seems to start increasing south of Hwy 37. North of Hwy 37, incision ratios are 1.0, except in the channelized reaches of Penobscot Creek. Those reaches have moderately incised ratios of 1.4 and 1.3. Descending south of Hwy 37, incision ratings range between slightly and deeply incised. The West Swan River has good flood-plain connection in the upstream half of the watershed, but somewhere between CR 442 and Hingeley Road the channel downcuts. The Hingeley Road site has an incision ratio of 1.5 and the site just before the confluence with the East Swan River has an incision ratio of 1.9.

Figure 13: Incision and entrenchment ratios for rapid assessment sites in the Swan River watershed

Looking at the entrenchment ratios of the 28 surveyed reaches, the upper reaches of the West Swan River and the reaches north of Hwy 37 are only slightly entrenched. Entrenchment ratios decrease longitudinally down the system, although the relationship between entrenchment and longitudinal location is not as strong as with incision. Most of the sites classify as “slightly entrenched”, although the ratios are much lower than would be expected for the stream and valley types found there. For example, the site on the East Swan River upstream of CR 442 has an entrenchment ratio of 2.8 (technically “slightly entrenched”). However, that is not painting the whole picture. The bankfull width is approximately 40 feet, and the valley width is around 400 feet. Thus the entrenchment ratio *should* be around 10. However, the flood prone area is much narrower than the valley (110 feet), indicating a downcut channel. The incision ratio of 1.3 at that site is further evidence of that.

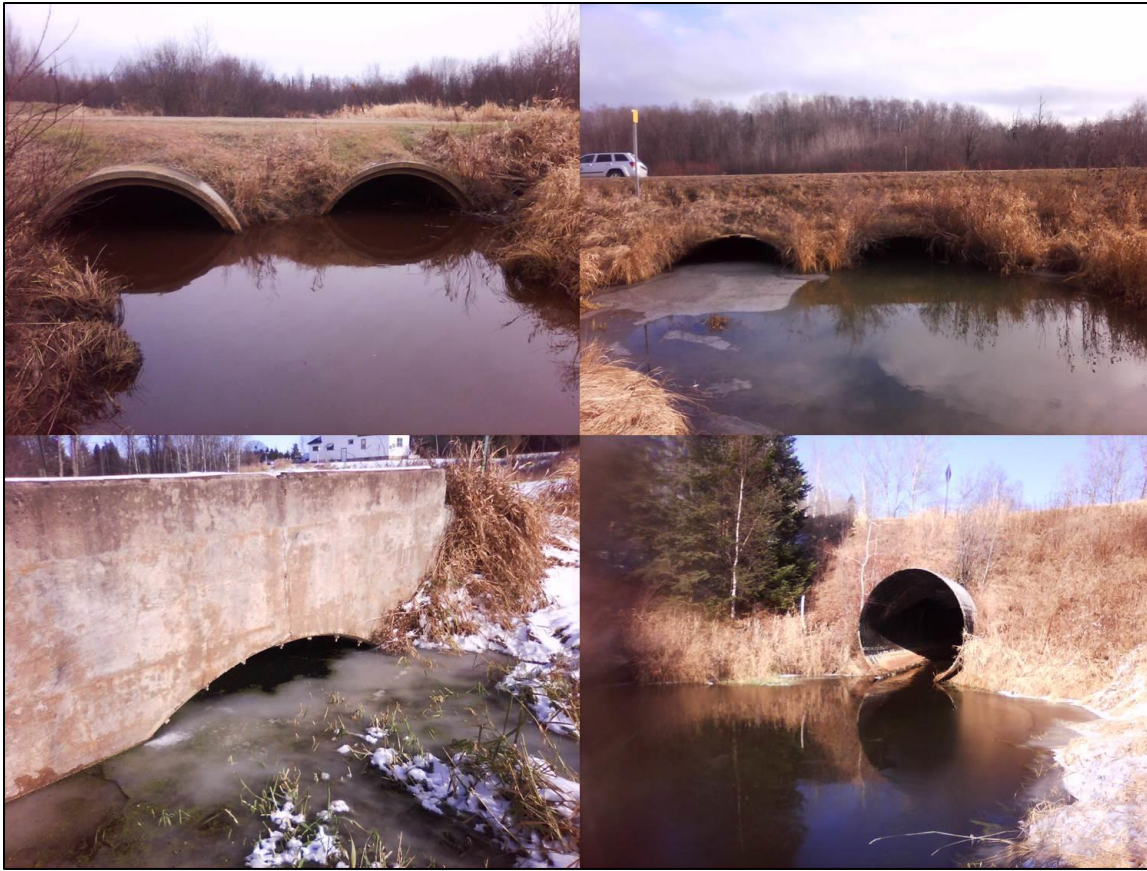
Complete culvert data and results are attached in Appendix 4. Some of the items that may have impacts on stream stability and biota are highlighted in Table 5 - Table 7. In many sites, scour pools had formed, indicating high water velocities through a too-narrow culvert during flood events. Another observed hydrologic issue was the low placement of many wetland culverts, which most likely increase head at high flows and greatly increase velocities. Some connectivity problems were also noticed, including perched culverts, beaver dams located at crossings, and subsurface stream flow through cobbles placed in the channel at road crossings. Examples of some of these issues are shown in the photos in Figure 24 and Figure 25.

Figure 24: Examples of inadequate capacity (above right, above left, and bottom left) and a scour pool caused by an overly narrow culvert

A priority list of culverts needing additional study and potentially replace was made as a result of this study, and will be included in a separate report.

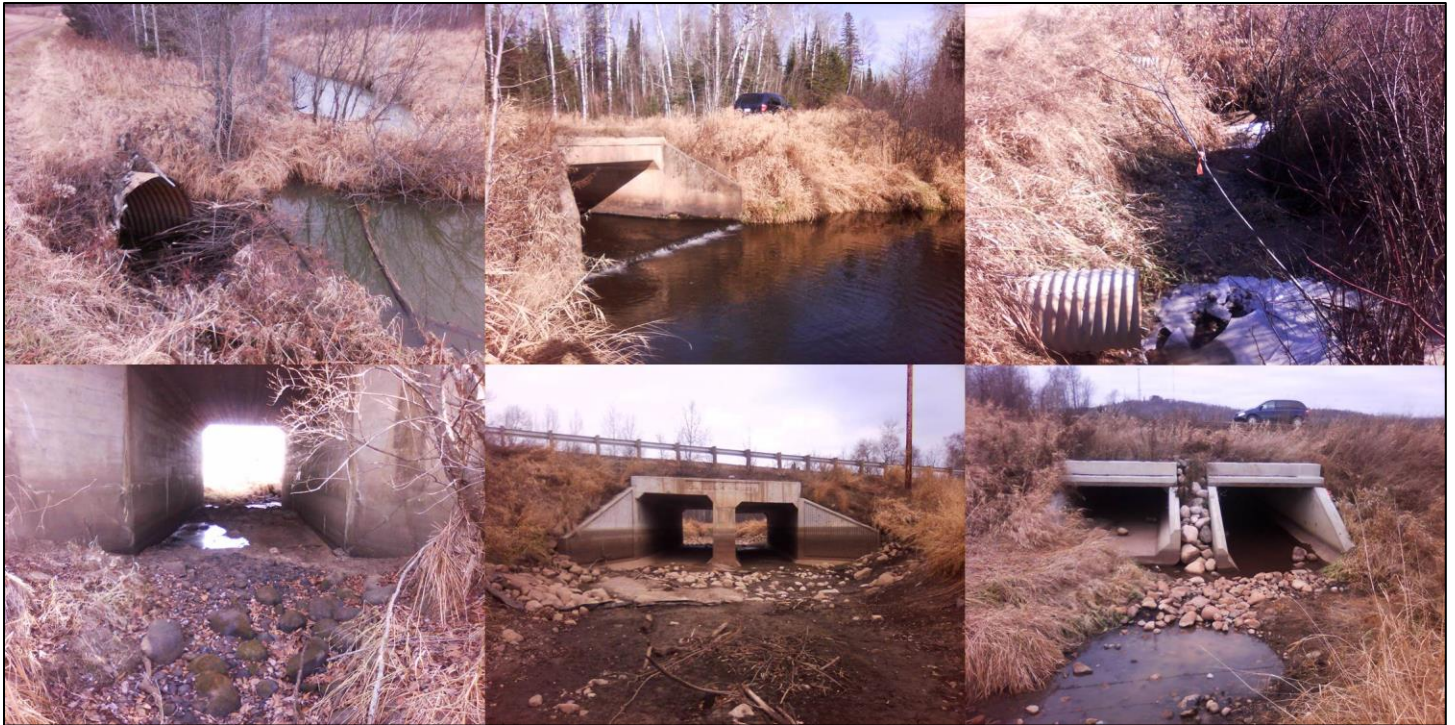
Figure 25: Examples of connectivity barriers. Pictured are a 4' high beaver dam built at a crossing (top left), slightly perched culvert with a very shallow low flow water depth (top center), >1 foot perched culvert (top right), and low flow disappearing in cobbles (bottom three photos)

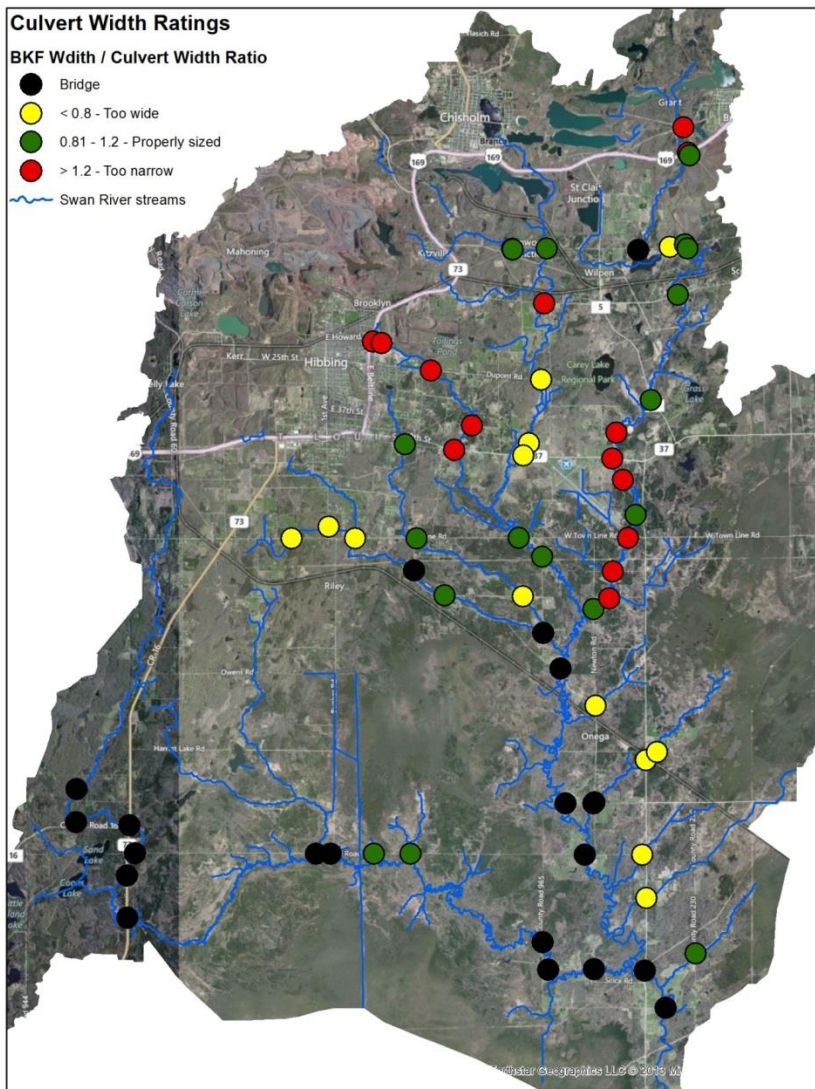
The most pervasive issue with the crossings in this watershed is inadequate culvert width. Properly-sized culverts should be comparable in width to the bankfull width of the stream. Crossings that had bankfull width / culvert width ratios of between 0.8 and 1.2 were considered to be adequate.

Figure 26: Assessment of bankfull widths / culvert widths. Ratios between 0.8 and 1.2 are not considered to negatively impact stream health.

Crossings with a ratio less than 0.8 are potentially causing stream impacts or fish passage problems. These culverts are overly wide, causing flow to become too shallow during dry periods. Excessively shallow water can create a fish passage concern, especially if culverts are long. Also, velocity and shear-stress decrease as width and area increase, leading to deposition and aggradation within culverts that are wider than bankfull.

Crossings with a ratio greater than 1.2 can also have stream impacts to stream stability. When culverts are significantly narrower than bankfull, flow constriction occurs during bankfull (and higher) flow events. This has several negative impacts on stream stability and the ability of the stream to move sediment. First, water velocities and shear stresses increase within the culvert and immediately downstream, causing erosion of banks and channel degradation leading to incision. Increased velocities within the crossing make it difficult for some species of fish to traverse. Upstream of the crossing, velocities are decreased due to backwater effects. This causes deposition and aggradation, filling in pools and destroying habitat. Lastly, narrow culverts have an increased risk of trapping debris, creating dams and the potential for road-overtop and massive failure.

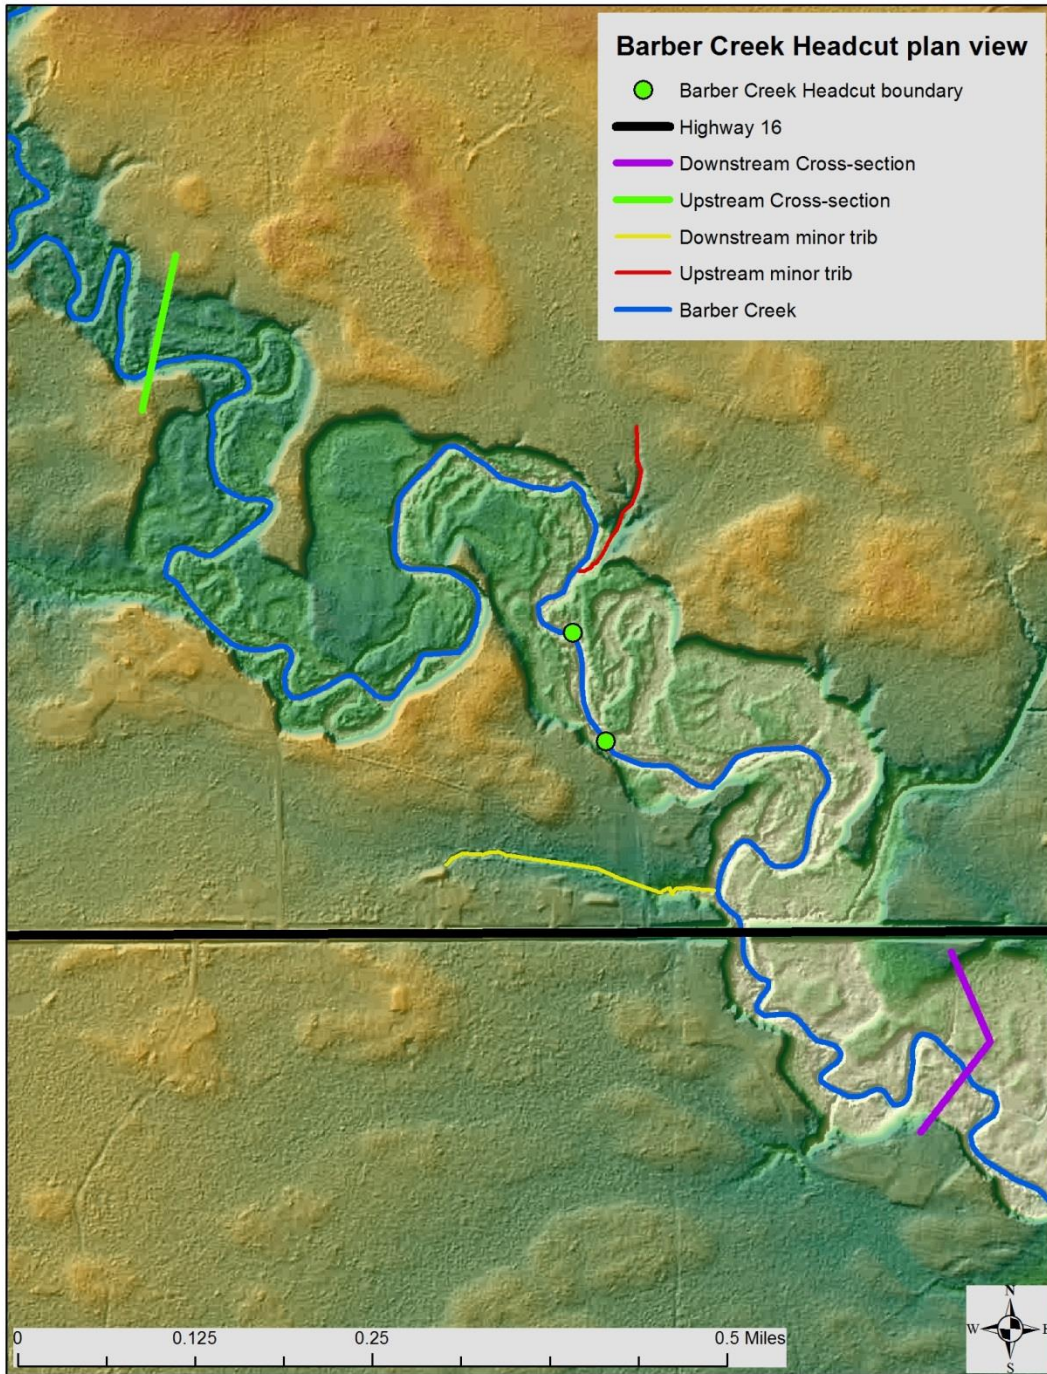
This turned out to be the case in at least six headcuts. Examples of headcuts on Barber Creek and the West Swan River that were determined to be mobile are shown in Figure 37 and Figure 39. In these cases, the bankfull surfaces in the upstream cross-section line up with the low terrace in the downstream cross-section. There is a lack of bankfull surfaces in both downstream cross-sections, indicating that the headcut moved through too recently for new bankfull surfaces to form. The Barber Creek headcut contained another clue – the presence of a similarly-sized headcut in a downstream tributary (see Figure 36 and Figure 38).

Figure 36: Plan view of headcut location on Barber Creek, just upstream of Highway 16

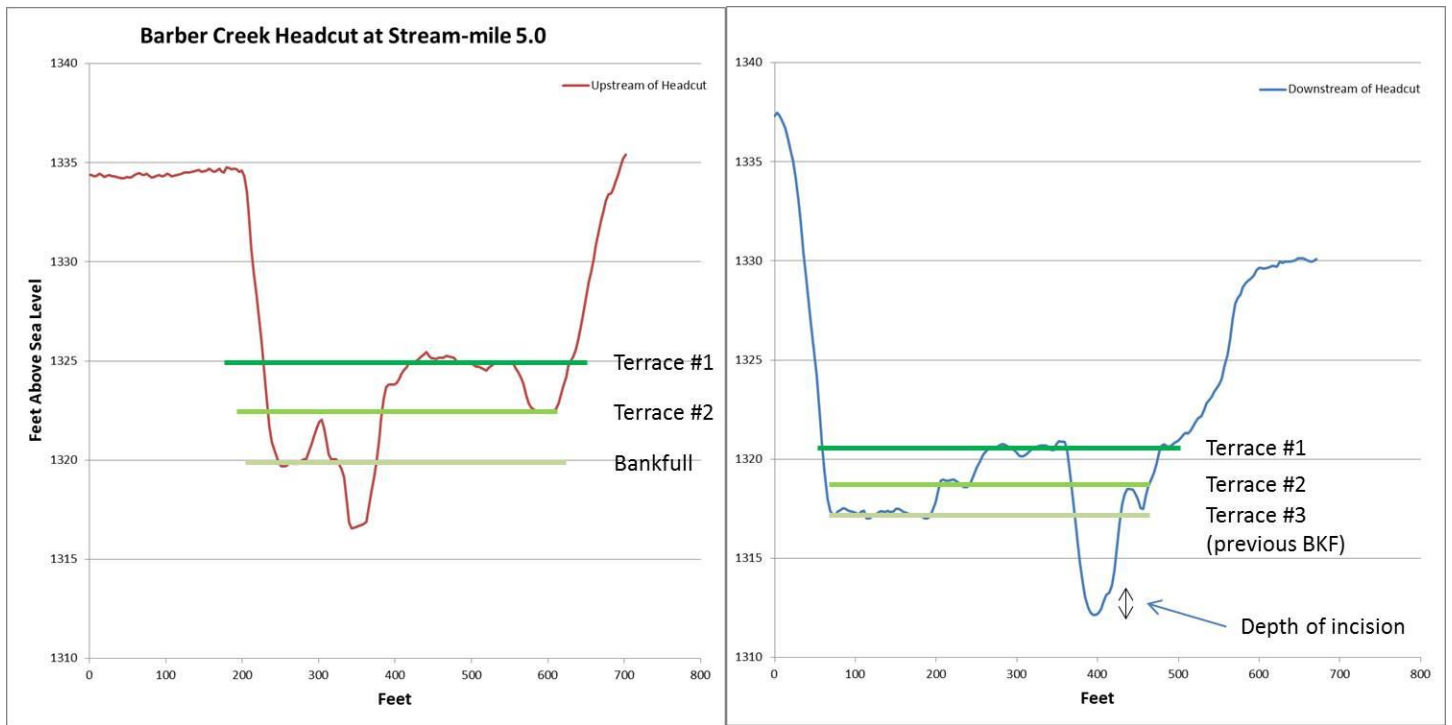
Figure 37: Cross-sections of Barber Creek, located above and below a suspected headcut.

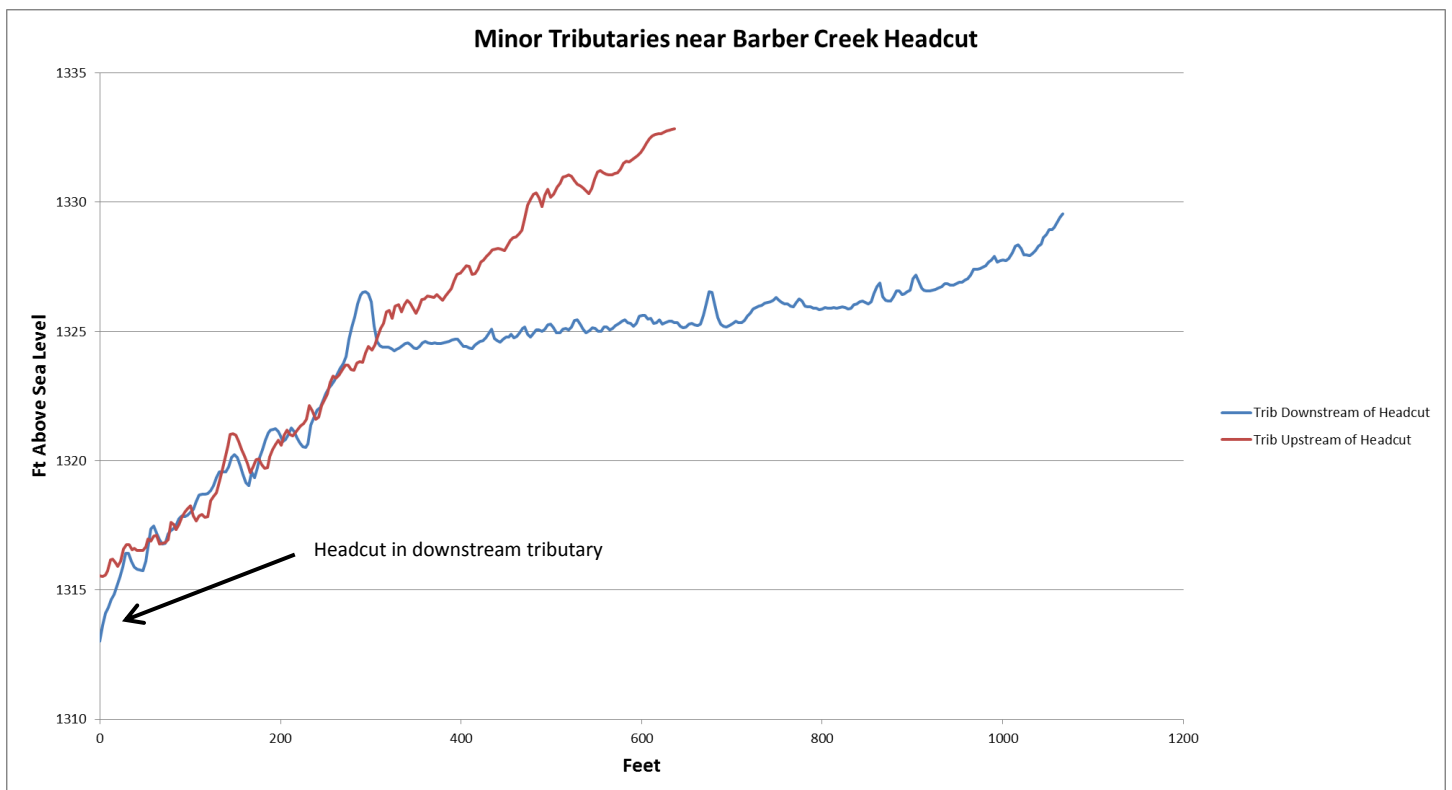
Figure 38: Longitudinal profiles of two minor tributaries to Barber Creek, located above and below a suspected headcut.

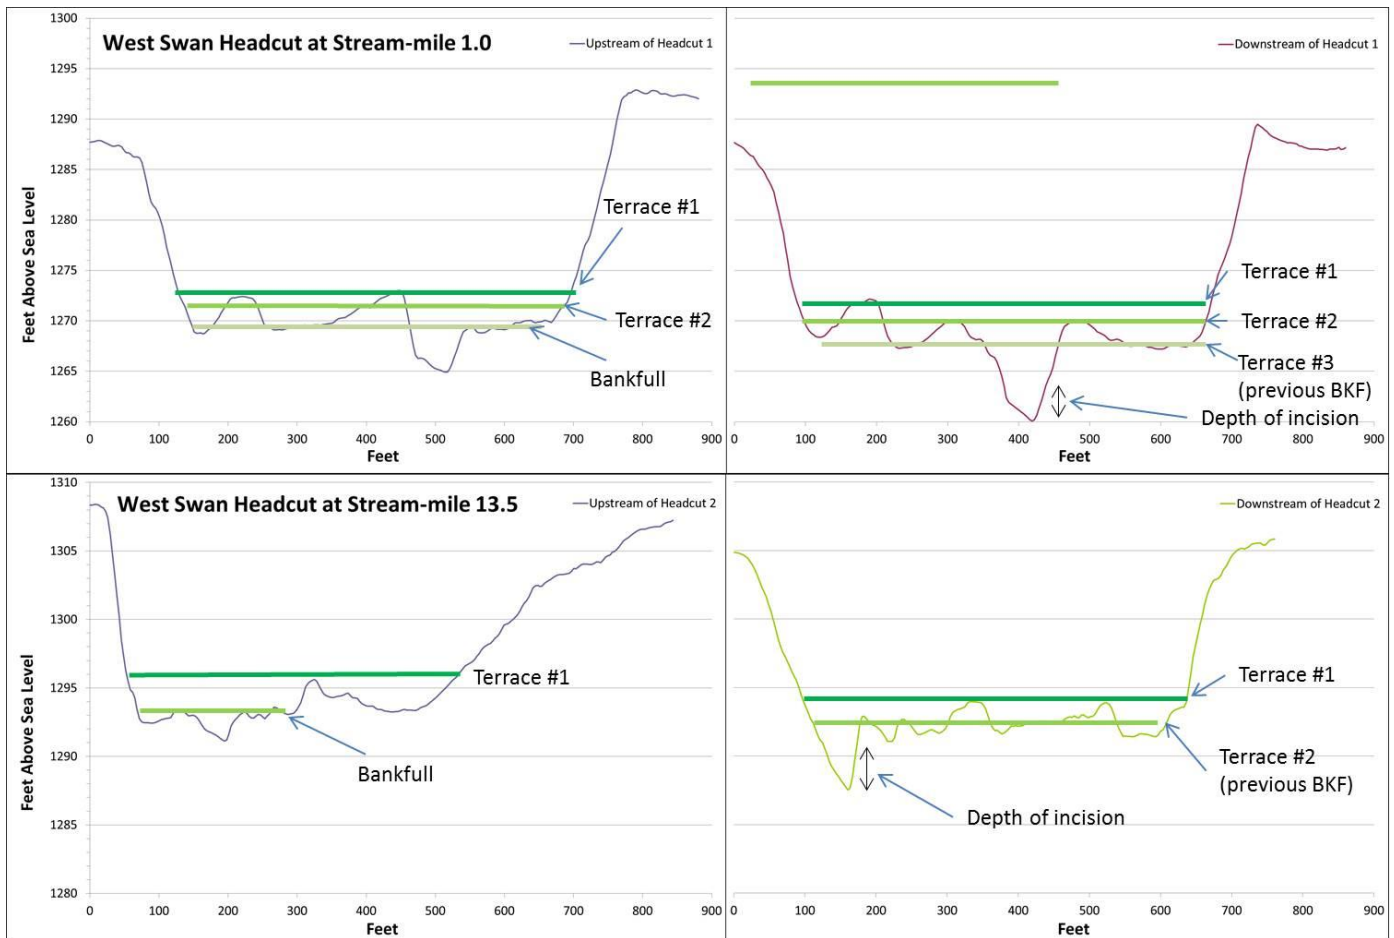
Figure 39: Cross-sections above and below two suspected headcuts on the West Swan River.

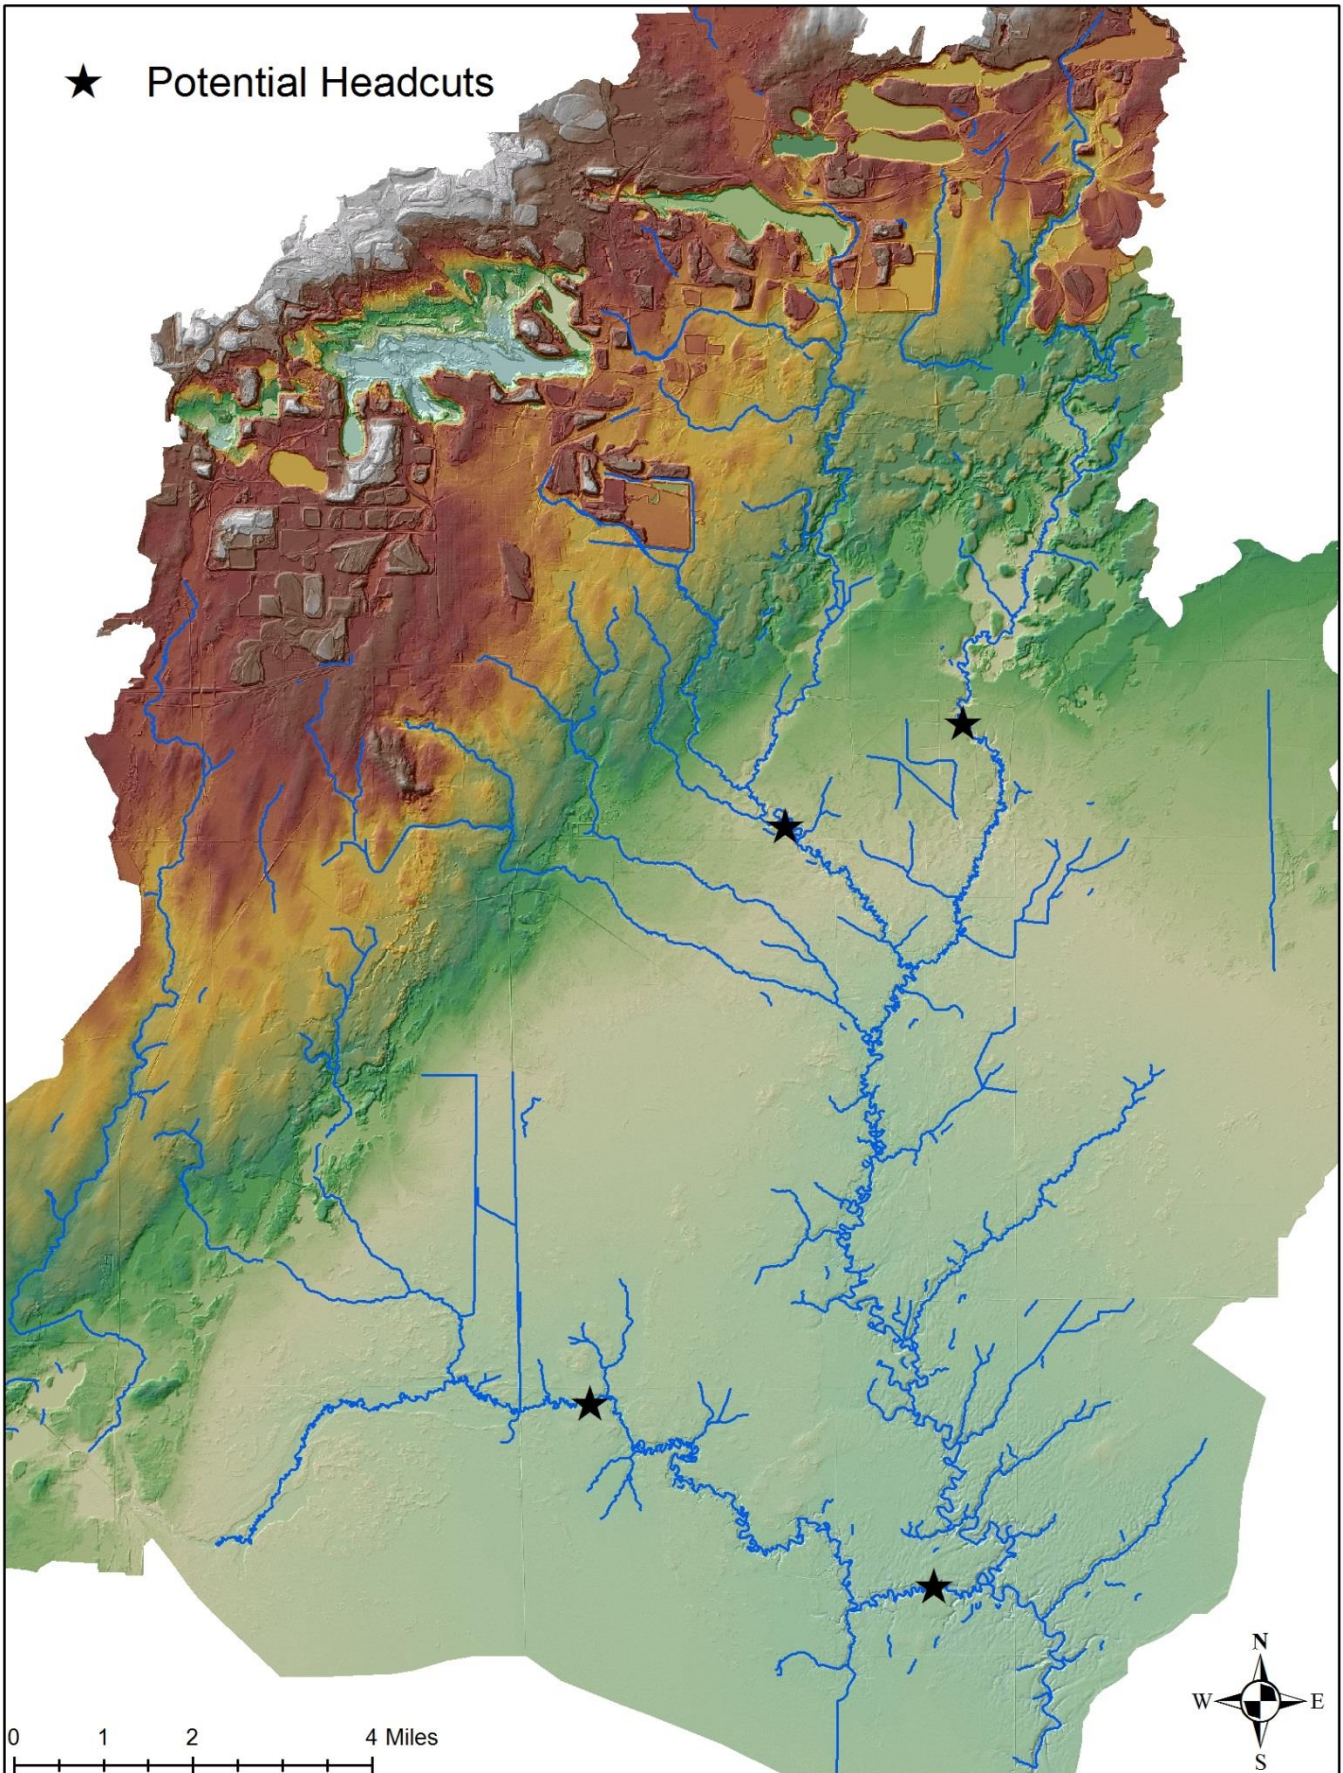
A map of all potential mobile headcuts is shown in Figure 40. The “mobile” headcuts are entirely contained within the glacial lakebed that encompasses the lower half of the watershed. The fine lacustrine deposits associated with that lakebed are probably not significantly impeding headcut progression. It is important to note two caveats that accompany this analysis. First, no attempt was made to determine the propagation rate of headcuts in this system. Such an attempt would require field data and long-term monitoring of the site. Second, labeling a headcut “mobile” at this point is not a guarantee. Although desktop reconnaissance is useful for narrowing the scope and focus of field forays, nothing can replace actual field reconnaissance and data collection. The authors recommend long term monitoring of these sites to validate the analysis made here.

Figure 40: Map of all potential headcuts contributing to stream instability in the Swan River watershed.

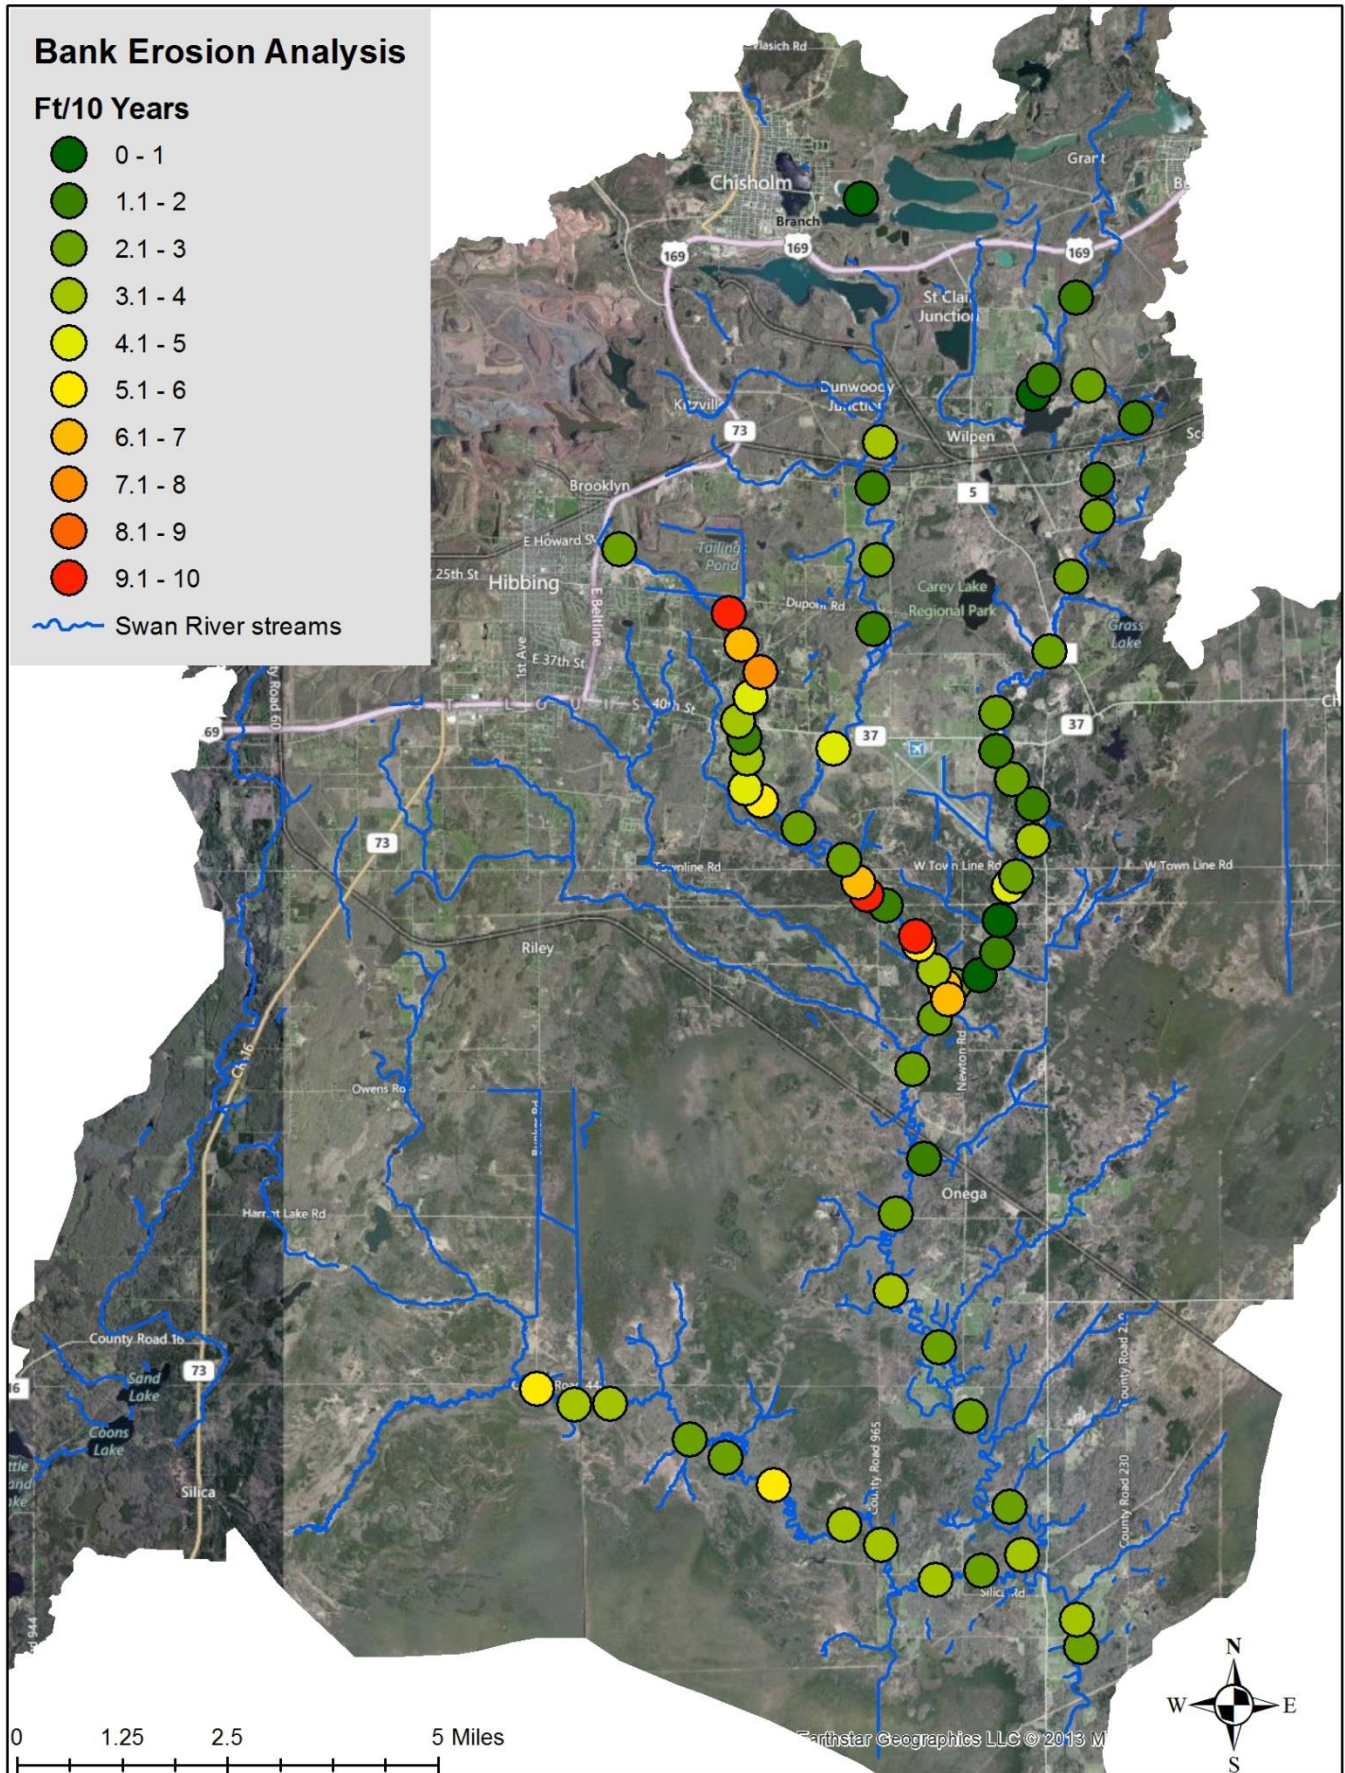
Figure 41: Measured erosion rates on outer bends in the Swan River watershed.

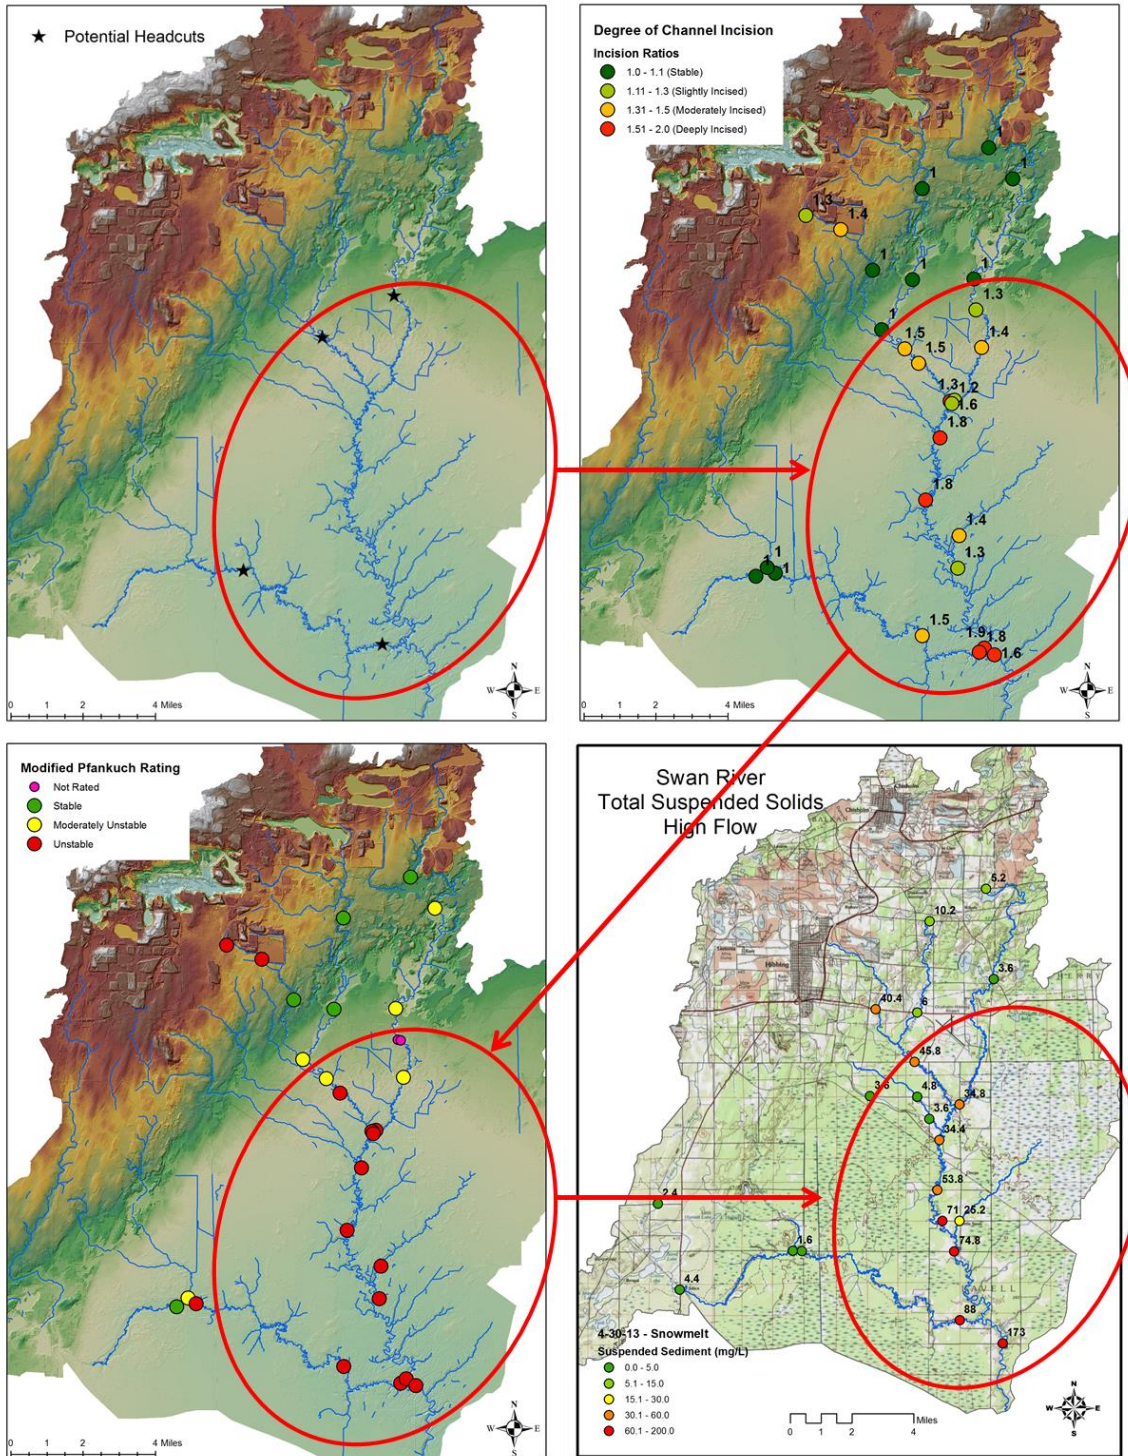
In these scenarios, the initial instability leads to degradation and incision. This report concludes that headcut propagation is the cause of instability in all the reaches except Penobscot Creek, which is unstable due to historic channelization. Propagating headcuts trigger incision, leading to higher shear stress on the banks and poorer condition of the channel, and then manifested in increase suspended sediment values. Figure 43 clearly shows this correlation in the Swan River watershed.

Figure 43: Headcut locations, compared with channel incision, Pfrankuch stability, and suspended sediment results.
