FIVE-YEAR REVIEW REPORT FOR
ST. LOUIS RIVER SUPERFUND SITE
DULUTH, MINNESOTA

Third Five-Year Review Report 2013
St. Louis River Superfund Site – Duluth, Minnesota

Volume 1.
FIVE-YEAR REVIEW REPORT FOR
US STEEL SUPERFUND SITE
DULUTH, MINNESOTA

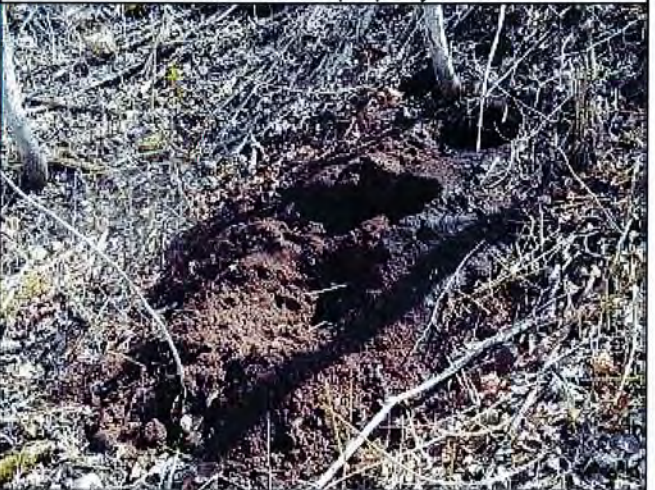
7: OU-A: Animal burrow noted in area.

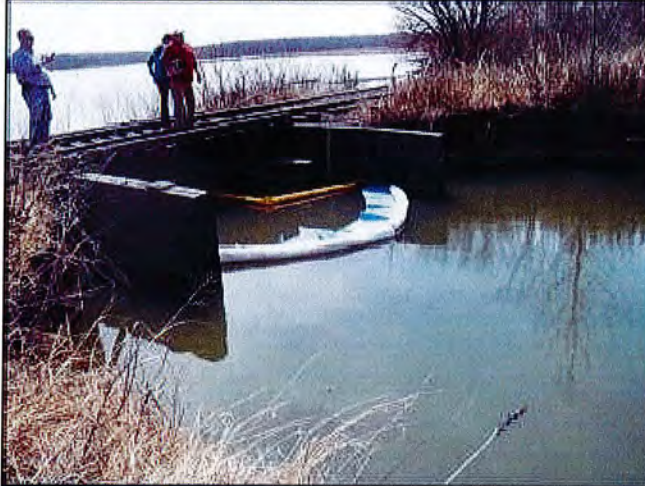
12a: OU-P: Wire Mill Pond Exit, no sheen noted

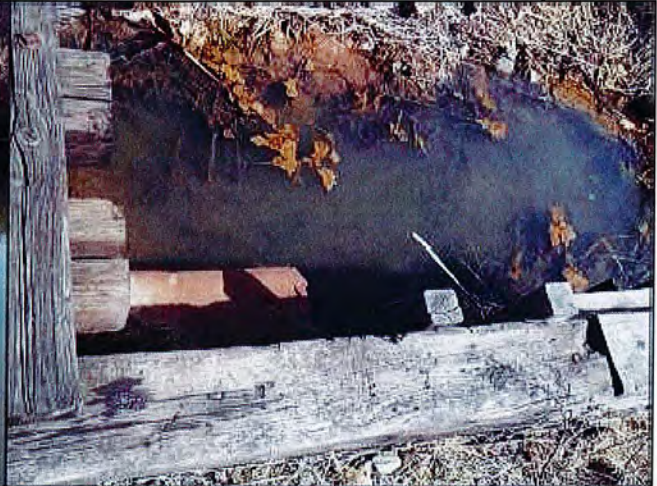
12b: Wire Mill Pond Exit, no sheen noted

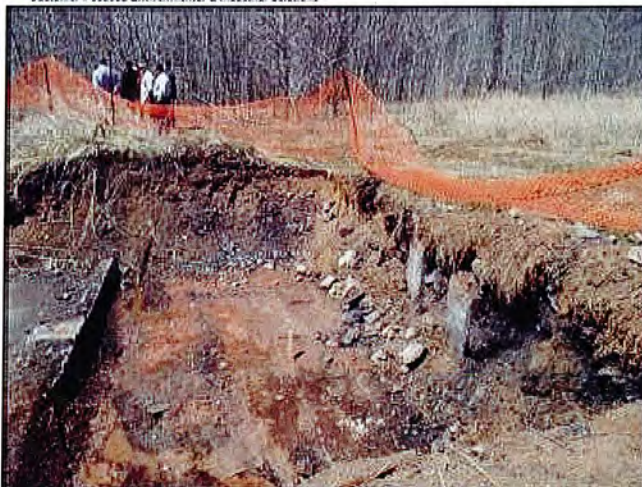
- While excavations for the numerous tar seeps and tar-contaminated soil were occurring, many excavations with exposed contaminated soil were left open, unfenced and unprotected. In addition, manholes with open covers were also found. These pose a risk to the frequent trespassers on the site. In addition, one of the open manholes contained product.

14a: Excavation of soils, fences down near Coke Oven Battery Foundation.

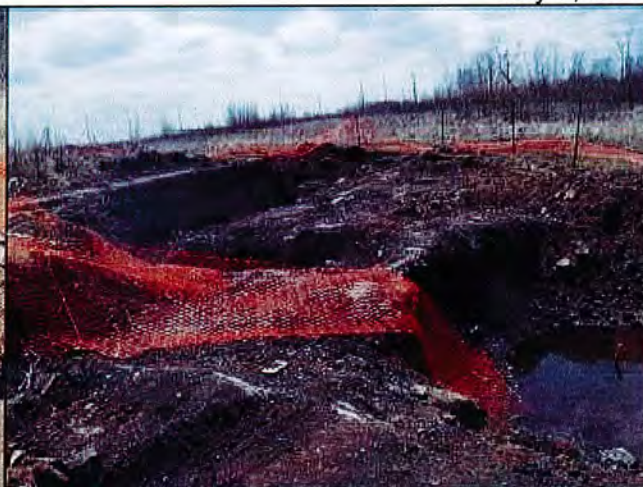
14b: Excavation of soils, fences down near Coke Oven Battery Foundation.

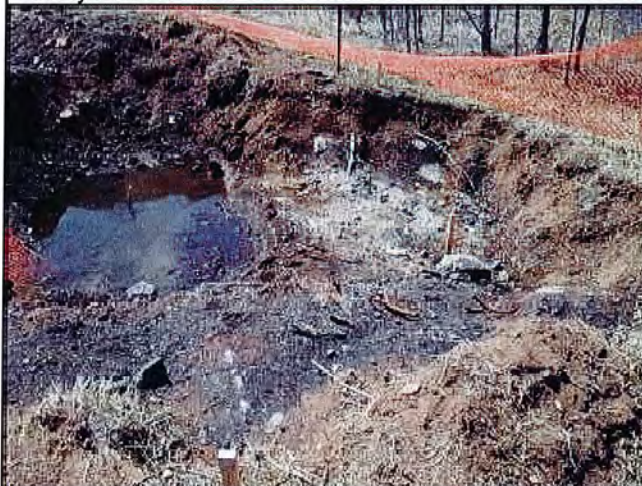
14c: Excavation of soils, fences down near Coke Oven Battery Foundation.

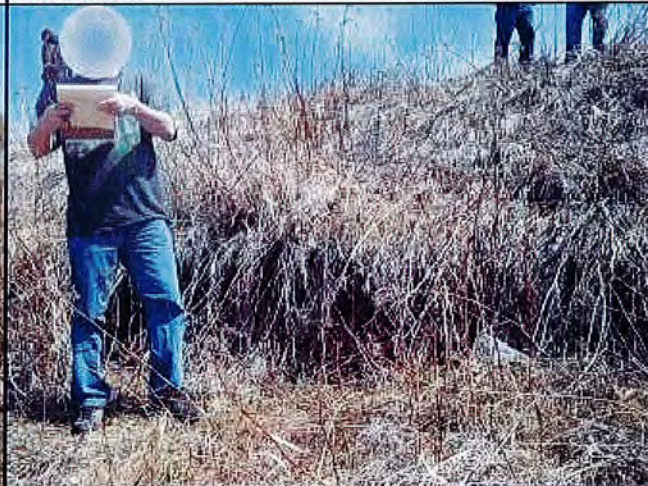
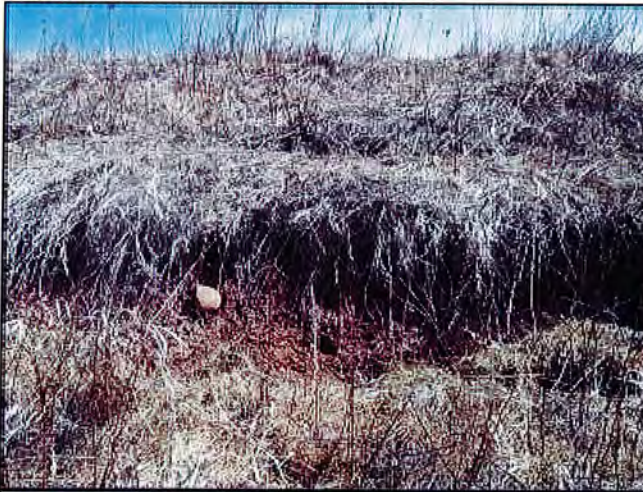
- Approximately three feet of slumping was identified along the sidewall of the OU-J containment cell nearest to the creek, which increased from only approximately six inches during the last site inspection. Survey points in this area have not been checked for several years. This slumping represents potential for rotational failure of the containment cell into the creek.

16: OU-J: Approximately 3' of slumping noted on cap/sidewall.

16: OU-J: Approximately 3' of slumping noted on cap/sidewall

- OU-J (Tar and Tar Contaminated Soil):** The remedy at OU-J currently protects human health and the environment because the contamination remains sequestered; however, in order for the remedy to be protective in the long term the cover stability must be monitored and repaired or reconstructed as needed.

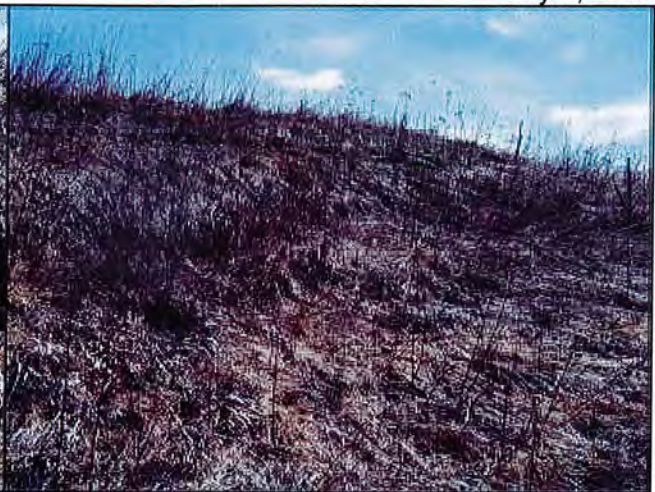
17: OU-J: Slumping noted above gabion wall

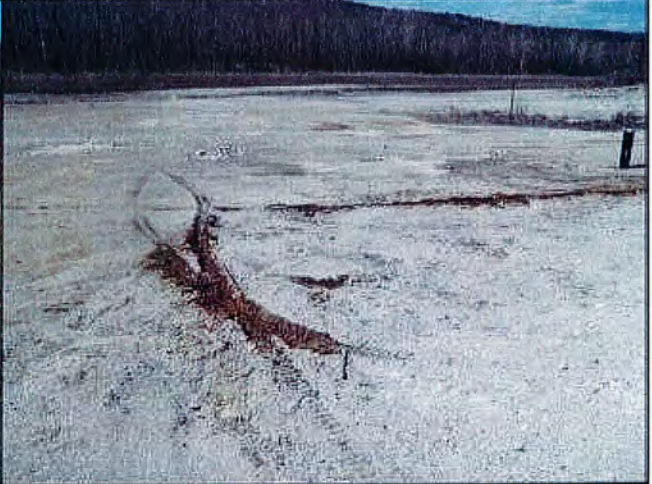
24: OU-S: Trespassing noted: dirt bike tracks.

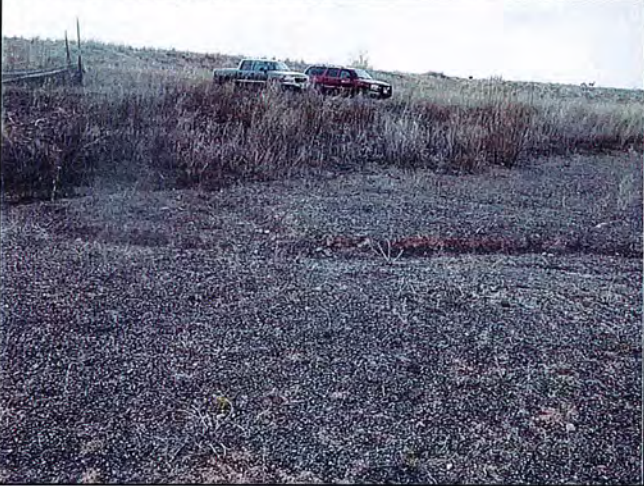
3a: SedOU: Mild erosion noted on Stryker Bay cap

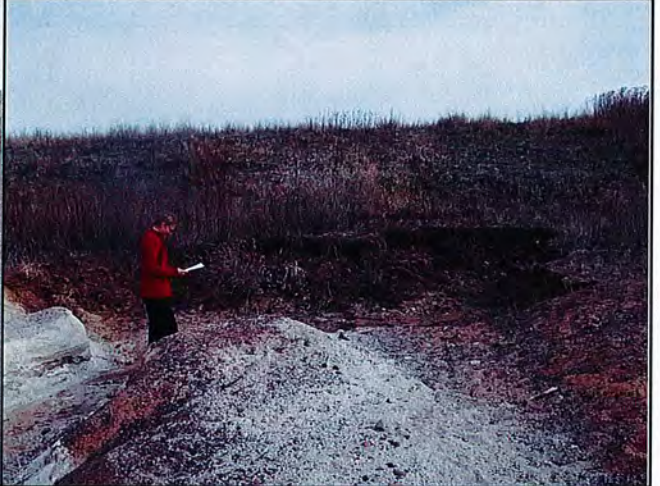
3b: SedOU: Significant erosion noted in native material near cap

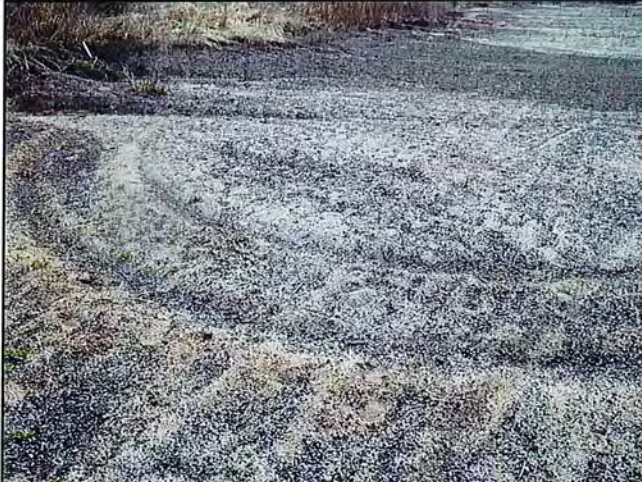
4: SedOU: Trespassing evidence (four-wheeler tracks) noted on Stryker Bay cap.

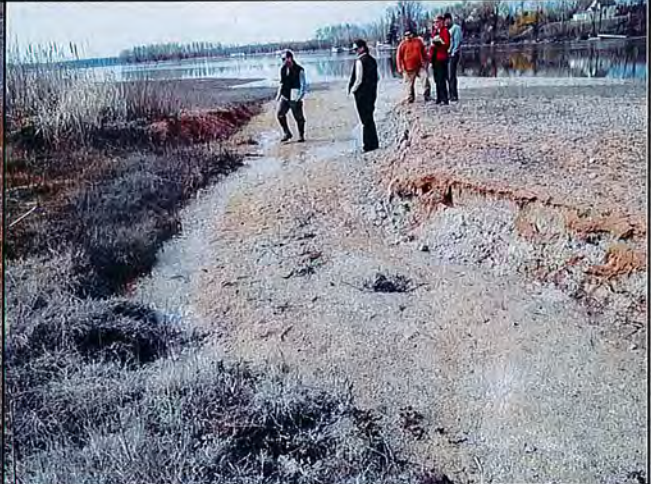
6b: SedOU: Erosion noted in water channel flowing onto Stryker Bay cap - riprap needed.

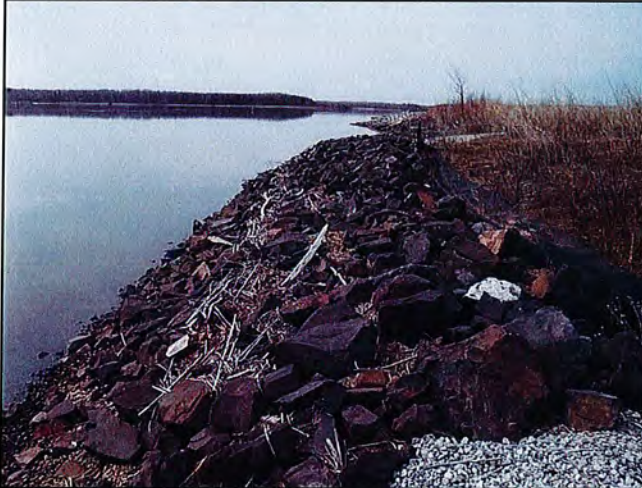
9b: SOU: Looking down slip 6, minor slumping

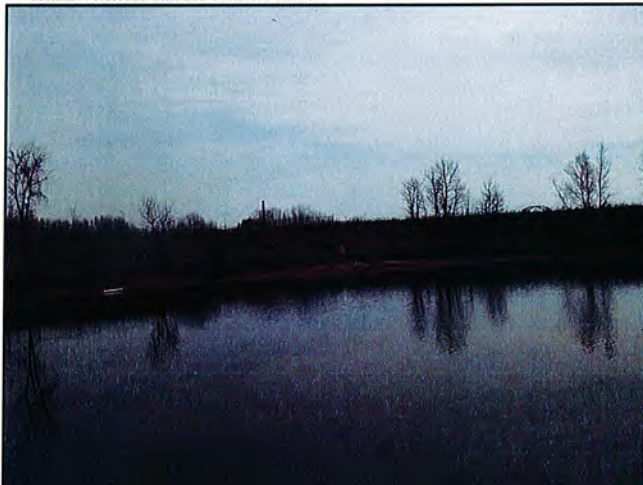
11a: SOU Area B/C: Some erosion noted end of slip 6.

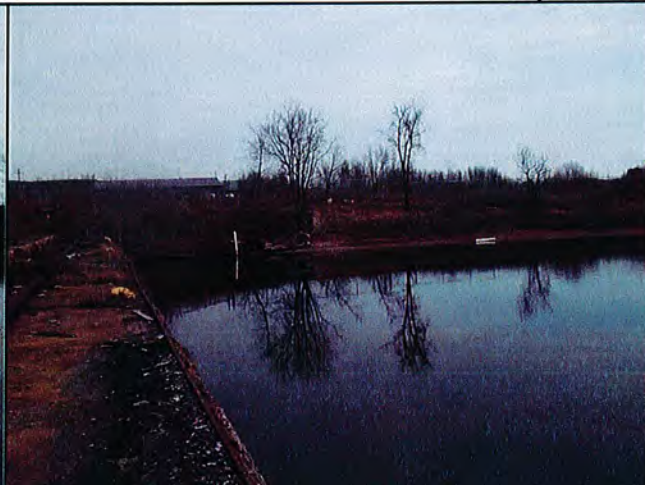
11b: SOU Area B/C: Erosion noted at end of slip 6.

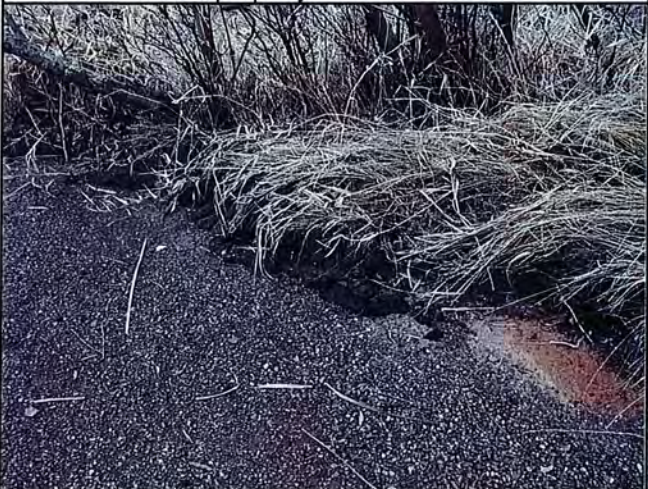
21a: Radio Tower (west side of Stryker Bay): Tarballs and tar layer noted on edge of beach area.

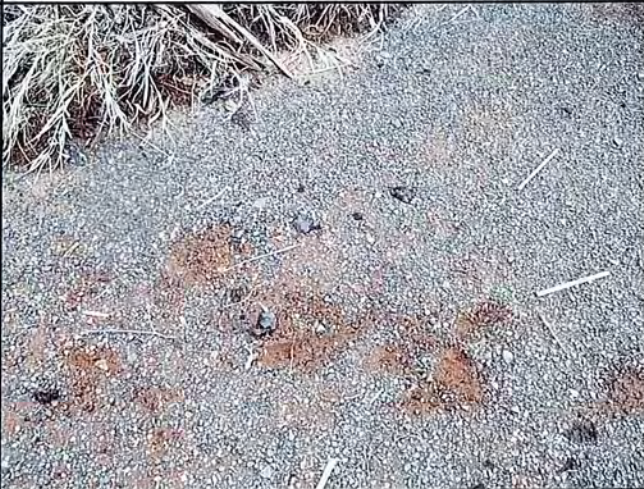
21b: Radio Tower (west side of Stryker Bay): Tarballs noted on beach area.

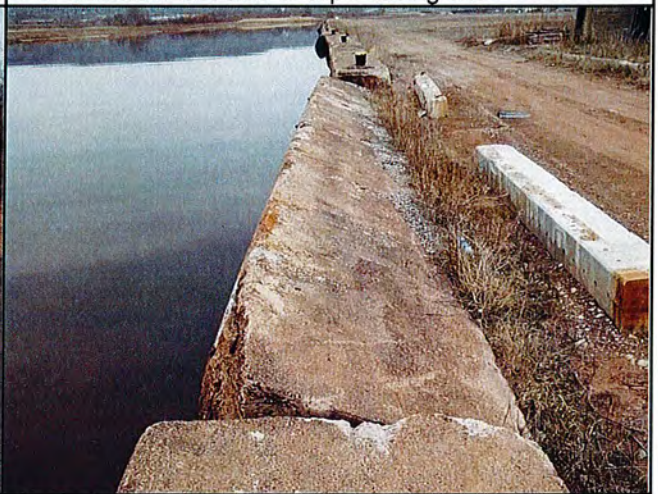
23: SedOU: Slumping of dock wall on slip 7.

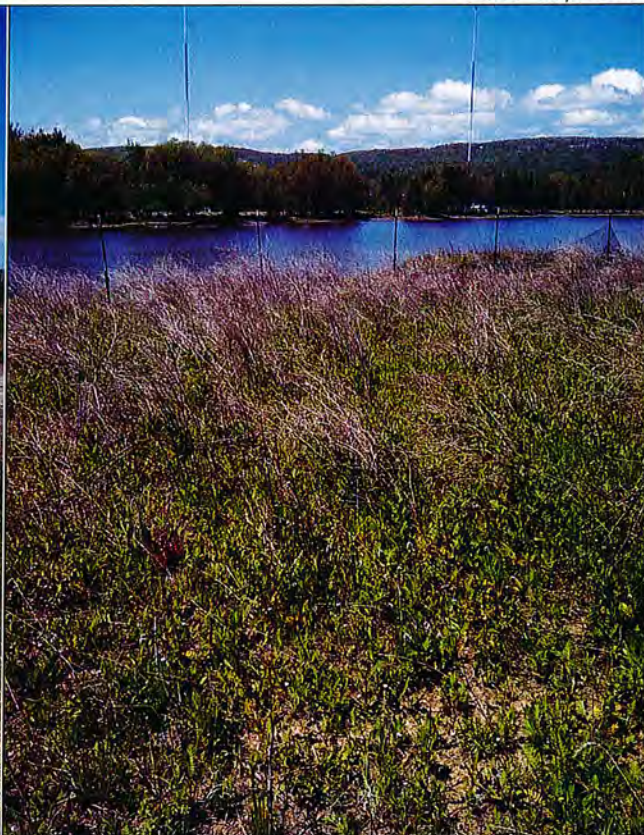
25 : Near Arrowhead Point. Some greenery, but larger bushes and trees did not survive.

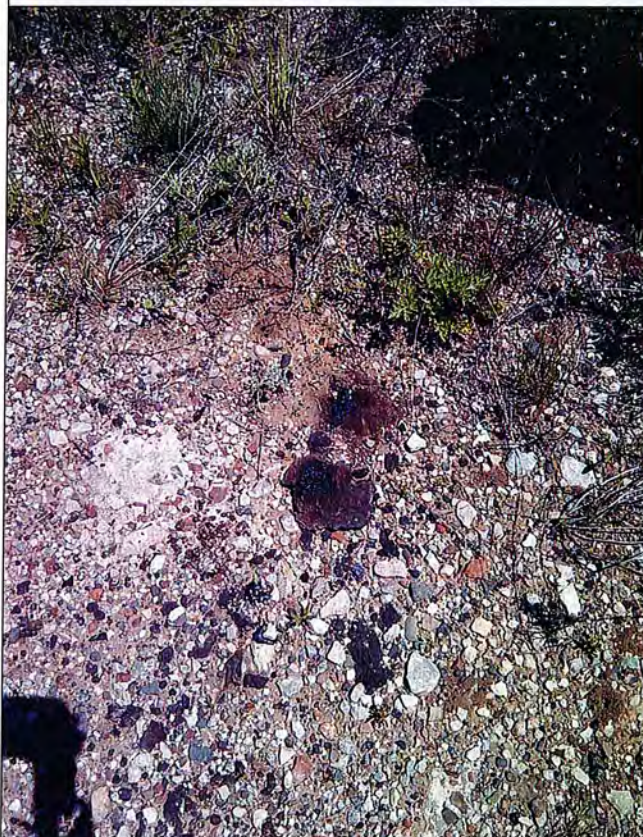
SOU: The remedy at SOU is not protective because of the tar seeps and tar contaminated soils found in several areas across the site. Remedial investigations and response actions are required. ICs exist for all but one parcel and are effective.

26: Tar seeps noted in Area B, near NW corner of Slip 6.

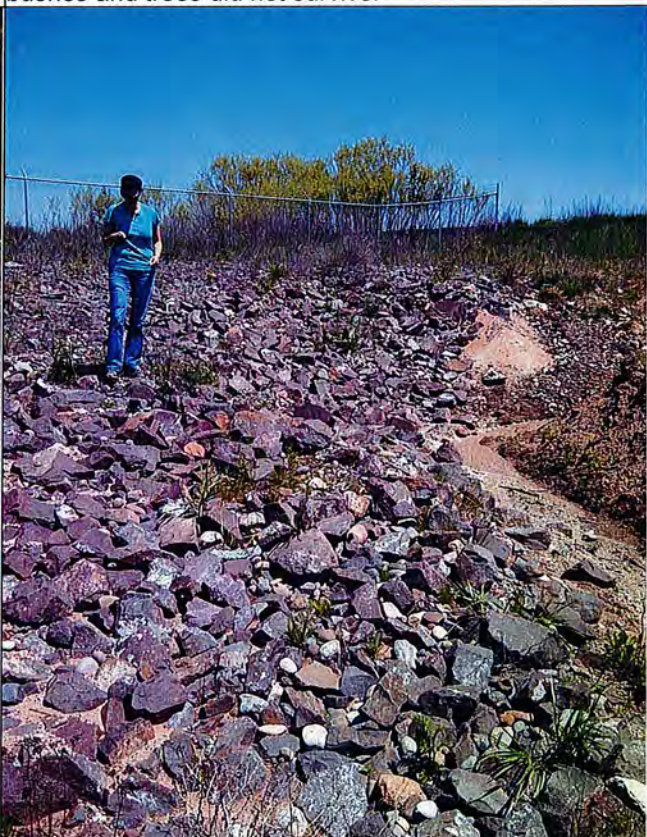
27: Repairs noted of previous erosion near Area B/C

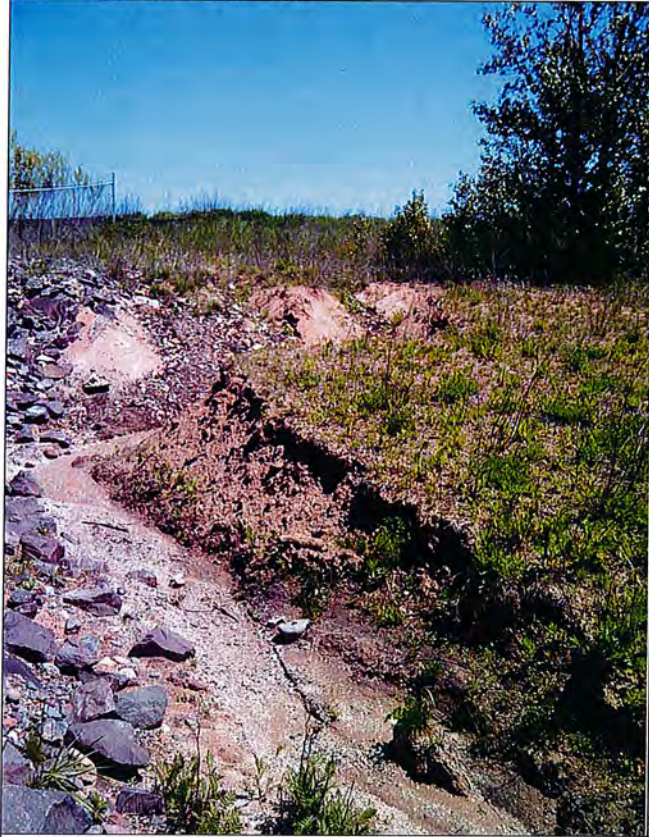
28: New erosion channel forming around repairs at NE corner of Slip 6.

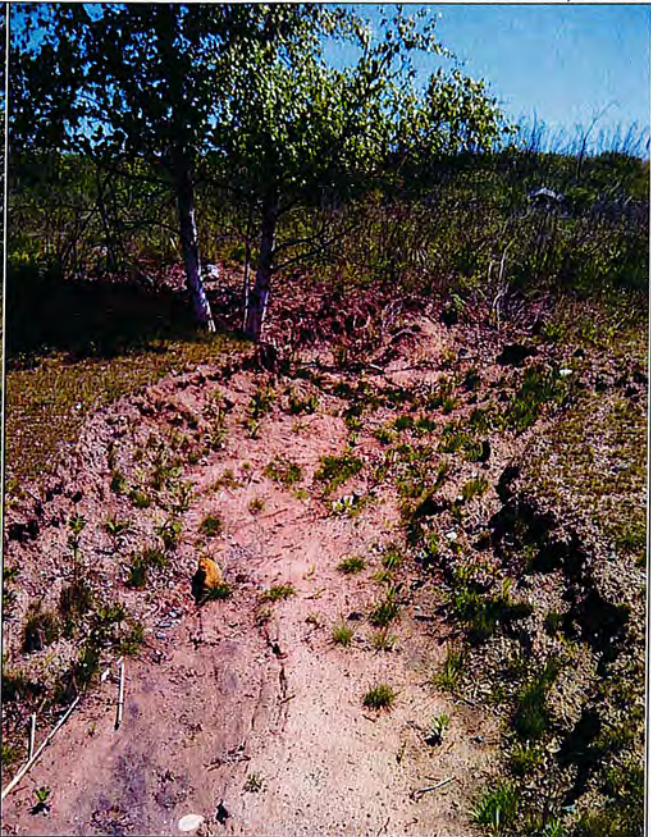
29: Erosion into cap along east side of Slip 6 (Area C).
