# OU-J REPAIR CERTIFICATION REPORT

U.S. Steel LLC  
600 Grant Street  
Pittsburgh PA 15219-2749

December 3, 2001

***URS Corporation***

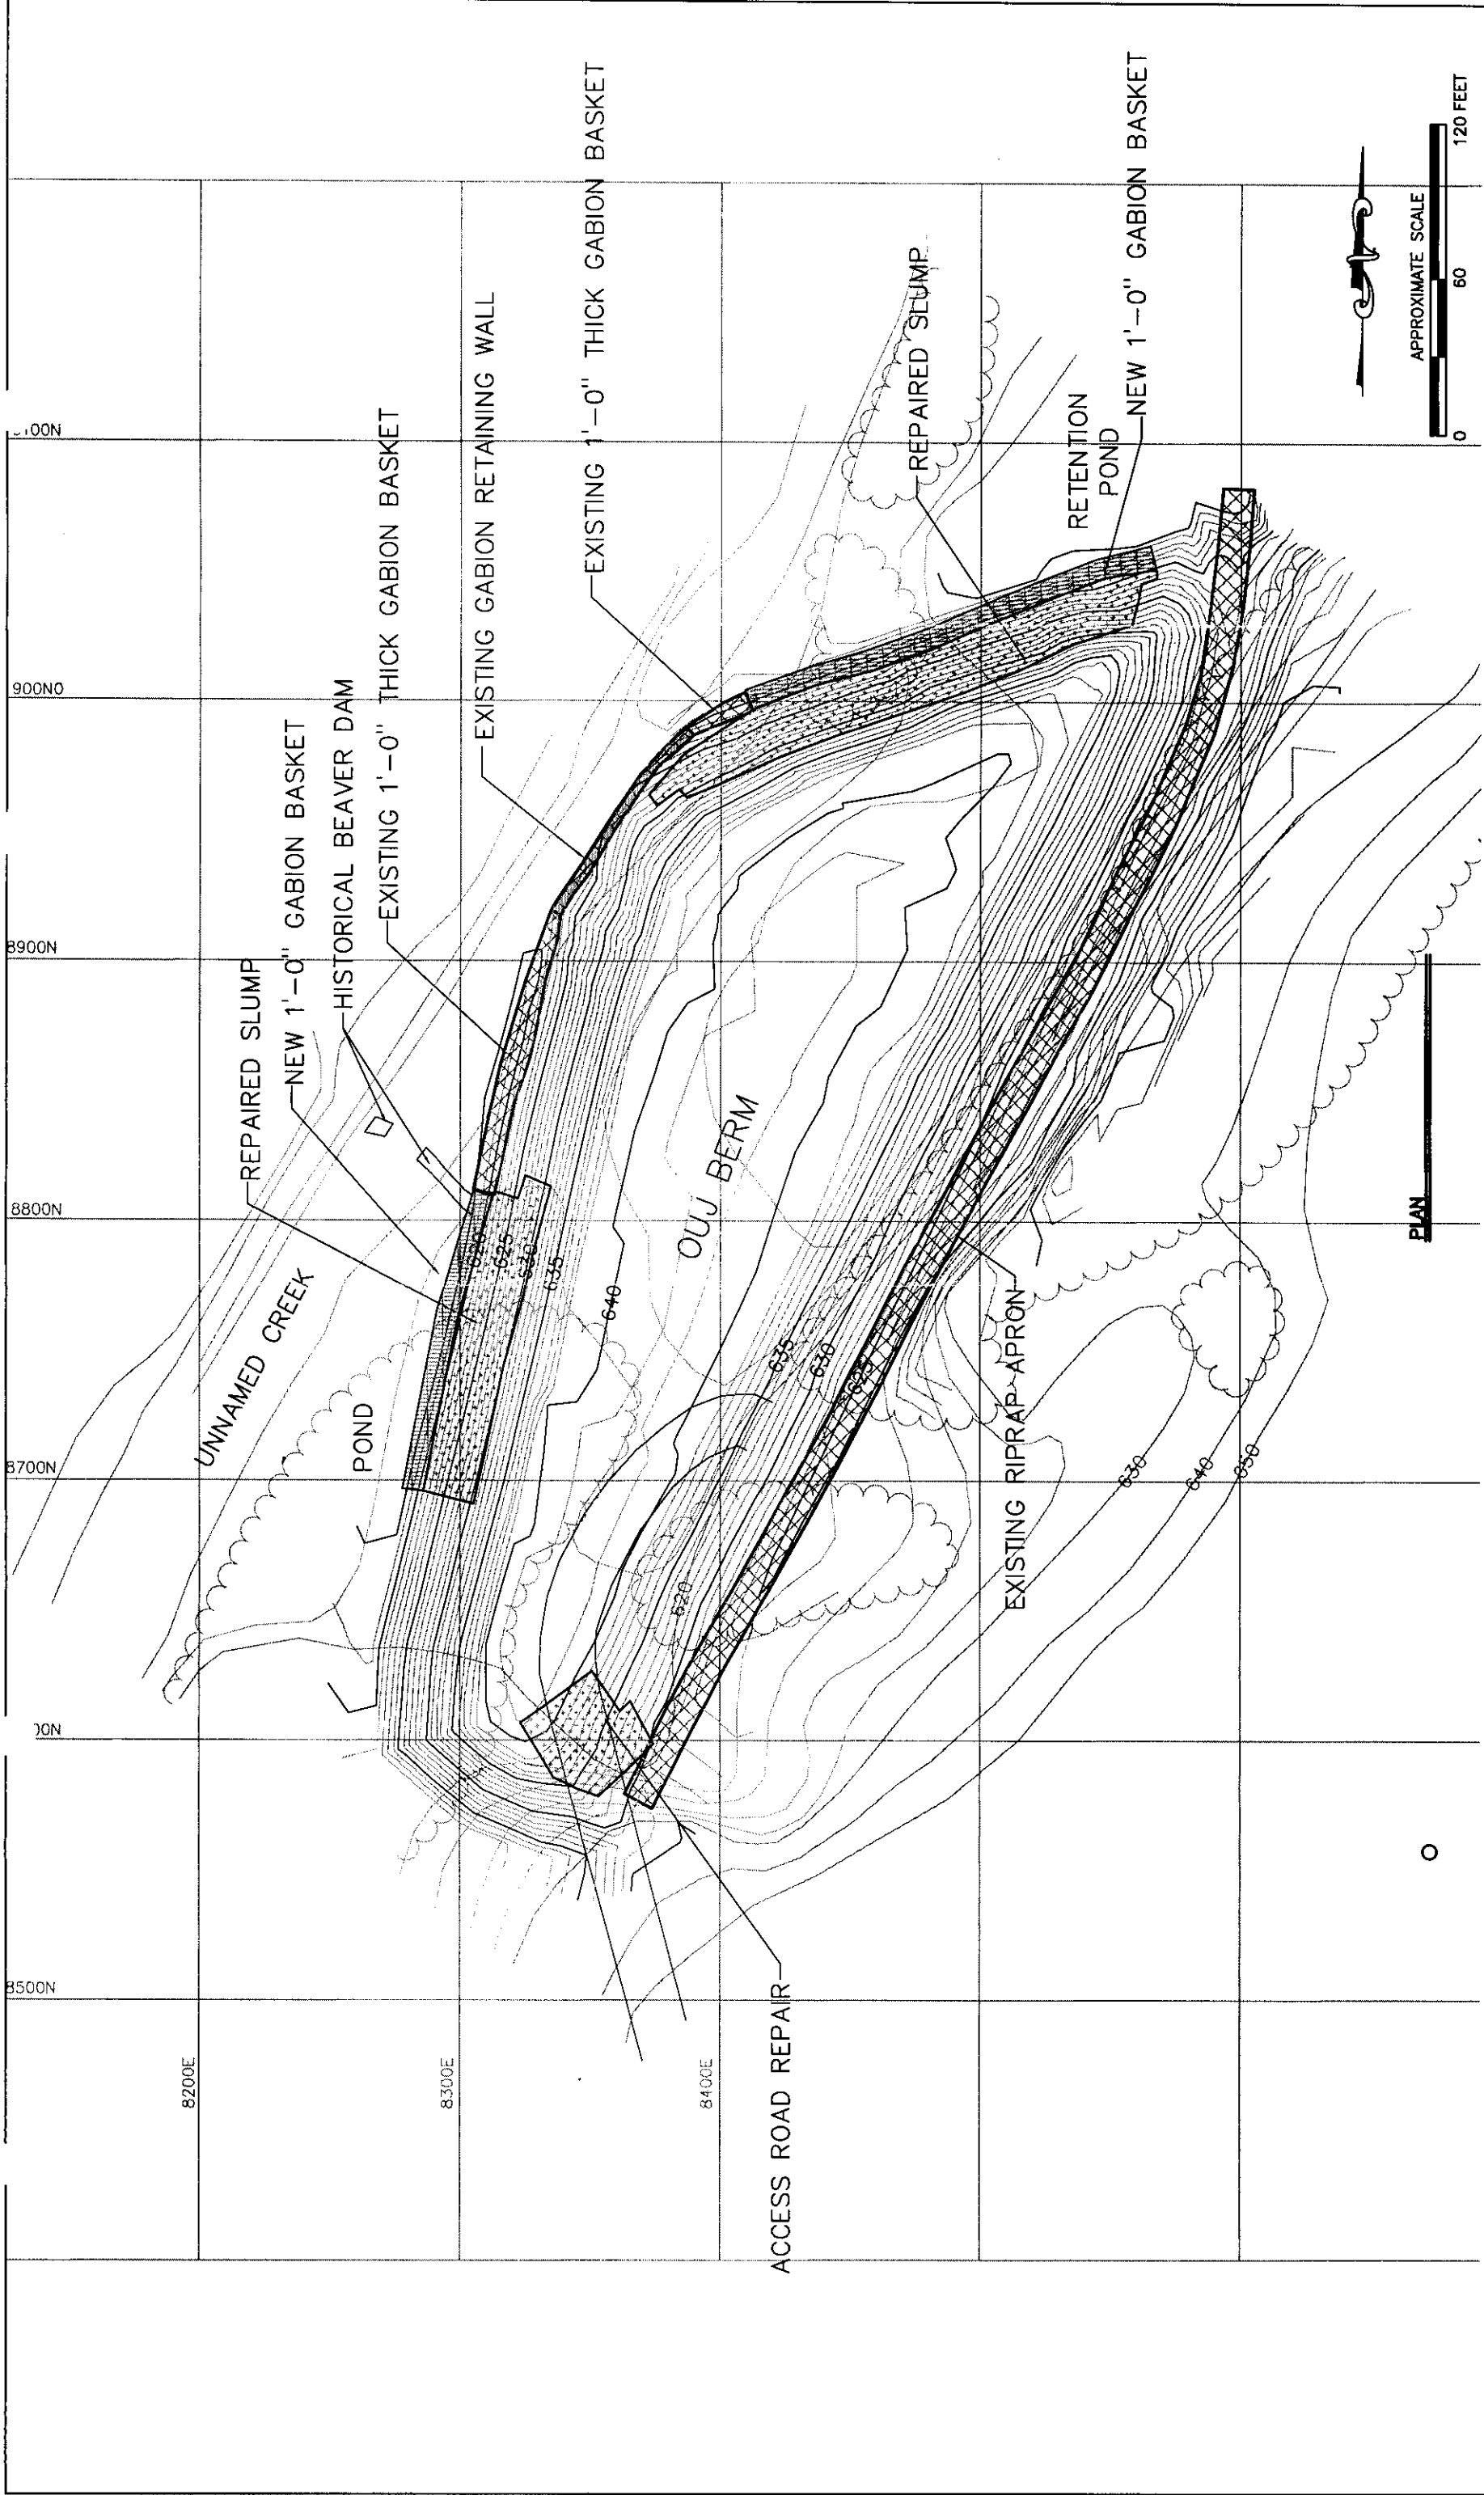
Project surveying services for the original layout of the berm repair was provided by URS. URS provided two benchmarks on top of the OIJ cap for use by Veit during repairs for elevation control. Veit established grade stakes to set the elevation of the top of the gabion baskets. A final survey of the completed cap repair was completed by URS. The data was used by URS to complete final record drawings for the berm repair (Figure 3).
