FIVE-YEAR REVIEW REPORT First Review

St. Louis River Superfund Site

Date
September 2003

St. Louis River/Interlake/Duluth Tar Site, Tar Seep OU – EPA OU 01

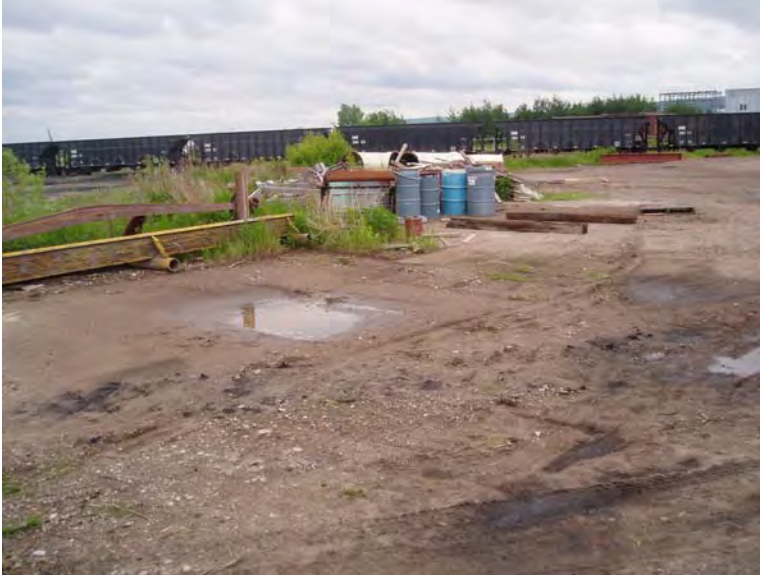
Area B, located on the north end of Slip 6, was inspected to verify the removal of visual tar from Tar Seep B and to assess the protectiveness of the Soil OU remedy. No tar or visual evidence of contamination was observed at the location designated as the Area B Tar Seep. However, hardened tar was observed near the water line at the northeast end of

Slip 6. The location of the tar appears to be just to the east of the Area B excavations, but directly adjacent to the Slip 6 sediment dredging area. The location of former above ground tanks looking to the southwest in Area B is shown in the picture to the left. This location is also shown on Figure 7 as Area B AST.

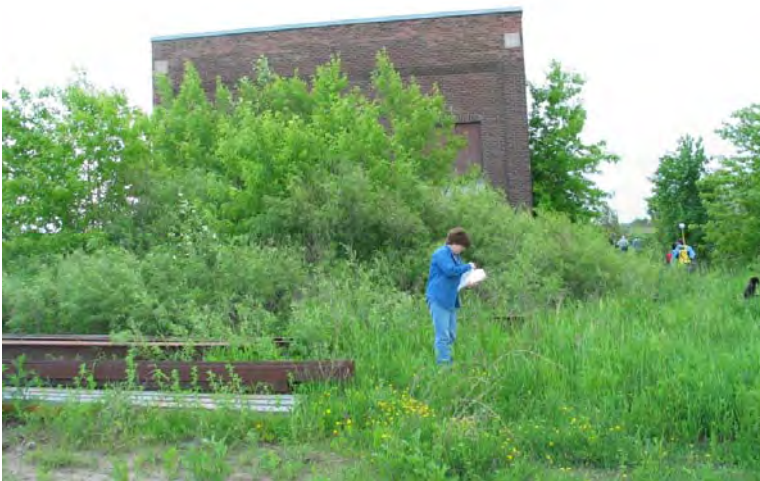
This photo looking east shows the approximate location of a former Tar Seep in Area B. This location was marked by GPS and is shown on Figure 7 as Area B Tar Seep.

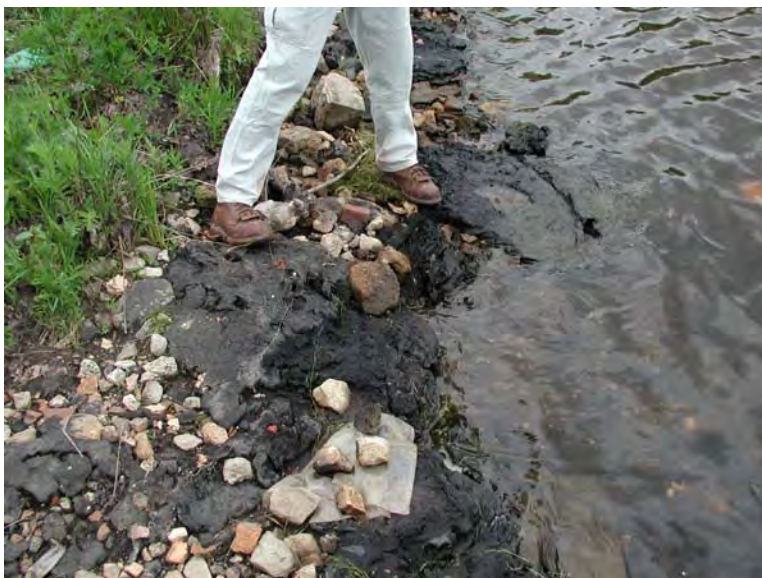
Hardened tar was observed at several locations along the water's edge on the north bank of Slip 6. These seeps appeared to be fairly fresh. The locations were marked by GPS and are shown on Figure 7.

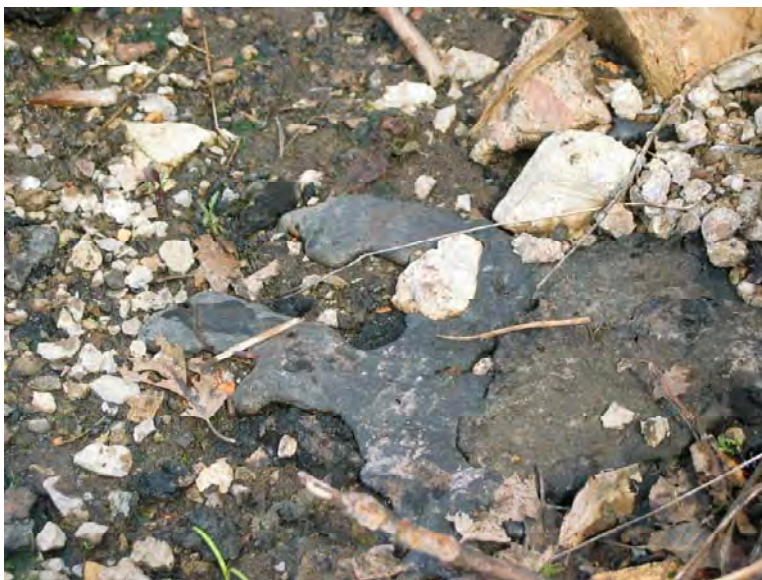
Tar located at the water's edge at the north end of Slip 6. The locations are shown on Figure 7 as Tar at Slip 6.

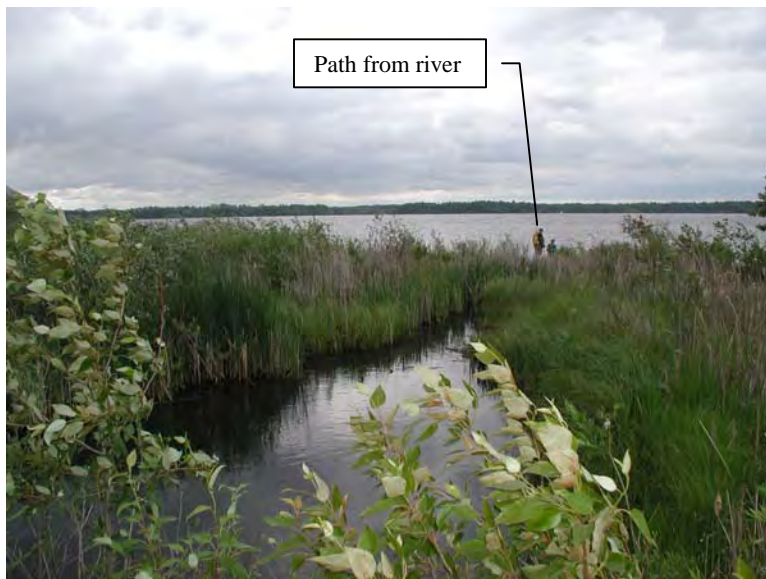
The inspection showed no visual evidence of tar or the presence of sheens on the water's surface. No stressed vegetation was noted. A worn path connecting the river's edge and the wetland area was observed. This area is shown on Figure 7 as 48" outfall.

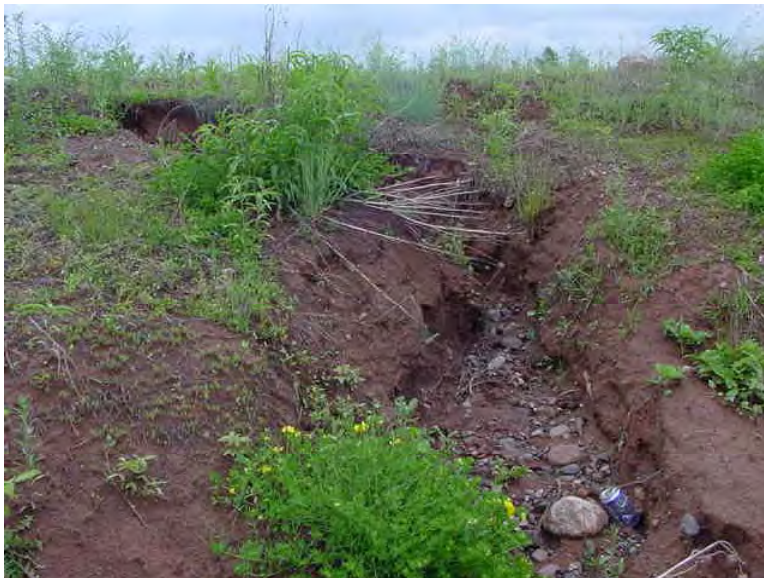
A few areas of erosion were observed in the fill placed by Hallett post remedial action. These do not appear to be impacting the original remedy based on the elevation of the original cover as compared to the fill.

The erosion in this photo is the deepest observed at approximately 3 feet. The location was marked using GPS and is shown on

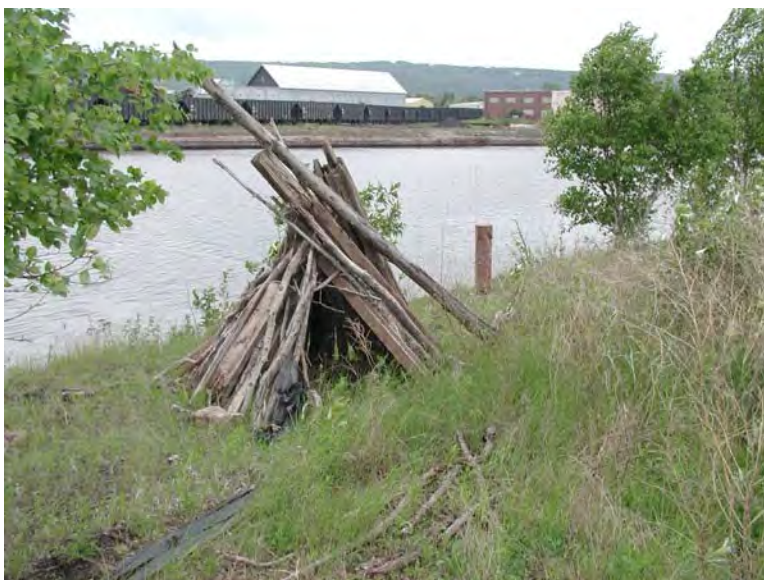
Figure 7.
Evidence of trespassing, like that shown here, was observed along the shoreline of the peninsula. Trash, debris, and small fire rings were common across the site.

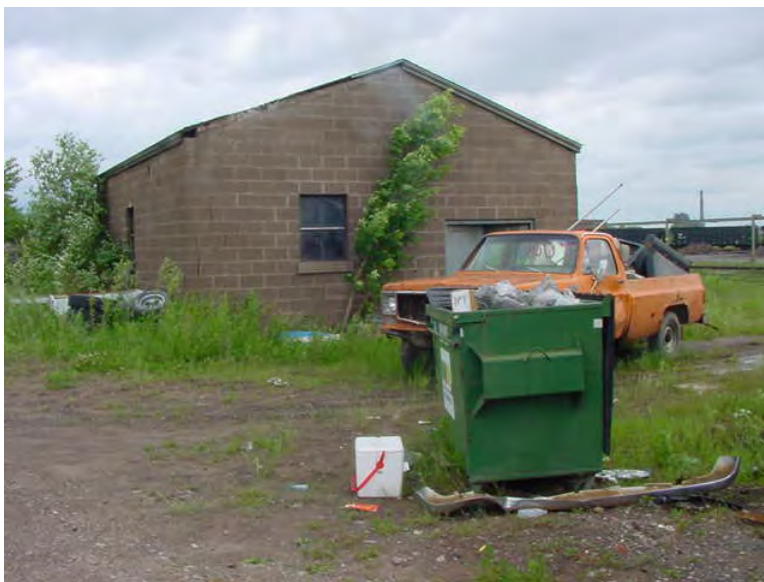
Residual Contamination is present under this pump house in Area D.

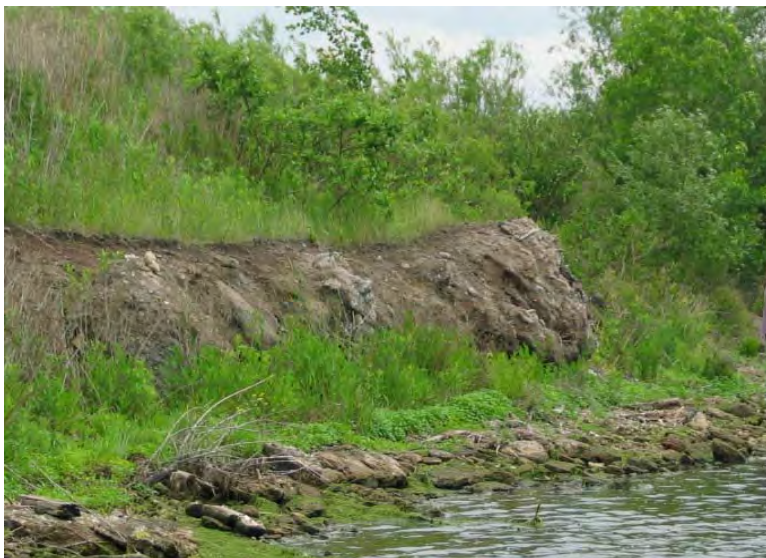
Erosion was observed along the west shore of the 59th Avenue peninsula. The location was marked using GPS and is shown as Area F 1 on Figure 7

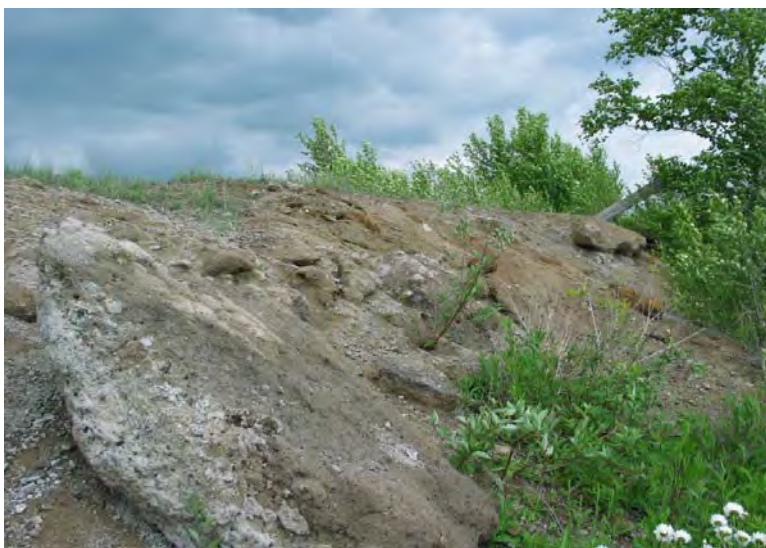
Erosion along the west shore of the 59th Avenue peninsula was observed. The location was marked using GPS and is shown as Area F 2 on Figure 7

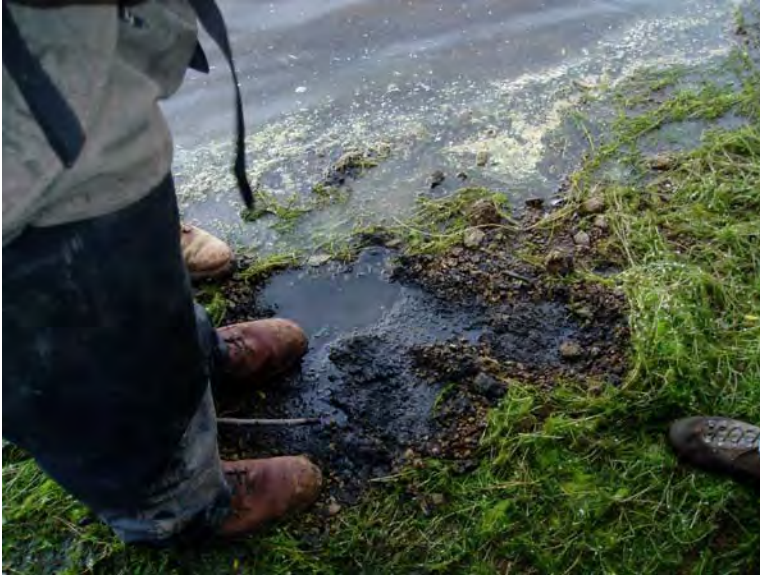
A few areas of oily material were observed along the west shoreline. Oil blooms were noted during the site inspection and it is speculated that the contaminated sediments present in Stryker Embayment may be the cause of the oil that gathers along the water's edge.

An example of the oily material was observed along 59th Avenue peninsula west shoreline.

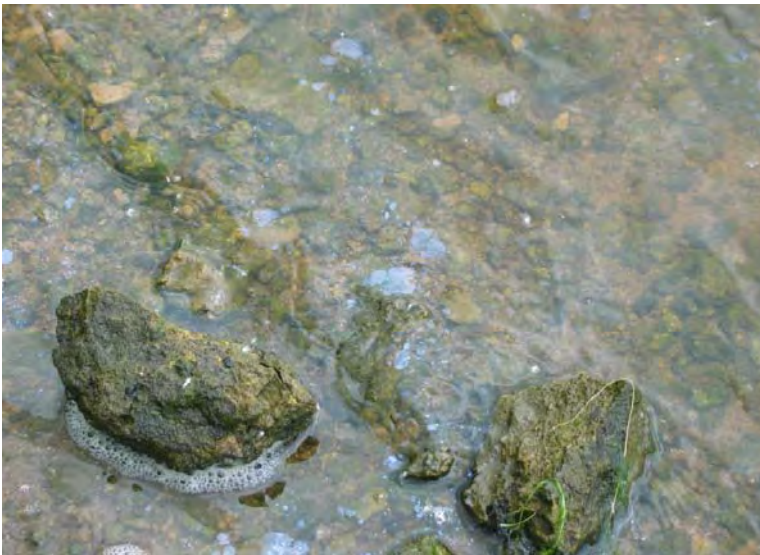
This is an example of the oil sheens observed on Stryker Embayment Surface.

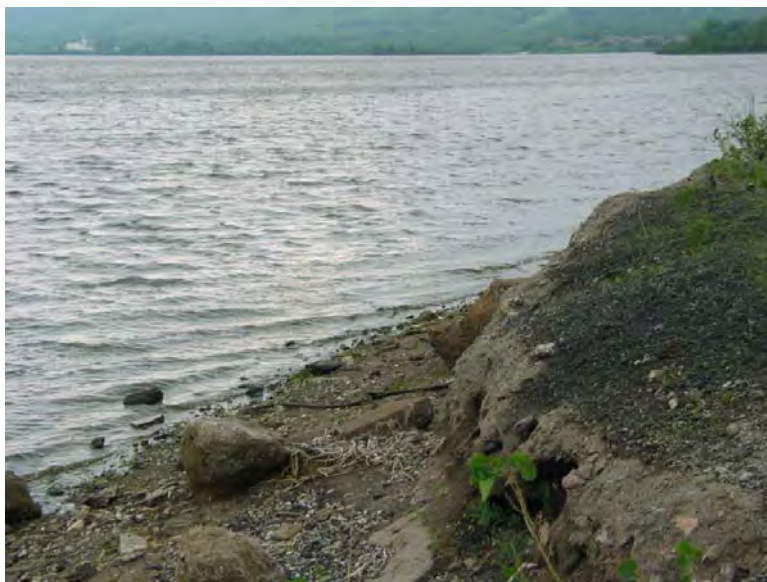
Viewed here is erosion observed at the southern tip of the 59th Avenue peninsula.

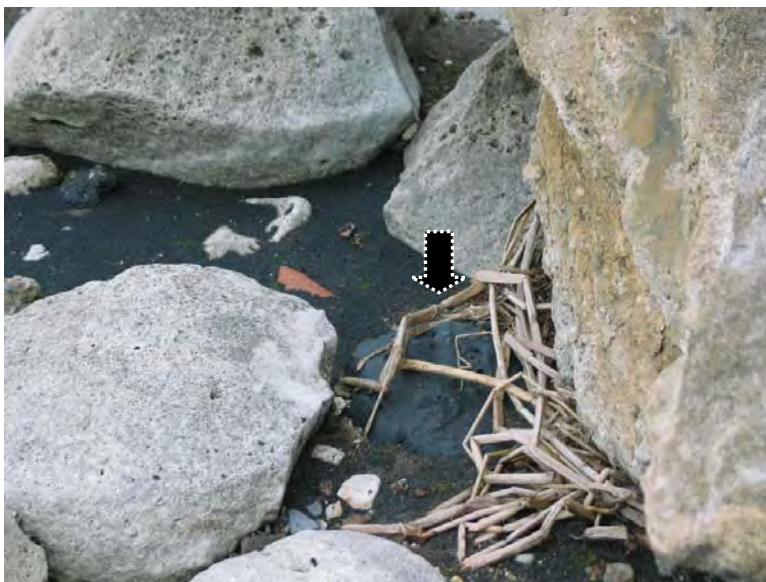
This tar was observed in the same general location that the erosion was noted. The tar and erosion location are approximated on Figure 7 as Area F 3.

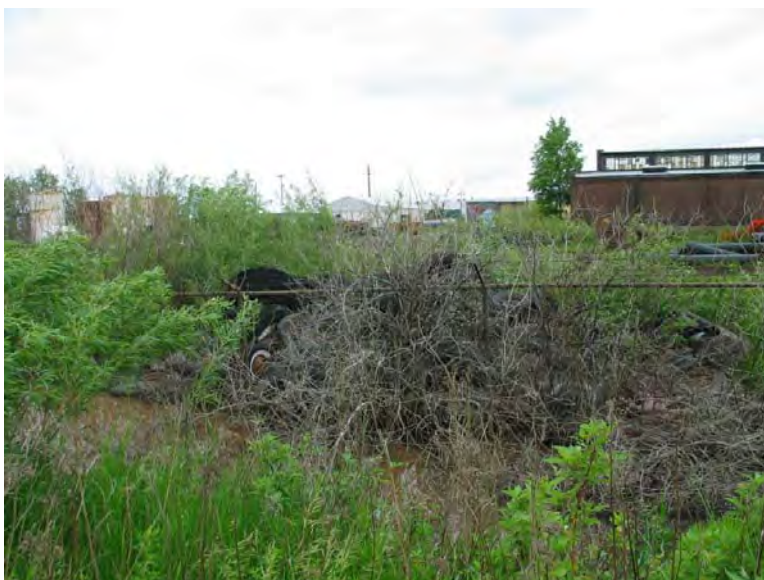
This photo is the west side of Area E, looking east, northeast. A low point with poor drainage is noted in foreground.

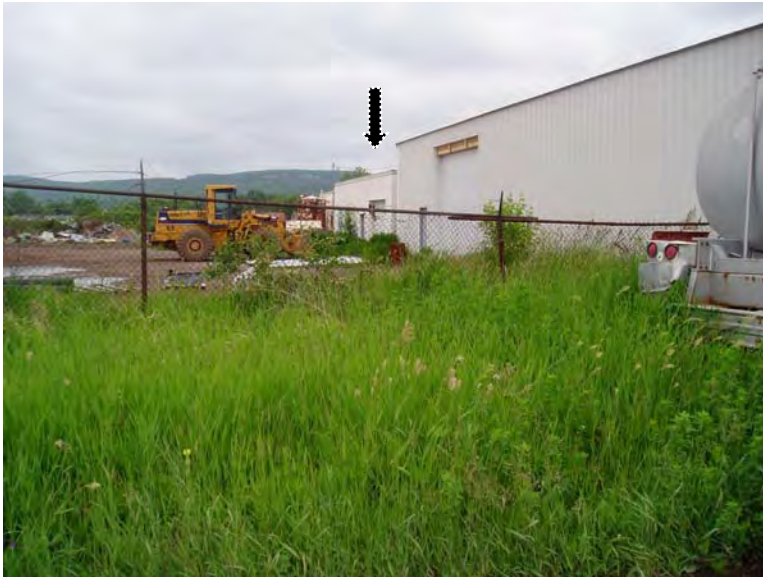
Represented by the arrow is the south side of former Duluth Auto Wrecking Inc. where residual contamination remains.

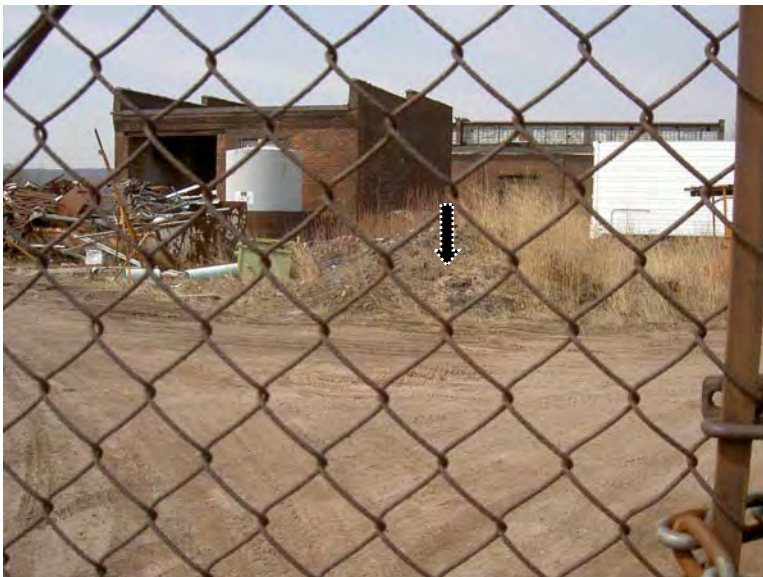
Looking west from the east side of Area E, this pile, excavated during gas line installation, reportedly contains coal tar.
