**Second Five-Year Review Report
Volume II
Attachments**

**St Louis River/Interlake/Duluth Tar Site
Tar Seep OU - EPA OU 01
Soil OU – EPA OU-3**

September 2008

Draft
SECOND FIVE-YEAR REVIEW SITE INSPECTION REPORT
St. Louis River/Interlake/Duluth Tar Site
EPA OU 01-Tar Seeps Operable Unit (TSOU)
EPA OU 03-Soil Operable Unit (SOU)
EPA OU 04-Sediment Operable Unit (SedOU)
May 5 and 9, 2008

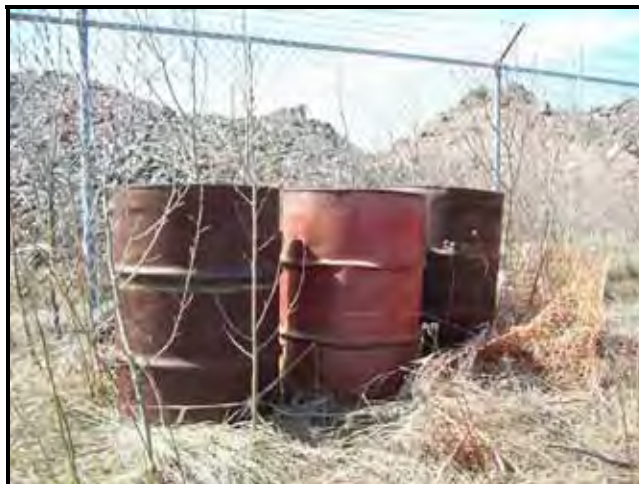
As shown in Photographs 1 and 2, three drums and several tires were stockpiled outside the fence of Area A. The drums appeared empty.

1: SE perimeter of Area E, Three empty drums

- Drums and Tires. The drums and tires in Area E and the Radio Tower should be removed and disposed of properly.
- Monitoring Wells. The monitoring wells are no longer necessary to monitor protectiveness of the remedy. Therefore, all of the monitoring wells located in Areas A and E should be abandoned.

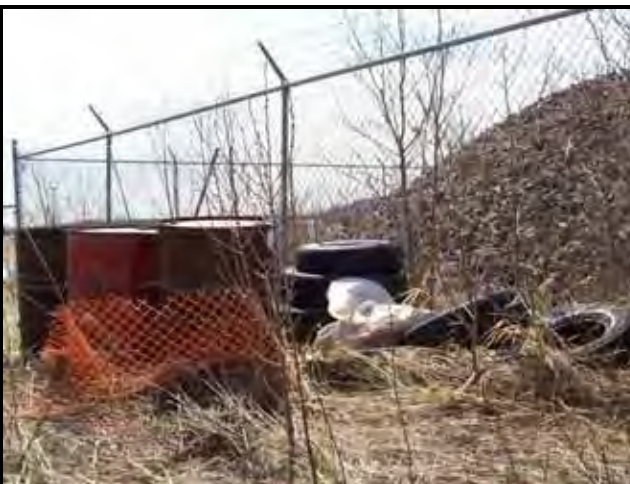
2: Tires behind drums in photo 1

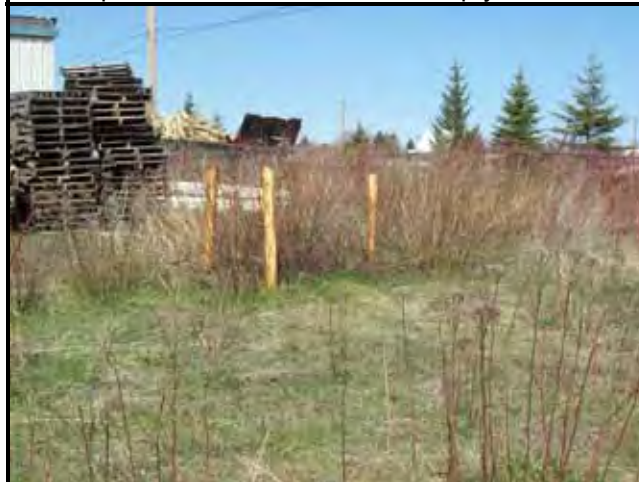
According to the MPCA, with the exception of Areas A and E, all monitoring wells have been abandoned on the Site. Some of the existing monitoring wells are shown in Photographs 3, 4, 5, 6, and 7. The monitoring wells in Areas A and E appeared to be good condition with locking caps. ENSR indicated that wells MW-17 and MW-19 had been abandoned. ENSR agreed to provide MPCA with a record of abandonment and well status summary for all of the Area A and E wells.

3: Monitoring Well 15: North of Area E on city property

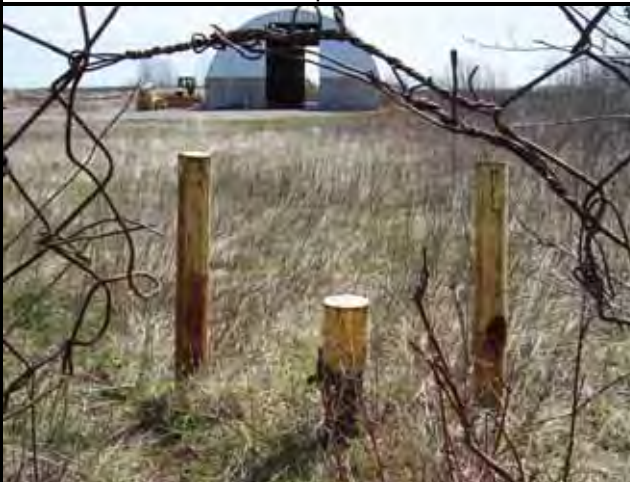
4: Monitoring Well 14, NE Corner of Area E

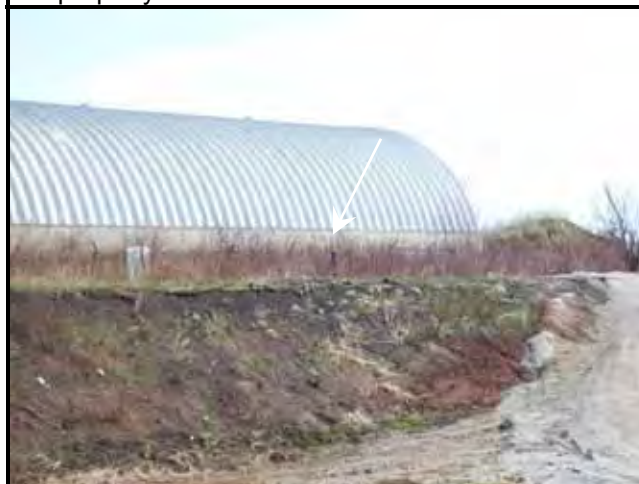
5: Monitoring Well 18R – West side of Area E

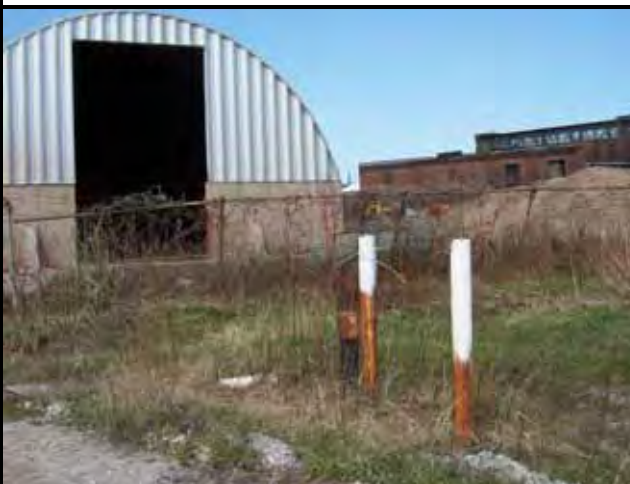
6: Area A. Monitoring Well 16 – west side of Area A

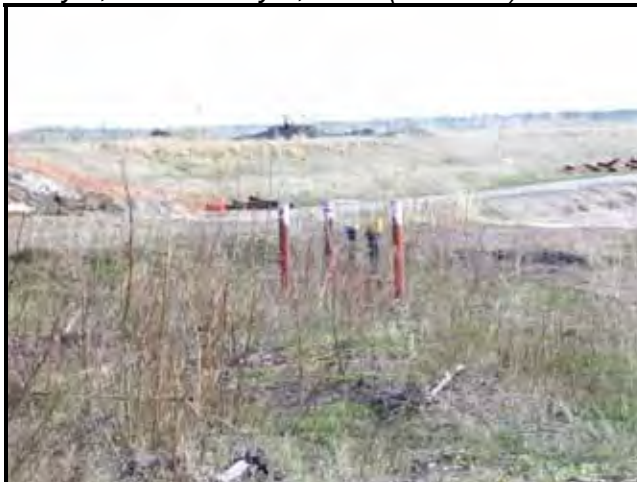
7: Area A. Nested Monitoring Wells 5 and 5 Deep

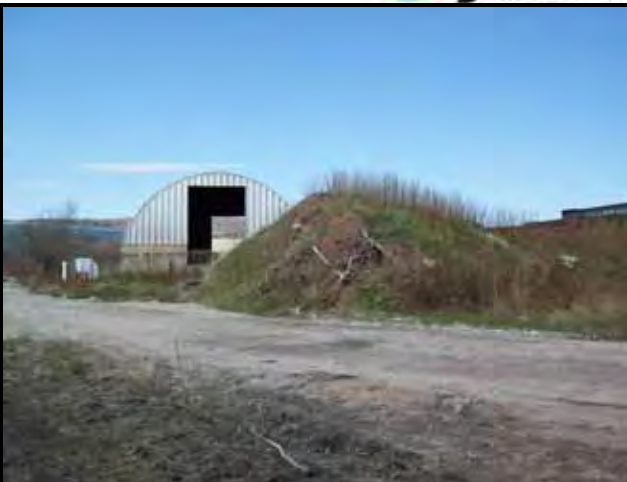
A soil stockpile exists as documented by Photograph 8 in Area A near monitoring well 16. Inspection participants were unsure of the source of the pile. The pile is believed to have been placed between 2005 and Spring 2006.

8: Area A. Stockpiled soil. Source unknown to inspection participants. Possibly placed between 2005 and Spring 2006.

- Stockpiled Soil in Area A. The origin and nature of the stockpiled soil should be determined.
- Residual soil adjacent to or potentially underlying existing buildings. There is a potential for indoor air quality concerns in areas where residual soil remains adjacent to or potentially underlying existing buildings. EBI's recent upgrades to the Pull Barn including insulation and heat could increase the potential risks associated with indoor air quality.

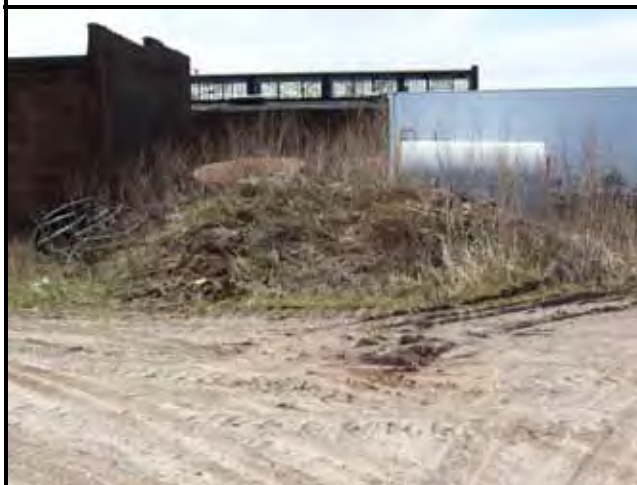
According to Mr. Anderson, he has performed property upgrades that have encountered soil contamination. In the late 1990s, Mr. Anderson excavated and stockpiled approximately 30 cubic yards of impacted soils during his installation of a gas and sewer service line to two buildings (Photograph 9). Mr. Anderson also stated that he encountered residual tar on buried footings. This stockpile still remains on the property and it includes a 6-inch pipe, possibly the tar delivery pipe, which was looked for during the soil cleanup activities. A copy of the EBI interview along with a sketch identifying these features can be found in Volume II, Attachment 4b of the Second Five-Year Review Report.

9: East side of Area E on EBI property. Stockpiled soil excavated by EBI during sewer and gas line installation, reportedly contains coal tar. Approximately 30 cubic yards.

- EBI Stockpiled Soil in Area E. The Stockpile Soil in Area E may contain contamination and should be sampled and disposed of in accordance with MPCA requirements. Mr. Anderson stated that he will work with the MPCA on the appropriate sampling and disposal methods for the stockpiled soil.

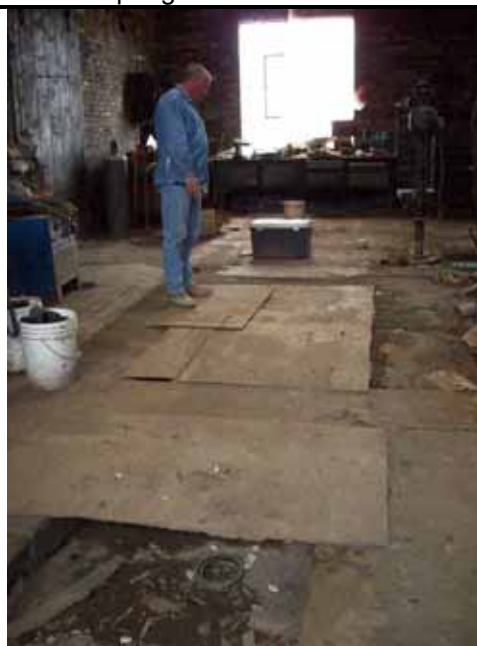
Mr. Anderson expressed his concerns regarding tar pits located in one of the on-site buildings. These buildings were filled with cars/car parts during the remedial investigation activities and the pits were not known to be present. One pit, filled with

water and tar, was observed inside of one of the buildings (see Photographs 10 and 11 and attachment 4b). It is possible that a second pit exists under flooring adjacent to the first pit. Two other small openings in the floor were also observed (Photographs 12 and 13). The smaller building to the east has openings in the concrete that appear to have been pits that are now filled in with soil (Photograph 14). A possible tank standpipe is also present in this building (Photograph 15).

10: May 9, 2008. Area E, southern building on EBI property. Wood covering pit filled with approximately 1 foot of water over tarry material.

- Residual Operational Material in Area E. Open pits or former storage vessels containing water/waste or that are filled in with soil were observed within the on-site buildings. These pits or former storage vessels may contain tar and/or tar impacted soil. Operational waste that was left behind could be a continued source of soil and groundwater contamination and should have been included in the SOU. Residual waste in the pits or former storage vessels indicates that there is a potential risk to human health and the environment and further evaluation and remedial action is recommended.

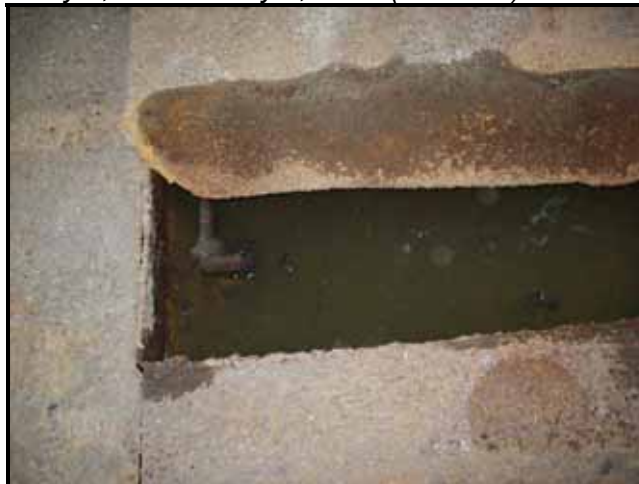
11: May 9, 2008. Area E, southern building on EBI property. Approximately 1 foot of water over tarry material in pit.

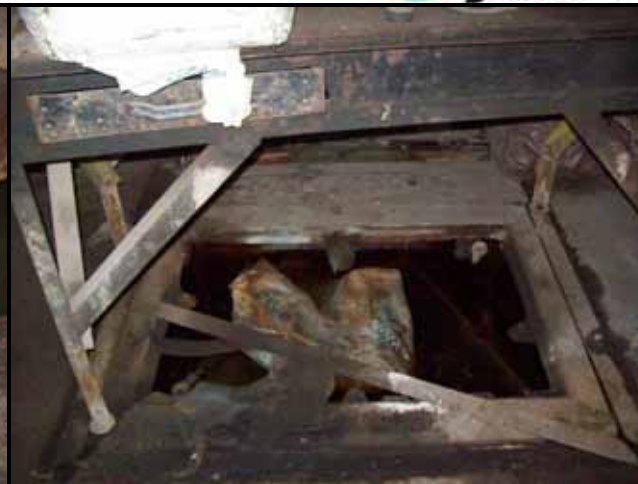
12: May 9, 2008. Area E, southern building on EBI property. Smaller opening in the floor filled in

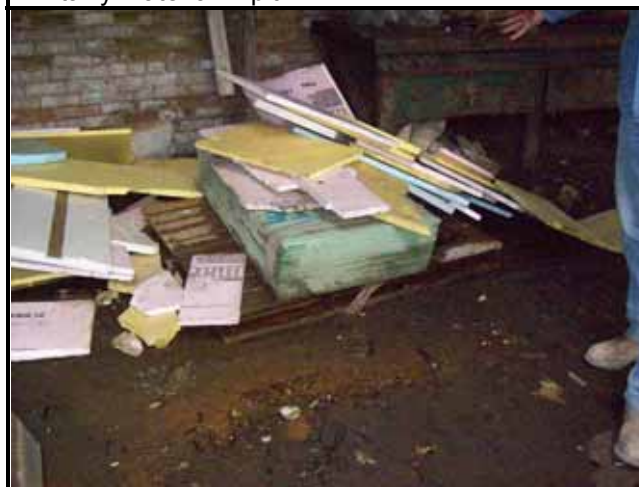
13: May 9, 2008. Area E, southern building on EBI property. Possible small opening in floor under material pile.

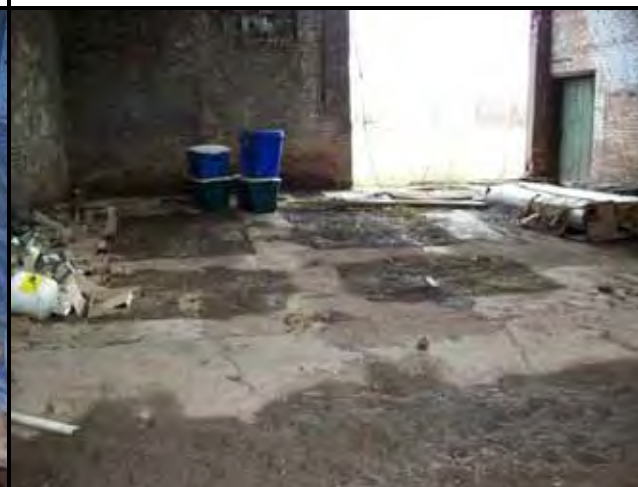
14: May 9, 2008. Area E, south-eastern building on EBI property. Openings in concrete floor filled in with soil.

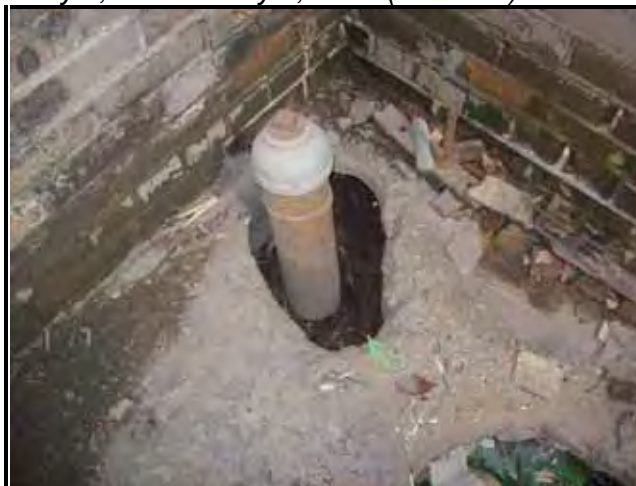
15: May 9, 2008. Area E, south-eastern building on EBI property. Stand pipe inside building.

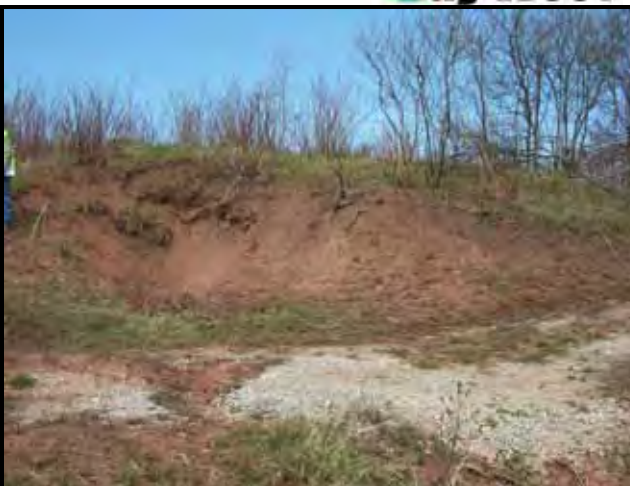
Photographs 16 through 19 were taken along the Area E shoreline, where two storm sewers discharge storm waters into Stryker Bay, adjacent to the SedOU surcharge area. One storm sewer is a city storm sewer from Freemont Avenue (Photograph 16) and the second one is from Area E (Photograph 17). Erosion of the SedOU surcharge material occurred during a storm event as a result of water flowing from the storm sewers. A french drain was installed to address future storm events (Photograph 18). An oil sheen was noted in the water discharge in the Area E outfall area (Photograph 19).

16: Area A. City storm sewer outfall from Fremont Avenue and resulting erosion. November 2006 – French drain installed to correct erosion problems in the surcharge cap in Stryker Bay.

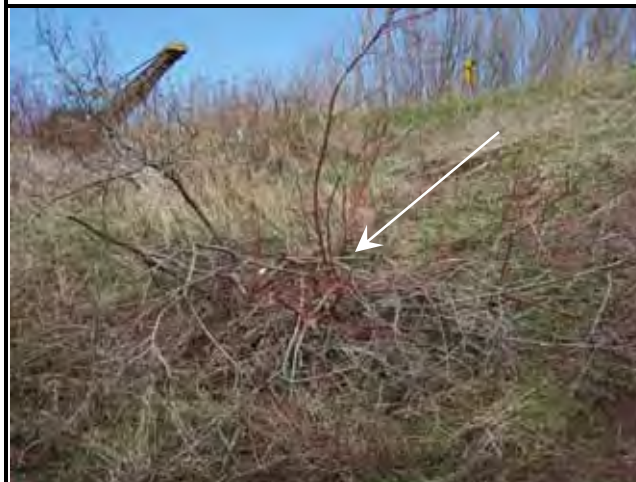
17: Area A. Storm sewer from Area E is believed to end near these bushes.

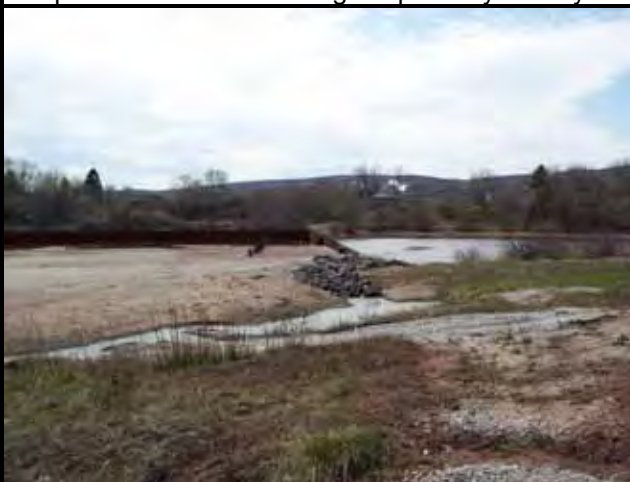
18: Area A. French Drain and outfall and/or spring flowing into surcharge cap and Stryker Bay

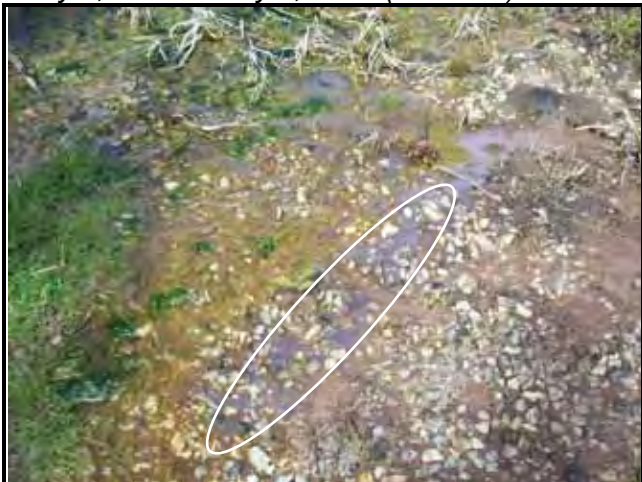
- Oil Sheen from Area E Storm Sewer outfall. The oil sheen observed in this area indicates that there is a potential risk to human health and the environment. Further

19: Area A. Oil sheen in the outfall stream

evaluation and possible remedial action is recommended to find the origin and nature of the oil sheen.

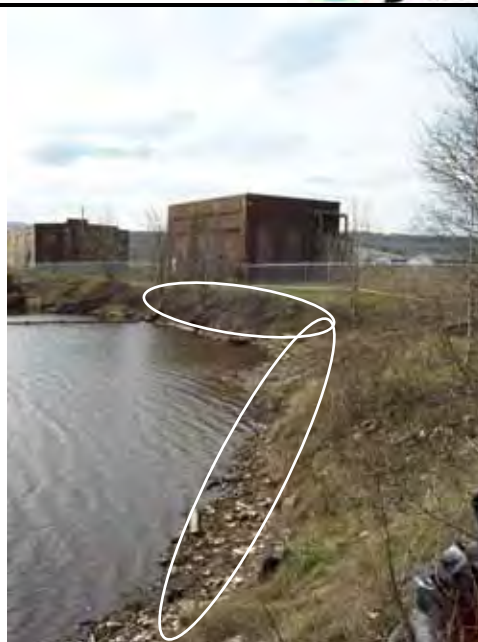
As shown in Photographs 20 and 21, hardened tar present during the first Five-Year Review is still present at the northeast end of Slip 6. This area, along with all of Area C (54th Avenue Peninsula), will be included in the shoreline buffer zone which will be established upon completion of the SedOU.

20: Tar seep at north end of Slip 6.

- Tar Residual and Erosion at Area B and C. The residual tar observed in this area indicates that there is a potential risk to human health and the environment. In addition, continued erosion could affect the protectiveness of remedial actions taken in Area C. The shoreline buffer zone that will be established upon completion of the SedOU should include measures to address the residual tar and erosion issues along shoreline in Slip 6.

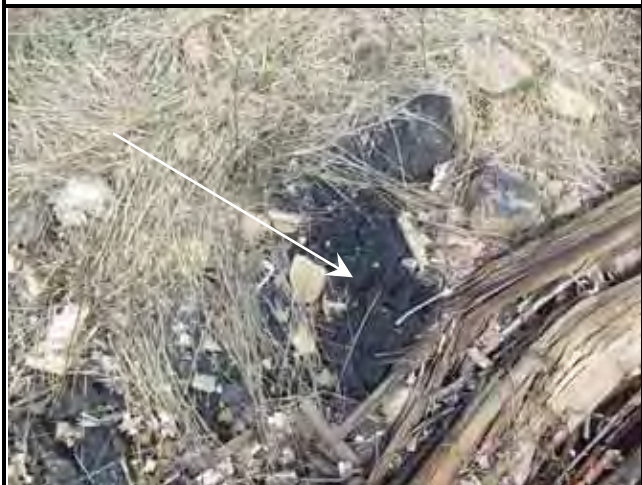
21: Tar at north end of Slip 6.

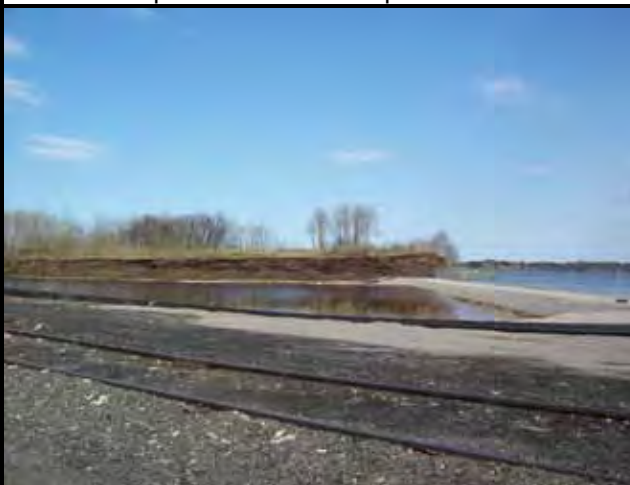
Area C was observed from the west side and north end of Slip 6. Photograph 22 shows bank erosion occurring at the end of the peninsula. Area C will be included in the shoreline buffer zone which will be established upon completion of the SedOU.

22: Bank erosion on 54th St Peninsula. SedOU CAD dike.

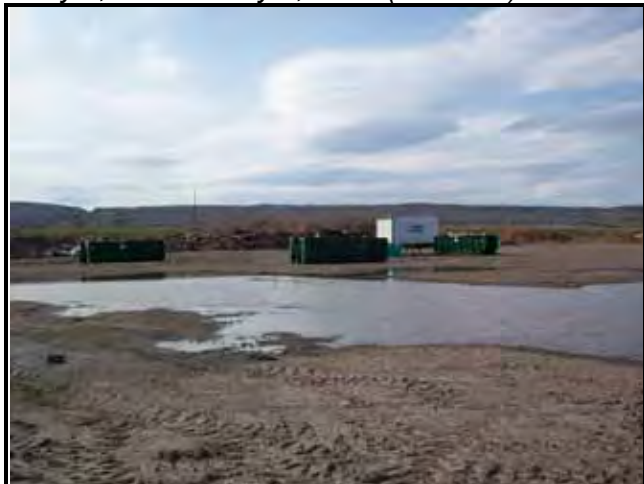
23: Concrete and asphalt crushing (inactive) on Hallett Dock property at the south end of 59th Ave Peninsula.

- Waste Material Stockpiles in Area F. Large quantities of waste material stockpiles were observed in Area F, at the former concrete recycling location. Although this facility is no longer in operation, stockpiles of waste and materials remain on-site. This material should be removed and disposed of properly.

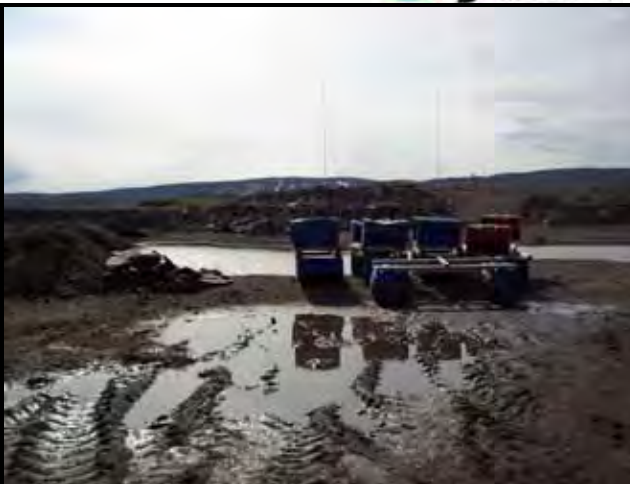
24: Concrete and asphalt crushing (inactive) on Hallett Dock property at the south end of 59th Ave Peninsula.

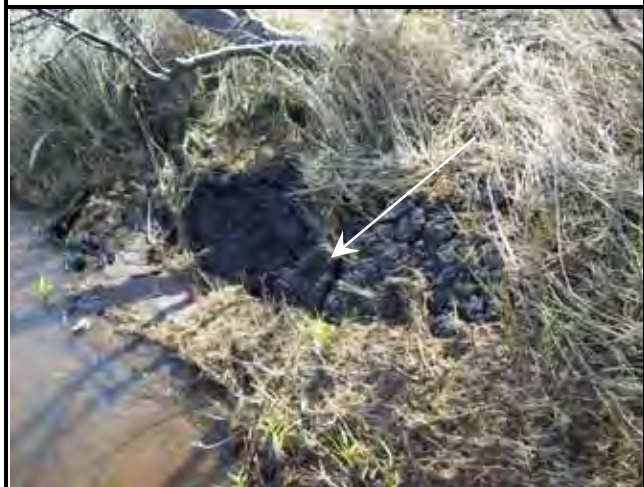
visible on the shoreline (Photograph 25). The tar layer was also present in another area along the Simonson's and Leland's shoreline (Photographs 26 and 27). According to Barr, the area of contamination was delineated with hand auger borings and flagged to show the lateral extent of the tar layer. Barr indicated that they would provide a report summarizing the extent of the tar layer.

25: Tar layer on west bank of Stryker Bay near the radio towers.

- Tar Layer by Radio Towers and Residents of Stryker Embayment. The tar layer near the Simonson's and Leland's shoreline has been included in the SedOU remediation activities and was being addressed during this Five-Year Review. The tar layer near the Radio Tower indicates that there is a potential risk to human health and the environment and further evaluation and remedial action is recommended.

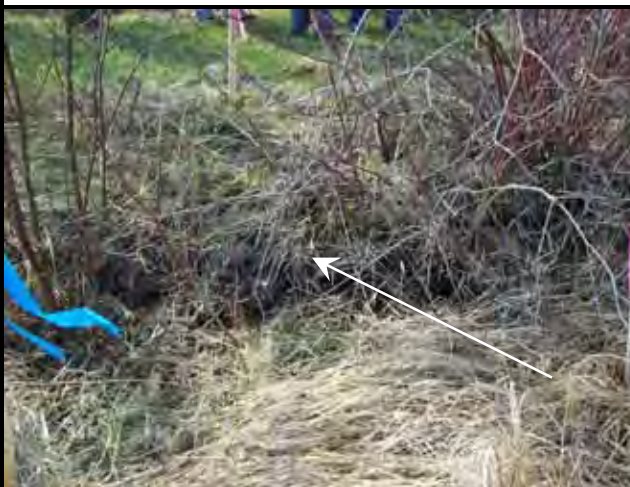
26: Tar layer between Leland's and Simonson's.

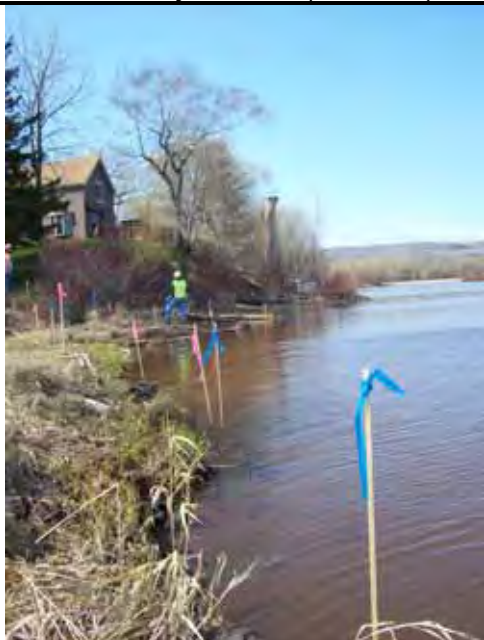
27: Markers delineate extent of a tar layer left after dredging along shoreline adjacent to Leland's and Simonson's on Stryker Bay.

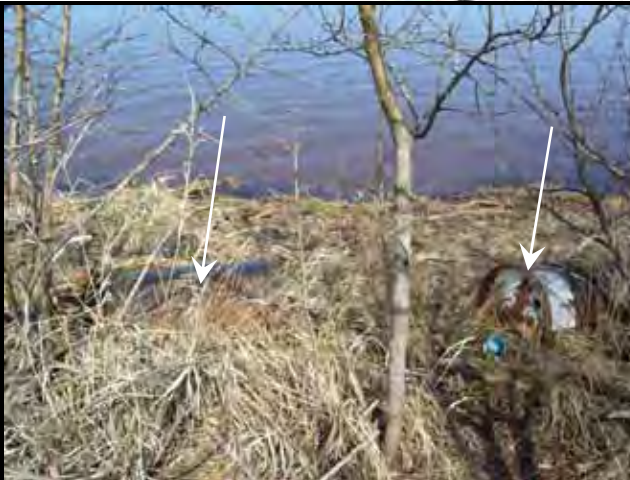
Three empty drums were also noted near the Radio Towers (Photograph 28).

28: Radio Tower area west of Stryker Bay. Two empty drums. A third drum, not pictured, is present in the same area.

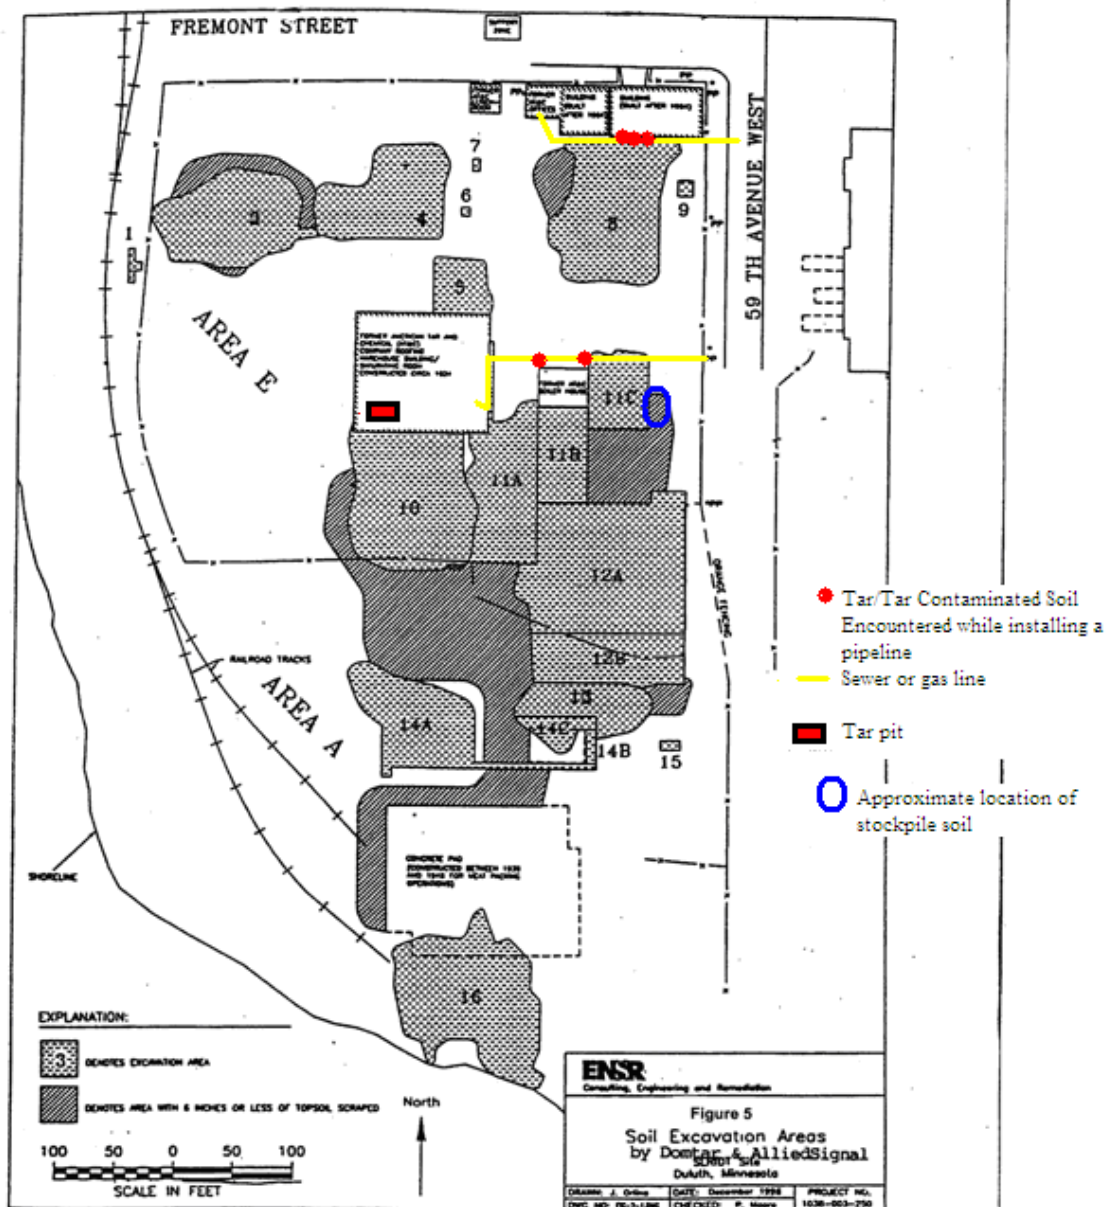
There is still tar on-site. At least one pit filled with water and tar is present inside of the building (see attached figure). It is possible that a second pit exists under flooring adjacent to the first pit. Two other small openings in the floor also exist. The smaller building to the east has openings in the concrete that appear to have been pits that are now filled in with soil. These buildings were filled with cars/car parts during the original remediation. No actions were taken inside of the buildings. Photographs of the tar pit are included in the site inspection photographs of the 2nd Five Year Review.
