July 2025

# Big Fork River Watershed Stressor Identification Report

A study of local stressors limiting the biotic communities in the Big Fork River Watershed.

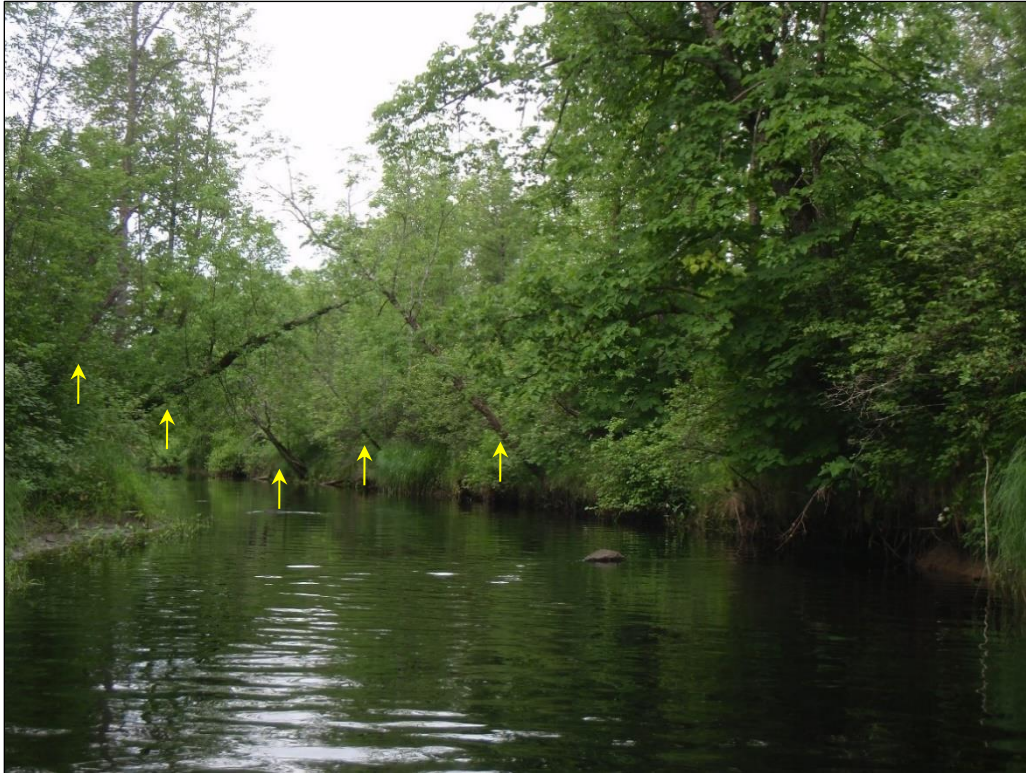
There is some visual evidence of channel incision and overwidening farther downstream in the Bear River, which is likely at least in part due to the addition of several miles of ditch segments to the headwaters area, creating higher peak flow volumes in the river. Photos from the biological monitoring visit at site 10RN048, at CSAH-1 show trees leaning into the channel on both sides of the river (Figure 9), and the channel eroding under the root zone of woody riparian vegetation (Figure 10).

**Figure 9. Trees leaning into the Bear River channel (at CR-1) from both sides of the river, a symptom of bank erosion.**

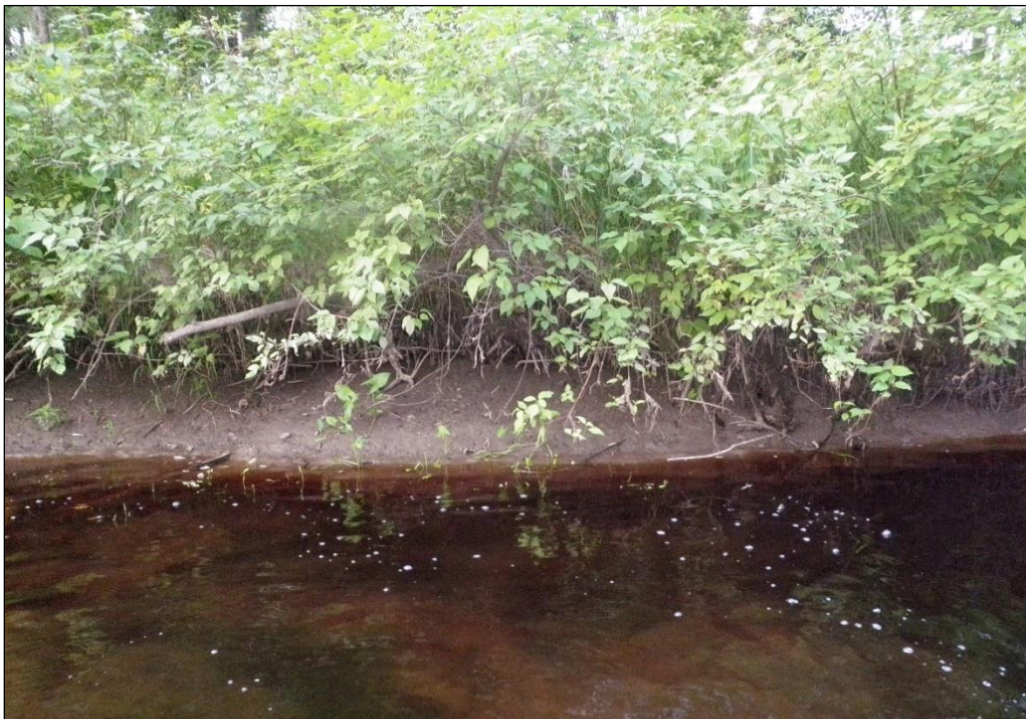
**Figure 10. There is undercutting of the woody shrub root zone along the bank, a sign that the channel has incised and is now over widening due to altered hydrology (excess flow volumes).**

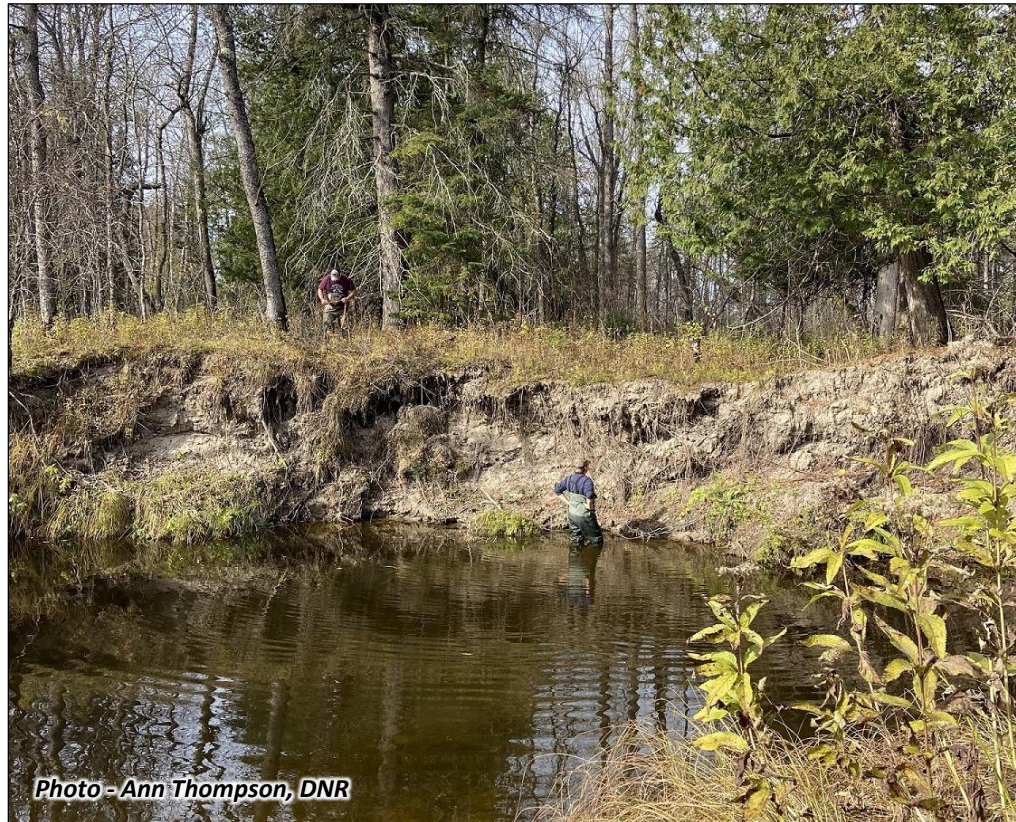
- A Pfankuch Stability Index score of 130, with a condition rating of “Poor”.
- High, steep, unvegetated sloughing banks (Figure 15).
- Unstable channel bottom that is in a frequent state of flux.
- Excessive tree toppling into the stream channel, including creation of large debris jams (Figure 16 and Figure 17).
- Measurements that classify the stream as an “F” channel type (Rosgen, 1996).
- Disconnection of the channel from its floodplain, leading to more erosive conditions in the channel.
- Accelerated lateral channel migration.
- Gravel in riffles is embedded by sand and fine particles.

The report concludes that the smothering of important bed features with fine sediment (due to the excessive erosion resulting from bank instability) has created a channel that lacks diverse habitat features, leading to a reduced diversity of fish species. Additionally, an estimate of sediment export was made using Rosgen methodology, which found that stream bank erosion from the study reach is approximately 214 tons. If the stream was in an un-incised condition, able to dissipate high flows onto the floodplain, only an estimated 47 tons of sediment would be coming from the reach’s banks. Thus, there is about 4.6 times more sediment in the channel and moving downstream due to its unstable

**Figure 15. Actively eroding raw vertical stream bank within the geomorphology study reach.**

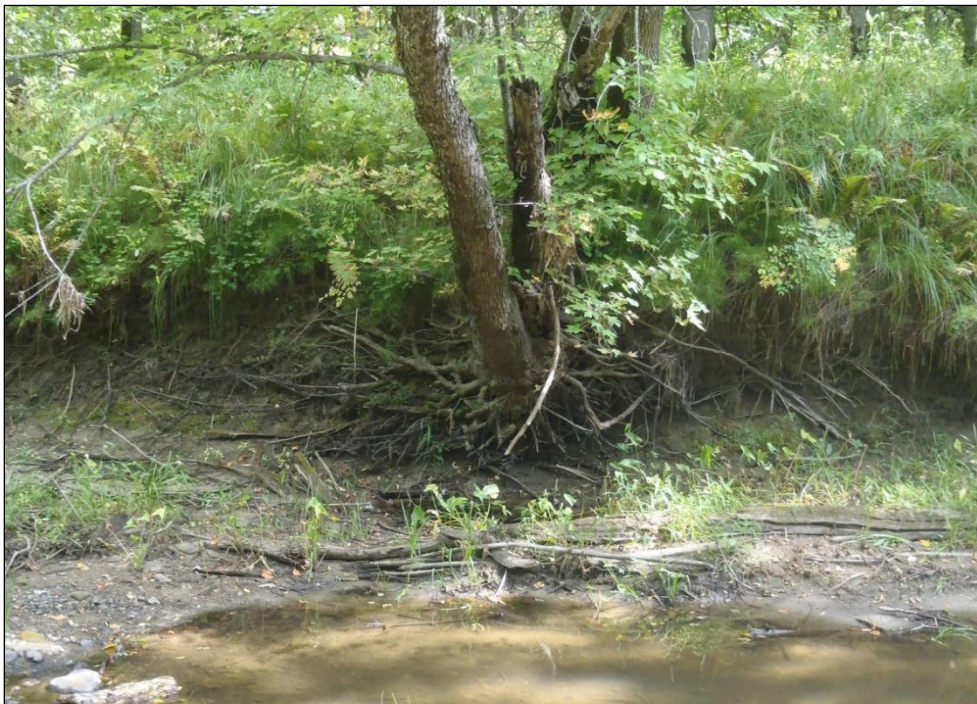
**Figure 16. A bank tree that has been completely undermined by erosion and is now down in the stream channel with most of its roots exposed, soon to be a contributor to one of the many log jams seen on aerial photos.**

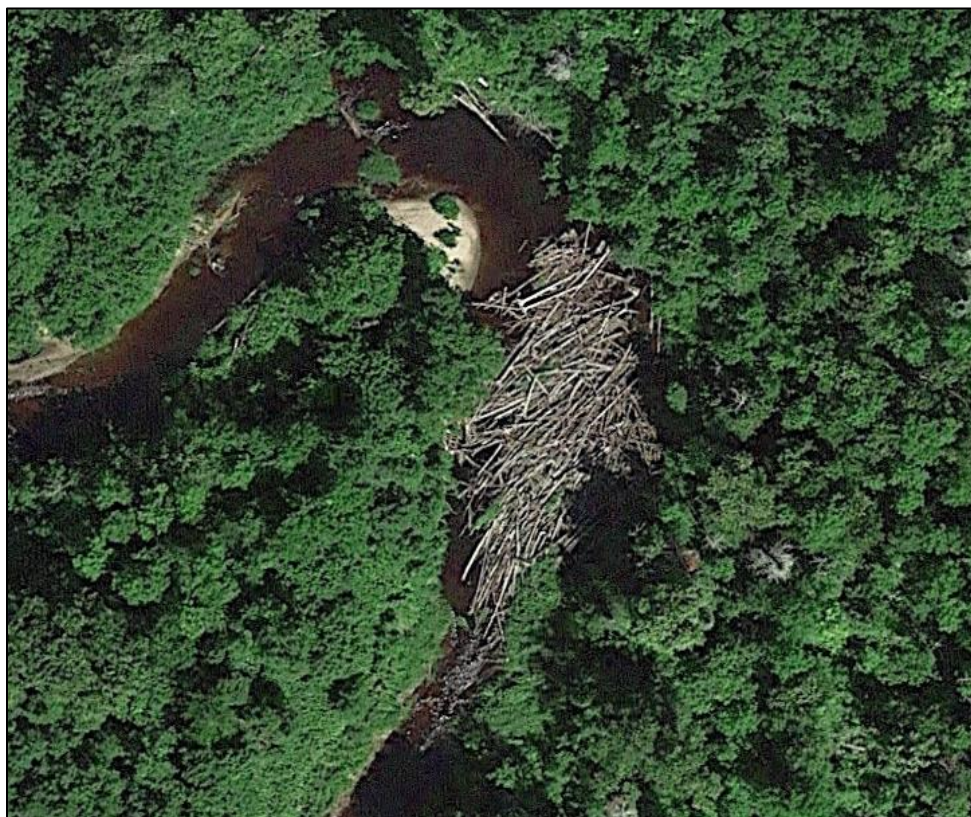
**Figure 17.** As a consequence of un-naturally fast erosion of stream banks of Caldwell Brook, trees along the channel are undermined and topple into the channel and form log jams. Many log jams were documented in Caldwell Brook. This aerial photo is from 7/18/2016. This logjam is still present in 2023 aerial photos.

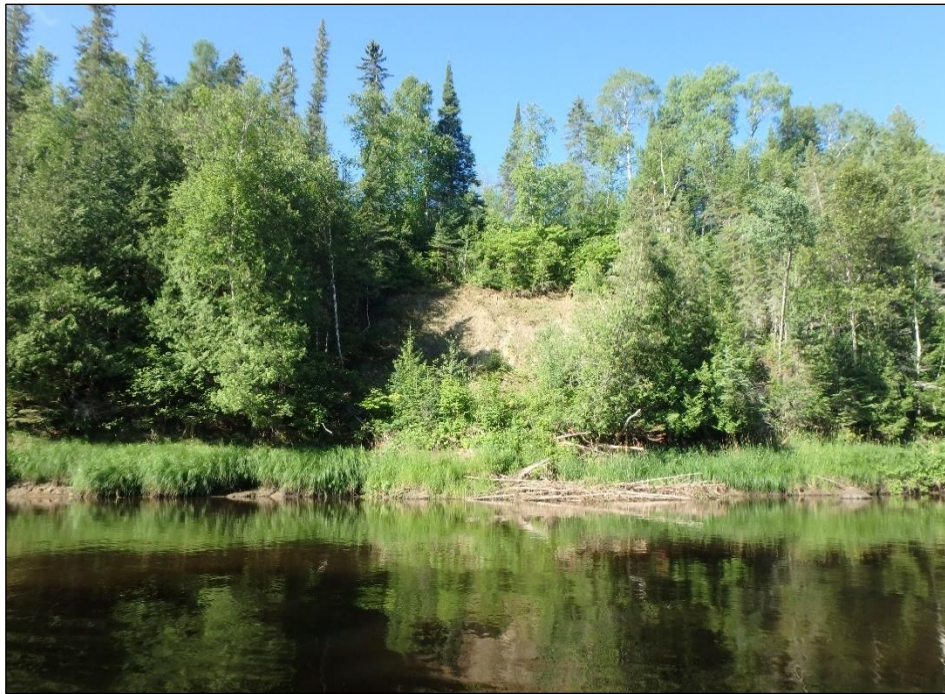
**Figure 21. Young trees are growing at both the top and toe of the eroded bank. A small floodplain also helps protect against lower flows being able to scour at the base of the bank failure.**

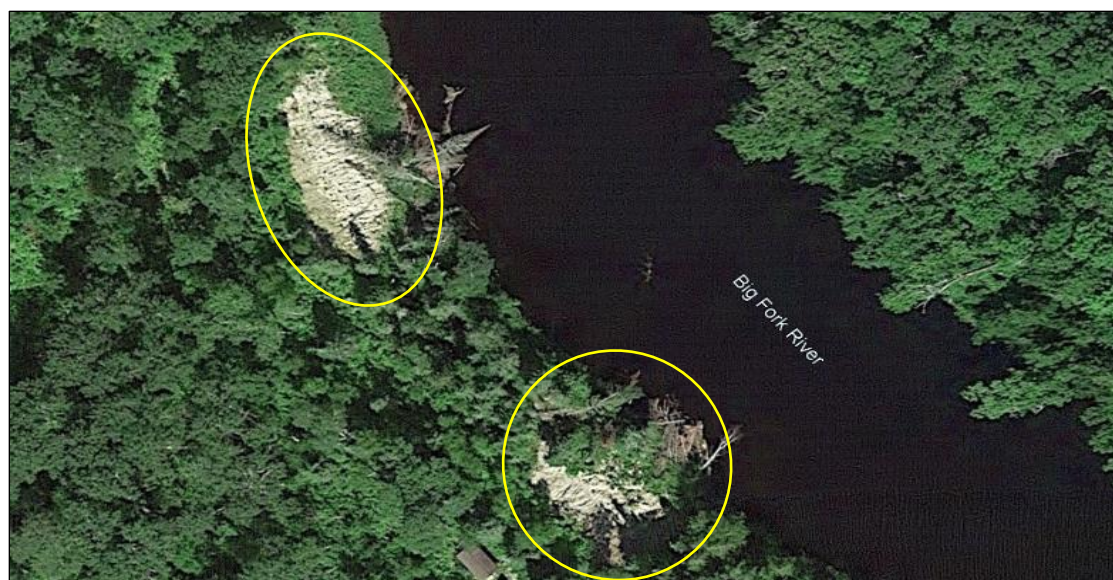
**Figure 22. Two nearby bank erosion locations, about 3.6 miles downstream of Big Falls. Collapsed dead trees can be seen at the base of both bank slides.**

It may be possible to do some bio-engineering solutions on these slumps to enable them to heal, including possibly planting some seedlings and using some erosion control products (e.g., coconut bales) to speed up natural healing processes. Boat access to at least some of these sites to bring in supplies looks manageable.

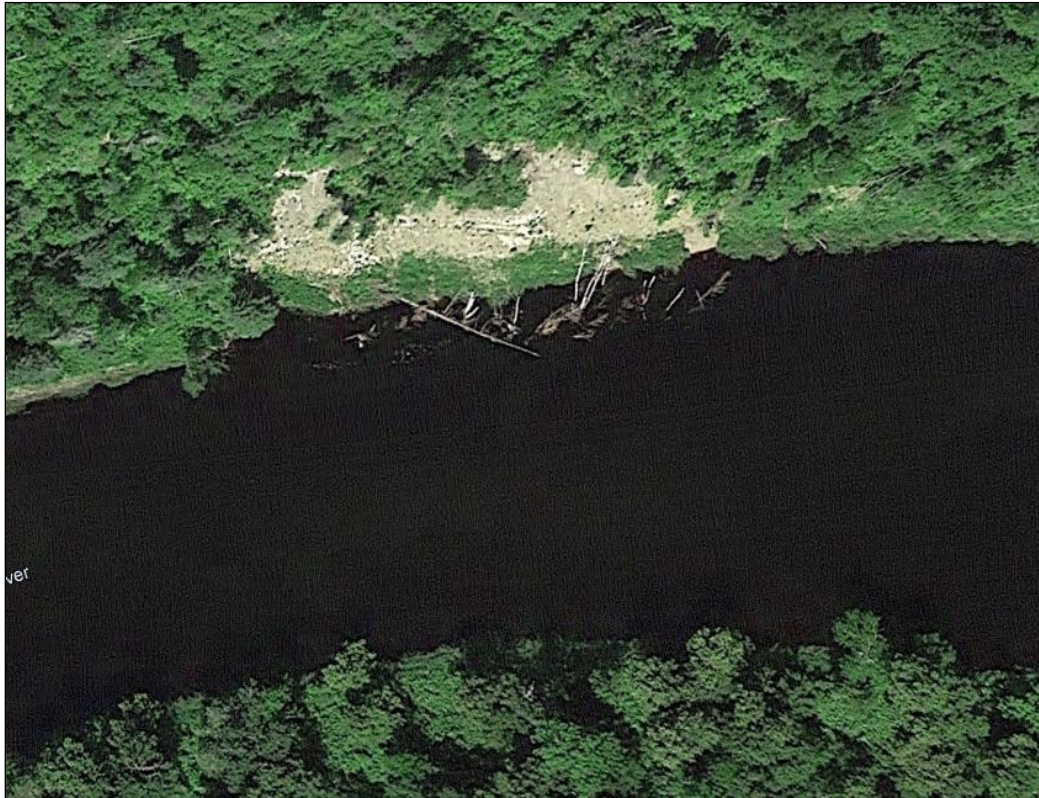
**Figure 23.** Another example of bank failure on the Big Fork River. The trees that toppled from the bank can be seen below the failure in the water.

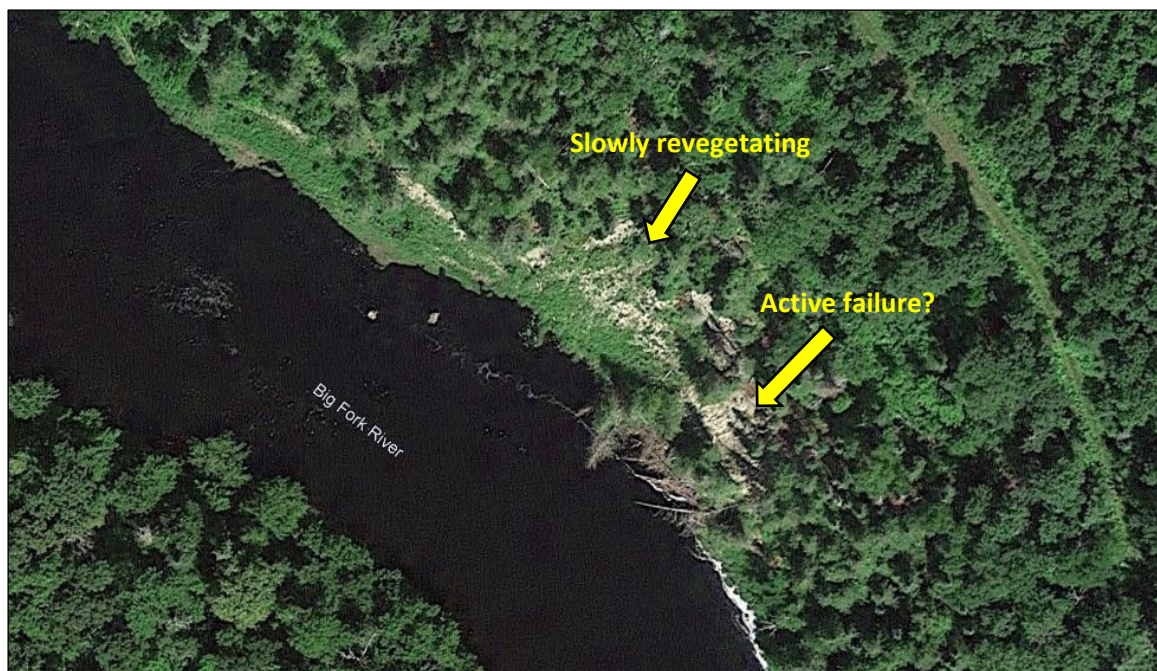
**Figure 24.** At this bank failure, it appears as though part of it is healing via new vegetation growth helping to stabilize the bank, while a part of the failure looks like it may still be actively eroding.

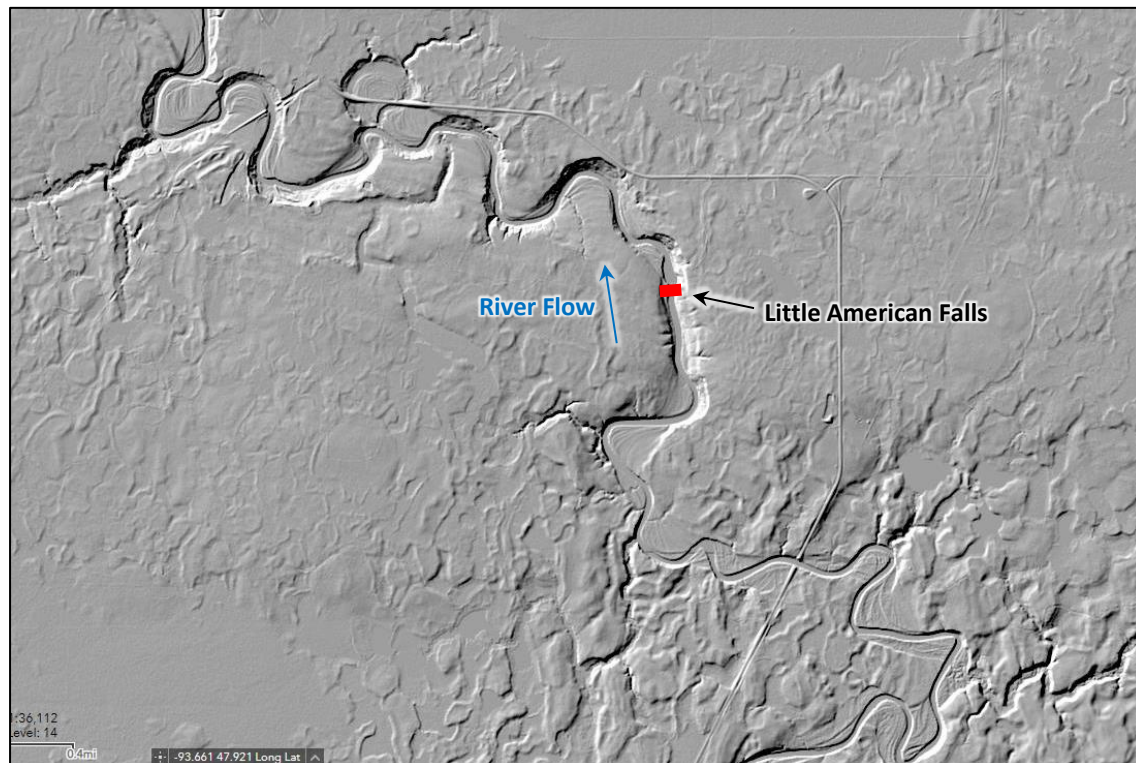
**Figure 25. Big Fork River entrenchment upstream versus downstream of Little American Falls.**

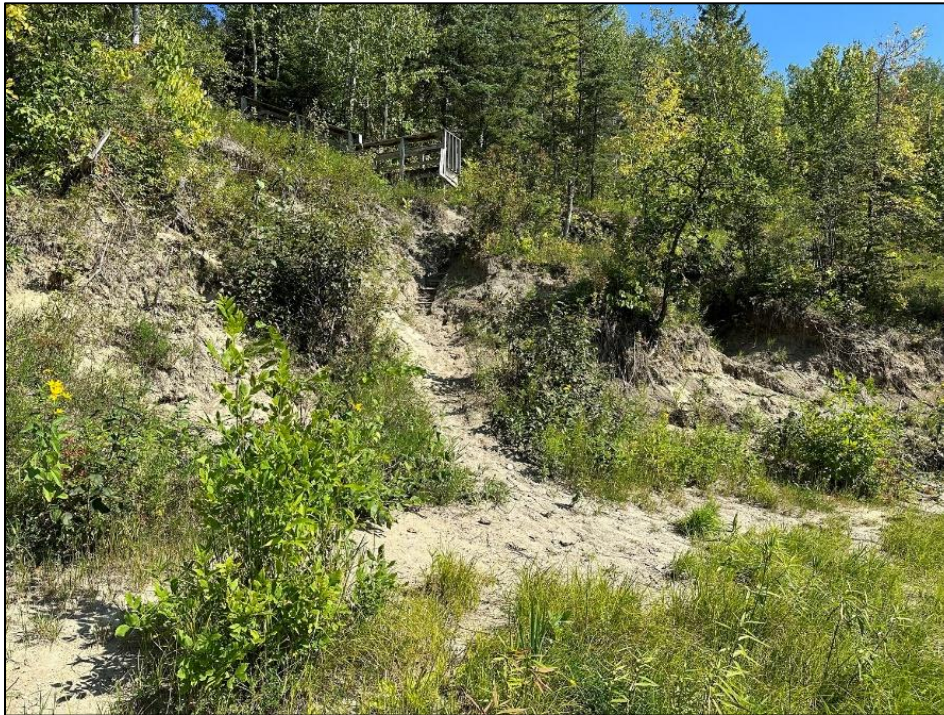
**Figure 26. Gullies and bare soil eroding down to the river's edge at Little American Falls.**

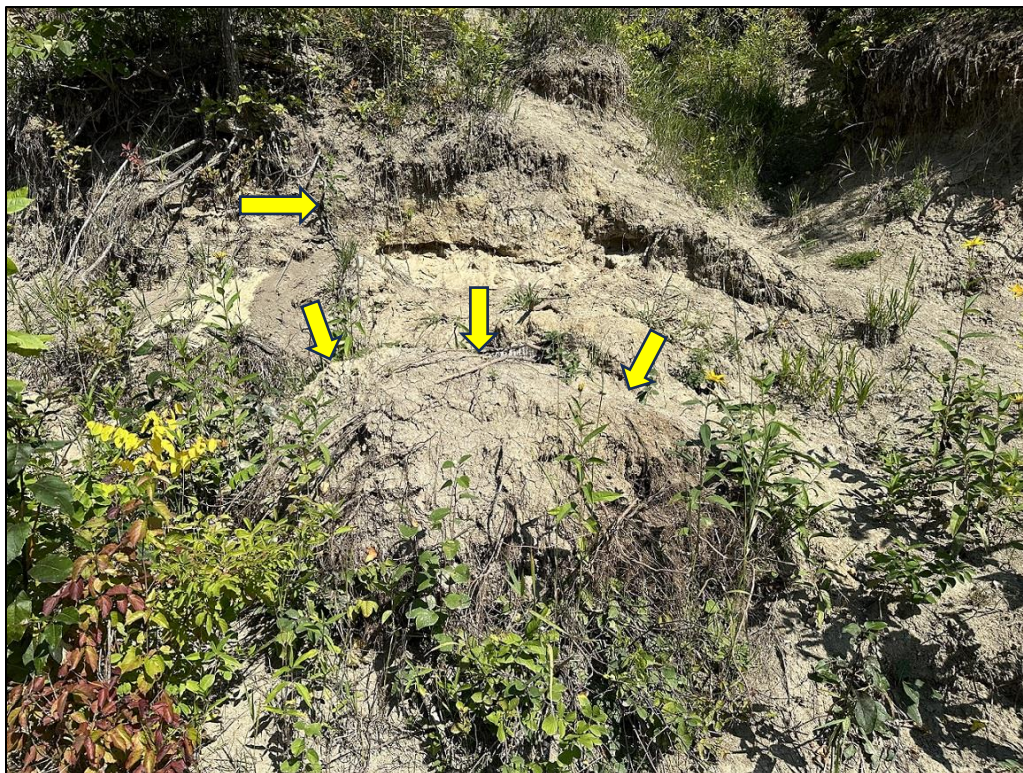
**Figure 27. Steep slopes adjacent to the campground/picnic area at Little American Falls have been destabilized over the years by recreation at the site. Active erosion and sloughing is occurring on these banks along the river. Arrows point to a large chunk of soil that has broken off and slid down the bank.**

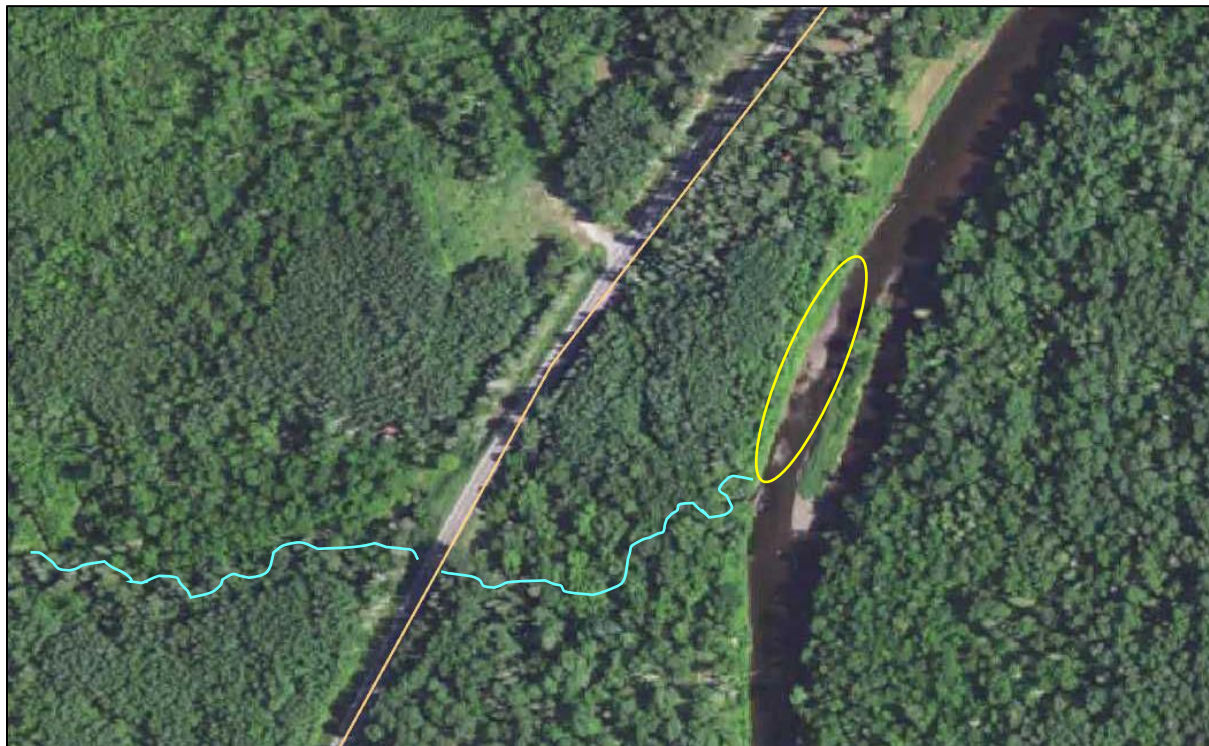
**Figure 35. Deposited sediment (circled in yellow) can be seen in the Big Fork River immediately downstream of where the short tributary from Figure 23 enters the river.**
