FOURTH FIVE-YEAR REVIEW REPORT FOR **ST. LOUIS RIVER SUPERFUND SITE** ST. LOUIS COUNTY, DULUTH, MN

MINNESOTA POLLUTION CONTROL AGENCY

Minnesota Pollution Control Agency Site Remediation and Redevelopment Section Duluth, MN

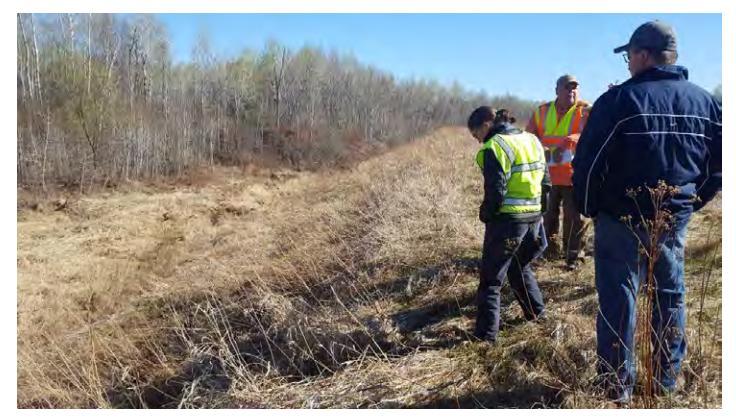
- OU-J: Significant (more than 3') of slumping was noted on sidewall of storage cell in the 2013 FYR site inspection. SWPPP inspections have been completed periodically. Remedial Design has been completed incorporating OU-J stability.

1a: OU-J: Areas of slumping noted in 2013. No issues noted.

OU: OU-J	Issue Category: Remedy Performance Issue: Significant (more than 3') of slumping noted on sidewall of cell. Stability plans for the side of OU-J adjacent to the creek have been incorporated into the remedial design for the proposed sediment response action.						
	Recommendation: Implement the proposed response action.						
Affect Current Protectiveness	Affect Future Party Responsible Oversight Party Milestone Date Protectiveness						
Yes	Yes	'es PRP EPA 2023

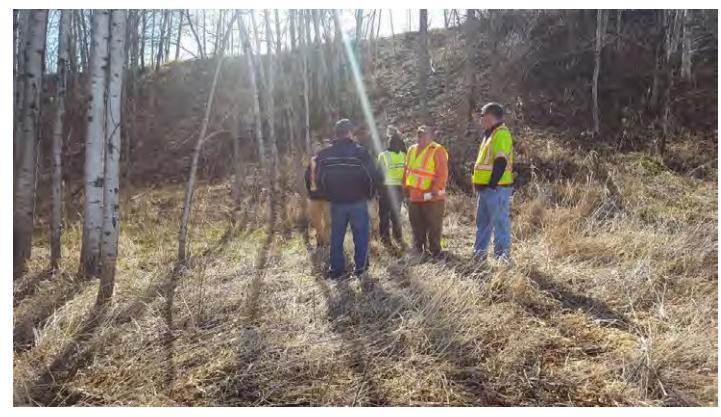
1c: OU-J: Areas of slumping noted in 2013. No issues noted.

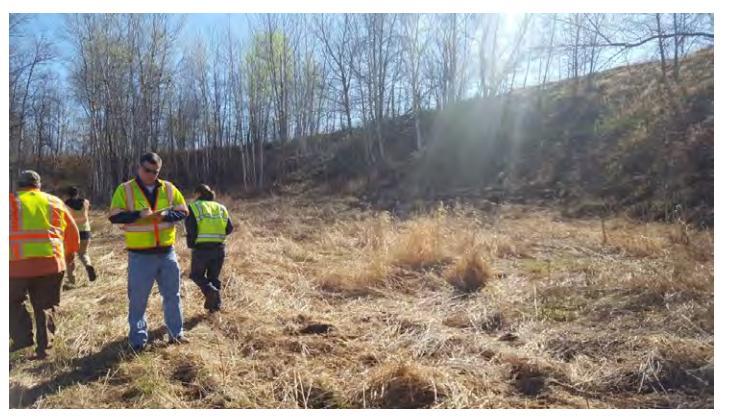
1b: OU-J: Areas of slumping noted in 2013. No issues noted.

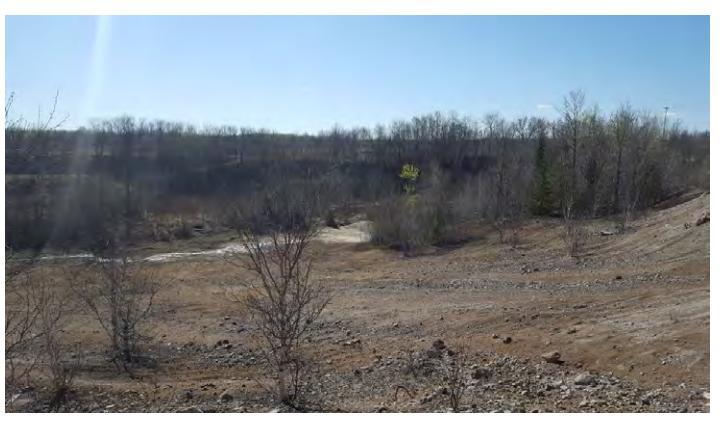
- OU-S/Concrete Disposal Area: Soil with high pH levels exists and evidence of trespassing, including dustgenerating activities such as motorcycling and four-wheeling, was noted. Unacceptable risk exists from direct contact, inhalation or ingestion of soil with high pH levels. Surface water has high pH and enters Steel Creek. The Concrete Disposal Area Development Response Action Plan is under preparation.

2: OU-S: No change from 2013.

OU: OU-S/Concrete	Issue Category: Changed Site Conditions				
Disposal Area	Issue: This area was not included in the original ROD, but does affect protectiveness at the site. Soil with high pH levels exists and trespassing, including dust-generating activities such as motorcycling and four-wheeling occur at this area. Unacceptable risk exists from direct contact, inhalation or ingestion of soil with high pH levels, and surface water has high pH and enters Unnamed Creek. U.S. Steel is preparing a Concrete Disposal Area Development Response Action Plan to address this area.				
	Recommendation: Develop and implement the response action plan.				
Affect Current Protectiveness	Affect FutureParty ResponsibleOversight PartyMilestone DateProtectiveness				
Yes	Yes	PRP	State	2023

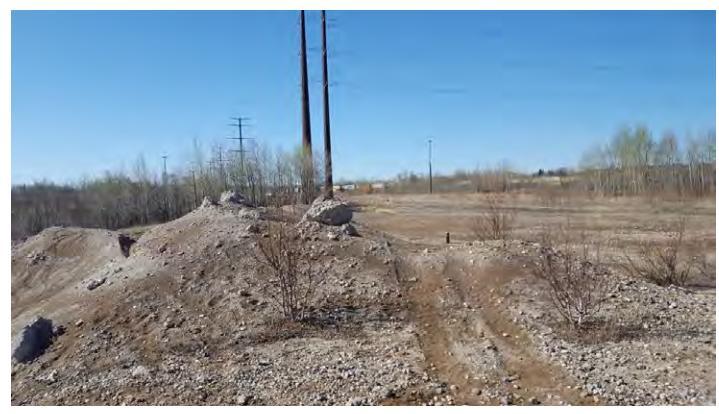
3 OU-S: No change from 2013.

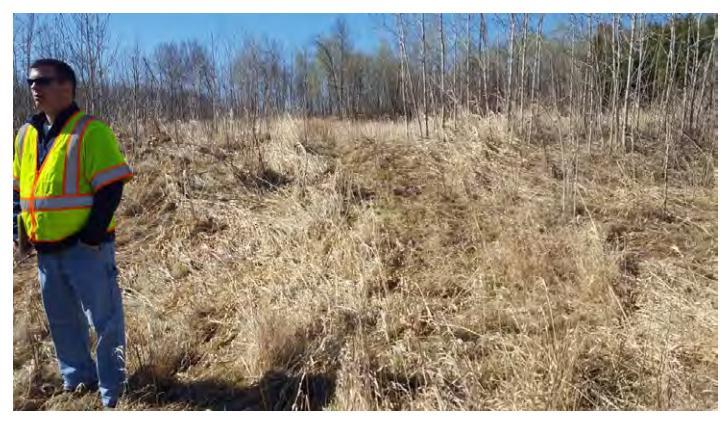
Tree saplings have been observed growing in the soil cover at OU-K. Annual maintenance of the OU-K cap has included spraying for woody vegetation, application of basal bark herbicide and brush clearing when necessary. No erosion of the cap was noted in 2017.

5: OU-K: Vegetation control area from 2013.

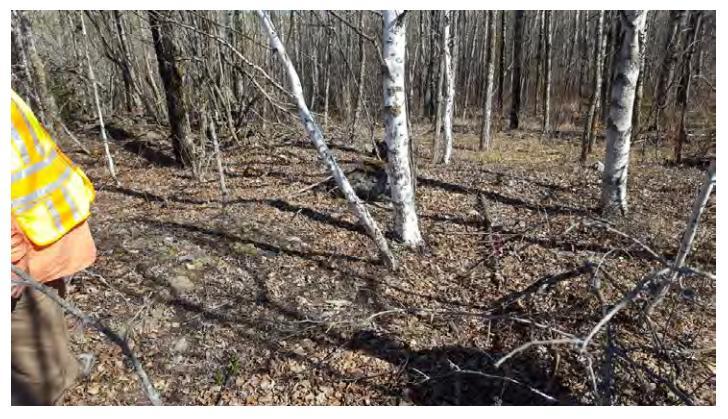
4 OU-S: Isolated areas of iron material, slated for treatment and disposal.

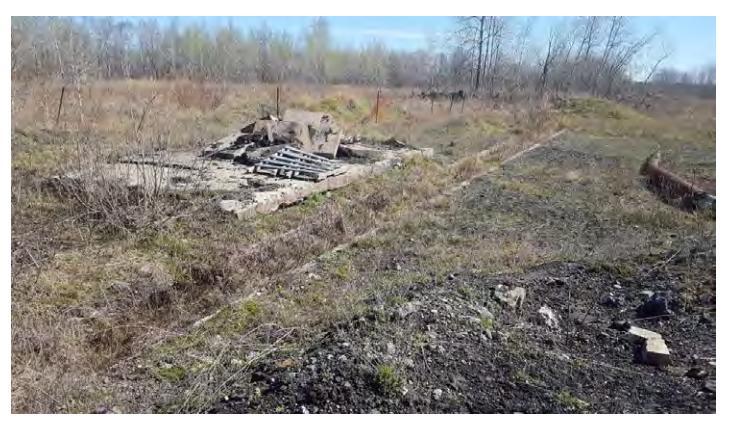
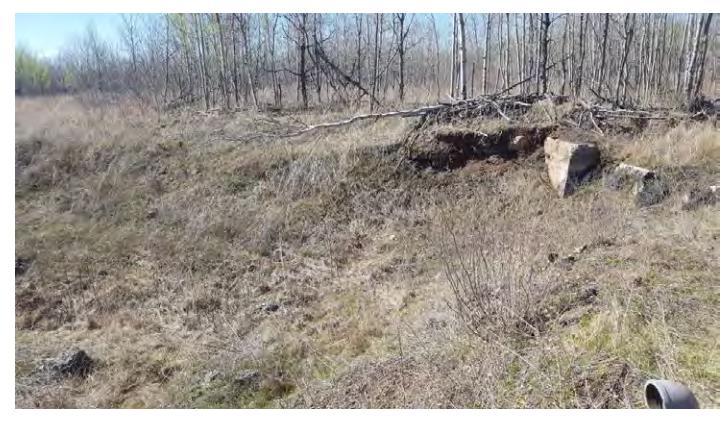
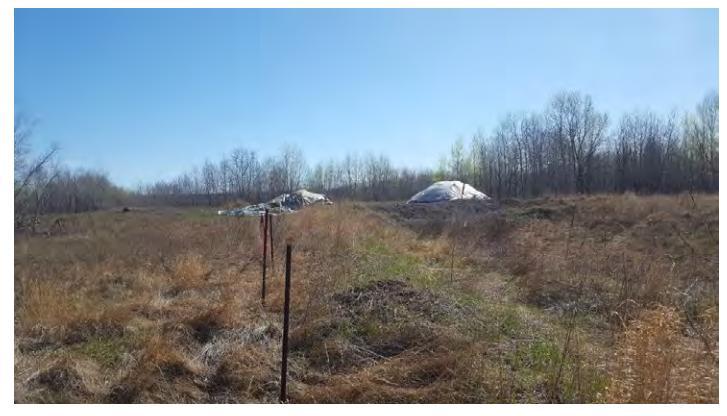
6a: OU-A: Tar pits, trench and fuel oil storage area remediated since 203.

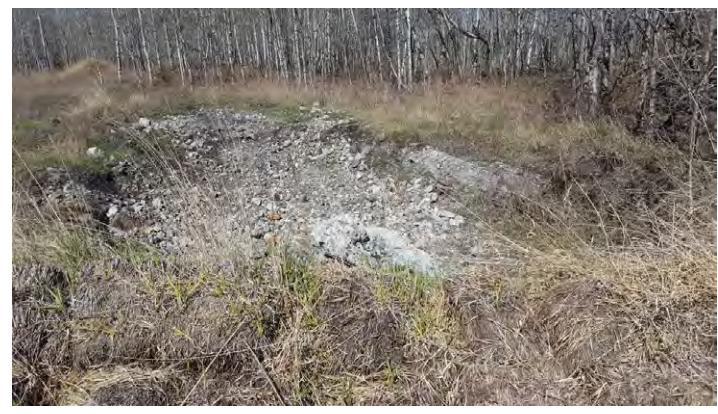
7: OUA: Manhole removed since 2013 inspection.

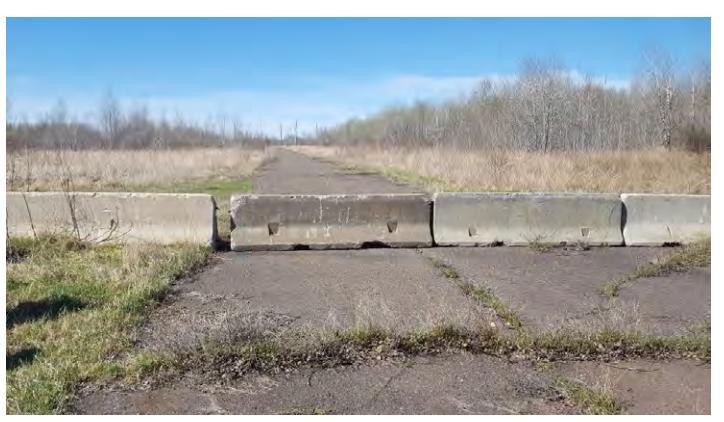
8: Improved site securing since 2013.

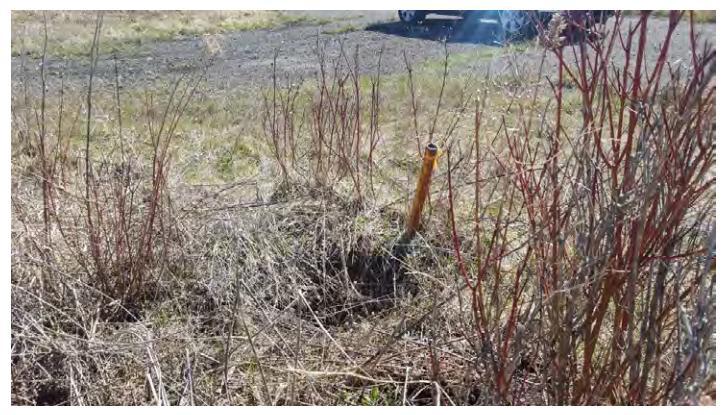
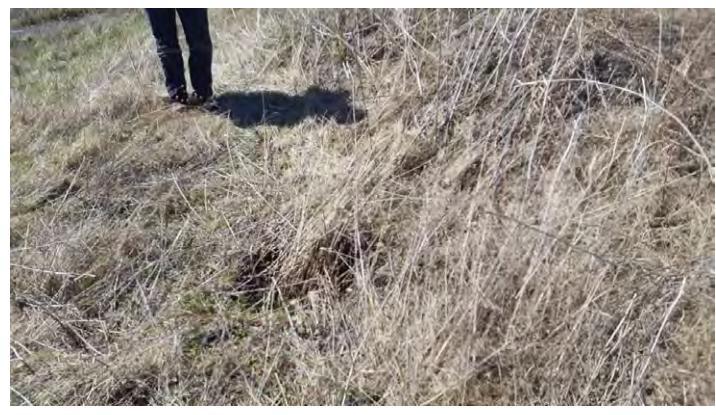
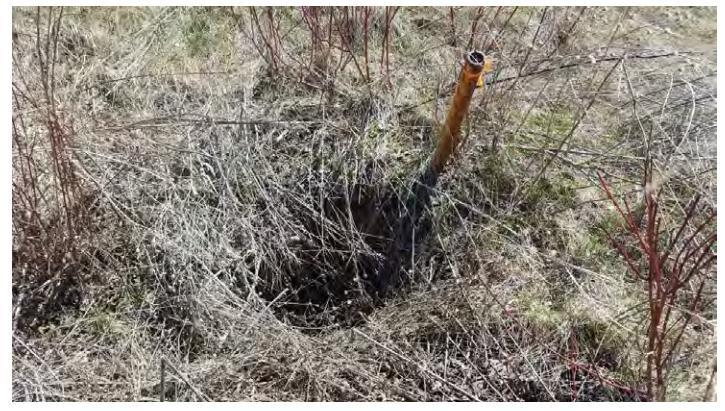
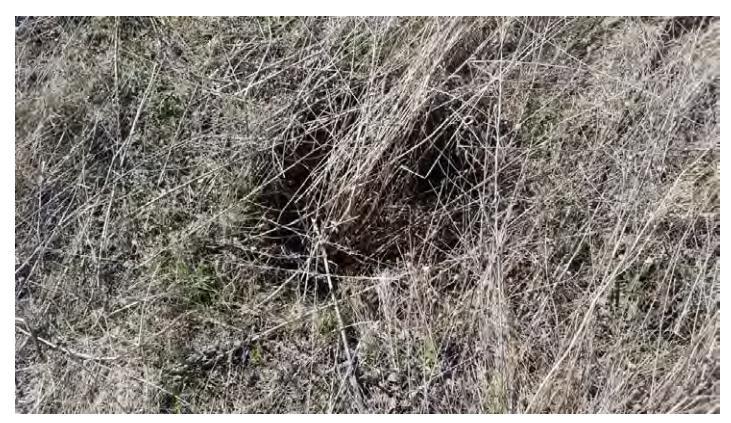
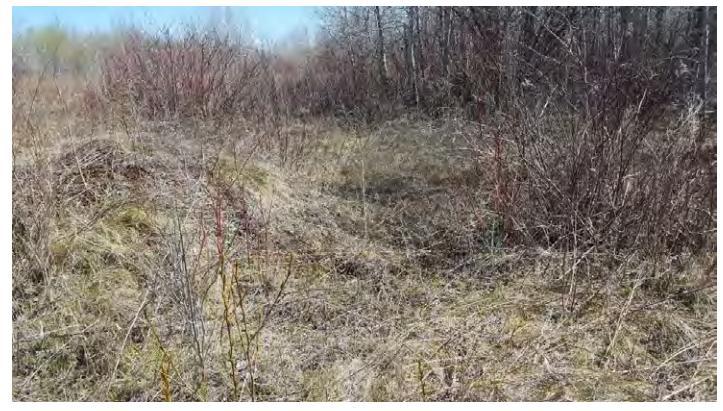
- OU-E: A manhole and pipeline was identified during 2013 FYR site inspection. The manhole (FOSA-2) has been abandoned. The manhole is within Leak Site 18199. A corrective action plan has been submitted and corrective action plan is in progress.

9a: OU-A: Manhole removed since 2013.

Issue: A manhole was identified during the 2013 site inspection with product in it, and has since been removed. Soil surrounding this piping has not been removed.Recommendation: For any future pipe excavations, evaluate soil to screening levels and remediate as necessary.						
Affect Current Protectiveness	Affect Future Party Responsible Oversight Party Milestone Date Protectiveness						
No	Yes	es PRP State 2023

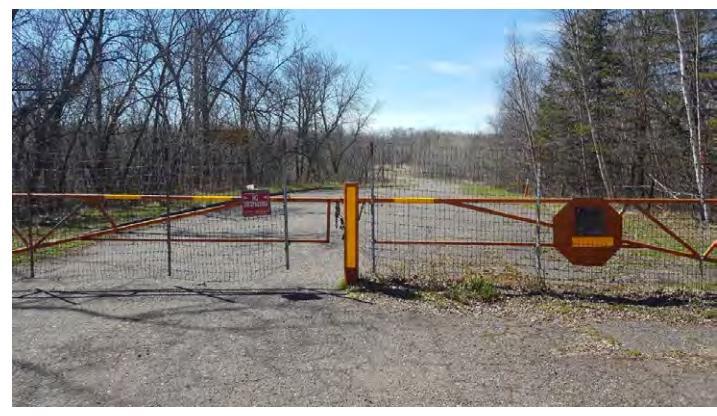
11: Main gate: Access control improved since 2013.

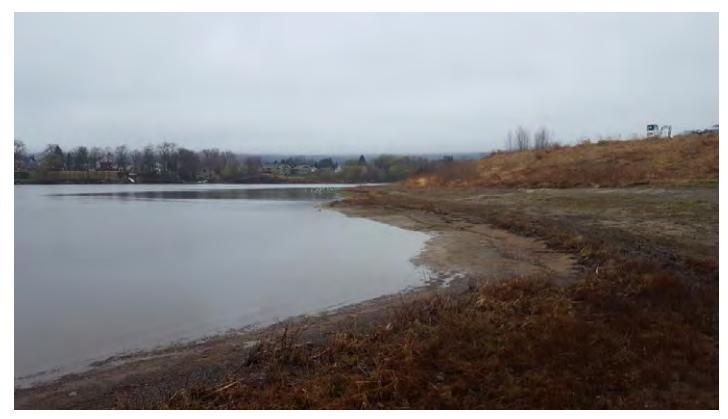
1c: Stryker Bay cap. Area of erosion noted in 2013

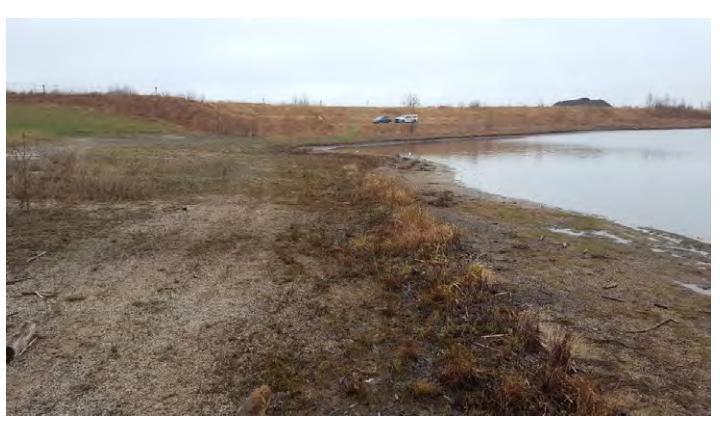
2: Stryker Bay cap. Area of erosion noted in 2013

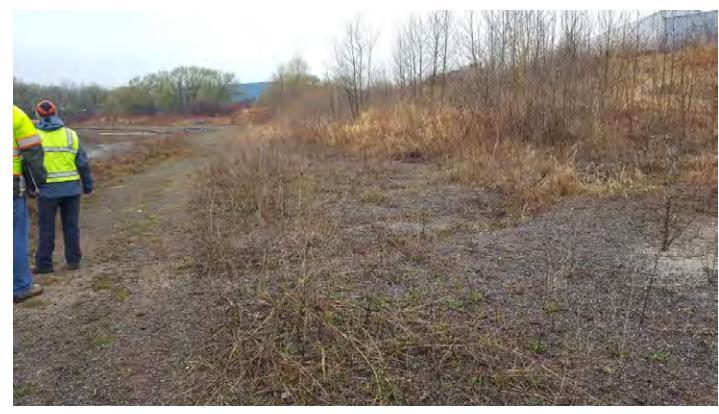
3: Area of erosion noted in 2013

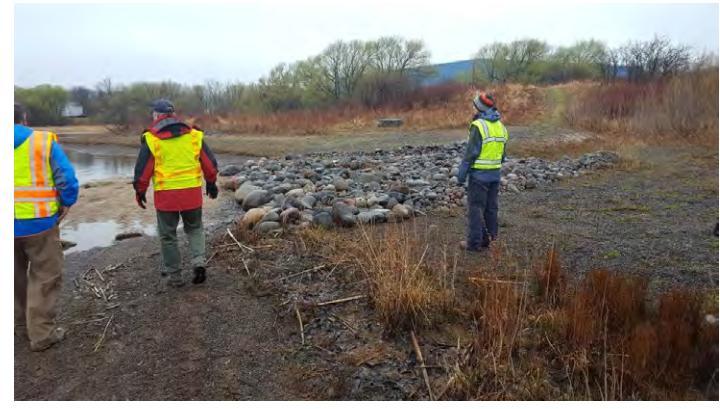
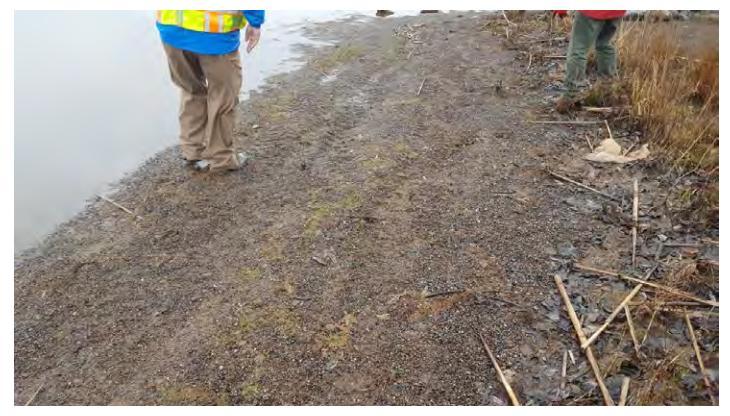
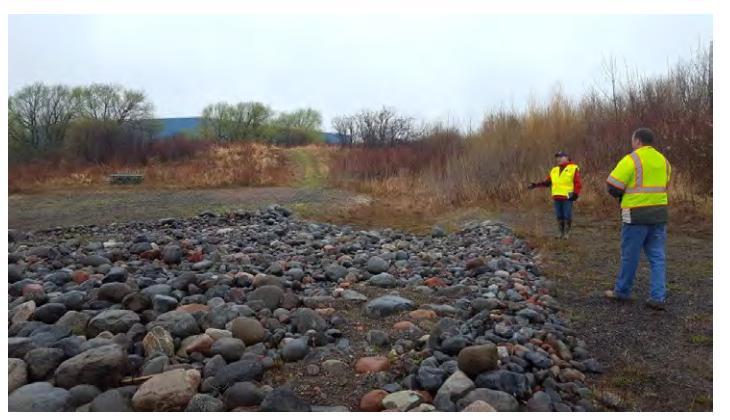
4b: Area of erosion noted in 2013

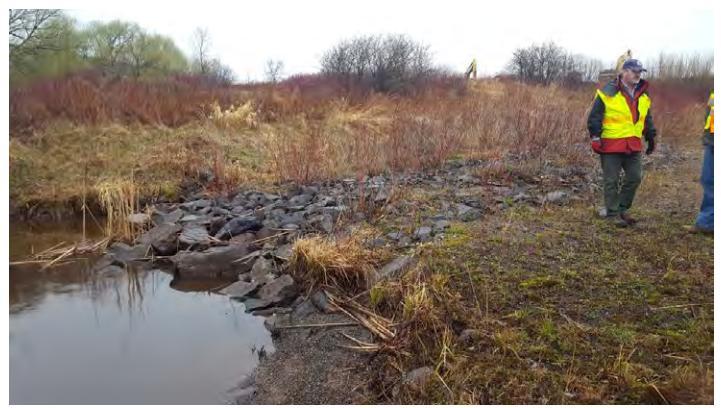
5: Area of erosion noted in 2013

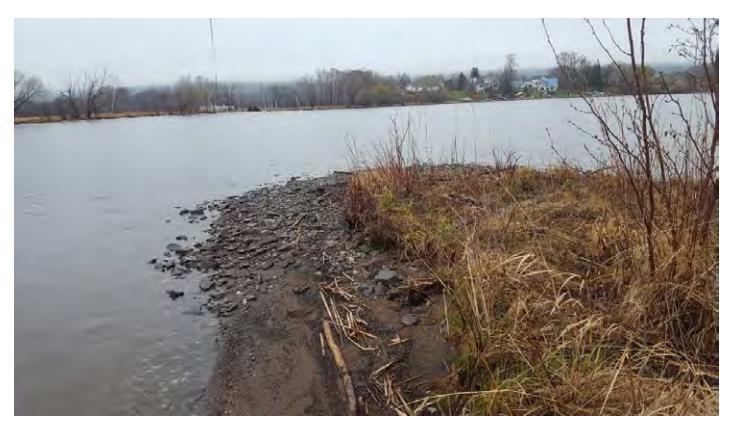
7a: Arrowhead Point, good condition

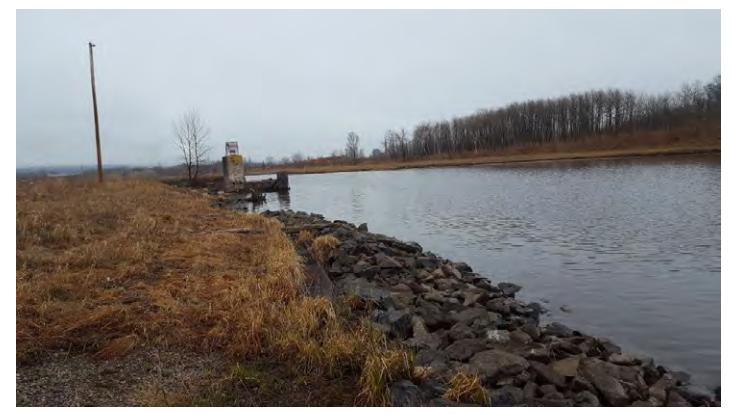
9: Looking down slip 6, good condition.

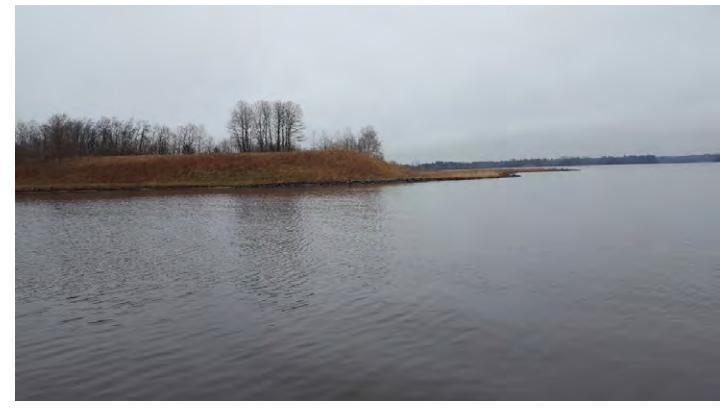
8: Near the end of Slip 6, good condition.

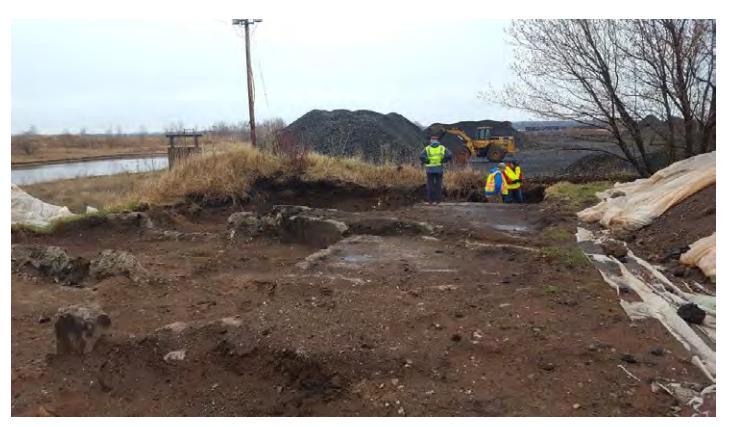
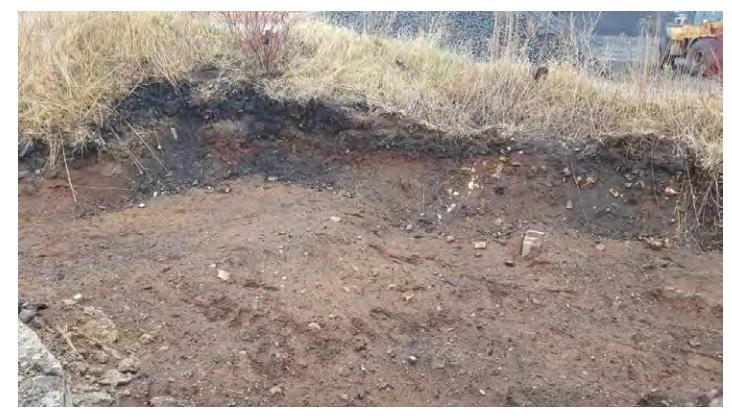
11a: Area excavated in Area B of tar seeps noted in 2013

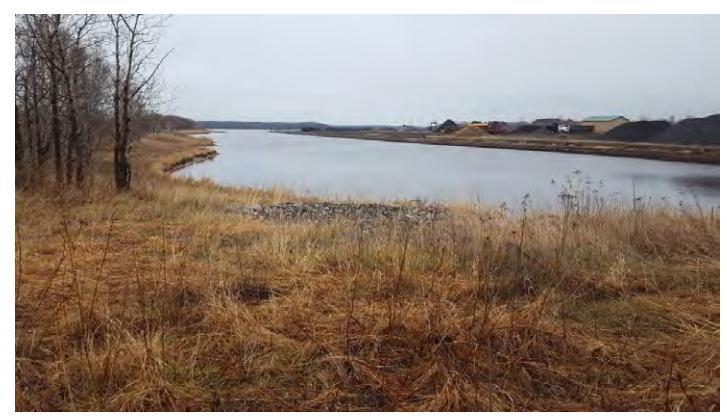
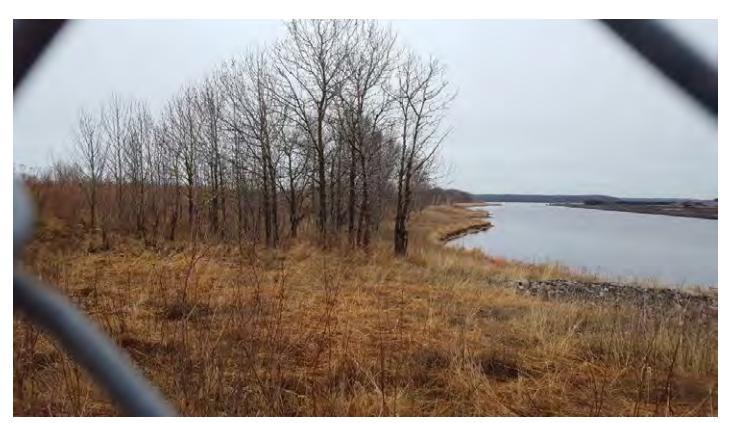
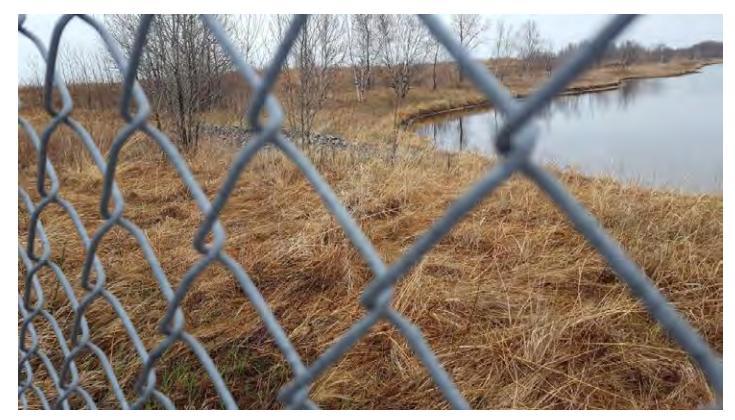
12a: Area of erosion noted in 2009 and 2013

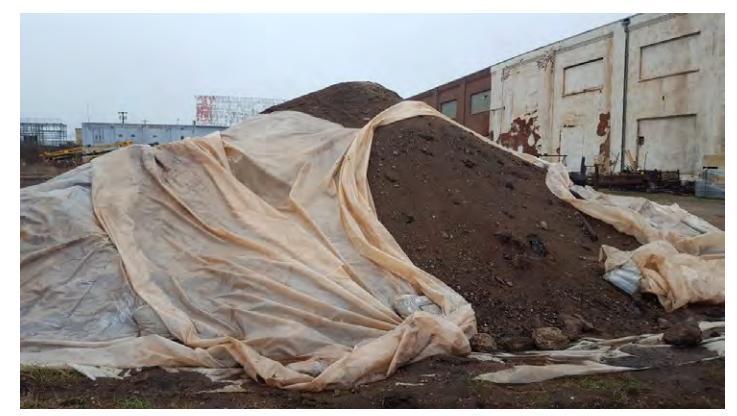
11c: Stockpile of area excavated in Area B

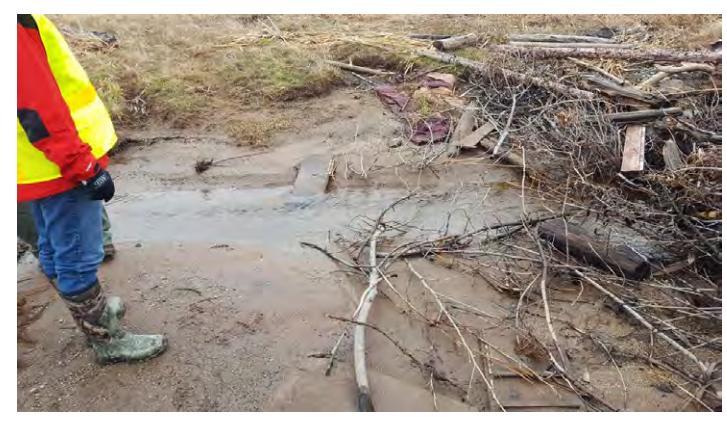
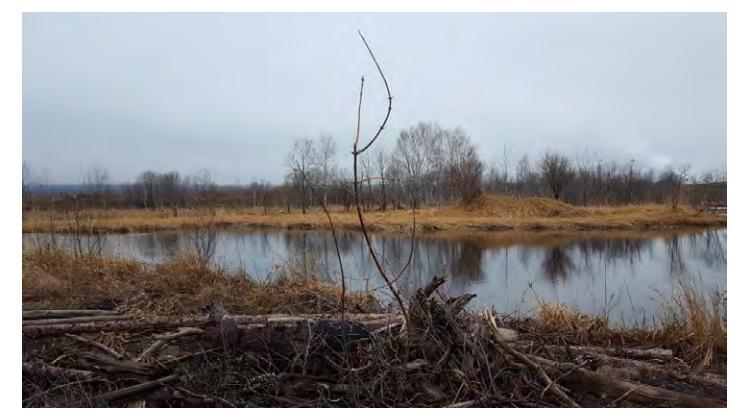
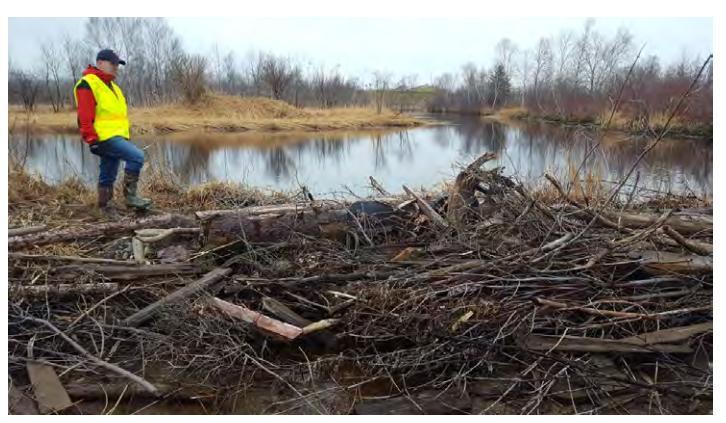
12b: Area dammed by trespassers at the corner of Slip 6

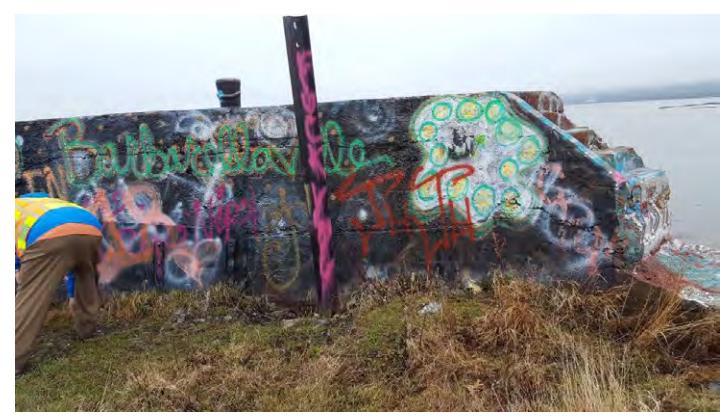
14: Graffiti on building on Slip 6

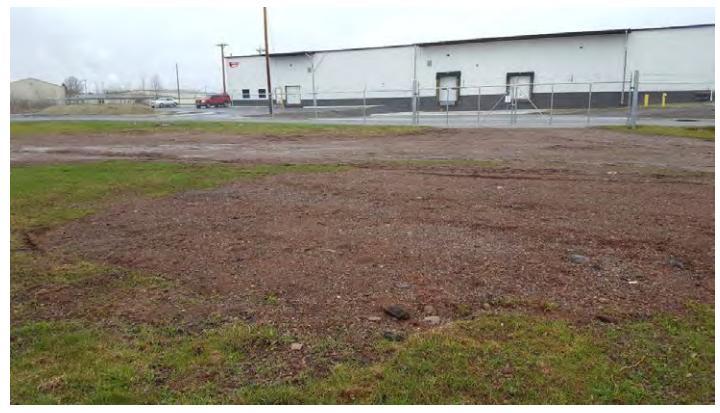
18a: Area E coal tar area observed in 20013

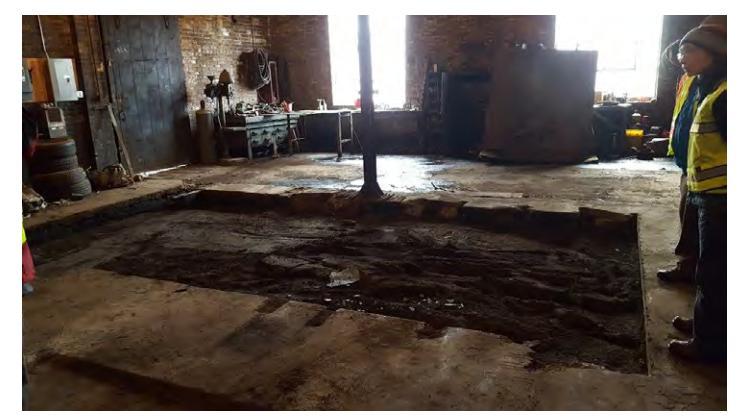
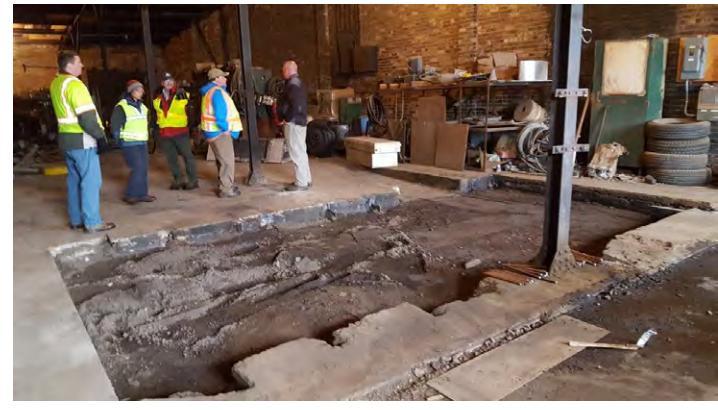
19a: Tar pit observed in 2013, excavated and backfilled
