Missouri River Basin Hydrology, Connectivity, and Geomorphology Assessment Report

MINNESOTA DEPARTMENT OF NATURAL RESOURCES:
DIVISION OF ECOLOGICAL AND WATER RESOURCES

October 10, 2014

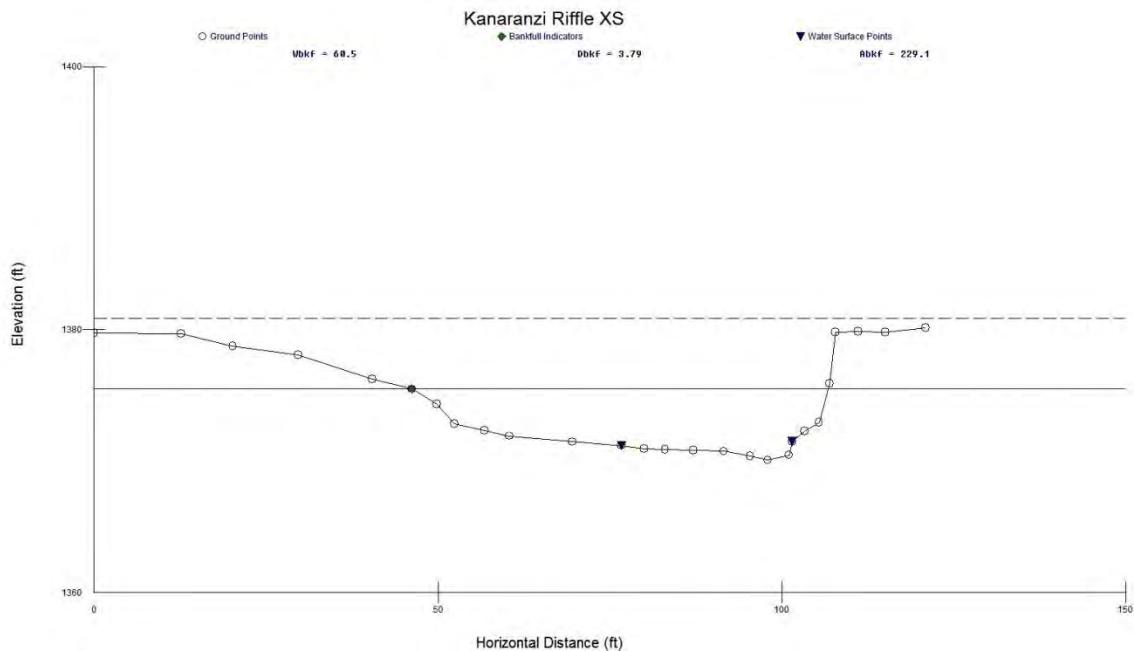
Figure 24. Riffle cross section at Kanaranzi Creek geomorphology site. Although there is still good floodplain connectivity, low bank height is only one foot lower than the floodplain elevation.

channel in its stable state that has evolved to a C channel. Bank Height Ratio (BHR) at this riffle cross section is 1.77, indicating that the channel is deeply incised at this location; however, other riffles throughout the reach had a lower BHR and were somewhat less incised. Raw banks at the site, Pfankuch stability rating, and aerial photo analyses suggest that this stream is going to continue widening out to a high width-to-depth ratio C and could likely go to an F stream type before reaching its stable stream condition again (Figure 25).

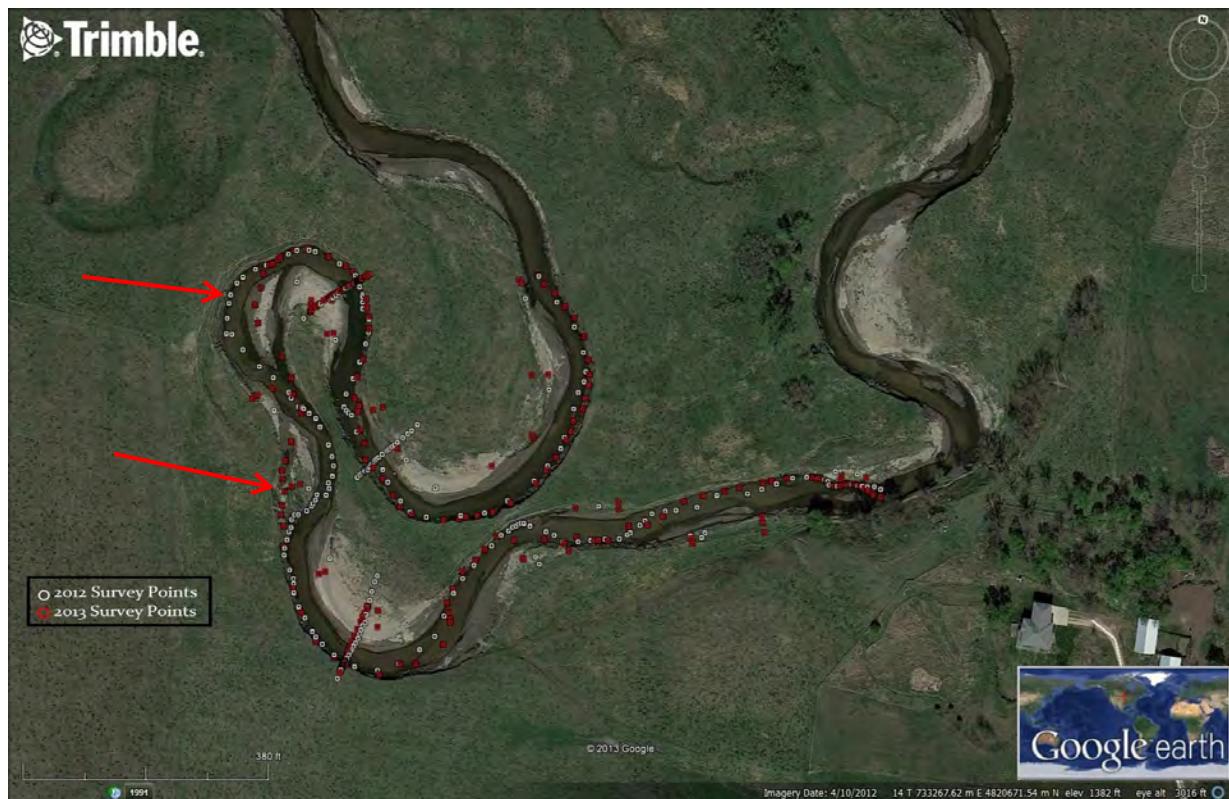
Figure 27. Aerial photo (from Google Earth) of the Kanaranzi Creek site with 2012 and 2013 survey points. Notice the thalweg migration in the areas pointed out.

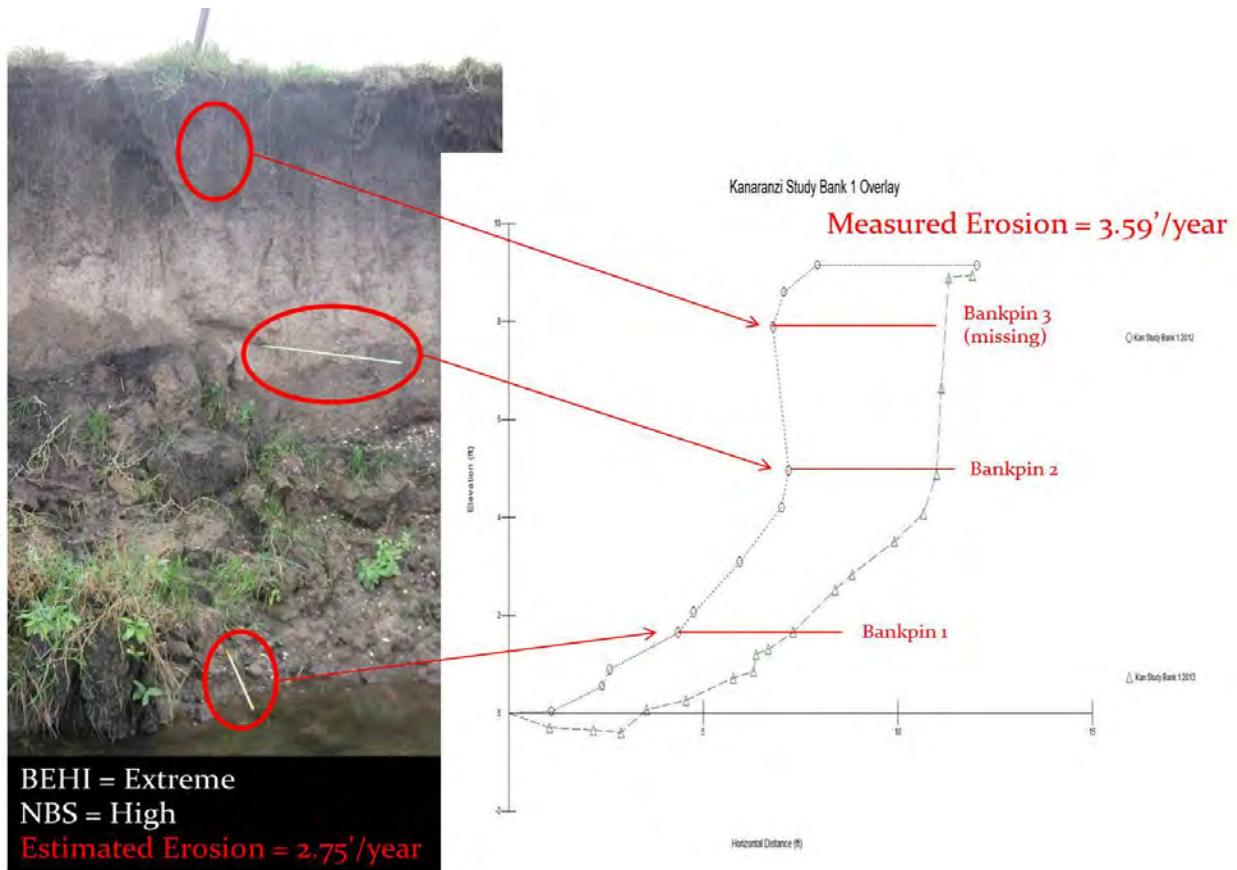
Figure 28. Visual of study bank used to validate bank erosion model by monumenting a cross section and installing three 4' bank pins into the bank. The model estimated there would be 2.75' of bank erosion and actual bank erosion was 3.59' in one year, with the top bank pin being completely removed from the bank. On the other study bank, the model estimated 1.074' and measured 1.86' of bank erosion; again, an underestimation.

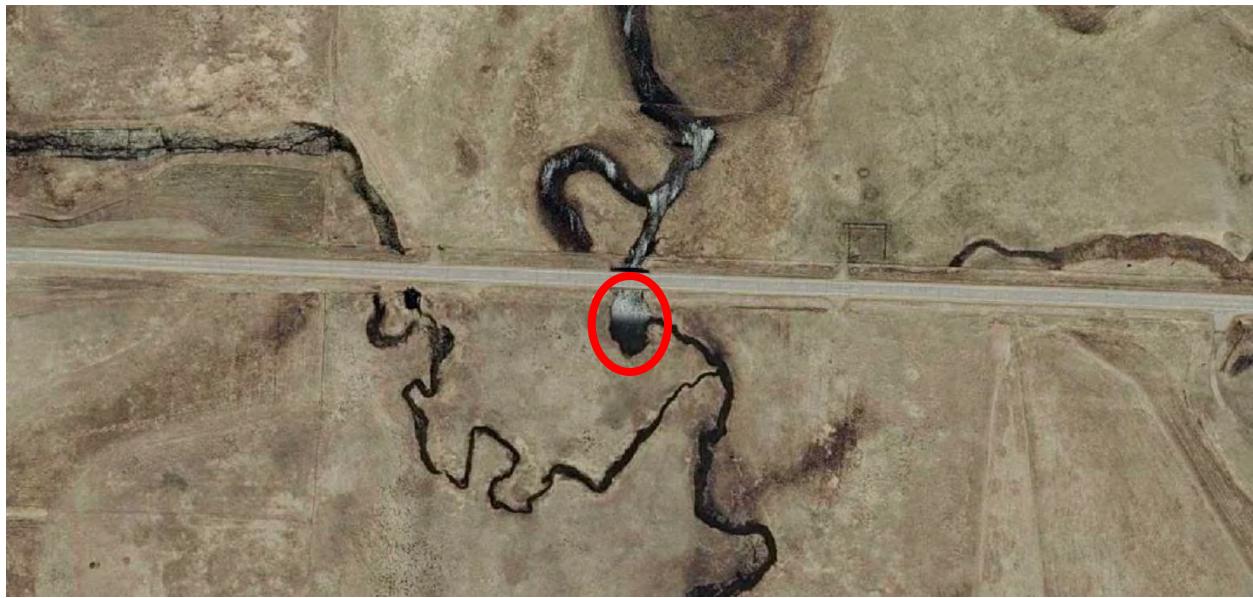
Figure 33. Aerial photo of oversized pool downstream of bridge, immediately upstream of the geomorphology survey reach.

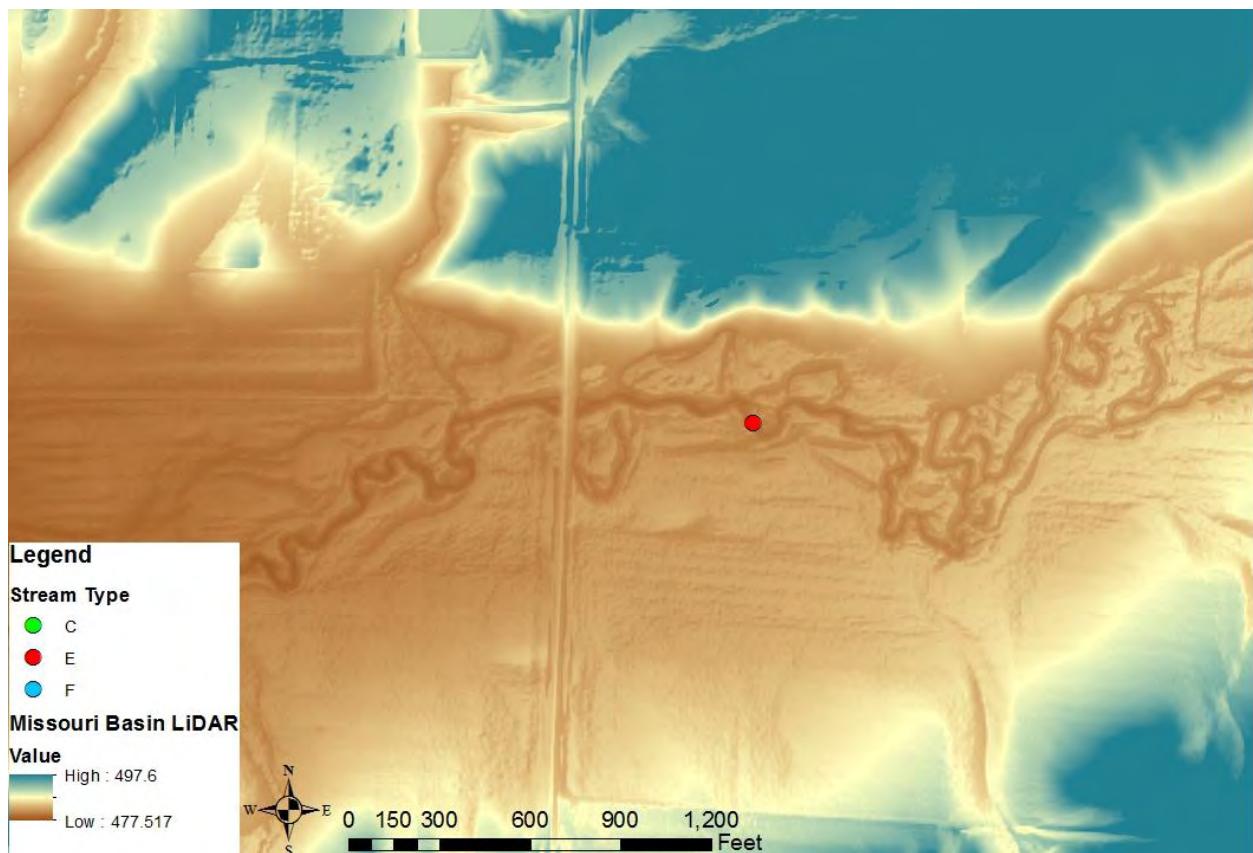
Figure 41. LiDAR imagery shows old meander scrolls in the study reach that had wider belt widths, more consistent with upstream and downstream than what is currently observed. This is likely due to straightening of the channel to go through the culverts under the road crossing.

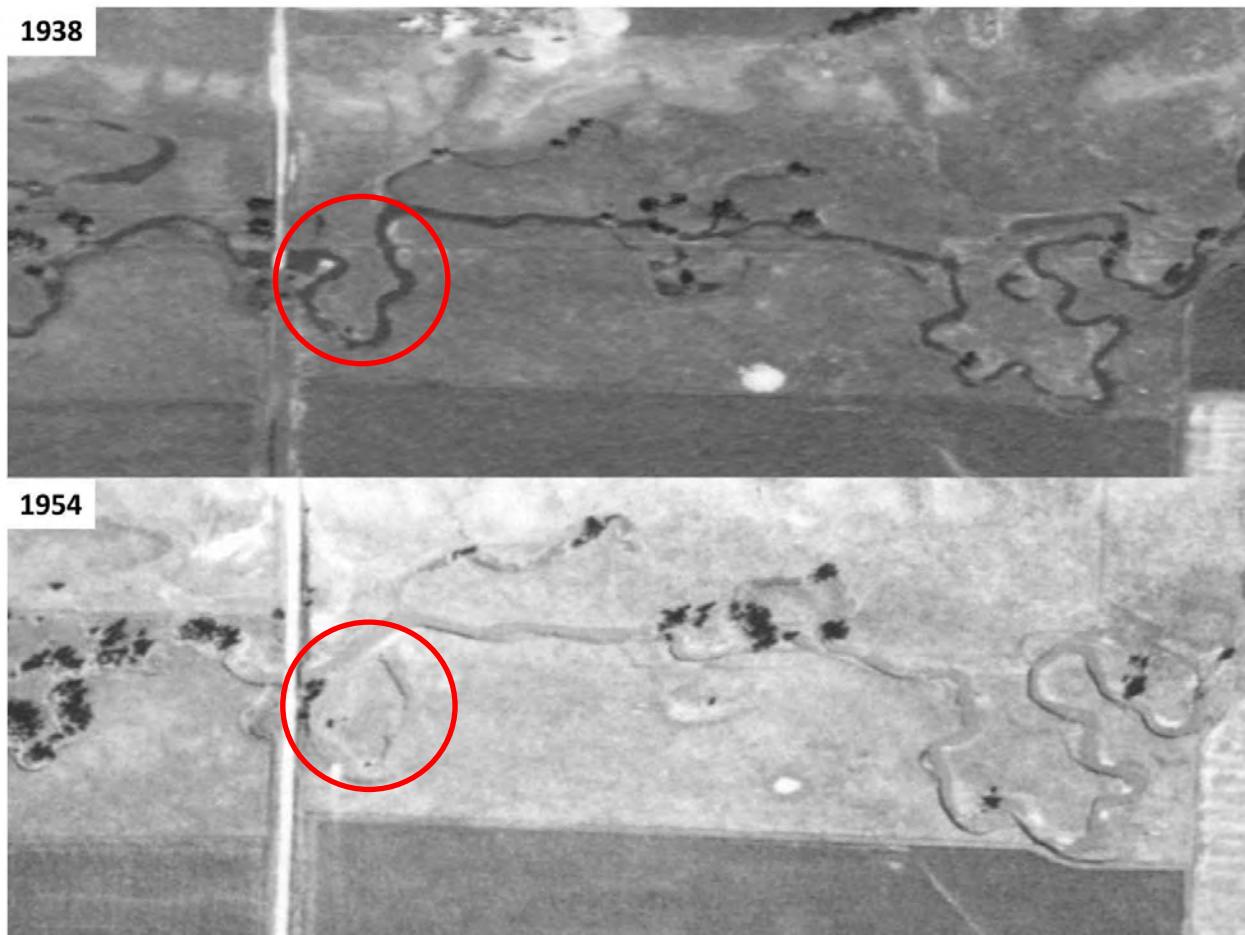
Figure 42. Comparison of the 1938 and 1954 aerial photos at the Little Rock River geomorphology site. Notice the abandonment of the channel (oxbow) immediately upstream of the road crossing from 1938 to 1954.

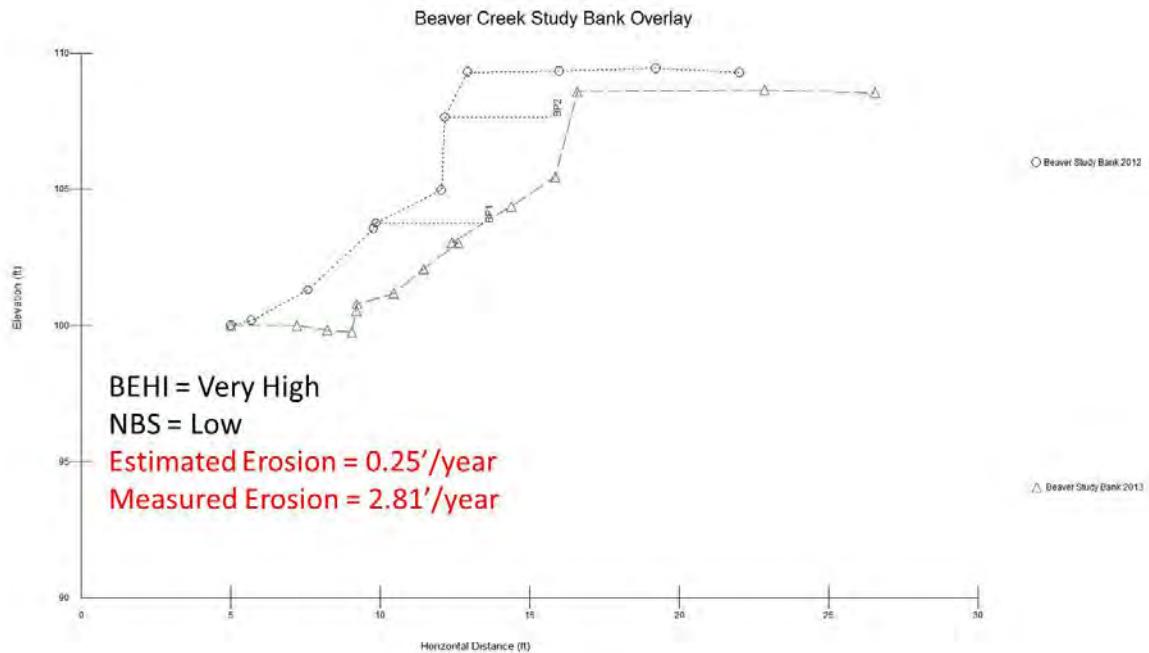
Figure 54. Study bank cross overlay for the Beaver Creek site with estimated and measured erosion rates. Both bank pins were missing when the cross section was resurveyed in 2013. There are some discrepancies with this cross section because the toe pin was buried from thalweg migration and the monument rebar was not there anymore.

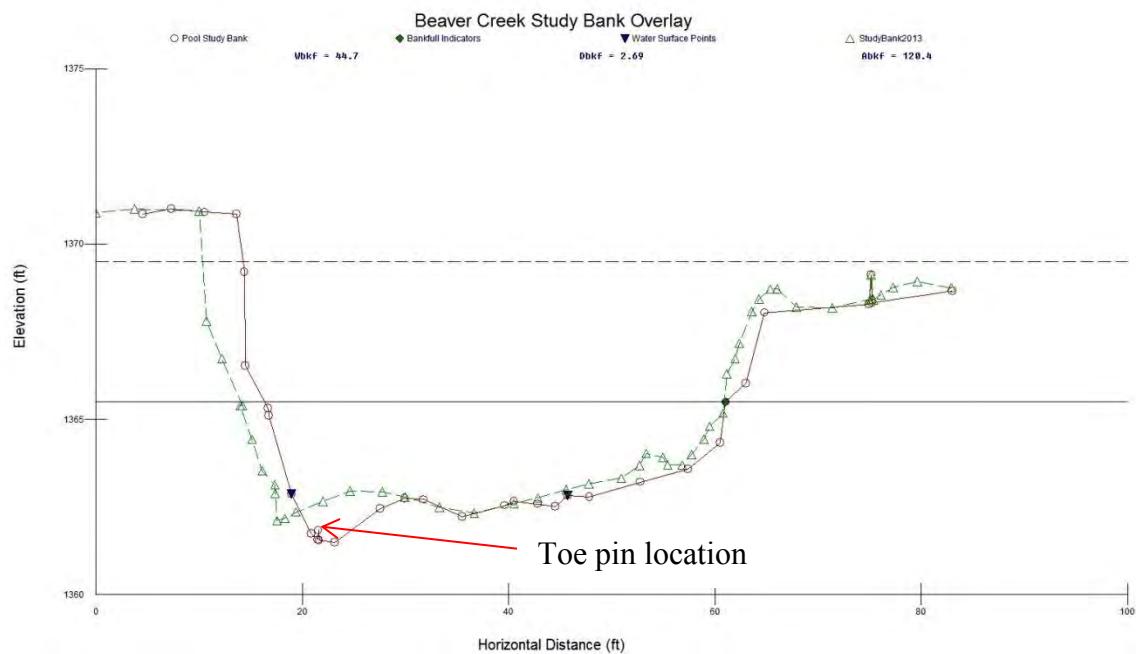
Figure 55. Study bank cross section overlay at the Beaver Creek site. Notice how the thalweg moved and buried the toe pin for the study bank.

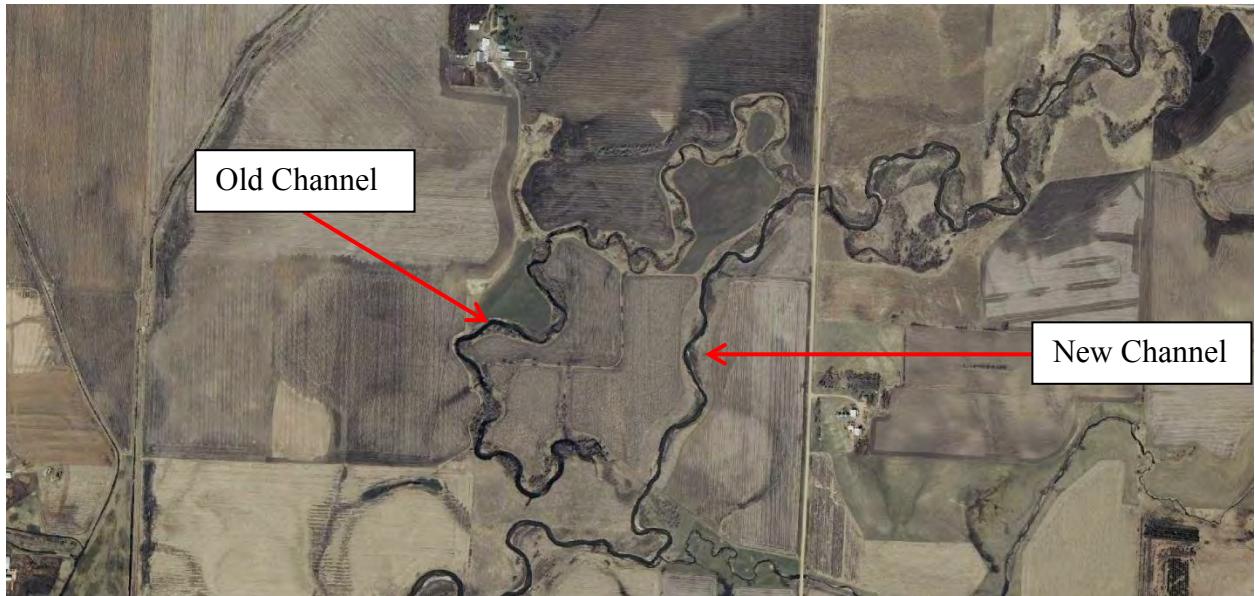
Figure 56. Historical channel cutoff on Kanaranzi Creek upstream of study site. The old channel measures out to be 10,708 feet, while the current channel measures out at 3,319 feet; a difference in 7,389 feet or 1.4 miles. Areas like this should be restored into their old channel in order to achieve higher water storage potential and maintain channel stability.

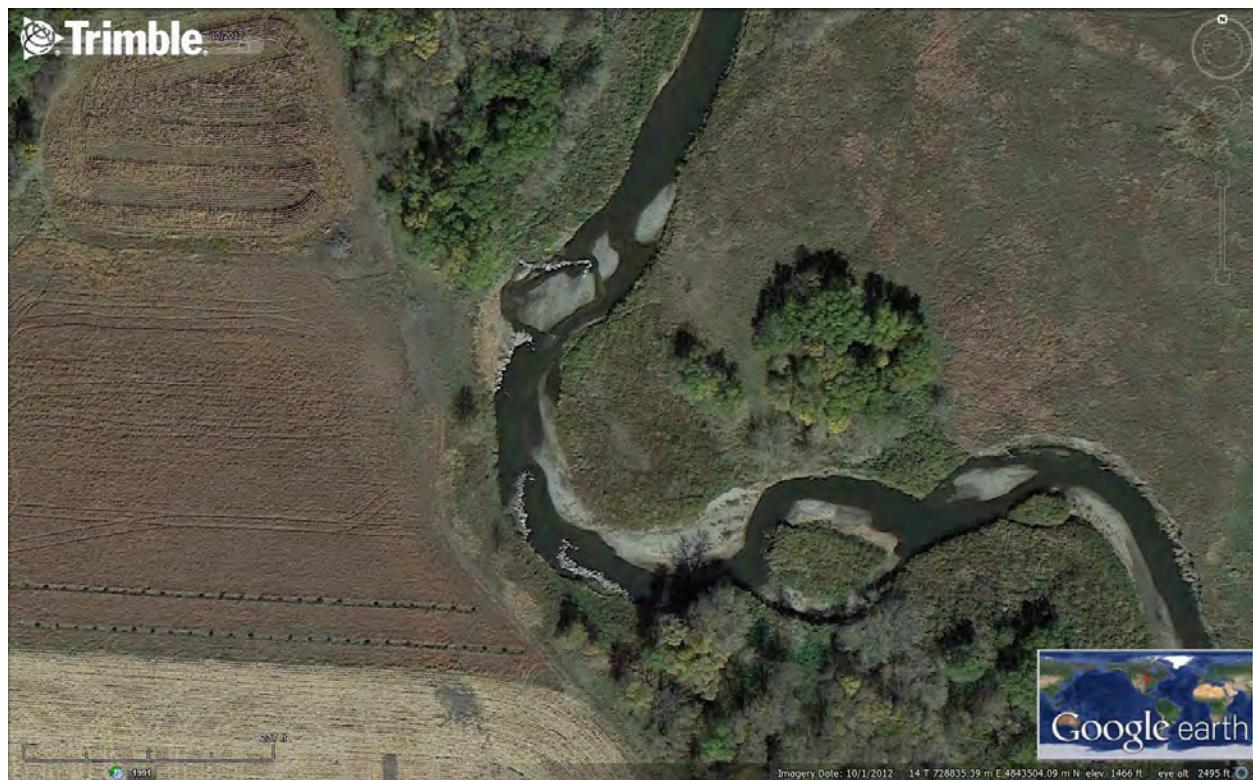
Figure 57. Aerial photo of a J-hook project on the Rock River that was designed outside of specifications made for J-hooks. This has resulted in issues with bedload deposition downstream of the 1st J-hook. Photo courtesy of Google Earth.
