Red Lake River Watershed Total Maximum Daily Load Report

This is a report for restoring waters throughout the Red Lake River major watershed that are impaired by total suspended solids, *E. coli*, low dissolved oxygen, or low index of biotic integrity scores.

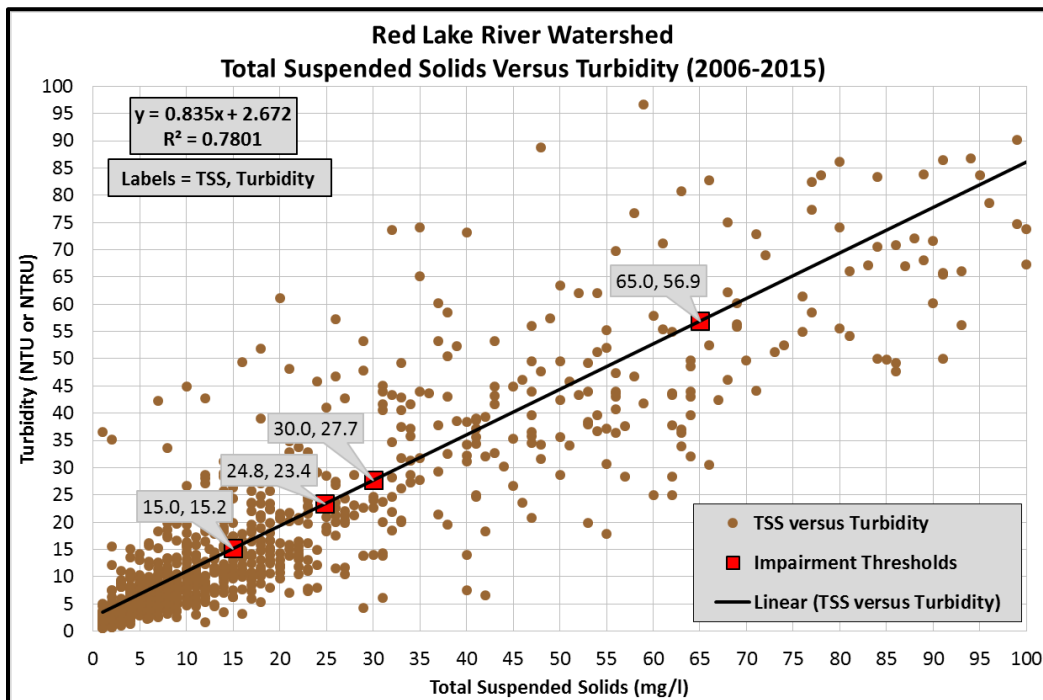
Figure 3-9. A comparison of TSS and turbidity values within the Red River (09020303) Watershed. The data source was all data collected in the years 2006 through 2015 that was stored in the EQuIS database in early 2016.

Prior to the MPCA’s adoption of TSS water quality standards to replace the 25 NTU turbidity standard, there was concern about whether or not it is possible for any of the rivers in the lower areas of the Red River Valley ecoregion to meet the 25 NTU standard based on the natural geology and soil types. The new 65 mg/l TSS standard that will be applied to rivers in the Red River Valley allows a level of suspended sediment that is approximately twice as high as the amount allowed by the former turbidity standard. A comparison of TSS and turbidity readings (Figure 3-9) shows that similar numerical values for the two measurements represent similar levels of sediment. Despite the raised impairment threshold; however, restoring the lower reaches to the point at which they are meeting the standard will still be challenging. In 2005 through 2014 data, the exceedance rate of the 65 mg/L TSS standard in the Red Lake River at the Fisher monitoring site (S000-031) was 55.3%. The impairment is less severe within upstream reaches (Figure 3-10). The decreased exceedance rate in 09020303-503 versus the upstream reach of 09020303-501 is a product of sampling schedules rather than improved water quality conditions. A longitudinal “snapshot” of water quality during a runoff event (Figure 4-14) revealed that TSS concentration increased significantly between Fisher and East Grand Forks. Sampling in East Grand Forks (09020303-503) is conducted for long-term condition monitoring programs. Sampling in Fisher (09020303-501) has also included sampling for load monitoring programs that conduct intensified sampling during high flows. The Red Lake River upstream of Crookston (09020303-512) was listed as impaired by high turbidity. It has very little TSS data, but TSS samples are now being regularly collected by local monitoring programs at Station S000-042. It remains on the list of impaired waters because there is insufficient TSS data to prove that it is meeting standards, and both upstream and downstream AUIDs are impaired by high TSS.

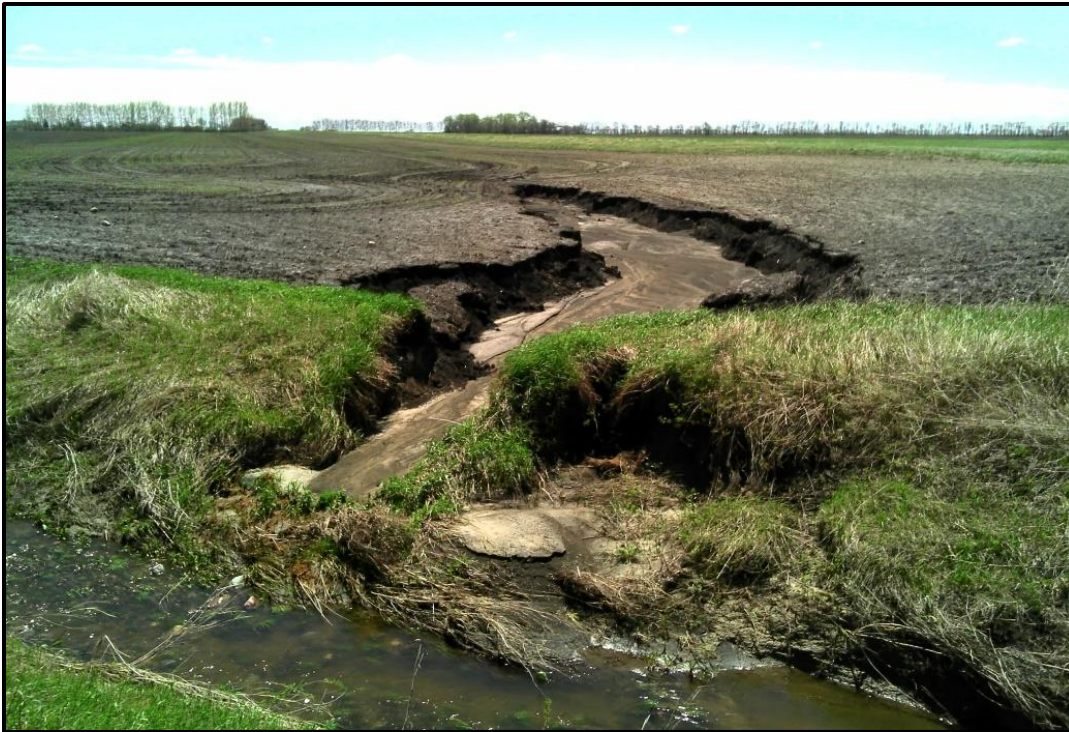
Figure 4-4. Large gully in the Burnham Creek Watershed, east of the 340th St. SW crossing.

Overland erosion has been documented in many forms. Gully erosion is occurring within cultivated fields. Gully erosion of private field ditch outlets has been documented in the watershed. Side water inlets and other BMPs need to be implemented to prevent future gully formation. Stream power index layers have been created to identify all flow paths that are highly susceptible to erosion. During windshield surveys, individual erosion sites like the one in Figure 4-4 were documented with georeferenced photographs. Figure 3-5 land use map shows the prevalence of agricultural land in the watershed – land that is susceptible to overland erosion.

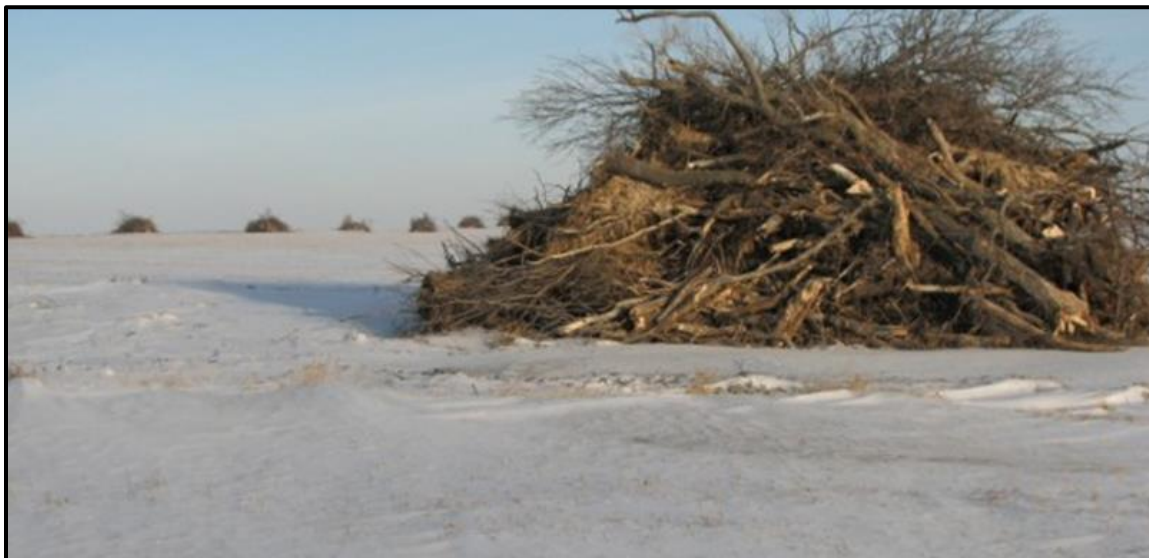
Figure 4-5. Photo of a field windbreak that is in the process of being removed.

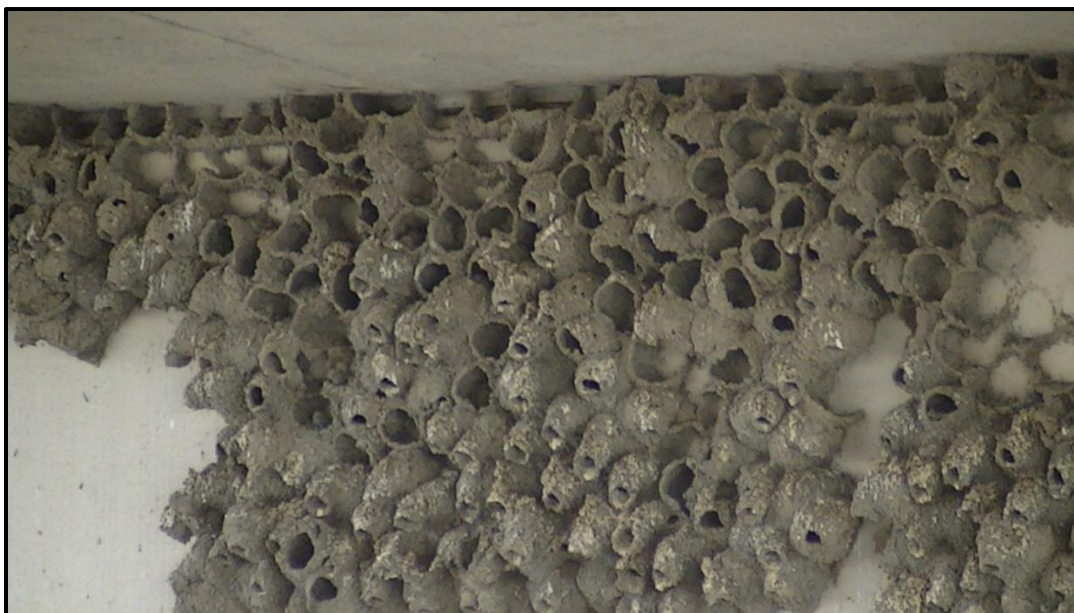
Figure 4-16. Cliff swallow nests under a bridge.

There are; however, situations in which natural sources of bacteria can become a source of excess bacteria. Concentrated populations of animals near a waterway can contribute enough *E. coli* bacteria to create an impaired condition. Birds and waterfowl congregate at locations that provide favorable habitat and food. Birds have been proven to be a source of *E. coli* in some of the impaired streams in the Red Lake River through Microbial source tracking analysis and observations made during sampling. Microbial source tracking is a method for identifying the type of animal that is the source of fecal coliform and *E. coli* pollution. Cliff swallow communities under bridges and inside box culverts are a significant source of fecal bacteria from birds. The nests are built above the water and are heavily concentrated. Swallows can be numerous in flocks that reside under a bridge (Figure 4-16) and they swarm over the water when disturbed (e.g., when someone is sampling at the site). During sampling visits, the birds swarm around the bridge and over the water. Their droppings fall with regularity into the water that is being sampled. Flocks of waterfowl congregating in wetlands or in stream/ditch channels can cause high *E. coli* concentrations in downstream waters in some circumstances. High *E. coli* concentrations in the Gently River were tracked upstream to the BR-6 impoundment. However, it is important to note that not all wetlands are sources of excess *E. coli* bacteria. Water flowing out of a restored wetland in the headwaters of Kripple Creek during a runoff event had an *E. coli* concentration that was safely below the 126 MPN/100ml standard.

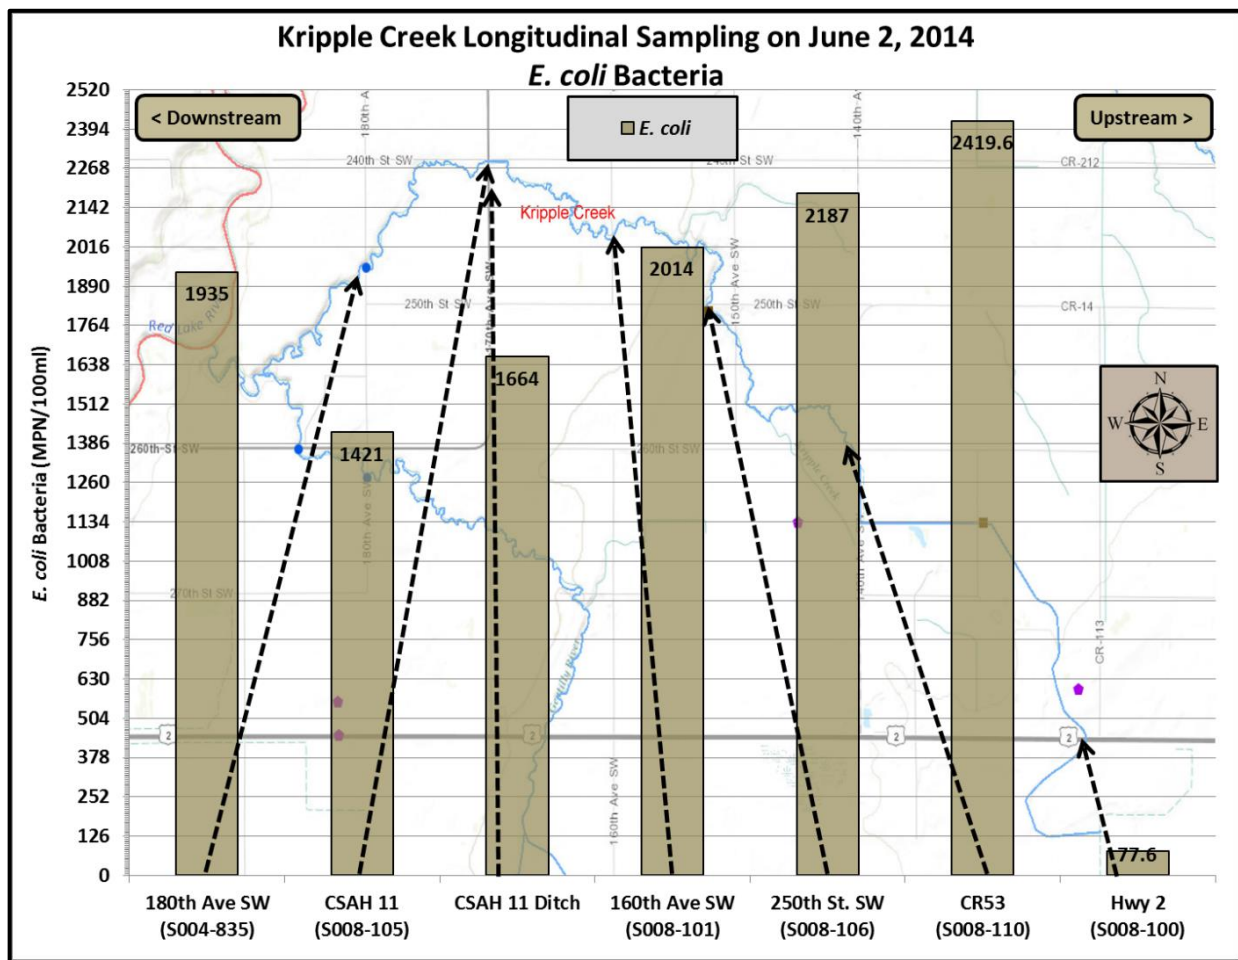
Figure 4-18. Longitudinal profile of *E. coli* concentrations in Kripple Creek during a June 2, 2014 runoff event.

Kripple Creek begins in Glacial Ridge National Wildlife Refuge and flows northwest (generally) to the Gentilly River. High turbidity and *E. coli* levels have been observed at the lower end of the watershed during routine monitoring. Longitudinal samples were collected along Kripple Creek on June 2, 2014 (Figure 4-18), during a rainfall event. The sampling revealed sources of sediment and *E. coli*. The longitudinal TSS results can be found in the Red Lake River WRAPS report. The longitudinal sampling results for *E. coli*, germane to the impairment, are shown in Figure 4-18. Water flowing from Glacial Ridge NWR at the upstream end of Kripple Creek was very clean. *E. coli* concentrations greatly increased downstream of a farm with livestock near the intersection of 260th Street Southwest and 140th Avenue Southwest in Section 30 of Pleasant Township in Red Lake County. *E. coli* concentrations actually decreased at each of the next three crossings that were sampled and then increased again downstream of CSAH 11 (where there are some horses along the stream).

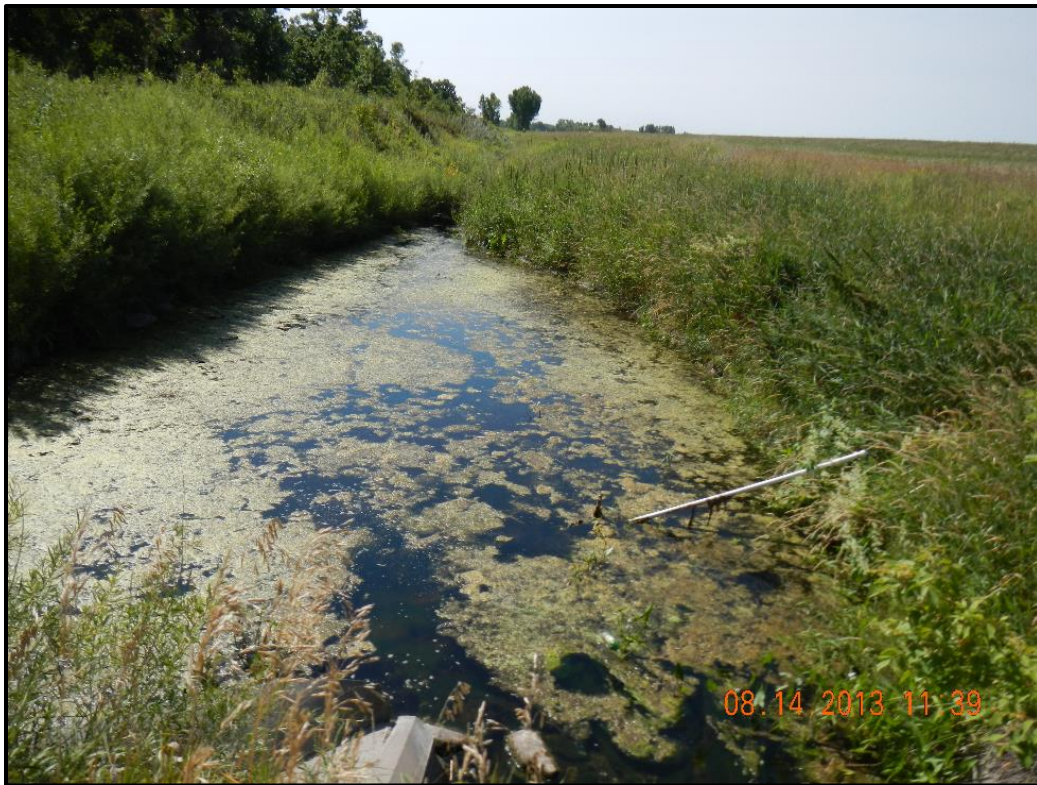
Figure 4-36. JD60 at S007-062 on August 14, 2013; DO was low, flow was 0 cfs, and filamentous algae growth was extensive.

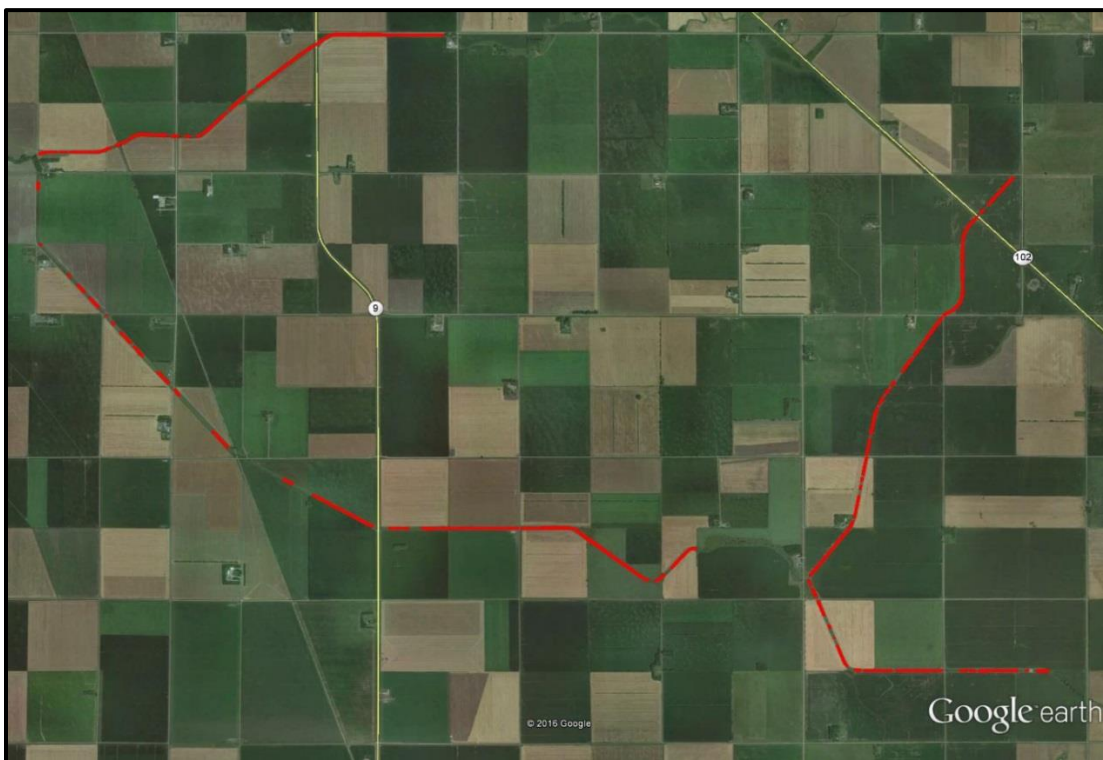
Figure 4-47. Extent of 2016 aerial herbicide application along Burnham Creek.

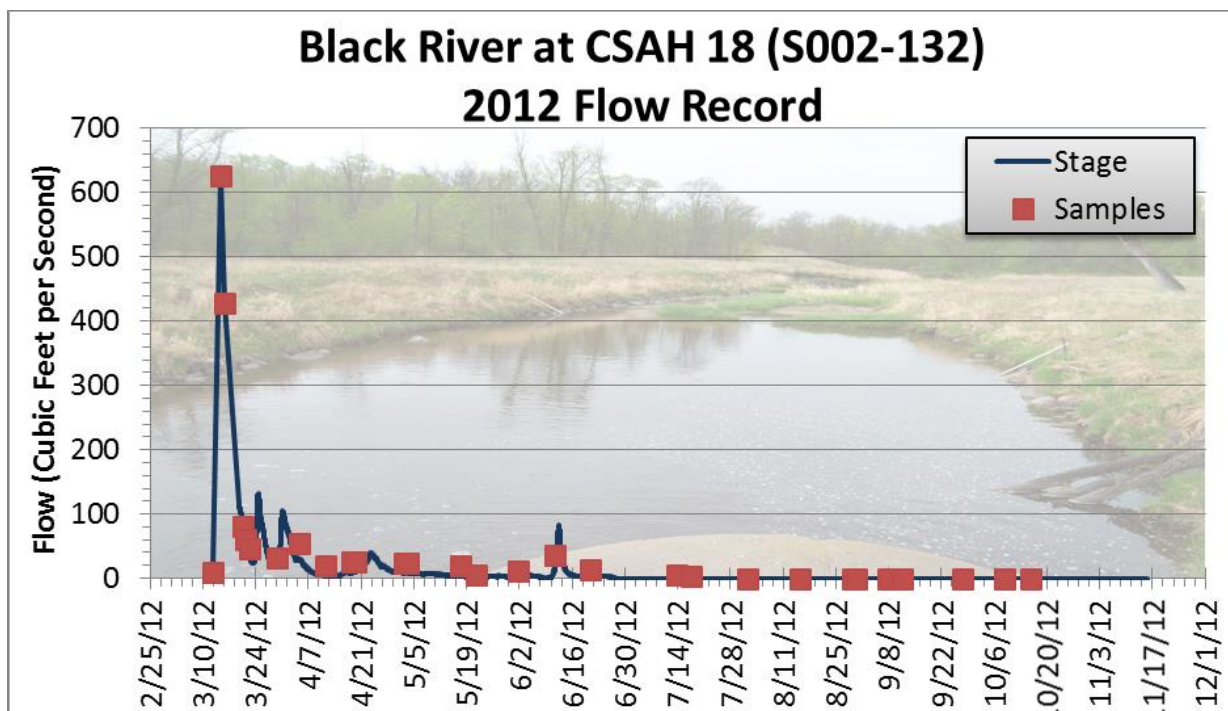
Figure 4-59. 2012 flow record for the Black River.

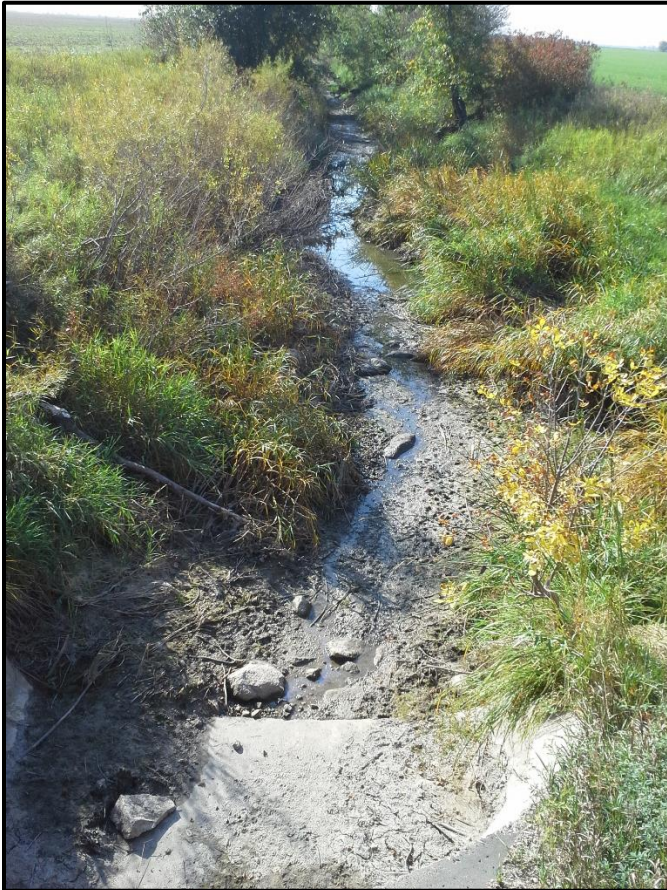
Figure 4-63. No-flow conditions in the Black River at 120th St. NW (S003-948).
