Mississippi River-St. Cloud Stressor Identification Report

Minnesota Pollution Control Agency

March 2013

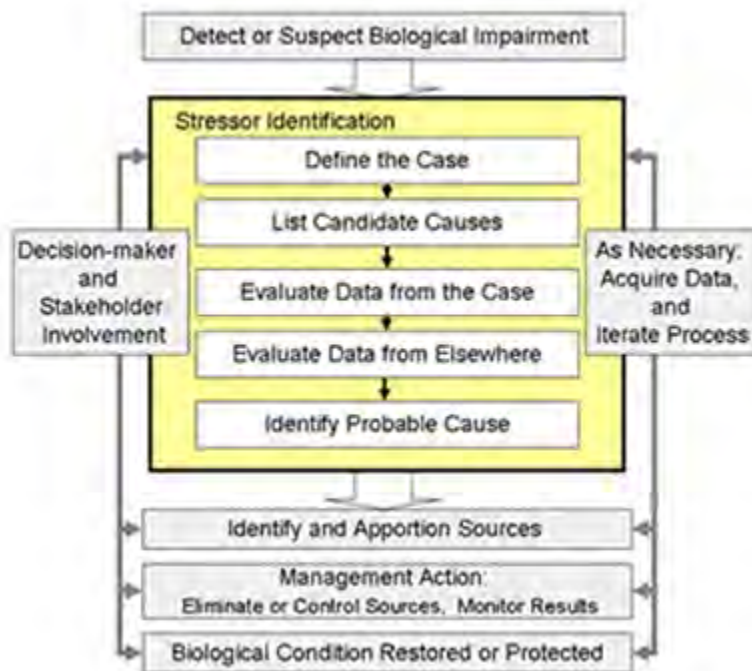
The Stressor Identification (SI) process is prompted by an assessment of biological monitoring data as not meeting the expected community composition. Through a review of available data, stressor scenarios are developed that may accurately characterize the impairment, the cause, and the sources/pathways of the various stressors. Confidence in the results depends on the quality of data available. In most cases, additional data is then collected from impaired reaches to accurately identify the stressor(s).

Figure 3: Conceptual model of stressor identification (SID) process

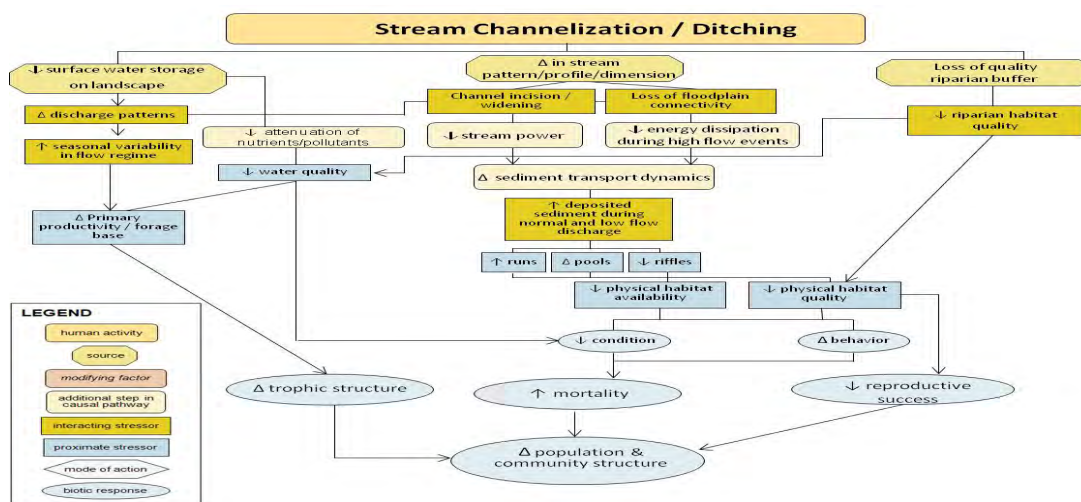
A conceptual model for stream channelization is shown in Figure 8. This candidate cause for impairment can influence biota via numerous pathways involving water chemistry, channel geomorphology, and physical habitat changes.

Figure 8: Candidate cause # 1: Altered biology based on stream channelization/ditching

The conceptual model (Figure 8) for this candidate cause highlights changes in trophic characteristics, reproductive success, and community structure as potential biological effects resulting from stream channelization. A selection of fish metrics covering these traits, along with their predicted response to stream channelization, is shown in Table 5. Fish metric values were calculated from a total of 30 sites in Class 6 streams scattered throughout the MR-SC watershed. Of the 30 sites used to investigate biological response to channelization, 18 were channelized and 12 remain in natural channel form. The natural channel sites are affected by upstream channelization in most cases. The quality of habitat in the natural channel sites is affected by altered flow regimes and the natural sites are negatively responding to these alterations.

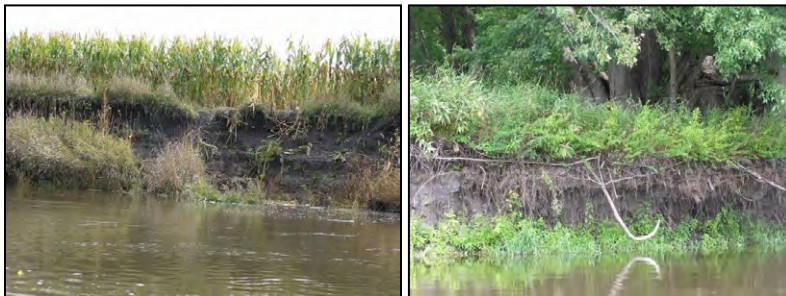
Figure 12 shows examples of bank erosion observed throughout the MR-SC Watershed. Bank erosion occurred within urban/developed areas, along the edges of cultivated cropland, and even heavily-wooded riparian corridors. This suggests that there are multiple land uses and erosional processes contributing to increased sediment inputs and sediment-related stressors to aquatic life. Buffers of inadequate width to protect streambank integrity and aquatic habitat were observed throughout the MR-SC Watershed.

Figure 12: Examples of bank erosion from various land cover types in the MR-SC Watershed

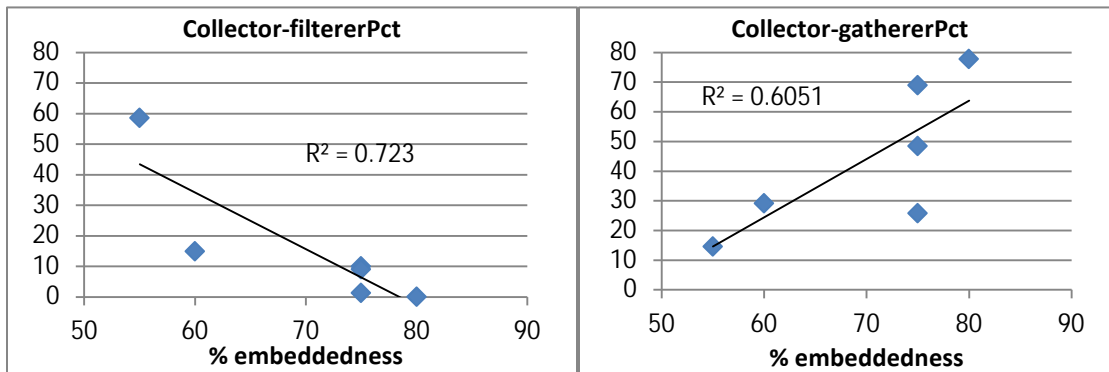
Filter feeding groups of macroinvertebrates are reduced in sites that are impacted by TSS and substrate embeddedness. Figure 13 displays the relative abundance of two macroinvertebrate functional feeding groups for streams where we had collected both macroinvertebrate and stream sediment data. This subset of sites is from impaired streams. There was little substrate data from unimpaired streams to use as a reference. As water quality degrades through the increase in suspended material, or increased fine material in stream bottom, filter-feeding groups are reduced in abundance. The filter-feeding group is composed of species that create nets or have special adaptations for filtering food out of the water column. An increase in turbidity or TSS would have an impact on the ability to filter. The collector-filterer group is generally clingers. If stream embeddedness increases and particle size decreases the clingers have less rock habitat to cling to. The high mineral content of fine sand that deposits may clog nets and impede the filtering process. There is an advantage to gathering your food, and the relative abundance of this feeding group will increase.

Figure 13: Macroinvertebrate functional feeding groups displaying filtering versus gathering over percent stream embeddedness

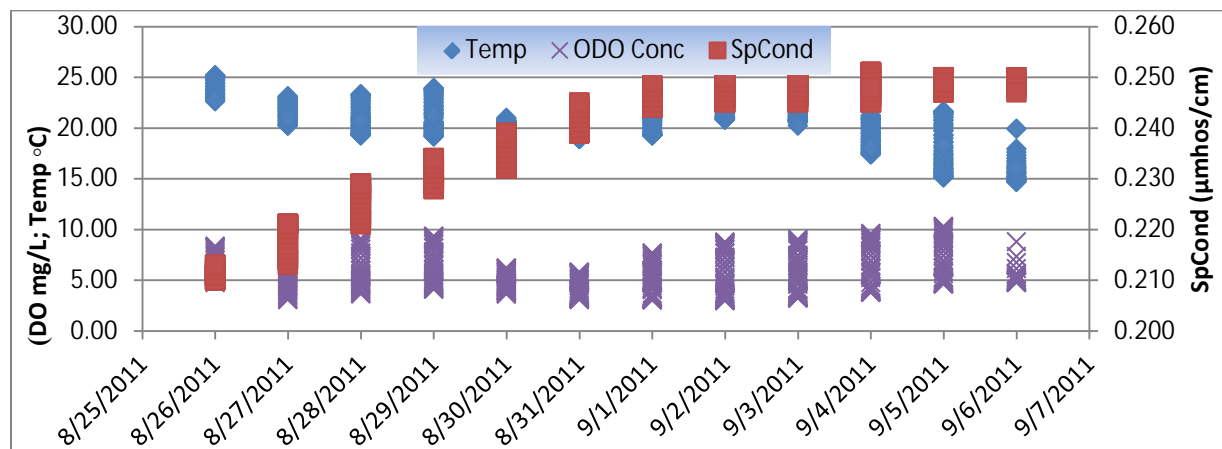
A YSI water chemistry sonde was deployed at biological monitoring site 09UM037. During the 12-day deployment, DO routinely dipped below the five mg/L standard and the daily flux ranged from 4-7 mg/L. During the 2011 monitoring season, DO is a cause of stress for the biological community. Figure 25 displays the continuous record for the YSI sonde readings.

Figure 25: Site 09UM037 continuous sonde readings from St. Francis River at 75th Street NE, SE of Highway 23

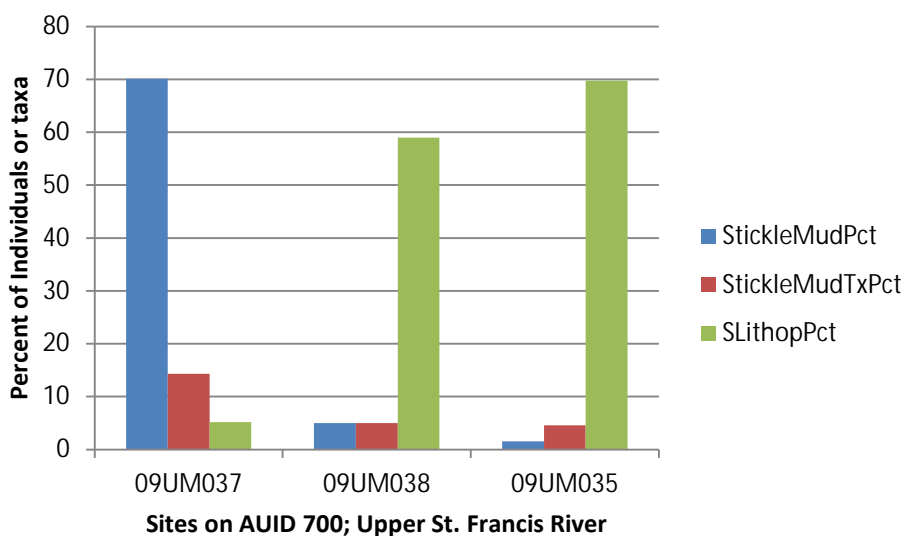
Figure 28: Percentage of fish in the sample that are very tolerant to pollutants

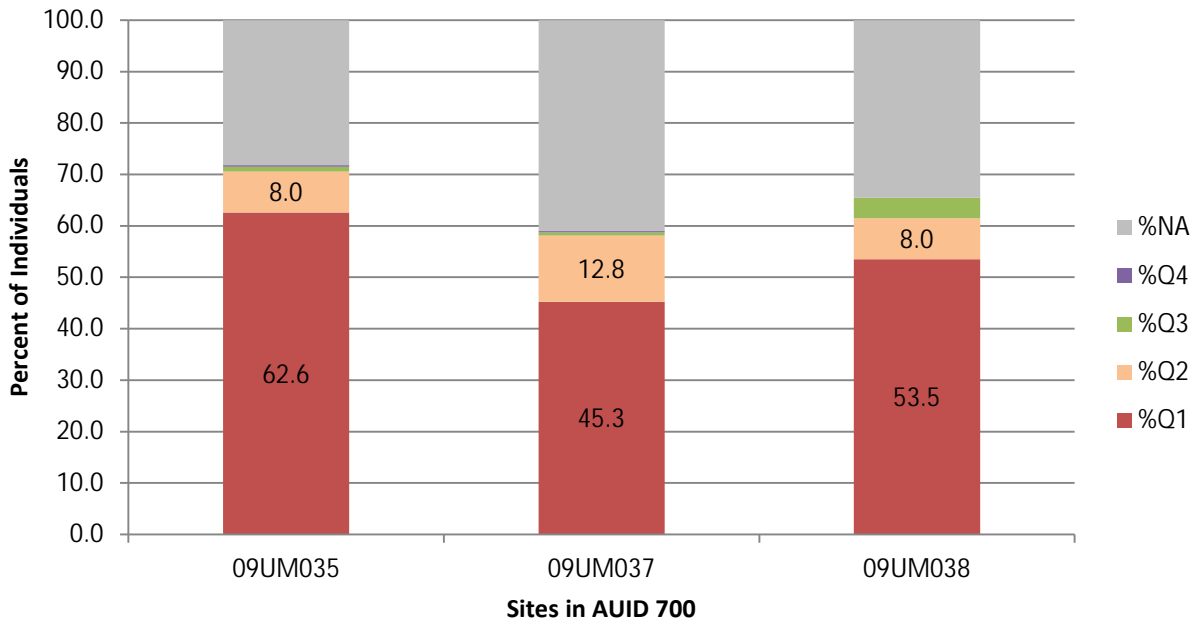
Figure 29: Percent of macroinvertebrate that are very tolerant to fine sediment

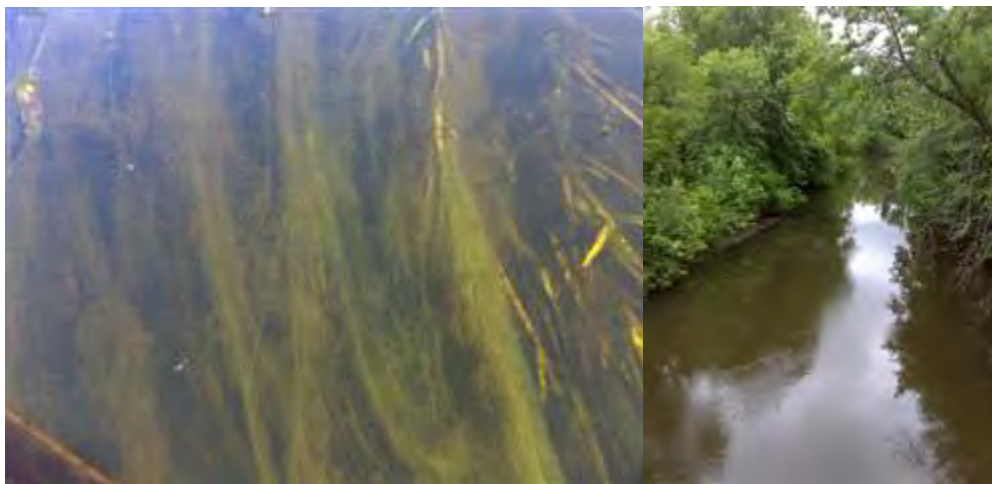
Figure 36: Photos of submerged aquatic plant growth at biological site 09UM015

Chlorophyll-a concentrations are commonly used to measure algal productivity in surface water, and have been shown to correlate with maximum DO concentrations and DO flux in no-wadable rivers (Heiskary et al., 2010). Field visits at biological monitoring site 09UM015 revealed significant submerged plant and algal growth (Figure 36). This site lies below the Sherburne National Wildlife Refuge which is currently managed for waterfowl production and has several wetland impoundments. These impoundments slow down the river flow and allow for plants to grow and export algal biomass downstream. Two samples were collected on June 25, 2009, and analyzed for chlorophyll-a (chl-a). These samples represented the water column algae and a periphyton algae sample taken from scraping rocks. The results were 11.2 and 1320 µg/L. Pheophyton for these samples were 3.38 and 275 µg/L. Pheophyton is a by-product of algal growth and is typically a percentage of the chl-a concentration.

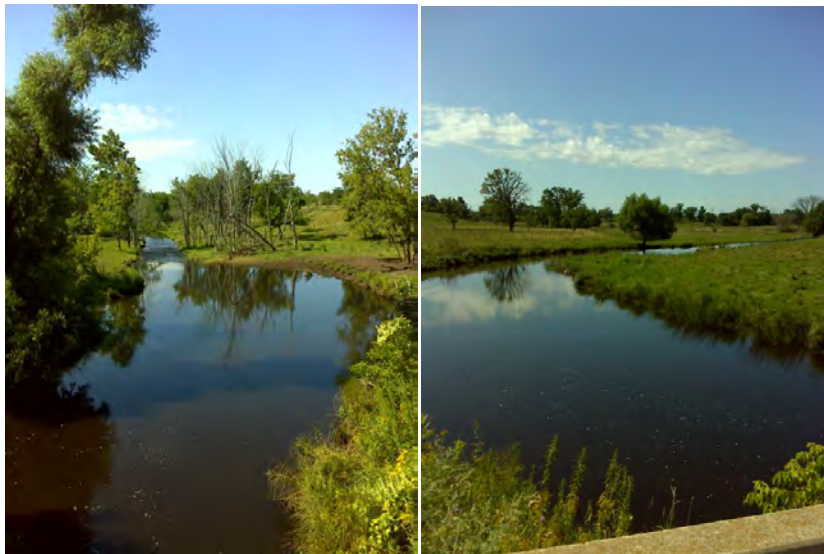
Figure 61: Photos of over widened channel at biological site 09UM001, along with green coloration to water

No Chl-a samples were collected in this region however the growth of periphyton along with the color of the water indicate that there is excessive Chl-a in the system (Figure 61). The growth of Chl-a producing plants is a result of the high phosphorus concentrations in the stream. The excessive plant growth will also lead to an increase in daily DO flux. As the plants actively grow during the day they produce oxygen, however at night respiration with consume oxygen. This leads to high fluctuation in daily DO concentrations.

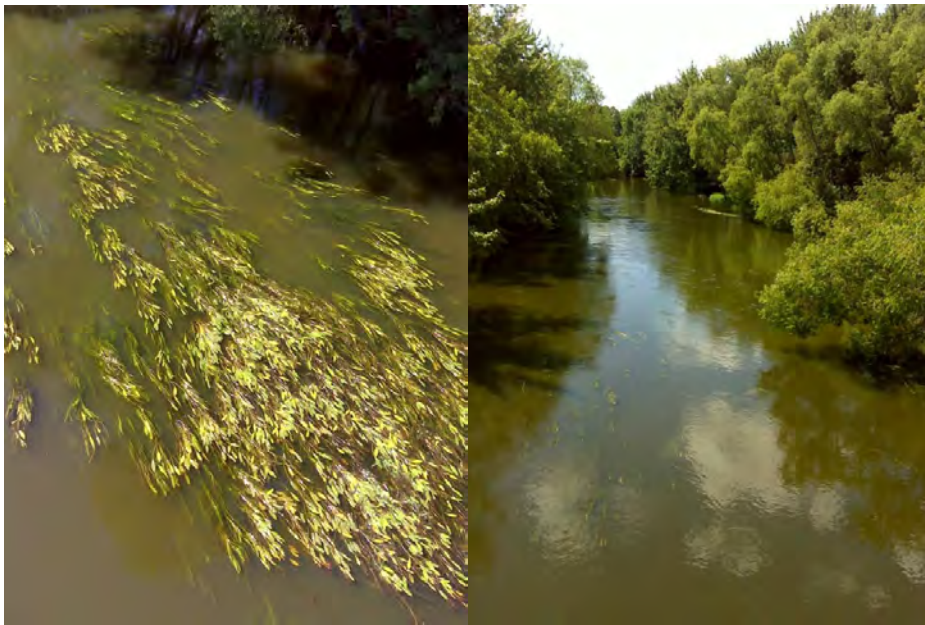
Elk River at CR11 (upstream of 09UM014)

Figure 73: Photos of heavily vegetated channel, one mile upstream of biological site 09UM014, along with green coloration to water

No Chl-a samples were collected in this region however the growth of periphyton along with the color of the water indicate that there is excessive Chl-a in the system (Figure 73). Since chlorophyll levels are directly related to phosphorus levels efforts to reduce phosphorus concentrations will in turn reduce chlorophyll levels.

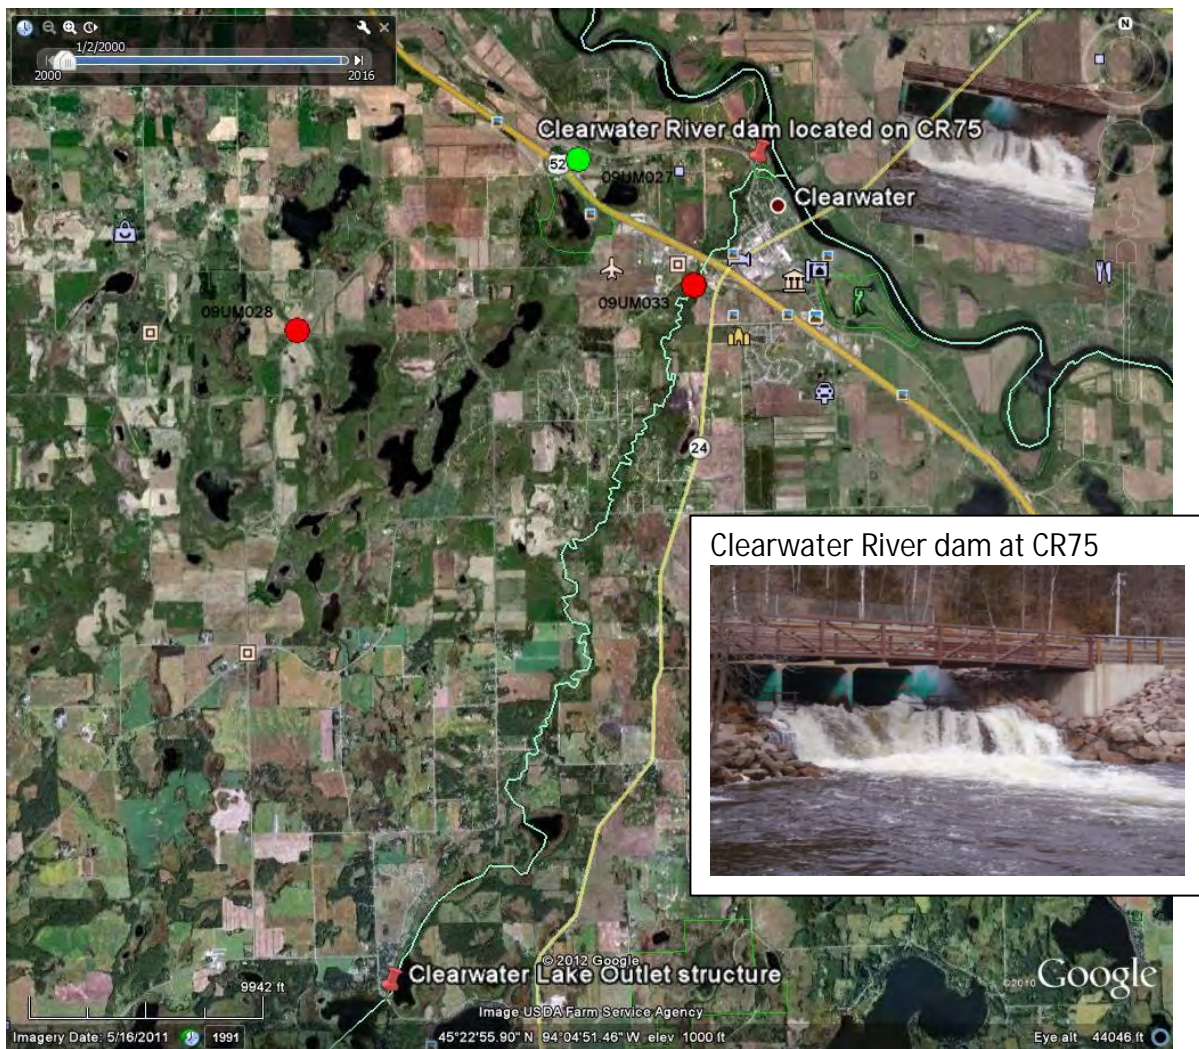
Figure 81: Clearwater River reach below Clearwater Lake outlet and the Mississippi River. This reach has a dam located at CR75 which prohibits fish passage and controls channel hydraulics

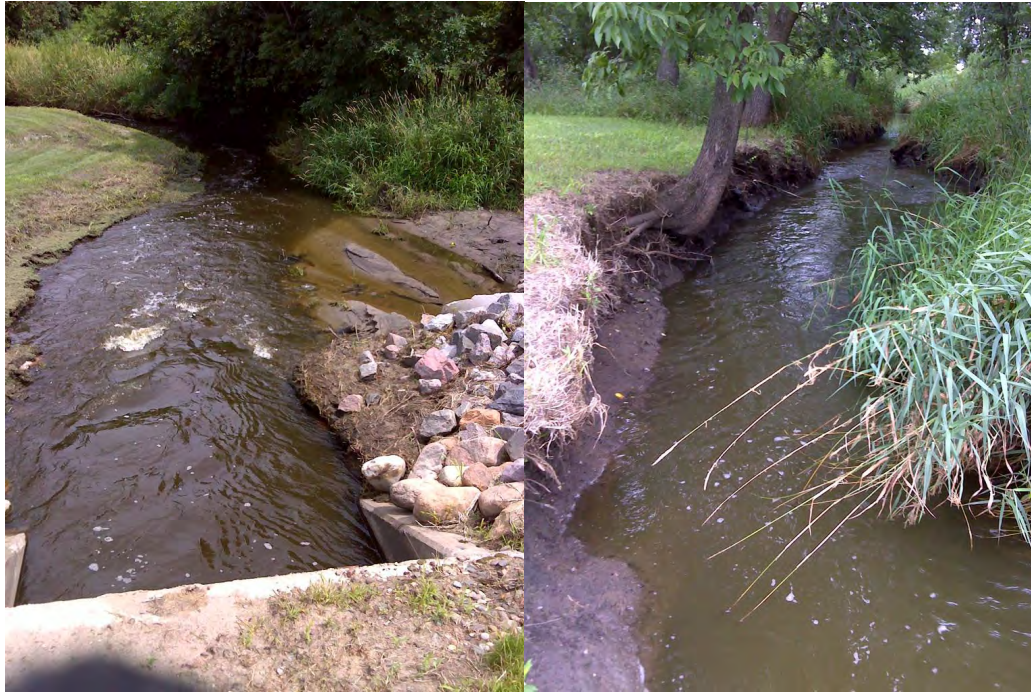
Figure 98: View of downstream stream section below the Nabor Avenue culvert. This site has a double culvert, one box and one arch culvert. The arch culvert is filled with sand and only carries flow during high flow events.

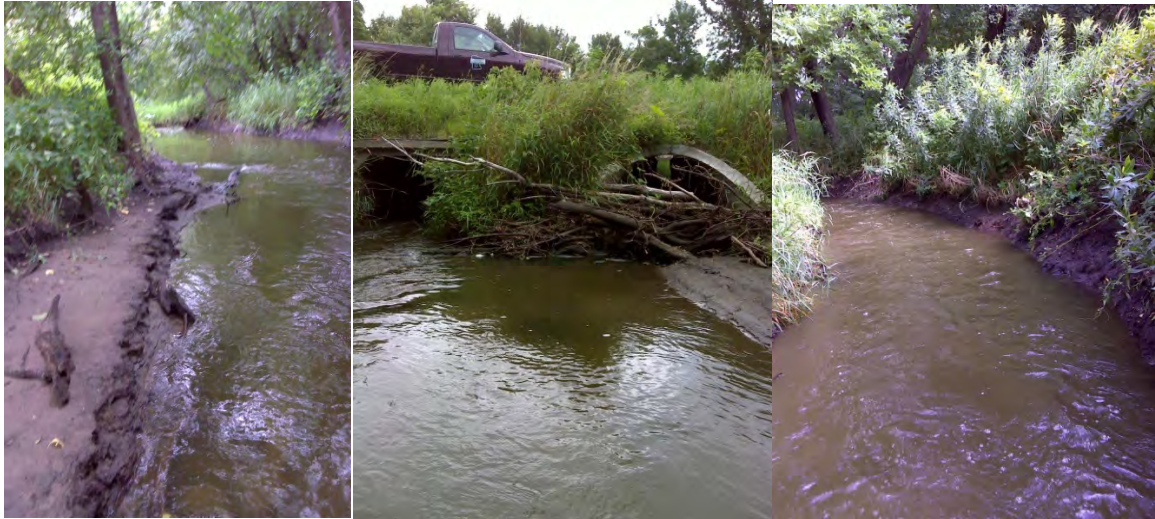
Figure 99: Typical bank condition on Unnamed Creek upstream from Nabor Avenue. Note the debris on culvert. Storm flows are cleaning out the channel moving any beneficial woody debris downstream. Note the brown color of stream on right photo.

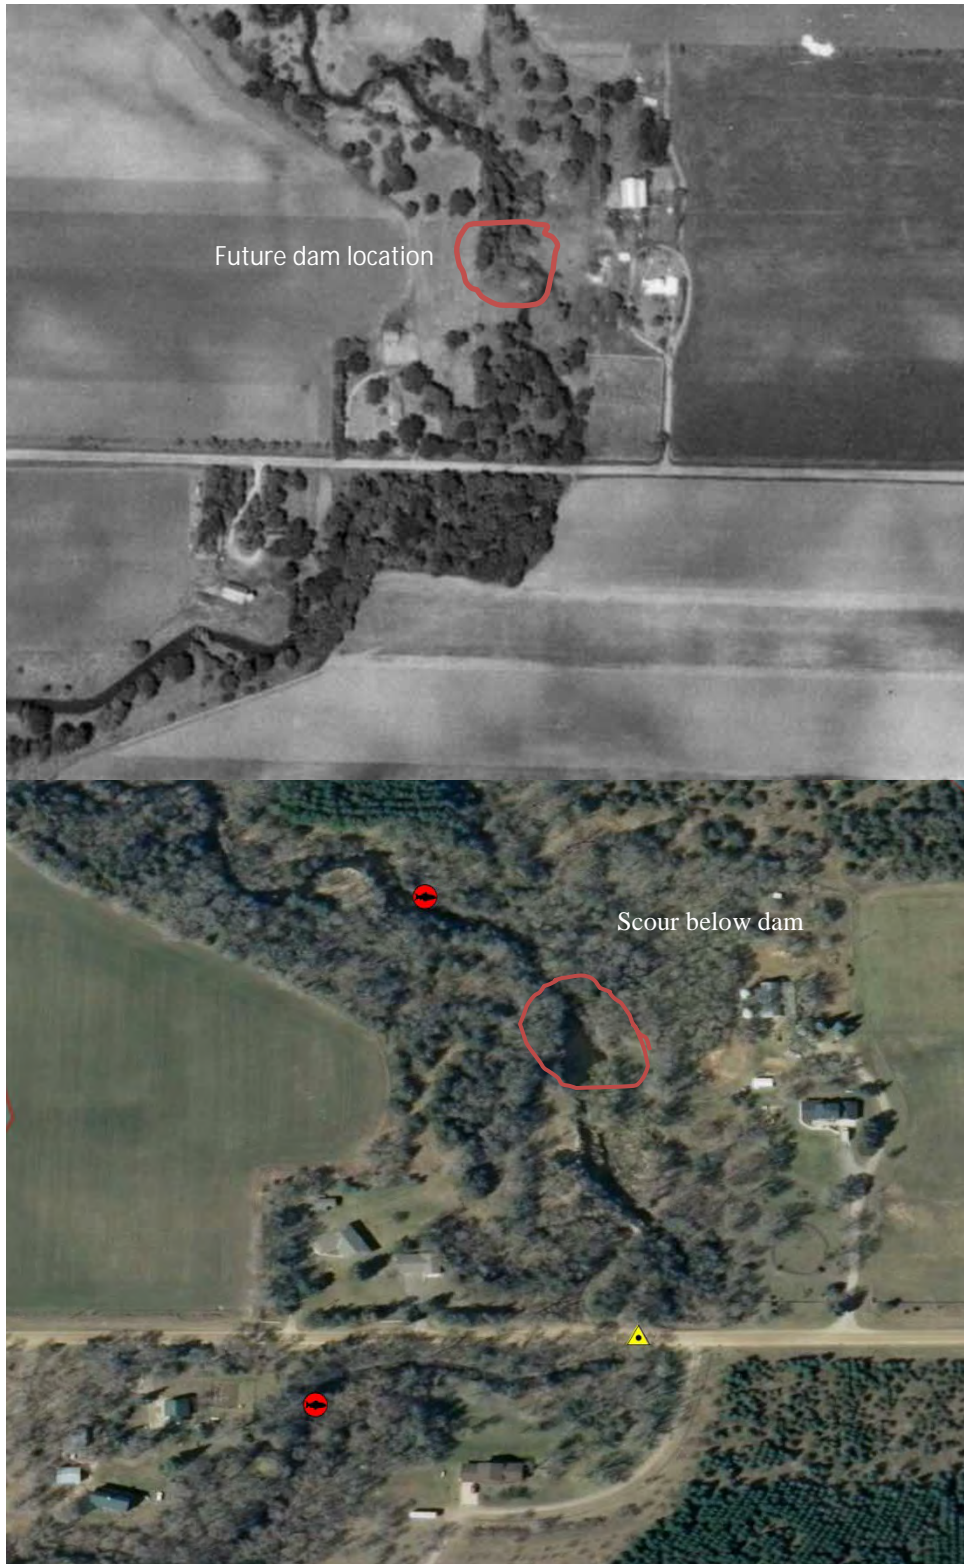
Figure 108: Comparison of location of dam in 1963 before installation and in 2010 after several years of dam being in place
