Mississippi River-Sartell Watershed (MRSW)

Watershed approach

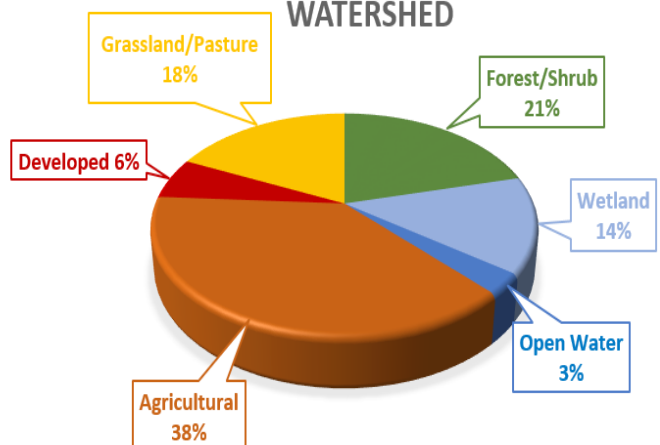
LAND USE - MISSISSIPPI RIVER-SARTELL WATERSHED

- Size: 1,020 square miles
- Counties: includes portions of Benton, Crow Wing, Mille Lacs, Morrison, Stearns, and Todd counties in central Minnesota
- Ecoregions: Northern Lakes and Forest & North Central Hardwood Forest
- The land use of the watershed is predominantly agricultural
- 232 lakes and 879 miles of streams
- The 8-digit hydrologic unit code (HUC): 07010201

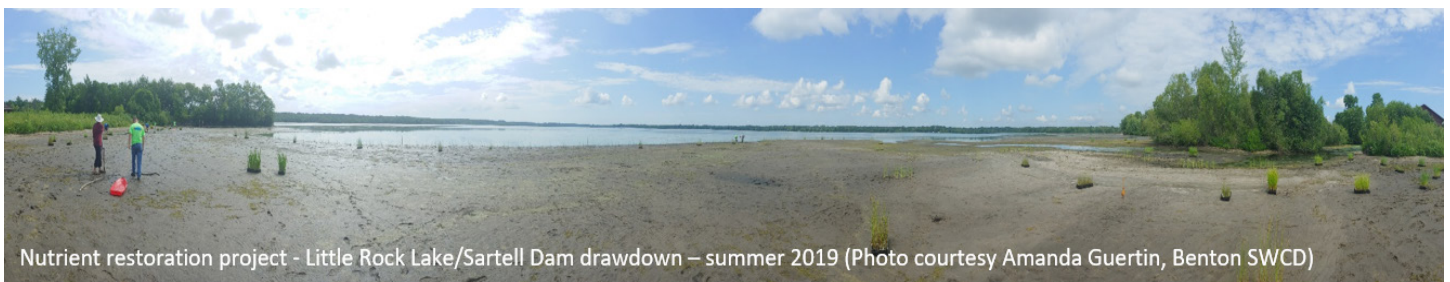
Nutrient restoration project - Little Rock Lake/Sartell Dam drawdown – summer 2019 (Photo courtesy Amanda Guertin, Benton SWCD)
