April 2024

Root River Watershed Restoration and Protection Strategy Report Update 2024 Appendices

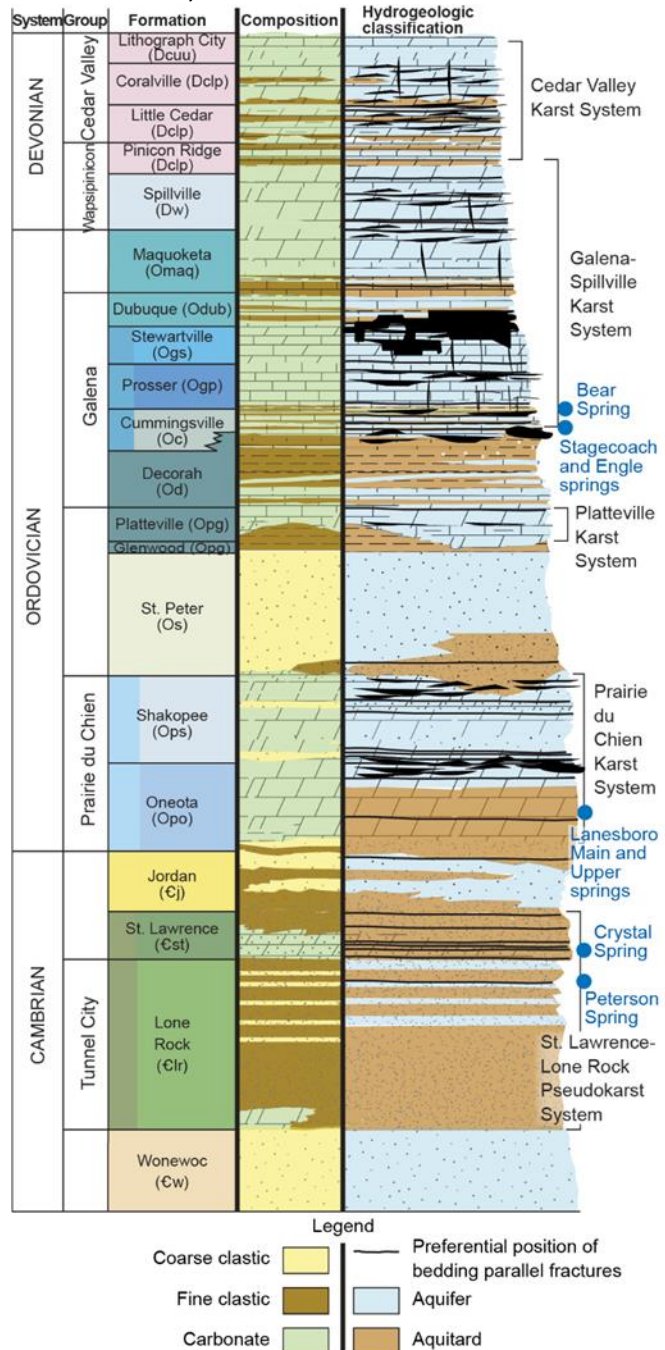
Figure A-1. Geologic and generalized hydrogeologic attributes of Devonian and Ordovician rocks in southeast Minnesota. Modified from Runkel et al., 2014.

A stratigraphic column for southeastern Minnesota (Figure A-1) combines lithostratigraphic and generalized hydrostratigraphic properties (modified from Runkel et al., 2014). Hydrostratigraphic attributes are generalized into aquifer or aquitard based on relative permeability, where aquifers are permeable and easily transmit water through conduits, fractures, or porous media and aquitards have lower vertical permeability that limits vertical flow. The horizontal hydraulic conductivity of the aquitards is, however, commonly comparable to that of the aquifers because of the presence of bed parallel partings and void networks that yield significant quantities of water (Runkel et al., 2018). The blue dots represent the stratigraphic positions of springs described below.

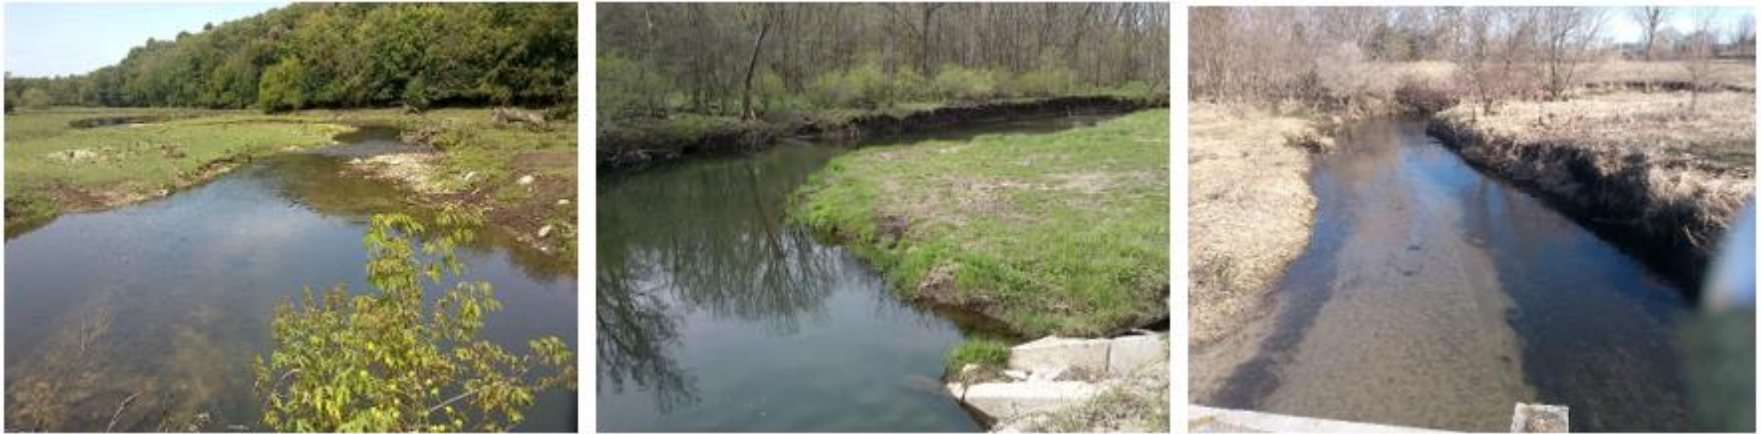
Sediment fingerprinting work from Belmont et al 2016 identified that streams in the North Branch HUC-10 of the RRW (including Spring Valley Creek) contribute approximately 70% of the sediment load. The MPCA field staff have noted several areas of severe bank erosion throughout Spring Valley Creek (Figure A-5).

Figure A-5. Areas of severe bank erosion on Spring Valley Creek. From left to right: (S000-769/08LM006—looking upstream, S000-769/08LM006—looking downstream and upstream of S000-772 at trail/bridge crossing).

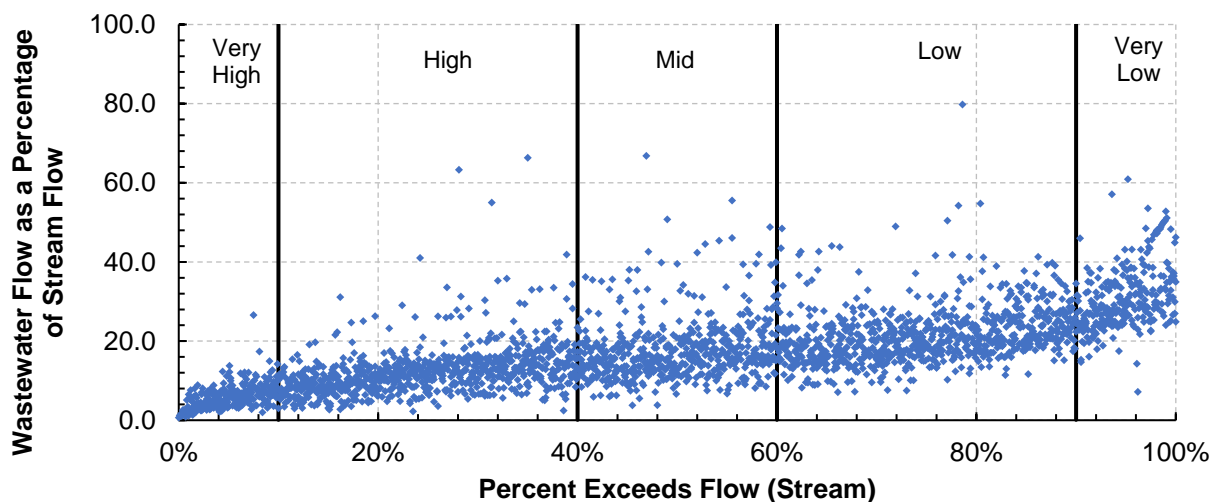
Of all permitted sources in Spring Valley Creek Subwatershed, Spring Valley WWTP has the highest potential to contribute nitrate to Spring Valley Creek (-536). Spring Valley WWTP does not have a TN permit limit, but the next WWTP permit (expected late 2023/early 2024) will include a limit for TN. The permit will also include a schedule of compliance involving construction at the facility to address nitrate in the effluent. Average WWTP effluent nitrate concentration from March 2014 through April 2022 is 18.9 mg/L. While Spring Valley WWTP effluent has relatively high concentrations of TN, effluent typically makes up 50% or less of the stream baseflow (Figure A-6). Dilution provided by Spring Valley Creek's baseflow oftentimes buffers the in-stream concentration at the effluent discharge point to at or below the 10 mg/L nitrate drinking water standard. However, in the very rare event when stream baseflow is low and WWTP effluent makes up greater than 50% of the baseflow, the nitrogen load from the WWTP effluent pushes in-stream nitrate concentrations to exceed 10 mg/L. Because Spring Valley WWTP can be a significant source of nitrate to Spring Valley Creek, the 2023 Root River Watershed Total Maximum Daily Load (TMDL) Report includes a nitrate wasteload allocation for the WWTP. For additional discussion on Spring Valley WWTP and its pollutant potential, please see Appendix B of the TMDL (MPCA 2023a).

Figure A-6. Percentage of stream baseflow made up of Spring Valley WWTP effluent (2014 – 2022).

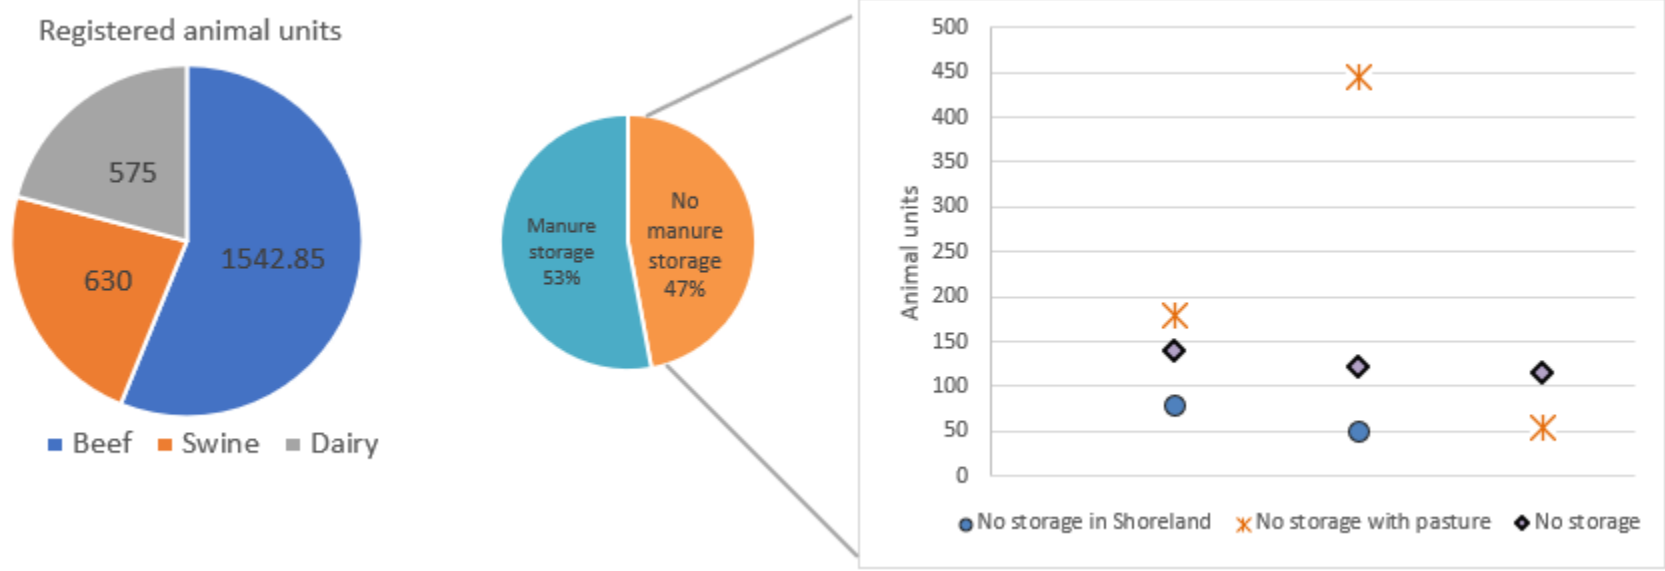
Similar to TSS and nitrate, nonpoint sources are largely contributing potential bacteria loads as compared to permitted sources. Animal feedlots have the potential of contributing *E. coli*, ammonia, nitrate, and phosphorus to local waters. Spring Valley Creek Subwatershed has 17 registered feedlots housing a total of 2,748 animal units (AU). This equates to 4,958 animals, primarily beef cattle. The average feedlot size is 162 AUs and no permitted CAFOs currently exist in this subwatershed. Of the 17 feedlots, about half have manure storage onsite while the other half do not. Feedlots without manure storage are primarily under 300 AUs (Figure A-7).

Figure A-7. Permitted feedlots, corresponding animal units and feedlot manure storage in Spring Valley Creek Subwatershed.

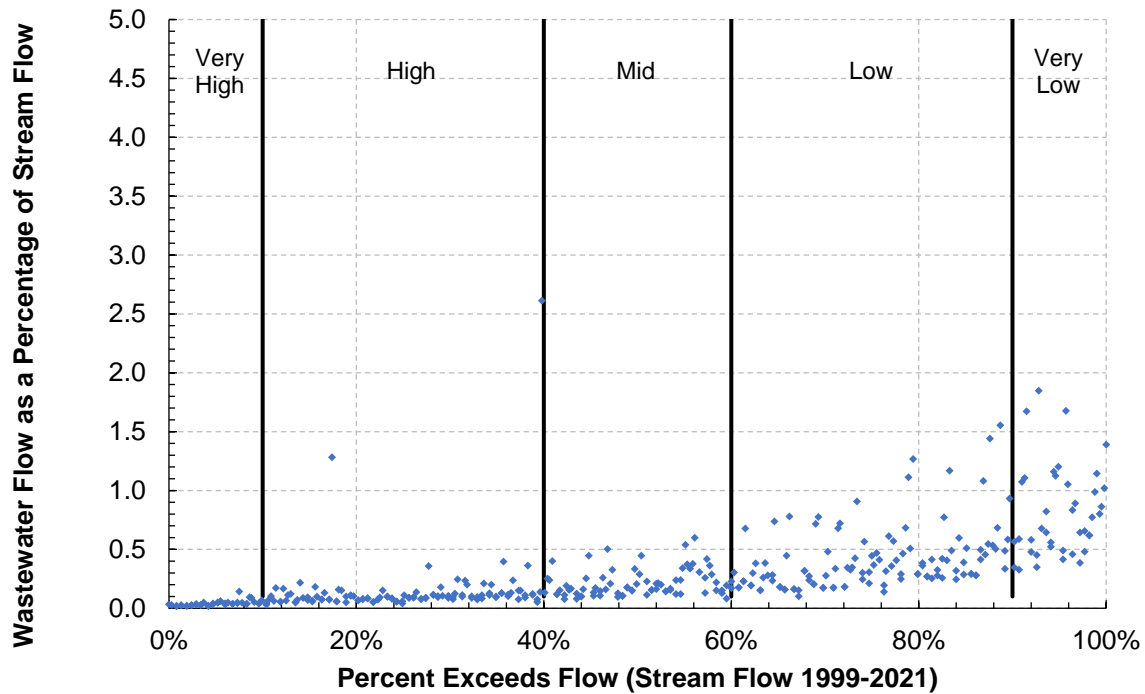
While Ostrander WWTP effluent has high TN concentrations, the effluent nitrogen input to South Branch Root is largely diluted by the river's base flow. Even in very low stream flow conditions, WWTP effluent is estimated to make up less than 2% of the South Branch Root River's flow (Figure A-9). Because of this, Ostrander WWTP is not considered a significant source of nitrate.

Figure A-9. Ostrander WWTP effluent as a percentage of stream base flow.

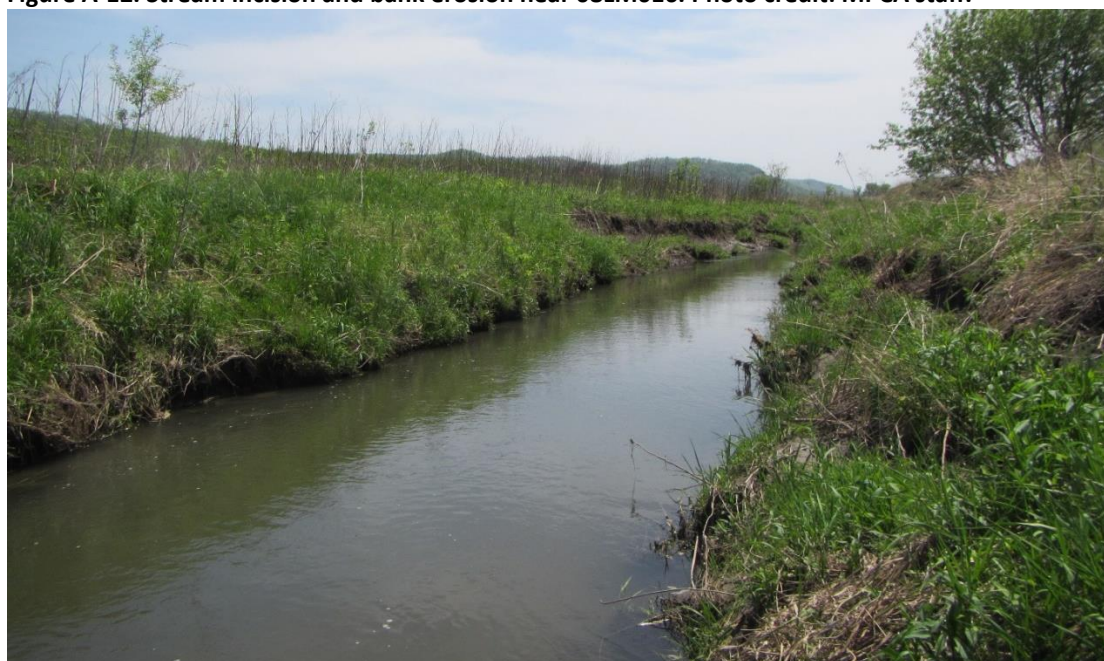
The physical characteristics of upper Money Creek are likely contributing to sediment loading to Money Creek. The high gradient of the headwater tributaries can exacerbate bank channel and bank scouring particularly during times of increased peak stream flow. Even though most of the riparian area in the headwaters appears to be well vegetated, major incision and increased peak flows continue to erode streambank areas (Figure A-12).

Figure A-12. Stream incision and bank erosion near 08LM016. Photo credit: MPCA staff.

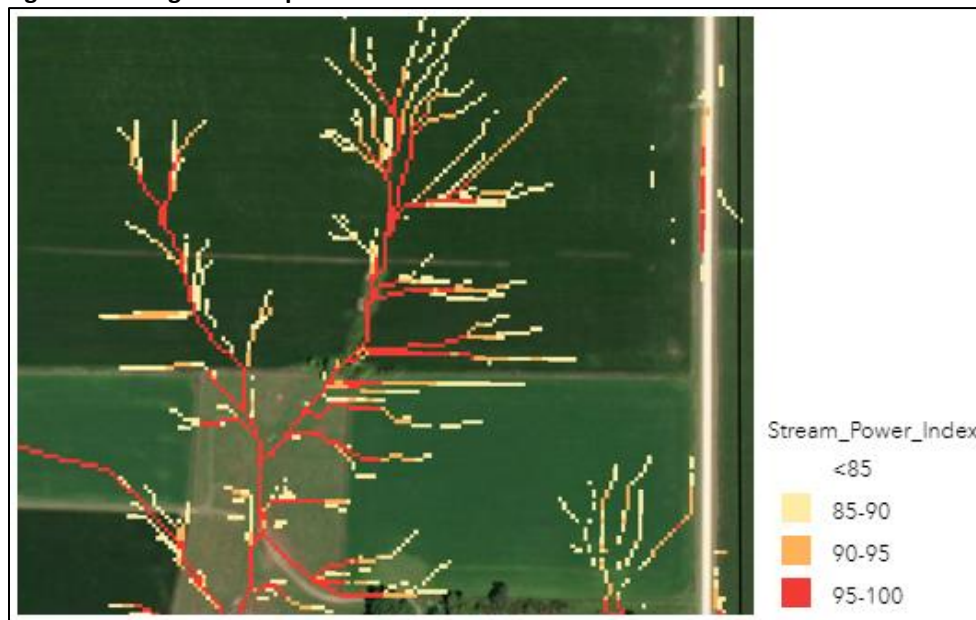
Sediment loading from agriculture fields may be most significant in the headwater areas of the subwatershed. SID work has found that headwater monitoring sites had significantly higher TSS concentrations and lower transparency measurements as compared to the main channel of Mill Creek (-536). The Minnesota Runoff Risk Advisory Forecast identifies many areas across the headwaters of Mill Creek Subwatershed as having a high SPI (Figure A-15). This means that there are many “conveyor belt” areas that can transport sediment (as well as nutrients/manure and pesticides) off cropland during snowmelt or storm events. Perennial vegetation in these high SPI areas (grassed waterways, prairie

strips) can work to reduce pollutant transport, particularly sediment. In several of these areas, there are no structural BMPs preventing sediment from entering a stream during runoff events. Practices such as prairie strips, filter strips, field borders, conservation cover, contour grass strips no-till or cover crops would be ideal in these areas.

Figure A-15. High stream power index areas in the headwaters of Mill Creek Subwatershed.

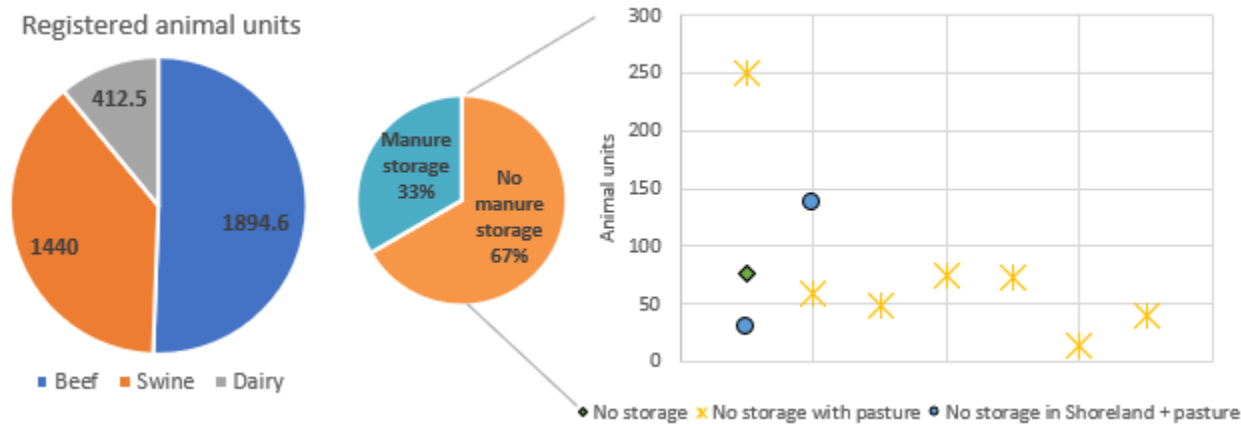
Mill Creek Subwatershed has 14 registered feedlots housing 2,558 AU (6,033 head); primarily beef operations, but most animals are swine. No CAFOs currently exist and a majority of the feedlots do not have manure storage on site (Figure A-17).

Figure A-17. Registered feedlots, corresponding animal units and feedlot manure storage in Mill Creek Subwatershed.
