# Cloquet River Watershed Stressor Identification Report

A study of local stressors limiting the biotic communities in the Cloquet River Watershed.

**Document number:** wq-ws5-04010202a

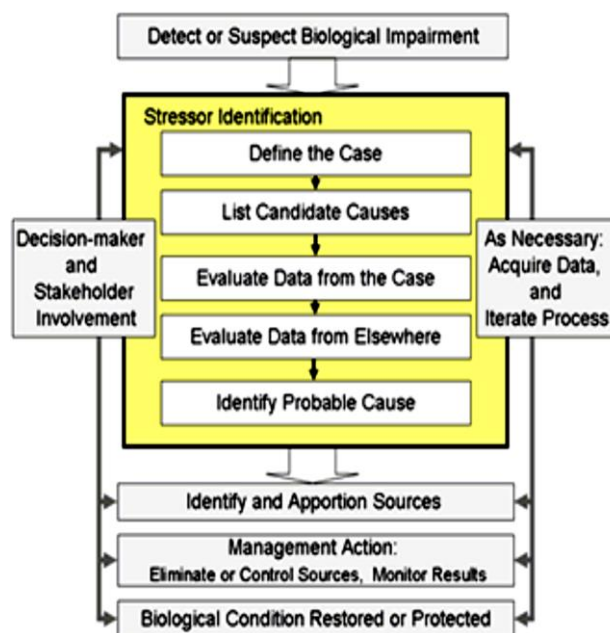
Figure 1. Conceptual diagram of the SID process for identifying the cause(s) of biological Impairment (Cormier et al 2003).

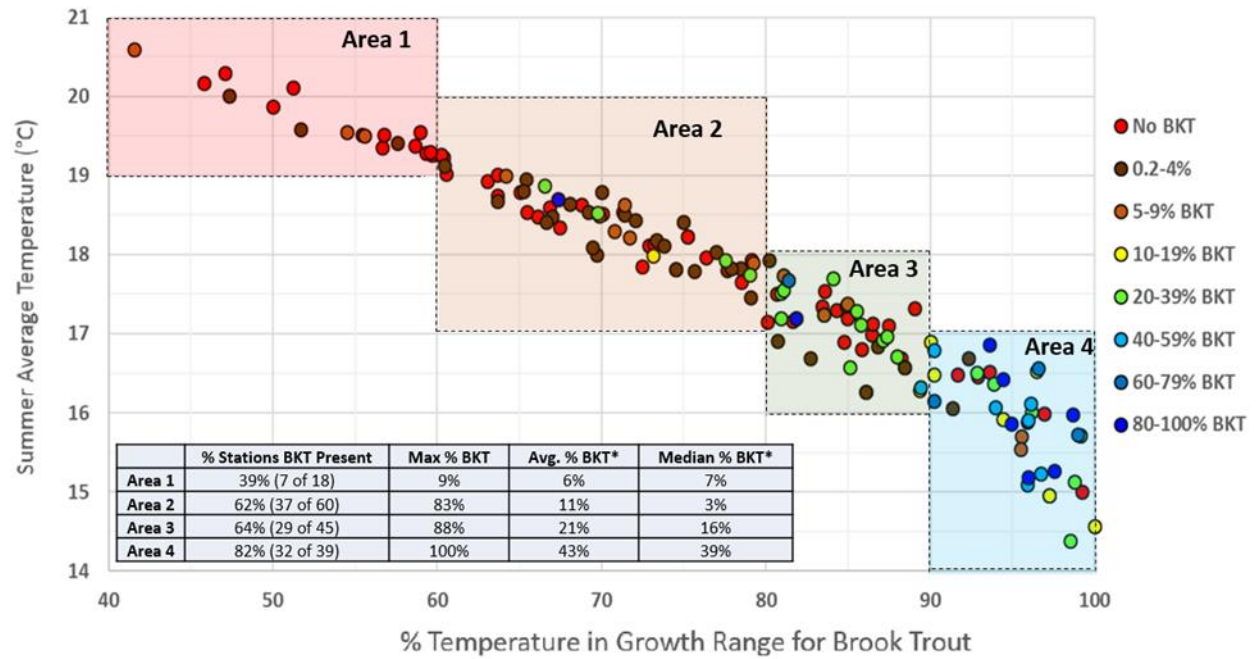
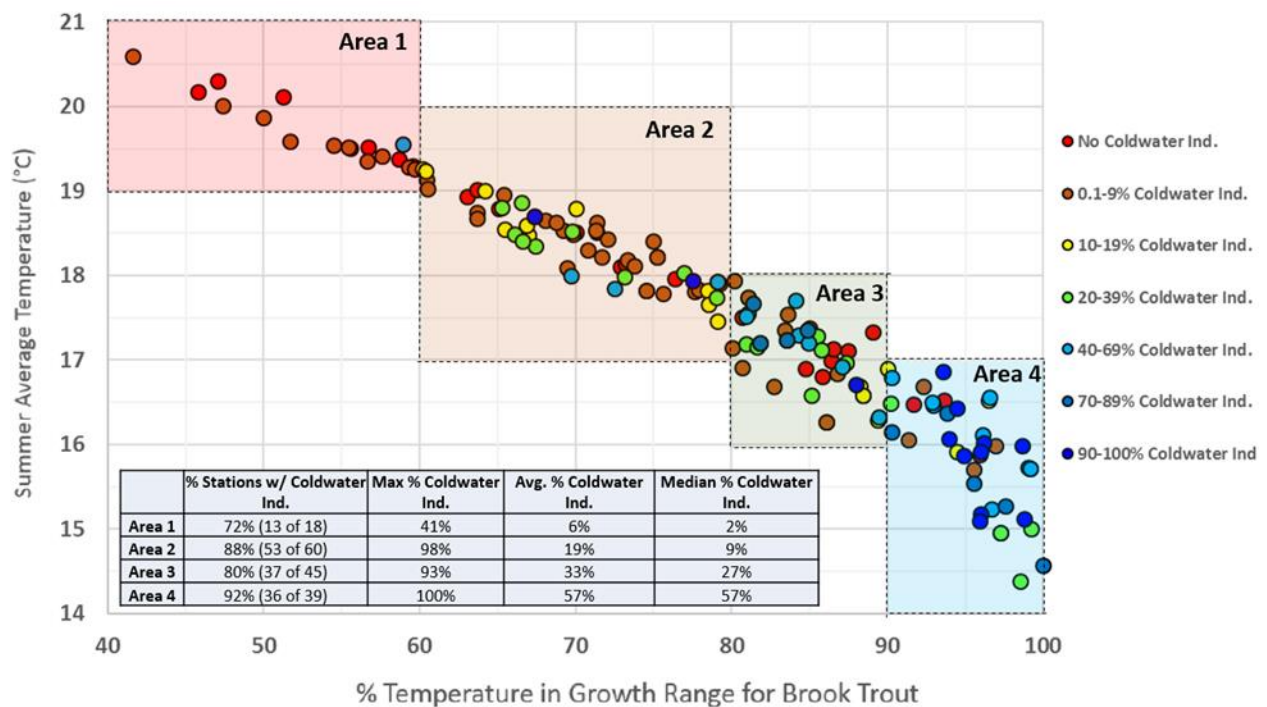
**Figure 3. Scatter-plot of summer average temperature vs % of time temperature within Brook Trout growth range. Marker colors correspond to relative densities of Brook Trout (top) and coldwater individuals (bottom) sampled. Data include all Lake Superior Basin coldwater (Northern Coldwater Fish IBI Class) stations with biological and temperature data from same season.**

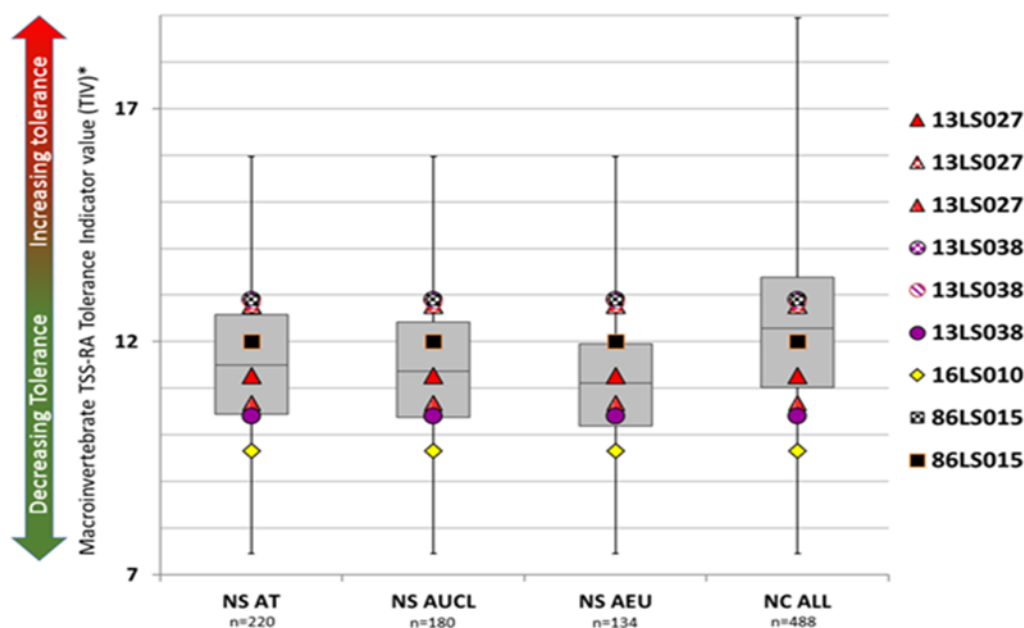
Figure 4. Example of TIV results as used in later sections of this report. Acronyms are described in Table 5.

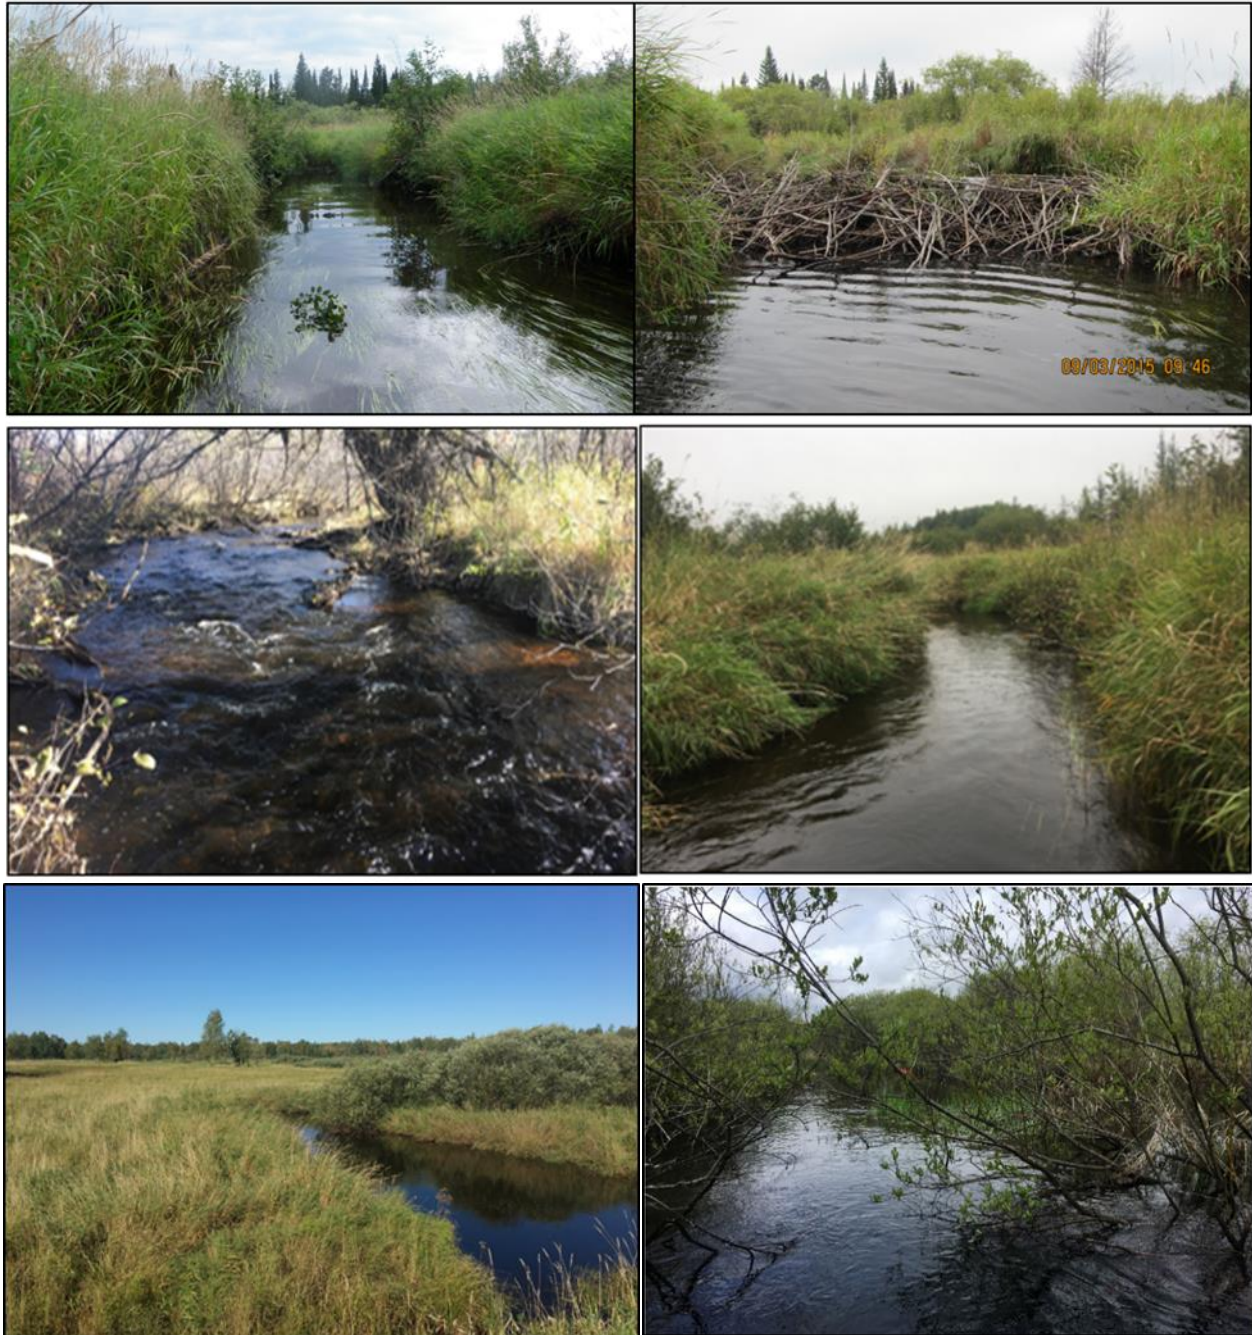
Figure 8. (TOP): Biological monitoring station BC 0.6 (MPCA Station ID: 01LS006) in July of 2016 (left) and September of 2015 (right). Fish community data were collected during the July 2016 visit. No biological data were collected in September 2015 due to the presence of several beaver dams within the sampling reach. (Middle): Biological monitoring station BC 1.6. Several gravel/cobble riffles offer high quality spawning habitat within this reach. Banks are stable and deep bend pools are present. (Bottom): Upper reaches of Beartrap Creek at BC 4.7. This area is low-gradient and substrates are composed mostly of fines (silt/sand). Dissolved oxygen levels are often below 5 mg/L due to natural background conditions (wetlands).

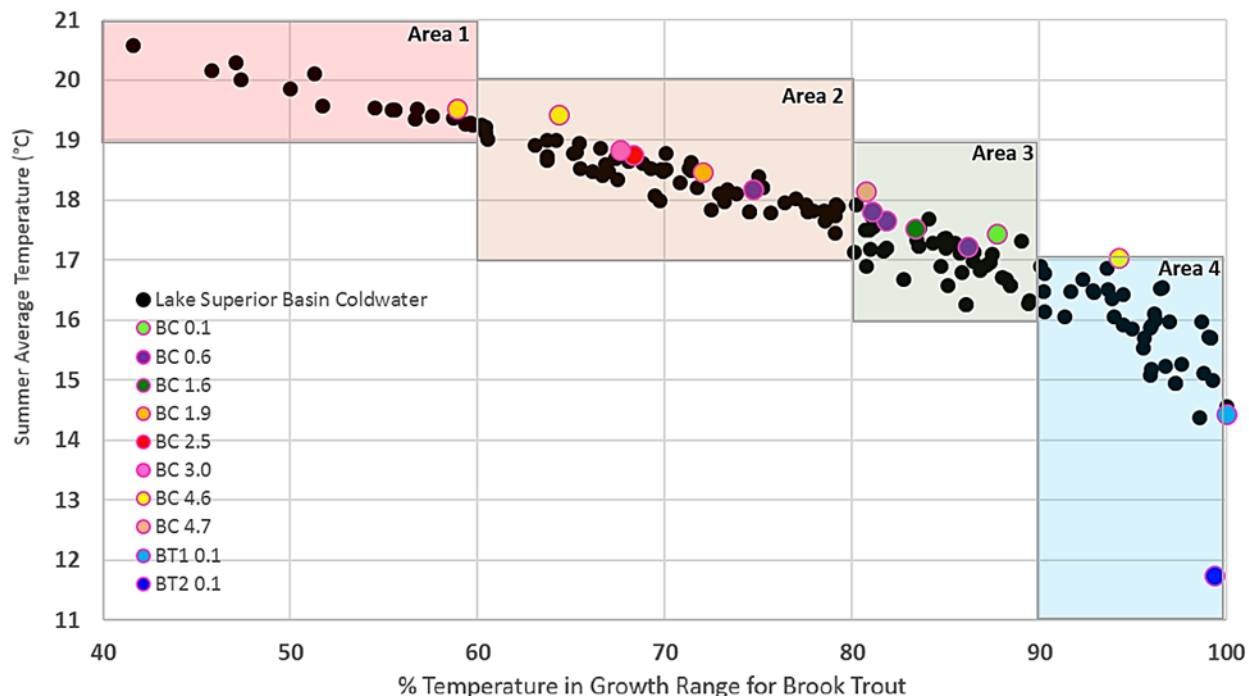
**Figure 9. Plot of summer average temperature vs % Time in Temperature range supportive of Brook Trout growth. Beartrap Creek monitoring stations are shown in colored markers, while all other coldwater stations in the Lake Superior drainage basin are shown as black markers.**

Grouping	% Temperature Reading in Brook Trout Growth Range	Summer Average Temperature (C)
Area 1	<60%	>19 C
Area 2	60-79%	17 – 20 C
Area 3	80-89%	16 – 18 C
Area 4	90 – 100%	<17 C

Grouping	Description
Area 1	Brook Trout and coldwater species sometimes present, more often a mix of cool/warmwater taxa
Area 2	Can support Brook Trout/other coldwater species, often a mix of cold, cool, and warmwater taxa
Area 3	Frequently supports Brook Trout and other coldwater species, lower relative densities
Area 4	Almost always support high relative densities of Brook Trout and/or other coldwater species, low taxa richness

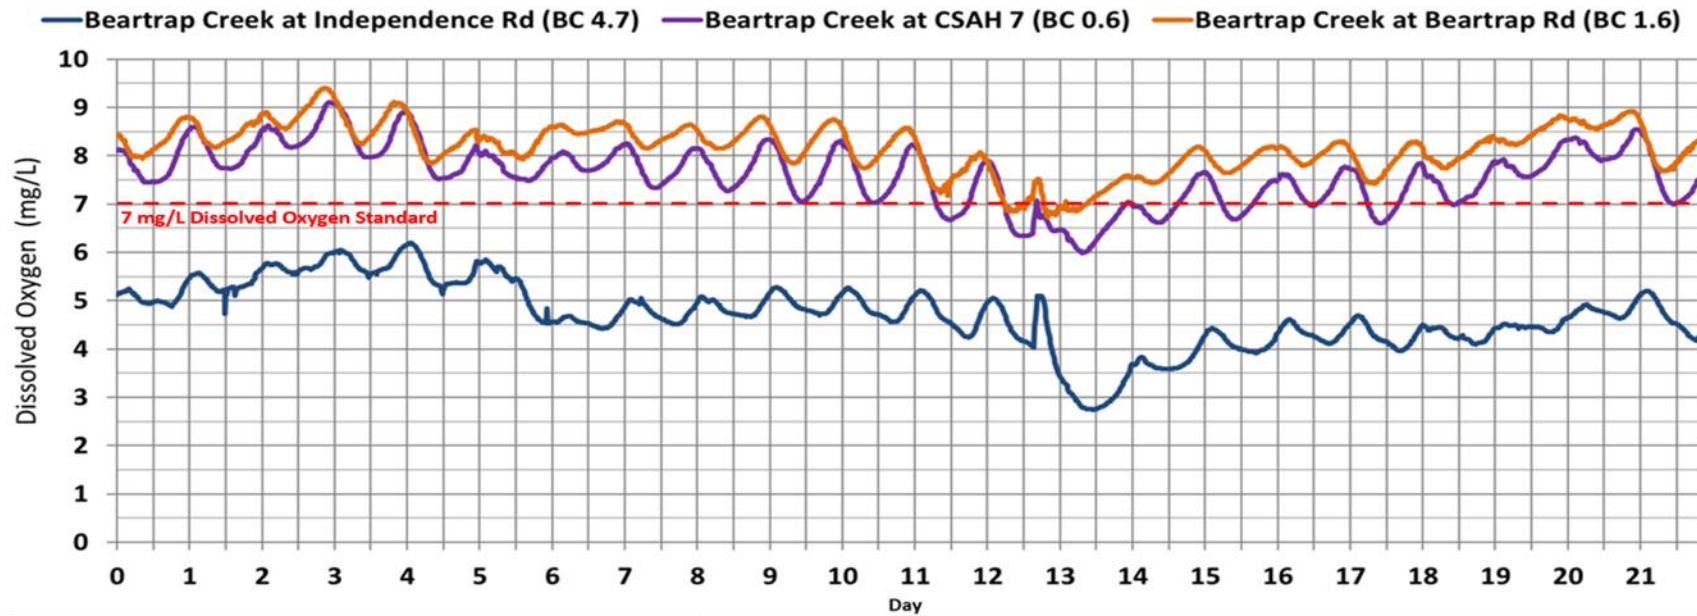
Figure 15. Results of continuous dissolved oxygen measurements at three Beartrap Creek monitoring stations collected June 22 – July 17, 2017.

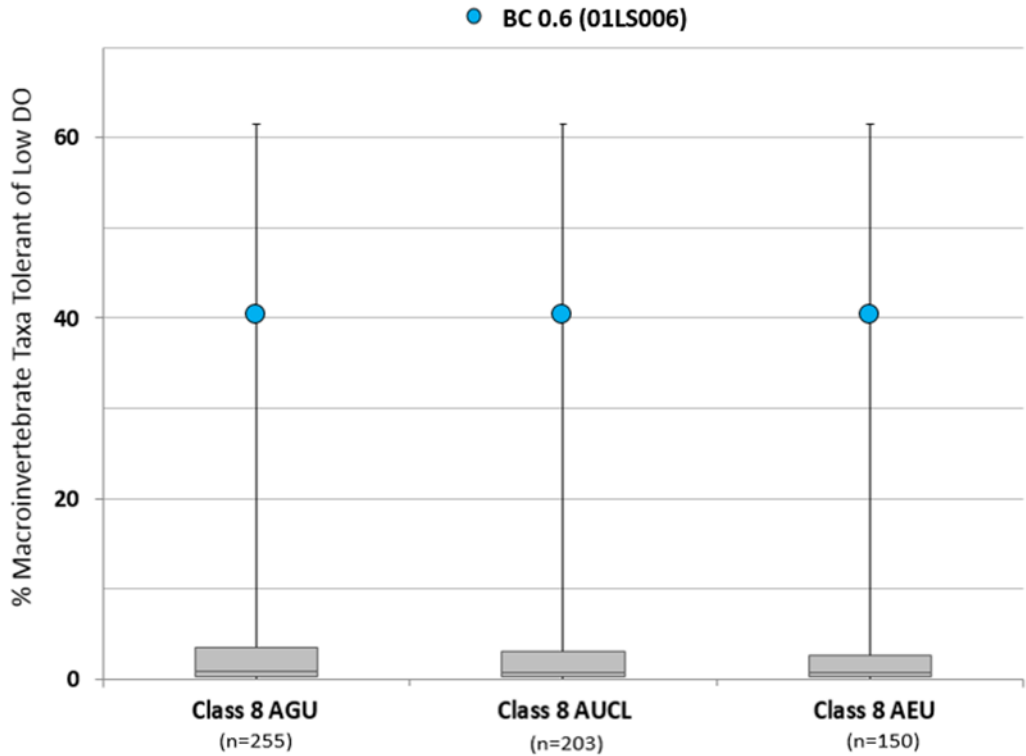
Figure 16. (Top) Dissolved Oxygen Tolerance Indicator Values for the fish community at Beartrap Creek station 0.6 (01LS006); (Bottom) Percent of the macroinvertebrate community rated at tolerant of low dissolved oxygen concentrations.

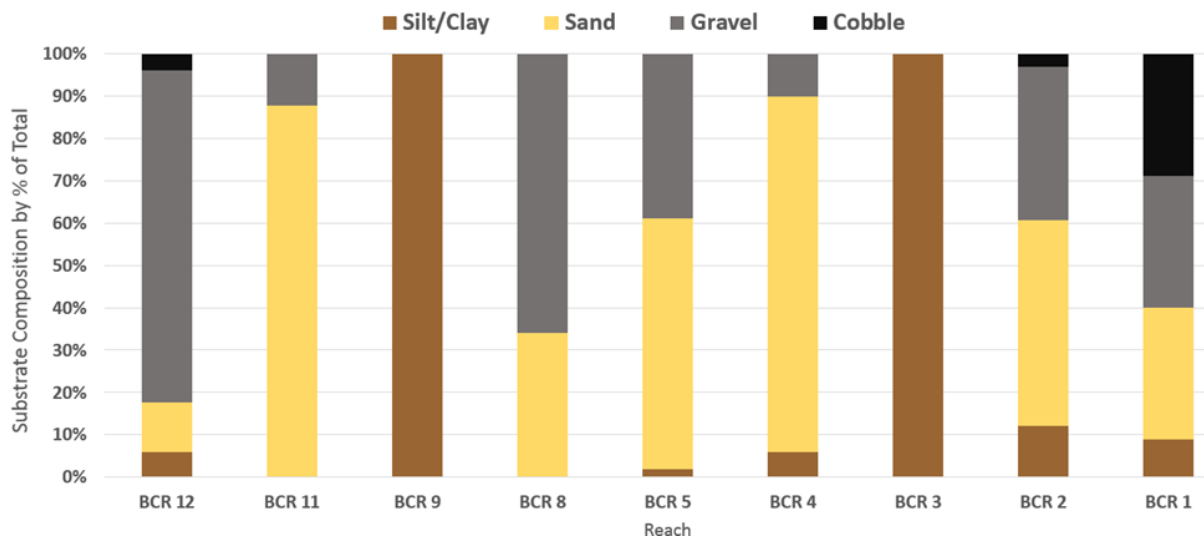
**Figure 19. Substrate composition measured at transects within Beartrap Creek sampling reaches.**

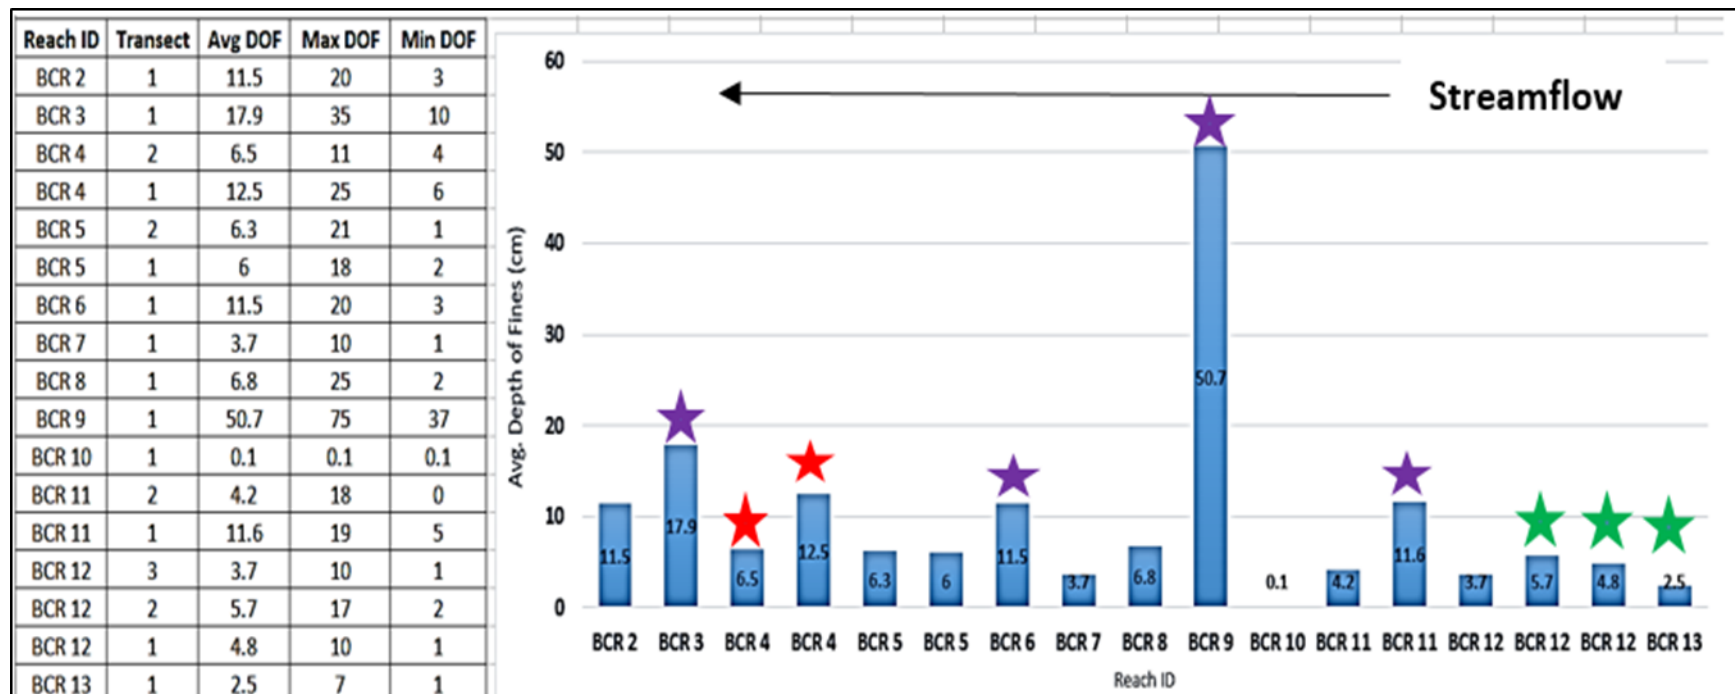
Figure 20. Depth of fine substrates measured within Beartrap Creek sampling reaches. **Green Stars** = high quality coldwater reaches with abundant wild Brook Trout; **Red Stars** = Impaired biological monitoring station; **Purple Stars** = Reaches affected by active beaver impoundments.

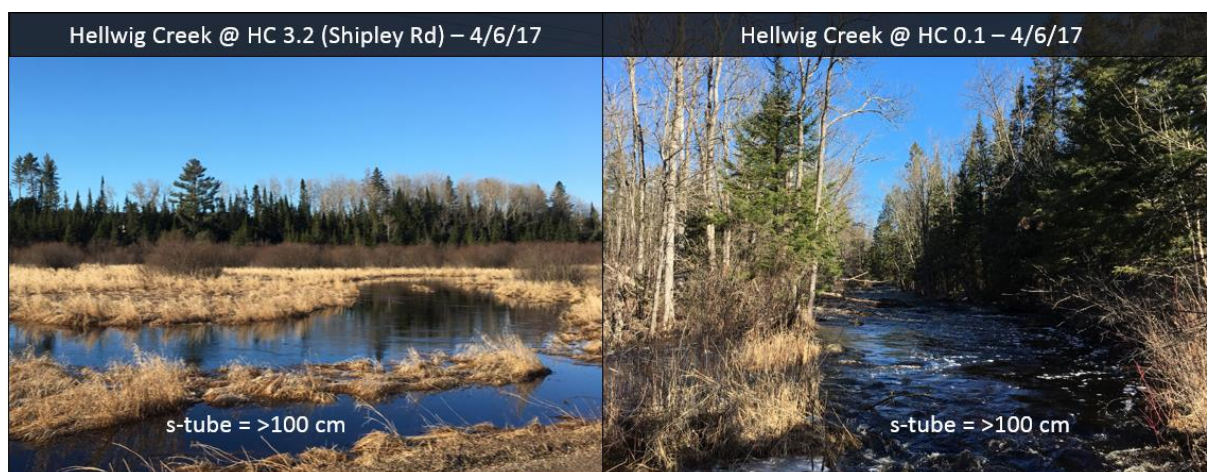
**Figure 23. Transparency sampling results and photos for several Hellwig Creek monitoring sites during high flow events.**

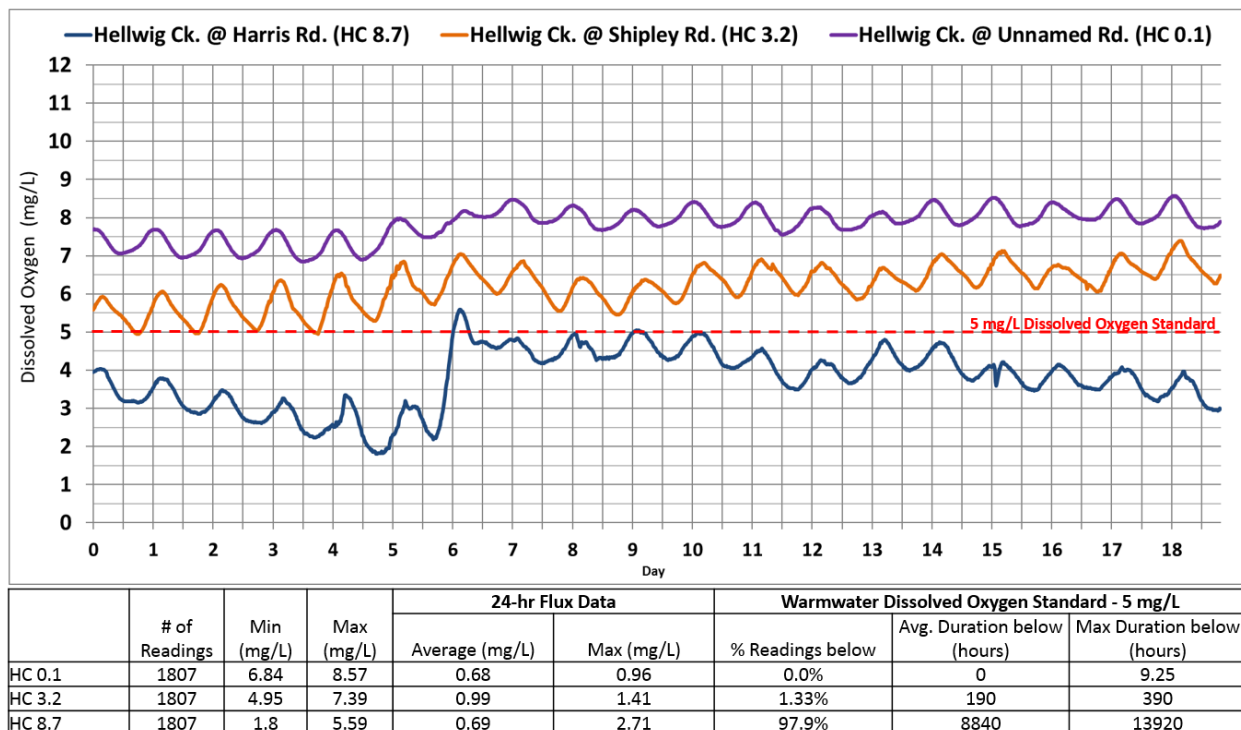
**Figure 24. Results of continuous dissolved oxygen measurements at three Beartrap Creek monitoring stations collected July 28 – August 15, 2017.**

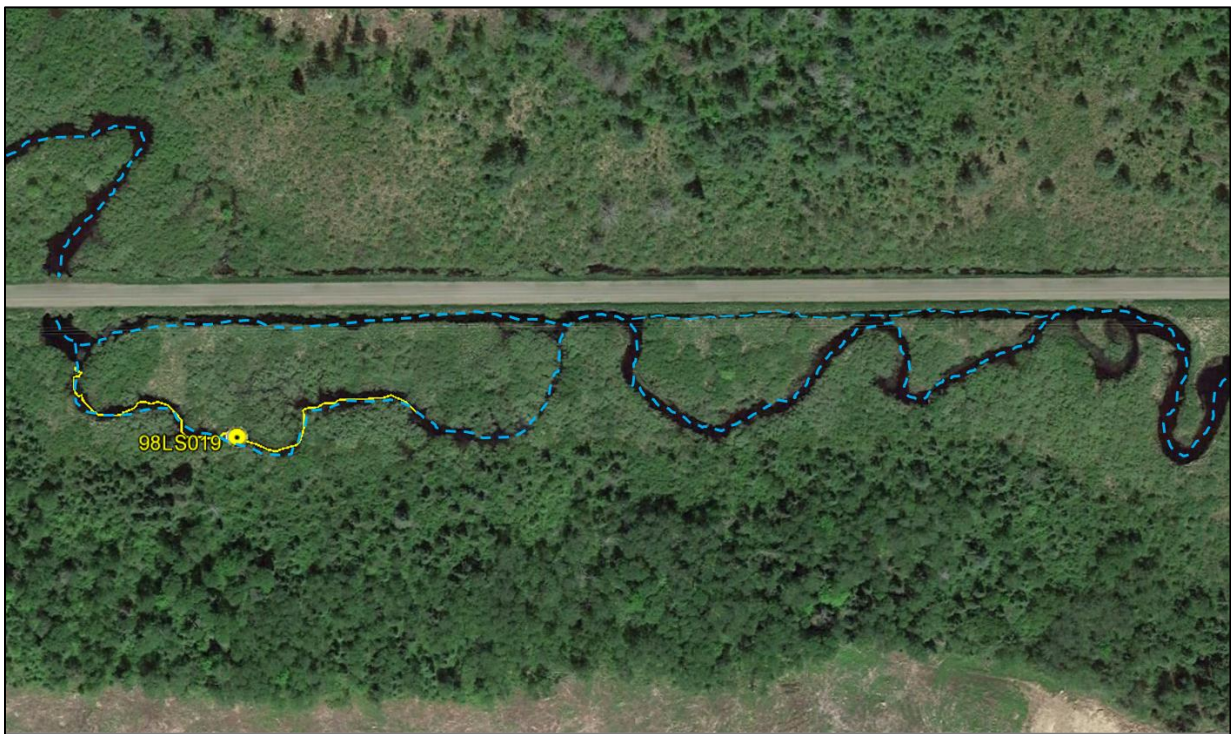
**Figure 27. Aerial photo of station HC 3.2 (98LS019) of Hellwig Creek showing the road ditch adjacent to the natural channel. This ditch diverts flow during all flow conditions. Yellow line indicates the reach that was sampled by biological monitoring crews.**
