# Nemadji River Watershed Stressor Identification Report

A study of local stressors limiting the biotic communities in the Nemadji River Watershed.

Minnesota Pollution Control Agency

August 2014

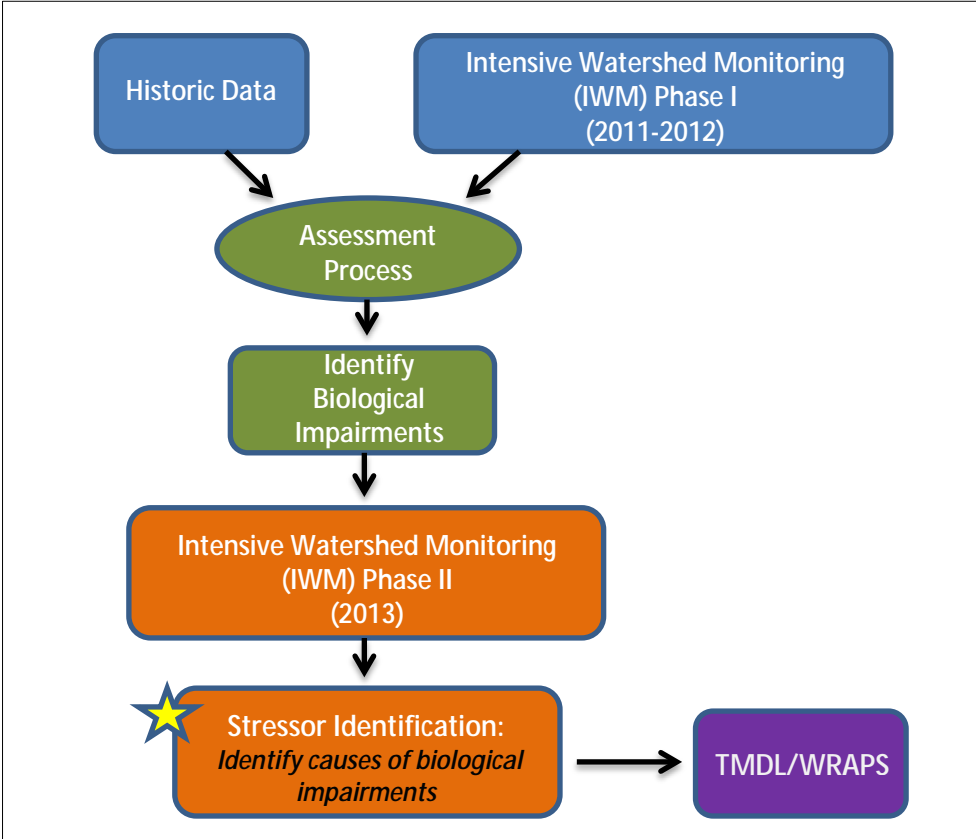
Figure 1. Process map of Intensive Watershed Monitoring, Assessment, Stressor Identification and TMDL processes.

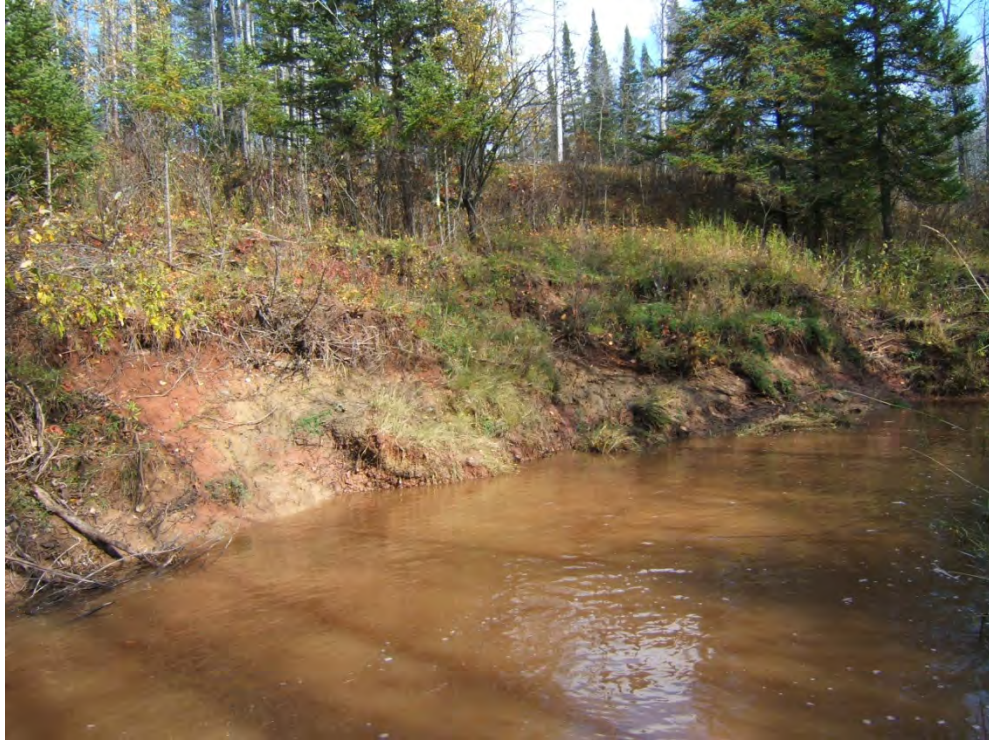
Figure 5. High turbidity in a clay soil stream in the Nemadji River Watershed

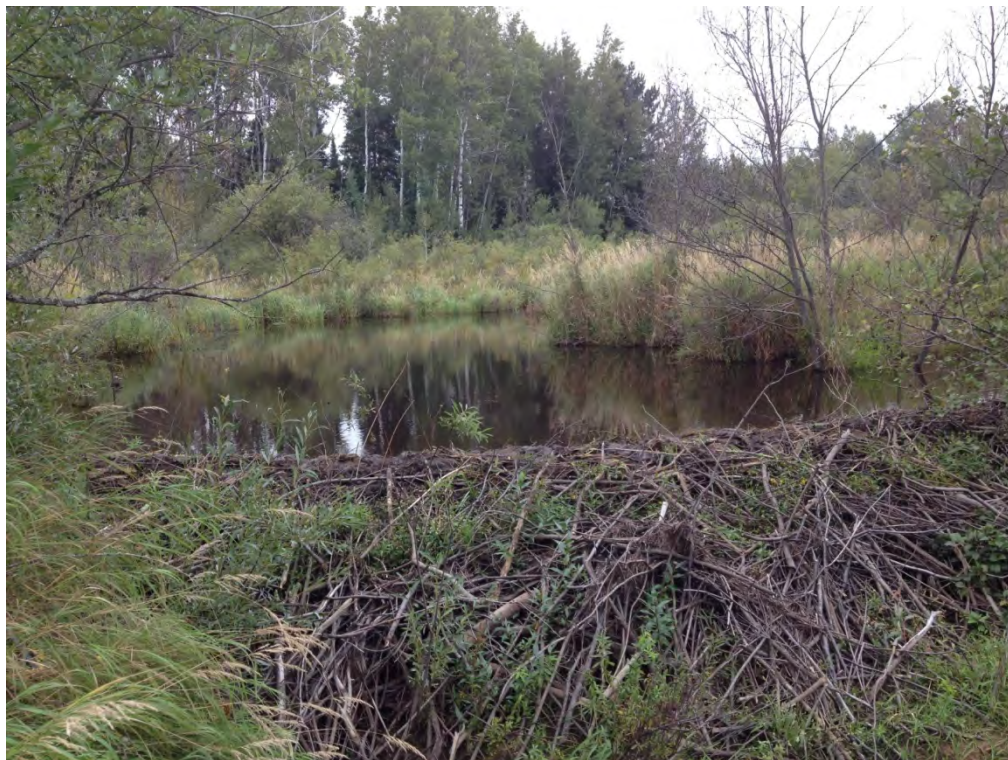
Figure 6. Upper watershed areas contain slow flowing streams, wetlands, and beaver dams

Streams outside of the red clay zone have significantly lower turbidity levels, and are characterized by slow moving streams, wetlands, and beaver dams (Figure 6). All or part of five of the six biologically impaired stream reaches addressed by this SID report is located in the red clay zone. Although there may be some consistent chemical and physical stressors found throughout the Nemadji River Watershed, most stressors are distinctly different in headwater versus red clay zone streams.

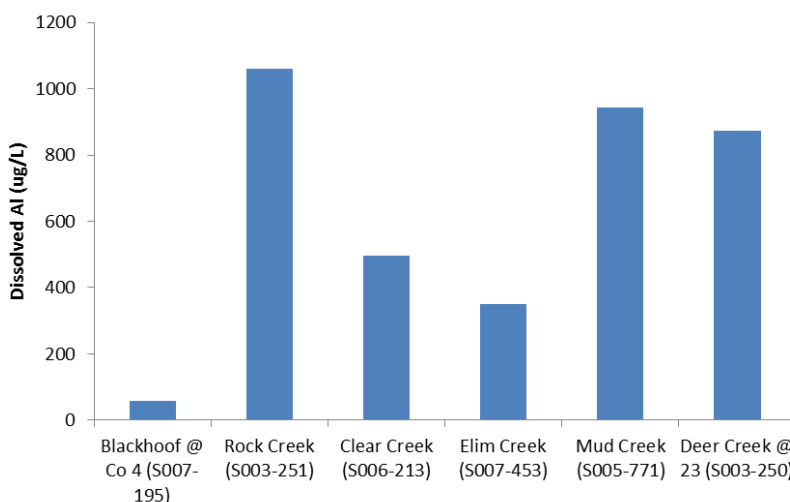
Figure 14. Dissolved aluminum concentrations in the impaired reaches (October 2013)

The acid-soluble aluminum values noted for the October 6, 2013 Nemadji sampling ranged from 58 to 1060 ug/L. These grab sample values suggest periodic exceedance of EPA criteria published in 1988 as described above. Rock Creek had highest dissolved aluminum concentration of all sites in October 2013 (1,060 µg/L) (Figure 14). However, the protocol for measuring the toxic dissolved form of aluminum is currently being updated. It is not known what fraction of the dissolved aluminum measured during this targeted investigation is toxic to biological life.

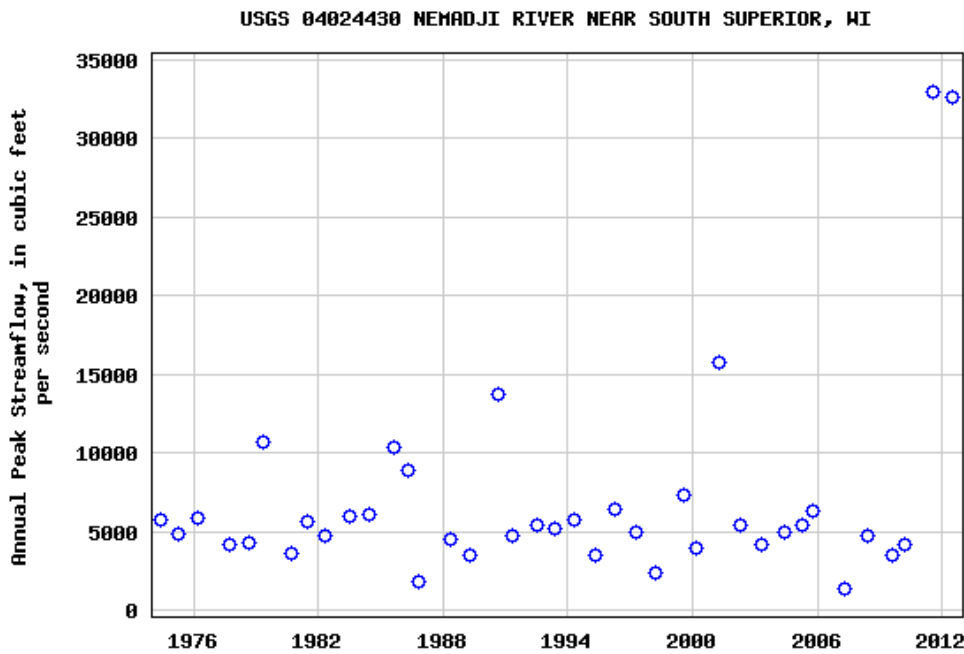
Figure 18. Peak flows in the Nemadji River at the Superior, Wisconsin USGS gauge

Wet and dry periods per year were tabulated for Foxboro, WI from 1970-2013. A wet period was tabulated if there was rainfall in the preceding 1, 2, 3, 5 or 10 day period with the converse for dry period tabulations. The number of wet periods per year in the Nemadji River Watershed appears to be declining (Figure 19) for all precipitation classes while the number of dry periods shows an increasing pattern (Figure 20). The floods of August 3, 2011 and June 21, 2012 were the two highest events recorded over the 39 year record.

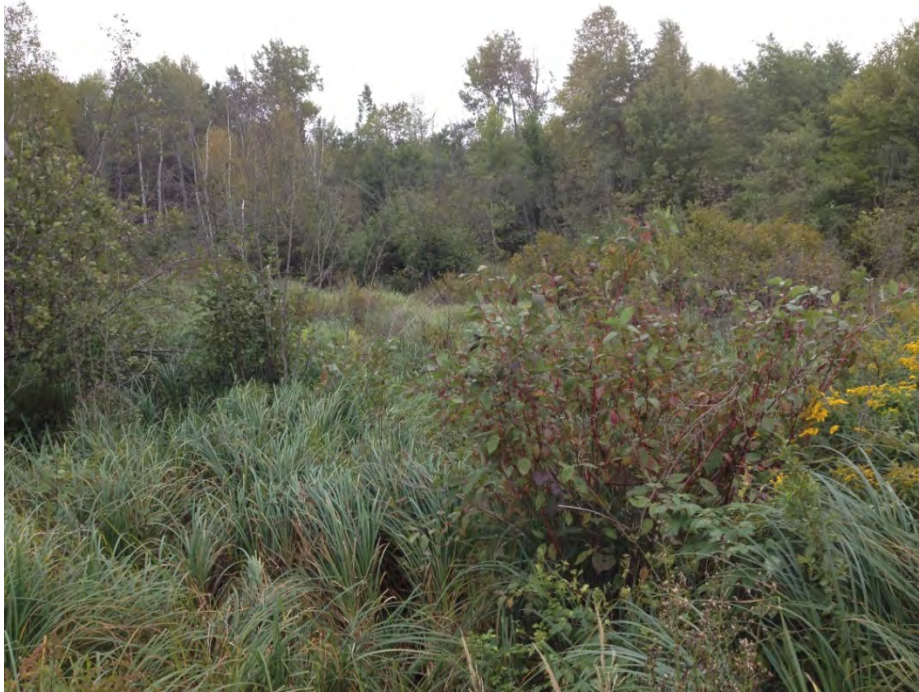
Figure 21. No discernible channel immediate downstream of beaver dam on Anderson Creek.

The Carlton SWCD recently conducted a road culvert inventory of the entire Nemadji River Watershed (Figure 22), and several culvert barriers have been replaced in the past decade. Carlton SWCD recently secured funding to survey ATV trail culverts and prioritize culverts for replacement. In addition, the Carlton SWCD is supporting projects to remove historic red clay dams throughout the watershed, beginning with the Hammitt Dam on Elim Creek. Beaver activity is also common along many of the stream reaches within the watershed. Impoundments created by beaver dams have affected the hydrology of many streams by reducing flow velocities above the dam and decreasing flow below the dams. This is especially evident on Anderson Creek where the dam had been in place so long that water no longer was observed flowing immediately downstream of the beaver dam in the fall of 2013 (Figure 21).

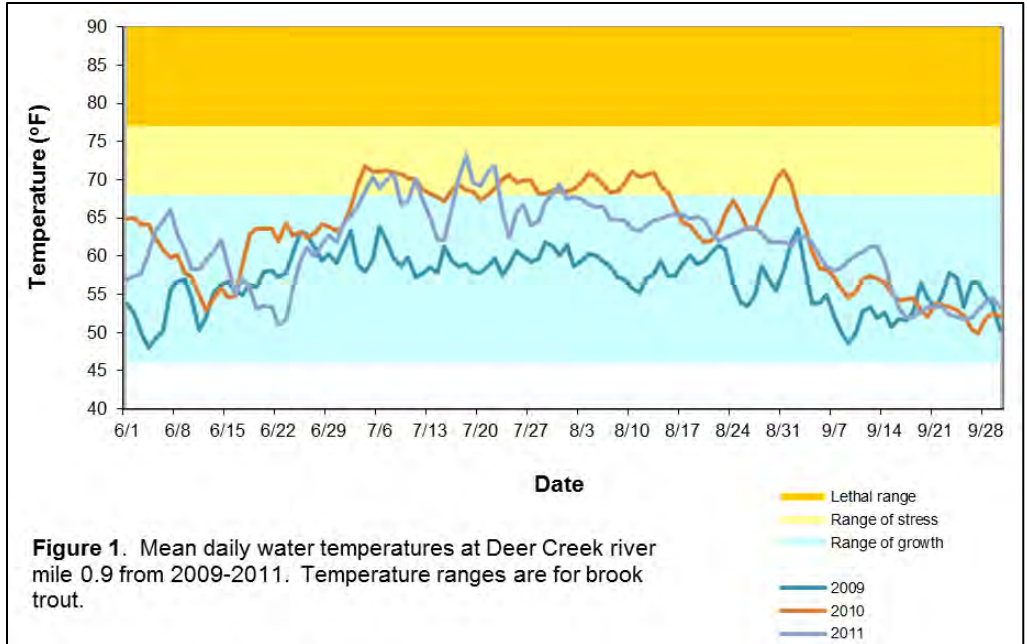
Figure 27. Mean daily water temperatures at Deer Creek at MN23 (MDNR 2009-2011)

Continuous water temperature data was collected at the biological monitoring sites by the MPCA in 2011, by MDNR at many sites along the impaired stream reaches within the past 5 years (Figure 27), and during the 2013 summer season by EOR (Figure 28). These data are used to assess the length of time stream water temperatures reach stressful or lethal temperatures for trout species, as listed in Table 11.

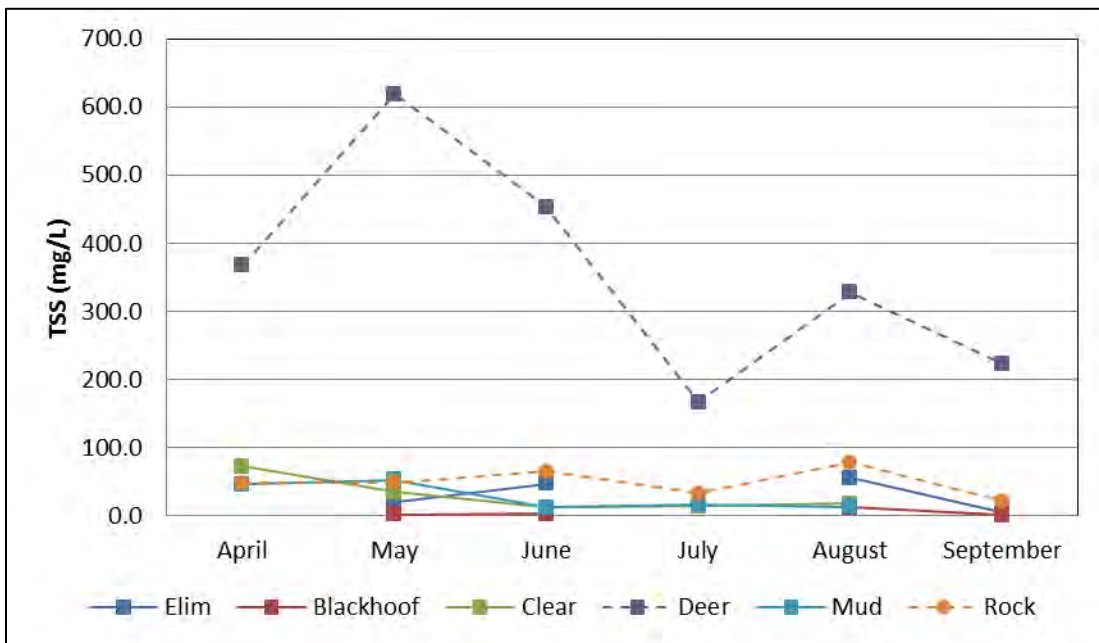
Figure 30. Mean TSS concentrations on impaired stream reaches between 2002 and 2013.

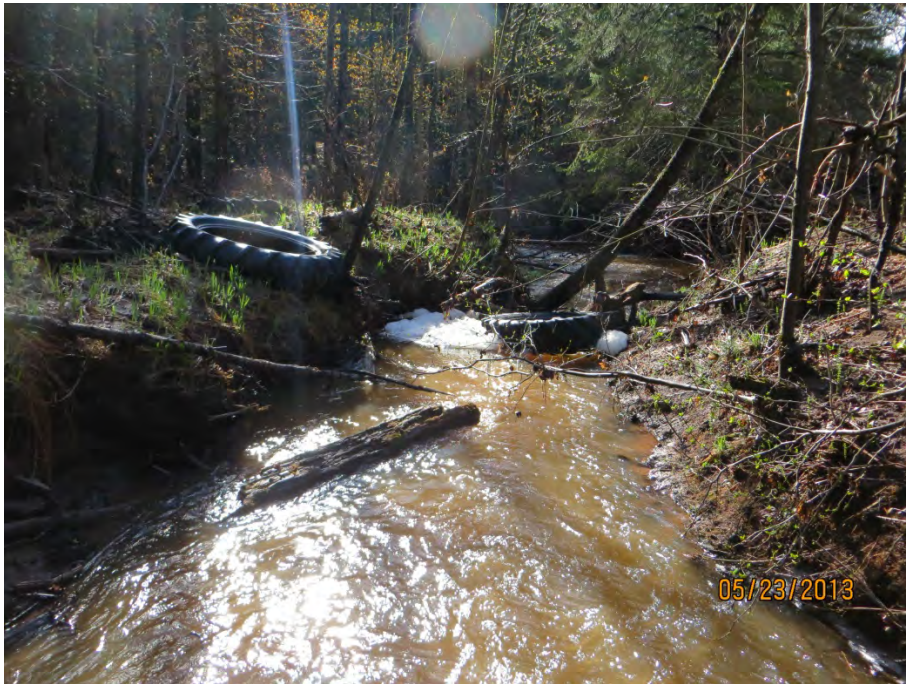
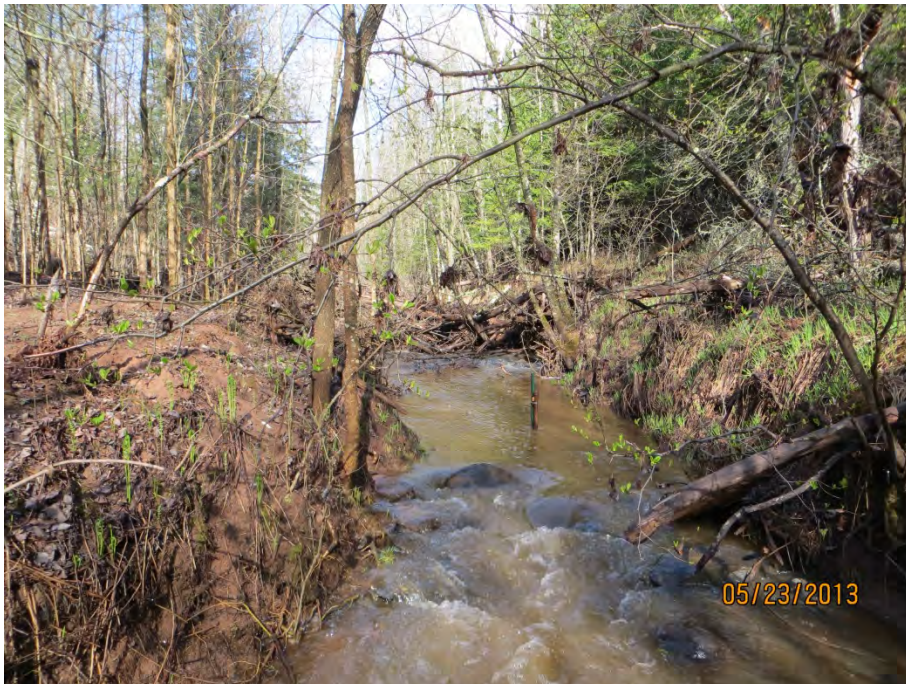
Figure 39. Log jam acting as a fish barrier on Elim Creek; facing downstream (above) and upstream (below)

by mottled sculpin and other sensitive species (longnose dace and pearl dace). Due to the isolation of fish species above the pipe barrier, habitat fragmentation was identified as the primary stressor to aquatic life in Elim Creek.

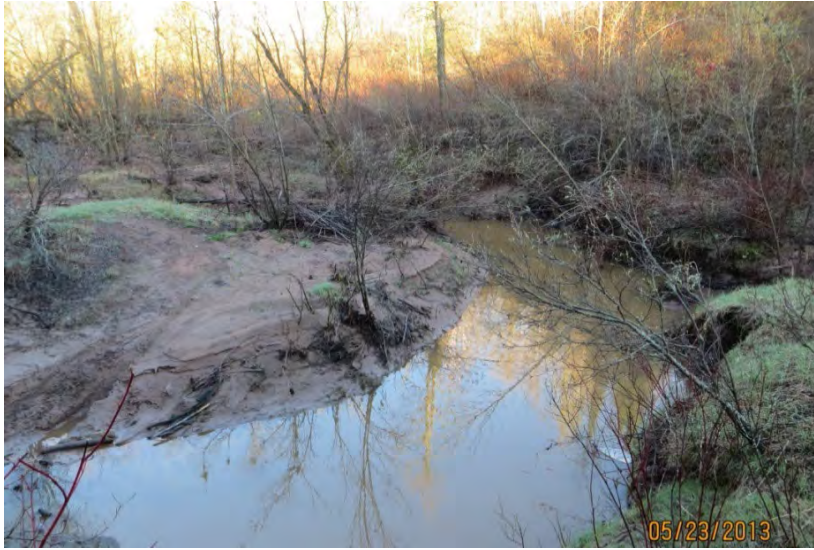
Figure 59. Eroding streambanks on Clear Creek

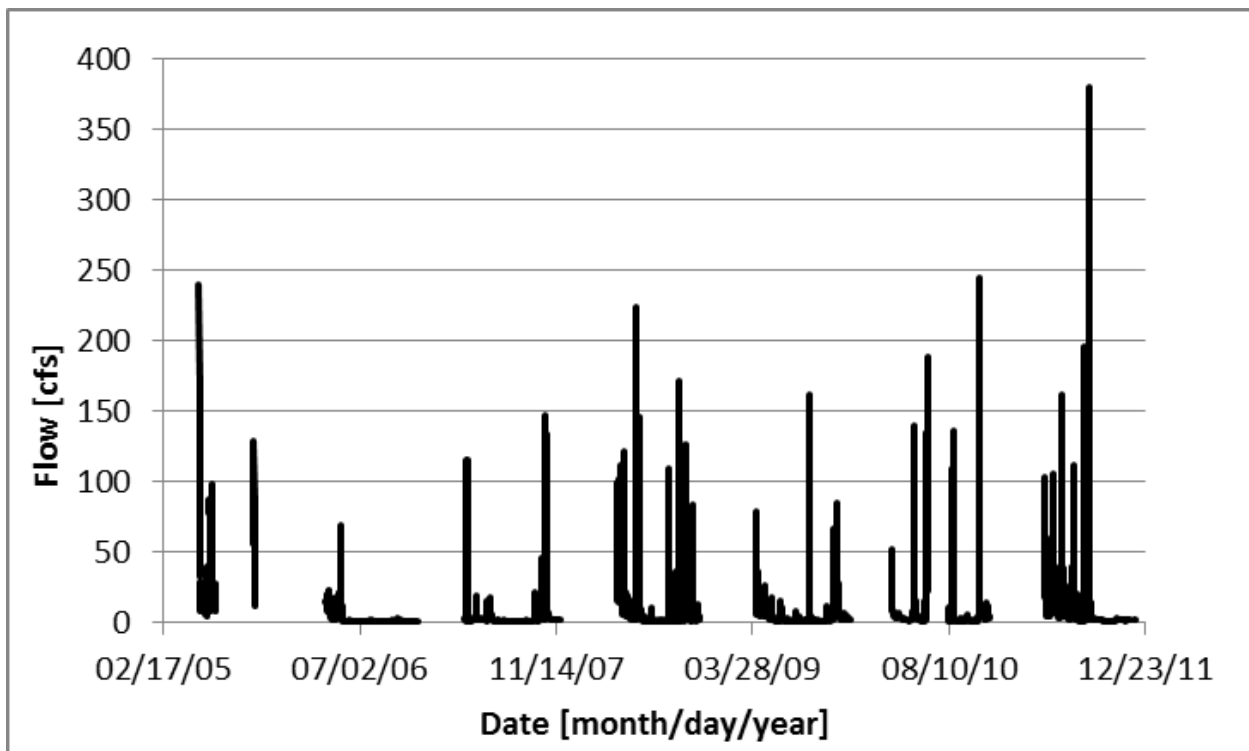
Figure 63. Continuous flow monitored in Deer Creek (2005-2011)

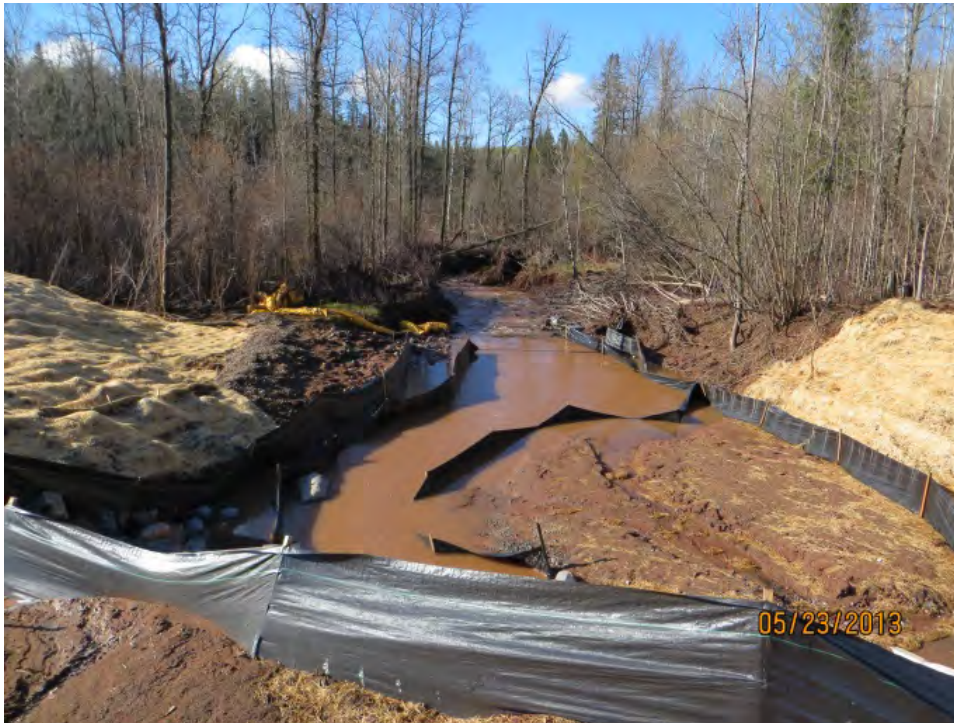
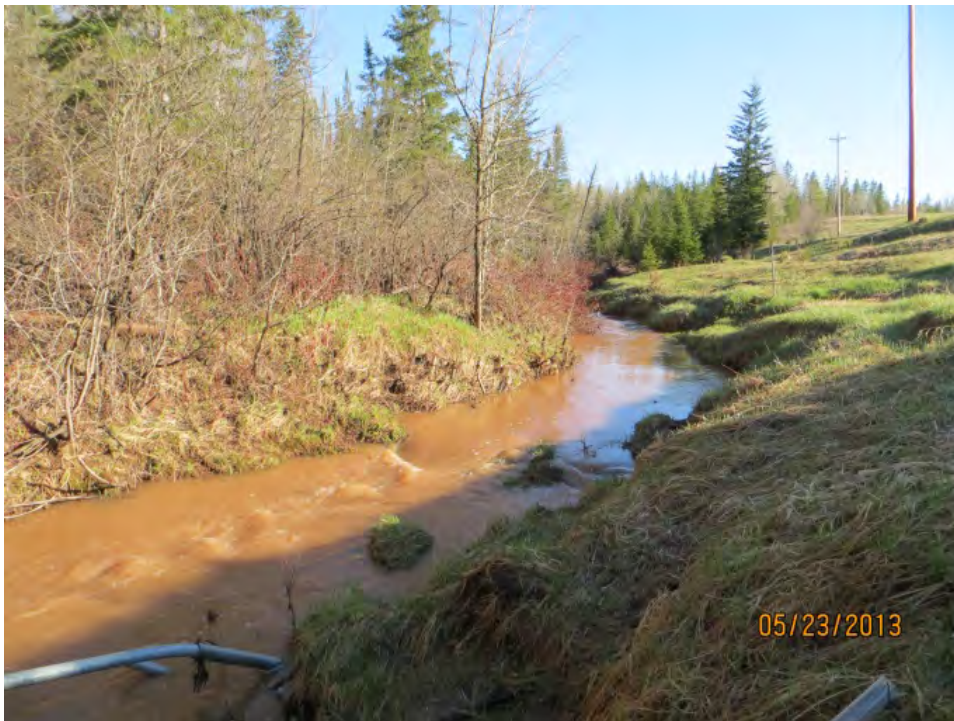
Figure 67. Turbid water in Deer Creek (2013)
