Pine River Watershed Stressor Identification Report

This report describes the stressors to the biological community in the Pine River Watershed

Document number: wq-ws5-07010105a

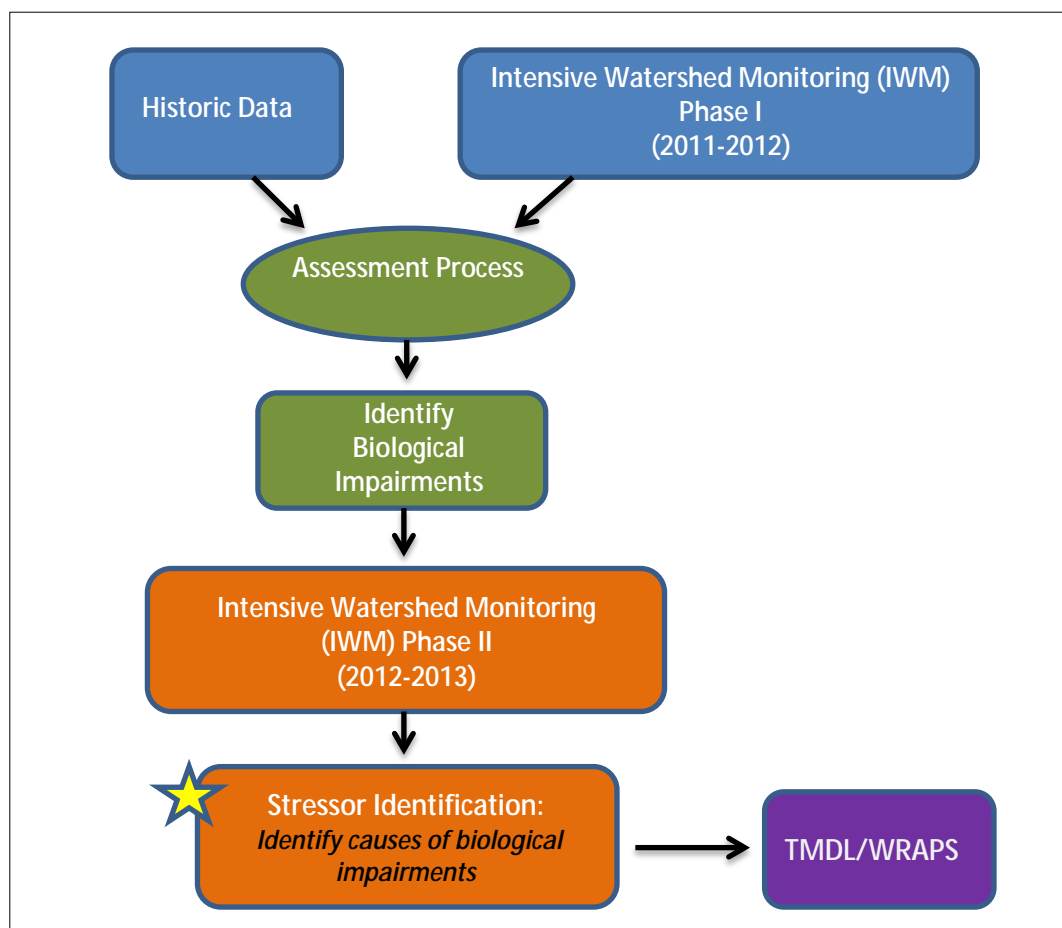
Figure 1.1.1: Process map of IWM, assessment, SID, and TMDL processes.

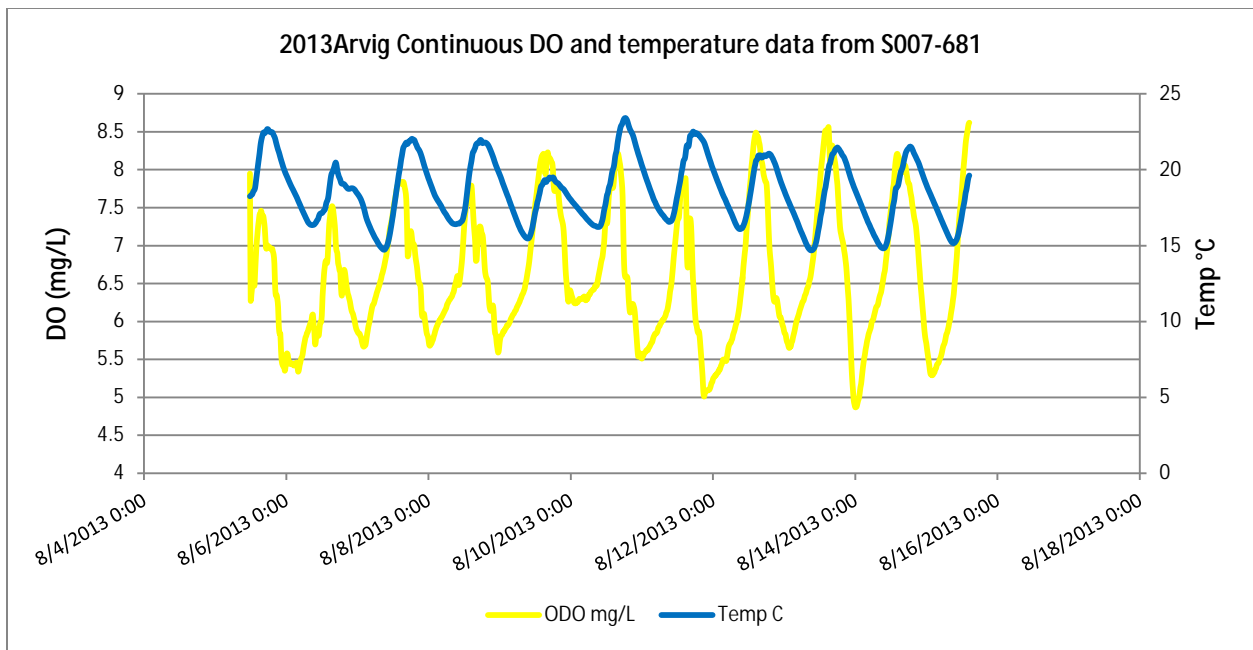
Figure 4.1.4: YSI continuous sonde data collected downstream of Biological Site 99UM042 in August, 2013. Dissolved oxygen levels are daily above the Class 2B five mg/L water quality standard.

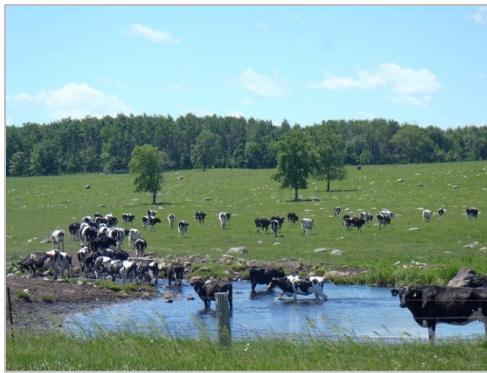
Photo 1 (06/27/2013)

Figure 4.1.9: Photos of active pasturing occurring along Arvig Creek in 2013. Photos 2 and 3 are located at the downstream end of 99UM042. Photos 1 and 4 are located just downstream on the road crossing on CR44. At this location Tributary to Arvig Creek joins in with Arvig creek. Tributary to Arvig flows south from CR 1 near the Pine River airport and flows through various pastures before joining Arvig Creek.

The section of Arvig Creek downstream of the biological sampling site is heavily pastured. The pastured areas have no riparian vegetation and many of the stream banks are exposed and actively eroding. Photographs of the stream just downstream of 99UM042 were taken in June and July of 2013 (Figure 4.1.9). These photos show the various bank erosion and lack of riparian cover along the stream in general. Above site 99UM042 the channel is also lacking in riparian vegetation. Aerial photograph review shows that this stream section between Rice Lake and 99UM042 is over widened and pastured. Figure 4.1.10 shows the current conditions of the stream channel and the riparian vegetation found along the stream corridor. The aerial photograph is from 2013. There appears to be a stream crossing located just upstream of sampling location 99UM042. This stream crossing is almost 10 times wider than the upstream and downstream channel width.

Stream channel that are classified as an E or C channel type are highly susceptible to over widening and becoming shallower if the riparian vegetation is disturbed. The w/d ratio at surveyed cross section 3 is 23.37. An E channel type w/d ratio would be less than 12 and a C stream type would be greater than 12. The surveyed cross section w/d ratio is within the range of C channel w/d ratios published by Rosgen. The mean particle size of 5.34 mm (small gravel in the riffle) places this channel in the C4 stream type. This data was collected near the 99UM042 sampling location which is in the non-pastured area of Arvig Creek. Using ARCGIS to estimate w/d ratios both above and below sampling location 99UM042 it appears that the w/d ratios range from 29 to 42. The larger w/d ratios can help with understanding that as the channel increases in w/d ratio it also is becoming shallower and wider. This appears to be happening in Arvig Creek. The lack of riparian vegetation and possible changes in hydrology due to land use changes is allowing the channel to become wider and shallower which in turn is causing degraded habitat for fish and macroinvertebrates.

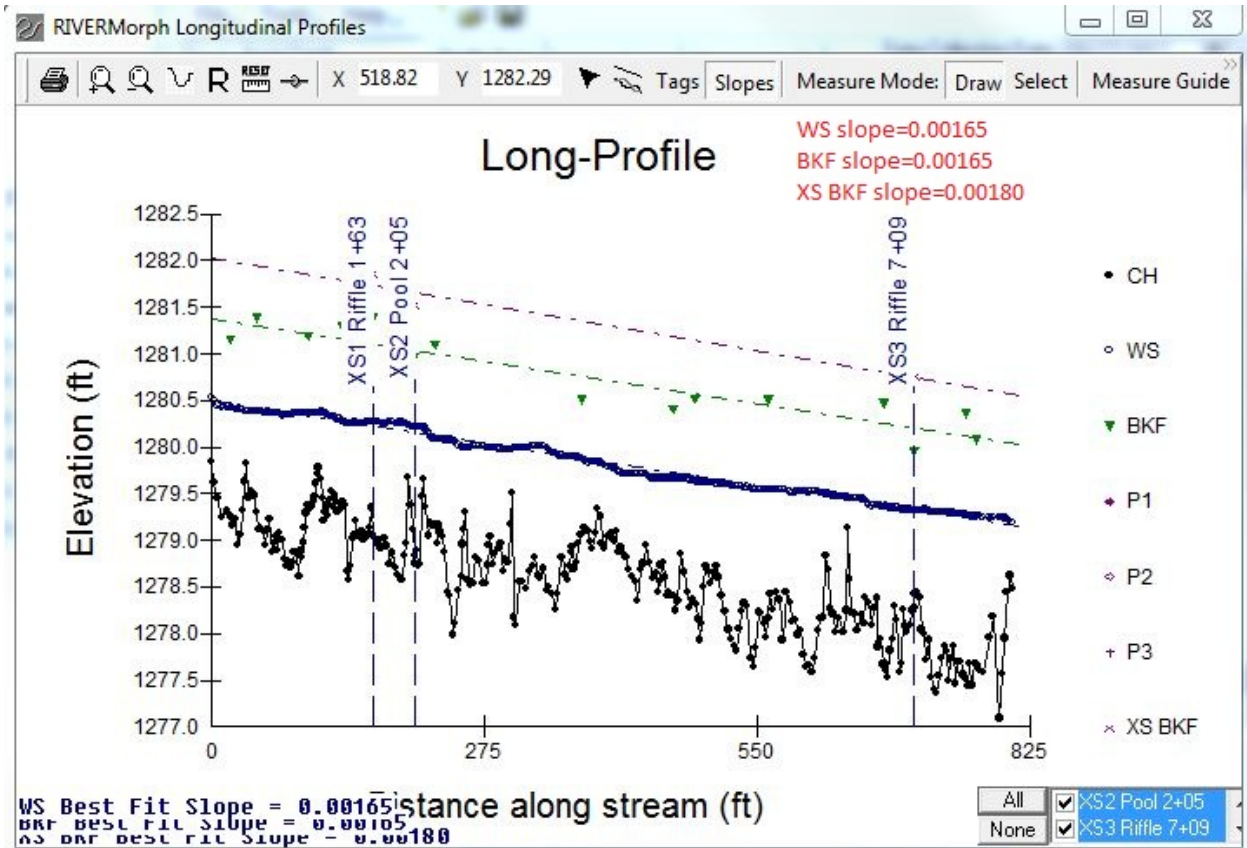
Figure 4.1.12: Longitudinal profile of Arvig Creek at site 99UM042.

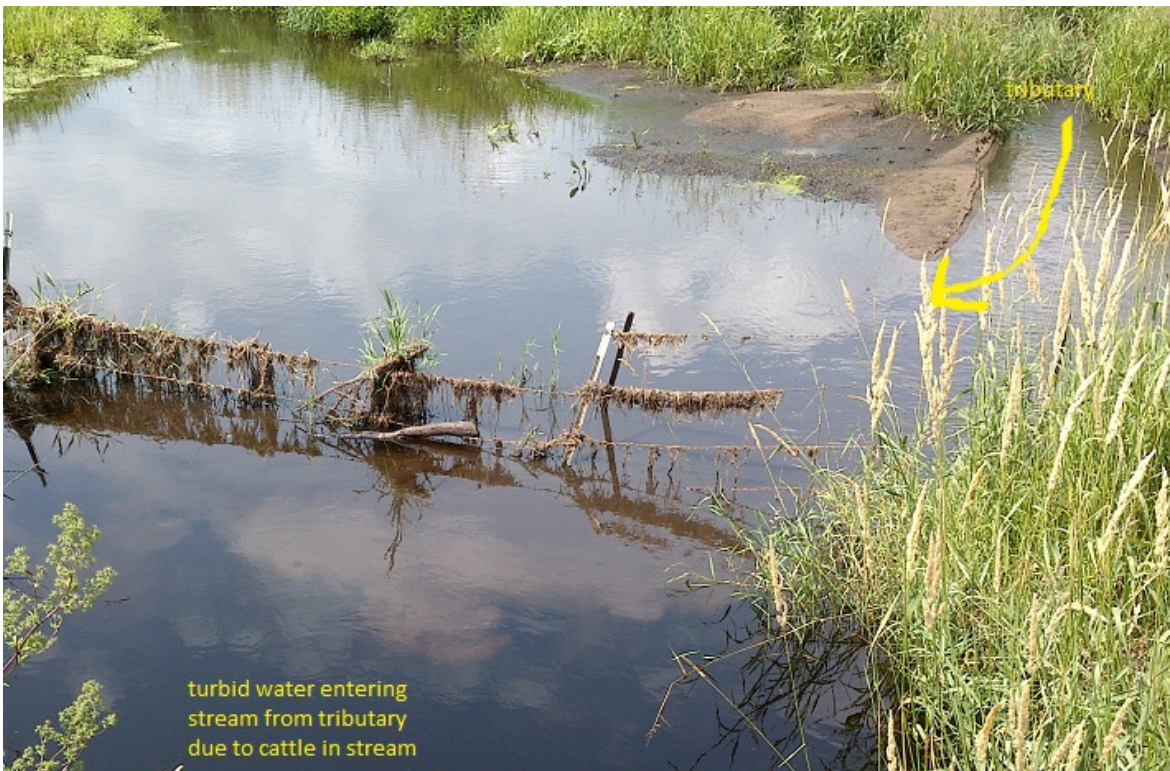
Stream turbidity being caused by upstream cattle standing in stream. Flows are elevated because of summer rainfall. Photo taken on July 17, 2014. Stube reading in tributary is 11 cm. Stube reading in Arvig Creek upstream is 91 cm.

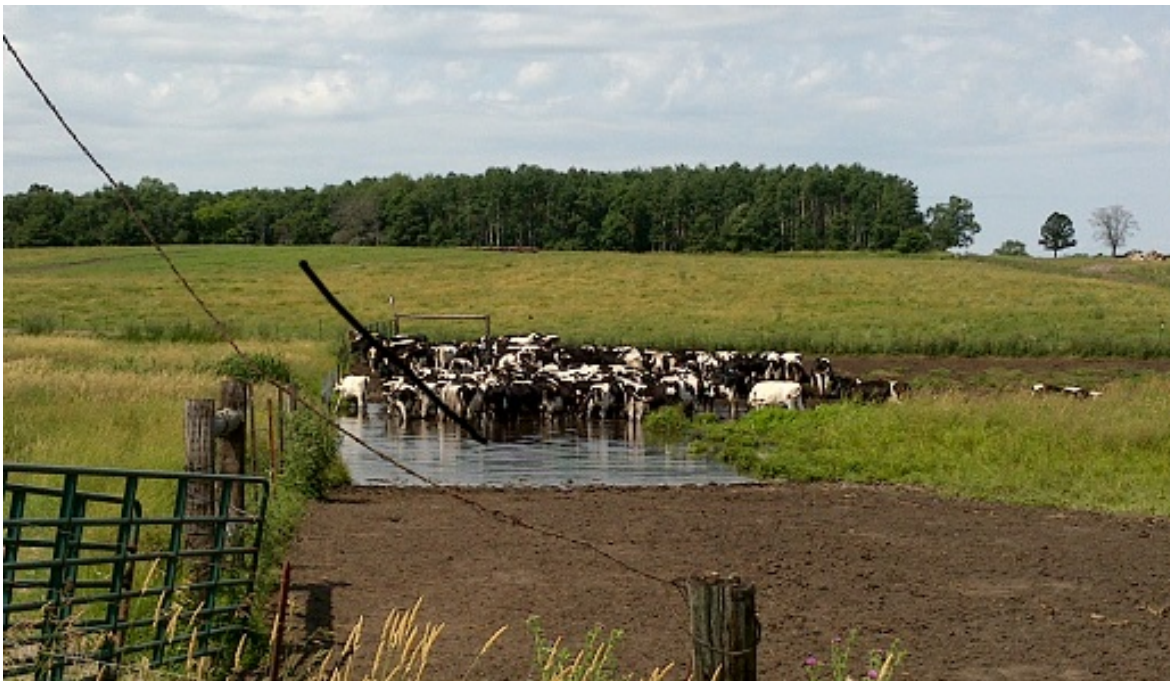
On July 17, 2014, these cattle were standing in tributary to Arvig Creek which is causing highly turbid water to be washed downstream into Arvig Creek. This turbid water is allowing suspension of fine sediment which will settle out downstream and cause a degradation of stream substrate.

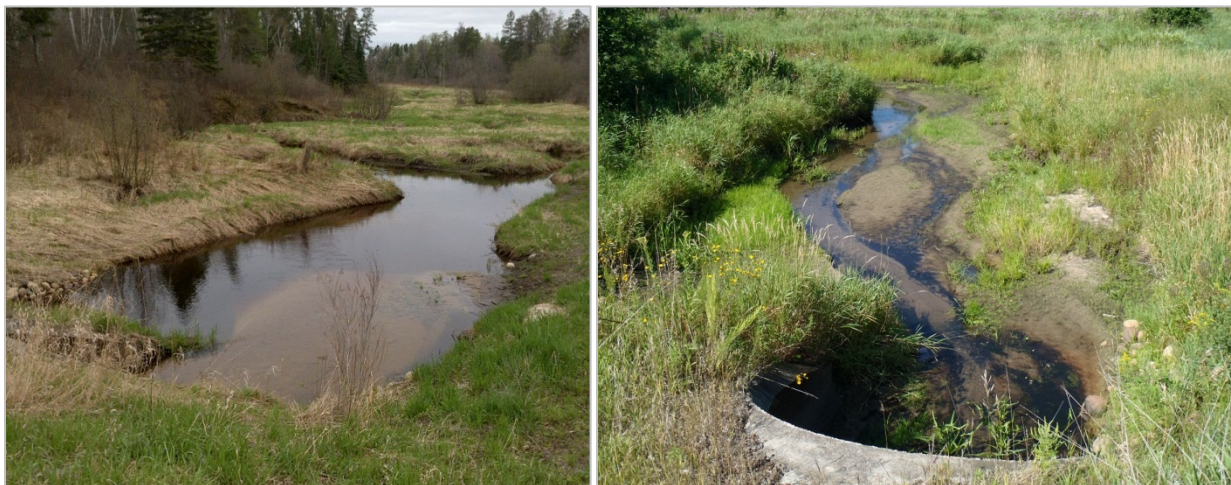
Figure 4.2.5: Photos of the road crossing above biological Site 12UM129. Photo on the left shows sediment delta downstream of road crossing. Photo on the right is looking at the same sediment delta after a summer of vegetation growth. Channel appears to have been cleaned out with a backhoe in the recent past and is now starting to recover and narrow back down. Sinuosity is being formed again in this section of channel.

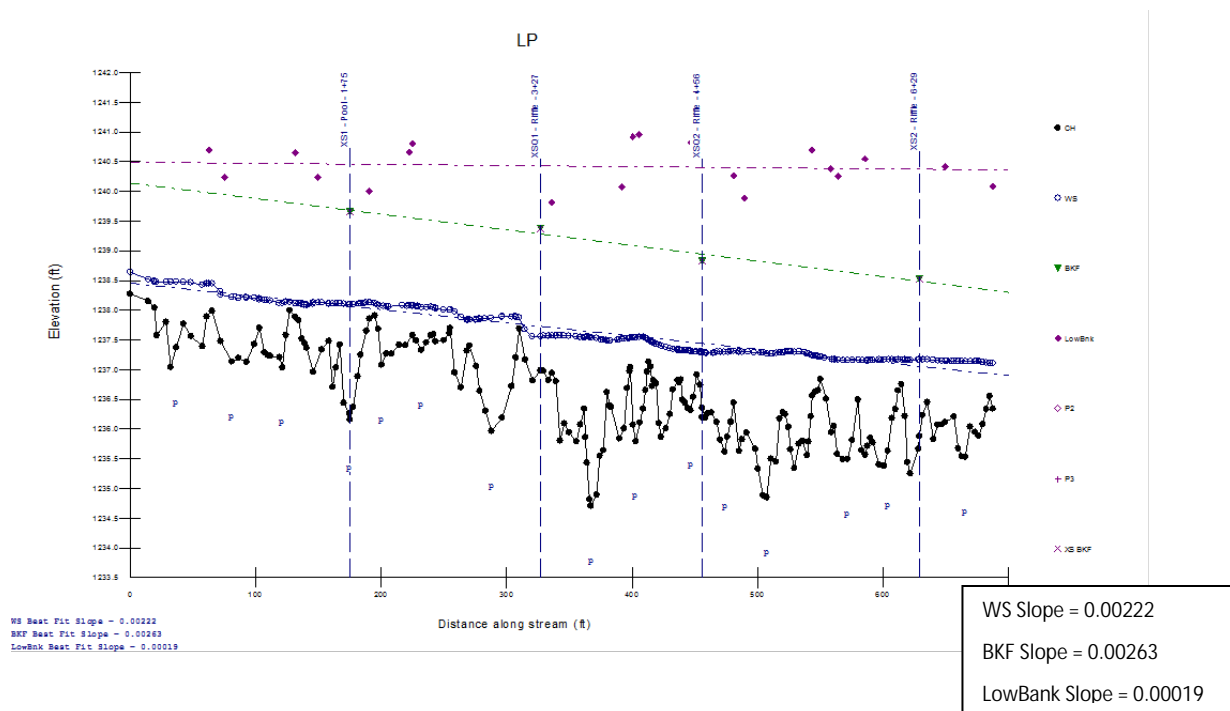
Figure 4.2.8: Longitudinal profile at 12UM129. Survey by MDNR in 2013.

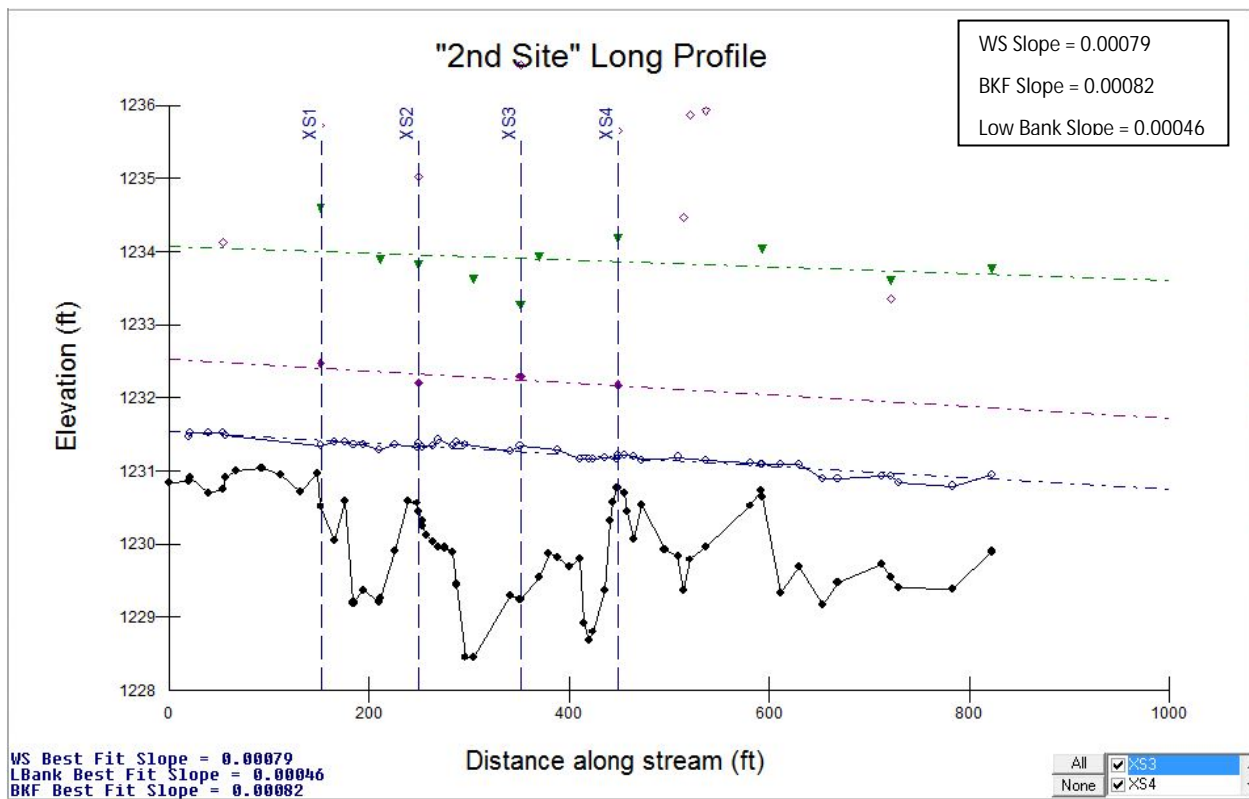
Figure 4.2.9: Longitudinal profile for Willow Creek downstream of Long Farm Road at "2nd Site" in pastured area. Survey by MPCA in 2014.

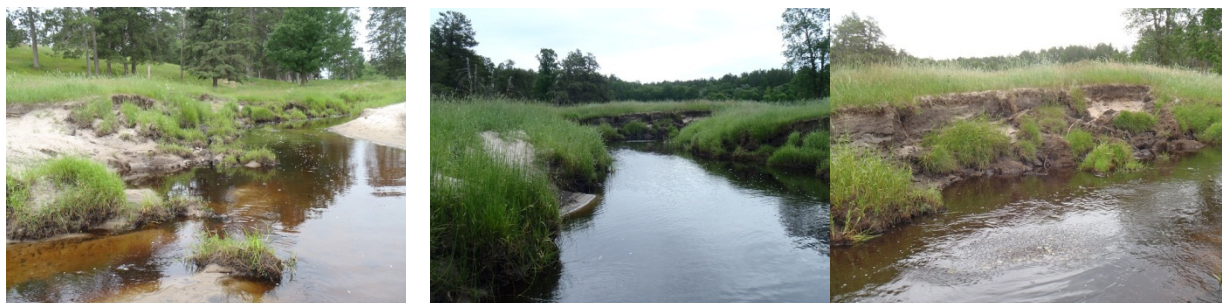
Figure 4.2.10: Map of BEHI stations located on Willow Creek downstream of Long Farm Road in pasture area. Photos are of representative bank erosion areas found within the study reach.

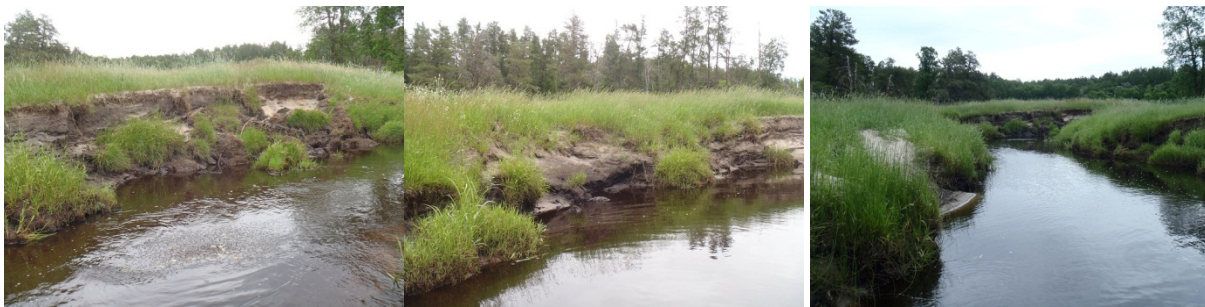
Figure 4.2.11: Photos of bank instability located downstream of Long Farm road near “2nd Site” sampling location.

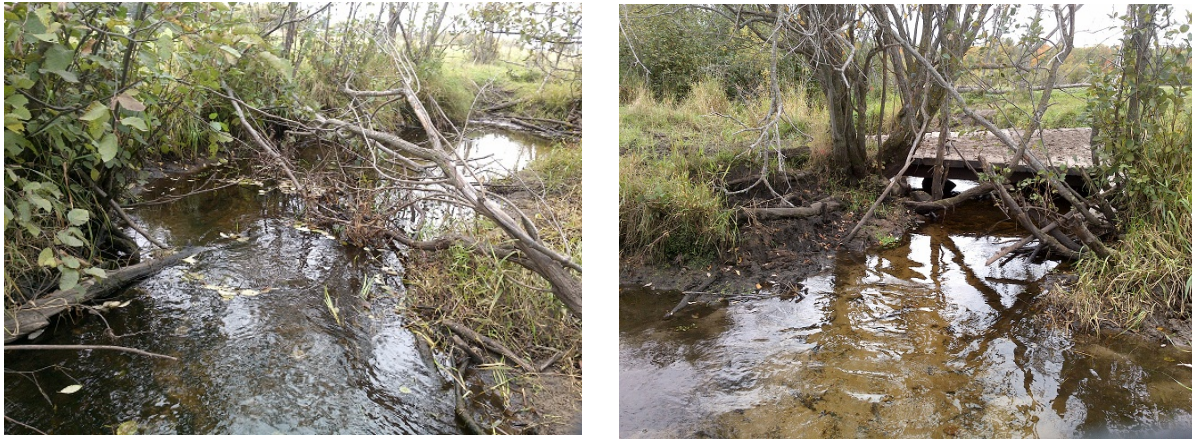
Figure 4.3.5: Wilson Creek 09/24/2014 pictures looking upstream from CR171. Lower section of reach near X-SEC4 of longitudinal profile.

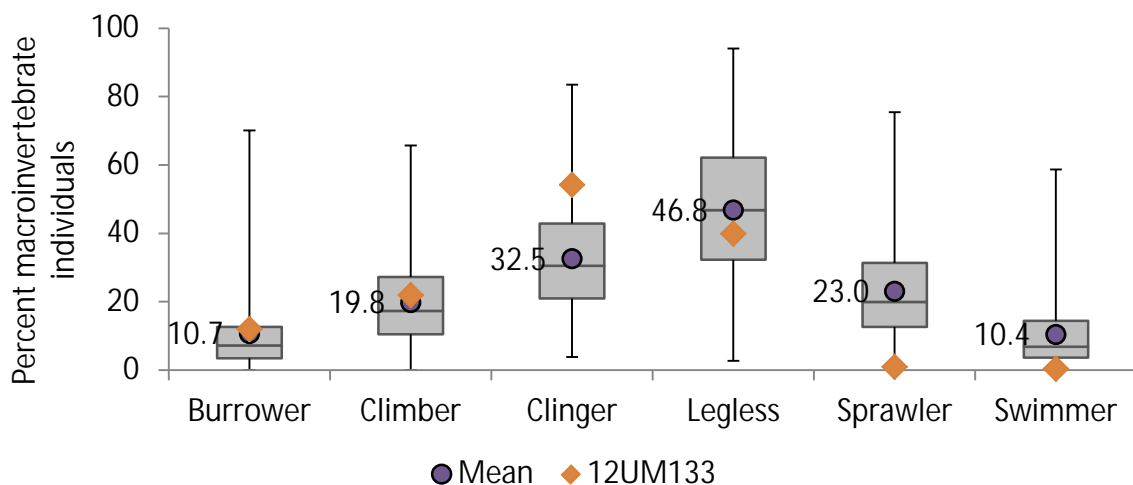
Figure 4.3.6: Macroinvertebrate habitat metrics with box plot showing range of values from natural channel Northern Forest Stream GP stations with MIBI greater than 46.8 (threshold), mean of those stations, and metric values from station 12UM133.

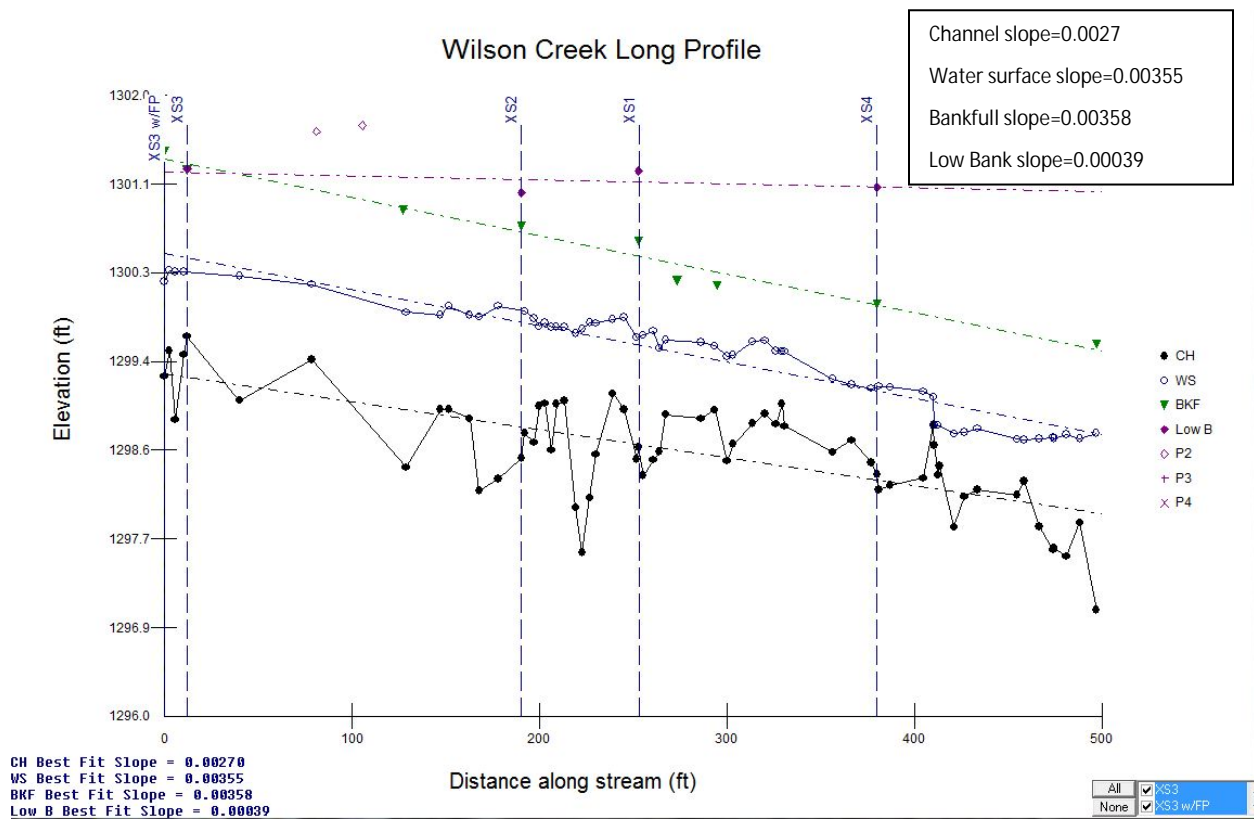
Figure 4.3.7: Wilson Creek survey channel profile. Stream channel becomes incised in the lower 250 feet of survey. This also is the area where cattle have appeared to congregate.

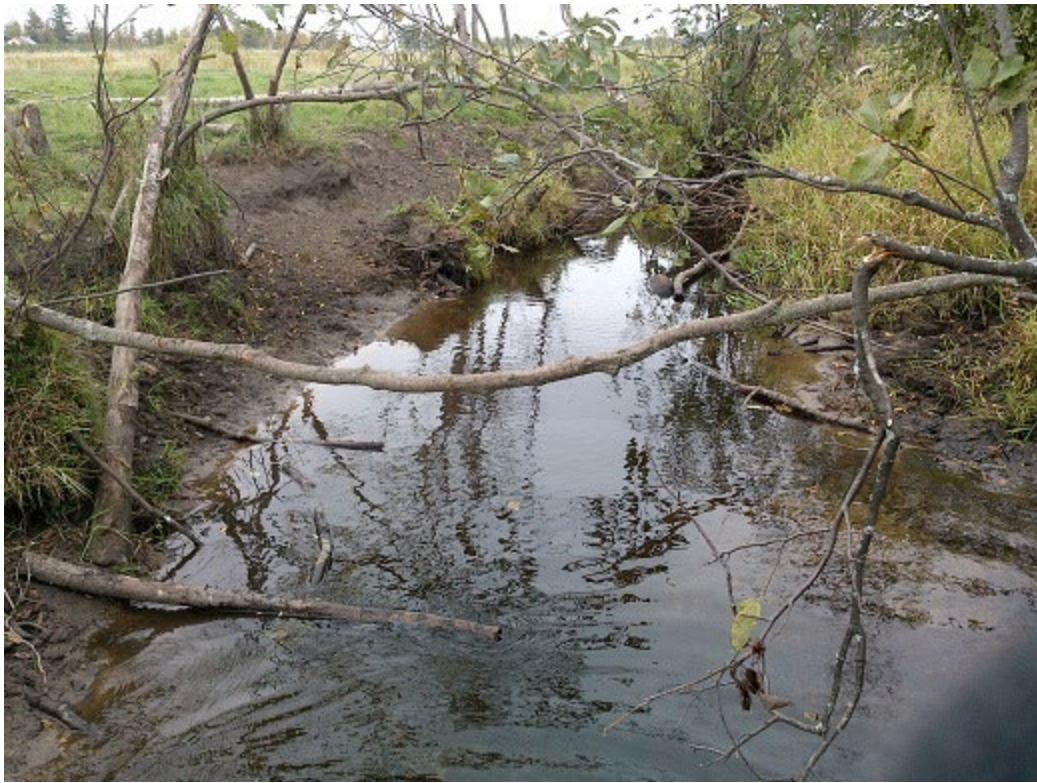
Photo 1: Looking downstream at Cross section 4 from the survey. Both banks are high compared to bankfull elevation.

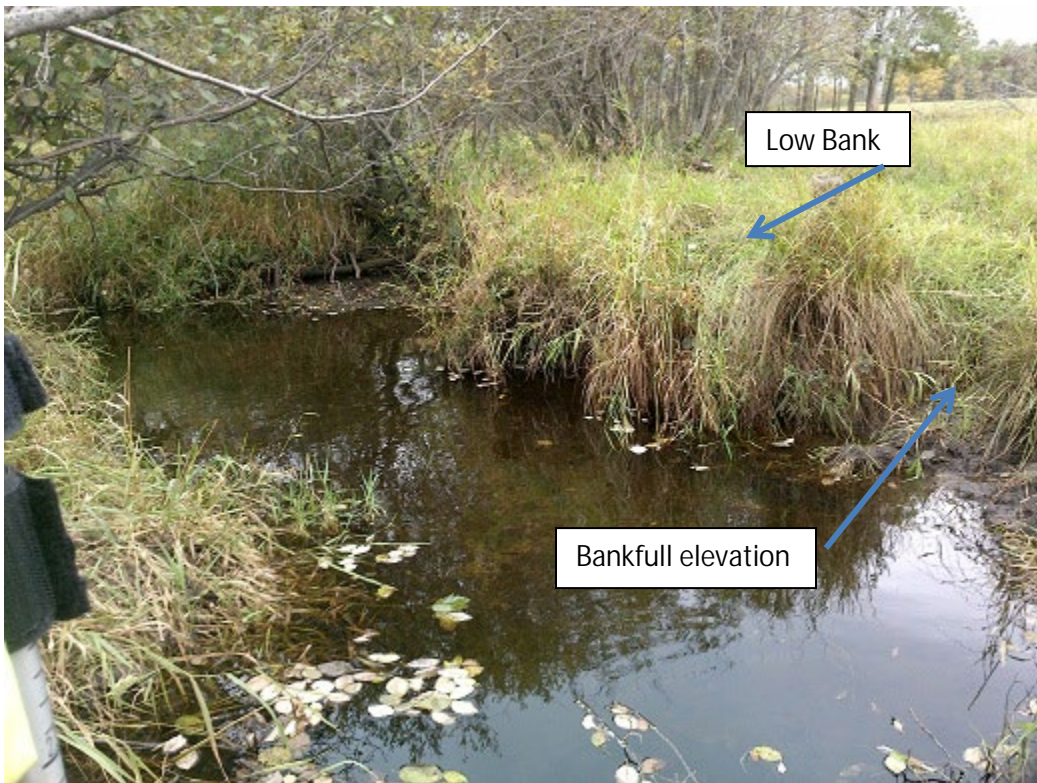
Photo 2: Taken looking downstream from cross section 1. Banks are high in respect to bankfull discharge.

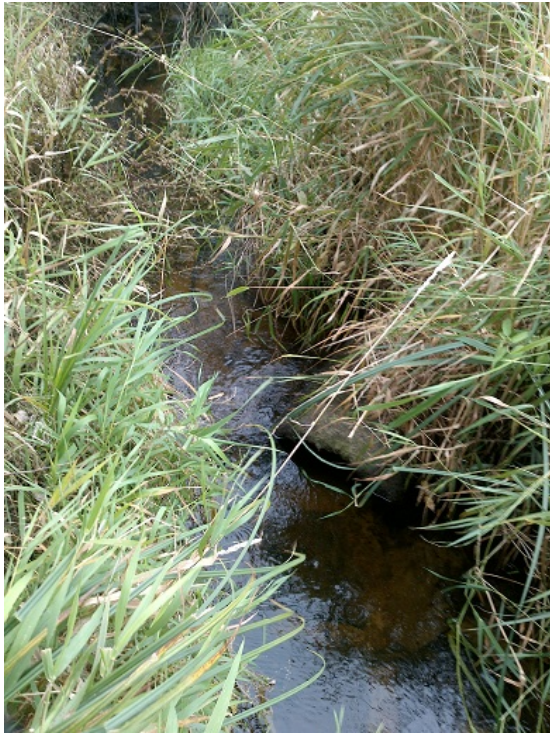
Review of the cross section surveys shows how the channel changes at approximately station 250+00 on the profile. Stations upstream of this point have low banks in relation to the bankfull height, and the stream can access its floodplain at bankfull discharge. The vegetation along this portion of the reach also changes. The willows found in the downstream section become sparse and the majority of the riparian vegetation becomes reed canary grass with some sedges mixed in. Photo 3 shows the riparian vegetation along the stream along with a typical view of the stream. This upstream portion is narrower and has slightly larger substrate size. There is small gravel located in this area of the stream.

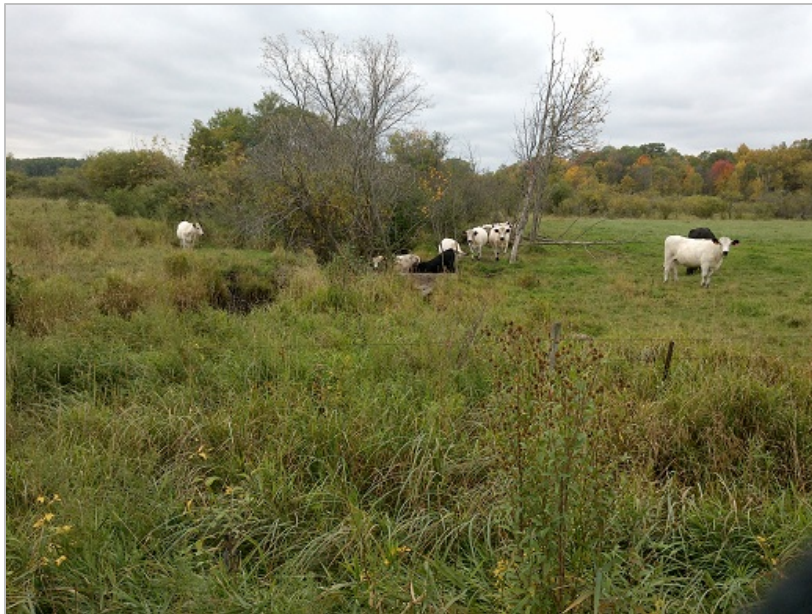
Photo to the left was taken on September 24, 2014. The cattle had just been placed in the pasture at the survey location. Previous field inspections showed no cattle at the site and the meadow was hayed in 2014 to recover some feed value for winter livestock. Around 10 cows were pastured for around one month in 2014. Various sections of stream channel in the headwaters area have been altered. The altered watercourse layer used to identify stream channels that have been channelized in the past is also

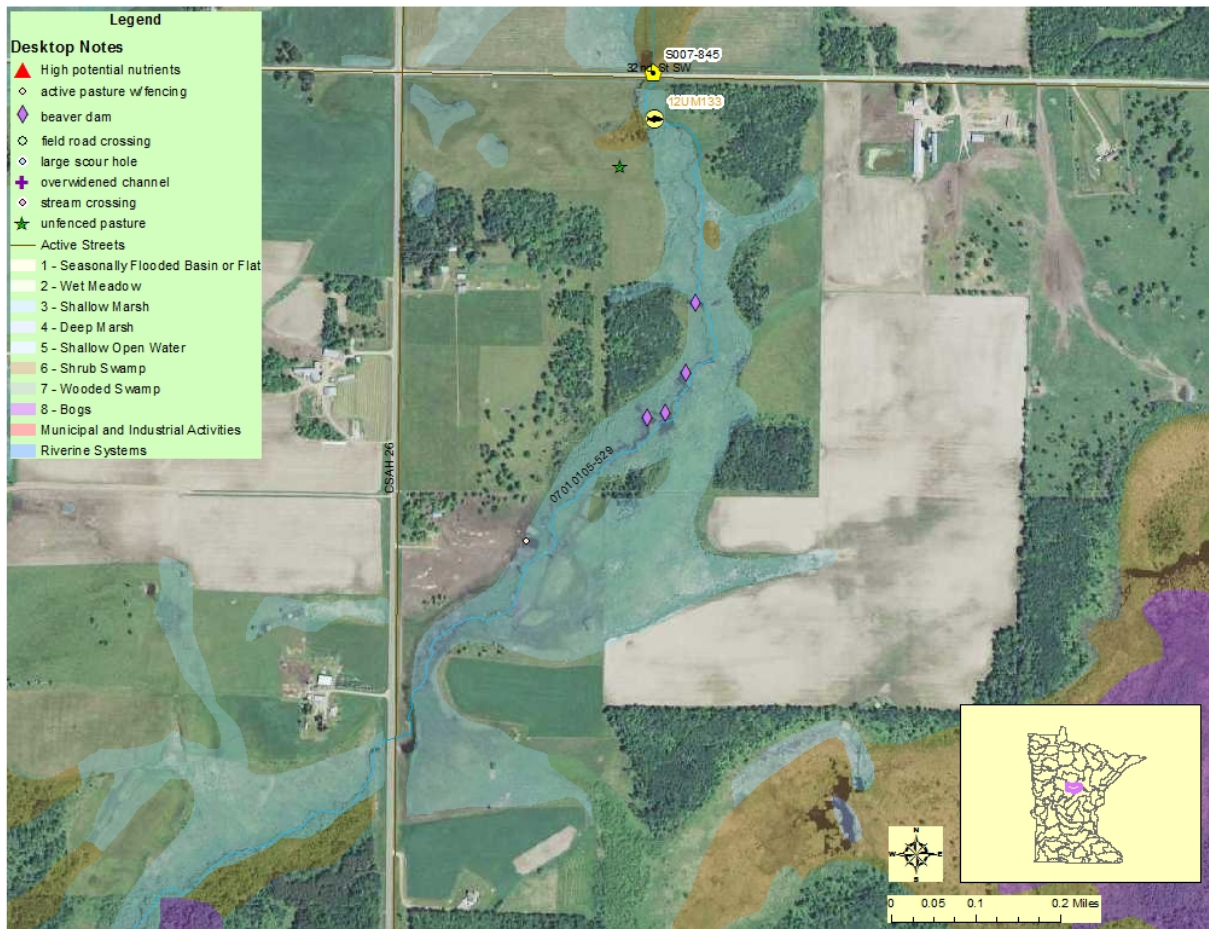
Figure 4.3.9: 2013 aerial imagery of sampling location 12UM133 along with NWI circular 39 wetland type and desktop review points of interest.

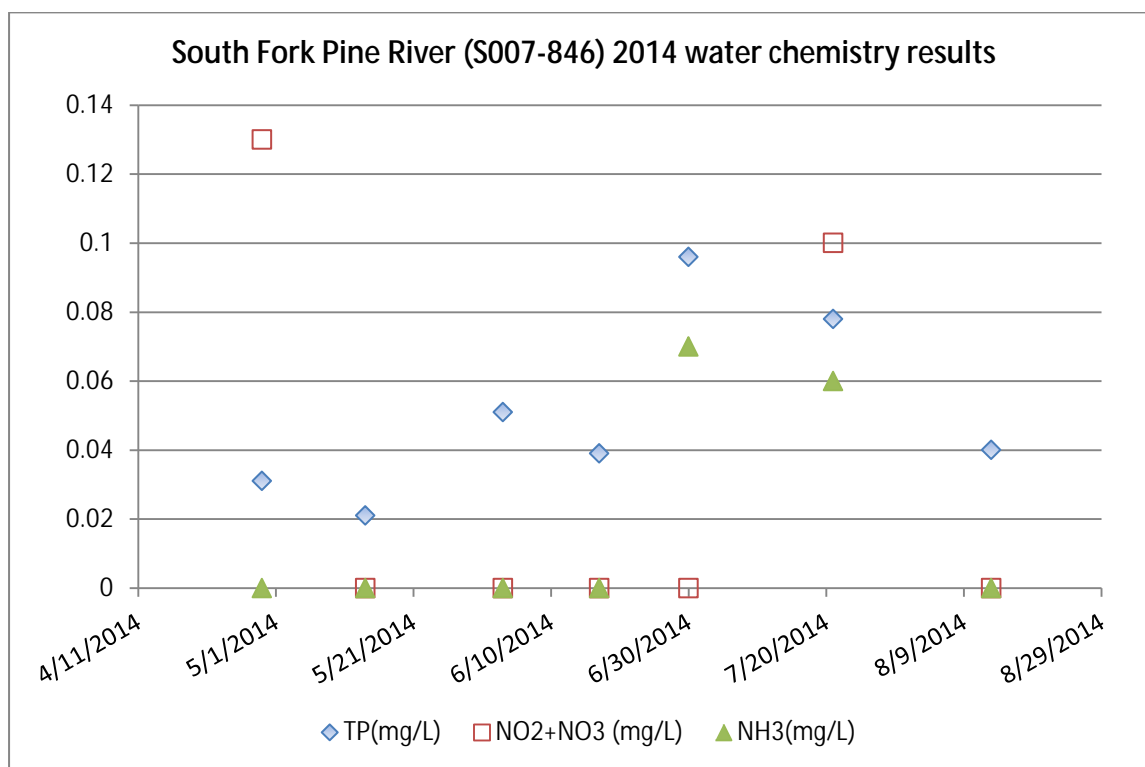
Figure 4.4.3: Nutrient concentrations at water quality sampling locations along the South Fork Pine River (S007-846). Data was collected in 2014.

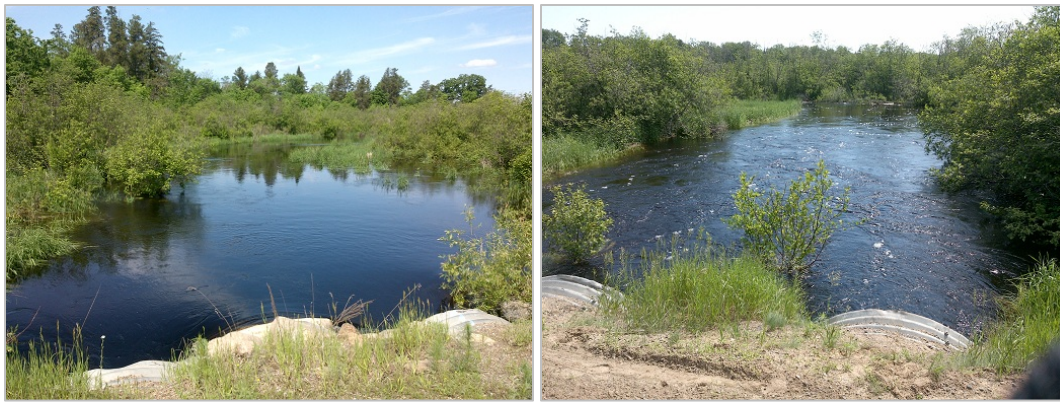
June 17, 2014, photos of 36th Avenue crossing. Left photo is upstream side. Right photo is downstream side. Note velocity differences from two sides of culvert. Upstream slope is flat. Downstream has greater slope with higher velocity.

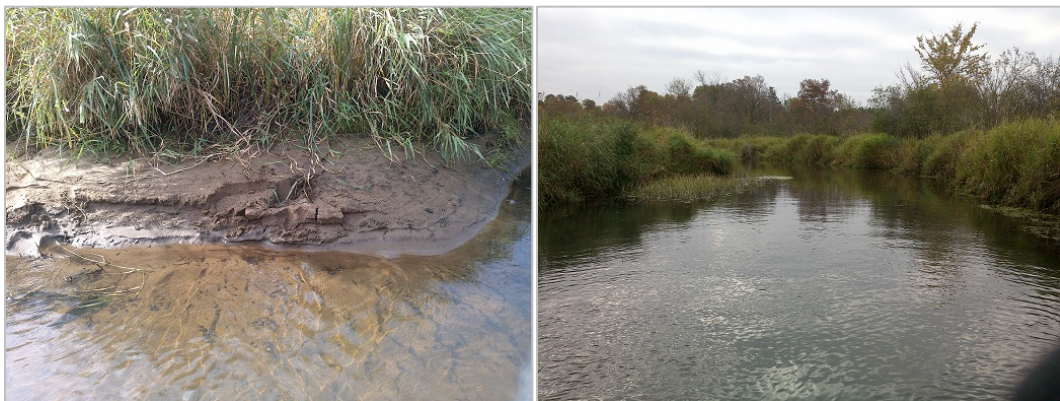
September 25, 2014, photos of deposition near site 12UM121 along with typical channel condition along reach.
