Crow Wing River Watershed Stressor Identification Report

Determination of stress factors affecting aquatic biological communities

Minnesota Pollution Control Agency

April 2014

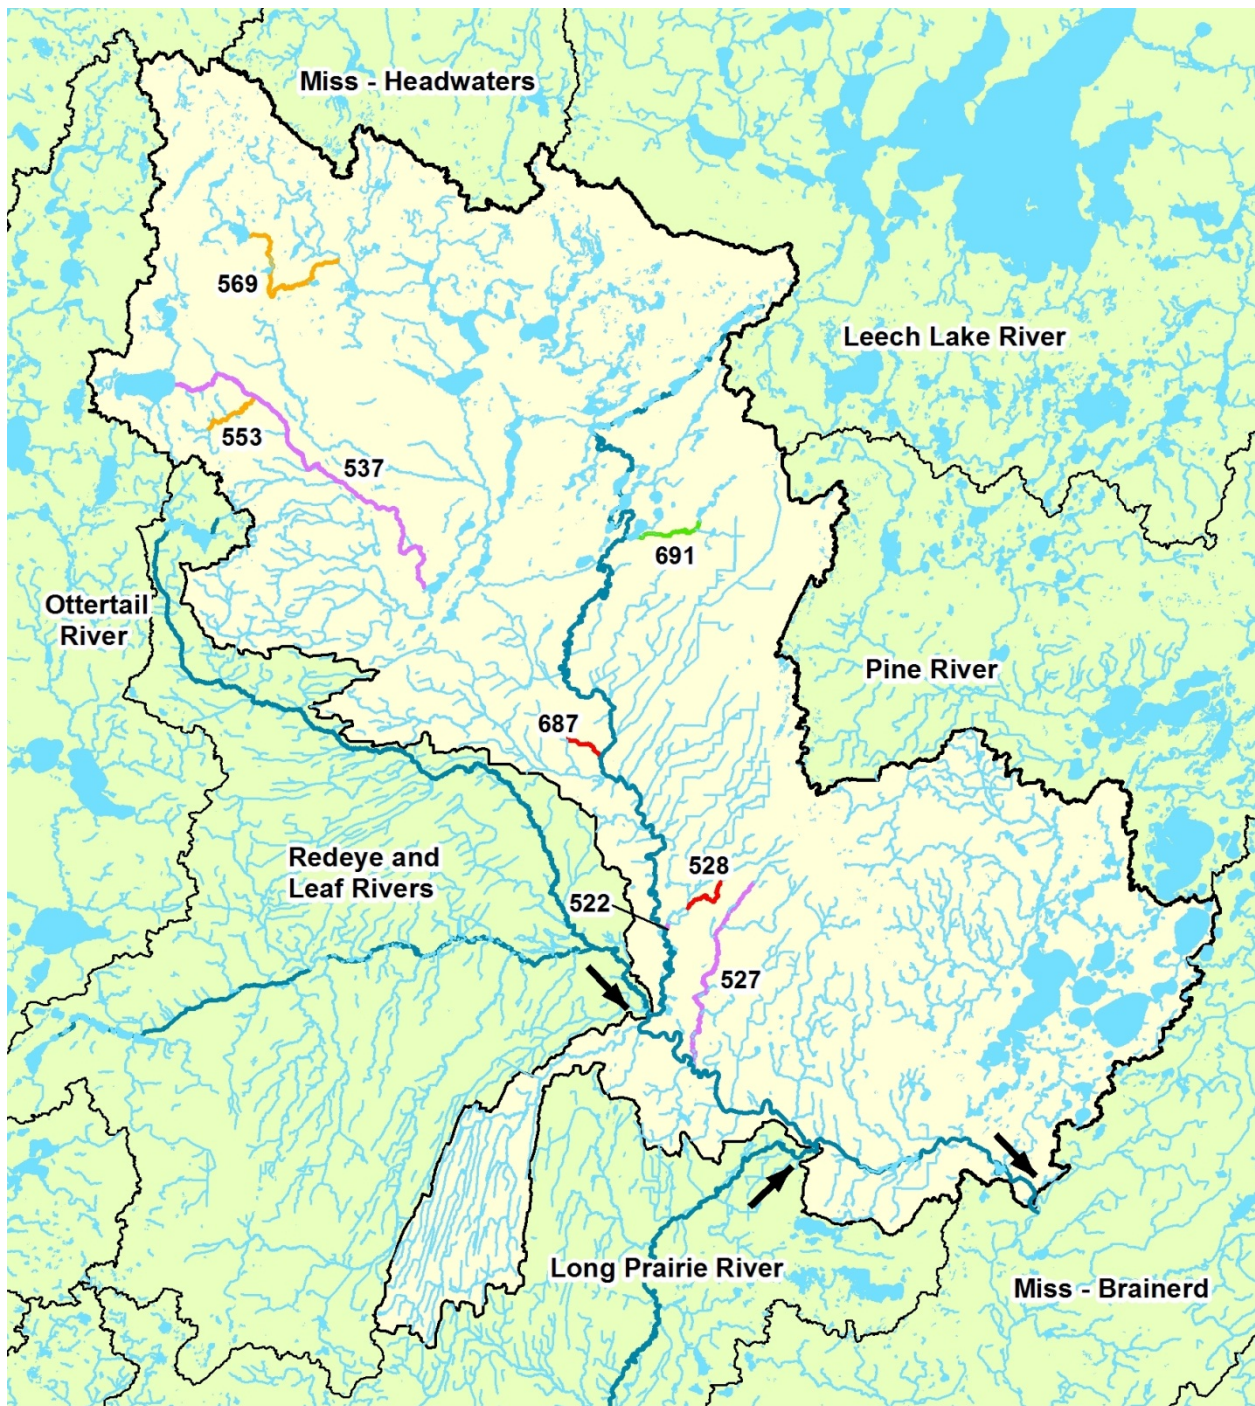
Figure 1. Stream reaches discussed in this report. Label numbers are the last three digits of the AUID number.

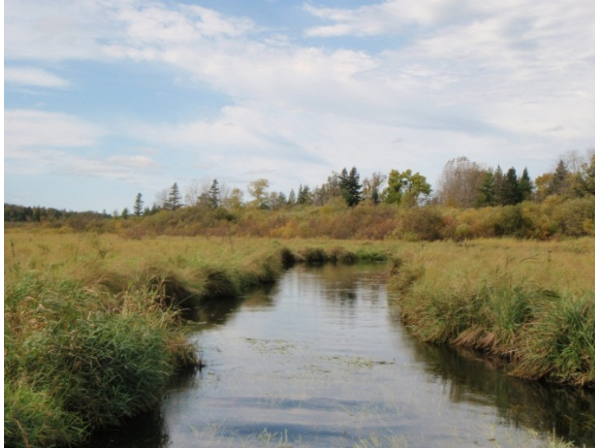
Photo 1. Blueberry River at Cty Highway 16 (384th St.)

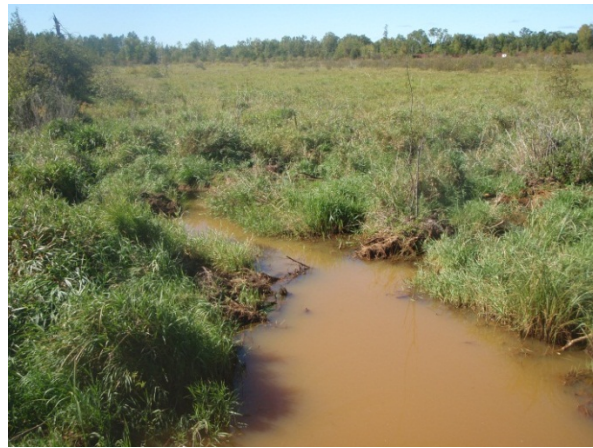
Photo 2. Iron Creek at 79th Ave SW

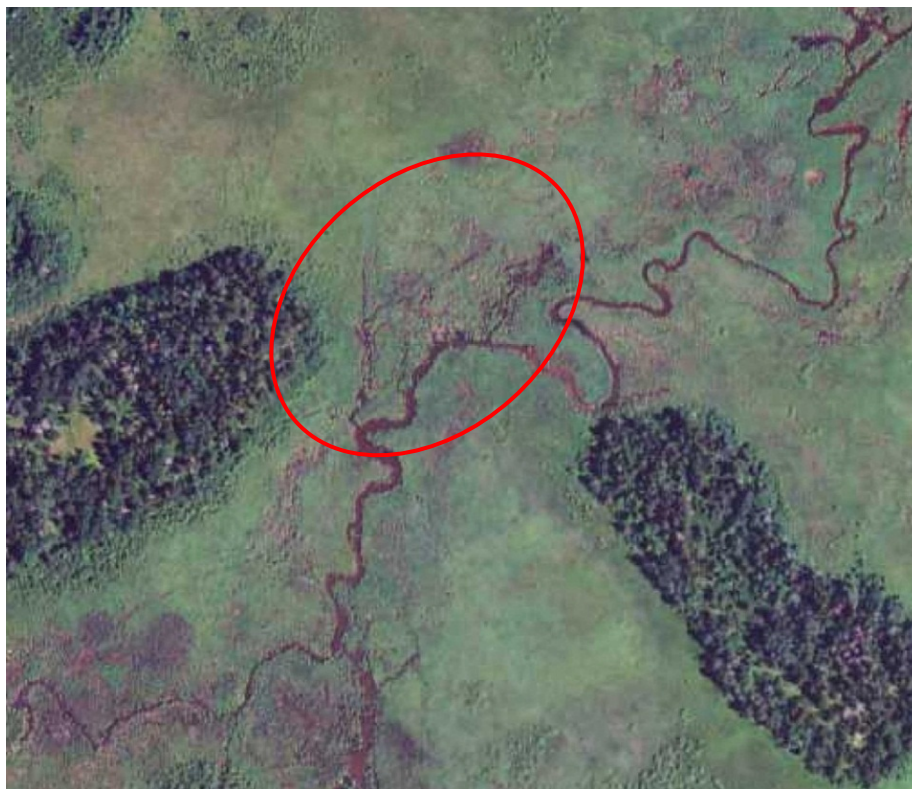
Photo 3. Farnham Creek groundwater seeps. The circled area shows shallow groundwater seeps emerging within the sedge meadow and entering Farnham Creek. Also note the orange color seen in many places along the channel due to iron inputs from groundwater.

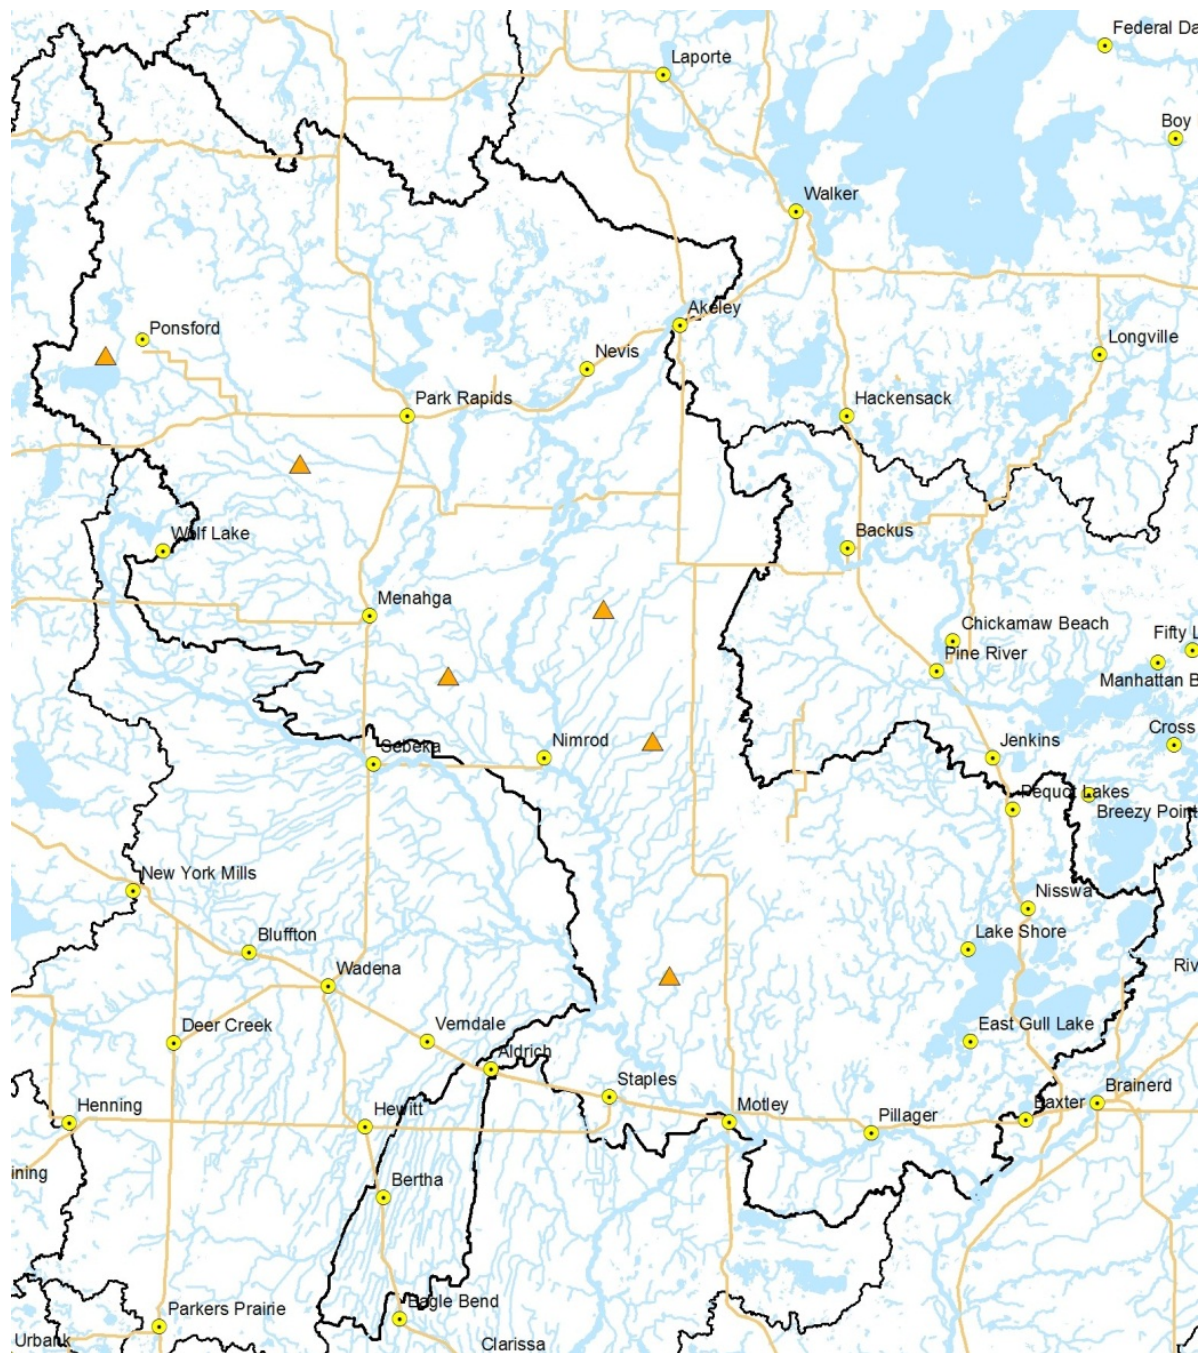
Figure 6. Map of the CWRW showing the six highest iron-content shallow wells (5.8 to 13.0 mg/L) found in the study by Helgeson (1977). Well locations are marked by orange triangles. The other 23 Pineland Sands Aquifer wells ranged between zero (below detection) to 3.3 mg/L iron, with 16 of those at < 1.0 mg/L.

borders (Photo 3). An area of high iron-content shallow groundwater is found along the whole length of the western side the Pineland Sands Aquifer (and also the CWRW) in an arcing band from the Staples/Motley area all the way north to near the town of Ponsford (Figure 6). The streams on the west side of the Crow Wing River in the central part of the CWRW show high iron content in their waters and become a turbid orange color in mid-summer, due to these high levels of iron (Photo 4). This will be elaborated on further along in this report. In order to put the nutrient (phosphorus and nitrogen) chemistry data into context, it is important to know what is naturally typical within a given area.

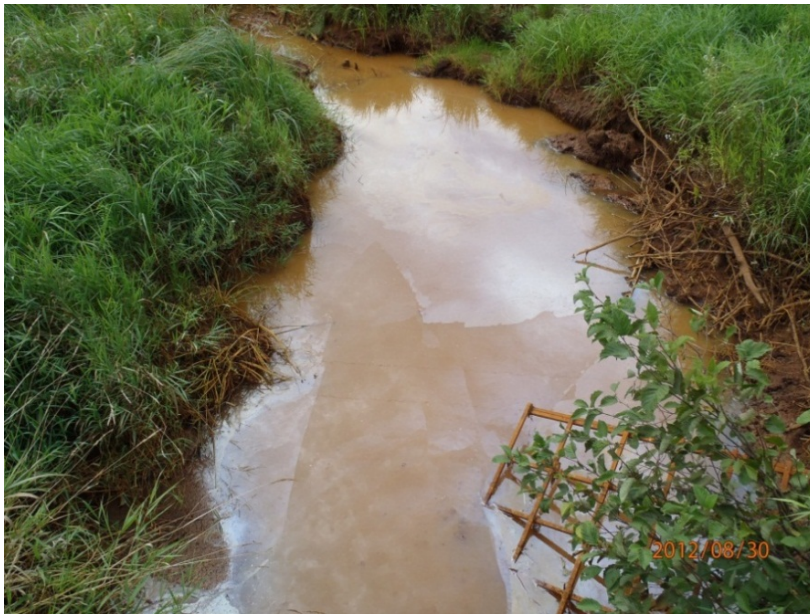
Photo 4. Iron Creek, a tributary to Swan Creek, north of Staples, MN. The water is turbid orange from the high iron content. Note the oily sheen on the surface, which is commonly seen in these high-iron waters.

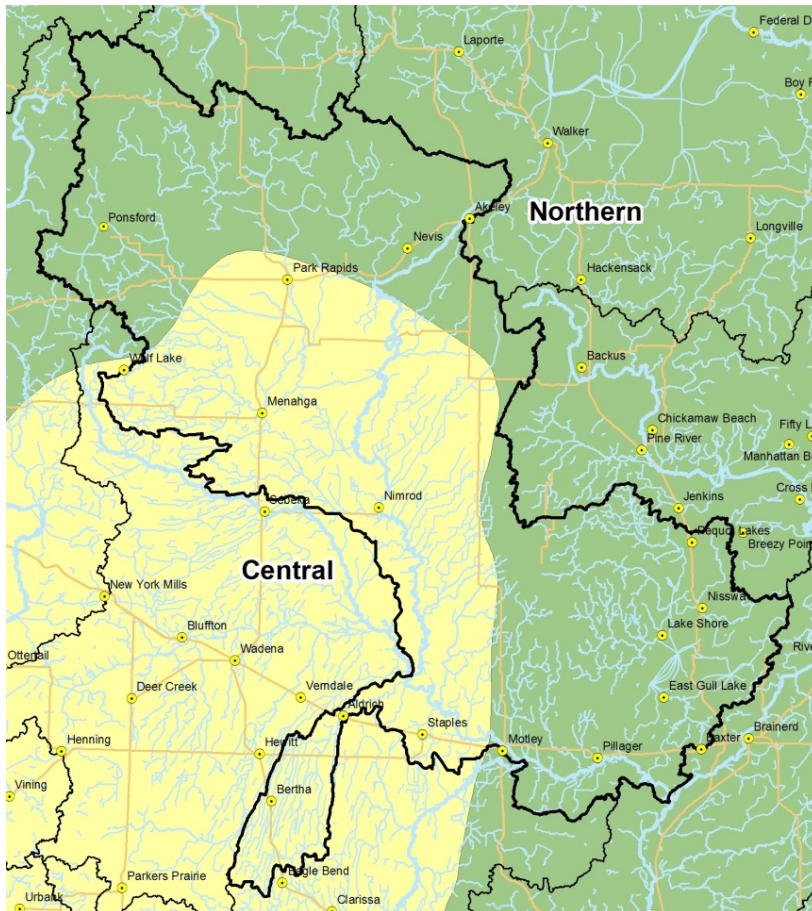
Figure 7. The CWRW and its nutrient regions

Expectations for river phosphorus concentrations, based on a number of landscape and climate factors, differ within the CWRW. The MPCA has developed nutrient regions geographically, and there are three; northern, central, and southern (MPCA [Heiskary, Bouchard, and Markus], 2013). The CWRW contains two of these, the northern and central (Figure 7). This situation adds yet another somewhat unique natural factor to this watershed and the analysis of its waters. The central part of the watershed will naturally have somewhat higher levels of phosphorus than the northwestern and southeastern parts of the watershed, which are within the North Nutrient Region. The draft standard for total phosphorus (TP) in the northern region is 0.050 mg/L, and in the Central Region, 0.100 mg/L.

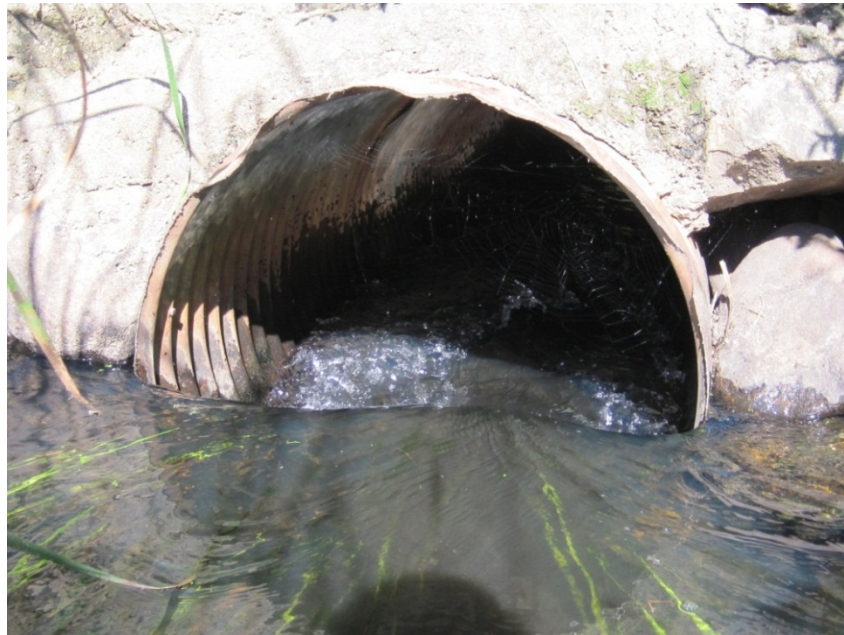
Photo 5. Upstream entrance to the Aspen Lane culvert. The culvert elevation is not correct, and it is also undersized, causing the flow to be quite swift.

Information via vehicle travel through the watershed revealed useful information. Each of the three road crossings on this AUID were inspected as to being possible migration barriers. The lowest crossing has a culvert that is undersized and is at an incorrect elevation. It appears to contribute to ponding of water upstream, and its small size causes water to have significant velocity within the culvert (Photo 5). It is a barrier to fish migration upstream. The uppermost culvert (Brayton Road) is apparently consistently blocked by beavers (Photo 6). The culvert at Bender Creek Road was found to be newly and partially plugged by beaver in summer 2012. Numerous beaver dams were also found on the recent aerial photos on more remote locations of the creek.

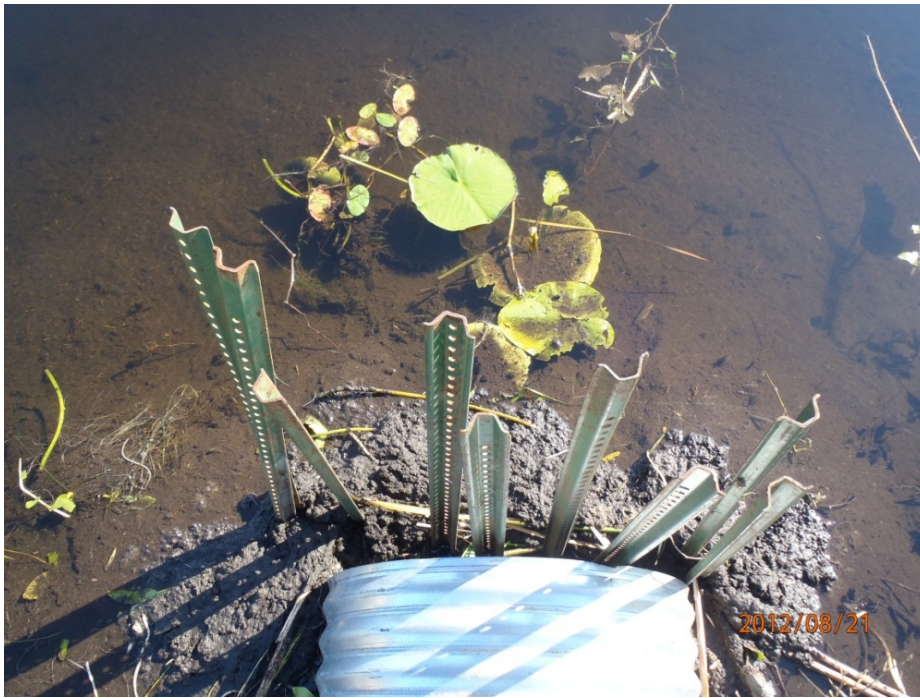
Photo 6. Outlet of Tripp Lake wetland, blocked by a mud beaver dam. There was evidence here of repeated attempts to maintain open flow in this culvert (debris pile, stakes over culvert opening).

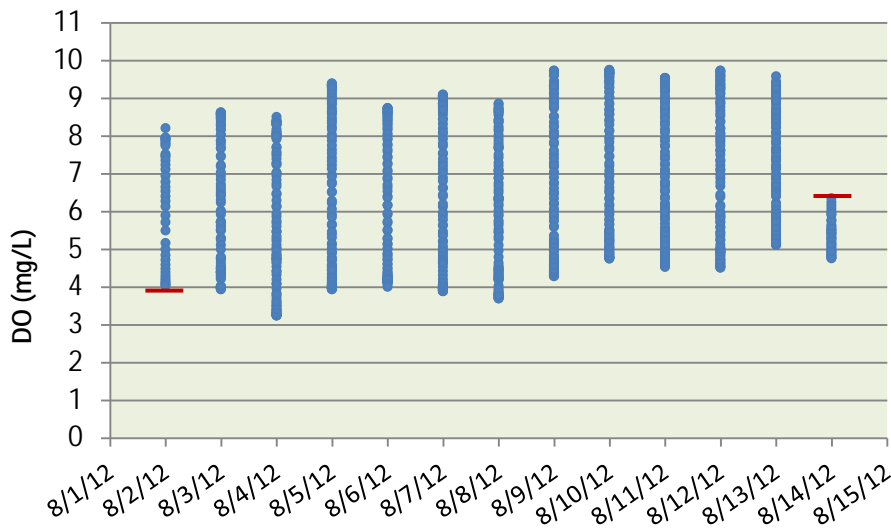
Figure 11. DO readings from the Sonde at Bender Cr. Rd

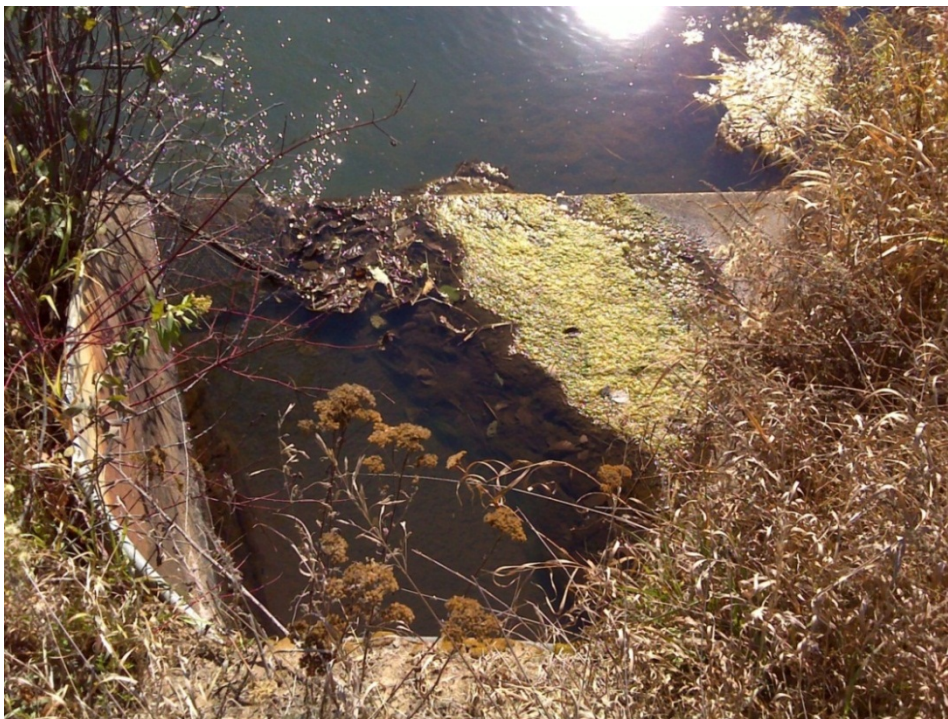
Photo 7. Culvert outfall at 294th Street, fall 2012. The algae here is not representative of the stream in general - this is just a warm, full sun exposure, damp microhabitat.

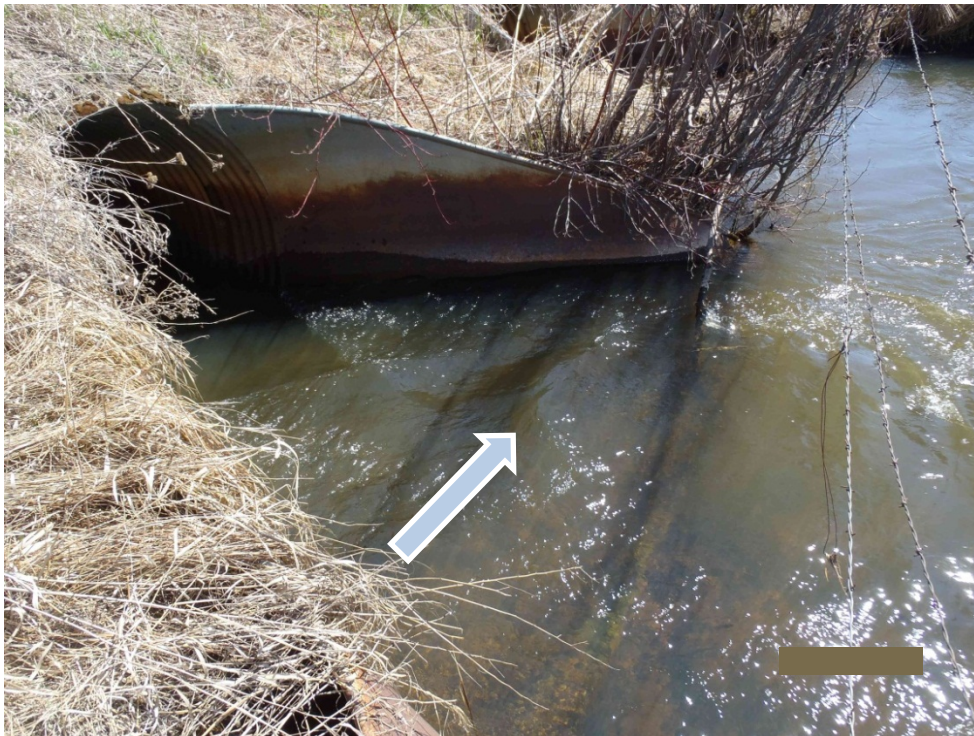
Photo 8. Outfall of right-bank culvert, May 2013. Note that even at high water, the lip of the culvert is only a few inches below the water surface. The arrow points to standing wave, a sign of high velocity.

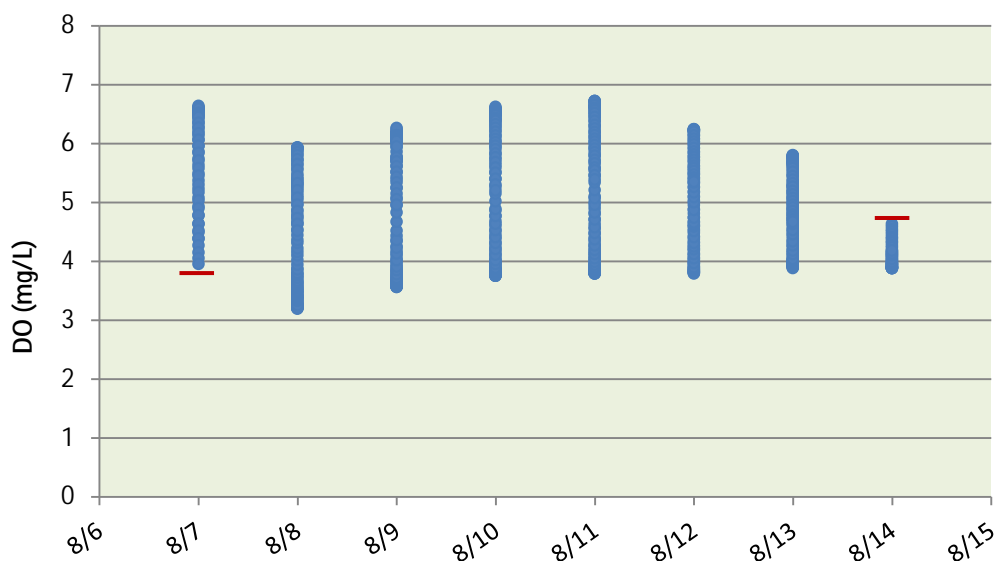
Figure 15. DO readings from the Sonde at 87th Ave. SW (10UM078)

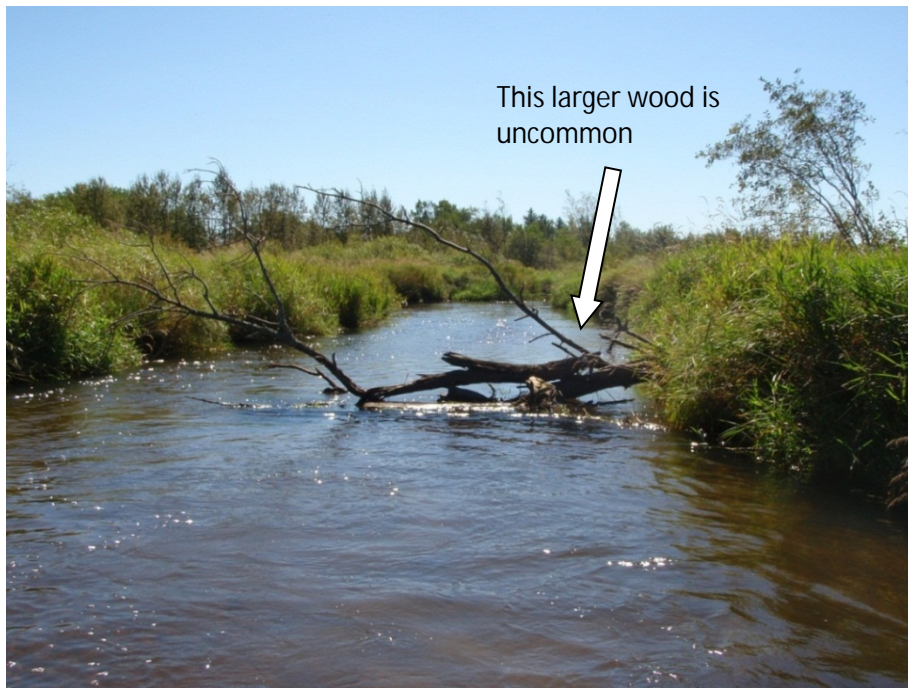
Photo 9. Mid-reach photo from 10EM133. Photo depicts the typical sandy, shallow, uniform depth, exposed, canopy-lacking, non-woody riparian condition common (and natural) throughout this AUID. Large pieces of downed wood are uncommon in this AUID.

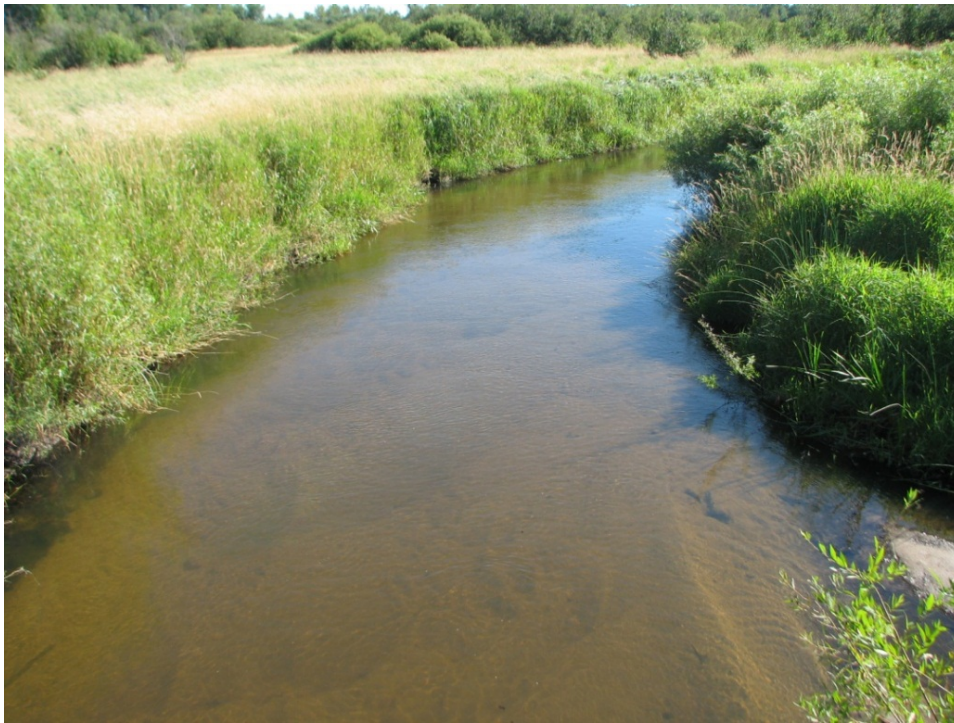
Photo 11. Shell River channel immediately DS of photo 10 (110th St.) showing poor instream and riparian cover, sand-dominated substrate, and homogenous channel habitat. Also shows the ubiquitous palustrine riparian habitat.

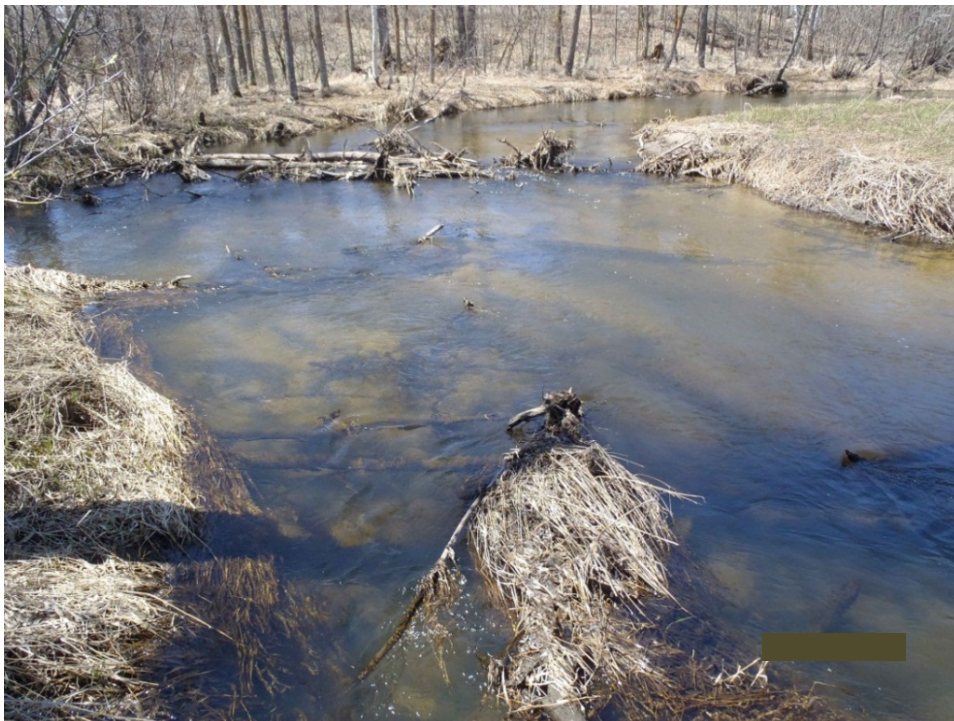
Photo 12. Large wood in the channel adds habitat complexity. In the areas where forest can exist in the riparian corridor (due to elevated topography), a more heterogeneous habitat (shade, cover, scour pools, food production, flow refugia) can be found. These forested riparian areas are uncommon however, due to saturated riparian soils.

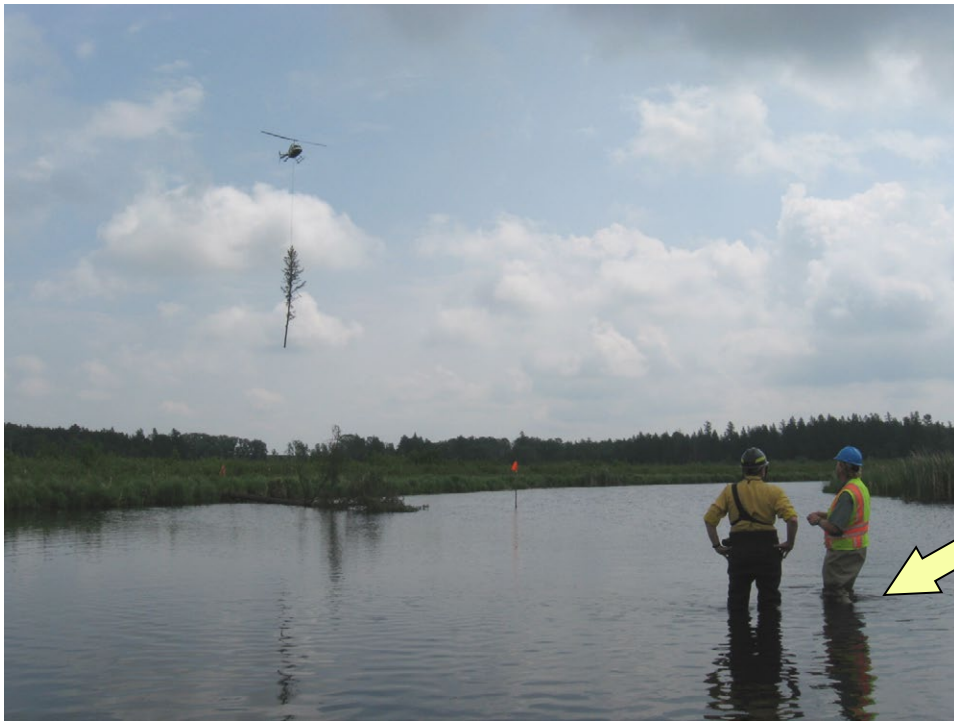
Photo 13. MDNR deemed that parts of the adjacent Straight River needed habitat enhancement due to the absence of structural habitat/cover and channel forming materials. Trees were imported and carefully placed to enhance the naturally bland, homogeneous channel morphology. *MDNR Photo*

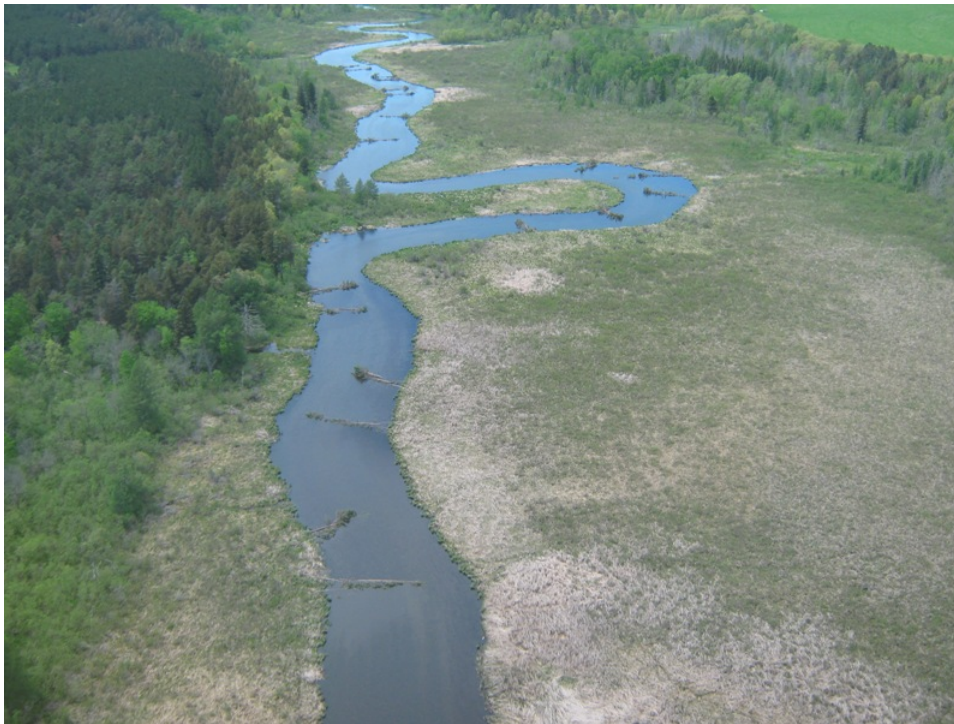
Photo 14. Placement of imported trees intended to deepen the thalweg, narrow the channel, add sinuosity, and add cover for fish. Again note the natural wide sedge meadows that occur in this region. *MDNR Photo*

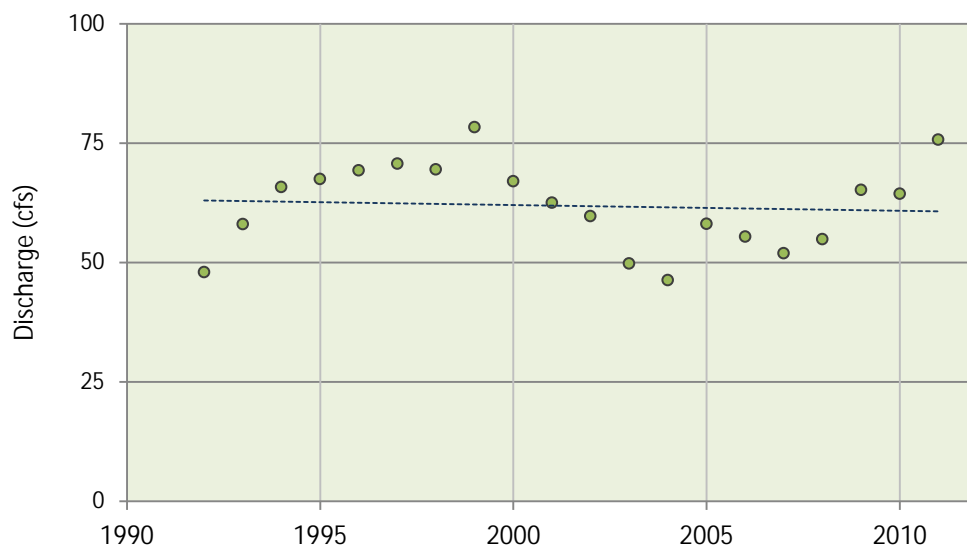
Figure 19. Straight River discharge for past 20 years. The Straight River watershed has more irrigation occurring than in the Shell, and does not have the adjacent high elevation natural area for groundwater input. Graph provided by Andrew Streit – MPCA

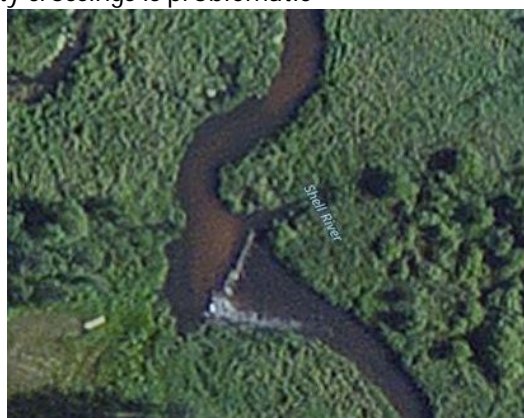
Photo 15: Possible barrier with turbulent overflow

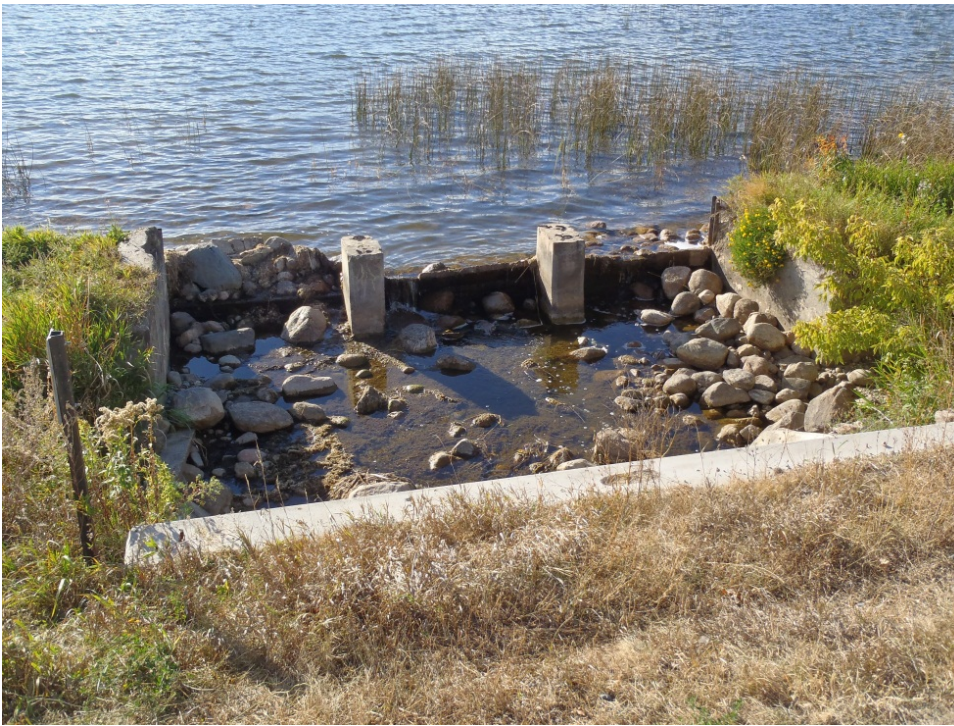
Photo 16. The small dam at outlet of Shell Lake (beginning point of AUID - 537) in fall 2012 - blocks fish movement between the lake and river, possibly restricting access to winter refuge habitat

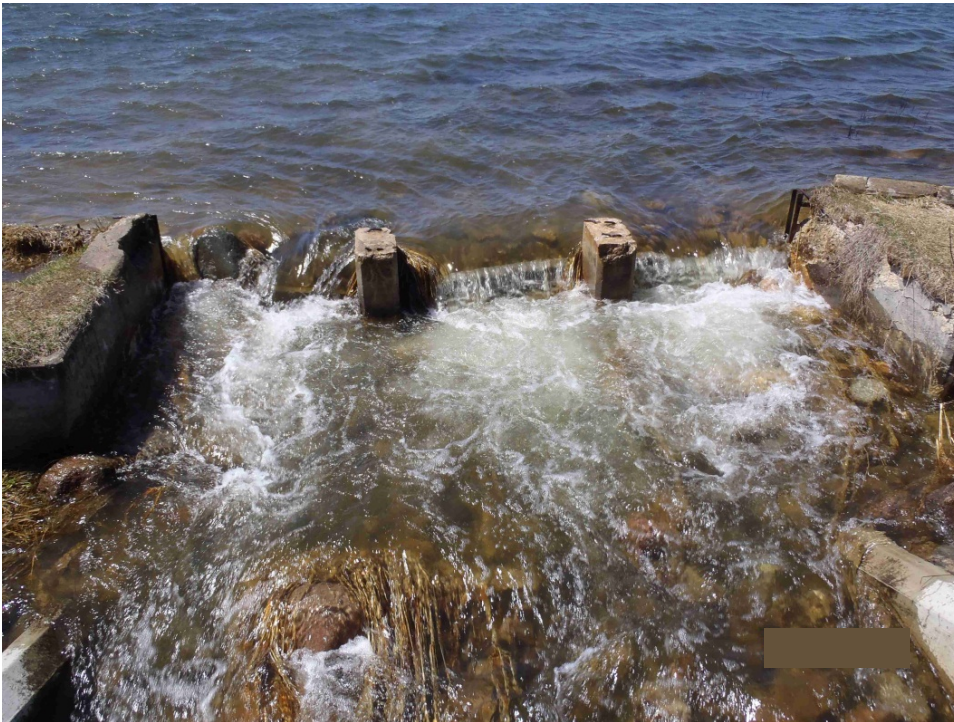
Photo 17. Dam at outlet of Shell Lake a week after lake opened, May 2013

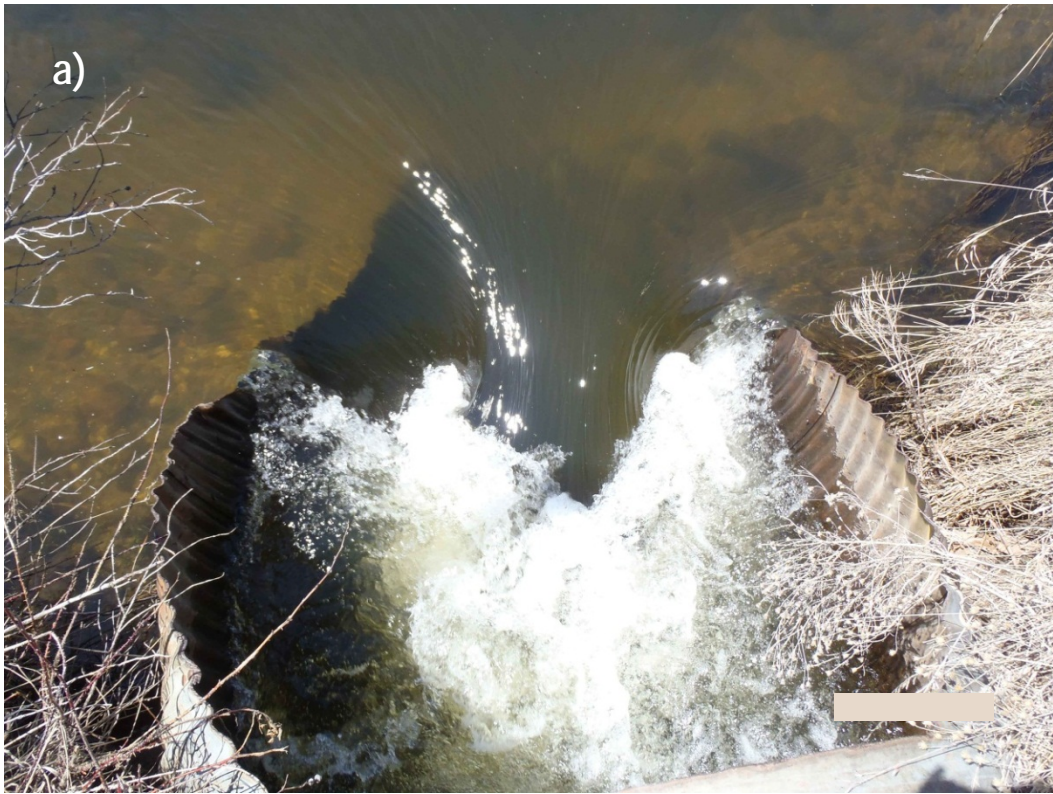
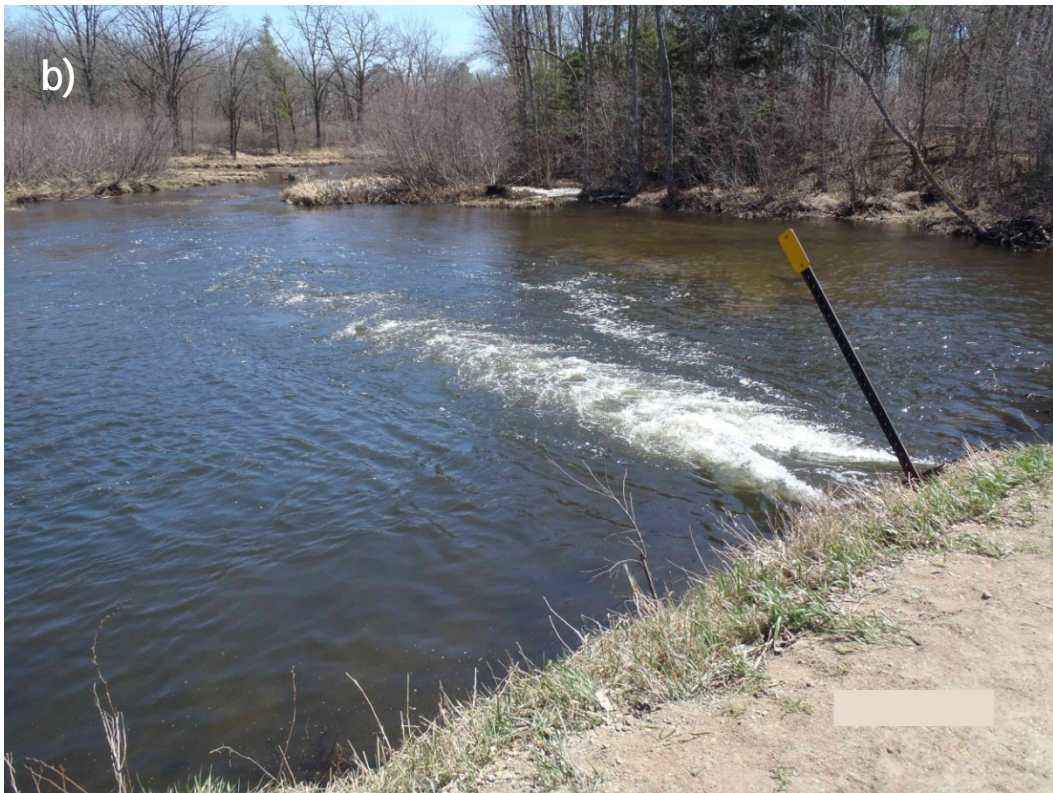
Photo 18. Culvert at Guyles Road, a) intake of culvert, b) outfall of culvert

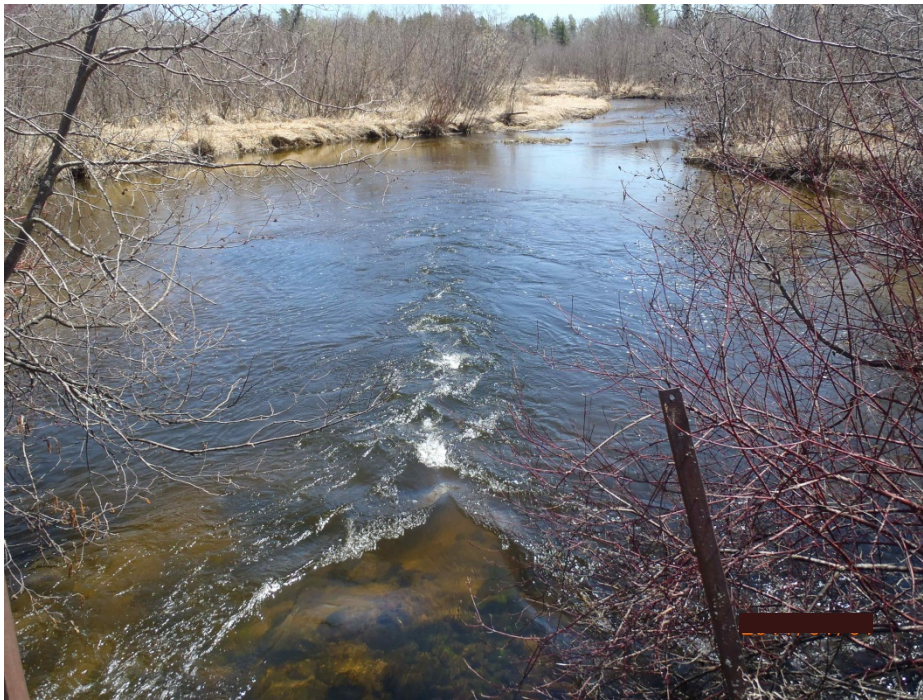
Photo 19. Old bridge structure at 580th Ave., May 2013. High velocity occurs through the constriction between the concrete bridge abutments and a large scour pool results. A couple large suckers (~14") were seen on upstream side of bridge. Small species would have much difficulty passing through this level of water velocity.

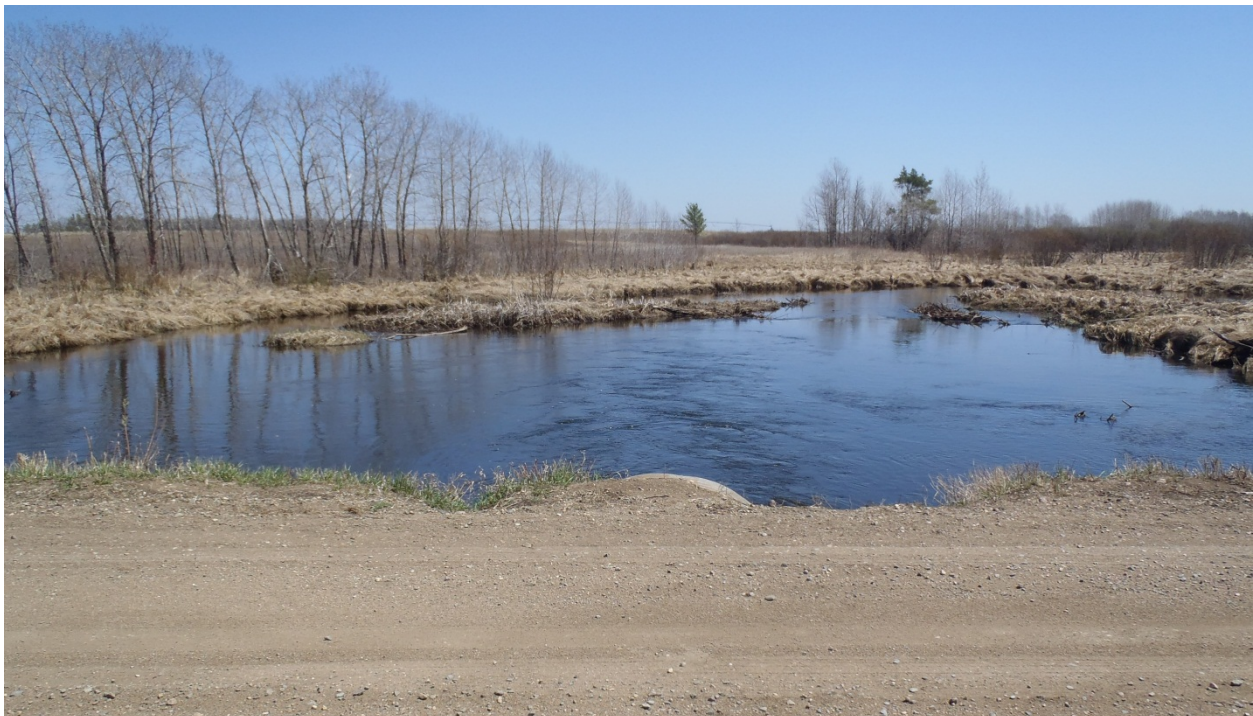
Photo 20. Culvert at 520th Ave. Strong velocity was observed coming from the culvert, which is undersized, and this large scour pool is the result of these more-erosive flows.

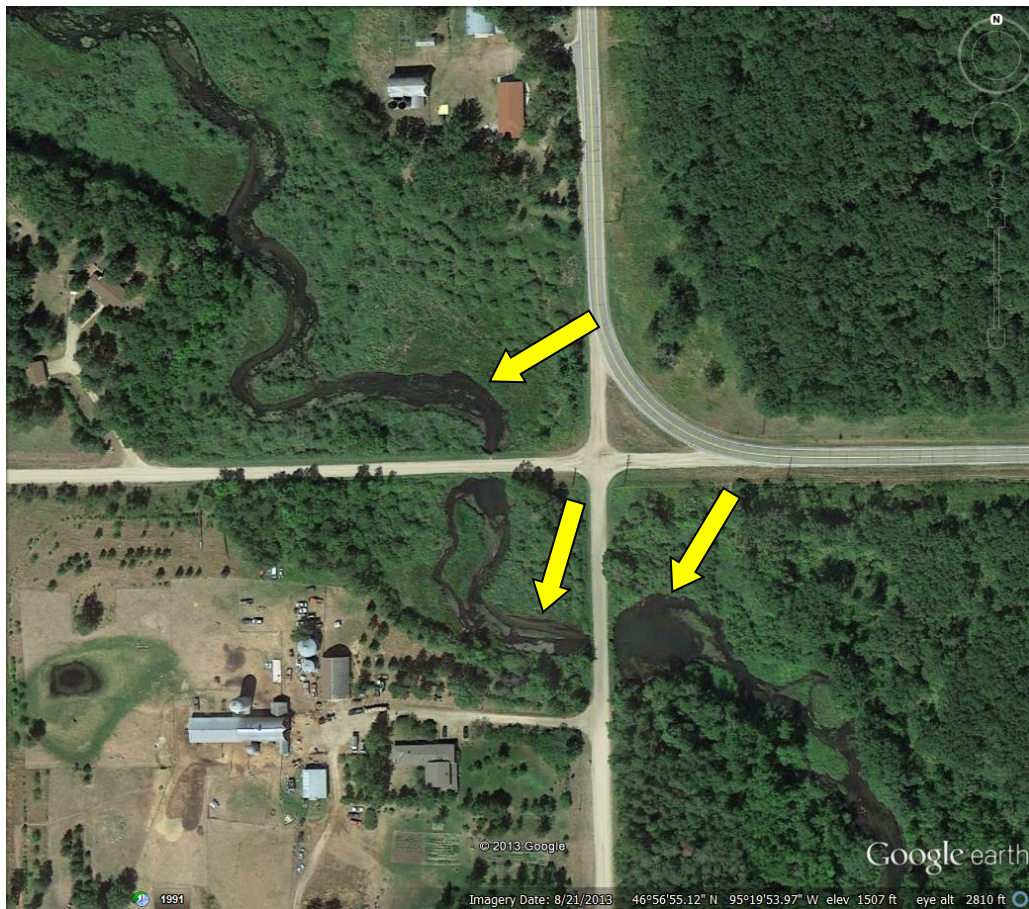
Photo 22. 2013 Aerial photo of site 10UM053. This is a low-flow period. Arrows point to detritus deposition areas.

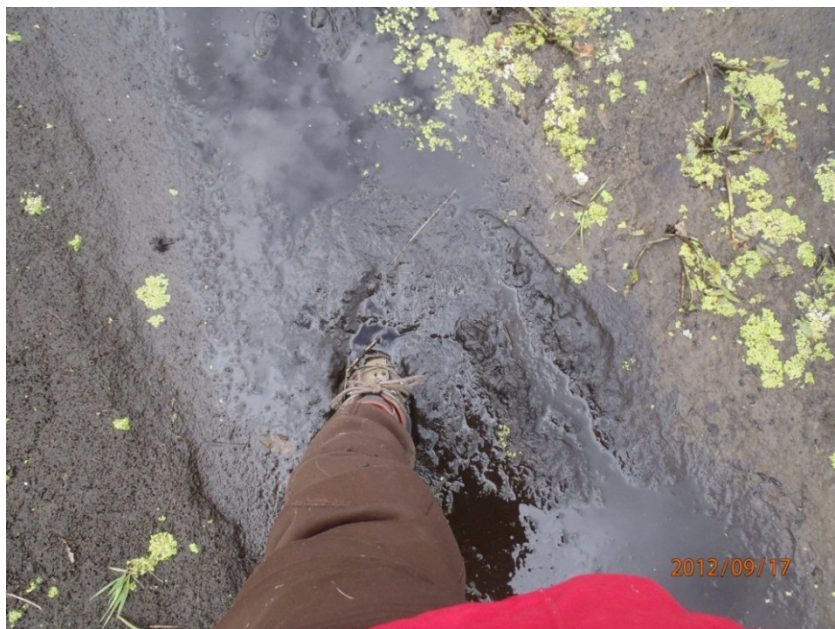
Photo 23. Muck at site 10UM053. Culvert downstream is set too high, decreasing gradient, and likely causing deposition of this organic material here. This organic sediment likely adds to the DO sag that occurs here.

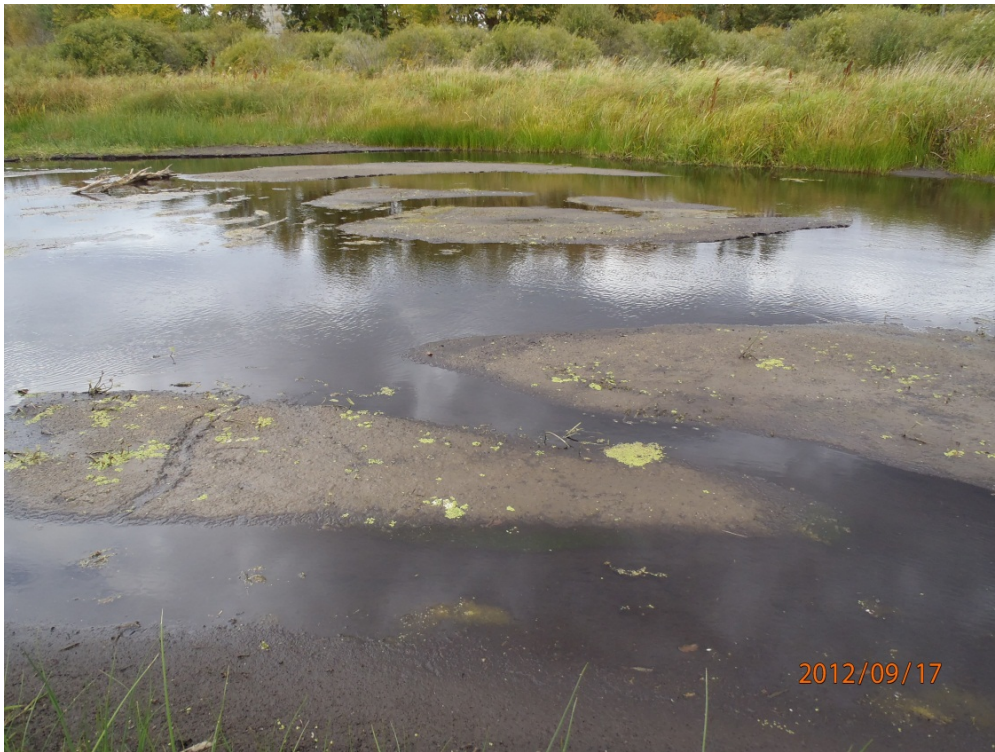
Photo 24. Sediment deposition at 10UM053 just above the Smokey Hills Road culvert

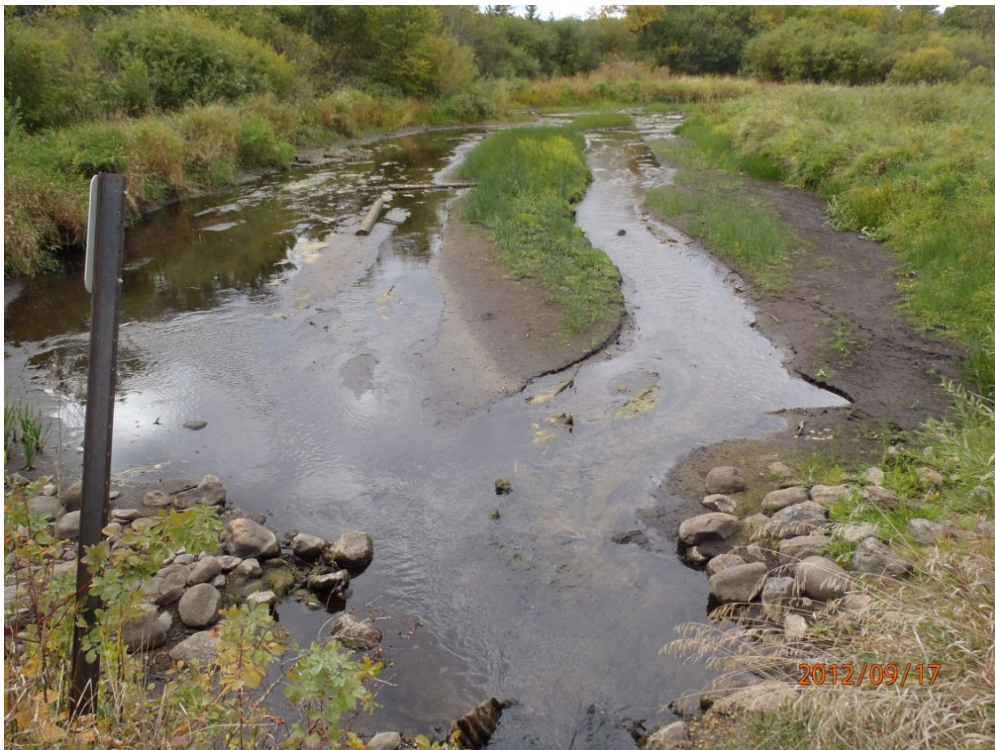
Photo 25. Sediment deposition just above the Guyles Road culvert
