Crow Wing River Watershed Stressor Identification Report

Determination of stress factors affecting aquatic biological communities

Minnesota Pollution Control Agency

April 2014

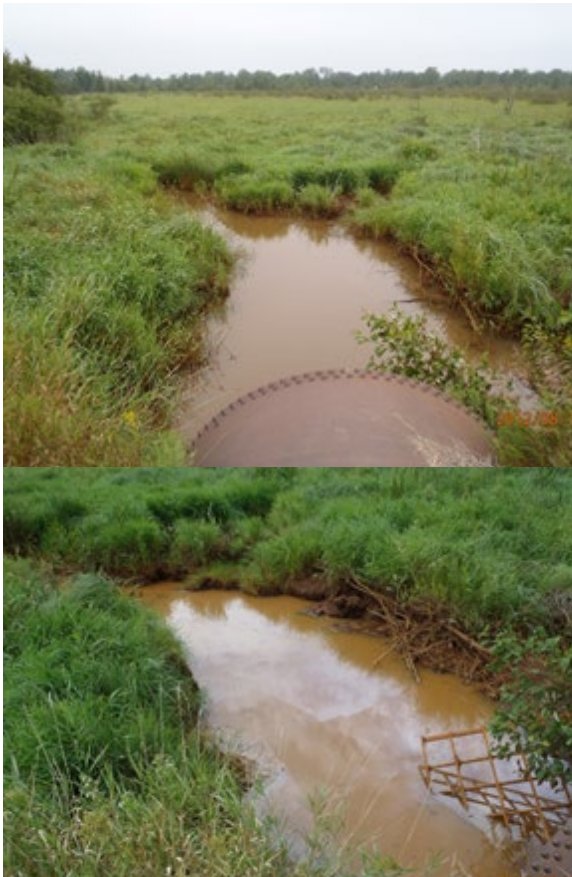
Photo 26. Iron Creek, showing the extreme iron conditions found in area tributaries, which are also found in the CWRW in the adjacent area north of Swan Creek. This iron is a sign that there is significant groundwater entering the creek.

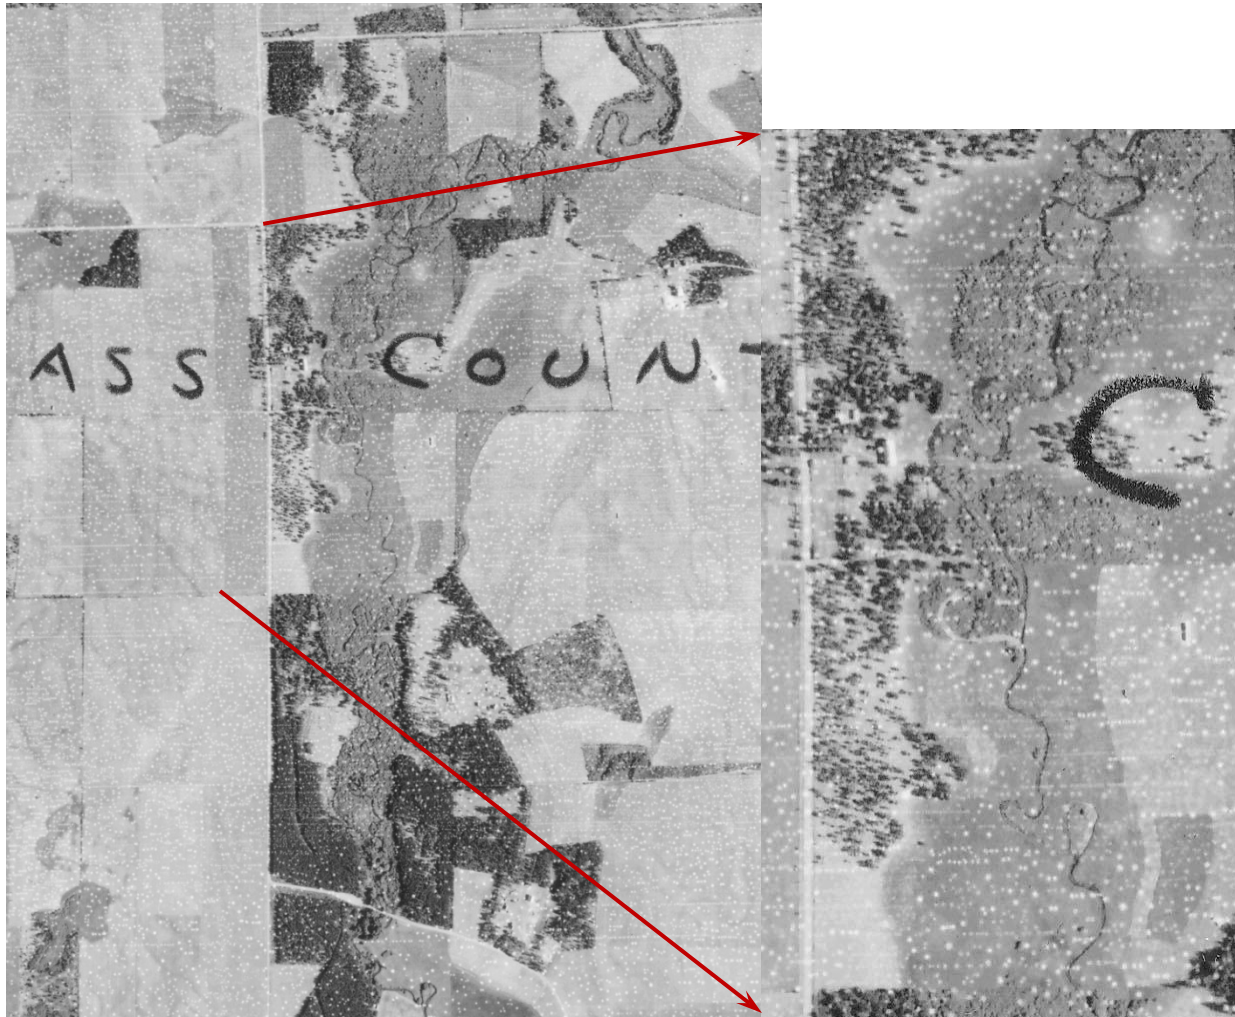
Photo 27. 1939 Swan Creek channel and land use around site 10EM086

Some of these effects can be seen at site 10EM086. Photo 27 shows the 1939 aerial photo of the channel and surrounding landscape. The inset on the right shows a closer view of the channel. The naturally wet soils along the stream here, as is so common in the CWRW, originally grew woody brush (alder and willow shrubs). This vegetation is seen in the photo both above and below this pastured area. On the lower part of the insert, it can be seen that all of the woody vegetation has been removed and only grasses remain. At this date, the channel still appears to be narrow, and of the same approximate width as upstream and downstream, where cattle were fenced out.

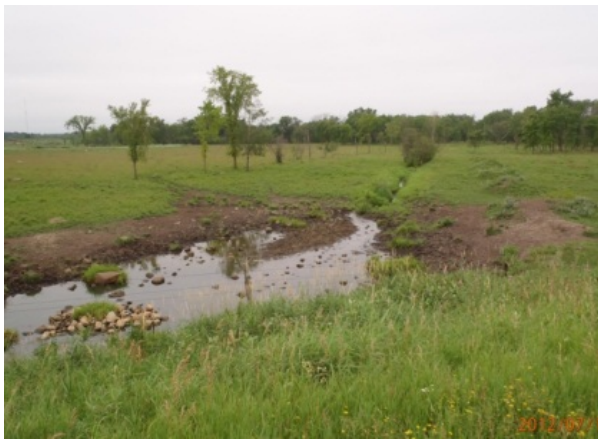
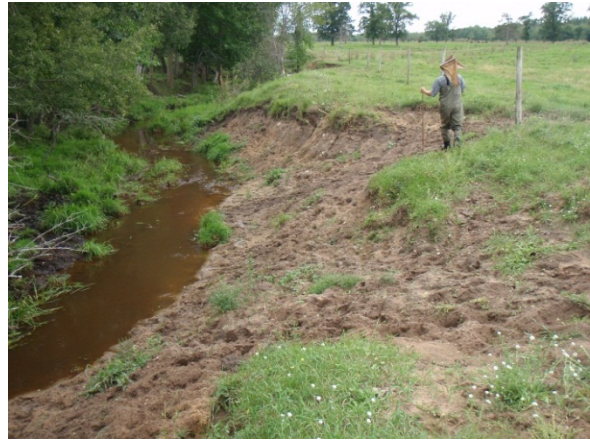
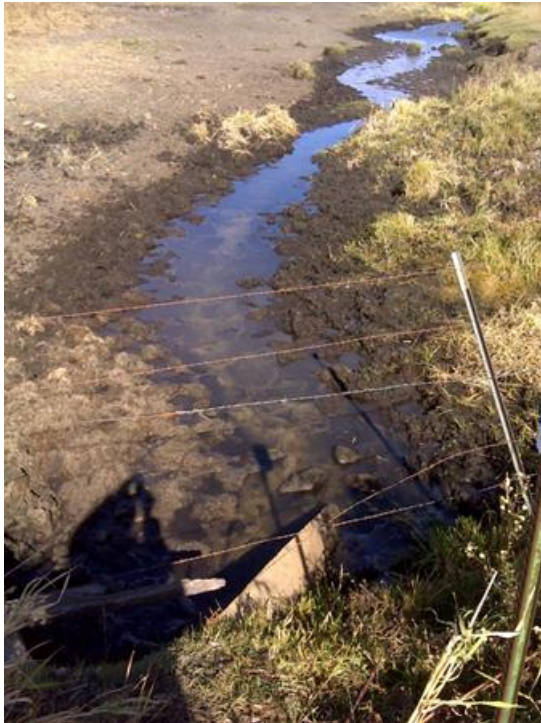
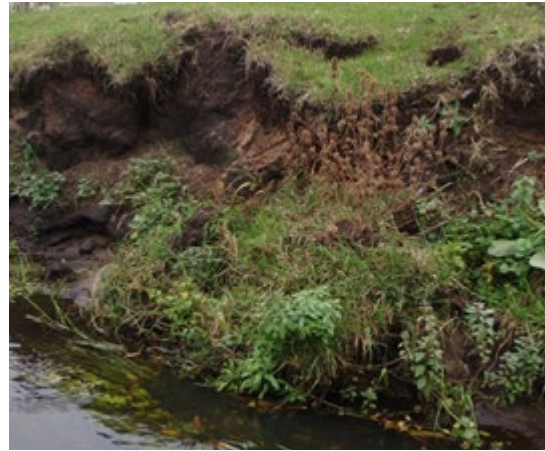
Photo 30. Riparian grazing damage to CWRW streams

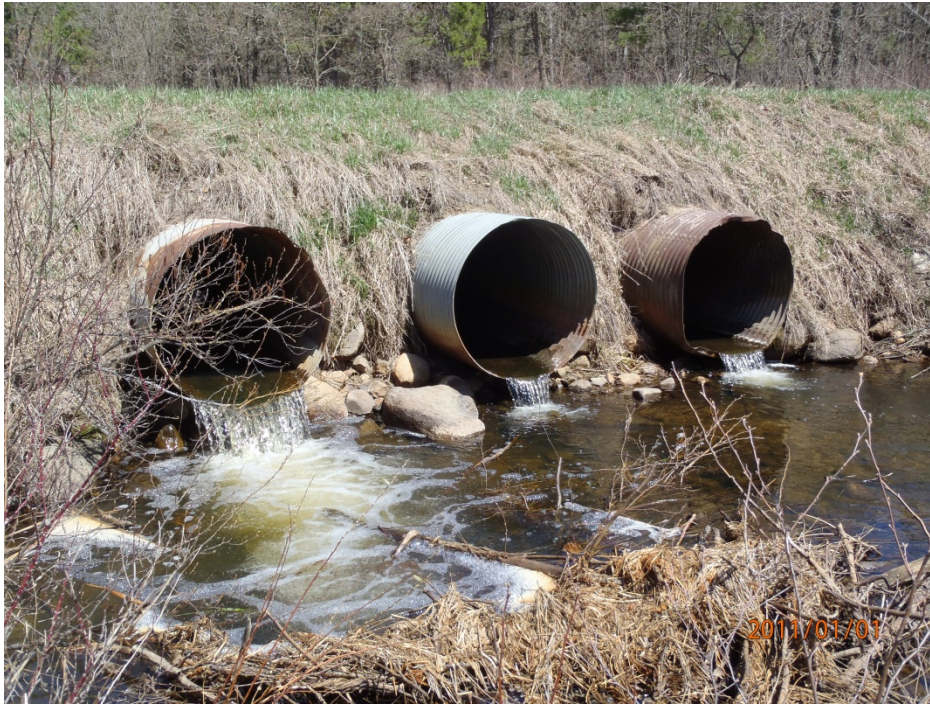
Photo 31. Perched culverts on the Blueberry River on Little Long Lake Road
