# Red Eye River Watershed Stressor Identification Report

This report will describe the stressors to the biological community in the Red Eye River watershed

**Document number:** wq-ws6-07010107

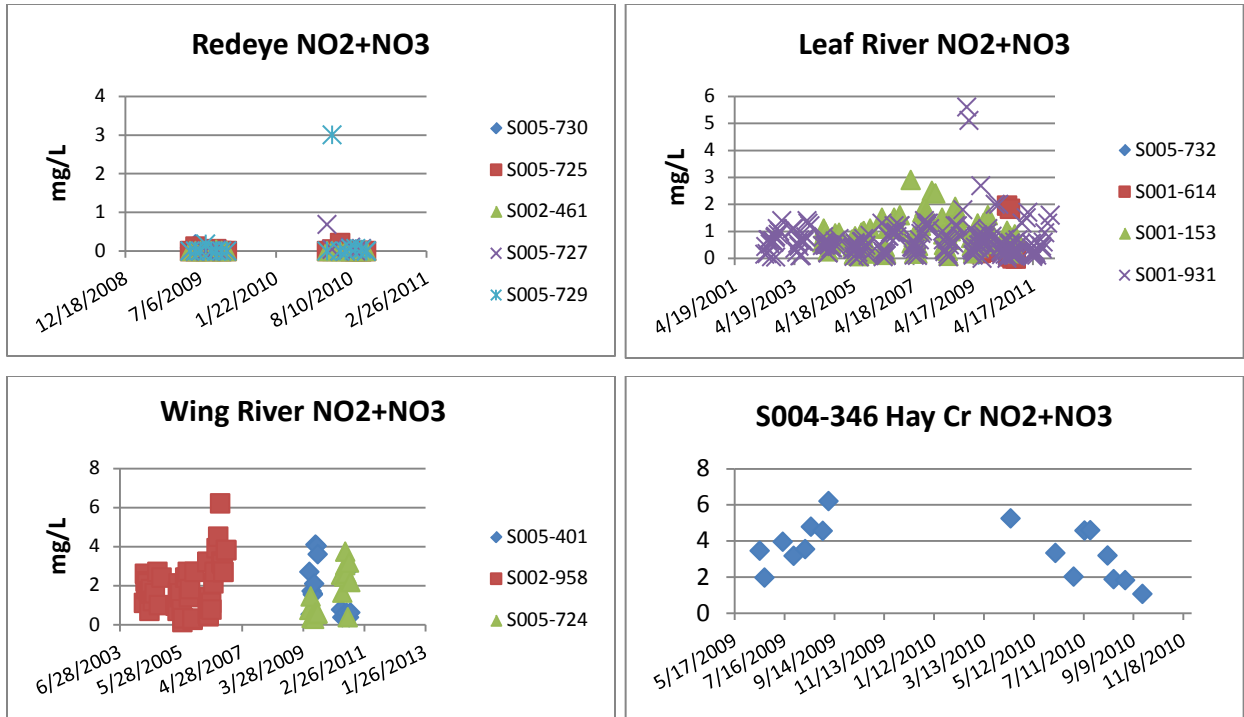
**Figure 3.3.3: Nitrite-nitrate concentrations at various stream locations throughout the Red Eye Watershed.**

Elevated  $\text{NO}_2+\text{NO}_3$  concentrations do not appear to be significant problem in the overall water quality of the Red Eye River Watershed. There are numerous water quality samples that have been collected throughout the watershed. Many of the streams have concentrations below 1 mg/L for the majority of the sampling period. The Wing and Leaf River sites have some concentrations that in the 3-5 mg/L range. These concentrations are generally seen during the mid-summer months and do not seem to persist for the entire summer. Hay Creek also has elevated  $\text{NO}_2+\text{NO}_3$  and during the summer of 2009 and 2010 the concentrations were often between 3 and 5.5 mg/L. Elevated  $\text{NO}_2+\text{NO}_3$  concentrations do not appear to be a watershed wide problem but rather isolated to a few tributaries. Figure 3.3.4 below displays the  $\text{NO}_2+\text{NO}_3$  data from EQUIS stations located around the watershed.

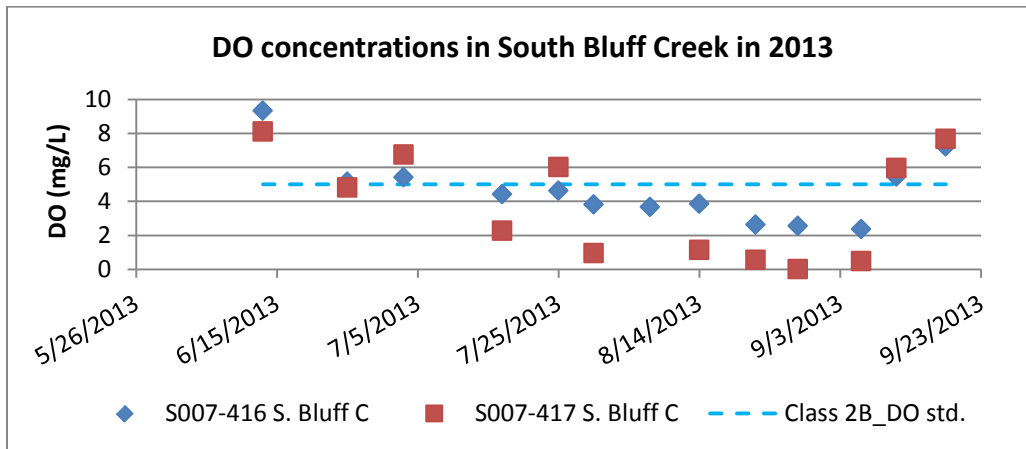
**Figure 4.1. 1: Early morning DO data collected at two EQUIS sites in South Bluff Creek in 2013.**

Dissolved oxygen (DO) was collected at two locations in the impaired South Bluff Creek AUID in 2013. DO data was well below the Class 2B standard of 5 mg/L at both sampling sites during late July through early September. Stream flow was very low to almost stagnant during some of the site visits during this time. Figure 4.1.1 shows the DO data collected at S007-416 and S007-417 on South Bluff Creek. The two sampling events at 11UM072 showed that central mudminnow were the dominant species found which are known to be tolerant to low DO readings. Figure 4.1.2 graphically displays the DO tolerance values for both 11UM072 sampling events. The majority of the fish sample is tolerant to low DO. Low DO is a stressor to the fish and macroinvertebrate community at South Bluff Creek (AUID 07010107-553).

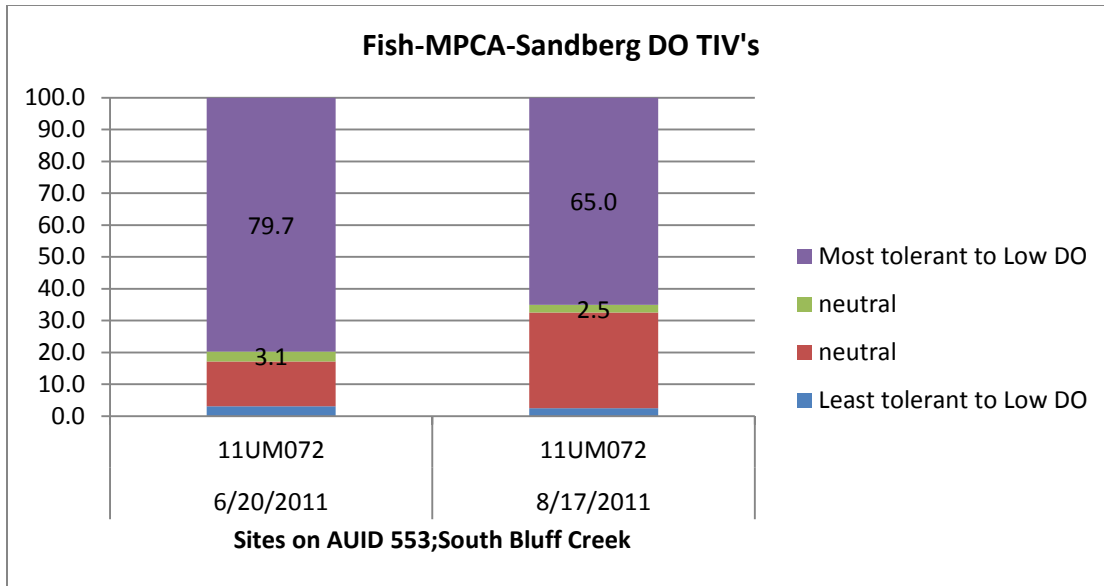
**Figure 4.1.2: DO tolerance values for fish at sampling site 11UM072 in South Bluff Creek from 2011.**

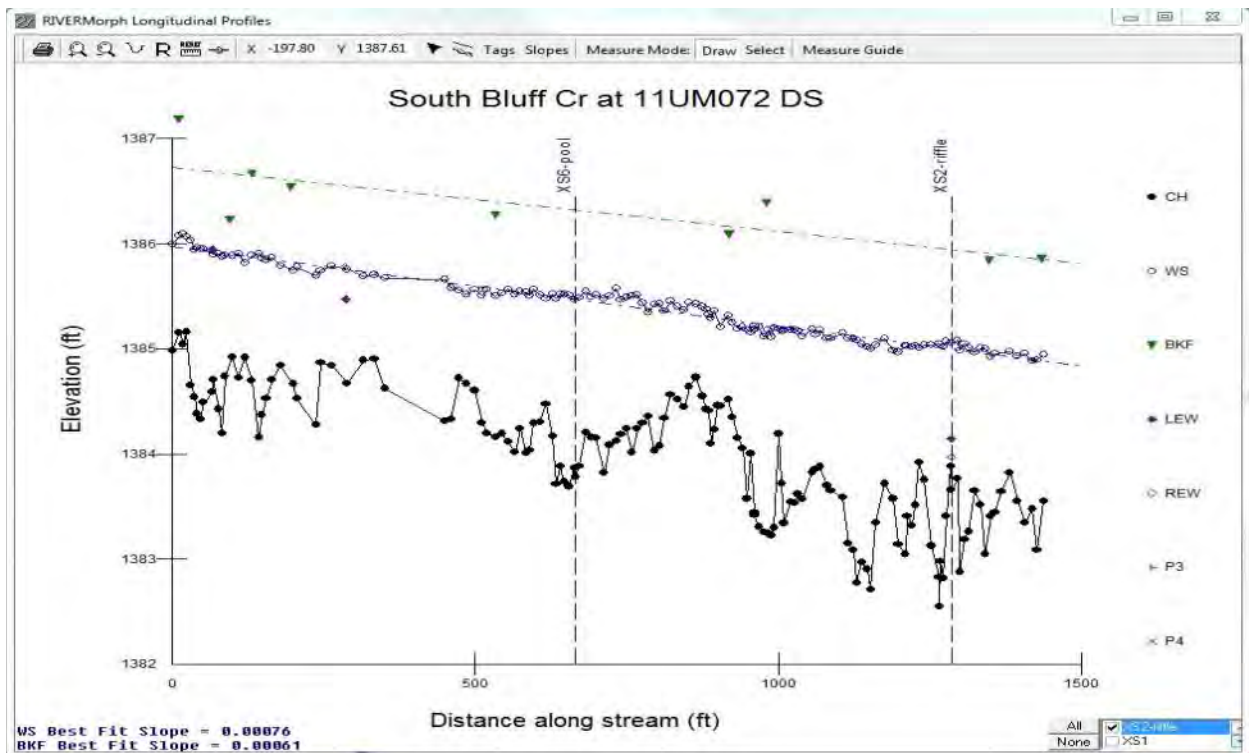
**Figure 4.1.5: Long profile of South Bluff Creek at site 11UM072.**

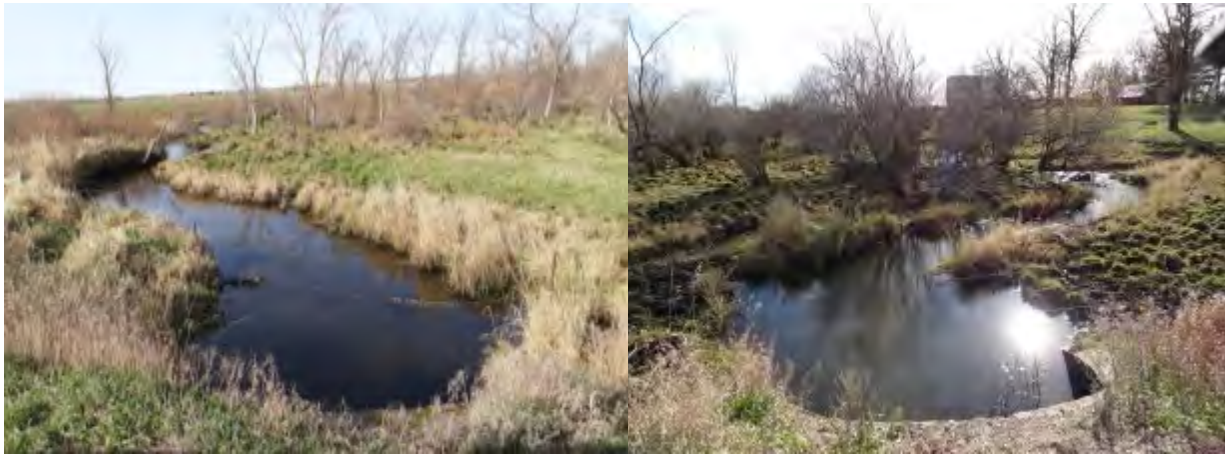
**Figure 4.1.6: Photo of the downstream and upstream pastured areas along 280<sup>th</sup> Street in South Bluff Creek. Both sides of the road have a fair amount of cattle and horse pasturing activity that is causing bank instability.**

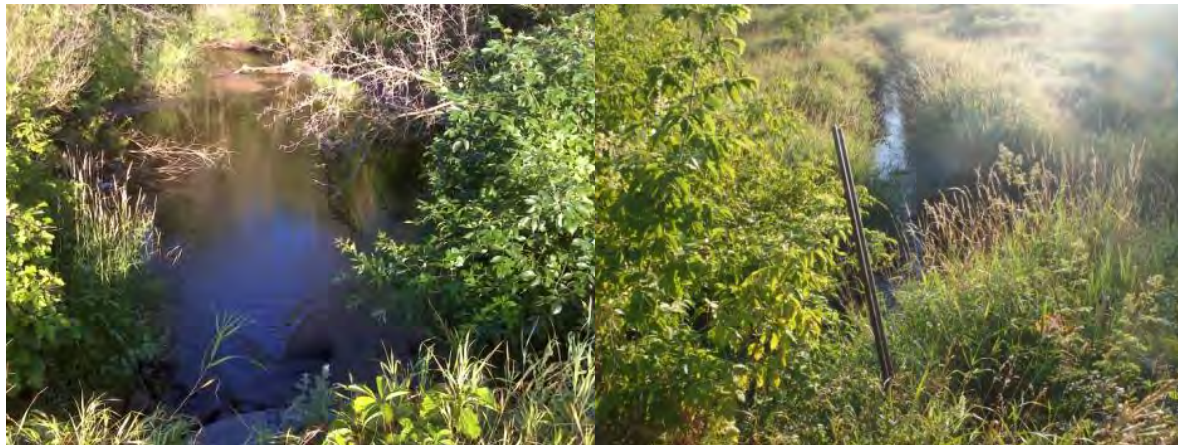
**Figure 4.2.4: Photos of the road crossing below Biological site 11UM065. Photo on the left shows sediment delta downstream of road crossing. Photo on the right is upstream of the road crossing and shows the narrow channel in an abandoned pasture.**

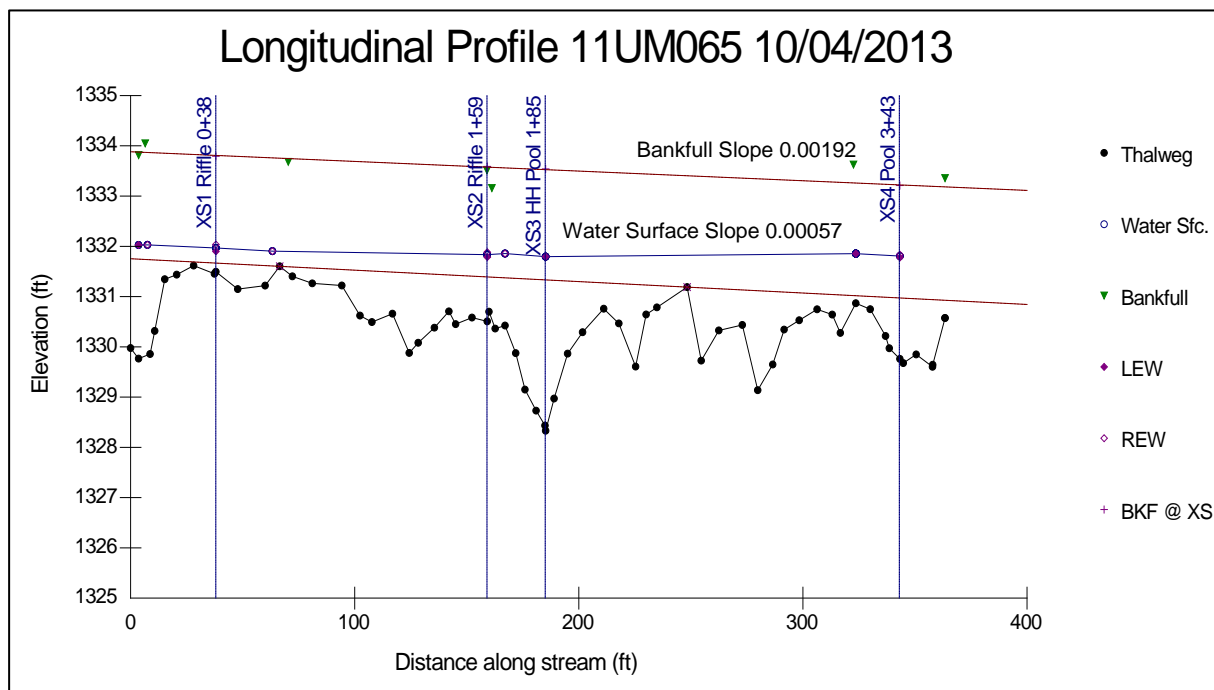
**Figure 4.2.5: Longitudinal profile at site 11UM065**

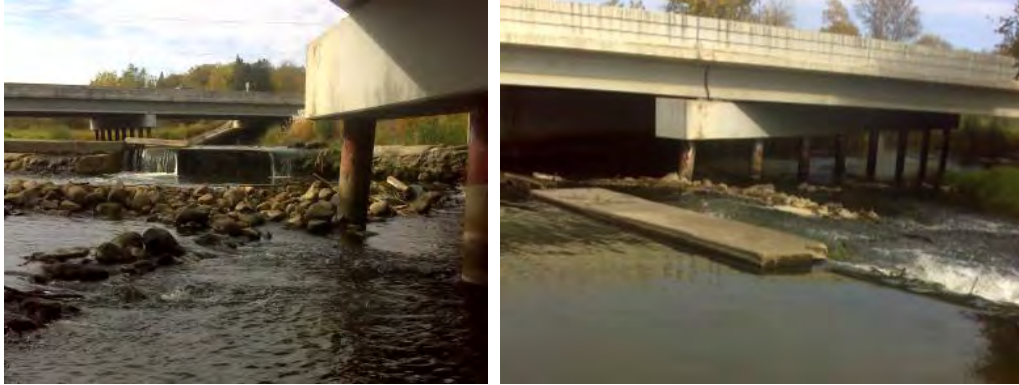
**Figure 4.3.6: Dam on the Wing River located at the intersection of Highway 210 and Highway 71 in Hewitt, Minnesota. The photo on the left is looking upstream toward dam. Photo on right is looking downstream at dam. 10/2/2013 date of photos.**

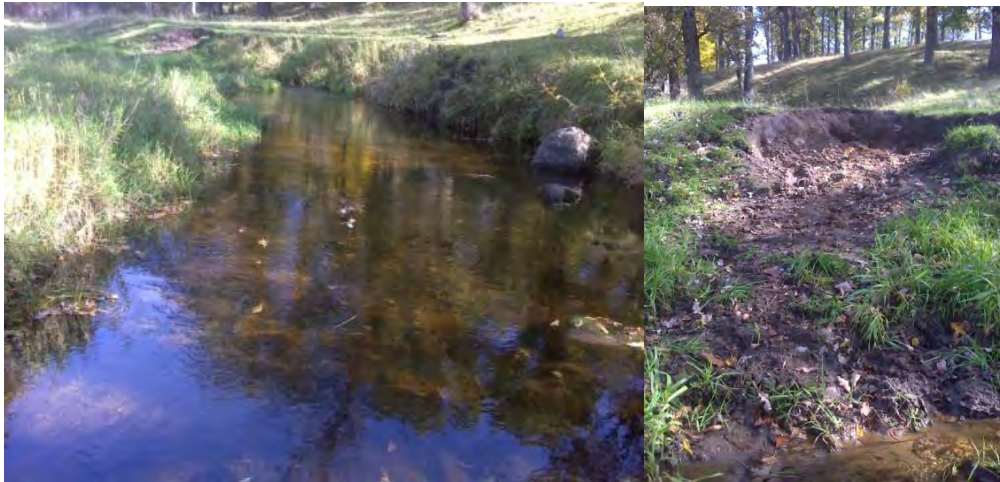
**Figure 4.4.4: Photos of typical stream run section and active cattle crossing at Biological Site 11UM055.**

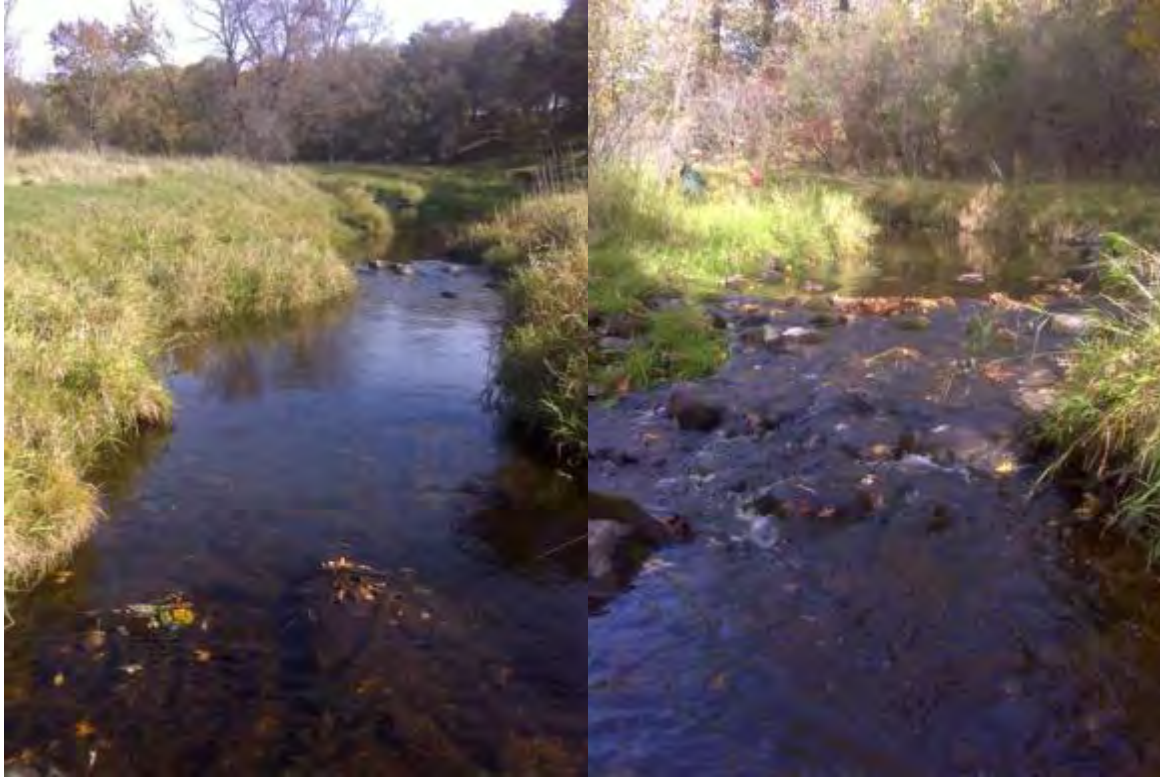
**Figure 7.0.3: Photos taken during channel survey on 10/8/2013. Photo on left is lower portion of reach taken from approximately 100 feet upstream of road crossing looking upstream. Photo on the right shows the rock structure that is acting as a slope change between the two streams surveyed sections. Upstream of rock structure is higher gradient and downstream is lower gradient.**

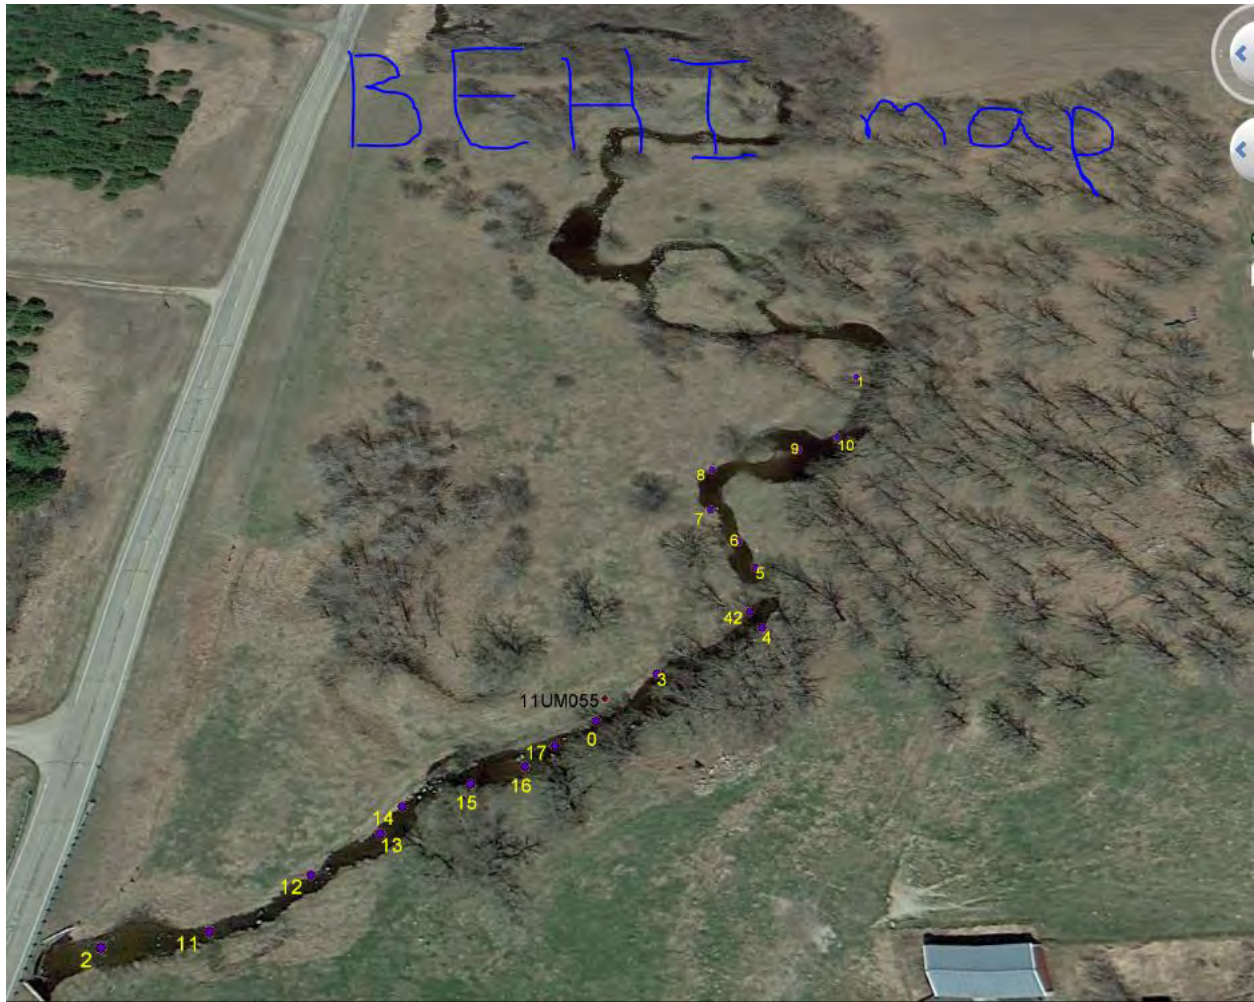
**Figure 7.0.4: Biological site 11UM055 location map of bank erosion areas used in calculation of BEHI.**

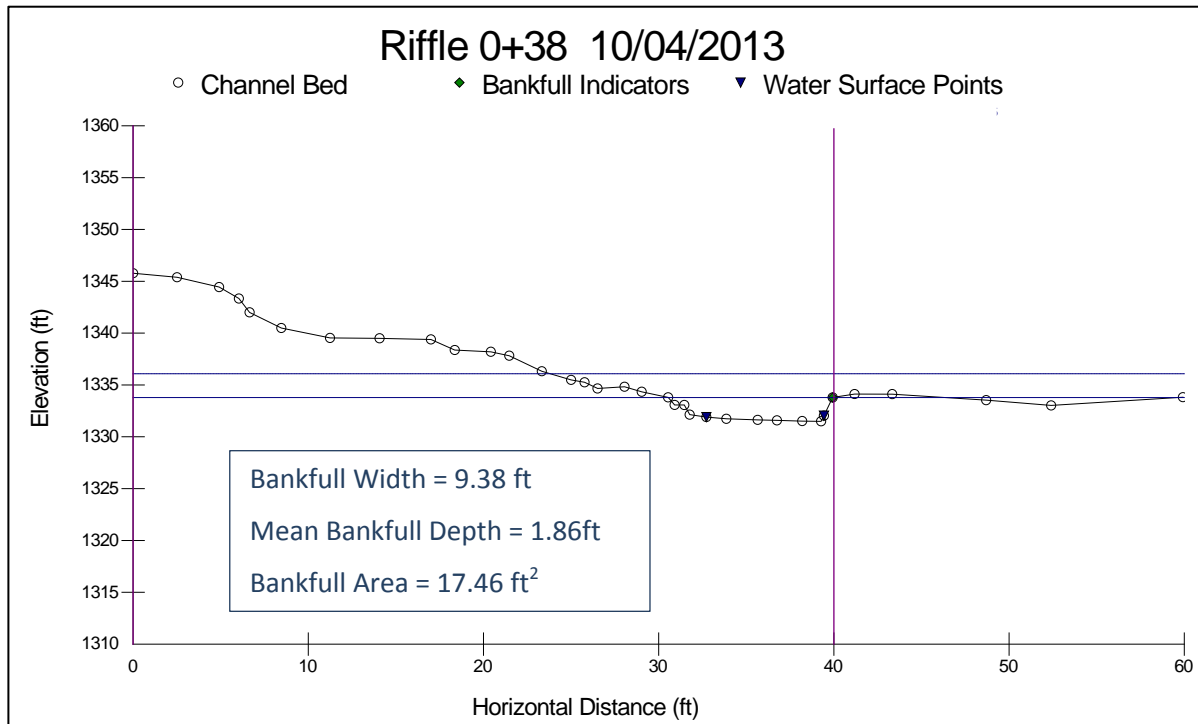
Figure 37: Riffle cross-section located at longitudinal profile station 0+38.

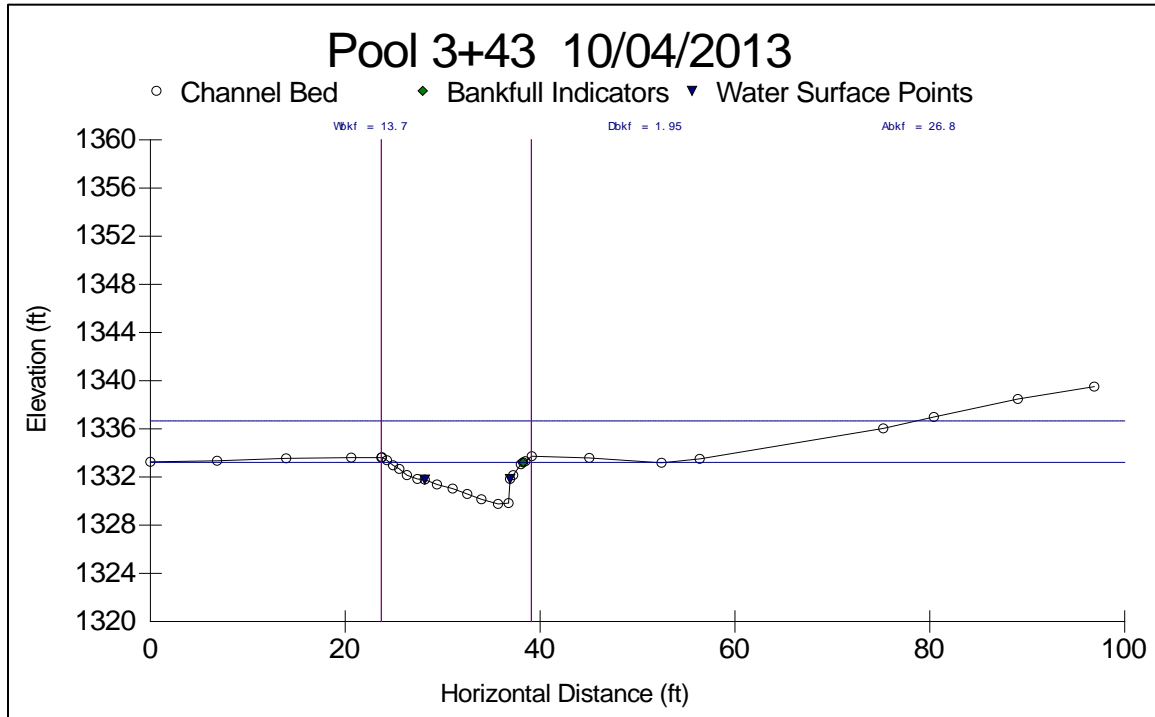
Figure 43: Pool cross-section at stationing 3+43.
