Pomme de Terre River Watershed

Stressor Identification Update

February 2024

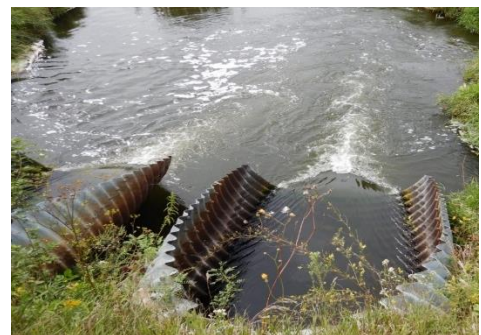
Figure 6. Perched culverts on Pelican Creek

- Connectivity is a significant issue in Pelican Creek. Station 17MN004 is located upstream of three migration barriers, which are preventing fish from moving upstream from the Pomme de Terre River; the dam that is part of the Pelican Creek Marsh Development upstream of CR4 (Figure 7), the two perched culverts upstream of I-94 (Figure 6), and the culvert at 320th St (Figure 8).

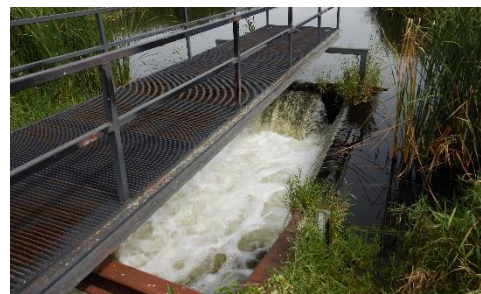
Figure 7. Dam on Pelican Creek (8/29/19)

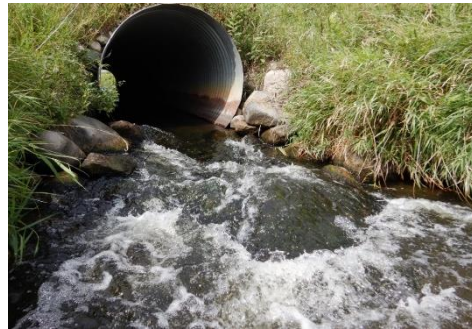
Figure 8. Velocity barrier from culvert

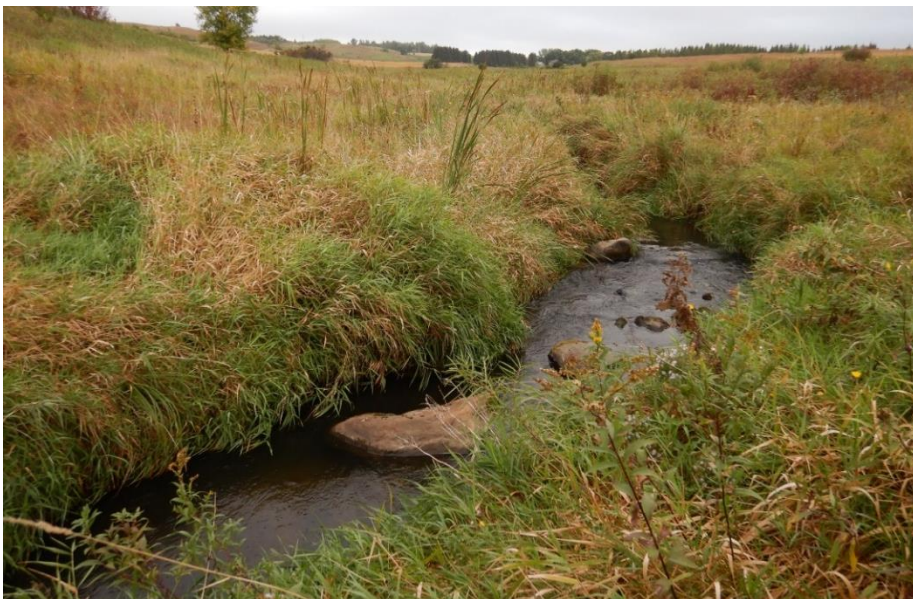
Figure 9. Site 17MN004 (9/14/18)

- Lack of habitat is an issue in the lower part of the creek. DNR found the channel at upper site 17MN004 to be stable with a good MPCA Stream Habitat Assessment (MSHA) score. MSHA scores were fair downstream at 07MN001. Factors limiting the habitat condition were a lack of riparian zone, a lack of channel development and lack of shade.
- DO, eutrophication, and TSS all had some values that exceeded standards. Further DO monitoring lower in the reach, phosphorus monitoring near the Ashby Wastewater Treatment Plant (WWTP), and further bank erosion investigation would help to understand and mitigate effects.
- MPCA wetland biologists found plants in the fresh meadow wetland community surrounding site 17MN004 to be high quality (Figure 31). This area should be a priority for protection.

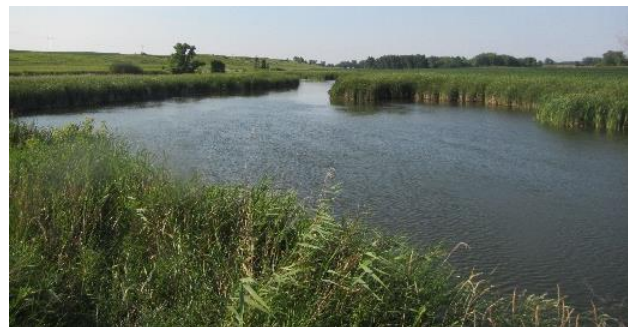
Figure 12. Pomme de Terre River near site 17MN006 (8/1/17).

- The Pomme de Terre River is low gradient and surrounded by wetlands (Figure 12). A low DO value of 0.44 mg/L was collected downstream of a wetland complex. Three plant surveys were done on wetlands along the two reaches and were found to have poor plant communities that have shifted toward tolerant species.
- Elevated phosphorus and DO values were collected on both reaches. Reach -562 is downstream of Perkins Lake which is impaired for nutrients. Chlorophyll-a values were near the river eutrophication standard (RES) on both reaches.
- Just over 5% of the samples exceeded the TSS standard. Rainfall can create very high TSS levels, with a recorded value in 2015 of 2,570 mg/L on the reach -563. On average, inorganic solids (sediment) made up the majority of the suspended solids.

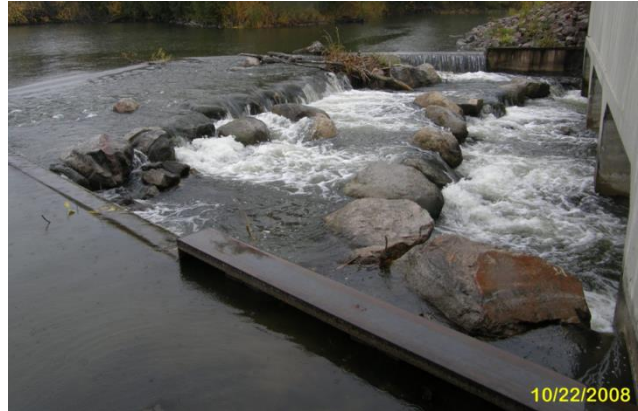
Figure 13. Barrett Lake dam (DNR).

- The Barrett Lake dam was modified in 2006 for fish passage (Figure 31). The Perkins dam is a partial barrier. The Crissy Lake dam is a full barrier in Morris. Migratory fish species and numbers decrease upstream of the Crissy and Perkins dams. There was an increase in migratory fish downstream of the dams in C2 since species have had more time to move up into the Pomme de Terre River after the Appleton Dam was removed. Connectivity continues to be a stressor to reach -563

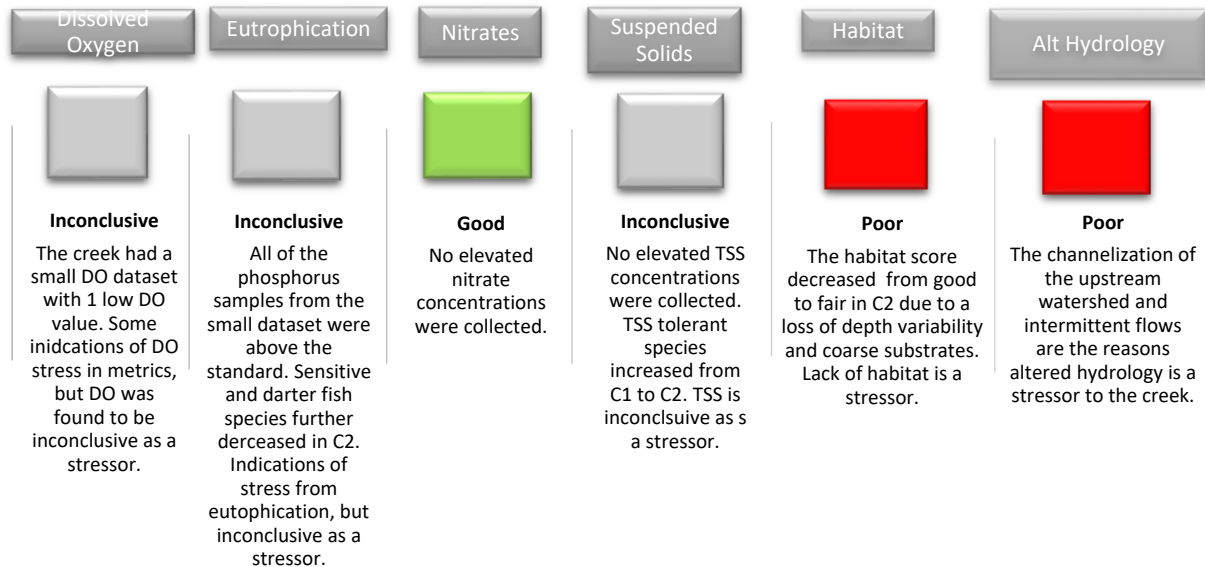
Figure 14. Biological stressor determinations for Middle Pomme de Terre River tributaries from 2022. Red boxes indicate poor conditions and therefore a stressor to aquatic life. Green boxes indicate good conditions that are not stressing aquatic life. Grey boxes indicate inconclusive stressors.

SID work was completed on the tributary, with lack of habitat and altered hydrology being identified as stressors, while DO, TSS, and eutrophication were inconclusive as stressors (Figure 14).

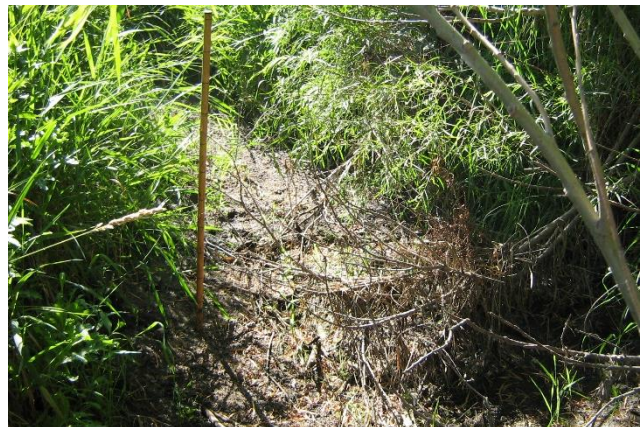
Figure 15. Parts of the creek were dry in July 2007 (7/11/07).

- Additional monitoring of phosphorus, diurnal DO and chlorophyll-a would help determine eutrophication stress.
- Limiting the habitat scores on the creek were a lack of riffles, channel development, a lack of depth variability, and lack of flow variability.
- The upstream watershed of the creek has been heavily altered. During the drier of 2007, the creek had intermittent flow in July 2007 (Figure 15) and was dry in August 2007. Altered hydrology exacerbates low flow conditions during drier years.
- A beaver dam impoundment was suspected to be present during the fish and invert sample in 2016, further altering the flow of the creek.

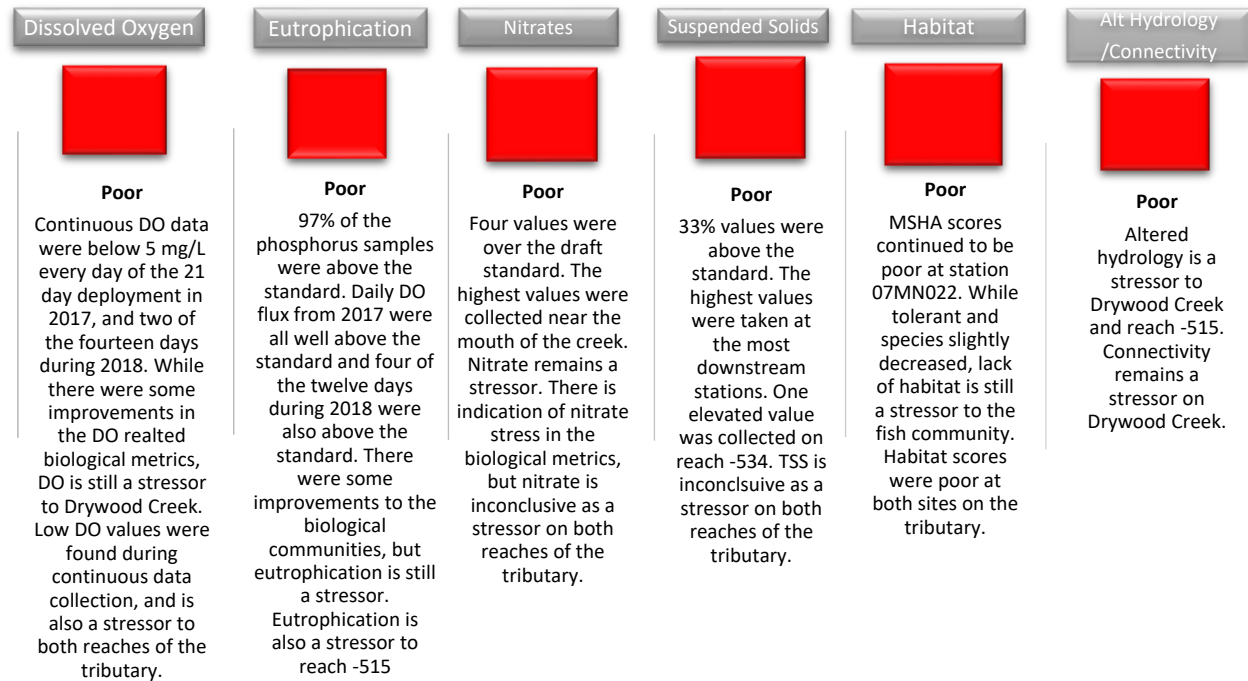
Figure 17. Biological stressor determinations for Drywood Creek from 2022. Red boxes indicate poor conditions and therefore a stressor to aquatic life.

SID work was completed in Drywood Creek during C1 SID. Low DO, eutrophication, nitrate, lack of habitat, high TSS, and altered hydrology were identified as stressors to the biological community during C1. Investigation of stressors in C2 work confirmed the same stressors are still present (Figure 17).

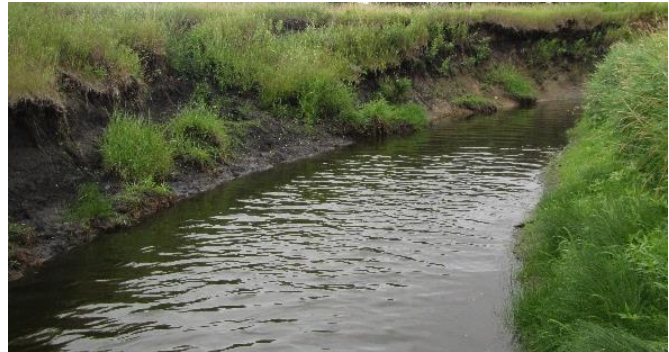
Figure 18. Bank erosion on Drywood Creek

- Habitat conditions were poor on Drywood Creek and the tributary. Limiting the habitat were bank erosion (Figure 18), embeddedness of coarse substrates, and a lack of channel development and lack of depth variability. A sedimentation survey by the DNR showed “Both the reach and riffle pebble counts were comprised of 100% silt during the 2018 resurvey at site 07MN022. This composition was different than the 2009 survey that showed a mixture of silts, sands, and gravel sized particles” (DNR 2022).

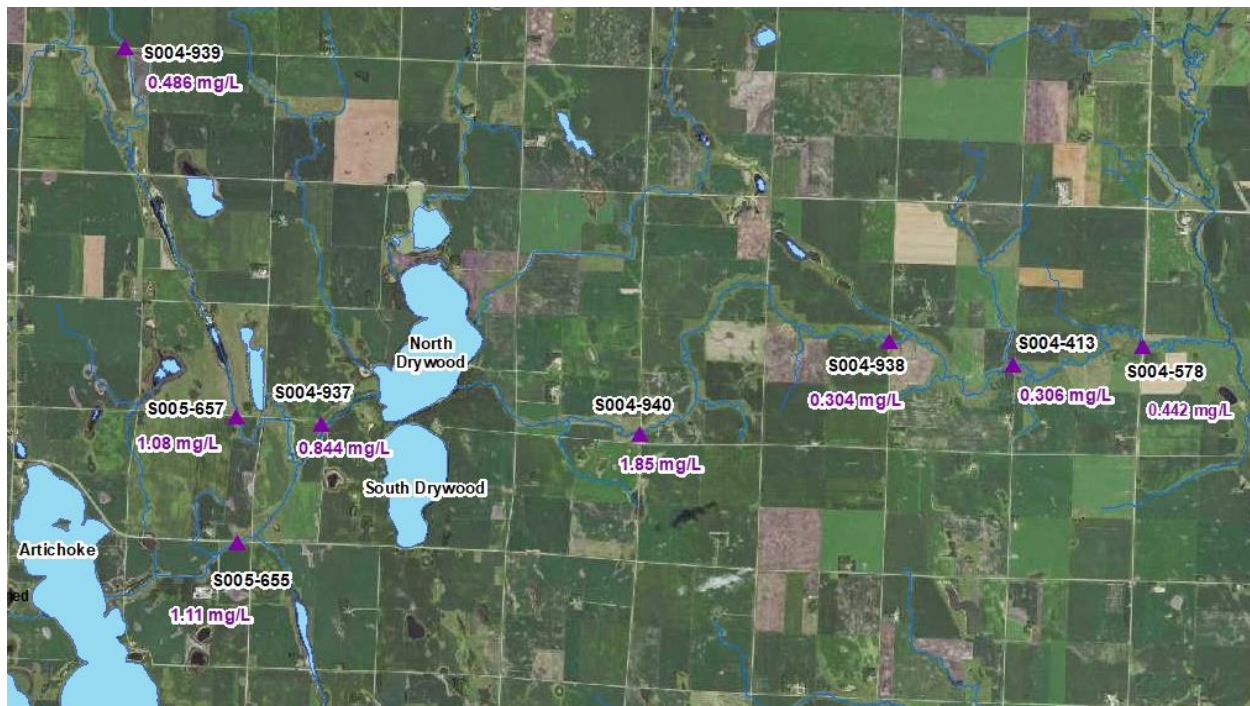
Figure 19. Phosphorus values in the Drywood Creek Watershed

- Drywood Creek is impaired for Turbidity. Site 07MN022 had signs of improvement in the fish community from C1 to C2, but TSS is still a stressor. “...Heavily grazed pastures between Dry Wood Lake and station 08MN087 are sources of fine sediment from sheet, rill, and gully erosion” (DNR 2021).
- Drywood Creek is downstream of North and South Drywood Lakes, which are both impaired for nutrients. Phosphorus was also elevated on Artichoke Lake. Longitudinal phosphorus values collected in 2020 were highest downstream of Artichoke Lake (1.11 mg/L), downstream of Drywood Lake (1.85 mg/L), and near the mouth of reach -534 (1.08 mg/L). Phosphorus concentrations decreased downstream of Drywood Lake but then increased near the mouth of the creek (Figure 19).

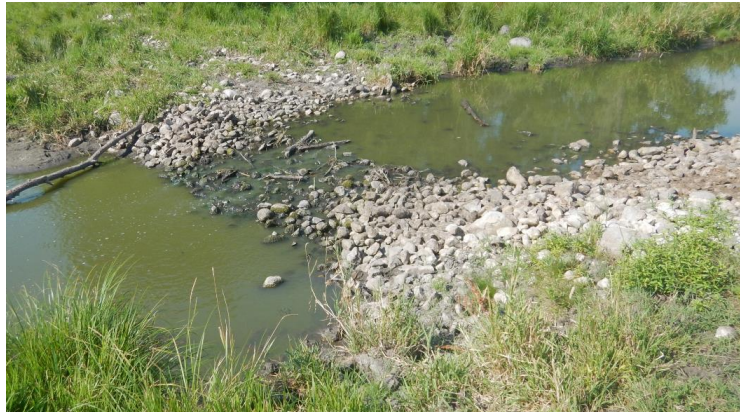
Figure 20. Fish barrier on Drywood Creek (DNR)

- The upper section of Drywood Creek was modified and some of the tributaries are channelized. While the biology shows a trend of improvement with metrics, altered hydrology is still a contributing stressor. Reach -515 is entirely channelized.
- A constructed riffle downstream of station 08MN087 is acting as a fish barrier to the most upstream station (08MN087) (Figure 20). Connectivity is still a stressor to Drywood Creek but there is no longer a fish migration barrier upstream of station 07MN022.

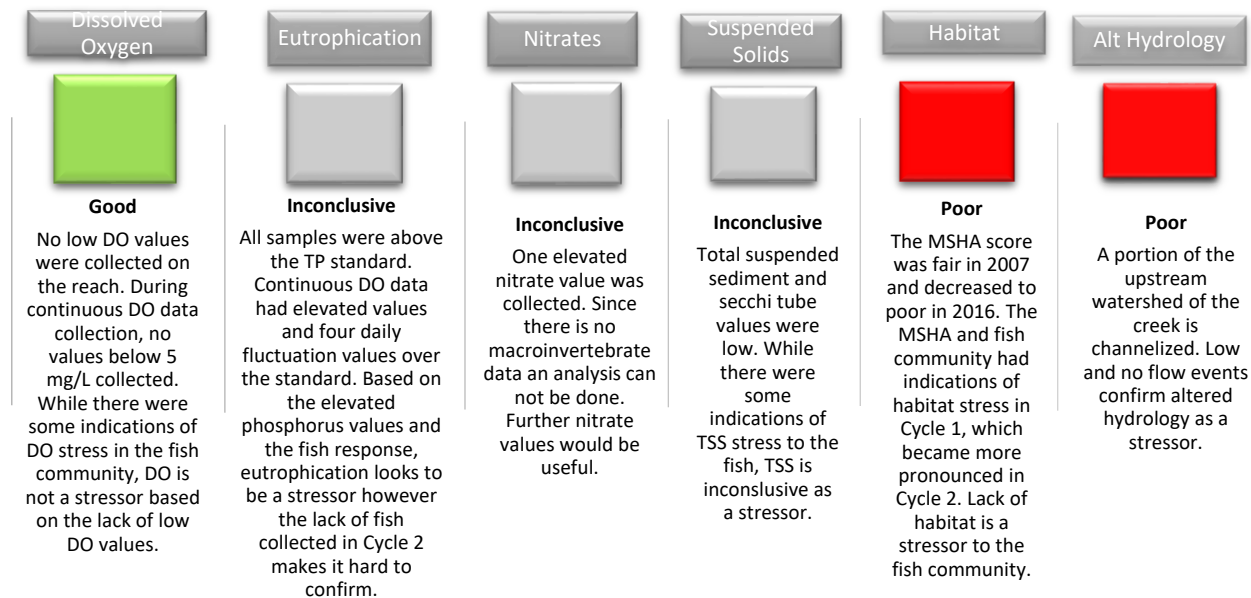
Figure 22. Biological stressor determinations for Muddy Creek from 2022. Red boxes indicate poor conditions and therefore a stressor to aquatic life. Grey boxes indicate inconclusive stressors. Green boxes indicate good conditions that are not stressing aquatic life.

SID work was not completed on the unnamed creek during C1 SID. The goal of C2 SID work was to gather and analyze the biological and chemical data to determine the likely cause of stress to the impaired fish community. Lack of habitat and altered hydrology were the identified stressors, while eutrophication, nitrate, and TSS were inconclusive and could potentially have a negative impact on aquatic life (Figure 22).

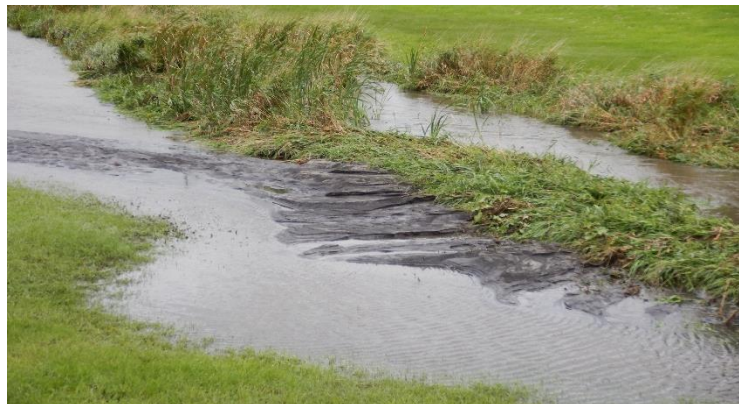
Figure 23. Sediment at site 07MN017 (9/13/2019).

- The decrease in the habitat score at station 07MN017 was due to the loss of depth variability, flow variation, and loss of a pool along the reach. Excess sediment was deposited near the tributary (Figure 23), an indication of a high sediment load.
- The creek was completely dry in August of 2007 and was too low in August 2016 to collect a macroinvertebrate sample. The fish sample during 2016 was collected after the attempted macroinvertebrate sample, which helps explain why the fish community was so low. The low flow and no flow events are indicative that altered hydrology is a stressor to the fish community.
- Phosphorus values and diurnal DO flux exceeded the eutrophication standard. A high value of 0.592 mg/L was collected in 2019. Fish data during normal flows would be helpful to determine impacts.

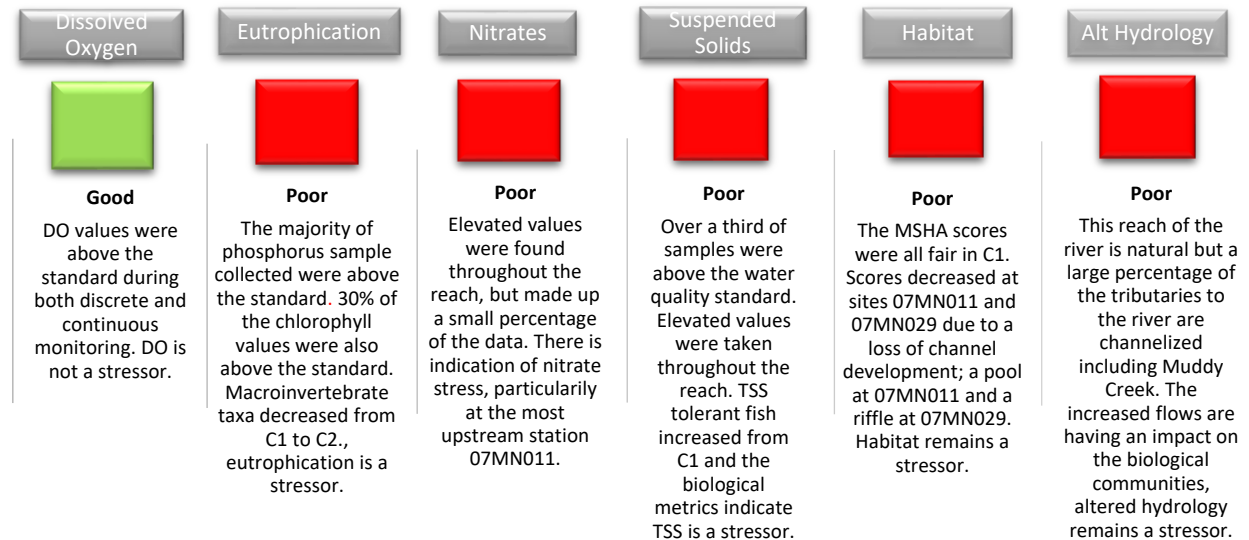
Figure 25. Biological stressor determinations for the lower Pomme de Terre River from 2022. Red boxes indicate poor conditions and therefore a stressor to aquatic life. Green boxes indicate good conditions that are not a stressor to aquatic life.

SID work was completed in the downstream reach of the Pomme de Terre River during C1 SID. Nitrate, lack of habitat and altered hydrology were identified as stressors to the biological community during C1. Eutrophication and TSS were found to be new stressors during C2 (Figure 25).

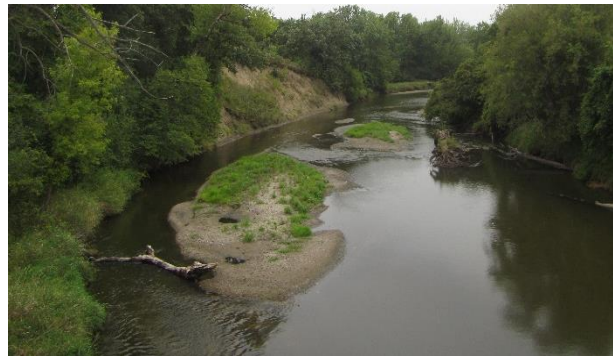
Figure 26. Excess sedimentation at site 07MN029.

- The decrease in the habitat score at station 07MN011 was due to the loss of channel development and loss of a pool along the reach. The increase at station 07MN032 was due to an increase in cover for the biological communities. The slight decrease in score at station 07MN029 was due to the loss of the riffle in the reach (Figure 26).
- A nitrate value of 11 mg/L was collected near the mouth of the Pomme de Terre River in 2016 after over an inch of rain.
- Eutrophication is also an issue on the Pomme de Terre and the tributary with elevated TP and chlorophyll-a.
- TSS concentrations were highest on the Pomme de Terre River near Appleton with a high value of 460 mg/L collected in 2015.

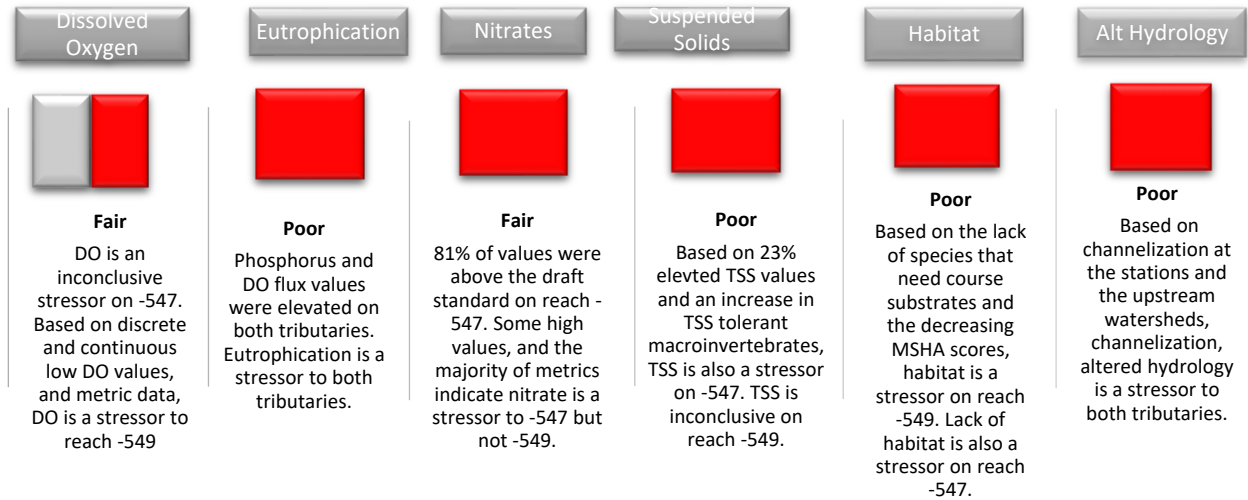
Figure 27. Biological stressor determinations for the Lower Pomme de Terre River tributaries from 2022. Red boxes indicate poor conditions and therefore a stressor to aquatic life. Grey boxes indicate inconclusive stressors.

SID work was not completed on JD 2 and the unnamed creek during C1 SID. The goal of C2 SID work was to gather and analyze biological and chemical data to determine the likely cause of stress to the impaired fish and macroinvertebrate communities (Figure 27).

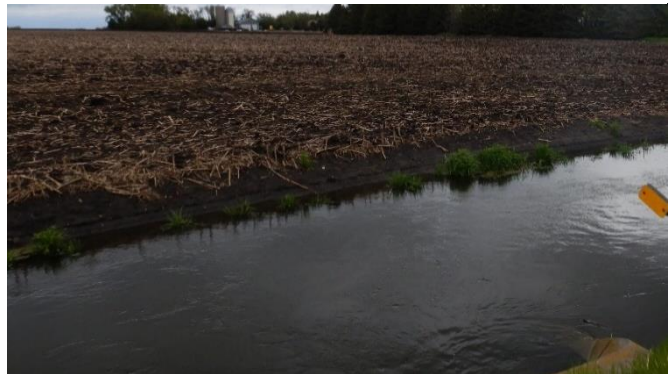
Figure 28. No buffer at site 07MN030 (5/23/2019).

- The habitat score at site 07MN030 decreased from C1 due to an increase in bank erosion and embeddedness of coarse substrates.
- No buffer along the stream at site 07MN030 (Figure 28), sediment will enter the ditch with any rainfall on the field or if the ditch floods into the field.
- The tributary had a high TSS value of 296 mg/L on reach -547 in 2017.
- A nitrate value of 29 mg/L was collected on the reach -547 in June 2017 and a value of 30 mg/L was collected on reach -549 in May of 2019.

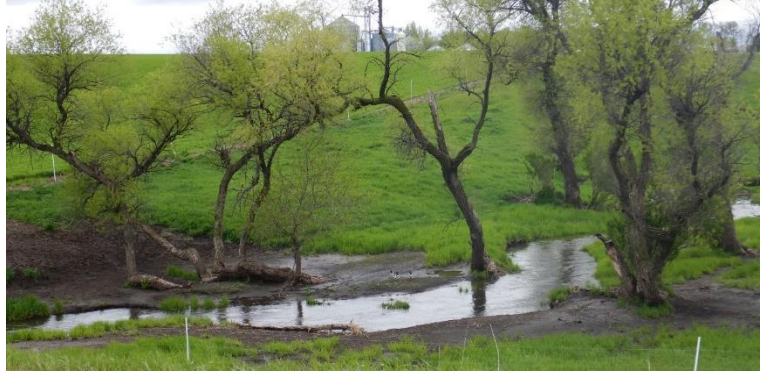
Figure 29. Eroding banks upstream of 07MN024.

- While there is a nice buffer at site 07MN024, just over a mile upstream (Hwy 59) is a pasture with eroding banks (Figure 29), which is a source of sediment.
- Both reaches have been channelized, and the upstream watershed to station 07MN030 is also channelized.
- Readings were below the DO standard of 5 mg/L during continuous data collection on JD 2 (-549). Eutrophication is likely driving low DO values on the ditch, with algal growth (Figure 30) and elevated daily DO flux. Seven of 18 daily fluctuations exceeded the standard of 5 mg/L (Figure 31).

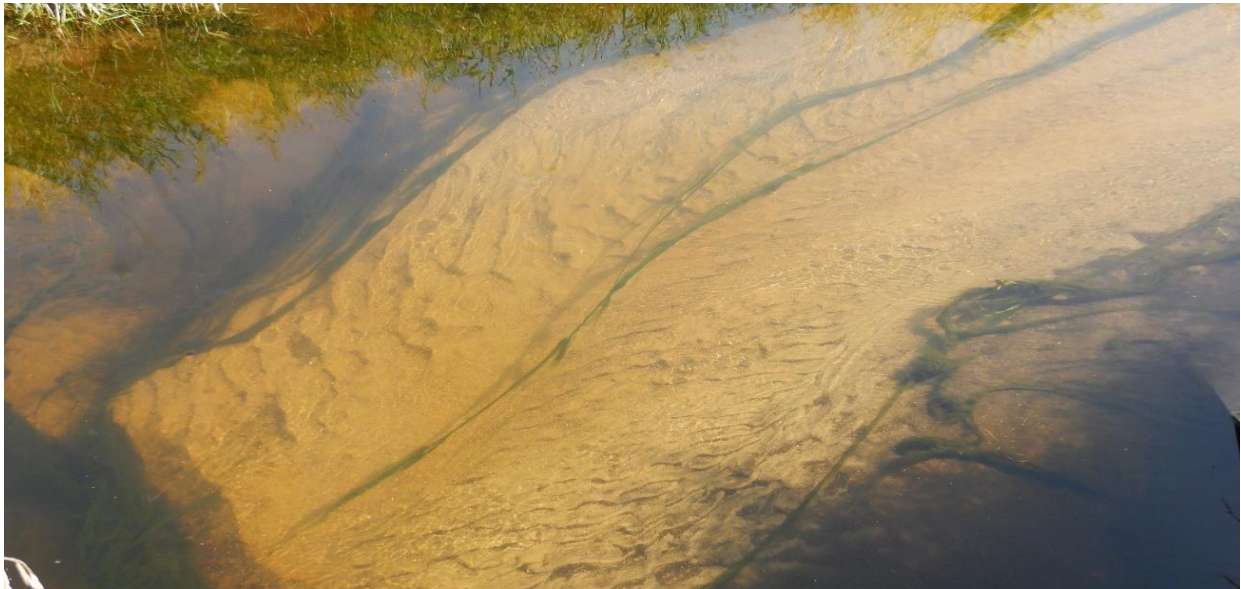
Figure 30. Algal growth at station 07MN030 (8/23/2019).

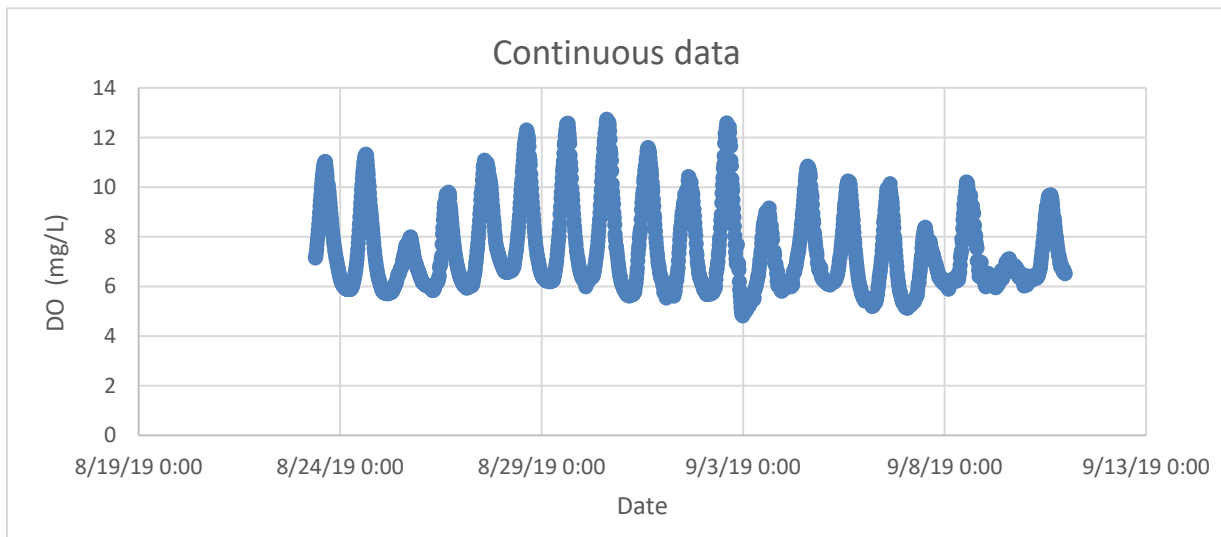
Figure 31. Continuous data at station 07MN030.
