# Vermillion River Watershed

Stressor ID Update, January 2022

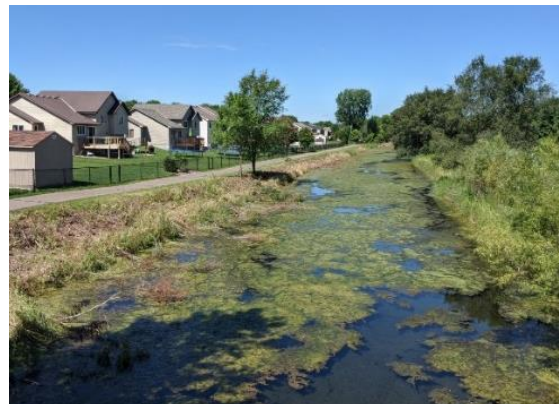
- A DO impairment was identified during the assessment process. DO concentrations tend drop to harmful levels and fluctuate greatly, which negatively impacts aquatic life. The impacts of stormwater runoff (low flow, stagnant water) in North Creek tributaries (Figure 2) and potential runoff from nearby agricultural fields have likely contributed to these conditions. Best management practices to prevent phosphorus from entering the stream system in this section, as well as upstream, are needed.

Figure 2: Eutrophic tributary to North Creek.

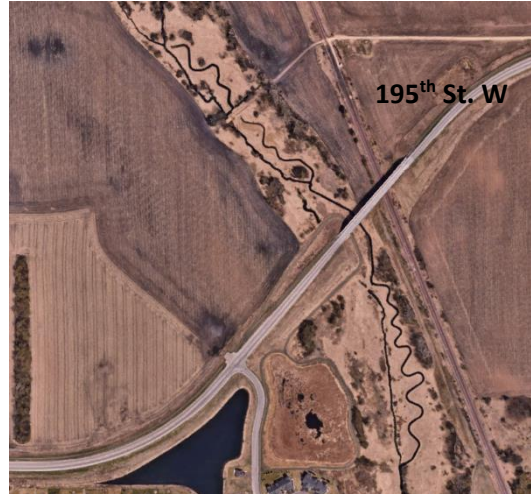
- The upstream portion of North Creek is improving in terms of habitat conditions, as a large amount of restoration and the re-meandering of the channel has taken place (Figure 3). This work can take time to show the desired results. Further downstream, the reach is still channelized resulting in lower MPCA Stream Health Assessment (MSHA) scores. Limiting the habitat in this altered section is the surrounding land use (proximity to development and agricultural fields), light stream shading, sand and detritus substrates, severe embeddedness, and fair channel development.

Figure 3: Re-meandering of upper portion of North Creek (-670).

The upper portion of North Creek (-670) was re-meandered to eliminate some channelized portions. This restoration work has shown positive results so far as site 14LM004 was resampled for fish in 2020 and had a FIBI score of 46.1.

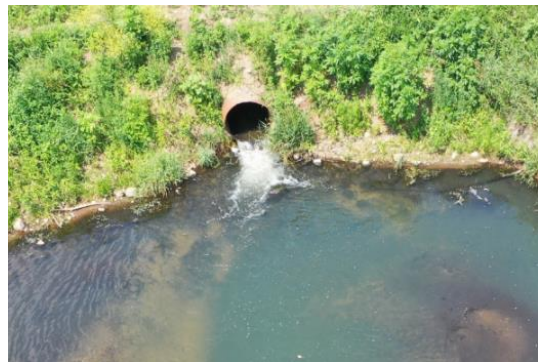
- Altered hydrology/connectivity is a significant issue in North Creek. A field road culvert is perched (Figure 4) and acting as a fish barrier in this reach preventing fish from migrating upstream from the Vermillion River. Proper size and elevation of this culvert would improve FIBI scores upstream as well as improve habitat conditions. Additionally, continued re-meandering of the channelized sections will provide better flow consistency, reduce erosion and sediment issues, while also improve the general habitat conditions.

Figure 4: Perched culvert in North Creek preventing fish migration.

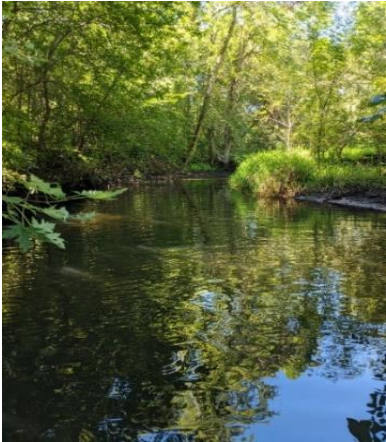
SID work was not completed in Unnamed Creek/Middle Creek (Figure 5) during C1 SID. The goal of C2 SID work was to get additional water chemistry information on DO, eutrophication, nitrates, and stream transparency. Stressors found in this reach were DO and habitat. More information is needed to determine if eutrophication and suspended solids are stressors to the impaired biological communities, while nitrates and altered hydrology/connectivity were both ruled out as stressors.

Figure 5: Unnamed Creek/Middle Creek at sampling site S007-657.

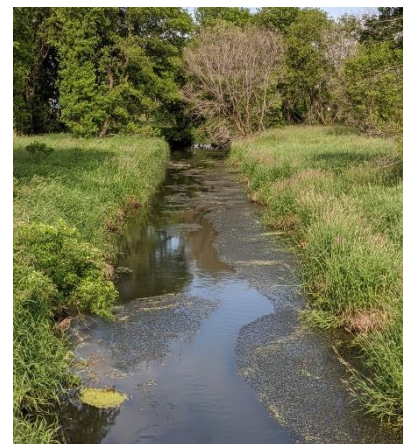
Figure 6: Eutrophic conditions in Trib to Rice Lake.

- DO and eutrophication (Figure 6) were also found to be stressors in this reach. High amounts of phosphorus in addition to the slow moving, low gradient nature of the stream are significant contributors to these issues.
