SID Update

Bancroft Creek Watershed 2022

This SID update document summarizes biological condition and provides monitoring highlights and stressor conclusions for Bancroft Creek Watershed.

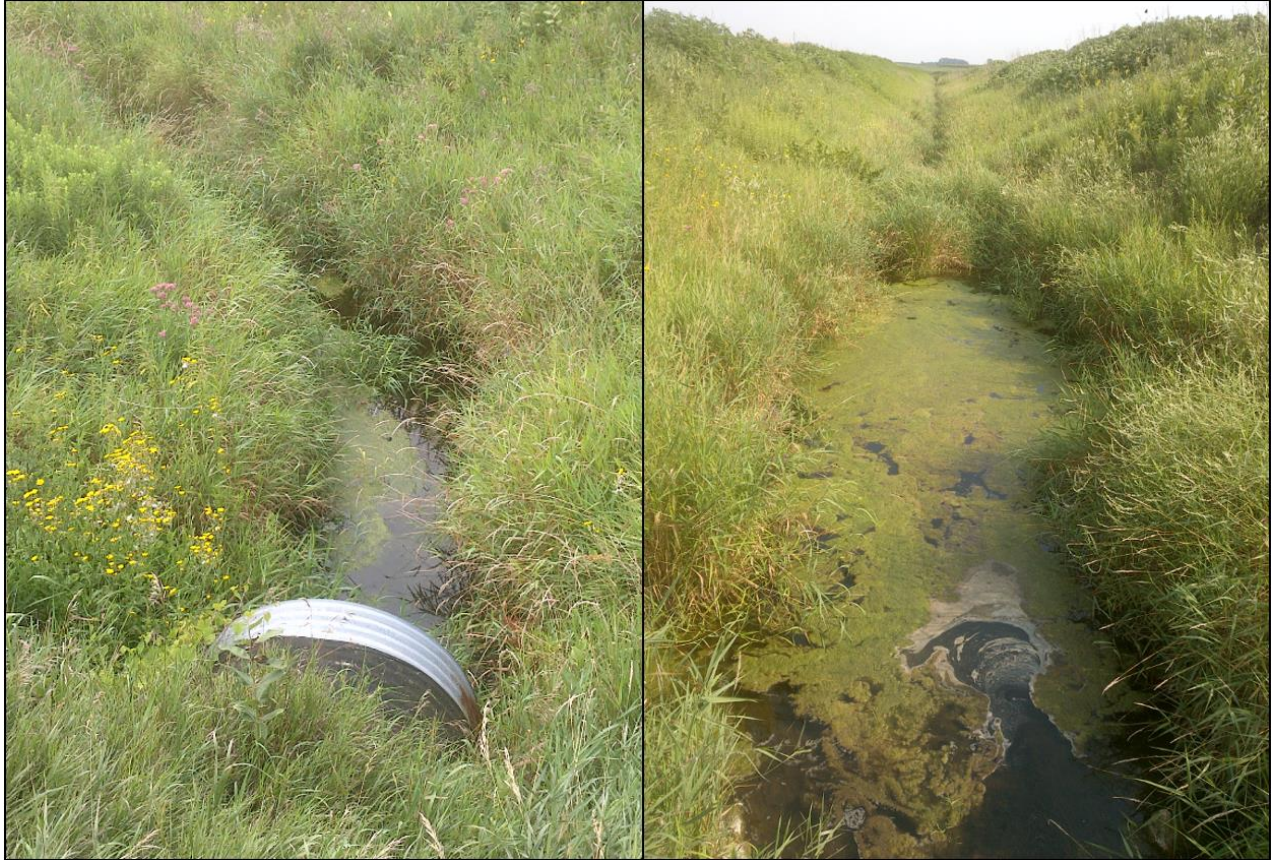
Figure 4: Eutrophic conditions and low DO (2.4 mg/L) were documented on County Ditch 65 (just upstream of stations S005-005 and 09CD085) in July 2021.

DO ranged from 4.8 mg/L to 10.1 mg/L across the watershed during early morning DO surveys in 2019. Early morning DO surveys were conducted on 7/23/19, 8/2/19, and 8/30/19 to characterize conditions and identify low DO. One exceedance (8%) of the warmwater DO standard (5 mg/L) was identified in the upper portion of the watershed (station S015-336). DO surveys were also conducted in 2020 in the lower portion of Bancroft Creek (station S006-535); all three samples were above the standard. Field work in 2021 identified low DO (2.4 mg/L) in County Ditch 65 at the 255th Street crossing (Figure 4). There were also several instantaneous (point) measurements collected throughout the watershed over the last decade (2011 through 2020), and one (1%) was below 5 mg/L. Fish low DO index scores and probability of meeting the DO standard were better than the statewide median, while most macroinvertebrate low DO metrics (low DO index score, % low DO intolerant, % low DO tolerant) were worse than the statewide median.

- Although inconclusive stressors at this time, eutrophication and low DO may be impacting biology in certain parts of the watershed during certain years (e.g. low flow years); reducing nutrient loading in Bancroft Creek Watershed is an important step for improving biological communities.

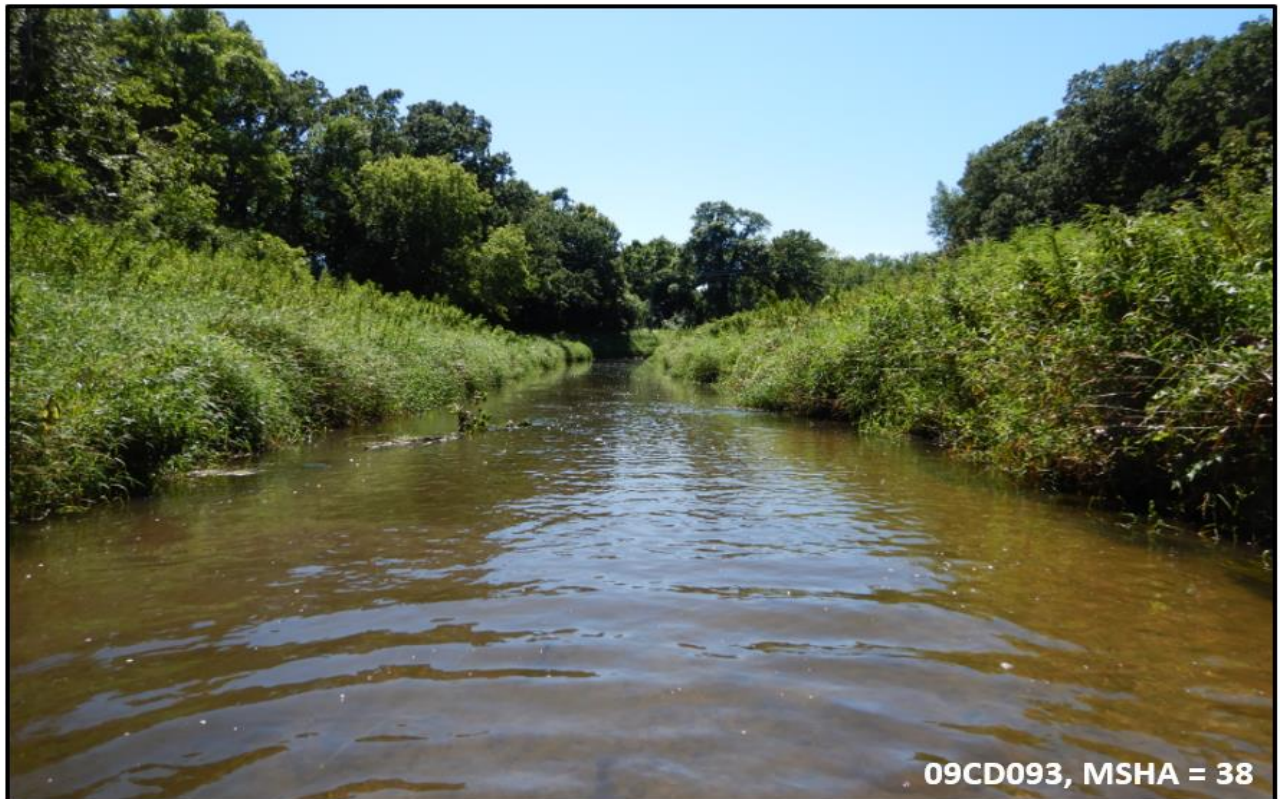
09CD093, MSHA = 38

Figure 5: Habitat example from biological monitoring station 09CD093 in Bancroft Creek Watershed in 2019.

MPCA Stream Habitat Assessment (MSHA) scores at station 09CD093 were similar between Cycle 1 and Cycle 2; Cycle 2 scores were 38 and 45. Most sub-category scores (Land Use, Riparian, Substrate, Cover, and Channel Morphology) were similar between Cycle 1 and Cycle 2; the highest score in Cycle 2 had increases in Substrate, Cover, and Channel Morphology scores. A habitat example from biological monitoring in 2019 can be seen in Figure 5. Although station 09CD093 was de-listed (fish and macroinvertebrates) following Cycle 2 assessment, habitat is poor with limited cover and coarse substrate, and associated embeddedness issues. Also, macroinvertebrate and fish metrics from deferred Cycle 1 stations not sampled in Cycle 2 are indicative of habitat stress. These stations have elevated burrowers and legless individuals, reduced clingers, limited riffle species, and are dominated by tolerant species. Often times this type of metric response is associated with lack of coarse substrate and/or woody debris, fine substrate, embeddedness, channelization, etc.

- Although TSS is not currently a stressor, sediment is impacting biology via habitat loss and degradation from an abundance of fine substrate and embeddedness.

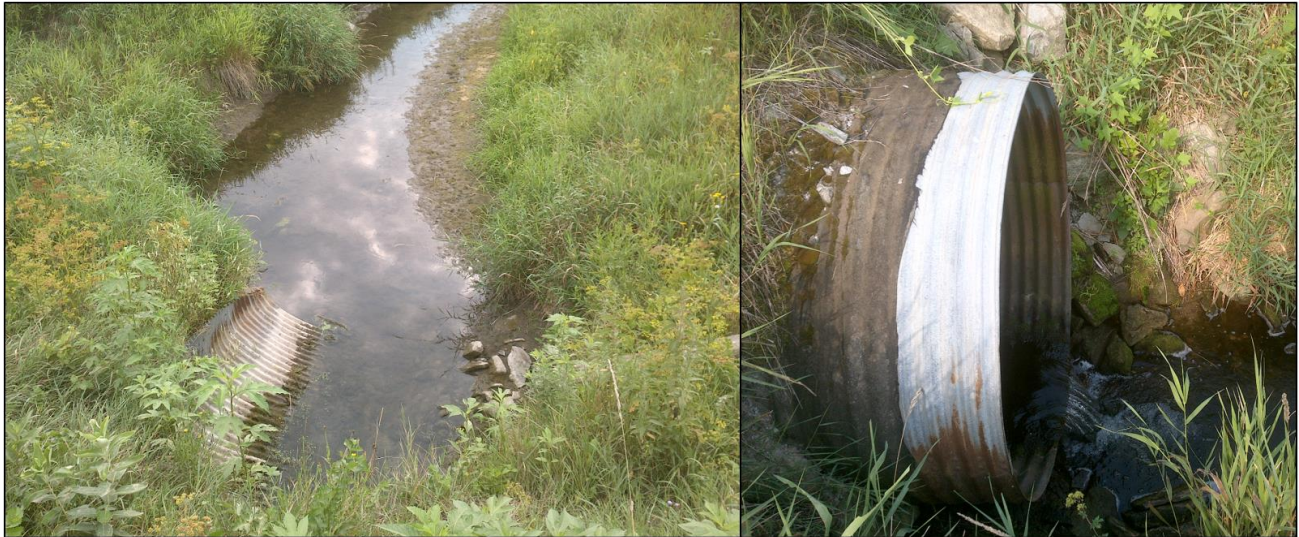
Low flow conditions and a perched culvert were documented in 2021 on County Ditch 65; both have the potential to negatively impact fish migration (Figure 6). Station 09CD085 had zero migratory fish species in 2009.

Figure 6: Low flow conditions (left) and a perched culvert (right) documented in 2021 on County Ditch 65; both have the potential to negatively impact fish migration. The perched culvert is located just upstream of AUID -529 at the 255th Street crossing.

- Low flow conditions and a perched culvert were documented in 2021 on County Ditch 65; both have the potential to negatively impact fish migration (Figure 5).

- Overall, reducing nitrate and phosphorus loading, improving in-stream habitat, ensuring proper connectivity for fish migration, and addressing flow alteration related issues (e.g. poor habitat,
