Buffalo River Watershed Biotic Stressor Identification

A study of local stressors limiting the biotic communities in the Buffalo River Watershed.

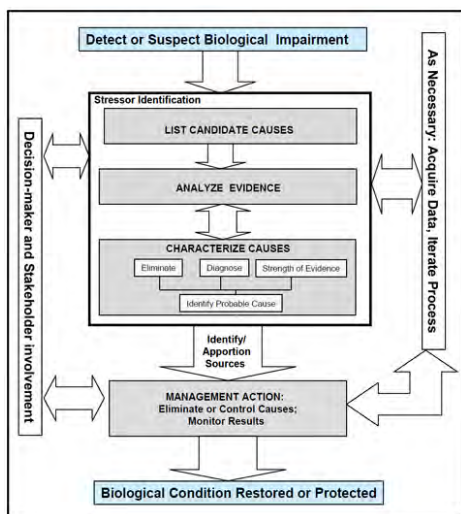
Figure 1. Conceptual model of stressor identification (SID) process (Cormier, et.al. 2000).

This report describes the step-by-step analytical approach, based on the EPA's SID process, for identifying probable causes of impairment in a particular system ([Figure 1](#)). In the Buffalo River Watershed, stressors that were examined for possible cause of biotic impairment were low DO, high nitrate-nitrite, excess phosphorus, high turbidity/sediment, lack of habitat, lack of connectivity, pesticides, and altered flow regime. Other stressors were considered but did not have sufficient evidence for further analysis.

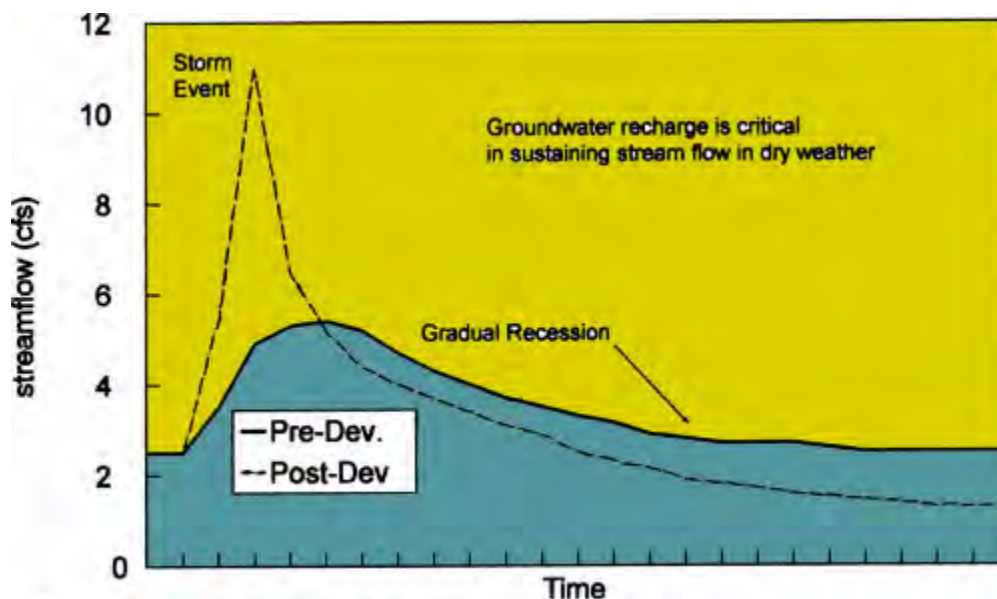
Figure 15. Change in storm event stream hydrograph from pre-development to post development. Note the change in peak stream flow that results from loss of storage within watershed due to drainage (wetland loss, ditching, channelization and tiling). Image credit: Deeproot.com with permission.

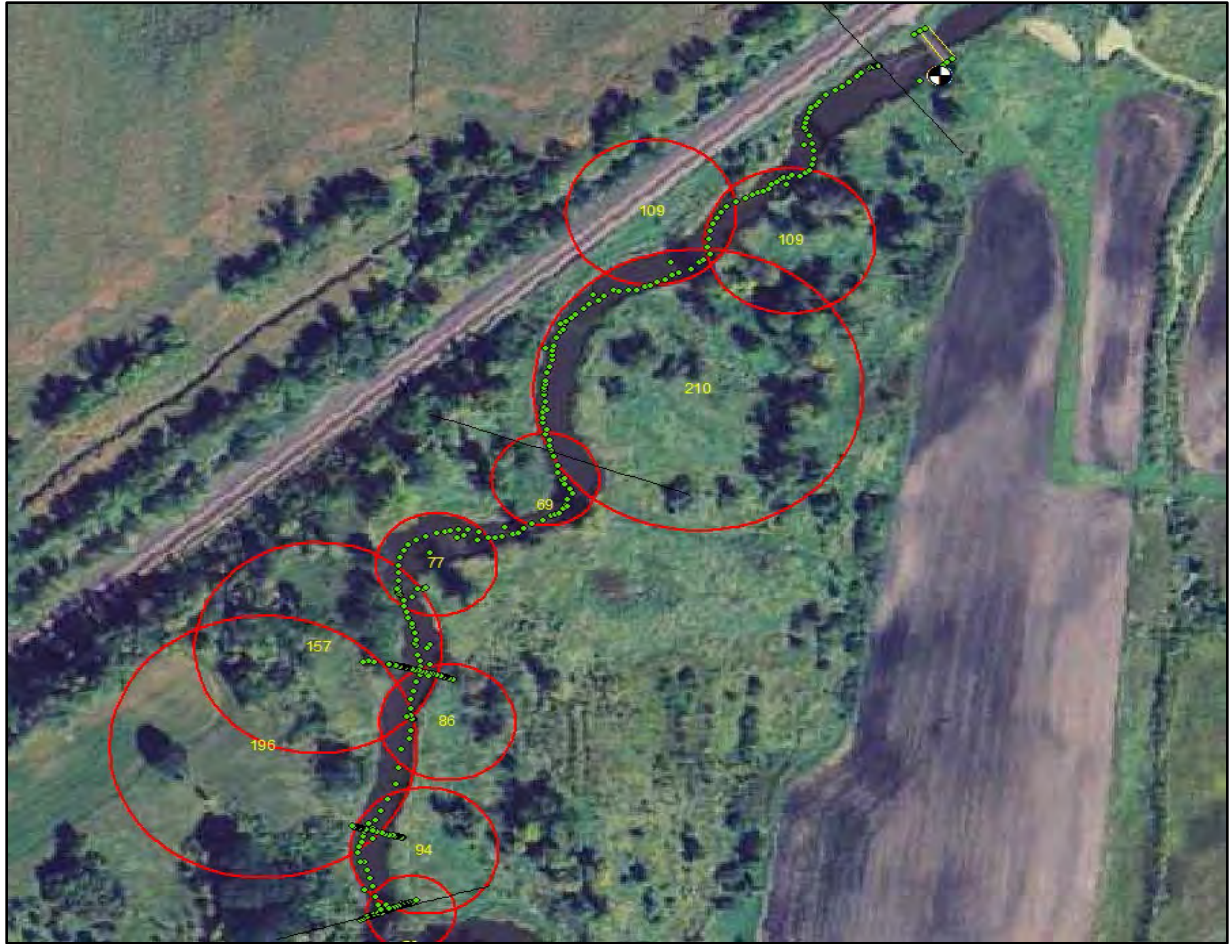
Figure 22. Near bank stress estimates using radius of curvature (yellow labels are radii of red or yellow circles that fit stream bends) divided by W_{bkf} .

NBS was later calculated using recorded bankfull widths and radius of curvature measured from aerial photographs (Figure 22 and Figure 23) using GIS software (NBS method 2, Rosgen 2008). This method uses the ratio of the radius of curvature of the meanders to the bankfull width of the channel, and is a measure of the tightness of the bends in the river and the degree of boundary shear stress acting on those banks. Bank lengths were also measured using GIS software from the start and end waypoint of each similar eroding bank. Known erosion rates from developed erosion curves were used with the BEHI, NBS combinations to predict erosion rates in feet per year and total erosion volume in tons/year/mile. This process continued for the entire length of the reconnaissance station which could be up to six stream miles in a day. Geo-referenced photographs were taken for each bank for future reference.

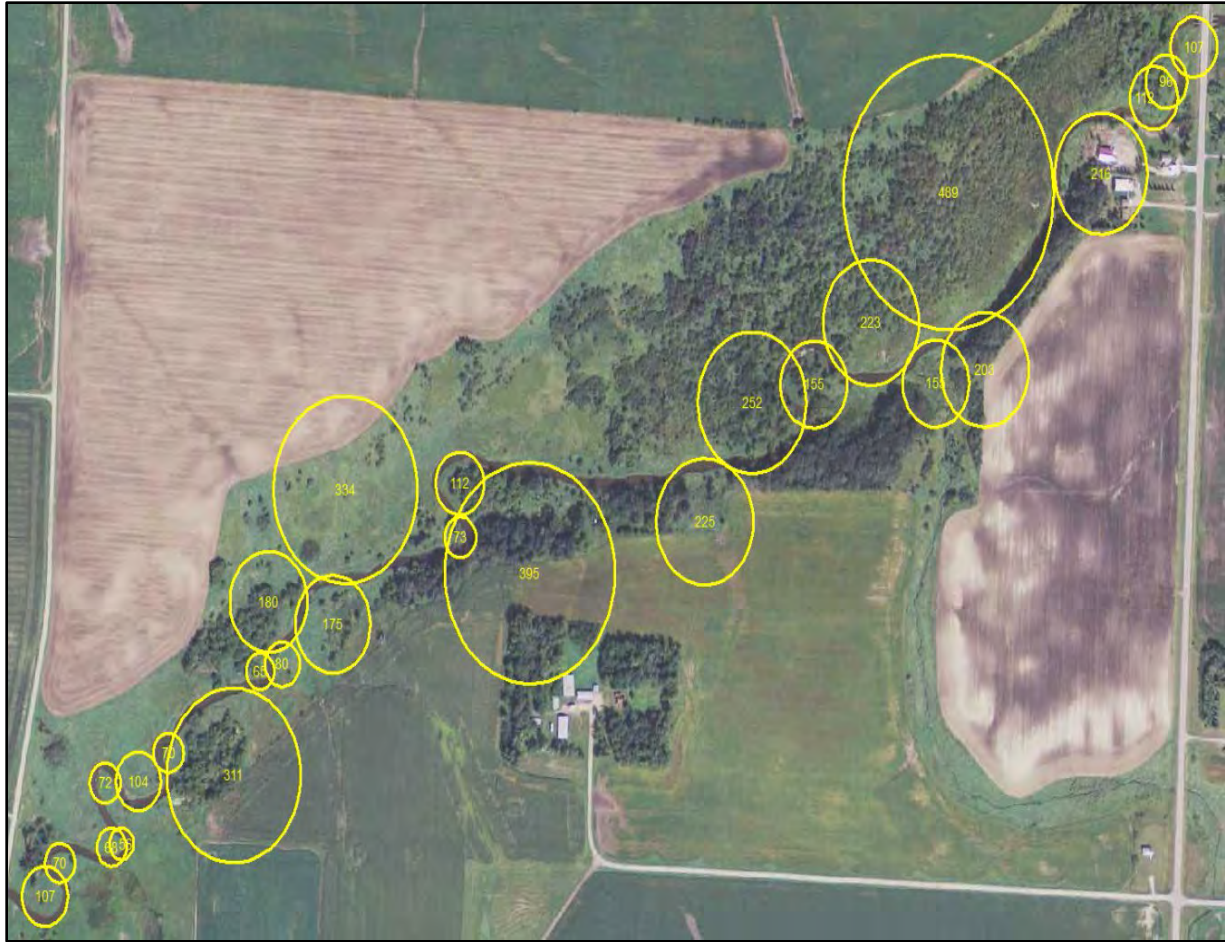
Figure 23. Near bank stress estimates using radius of curvature (yellow labels are radii of red or yellow circles that fit stream bends) divided by Wb_{kf} .

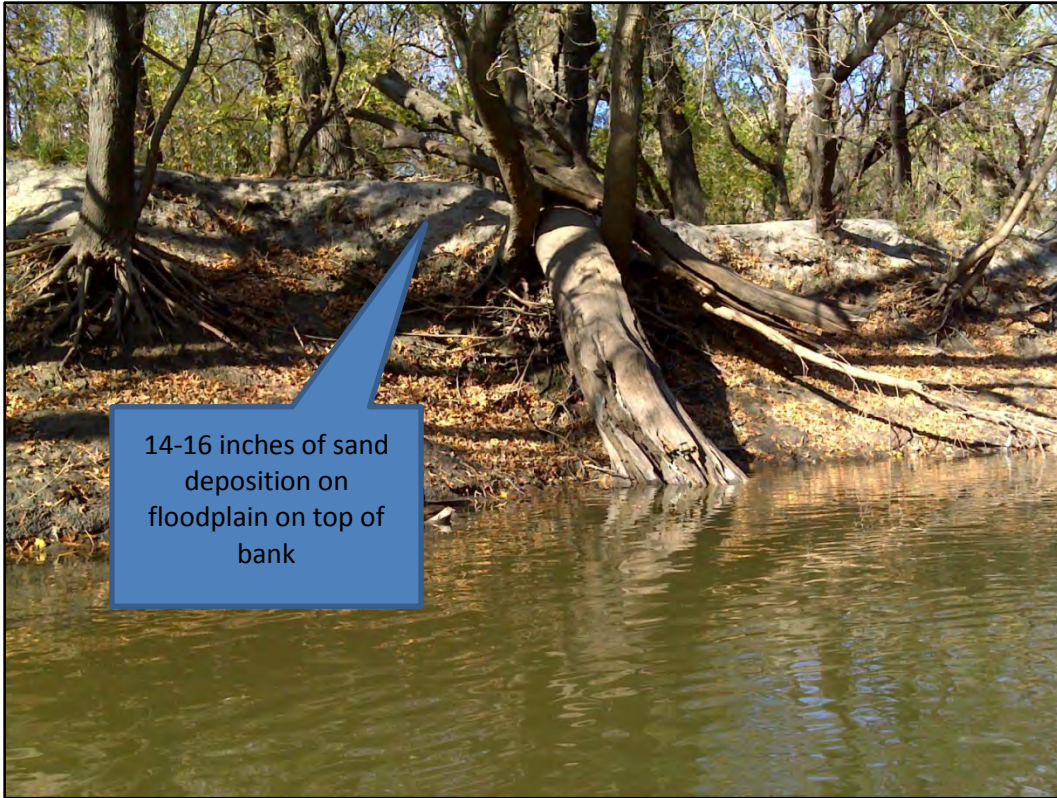
Figure 29. Clay County 91 to Highway 11 reach, deposition of fine sand on floodplain surface.

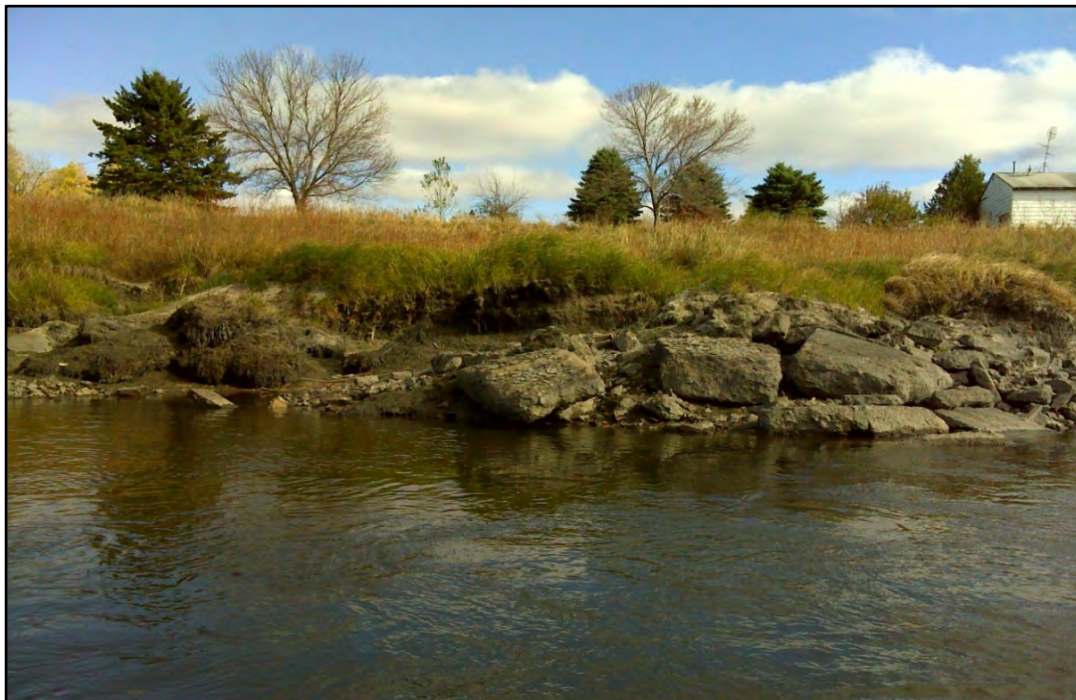
Figure 30. Failed erosion prevention efforts near waypoint 598.

This station lies in the glacial lake plain tightly consolidated clays and is a fairly stable reach with adequate access to a flood plain with a few exceptions noted on [Figure 28](#). Deposition of about 14 – 16 inches of sand was evident on the floodplain throughout the reach ([Figure 29](#)). Best management options for this area include toe-wood sod-mat bank protection from waypoint 597 through 599 along with improved buffers from 596 through 599 ([Figure 30](#)).

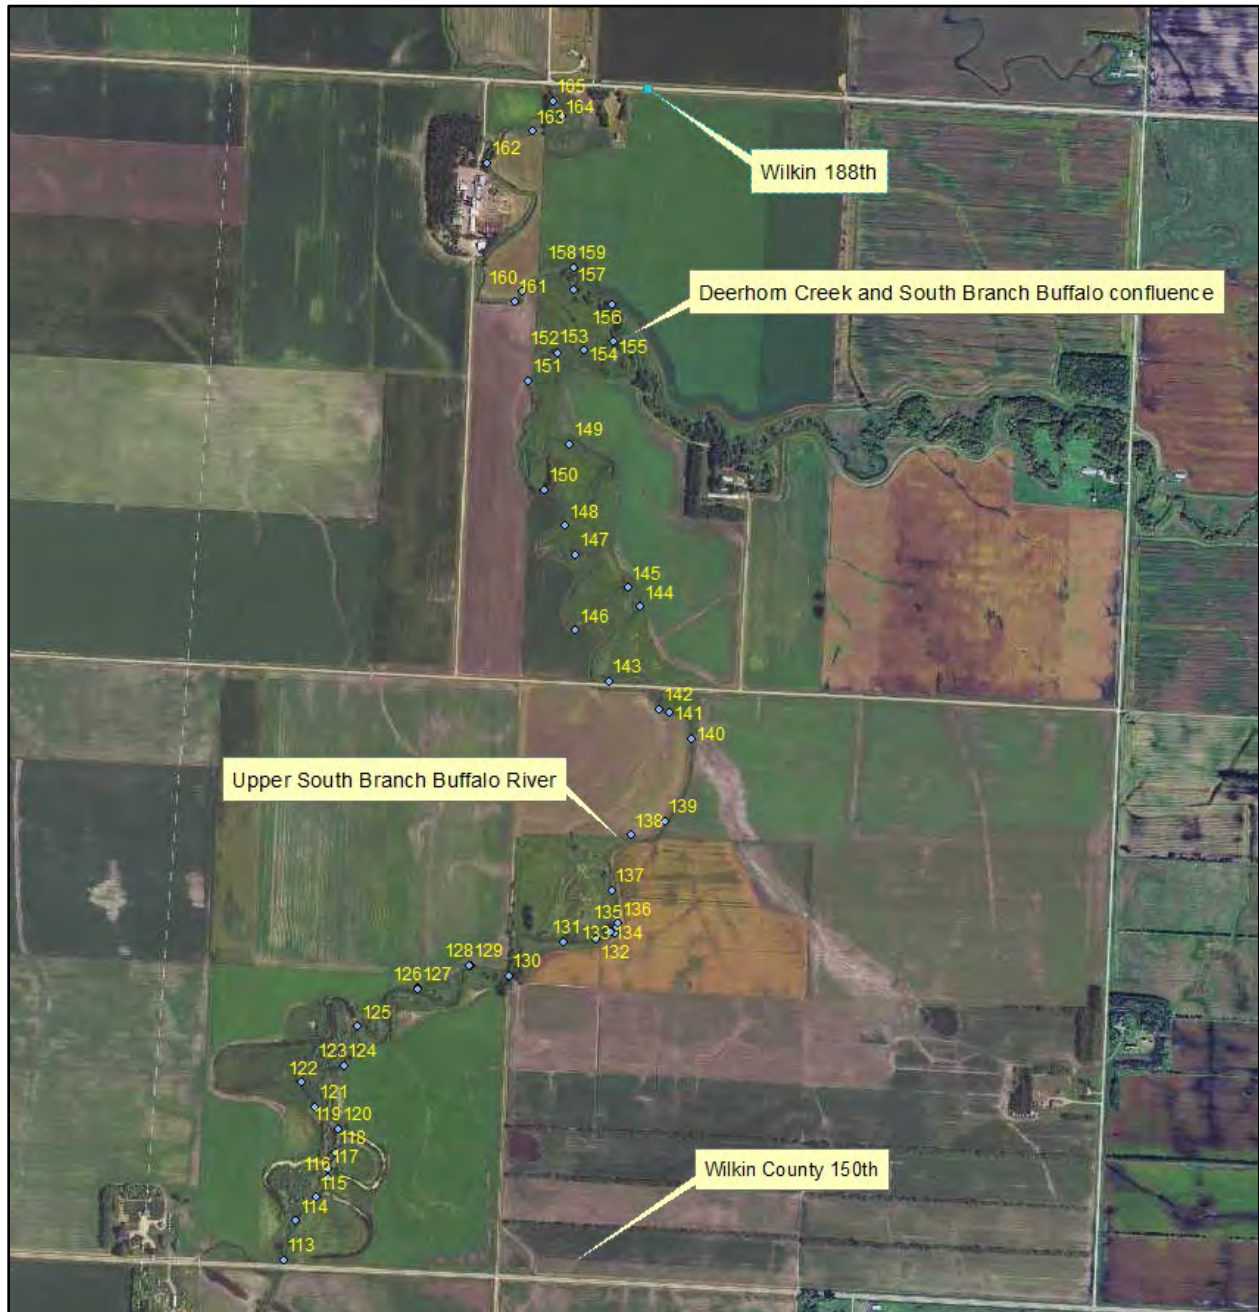
Figure 31. Upper South Branch Buffalo River through Deerhorn Creek confluence.

This reach exhibits very low erosion rates and depositional tendencies from Wilkin County 150th to the confluence of Deerhorn Creek, and then erosion and sediment (various depositional patterns with fine sand particle size) are evident below the confluence of Deerhorn Creek (Figure 31). A field gully at waypoint 140 is contributing a substantial amount of sediment into the South Branch Buffalo River.

Part of the reach has been channelized and meanders have been cut off from waypoint 113 to 125. Opportunities for best management practices include restoration of meanders, improvement of buffers where they are too narrow, and control of sediment from the gully at waypoint 140. Deerhorn Creek, with its 67 square mile drainage area appears to be contributing a substantial amount of fine sediment to the South Branch Buffalo River below the confluence. Stream channel bank erosion increases substantially on the South Branch Buffalo River below the Deerhorn confluence. Altered hydrology and channel enlargements are evident on the South Branch Buffalo River below Deerhorn Creek.

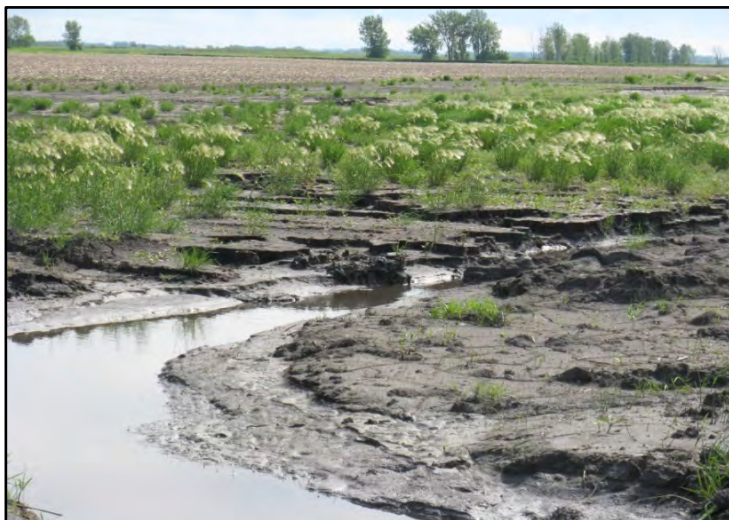
Figure 32. Field source erosion on the Upper South B above Wilkin County 150th.

The Upper South Branch Buffalo River from Wilkin County 150th to the confluence of Deerhorn Creek is relatively stable and well vegetated, but is exhibiting depositional tendencies, indicating an abundant source of fine sediment from upstream. Virtually no bank erosion exists in this reach and for much of the South Branch Buffalo River upstream, so sediment supply is largely field source. Main stressors are altered hydrology and excess fine sediment ([Figure 32](#)).

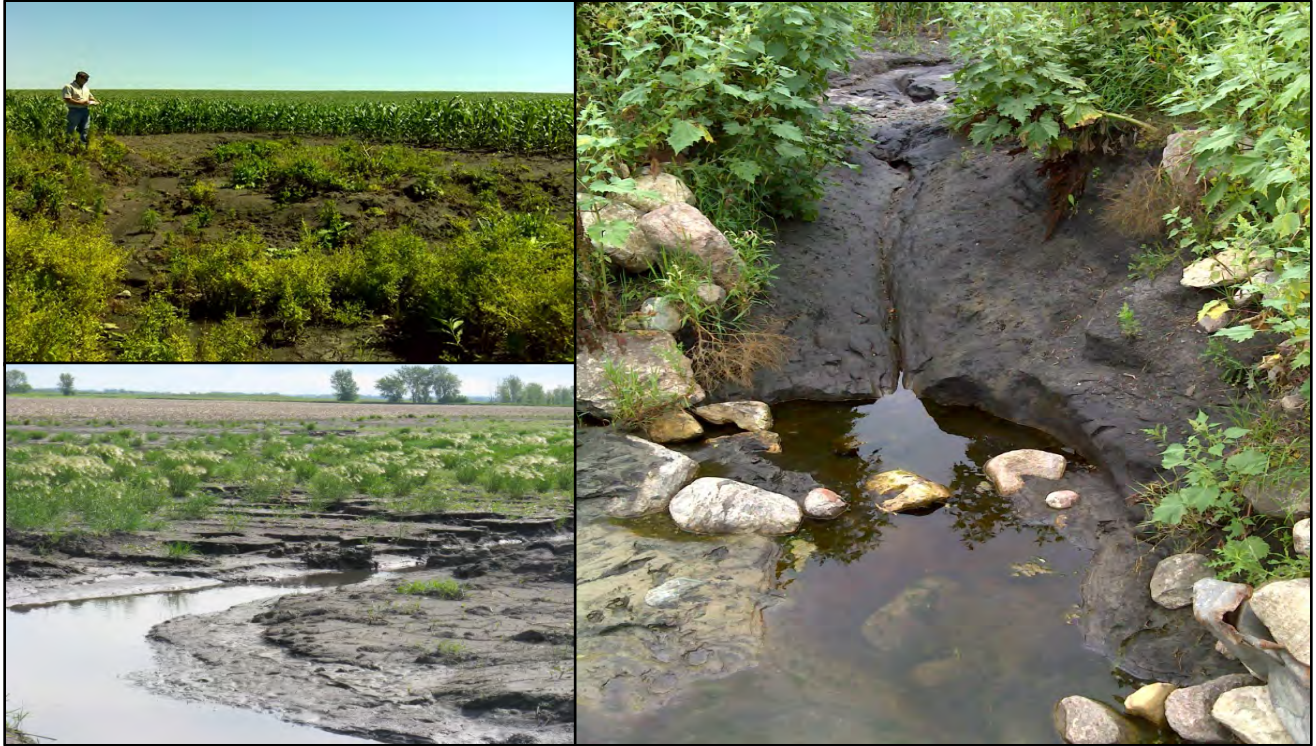
Figure 35. High SPI sites with gully erosion evident.

Field assessments revealed substantial erosion at high SPI sites without adequate vegetation and little or no erosion at sites with adequate perennial vegetation in most cases ([Figure 35](#) and [Figure 36](#)). This revealed how important good perennial cover is as a boundary condition for controlling erosion. A spreadsheet was developed to record conditions at SPI assessment locations ([Table 16](#)). Stream Power Index rating, coordinates, and various key parameters including erosion problems encountered and recommended site-specific best management practices are recorded in that spreadsheet.

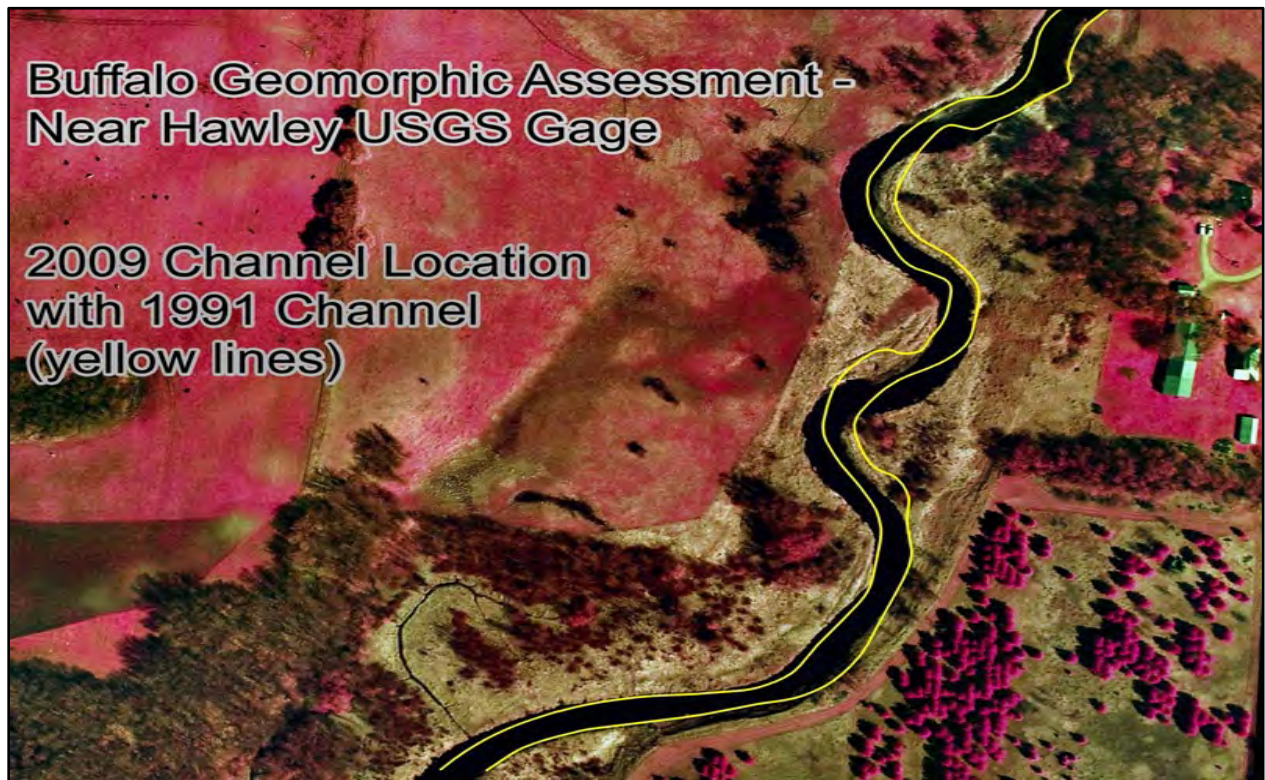
Figure 44. Aerial photography validation of bank erosion rates at the Haugen site.

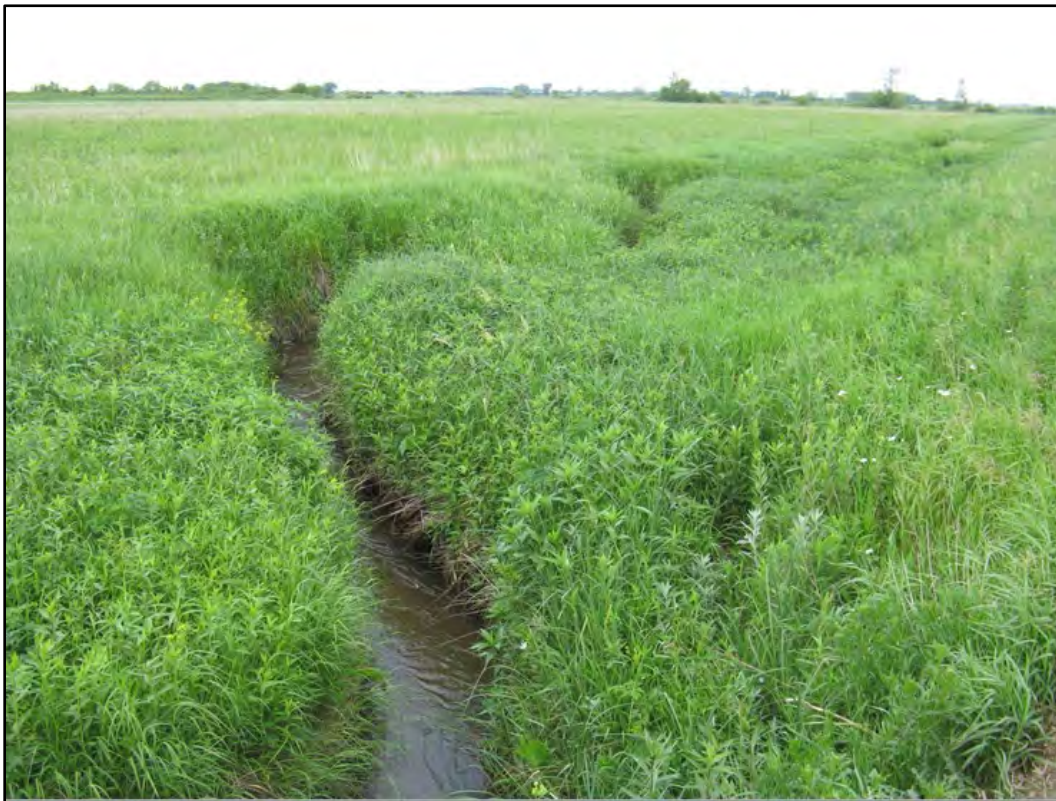
Figure 49. South Branch Buffalo River before ditch repair. Note the rich, diverse riparian vegetation comprised of native grass and forbs.

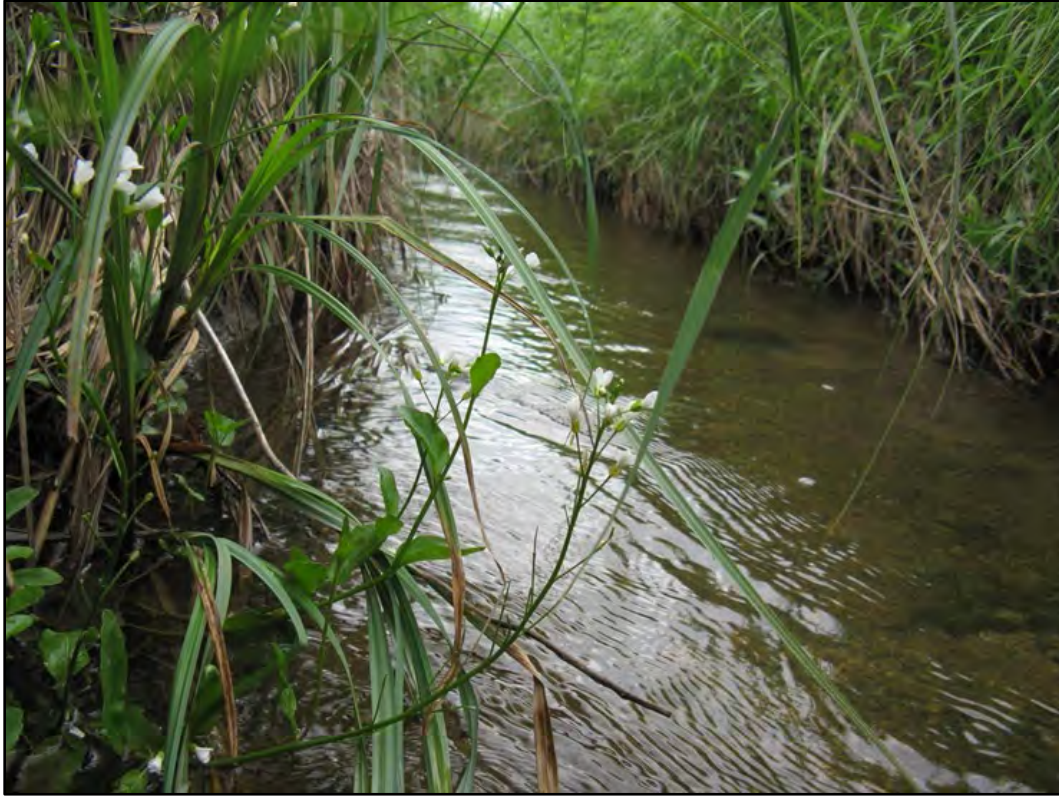
Figure 50. Stable form, native vegetation, gravel substrates, efficient water and sediment transport.

The following figures ([Figures 49 to 57](#)) are in chronological order and tell a story of a ditch law system that is not conducive to long term stream stability, biological health and water quality. Recommendations for implementation strategies include discussions on revising ditch law to fit with the goals of improving water quality, providing storage and reducing biological impairments.

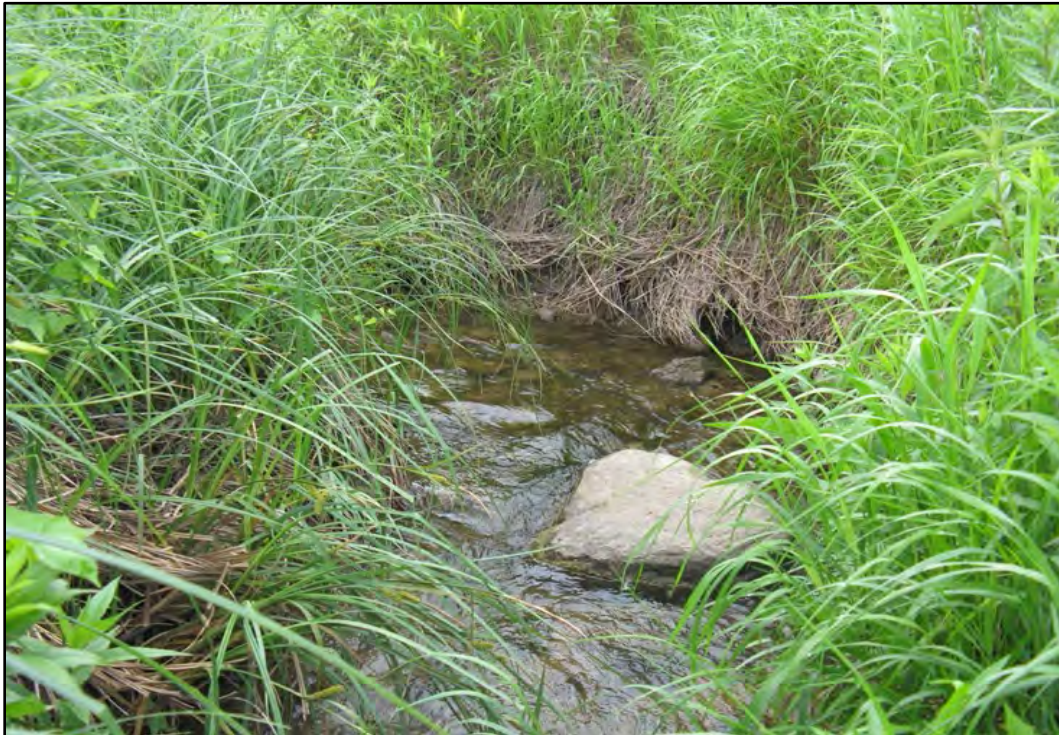
Figure 51. Riffle area with cobble and gravel substrate.

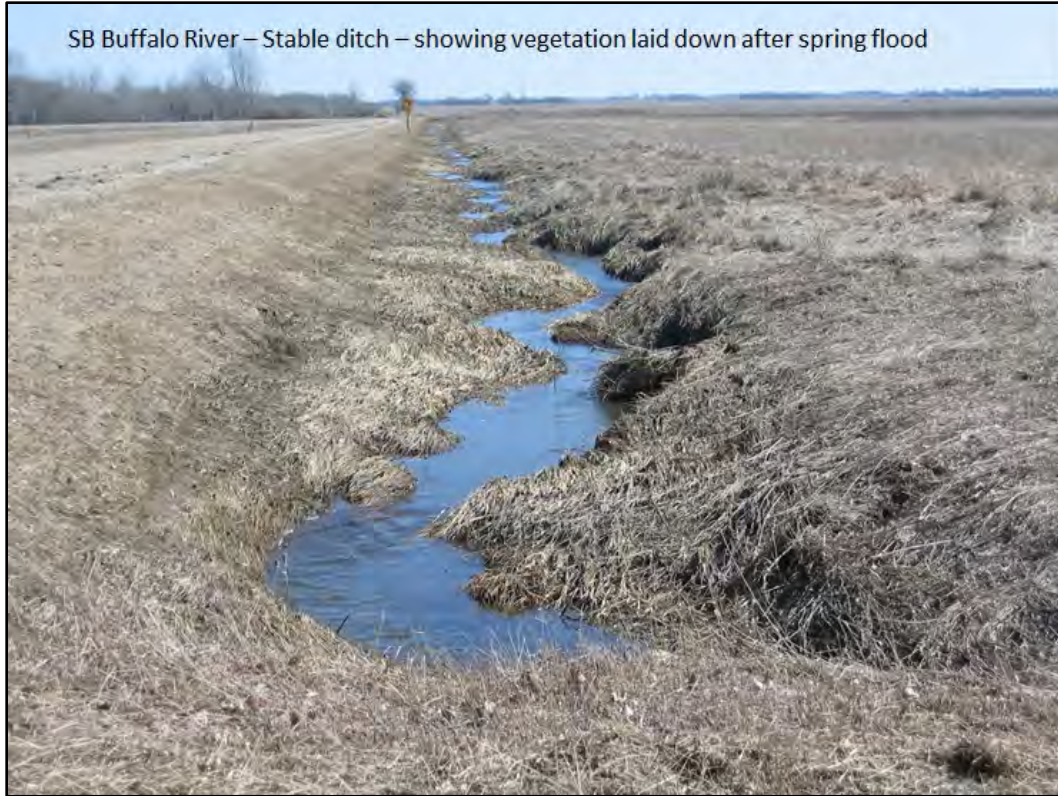
Figure 52. Low flow channel at near bank full. The meander pattern adds storage and reduces velocities.

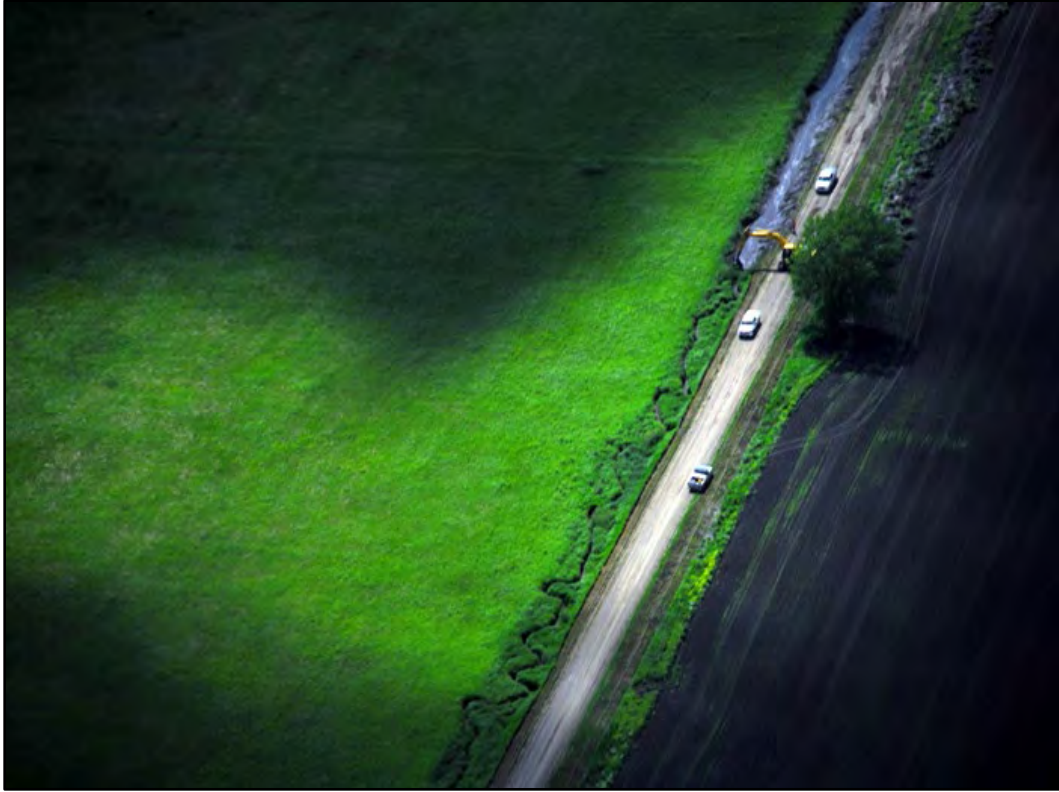
Figure 54. Ditch repair in progress.

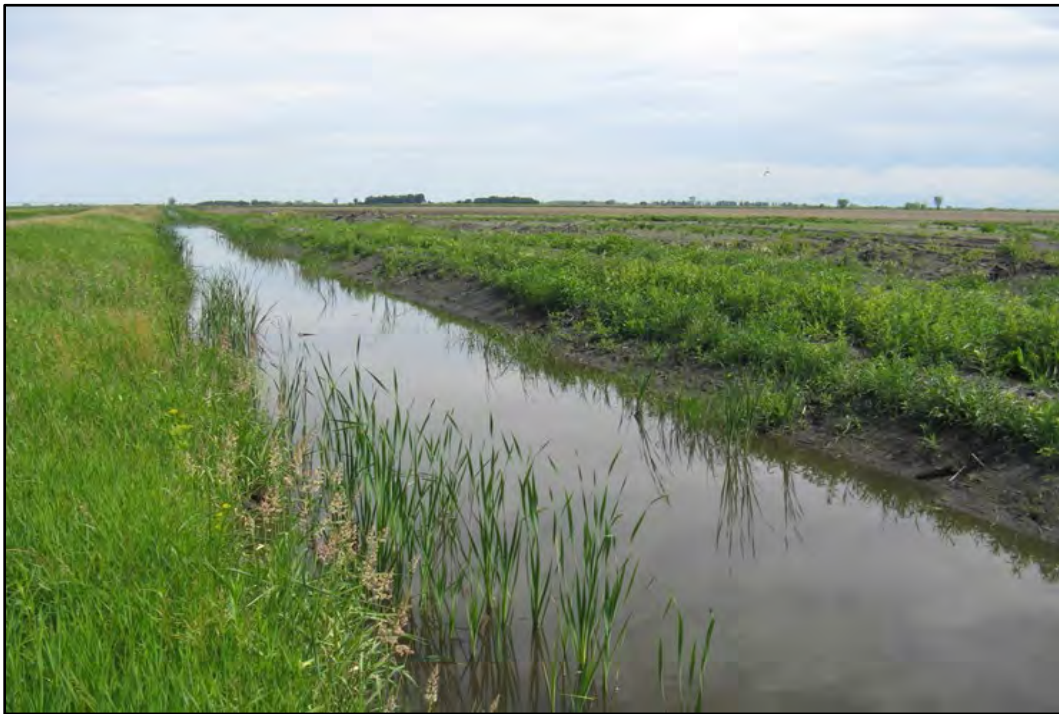
Figure 55. Photo after repair showing high width depth ratio, fine sediment, and cattail colonization.

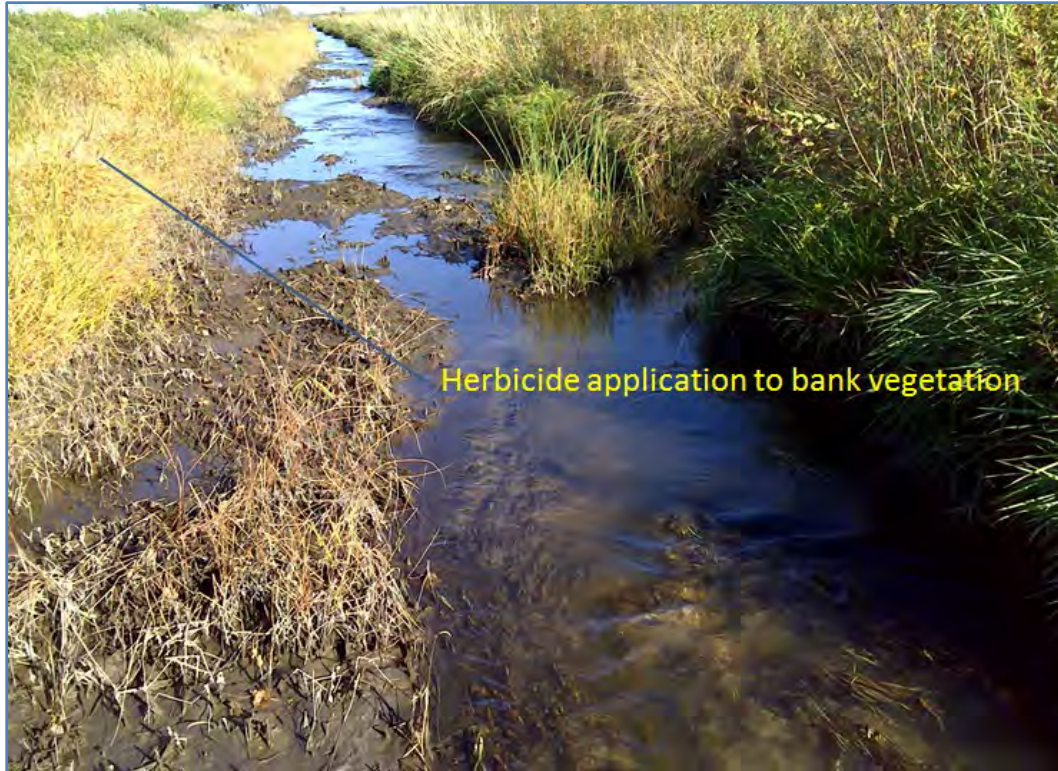
Figure 56. Herbicide application destroying high quality riparian vegetation.

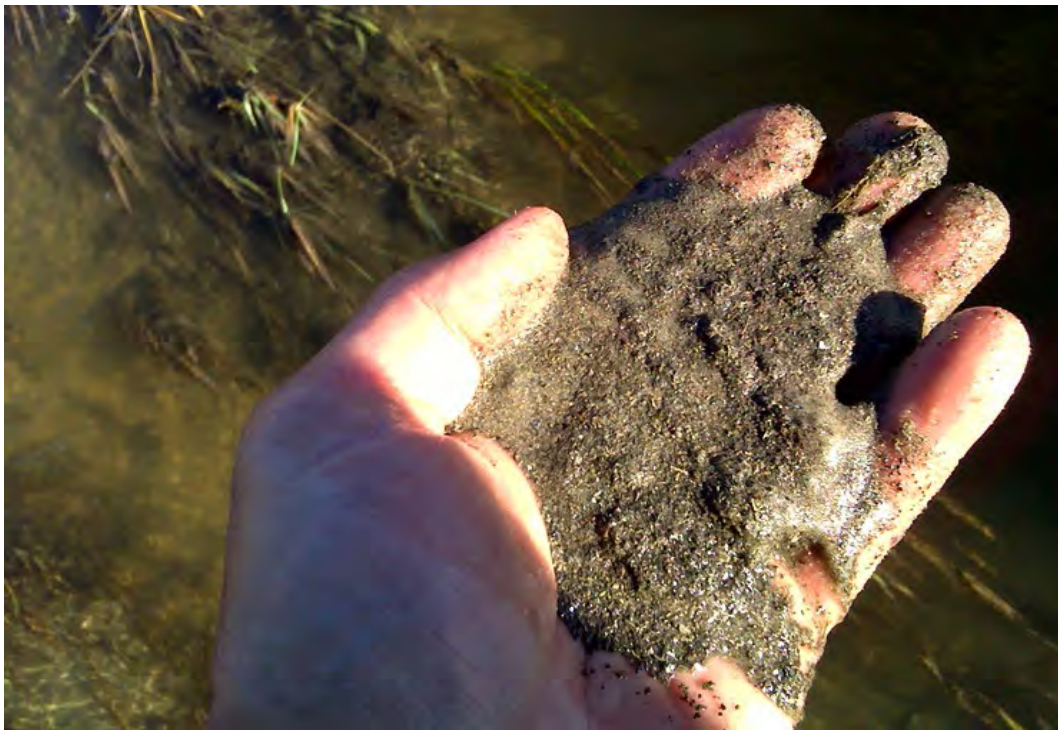
Figure 57. Bottom composed of fine sediment and organic material after cleanout.

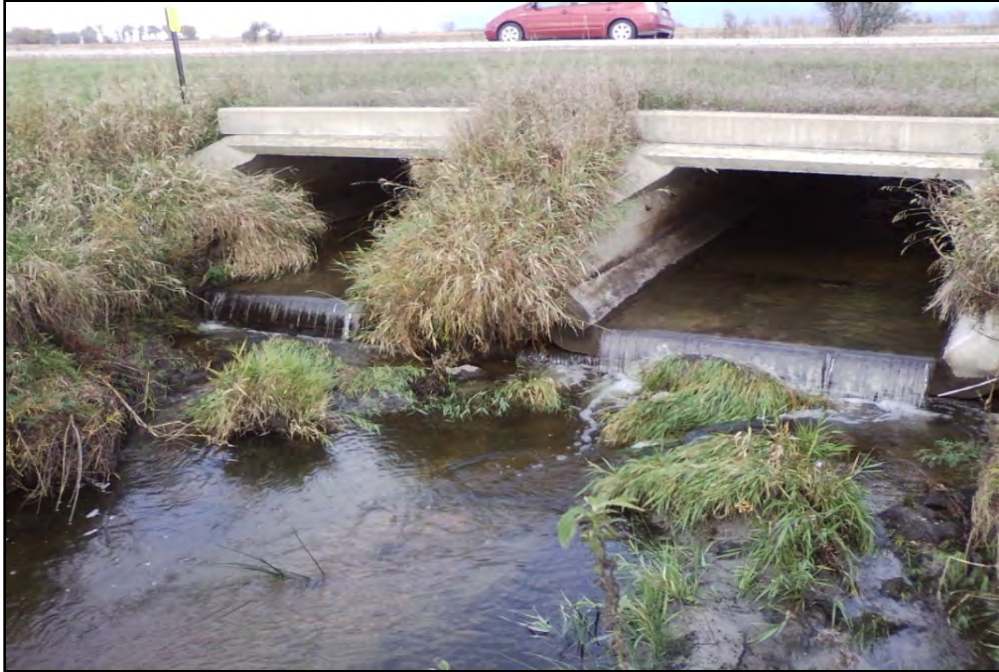
Figure 68. A perched culvert on Deerhorn Creek prevents the upstream migration of fish during low to moderate flow conditions.

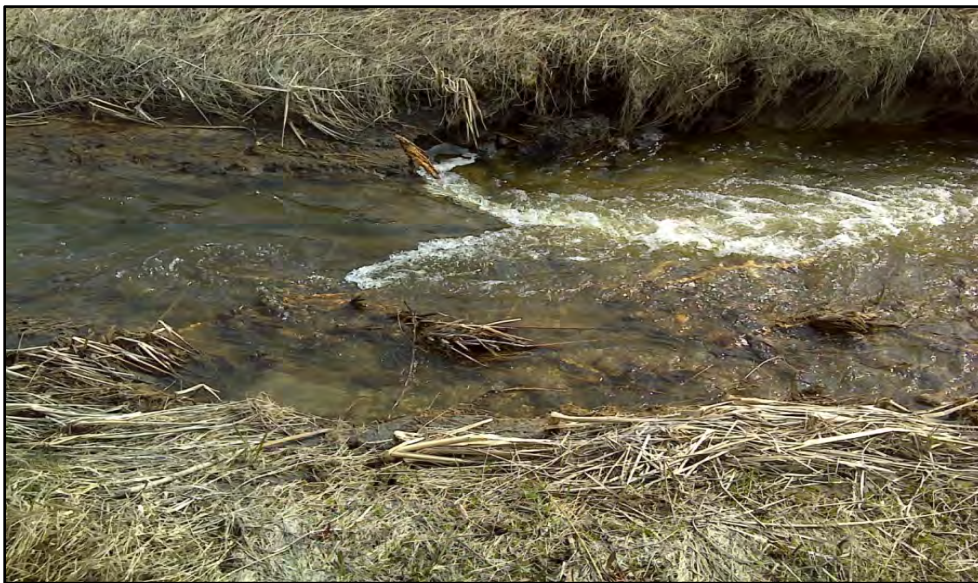
Figure 69. A head-cut in the Buffalo River system works its way upstream by eroding the stream bed.

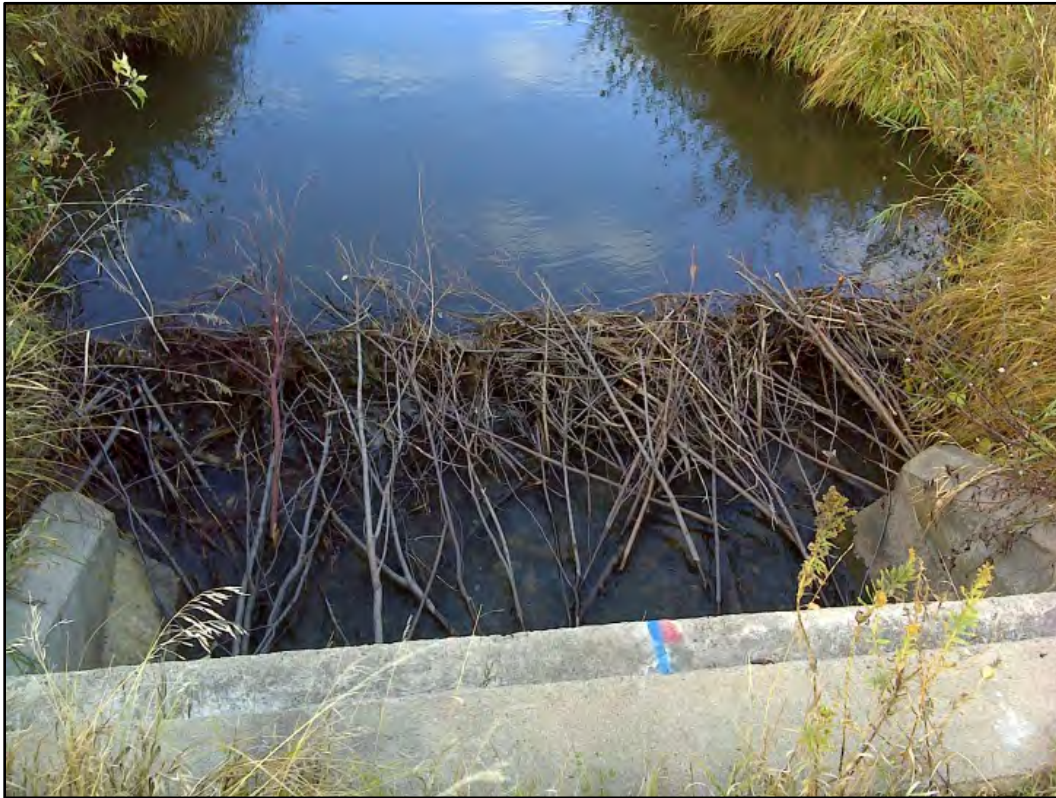
Figure 78. Beaver dam across the inlet of a box culvert found in the Upper Buffalo River.

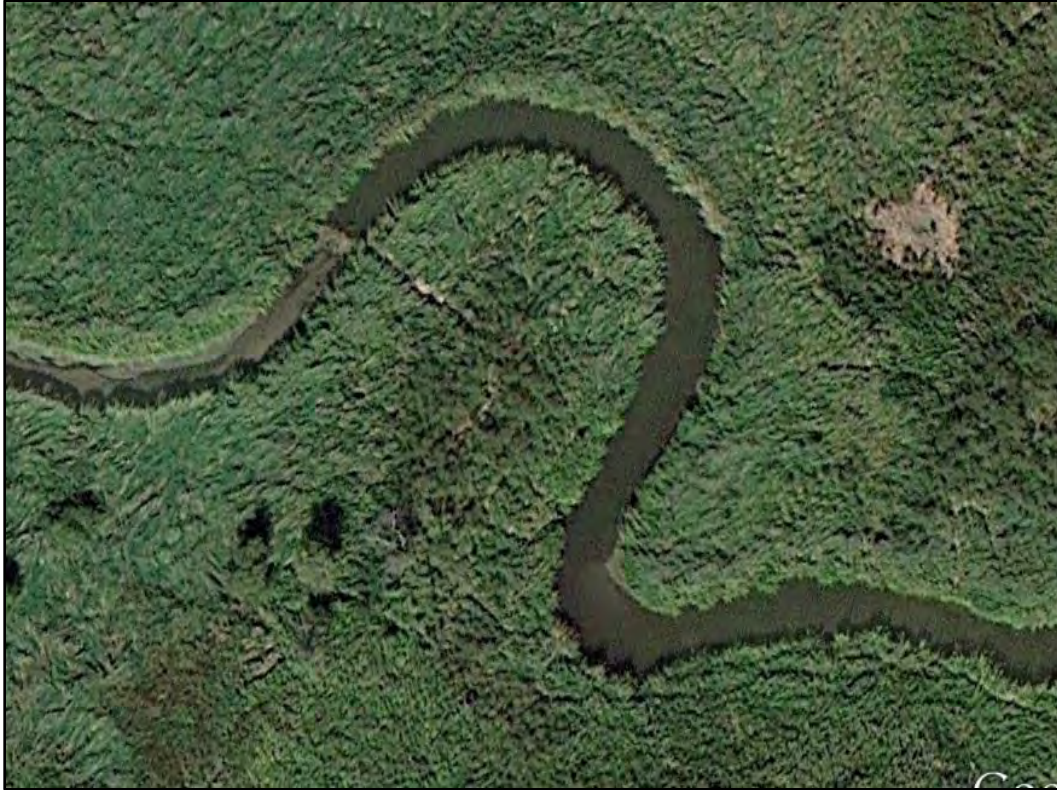
Figure 79. Apparent beaver dam located in the Upper Buffalo watershed. This photo is from Google Earth and was taken on September 5, 2011.

The flow station previously located at Becker CSAH 14 was impacted by a beaver dam in 2010 and 2011 and was relocated upstream to another location that was subsequently impacted by a beaver dam. A Google Earth flyover of the Upper Buffalo Reach found what appear to be as many as 12 beaver dams across the stream. This number is only an estimate as a large portion of the riparian area is forested and is not very visible via Google Earth. One example that appears to be either a beaver dam or some type of diversion dam is located 2.32 miles NW of where the Buffalo River crosses Minnesota Hwy 59 ([Figure 79](#)).

This dam was erected sometime between the Google Earth photos of April 25, 2011 (dam not present) and September 5, 2011. The biological data for this study was collected during 2009 so this particular dam was not a factor in restricting fish movement during 2009 but it shows a representative example of the types of dams present throughout the Upper Buffalo watershed. The photo shows the flooding above the dam as well as the severe low water condition below the dam that would make it very difficult for fish migration.

Connectivity issues are not limited to beaver dams. There are two stream crossings east (upstream) of the beaver dam in [Figure 79](#) (about four miles NW of Callaway) that appear to be perched culverts that are barriers to fish migration. The first is a railroad (RR) crossing located about one third of a mile west of State Hwy 59 and the second is a private field crossing located another 2/3 of a mile downstream (NW) of the RR crossing ([Figure 80](#)). The perched private culverts shown below appear to be the result of a head cut that worked its way upstream following some channelization work that had taken place.

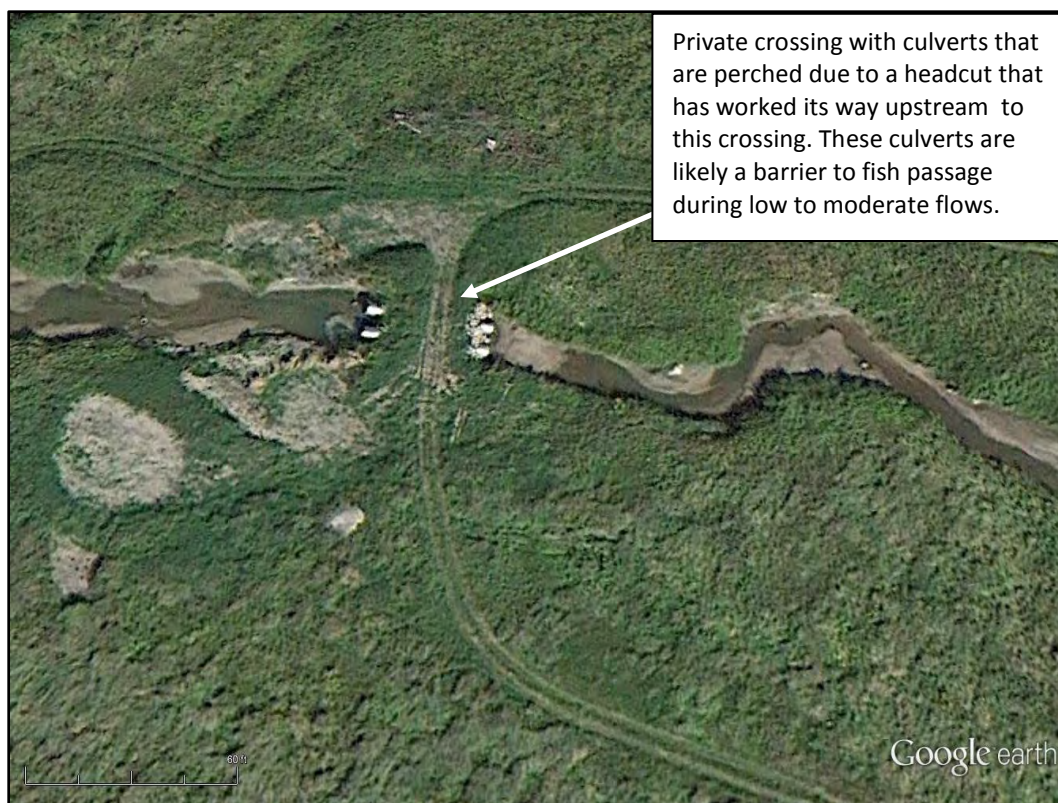
Figure 80. Google Earth photo 9/5/11 showing a pair of culverts on a private stream crossing located about 4 miles NW of Callaway that appear to be perched creating a fish passage barrier.

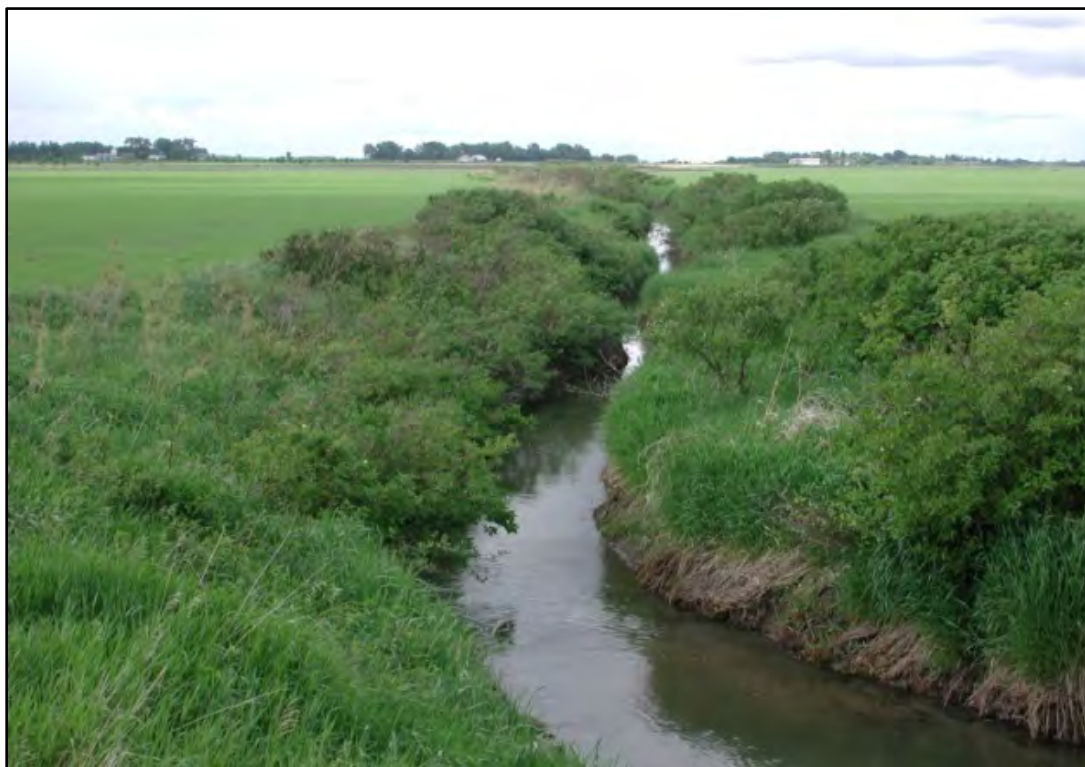
Figure 85. Lawndale Creek with relatively good riparian cover. State WMAs in the watershed along with groundwater springs supply water of good quality and base flow that supports healthy stream biology.

There exist two sites in the upper watershed side of the figure with F-IBI scores above 70. These sites on Judicial Ditch No 32 (09RD034) and Lawndale Creek (a.k.a. State Ditch 14) (09RD048) have extensive wetland and prairie habitat located upstream that contribute base flow to their flow regime. Both sites have the Rothsay State Wildlife Management Area (WMA) contributing good water quality and base flow and Lawndale Creek (Figure 85) has the Atherton WMA natural area and at least two large springs that contribute more than two cubic feet per second (cfs) of groundwater to the stream year-round. These natural areas provide high quality water and consistent flow to these streams and this continual input of flow sustains these streams during dry periods. It is the base flow that sustains these streams during dry periods that is generally missing from most of the other upper watershed sites that have poor F-IBI scores. It should be noted that the site (09RD033) with the third highest ranking IBI score on the upper watershed side of Figure 84 is also connected to the Rothsay WMA and derives base flow benefit and good water quality from it. If these three sites were removed from the chart, the mean F-IBI score for the upper watershed sites would be 11.4 points lower or 29.9.
