Buffalo River Watershed Biotic Stressor Identification

A study of local stressors limiting the biotic communities in the Buffalo River Watershed.

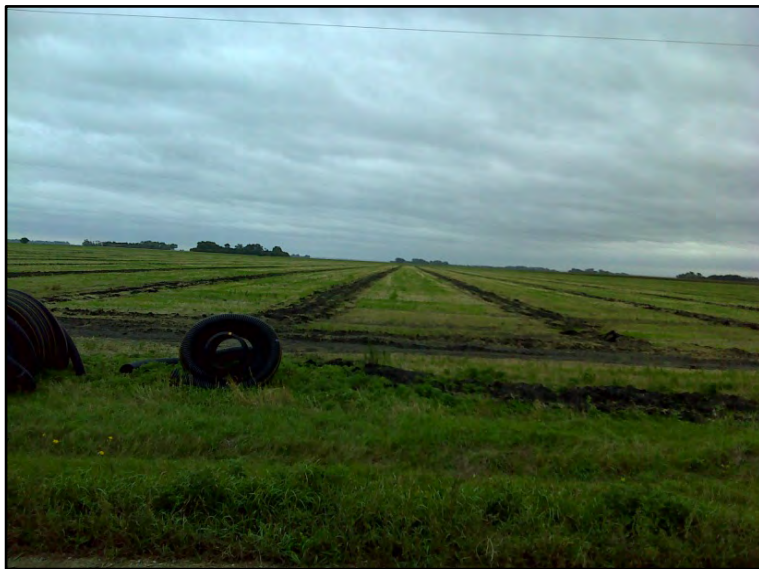
Figure 93. Agricultural tiling has resulted in elevated nitrate levels where it is prevalent in Minnesota and Iowa.

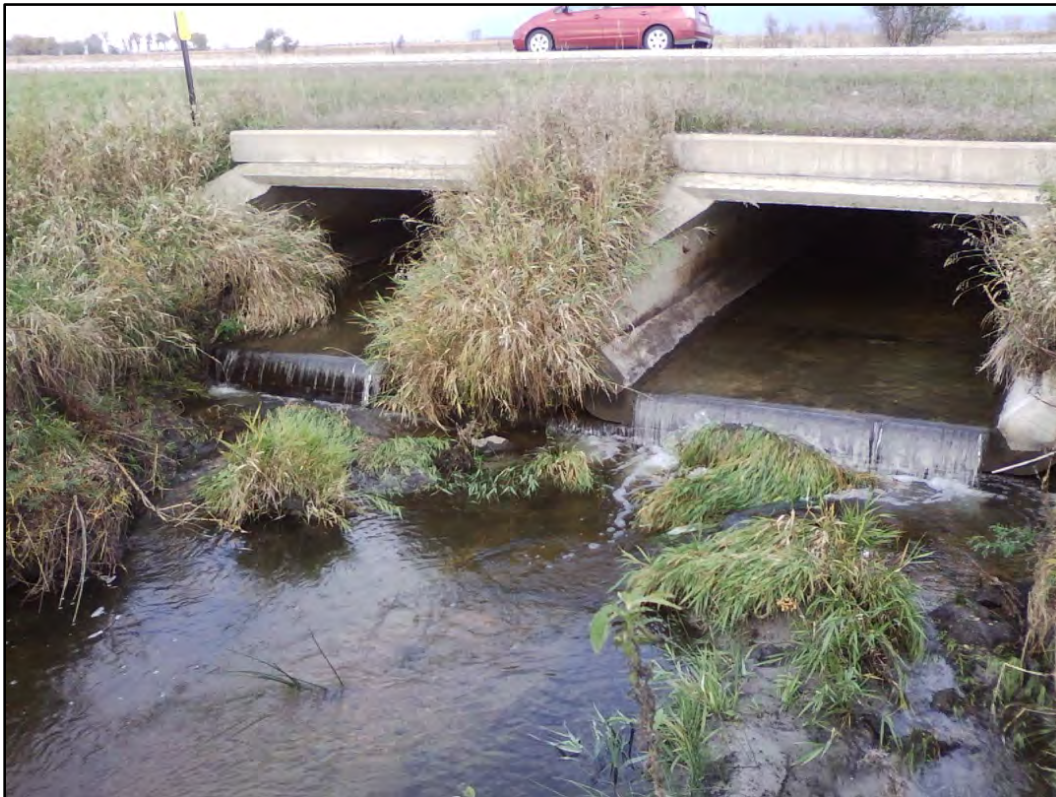
Figure 97. Photo of Deerhorn Creek at the downstream end of box culverts under Wilkin County Hwy 52.

Connectivity problems also exist within Deerhorn Creek as shown in [Figure 97](#). This photo was taken at the downstream end of the box culverts under Wilkin CSAH 52. It shows that the culvert is positioned about 18 inches above the bottom of the stream and about 9 inches above the downstream water level. This perched culvert is a fish migration barrier during low to moderate flows and because of its location on the downstream portion of Deerhorn Creek it affects the fishery of both Deerhorn Creek and Lawndale Creek. There may be other fish migration barriers that have not been identified but based on the two that are discussed above, connectivity is a primary biological stressor on the Deerhorn Creek fishery.

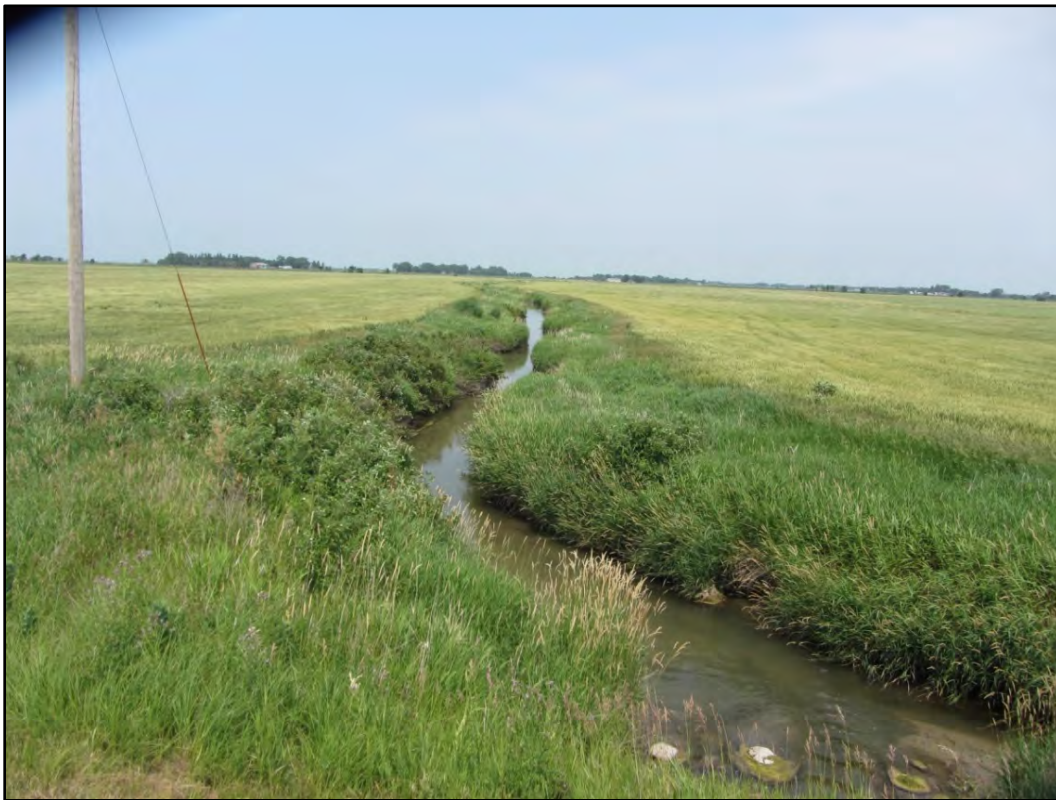
Figure 100. Maintaining adequate riparian buffers on streams and wetlands is critical to the health of the aquatic biology.

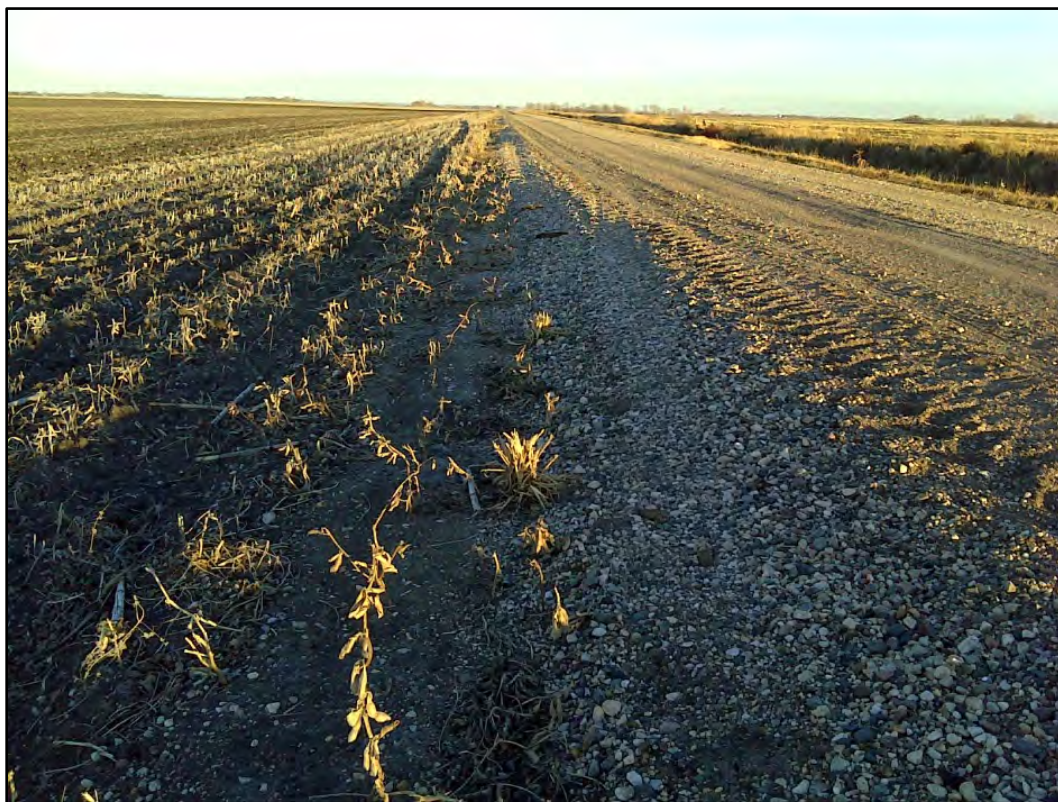
Figure 101. Example of row crop planted within the gravel shoulder of a township road.

The loss of set aside (CRP, CCRP, etc.) land to cultivation is of primary concern. Land enrolled in CRP is typically the more sensitive land within the watershed. Steep slopes, highly erodible soil, wetland, stream and lake riparian fringe and floodplain are the types of land that were preferred for enrollment. Many landowners enrolled into these programs in order to protect surface water from sedimentation, keep hill slopes from further erosion, and to generate steady income from marginal land that produced crops on an inconsistent basis (often unable to plant in the spring due to moisture or summer flooding of crops). High commodity prices, the aggressive use of tile, along with high land rental rates has resulted in many of these sensitive areas being worked up for crop production. The desire to farm as much as possible is demonstrated by [Figure 101](#) that shows cultivation and crop production within the gravel on the shoulder of a township road within the Buffalo River Watershed.
