January 2018

# Wild Rice River Watershed Stressor Identification Report

**Document number:** wq-ws5-09020108a

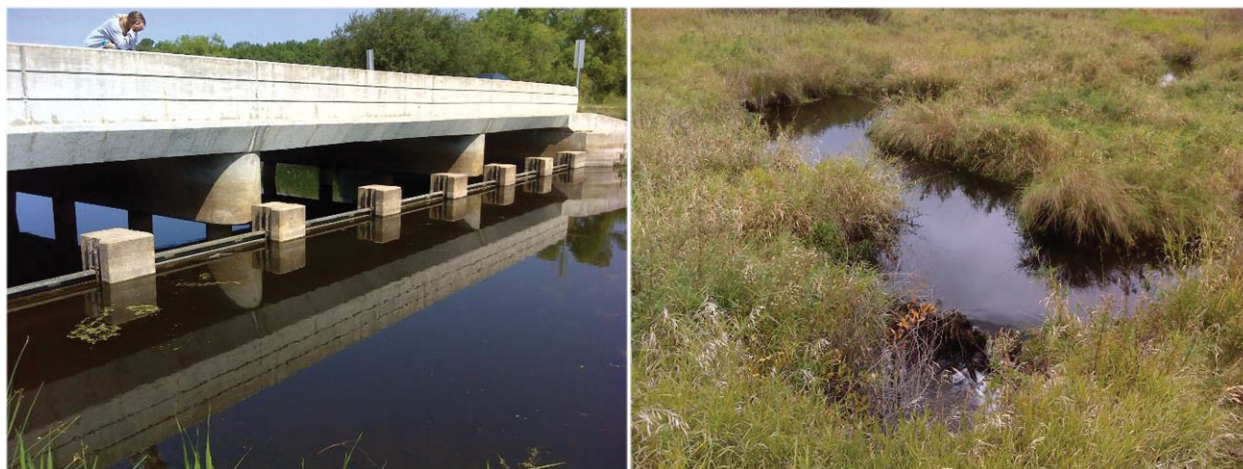
The MPCA biological monitoring staff did not encounter any connectivity-related issues during the sampling of Station 95RD005 along AUID 646. The Lower Rice Lake Dam (Figure 6) is located downstream of the reach on the Wild Rice River, at the outlet of Lower Rice Lake (Dam Drive crossing). The dam is comprised of a series of concrete pillars and adjustable metal gates. The maximum height of the structure is approximately four feet above the downstream water elevation. Depending upon the position of the metal gates, the dam is either a partial or a complete barrier to connectivity. On September 28, 2016, MPCA SID staff conducted a connectivity assessment along the reach. Staff viewed all of the road crossings on the reach as part of the assessment. The remnants of a beaver dam (Figure 6) were noted at the County State Aid Highway (CSAH) 36 crossing. In addition to the assessment, MPCA SID staff performed a detailed review of an April 14, 2015, aerial photo (courtesy of Google Earth) of the reach. No additional connectivity-related issues were identified in the photo. In summary, the Lower Rice Lake Dam interferes with connectivity along the reach.

**Figure 6. Images of potential connectivity barriers along AUID 646, including the Lower Rice Lake Dam at the Dam Drive crossing on July 20, 2017 (left); and a beaver dam upstream of the CSAH 36 crossing on September 28, 2016 (right).**

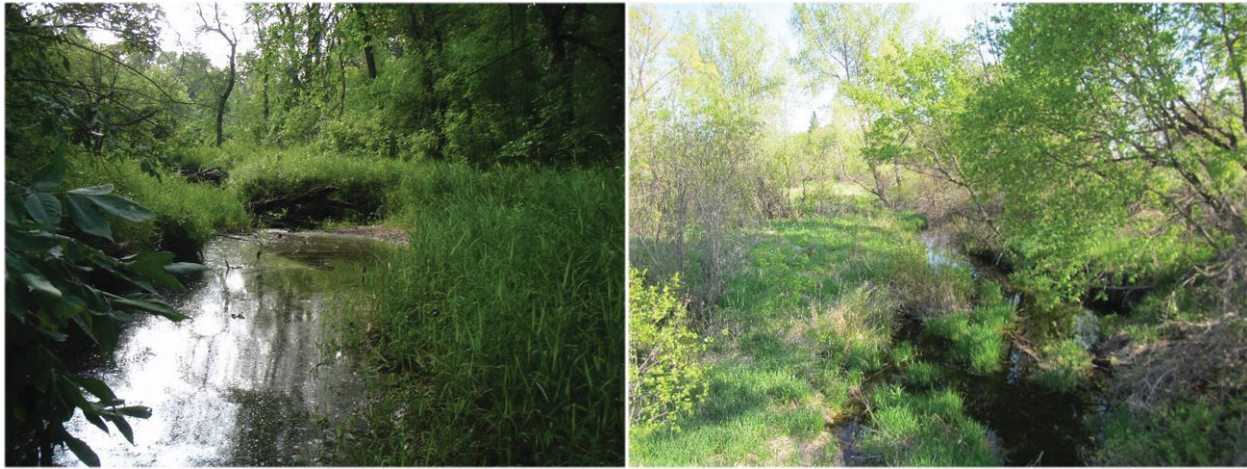
According to the DNR (2003), the reach has an intermittent flow regime. Approximately, 57% of the watercourses in the subwatershed have been physically altered (i.e., channelized, ditched, or impounded), including 56% of AUID 579 (MPCA, 2013). The MPCA biological monitoring staff was unable to sample Station 14RD037 on August 4, 2014 due to the absence of flow (Figure 17). Additionally, staff encountered stagnant conditions at Station 14RD037 during a May 17, 2016, reconnaissance visit (Figure 17); a beaver dam was noted upstream. There is no flow monitoring data for the reach. The USGS (2016) estimated that the normal range of flow values for the reach at its outlet was 0.2 (Q25) to less than 0.1 (Q75) cfs. Additionally, the estimated median flow (Q50) was less than 0.1 cfs, while the projected Q5 flow was 6.3 cfs and the Q95 flow was less than 0.1 cfs. The Q25 to Q75 flow values ratio was 35:1, which is high and indicative of a flashy system that is highly influenced by runoff. By comparison, several of the more hydrologically stable rivers in the Red River Basin (i.e., Buffalo River, Clearwater River, and Otter Tail River) had a ratio of 7:1 or less. The MPCA SID staff conducted reconnaissance along the reach on four separate dates (i.e., August 4, 2016, August 19, 2016, September 1, 2016, and September 14, 2016) and documented flow conditions. Minimal flow (≈0.1 cfs)

was noted along the upstream extent of the reach (i.e., at and upstream of the 260<sup>th</sup> Avenue crossing) on September 14, 2016. Overall, the available data suggest that the reach is prone to extended periods of minimal to no flow.

**Figure 17. Images of stagnant conditions at Station 14RD037 along AUID 579 on August 4, 2014 (left) and May 17, 2016 (right).**

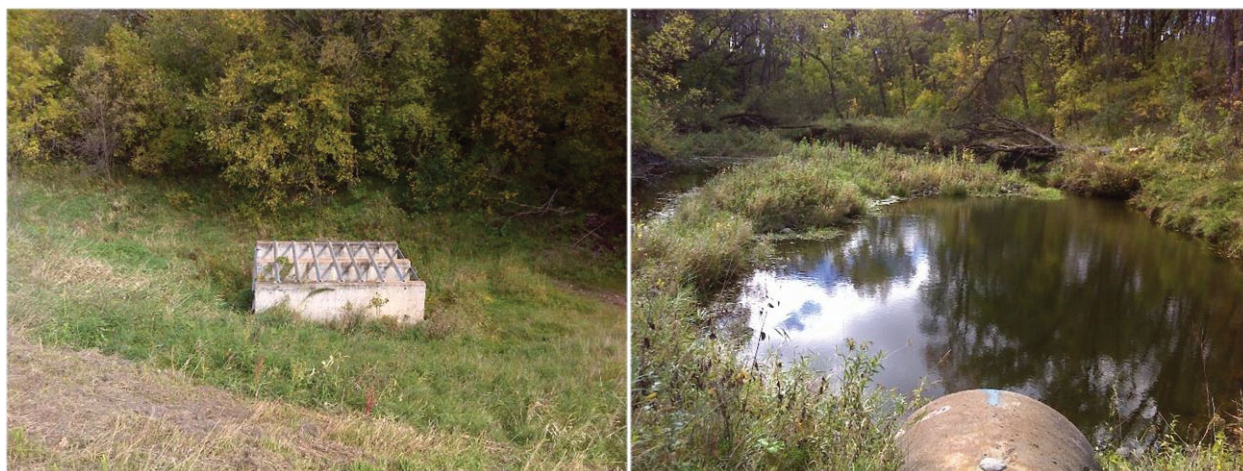
The MPCA biological monitoring staff did not encounter any connectivity-related issues during the sampling of Stations 05RD114, 14RD014, and 14RD034 along AUID 650. According to the DNR (2014), the Mashaug Creek No. 10 Dam (Figure 21) is located at the CSAH 34 crossing, near the upstream end of the reach. The dam, which is jointly owned and operated by Norman County and the WRWD, is a 30-foot high earthen structure that was completed in 1984 for the purpose of flood control. The dam is a complete barrier to connectivity at all flow conditions. On September 28, 2016, MPCA SID staff conducted a connectivity assessment along the reach. Staff viewed all of the road crossings on the reach as part of the assessment. No additional obstructions to connectivity (e.g., perched culvert and beaver dam) were identified. In addition to the assessment, MPCA SID staff performed a detailed review of an April 14, 2015, aerial photo (courtesy of Google Earth) of the reach. No additional connectivity-related issues were identified in the photo. In summary, the Mashaug Creek No. 10 Dam is the only known barrier to connectivity along the reach.

Figure 21. Images of the Mashaug Creek No. 10 Dam on September 28, 2016, including the intake structure (left) and the outflow pipe (right).

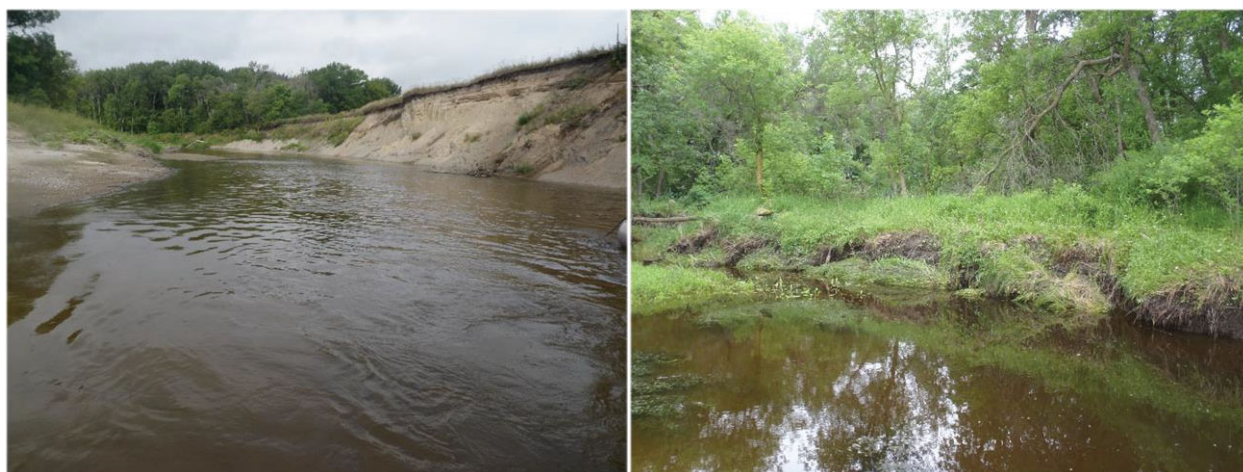
indicate that the deposition of excess fine sediment caused the “moderate” level of embeddedness of coarse substrate documented at Stations 14RD014 and 14RD034. Figure 24 shows images of streambank instability along the reach. Overall, the available data suggest that the reach experiences at least occasional periods of high suspended sediment.

**Figure 24. Images of bank instability along AUID 650, including Station 95RD014 on August 21, 2014 (left) and Station 14RD034 on June 24, 2014 (right).**

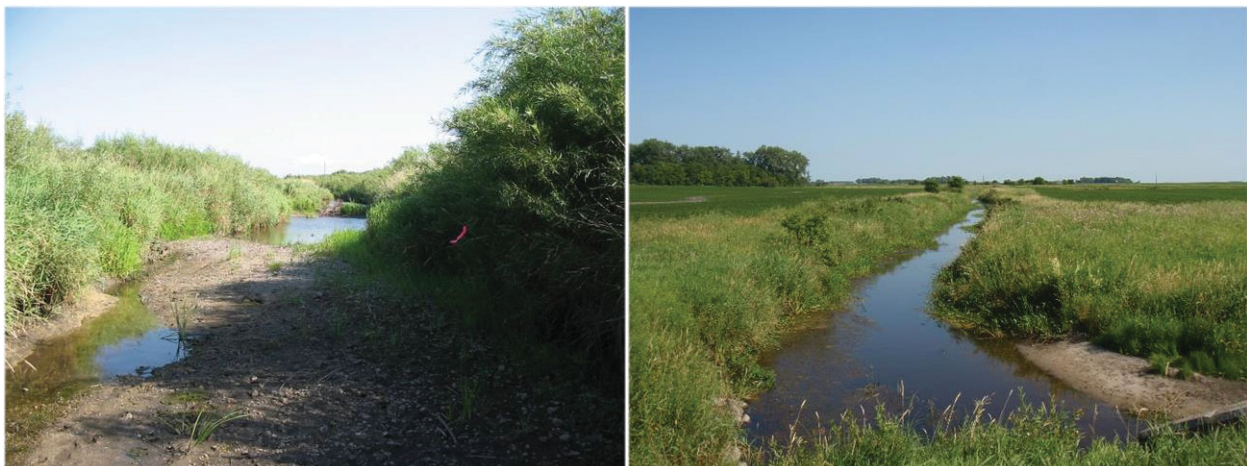
According to the MPCA (2013), 66% of the watercourses in the subwatershed have been physically altered (i.e., channelized, ditched, or impounded), including the entire length of AUID 661. The MPCA biological monitoring staff noted intermittent conditions at Station 07RD028 on August 6, 2007 (Figure 27). Additionally, staff was unable to sample Station 14RD081 on August 4, 2014 (Figure 27) and August 27, 2014 due to the absence of flow. There is no flow monitoring data for the reach. The USGS (2016) estimated that the normal range of flow values for the reach at its outlet was 6.3 (Q25) to 0.5 (Q75) cfs. Additionally, the estimated median flow (Q50) was 1.7 cfs, while the projected Q5 flow was 65.6 cfs and the Q95 flow was 0.1 cfs. The Q25 to Q75 flow values ratio was 12:1, which is indicative of a relatively hydrologically stable system. By comparison, several of the more hydrologically stable rivers in the Red River Basin (i.e., Buffalo River, Clearwater River, and Otter Tail River) had a ratio of 7:1 or less. The MPCA SID staff conducted reconnaissance along the reach on four separate dates (i.e., August 4, 2016, August 11, 2016, August 24, 2016, and September 14, 2016) and documented flow conditions. Minimal flow ( $\approx 0.1$  cfs) was noted at the CR 157 crossing on August 24, 2016. Overall, the available data suggest that the reach is prone to extended periods of minimal to no flow.

**Figure 27. Images of intermittent/stagnant conditions along AUID 661, including Station 07RD028 on August 6, 2007 (right); and Station 14RD081 on August 4, 2014 (left).**

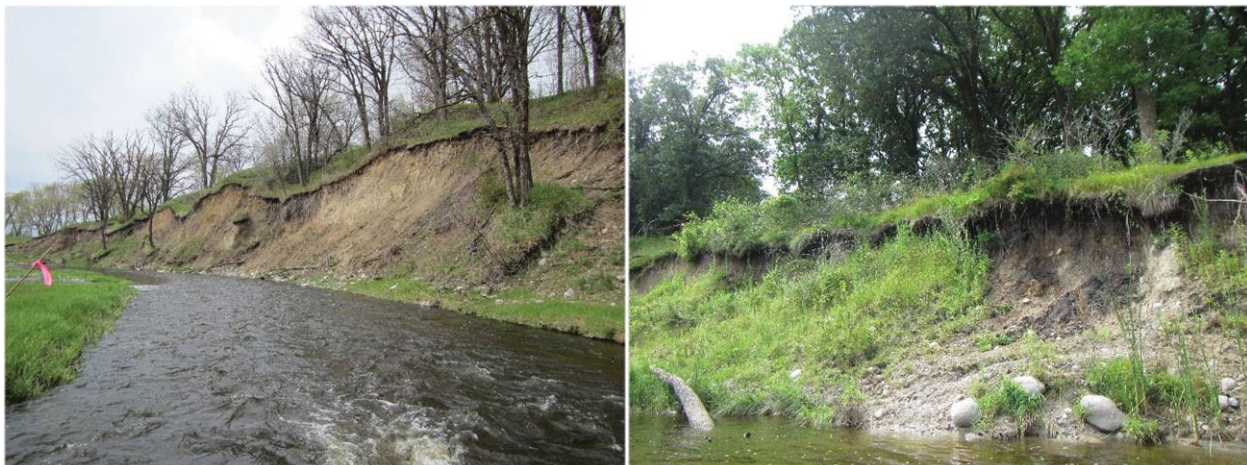
**Figure 33. Images of bank erosion at Station 94RD012 along AUID 650 on May 19, 2014 (left) and July 24, 2014 (right).**

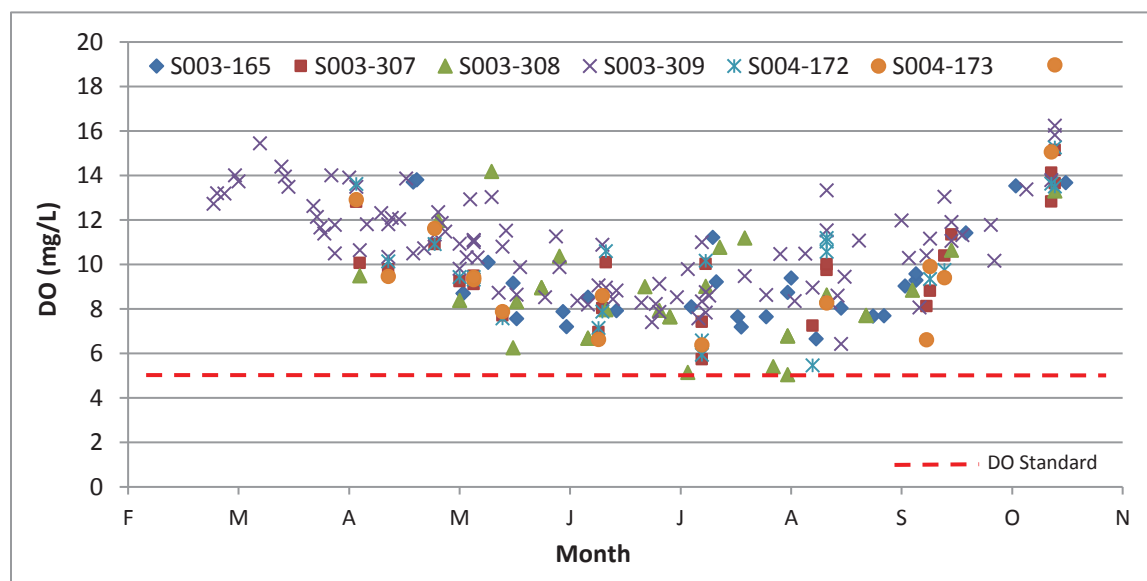
**Figure 34. Discrete DO data for Sites S003-165, S003-307, S003-308, S003-309, S004-172, and S004-173 along AUID 662.**

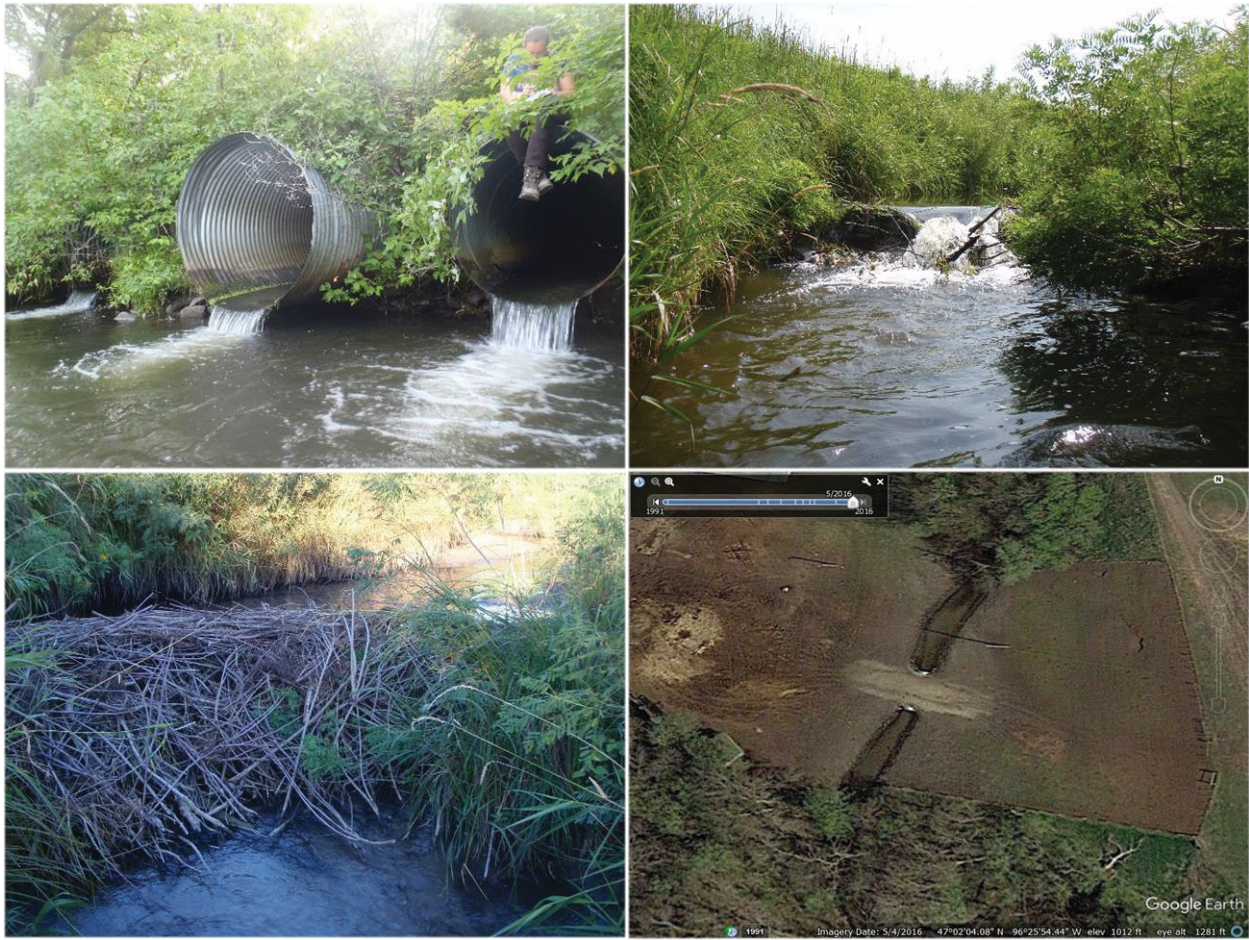
**Figure 38.** Images of connectivity-related issues associated with AUID 654, including perched culverts at the 170<sup>th</sup> Street North crossing on August 7, 2014 (upper left); the remnants of a beaver dam at Station 14RD046 on August 5, 2014 (upper right); a beaver dam at Station 15RD035 on September 8, 2015 (lower left); and a private road crossing upstream of the 170<sup>th</sup> crossing on May 4, 2016 (lower right), courtesy of Google Earth.

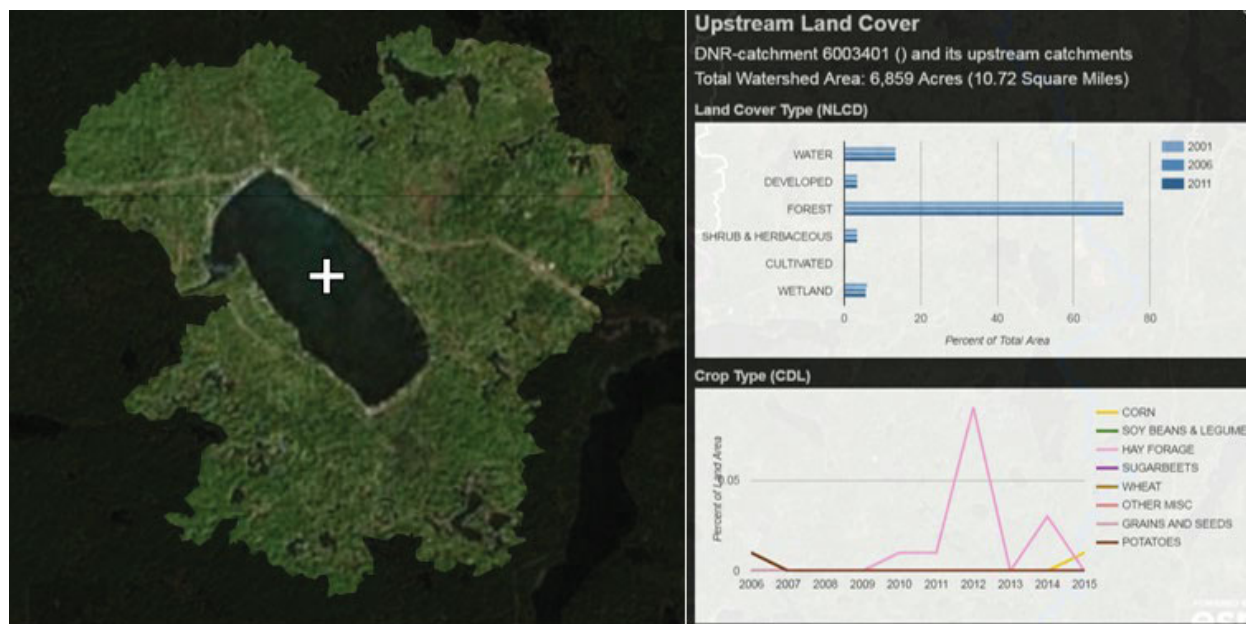
Often we observe changes to the fish community from land use practices in the upstream contributing watershed away from the lake, but this appears to be unlikely as a major contributor to the impairment on Tulaby Lake. Tulaby is a headwater lake with only about 3% of contributing land use classified as disturbed. The contributing watershed has a watershed to lake size ratio of about 8:1. Watershed land cover remained stable between 2001 and 2011 based on National Land Cover Datasets (WHAF, 2016). Land cover within the watershed is primarily forest (73%). The remaining undeveloped land is a combination of open water (14%), wetlands (6%), and shrub or grassland (4%). Residential and commercial development (3%), including paved and unpaved roads, account for the remaining land cover within the watershed and is primarily located directly on the lakeshore. Less than 1% of land is in cultivation, including a small amount of grains and corn in recent years. This low level of disturbance

within the contributing watershed is significantly lower than where we typically observe impacts to the FIBI.

Figure 3.2. Contributing watershed for Tulaby Lake and land cover within the upstream catchments (WHAF, 2016).
