# Clearwater River Watershed Stressor Identification Report

A study of stressors limiting the aquatic biological communities in the Clearwater River Watershed

Minnesota Pollution Control Agency

March 2017

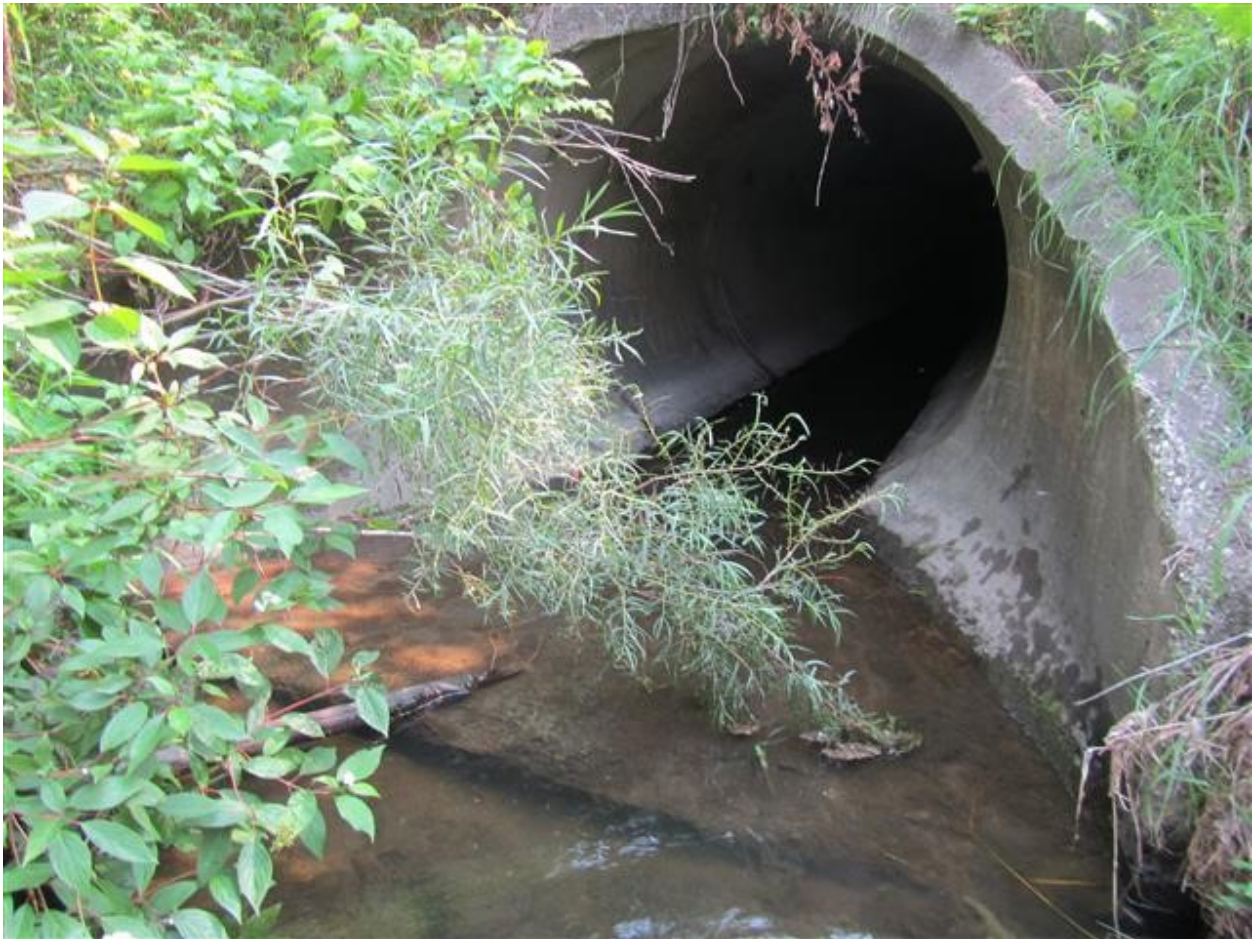
**Figure 8: Picture of culvert at road crossing on 200<sup>th</sup> Street SE on County Ditch 23, showing less than 0.10 feet of water.**

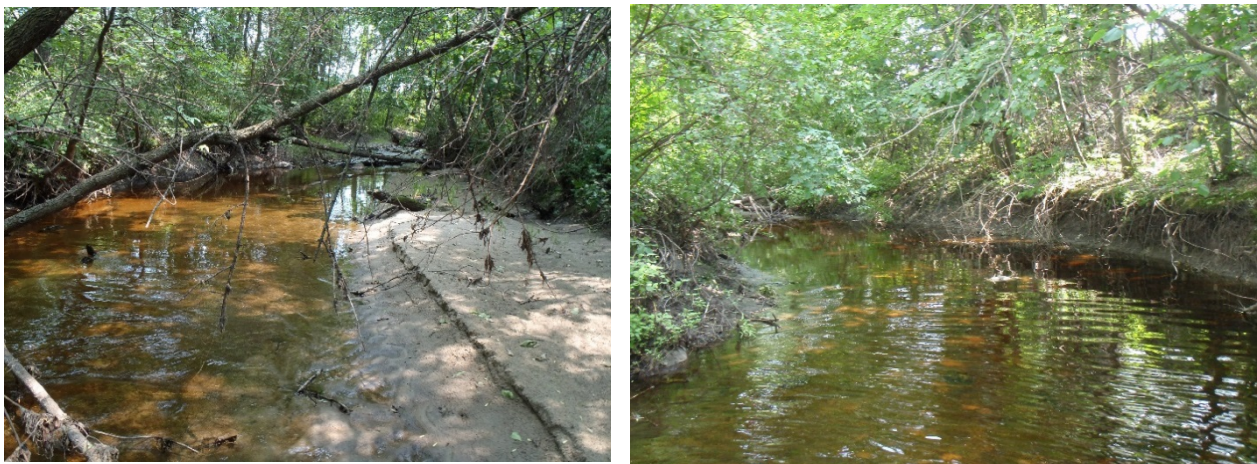
**Figure 14: Pictures of Beau Gerlot Creek stream channel, taken in July of 2014, showing excessive in-channel deposition (left) and entrenchment (right).**

The modeled HSPF data, the measured continuous discharge data, and pictures of the channel (Figure 14) all indicate that this AUID suffers from a lack of baseflow and has a highly unstable channel due to flow regime alteration. To further characterize the stability of this channel, the DNR Clean Water Specialists performed multiple geomorphologic surveys and assessments, such as Pfankuch and Rosgen assessments. Based on the entrenchment ratios (~1.5) measured at various locations along AUID 652, the channel is highly entrenched. The high entrenchment ratio means that flood flows cannot reach the floodplain, which increases the shear stress on stream banks and causes bank erosion. A Pfankuch inventory of the stream reach near station 14RD255 resulted in a stability rating of 95, which is moderately unstable for this stream type (type C4). The Pfankuch stability rating looks at three stream channel zones: the upper bank, the lower bank and stream bottom. Each zone analyzed had at least one subcategory that was rated poor. In the upper bank zone, bank slope was greater than 60% and there was a high potential for debris jams. The lower bank zone had significant bank cuts of 12-24 inches in height. The stream bottom also scored poorly in the category of scour and deposition; nearly 50% of the channel bottom is affected by scour or channel deposition. The DNR survey indicated that the reach was lacking in pool depth and holding cover. Aerial photos show that there also are localized areas where stream banks have been damaged by livestock. While the final results of the geomorphologic surveys conducted by DNR will be published with this report at a later date, we can use some of the preliminary information to conclude that Beau Gerlot Creek has an unstable stream channel due to flow alterations, which are stressing the biological communities.

Upstream of AUID 652, Beau Gerlot Creek has been channelized (AUID 651). The drainage improvements have most likely increased the flashiness of flows in the watershed. Increased peak flows from the channelized portion are likely contributing to instability along the natural channel, particularly within the well-buffered portions. The Red Lake County Ditch 2 system, constructed in 1901, forms the headwaters of Beau Gerlot Creek. LiDAR data and faint meander scars indicate that the system may have diverted water north (near 47°46'44.63"N. & 96° 8'18.85"W) into Beau Gerlot Creek that would have (historically) continued to flow west into Lower Badger Creek. If this is the case, the natural drainage area of Beau Gerlot Creek would have been increased by an estimated 18.84 mi<sup>2</sup>, which would increase flows to the channel and overcome its natural ability to maintain baseflow.

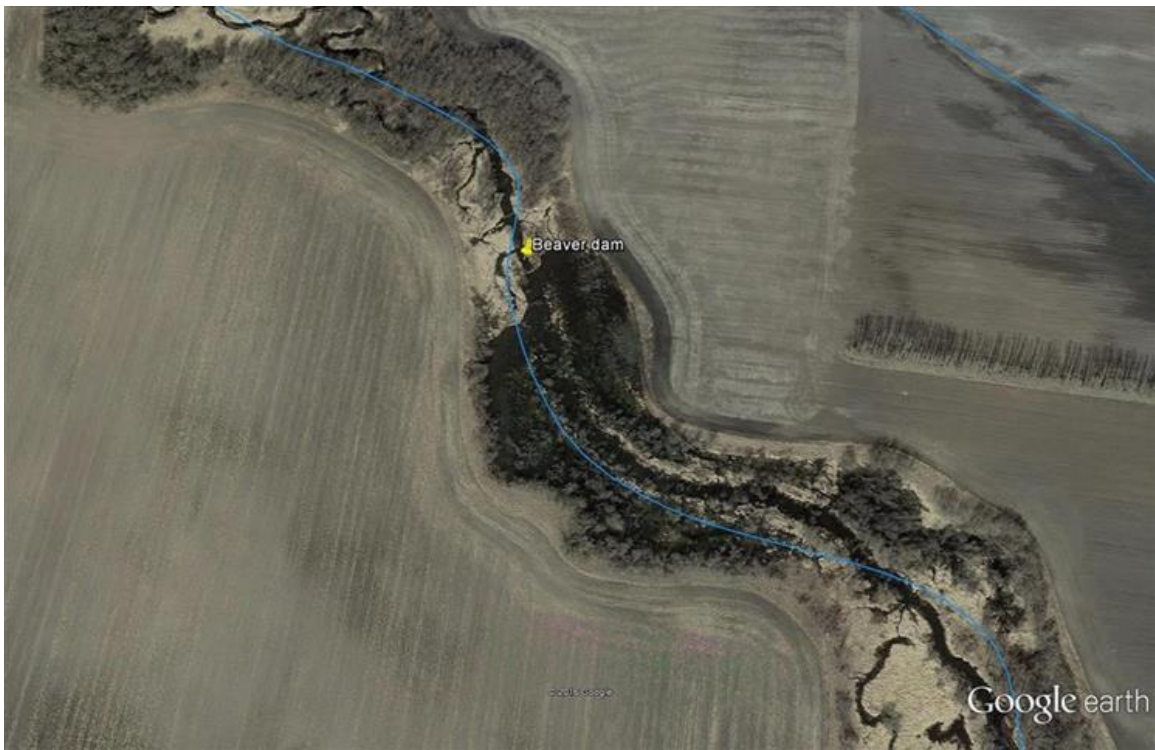
**Figure 16: Beaver dam on Beau Gerlot Creek. Imagery taken on 4/14/2015.**

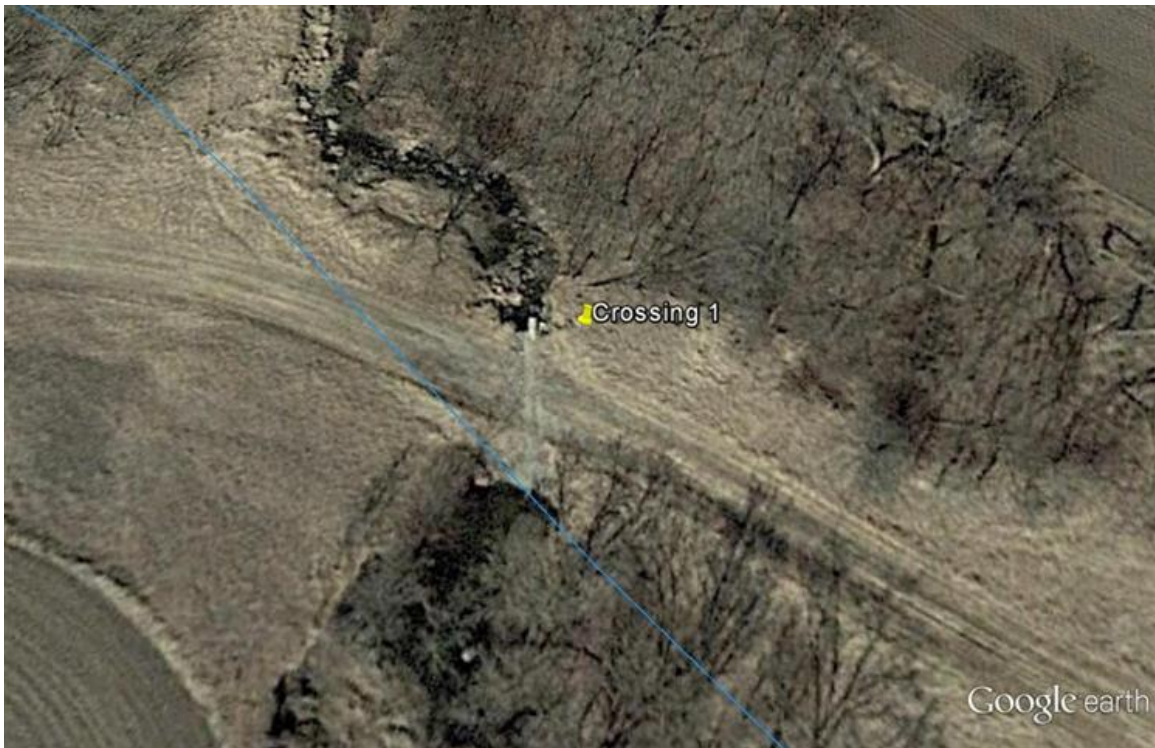
**Figure 17: Crossing 1: potential fish barrier (if white pipe in photo is the only flow path under the road). Imagery taken on 4/14/2015.**

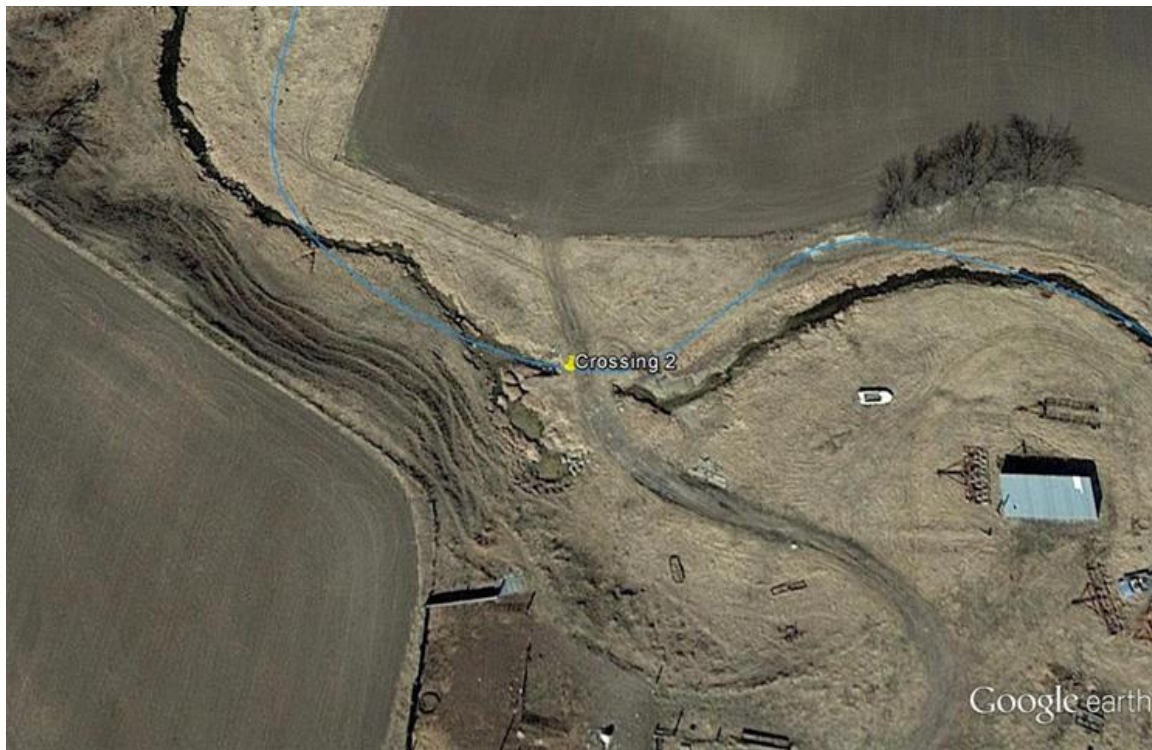
**Figure 18: Crossing 2: potential fish barrier, especially in low flow conditions. Imagery taken on 4/14/2015.**

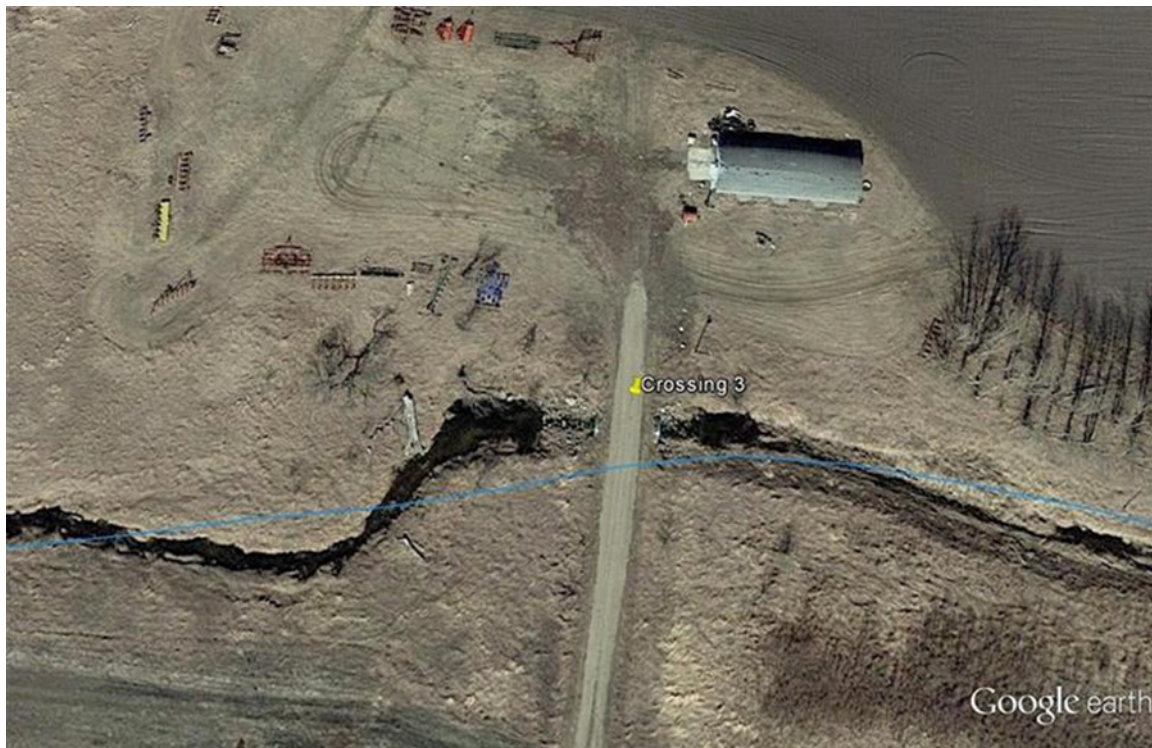
**Figure 19: Crossing 3: potential fish barrier, especially under low flow conditions. Imagery taken on 4/14/2015.**

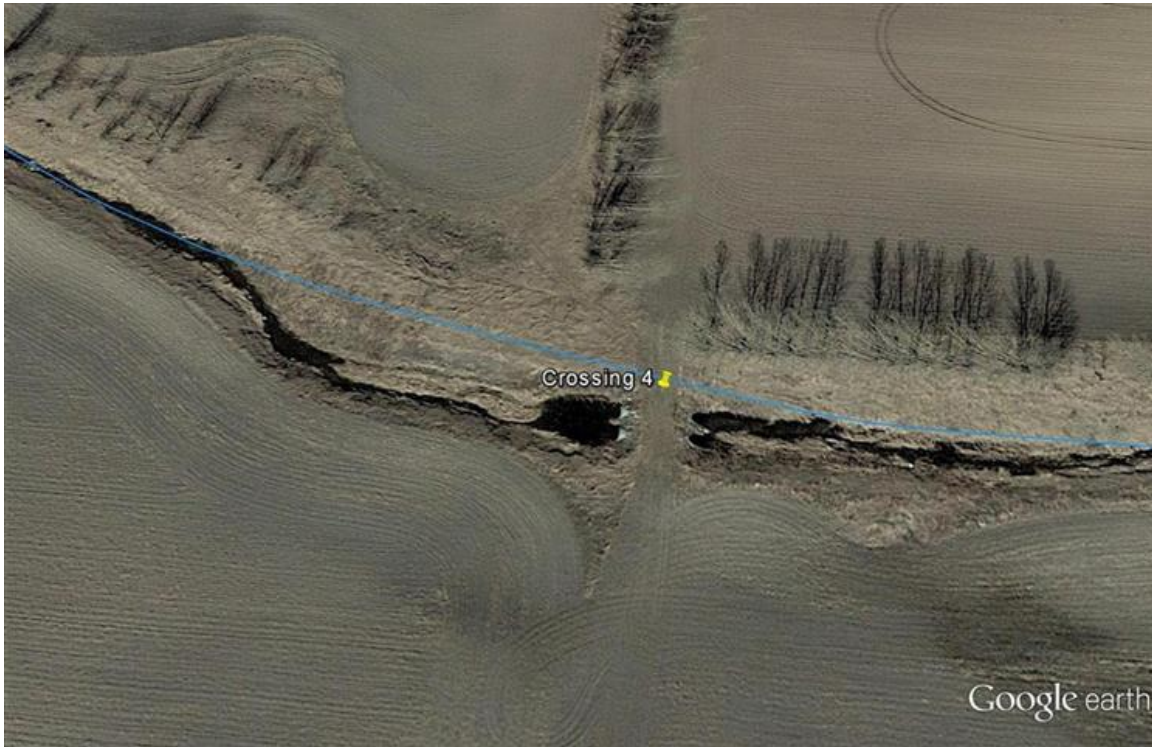
**Figure 20: Crossing 4: potential fish barrier, especially under low flow conditions, due to improperly sized or sloped culvert. Imagery taken on 4/14/2015.**

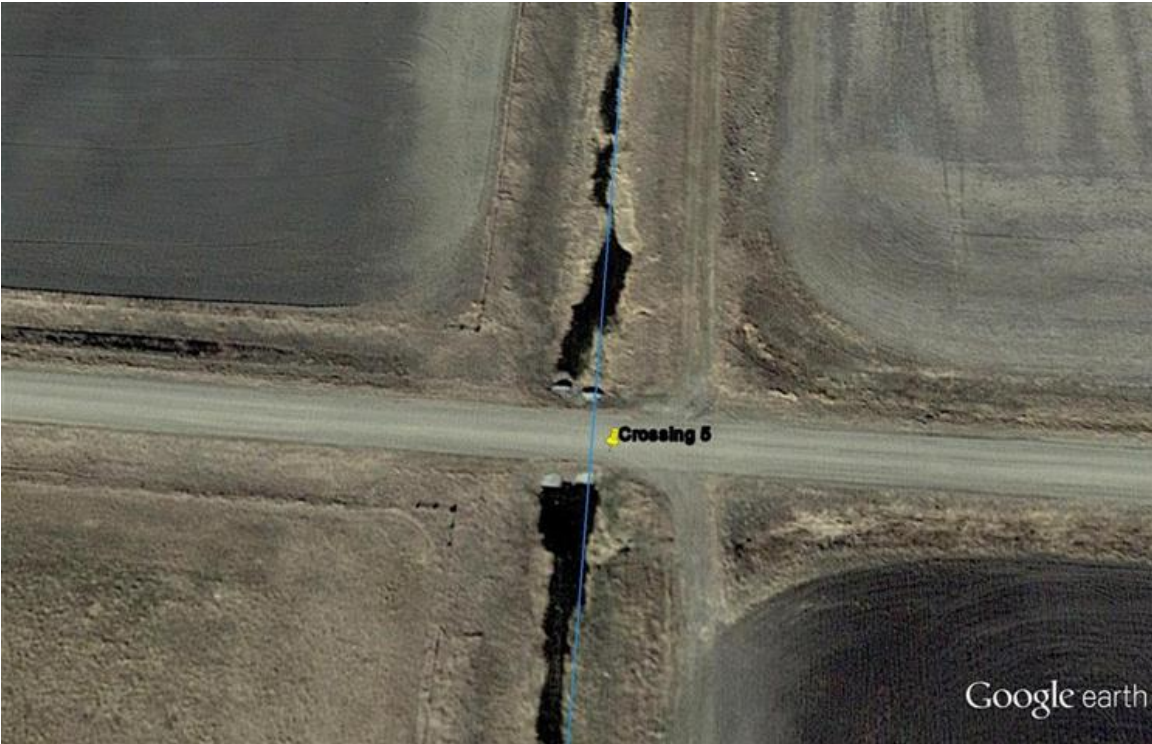
**Figure 21: Crossing 5: potential fish barrier, especially under low flow conditions. In this photo, there appears to be no water flowing through the culverts. Imagery taken on 4/14/2015.**

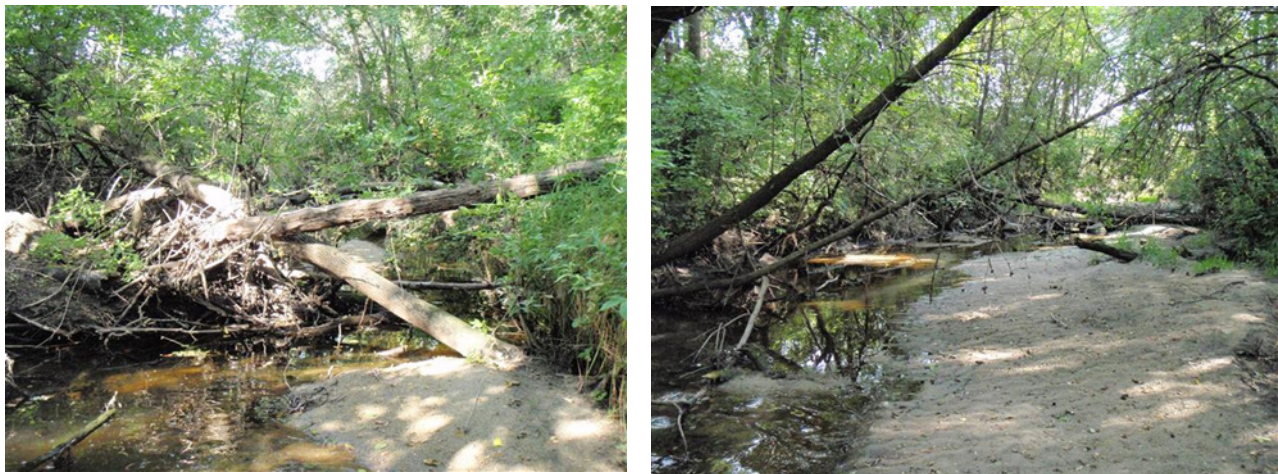
**Figure 22: Evidence of channel deposition and over widening of channel cross section. As the channel becomes wider, the riparian trees can fall into channel causing even more stress on stream banks, which in turn causes more erosion and deposition.**

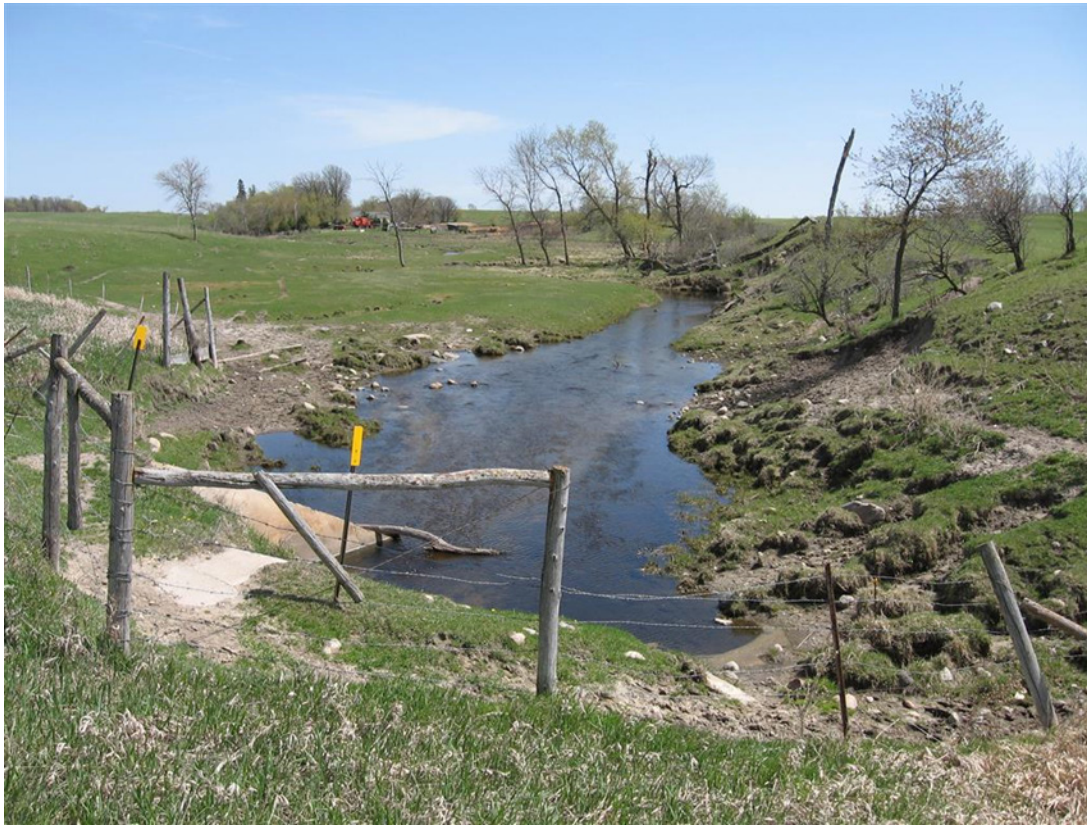
**Figure 24:** Looking up stream at the Poplar River/CSAH 27 crossing (AUID 518), where EQuIS station S009-389 is located. Photograph taken on 5/3/2007.

EQuIS station S009-389 (located at the CSAH 27 crossing) is the furthest upstream water chemistry monitoring station analyzed (Figure 24). This site is nearly co-located with the 14RD218 biological sampling site. Seven TP samples were collected here in 2016 (Figure 25). The TP concentrations in these seven samples averaged 0.111 mg/L, with the July 8<sup>th</sup> sample being 0.195 mg/L, all of which exceeds 0.100 mg/L TP standard; however, more TP data and DO flux data are needed to determine if eutrophication is occurring at EQuIS station S009-389. On average, orthophosphorus (OP) represented 88% of the TP concentration. This suggests that soluble, inorganic phosphorus is being released from sediment in the stagnant, low-gradient portion of the stream that tangentially flows past Whitefish Lake.

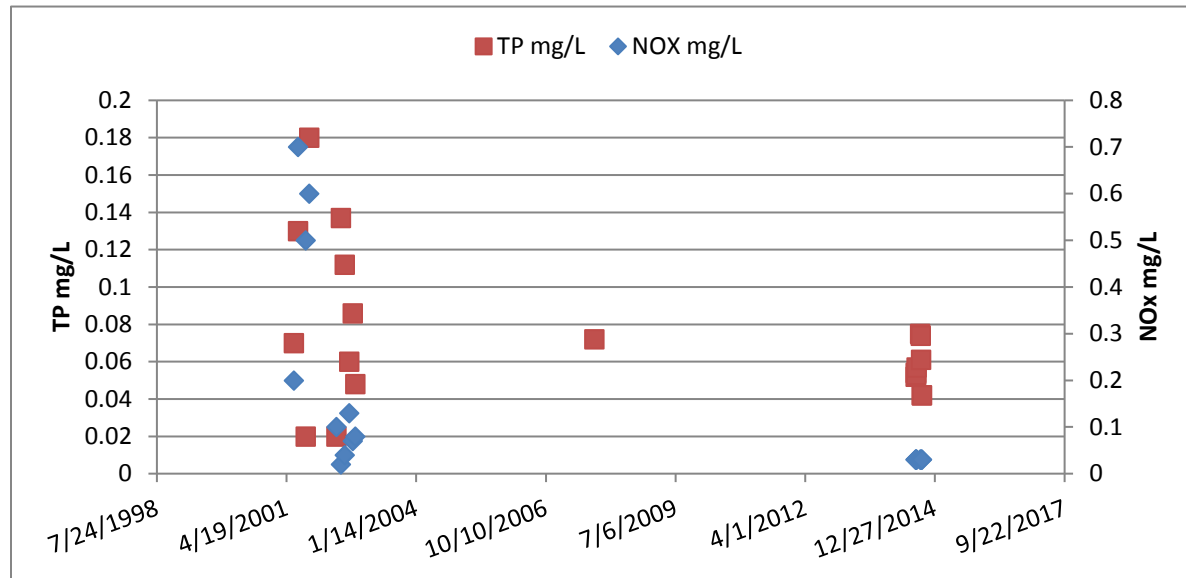
**Figure 25: Water chemistry data collected from EQuIS site S000-477 near biological station 05RD078. TP concentrations are generally below the eutrophication standard and NOx concentrations are all below 1 mg/L for the sampling record.**

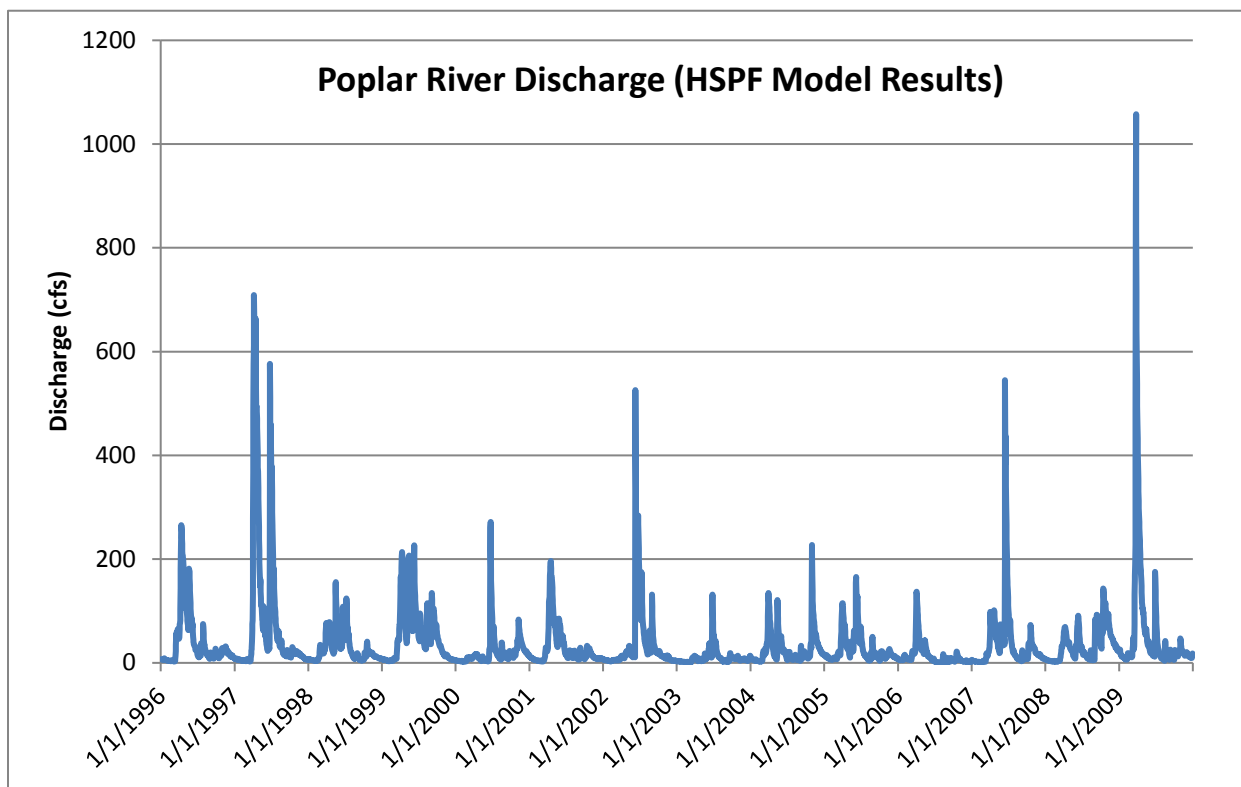
**Figure 31: HSPF modeled daily discharge data for AUID 518.**

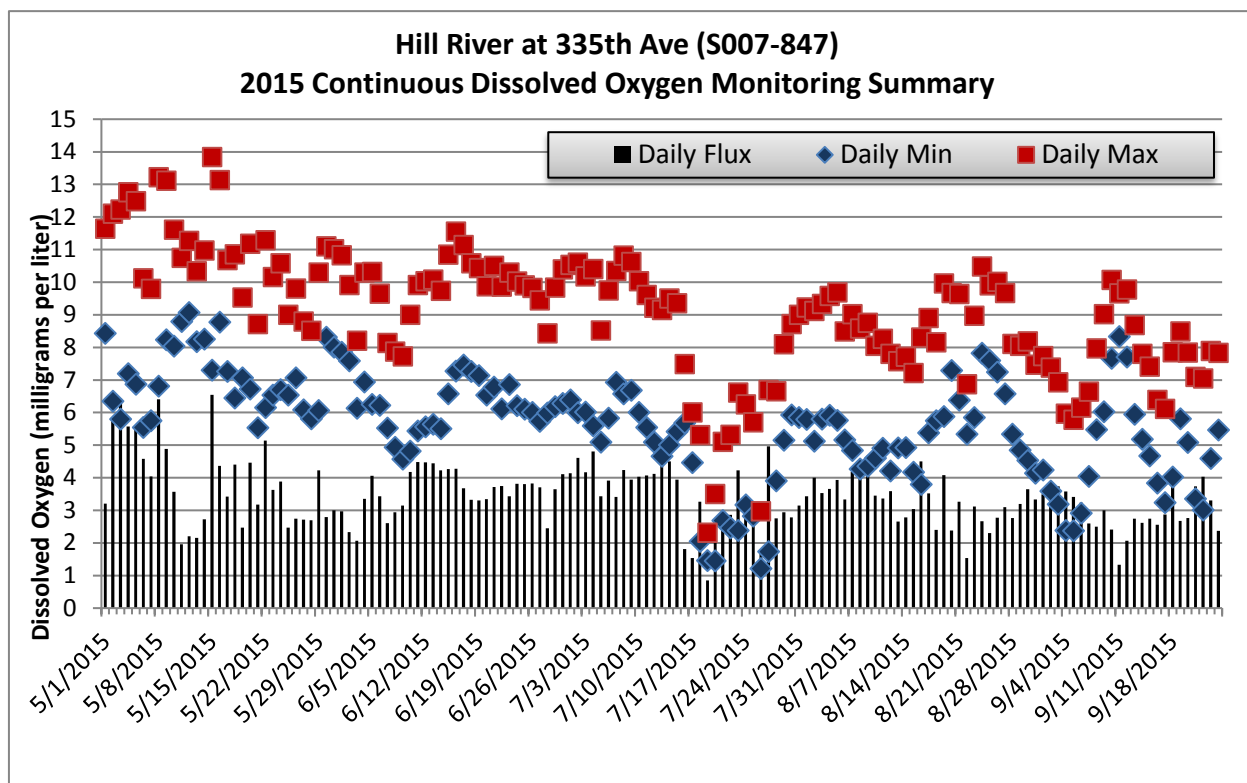
Figure 41: Continuous DO data collected by RLWD during the summer of 2014 at EQUIS station S007-847.

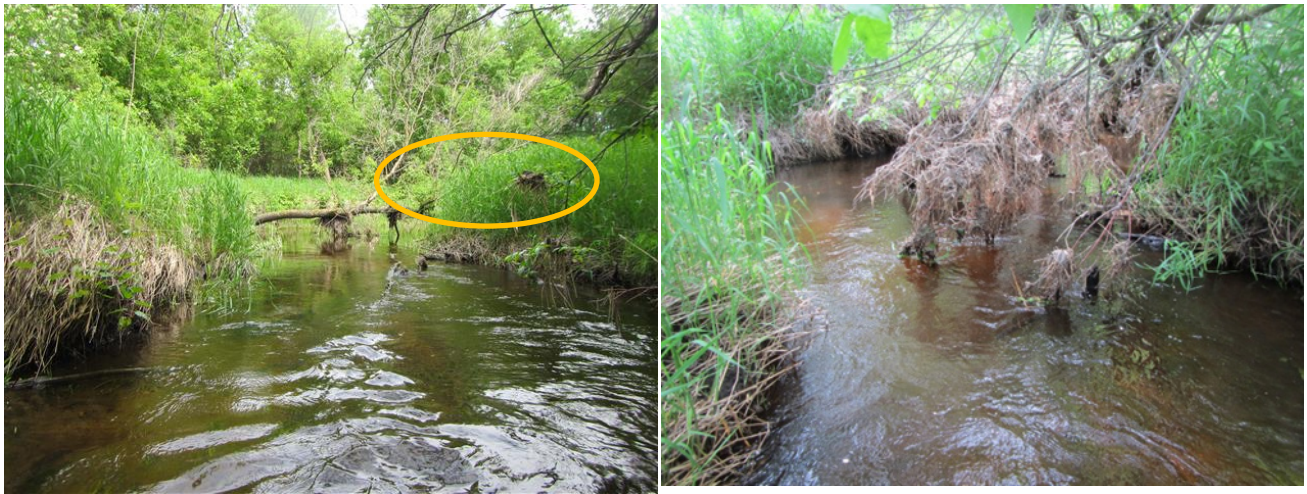
**Figure 43: Pictures from biological station 14RD246, showing debris on trees well above the current water level. This shows the flashy nature of the flow regime. Pictures taken June 10, 2014.**

The hydrologic model (HSPF) results indicate that during the modeled time period (1996-2009), discharge in this AUID of the Hill River is flashy and periods of extreme high and low flow occur. The model summary discharge statistics show a peak discharge of 915 cfs, mean discharge of 26.9 cfs, and a minimum discharge of 0.0 cfs. The record also shows that 22% of the time the stream is below 5 cfs, and 4% of the record shows discharge above 108 cfs, which is 4 times the mean discharge. Low flows of less than 1 cfs were also estimated to occur 3.2% of the record. Overall, the available data suggest that the reach is prone to extended periods of minimal to no flow, and has periods of high flow that occur rapidly and return to low flows quickly (Figure 43).

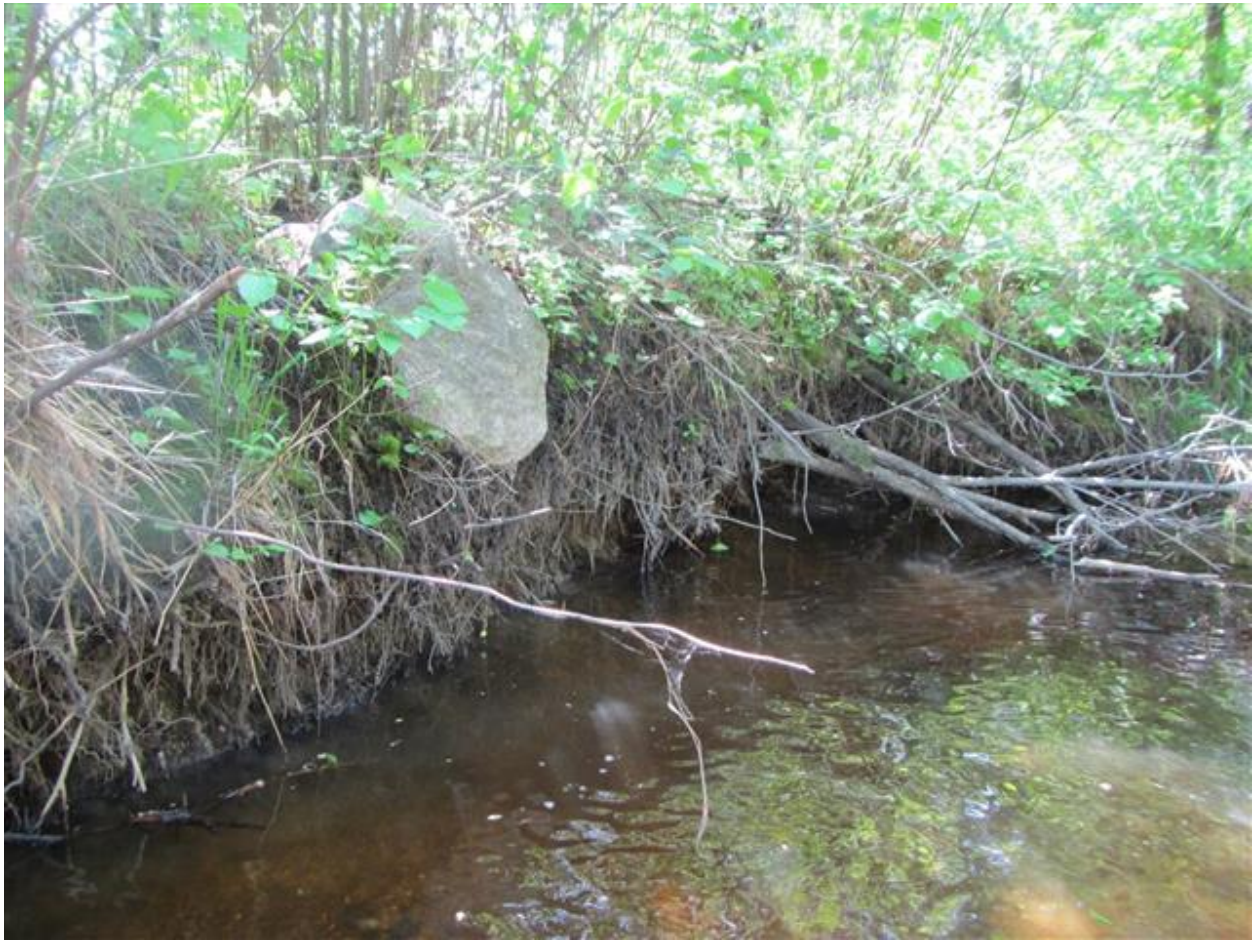
**Figure 44: Picture from biological station 14RD246, taken on June 10, 2015, showing bank erosion on the Hill River.**

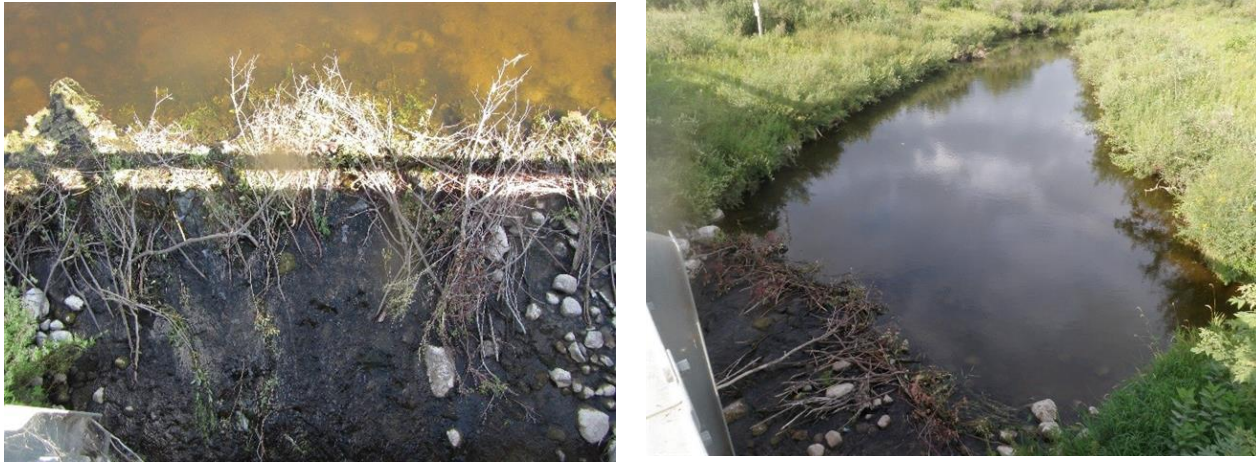
**Figure 49: Beaver impoundment at site 14RD226 photographed on 8/10/2014 (left) and again on 8/18/2014 (right). This dam may have been prohibiting some fish passage as well as diminishing flows that could then trigger a decrease in DO.**

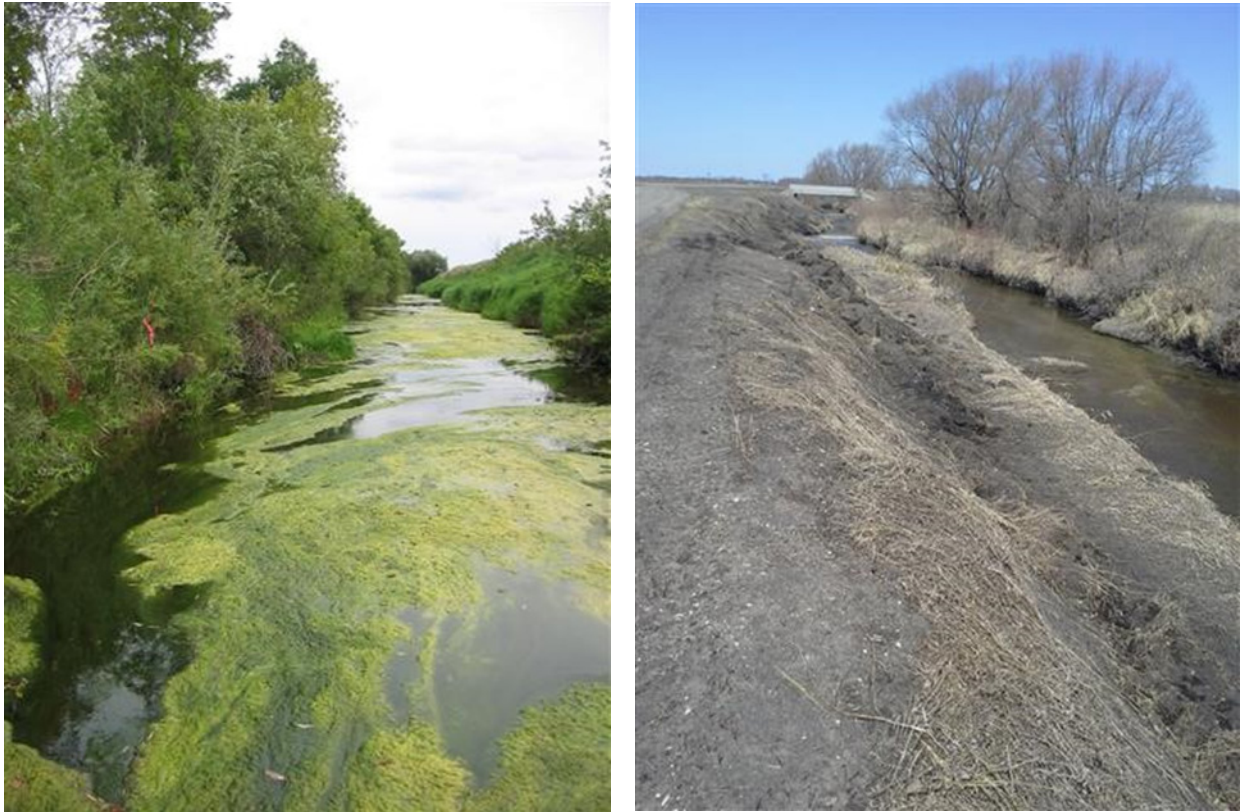
**Figure 50: Left - dense algal growth at station 07RD024 on 8/14/2007. Right – Same station (07RD024) on 4/10/2015, showing disturbed unstable stream banks.**

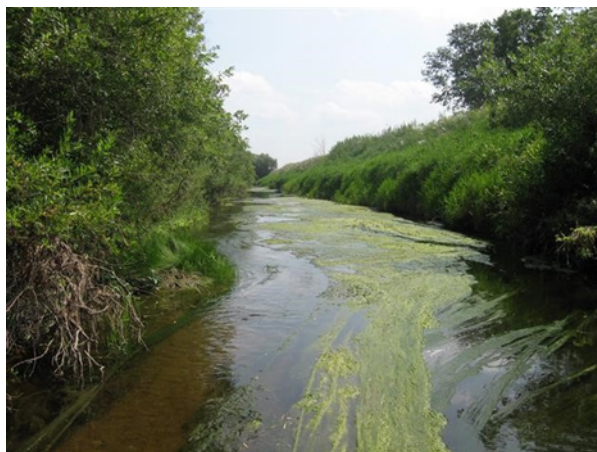
**Figure 52: Site 07RD026. Photo on left is from the August 8, 2007 sampling event and photo on the right is same station on July 29, 2014. Both photos are located in middle of reach looking upstream.**

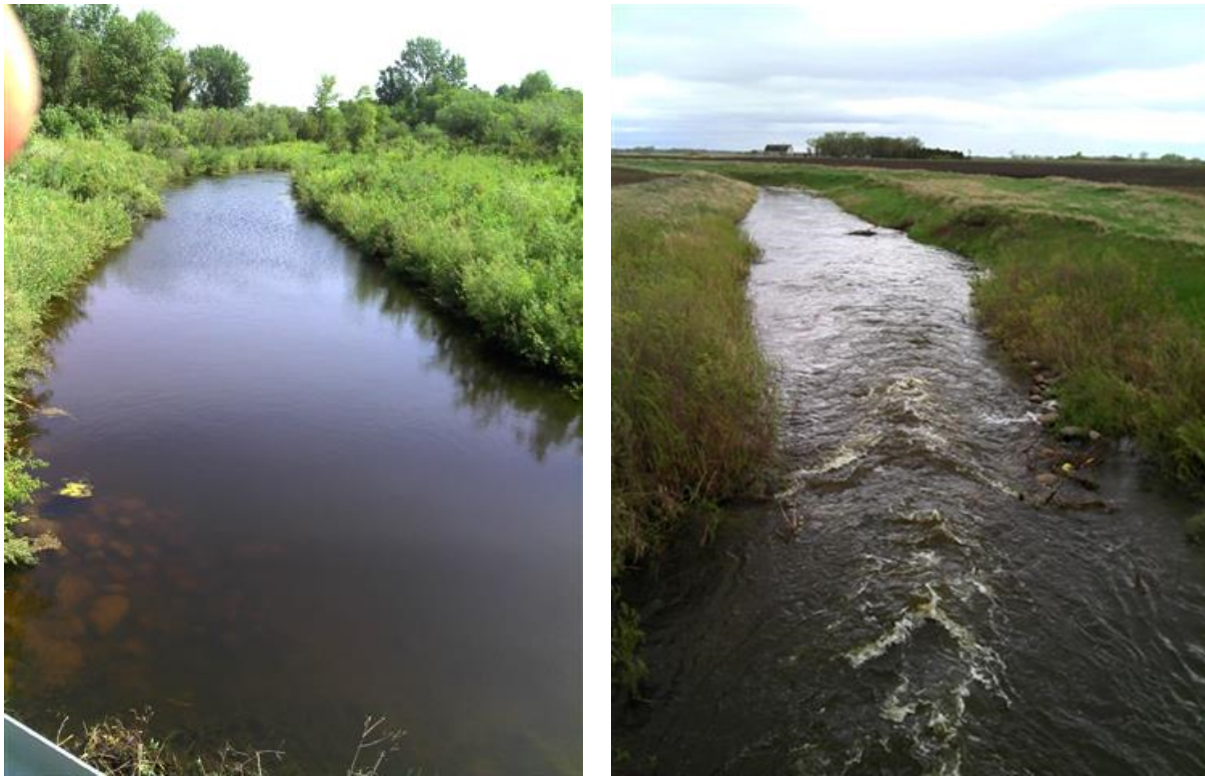
**Figure 55: View upstream (left photo) and downstream (right photo) of the Lost River at CSAH 28 (S007-849).**

In 2015, continuous DO data was collected by the RLWD using a sonde deployed at S007-849, which is located near 14RD226 (Figure 55). The sonde was deployed from May 4 through September 24 (126 days). The DO fell below the 5 mg/L standard for 54% of the daily minimums and the DO flux exceeded the 3.5 mg/L standard 62% of the days sampled (4.67 mg/L summer average). With the high daily DO flux any increase in phosphorus, concentrations above the 0.100 mg/L standard would cause an even greater potential for periphyton growth. This reach of the Lost River should be monitored for phosphorus in the future and phosphorus export bmp's (best management practices) should be investigated to minimize phosphorus export.

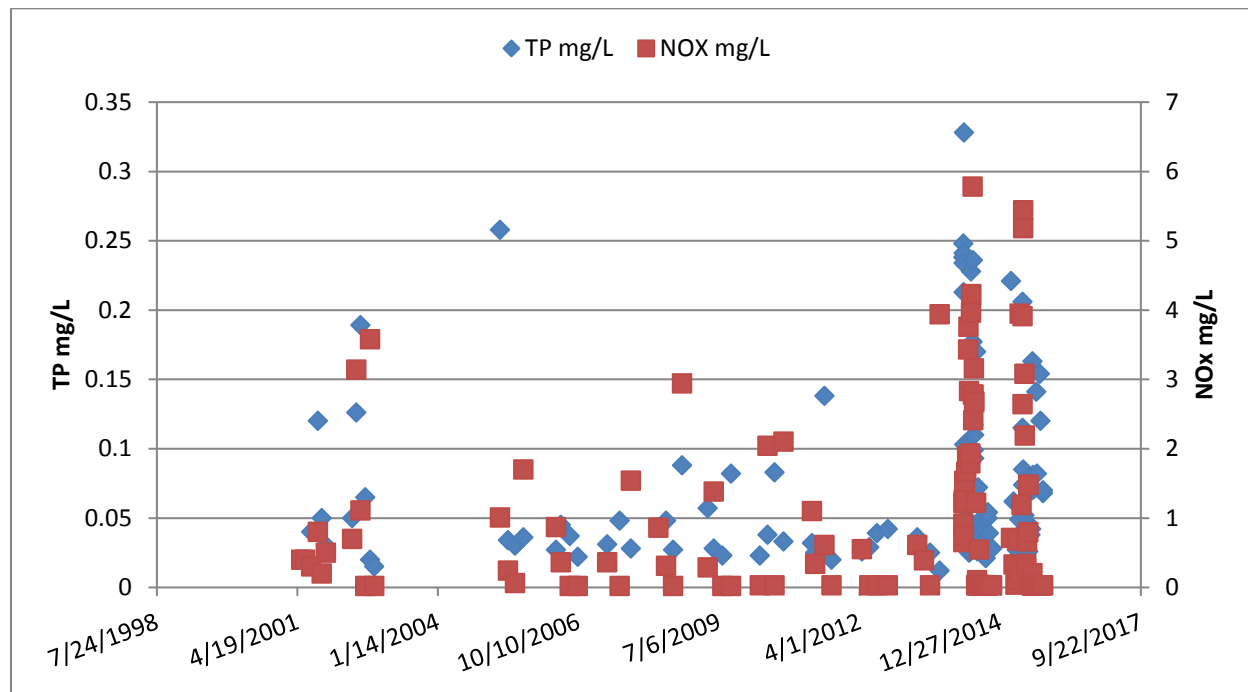
**Figure 59: Water chemistry data for nutrients on AUID 646 of the Lost River at EQuIS station S002-133.**

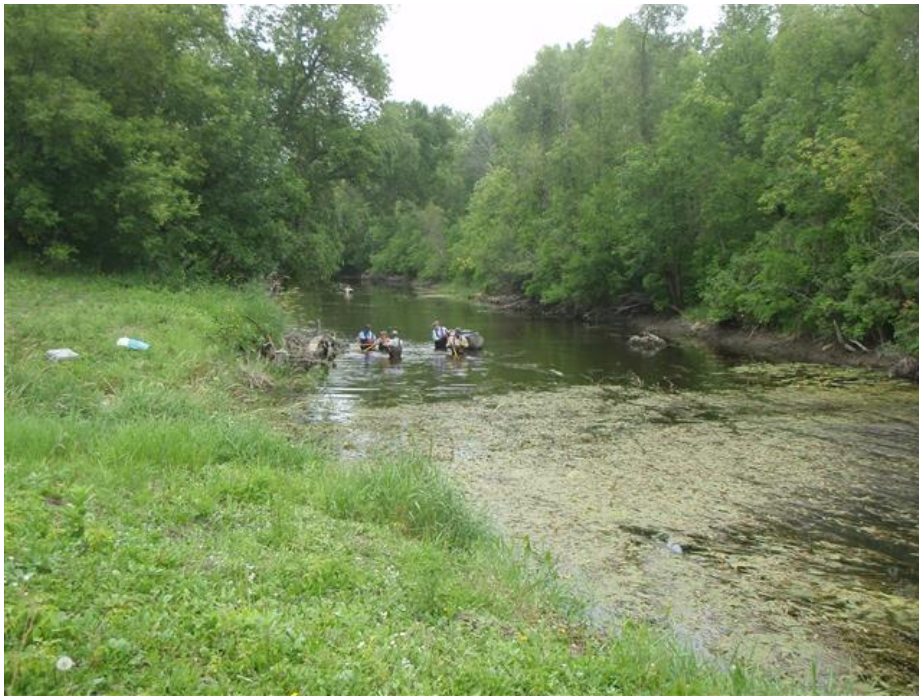
**Figure 60: Extensive submerged plant growth in the channel at site 05RD046.**

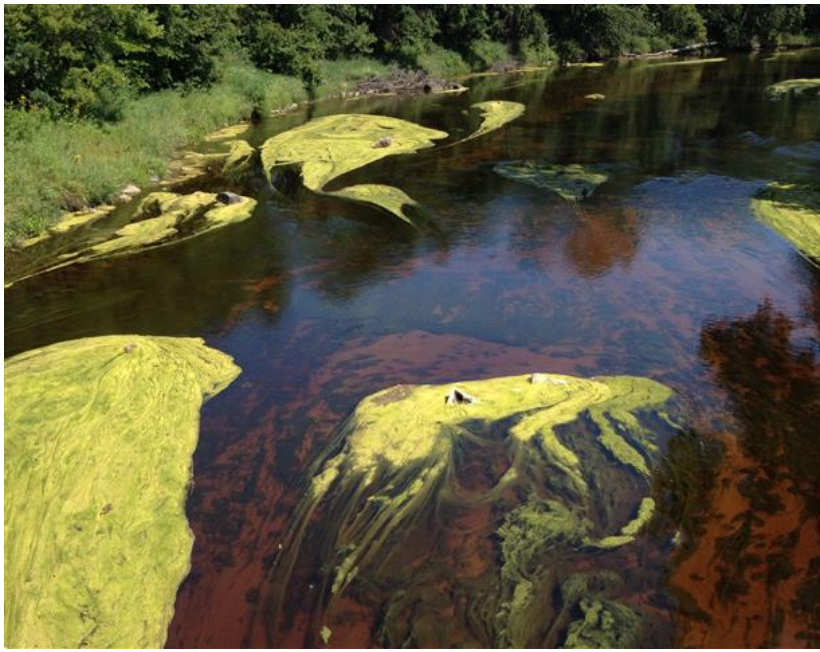
**Figure 63: Filamentous algae growth, photographed at EQuIS station S002-133 (which is co-located with biological station 14RD259) on 6/25/2015. Continuous DO data from this site recorded excessive DO flux, likely caused by the photosynthesis and respiration of the algae.**

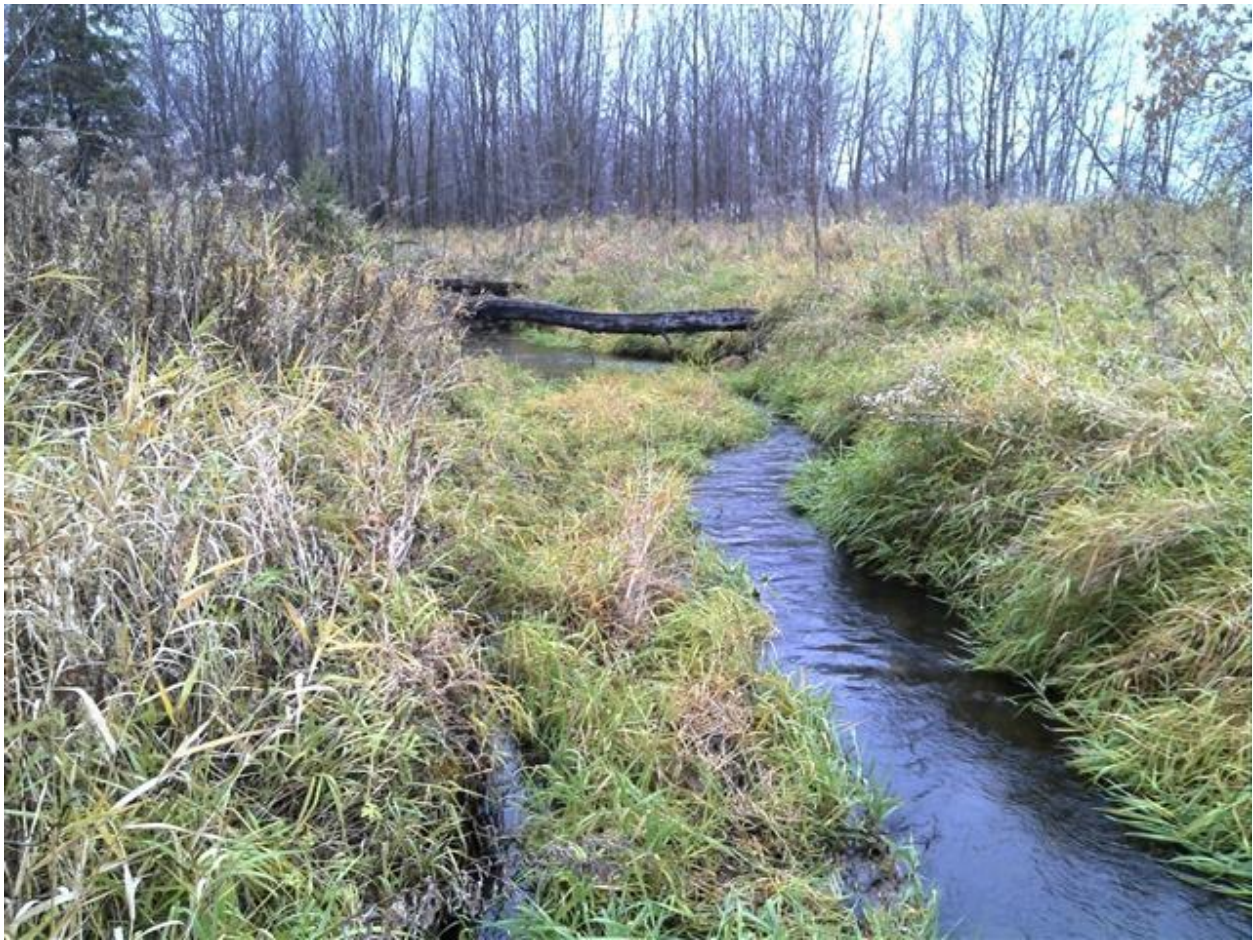
**Figure 68: Station 14RD231, mass wasting shown on left side of photograph.**

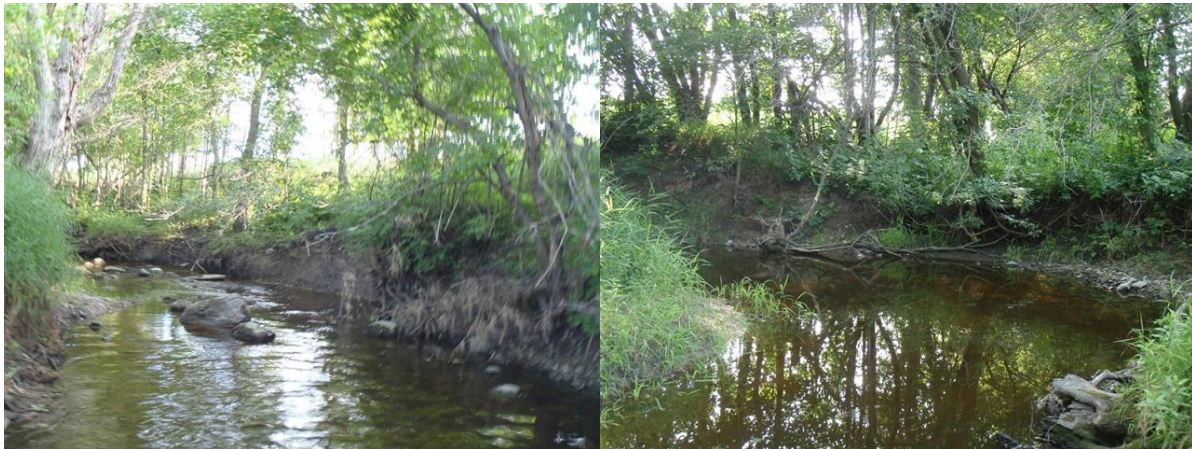
**Figure 69: Station 14RD231 during the July 16, 2014 fish-sampling event. Note bank failure but stream has velocity. Photograph on the right is at the same station on July 30, 2014. Note that the channel has water but there appears to be no velocity as documented by the RLWD stream gage.**

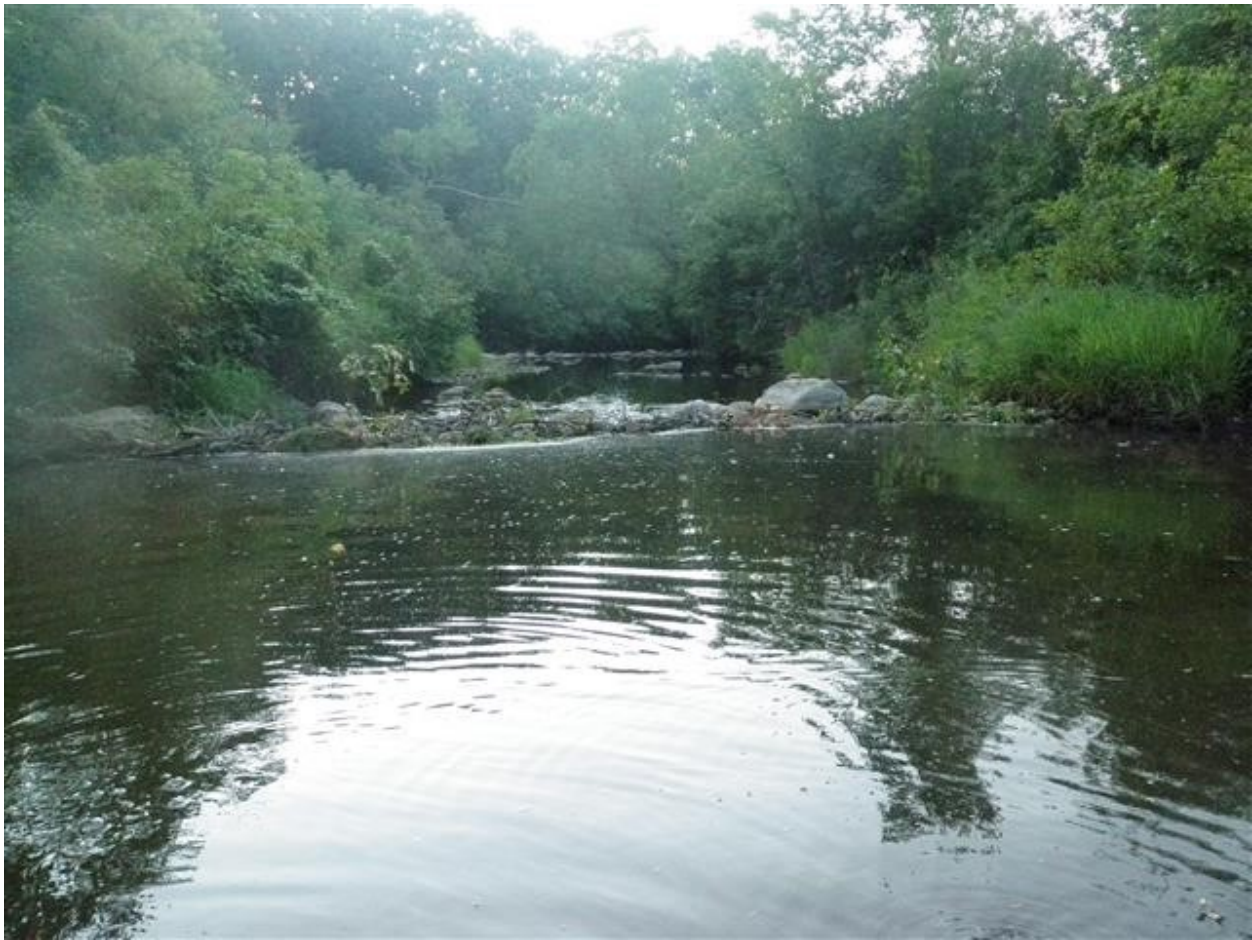
**Figure 75: Beaver dam, photographed on August 19, 2014, partially obstructing the channel in the farthest downstream portion of Lower Badger Creek, site 14RD237.**
