# Clearwater River Watershed Stressor Identification Report

A study of stressors limiting the aquatic biological communities in the Clearwater River Watershed

Minnesota Pollution Control Agency

March 2017

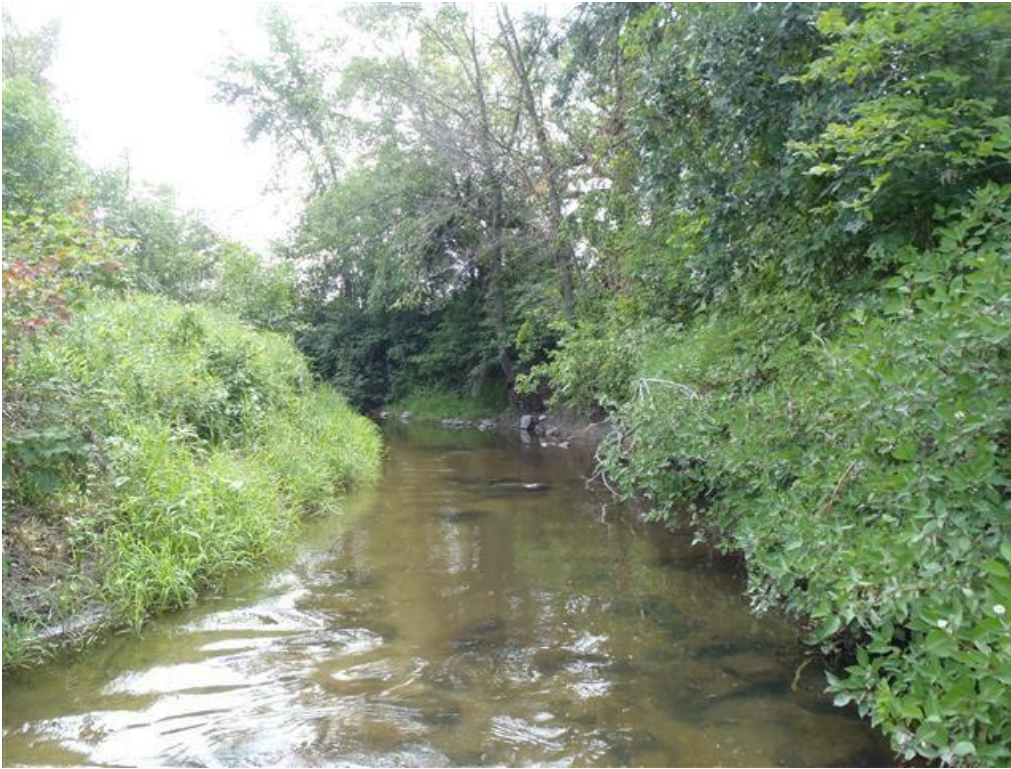
**Figure 76: Site 14RD239 (August 5, 2014). Channelization begins in the AUID at this point, and is significantly altered upstream. Note the heights of the banks. Channel appears incised, not allowing high flows to access the floodplain during the bankfull flow event.**

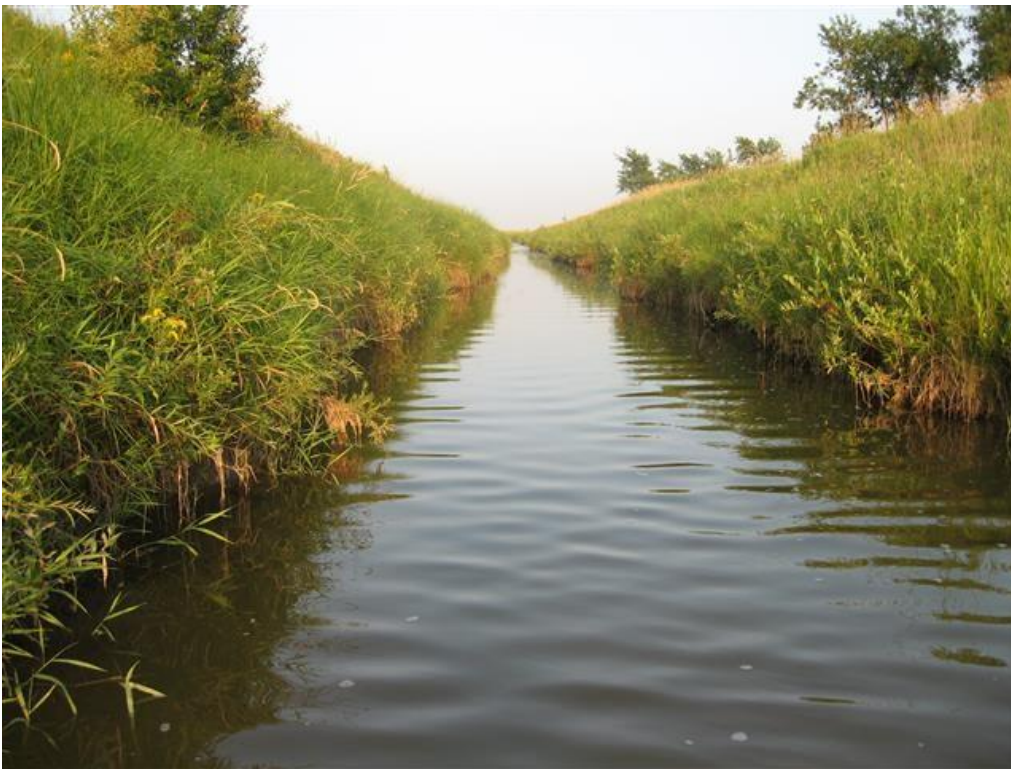
**Figure 77: Site 07RD026 on 8/9/2007. Site is channelized. Based on MSHA from 2007, the site meets General Use category. Site will be resampled in 2016 and new MSHA (42.9) to determine its attainable use class.**
