July 2019

Rainy River Headwaters Stressor Identification Report

A study of local stressors limiting the biotic communities in the Rainy River Headwaters Watershed

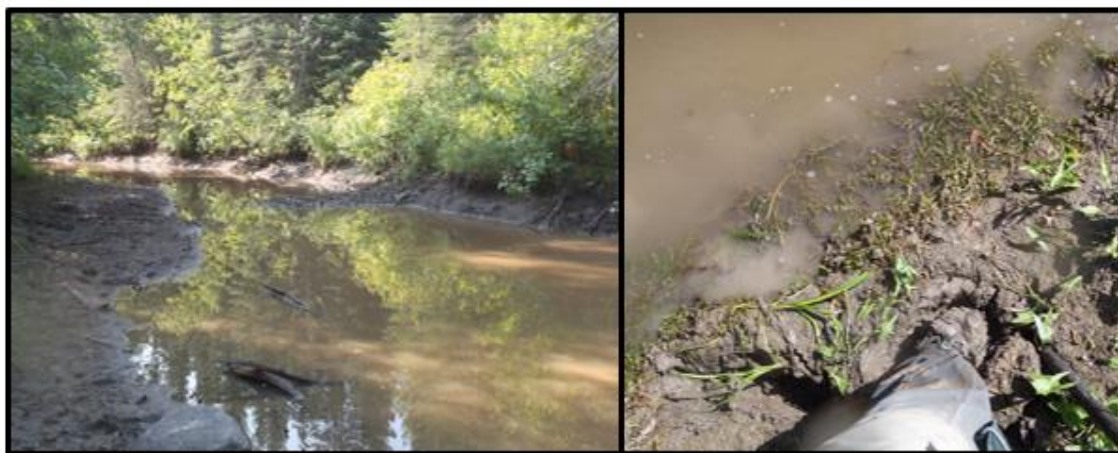
Figure 10. Images of low flow conditions of the Ash River Lower at station A4c show TSS suspended in the stream channel and the exposed silt banks that form the channel.

The longitudinal data indicated that a portion of the suspended sediment generated in the Ash River Upper settled out within the Ash River Lower reach. This infers that particle detachment in the upper river may have contributed to increased siltation and depth of fines in the Ash River Lower, indirectly increasing TSS concentrations under low flow conditions in the Ash River Lower. The banks and bed of the stream at station A4c also had a naturally high silt content ([Figure 10](#)).

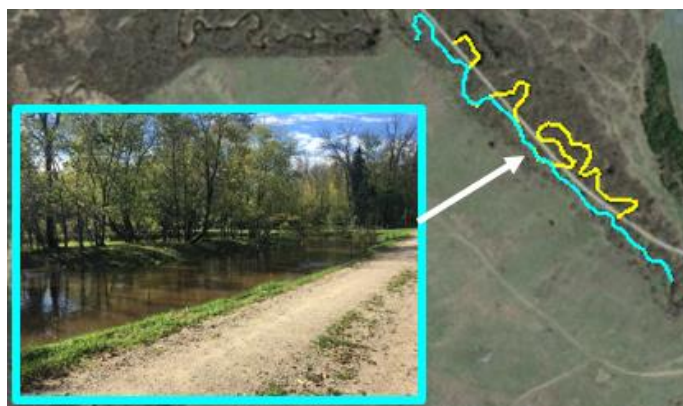
Figure 12. Channelized section (blue line) of the Blackduck River that occurred prior to 1939, reducing the historical stream (yellow line) length by 34% and increasing stream slope by 60%. The photo shows the channelized reach along the roadway.

Land use practices in this area over the past 20 years have likely exacerbated the instability by increasing surface runoff (adding more flow volume) to this already unstable reach during snowmelt and rain events. Field observations suggest that land management practices such as clear cutting, loss of riparian area vegetation, improperly sized or aligned culverts, and cattle access are perpetuating instability.

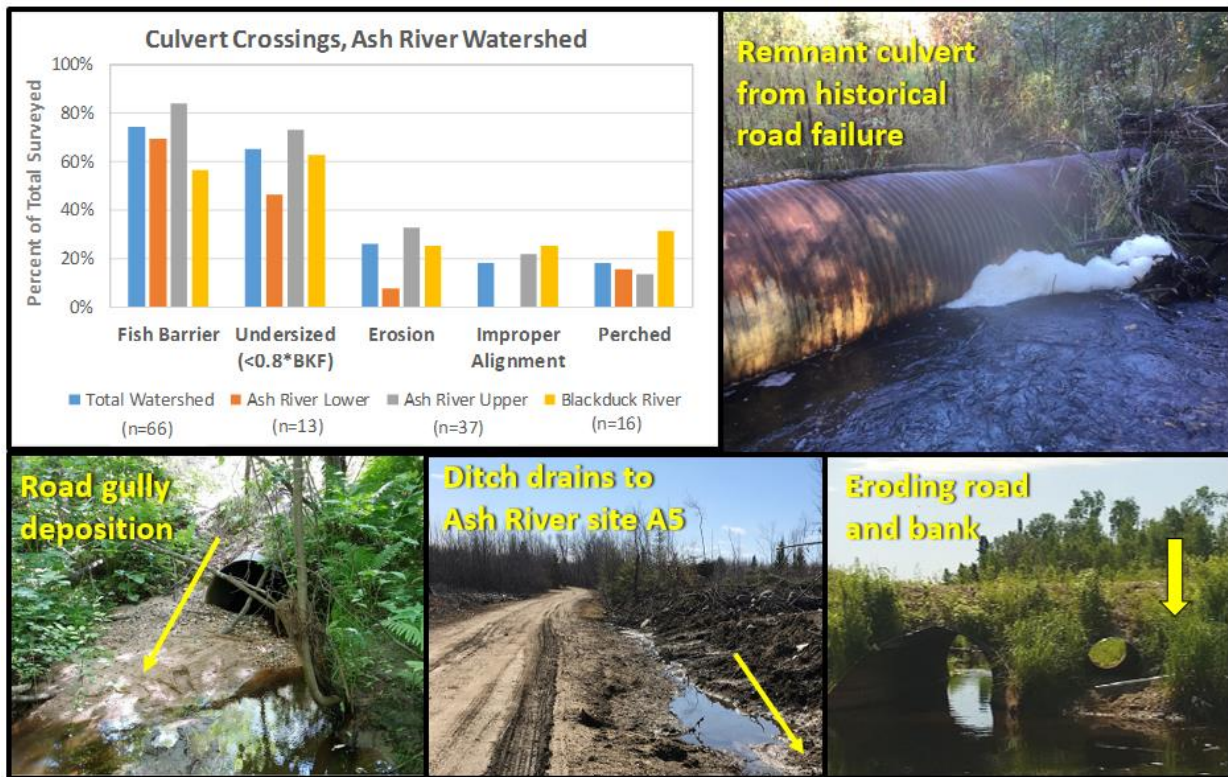
Figure 13. Culvert inventory results (Top Left) in the Ash River Watershed identifying the most commonly found problems at stream-road crossings. Photos: Examples of culverts and roadways that have contributed sediment to stream channels in the Ash River Watershed.

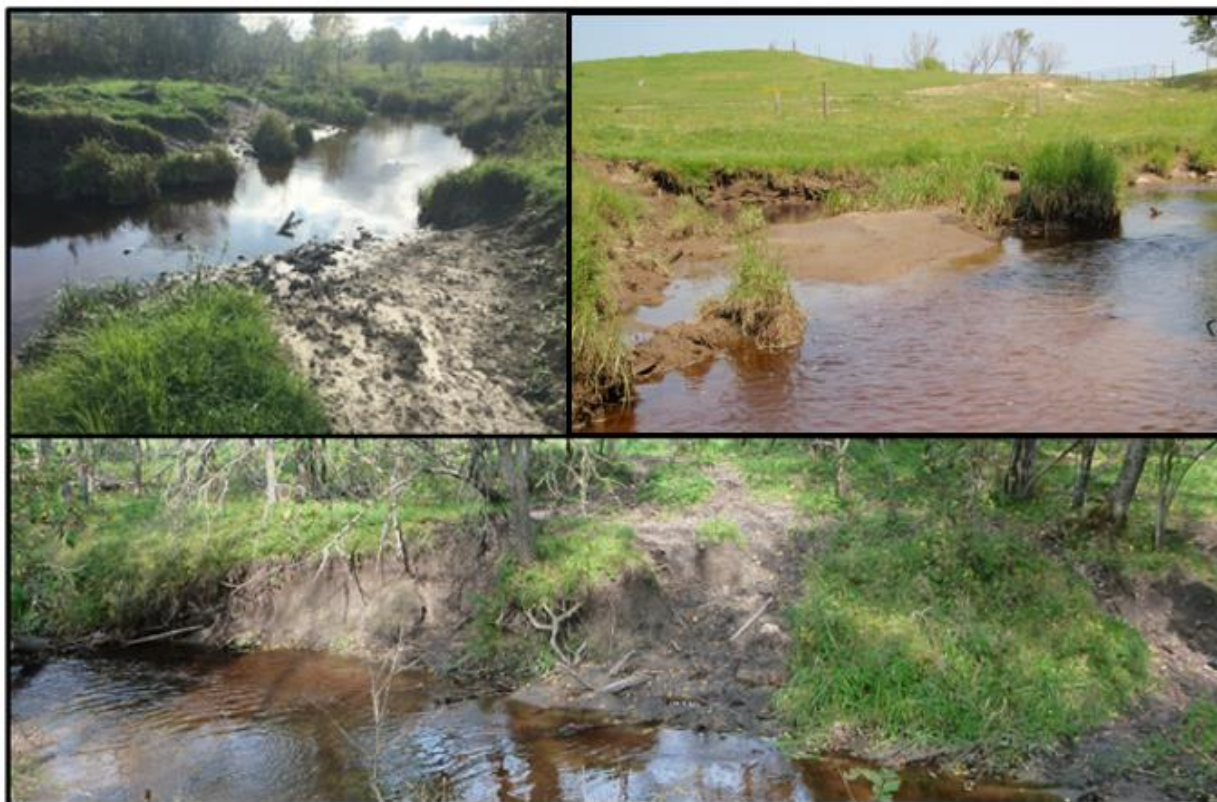
Figure 14. Cattle access areas on the Blackduck River and Ninemile Creek showing trampled banks (top left), sediment deposition (top-right), and steep eroding banks from a combination of streamflow and cattle access (bottom).

Cattle had access to over 3 miles of stream within the ranch including reaches of the Blackduck River, Ninemile Creek, Fawn Creek, and an unnamed tributary. Additionally, smaller ephemeral streams were also being grazed. The total number of cattle varied by season with approximately 500-700 cattle occupying the pasture during summer. While many stream banks remained fully to partially vegetated, cattle access in other areas resulted in trampled banks that were void of vegetation ([Figure 14](#)). While overall, the Blackduck River is incised due to historic channelization, areas over-accessed by cattle were widened in localized areas where banks had been trampled. Fine streambed materials were more dominant in highly accessed areas, burying coarser gravel that is desirable to Coldwater fish and invertebrates.

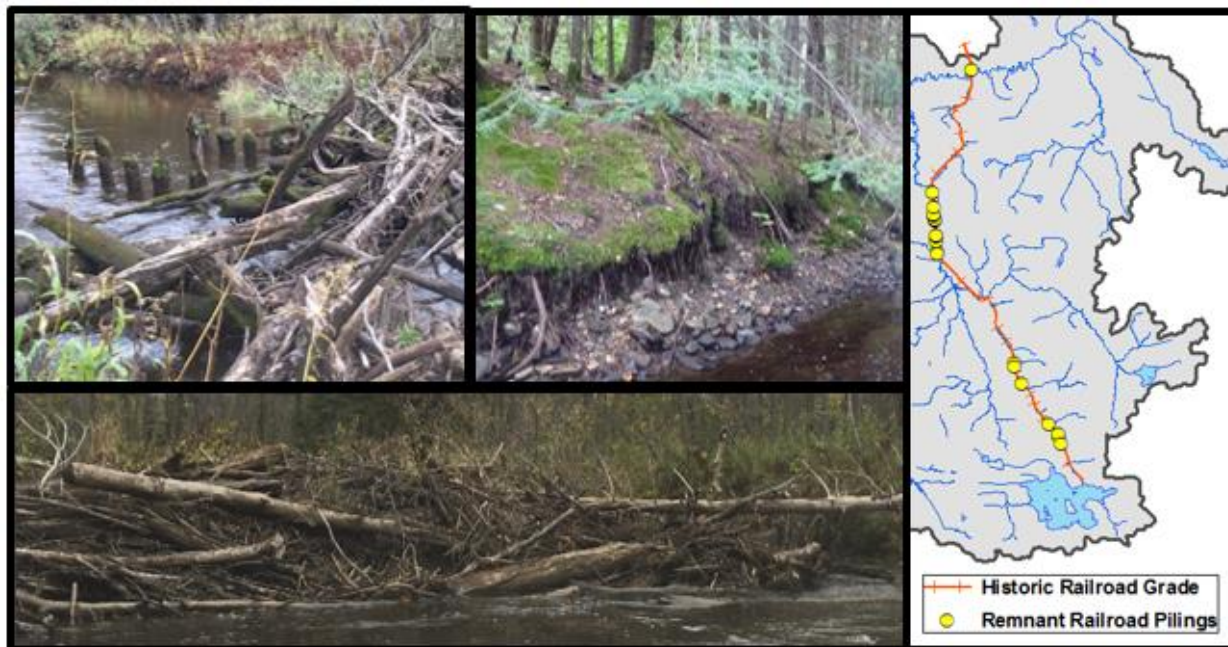
Figure 15. Map (Right) identifying locations where the old railroad historically crossed the Ash and Blackduck Rivers including one location on the Ash River and 18 on the Blackduck River. Pilings remain in the stream at many of these historic crossings causing debris pile-ups (top left and bottom). Bank erosion was identified in the Blackduck River in areas where the old railroad runs parallel with the Blackduck River (Top center).

The BANCS survey identified old railroad grade and in-channel pilings left behind from remnant railway bridges as sources of erosion in the ARW. The old railroad grade transects the ARW from Blackduck Lake to the Ash River Lower. Visual observations of aerial imagery showed eighteen possible railroad crossings on the Black Duck River. Six of those were confirmed to have pilings. The status of pilings are unknown at the remaining nine locations. Pilings were also present at the Ash River water quality station A3, located in Ash River Lower.

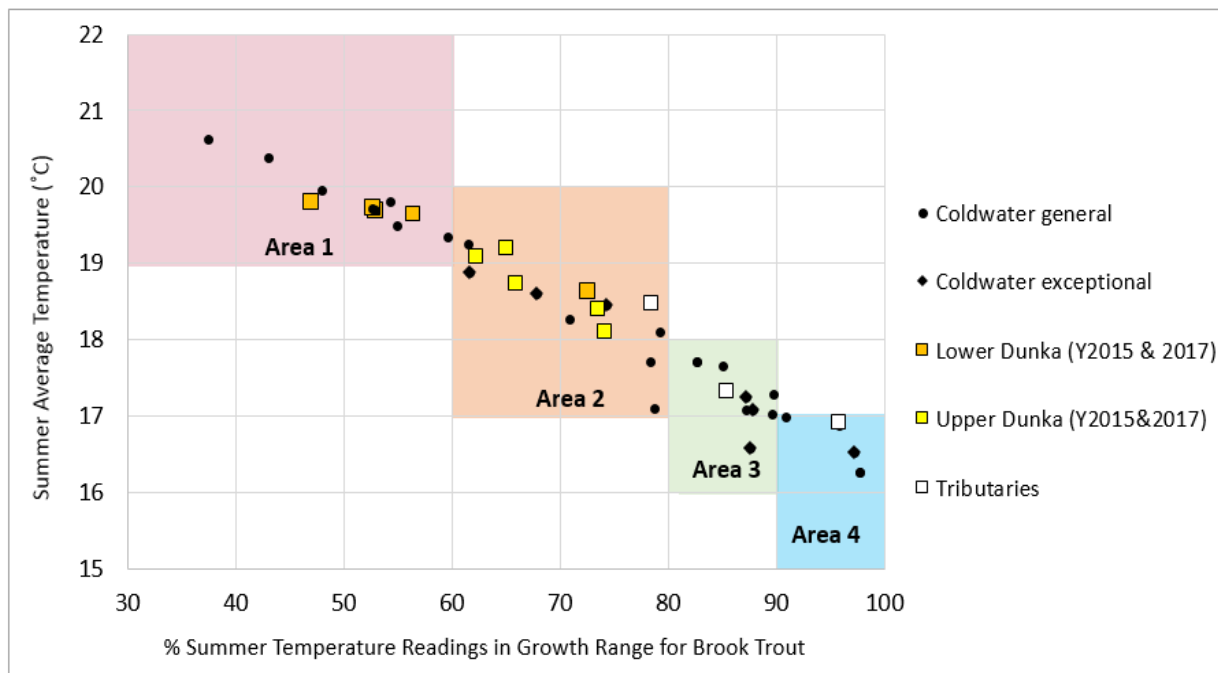
Figure 24. Plot of Summer Average Temperature vs. Percent of Summer Readings within the growth range for Brook Trout. The Dunka River temperature stations are shown in colored markers and tributaries to the Dunka in white. All other RRHW Coldwater station data are shown in black, with diamonds indicating streams with exceptional Coldwater communities.

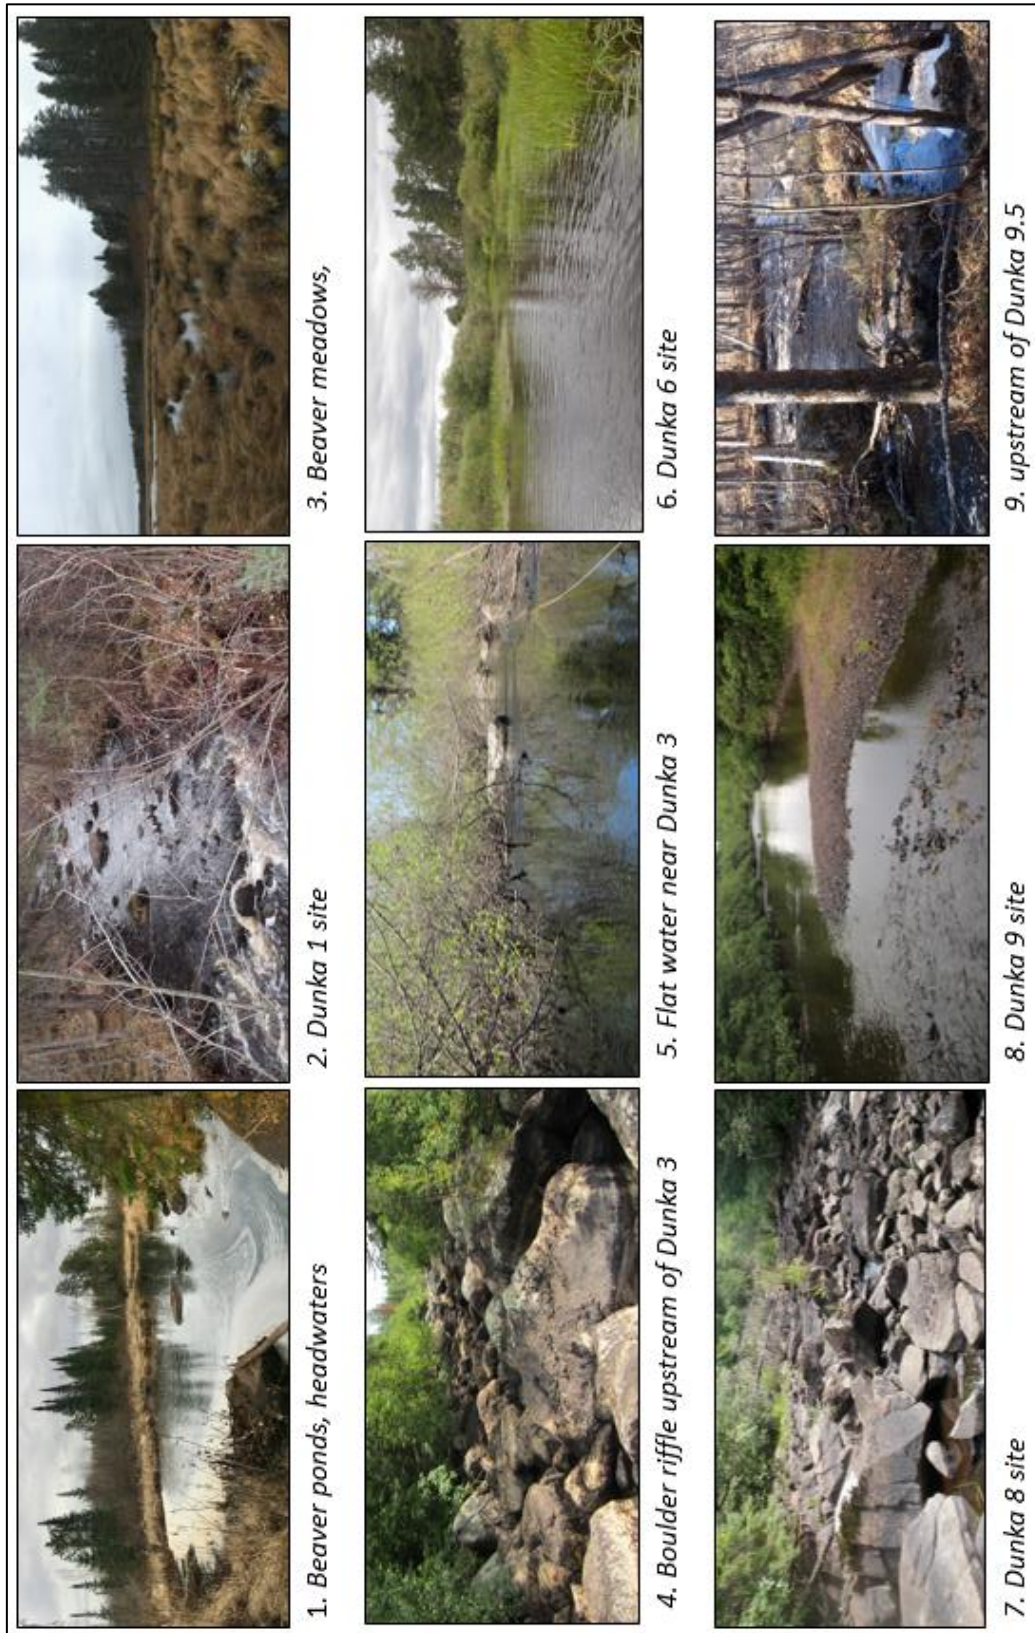
Figure 27. Photos showing physical habitat variations from the headwaters to the mouth on the Dunka River.
