Fairview Addition

Contingency Plan Implementation Case Study

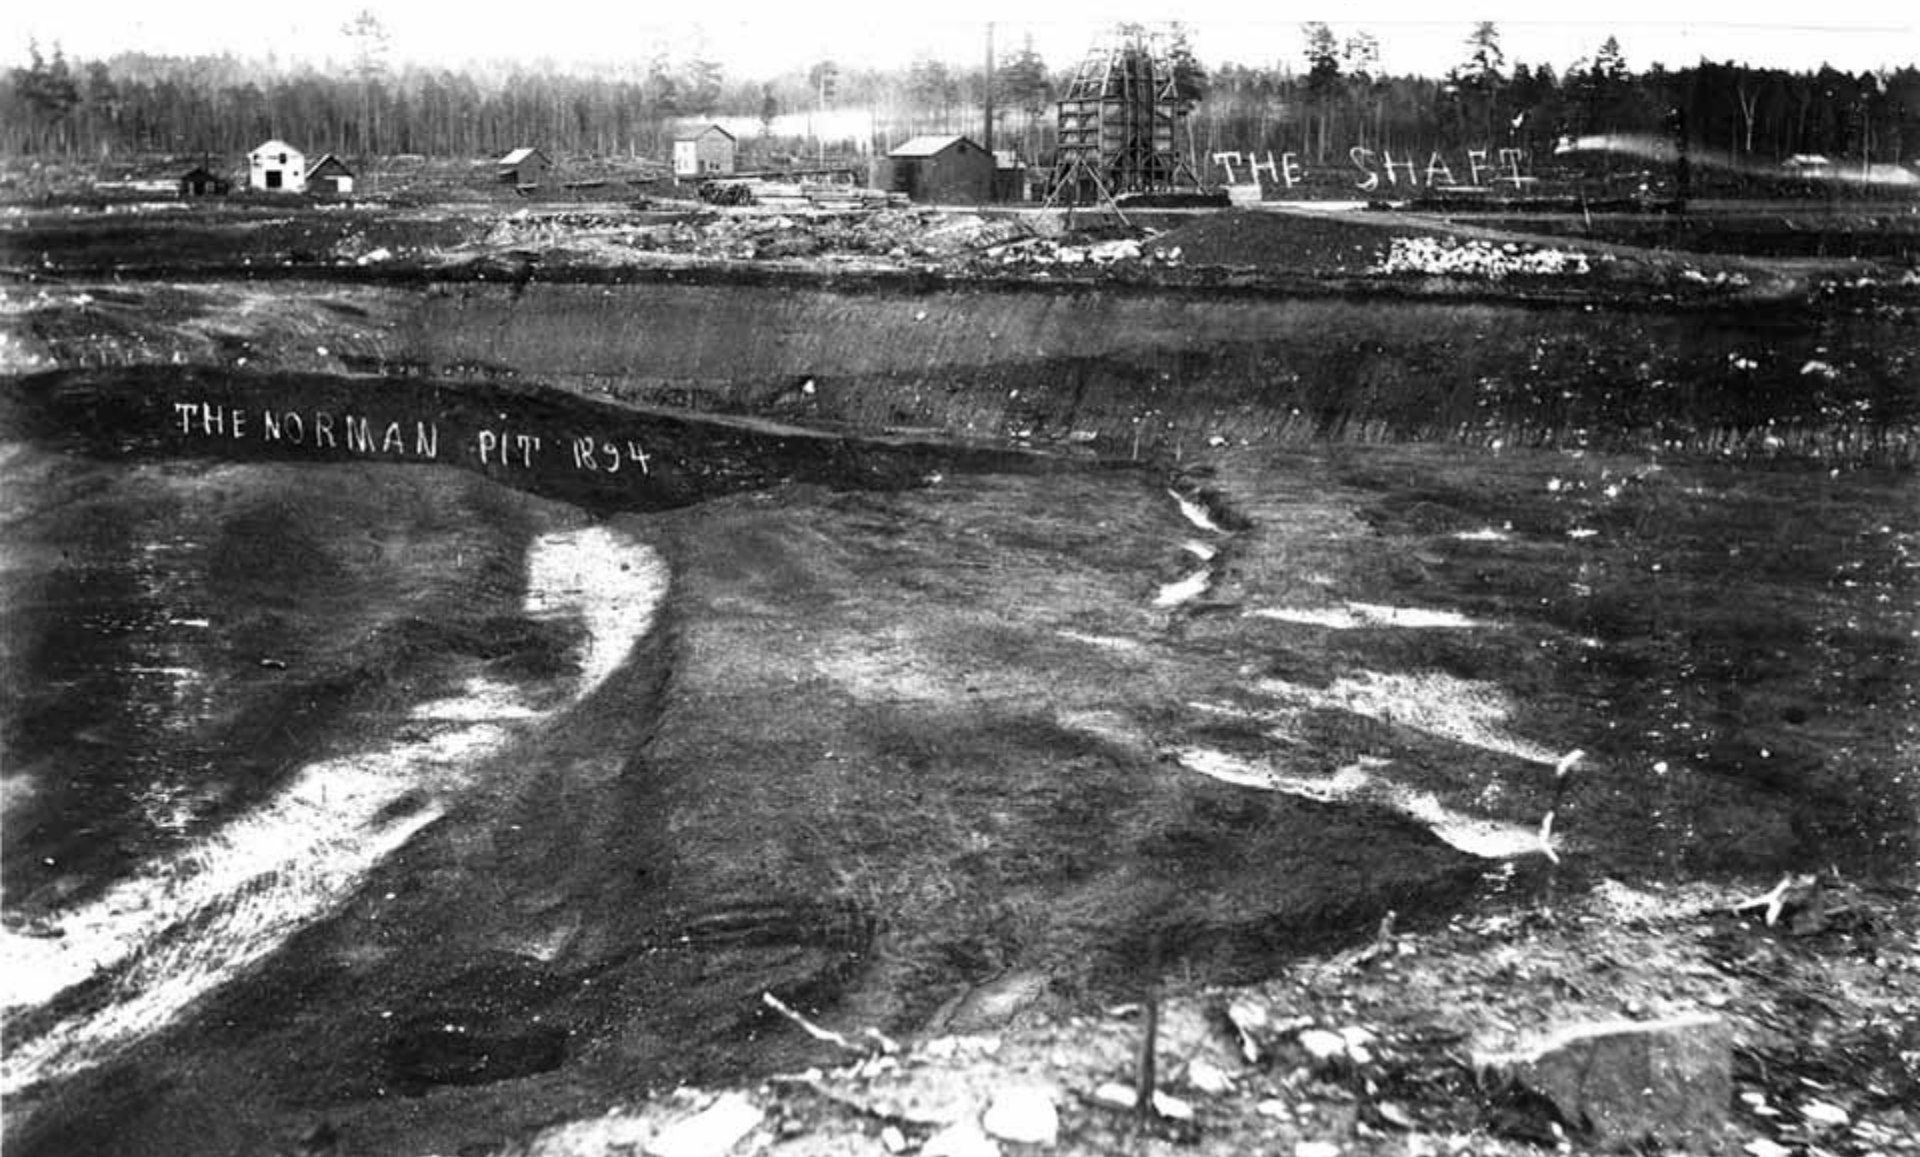
Norman Mine pit 1894.
It had just been stopped and
was now ready for mining.

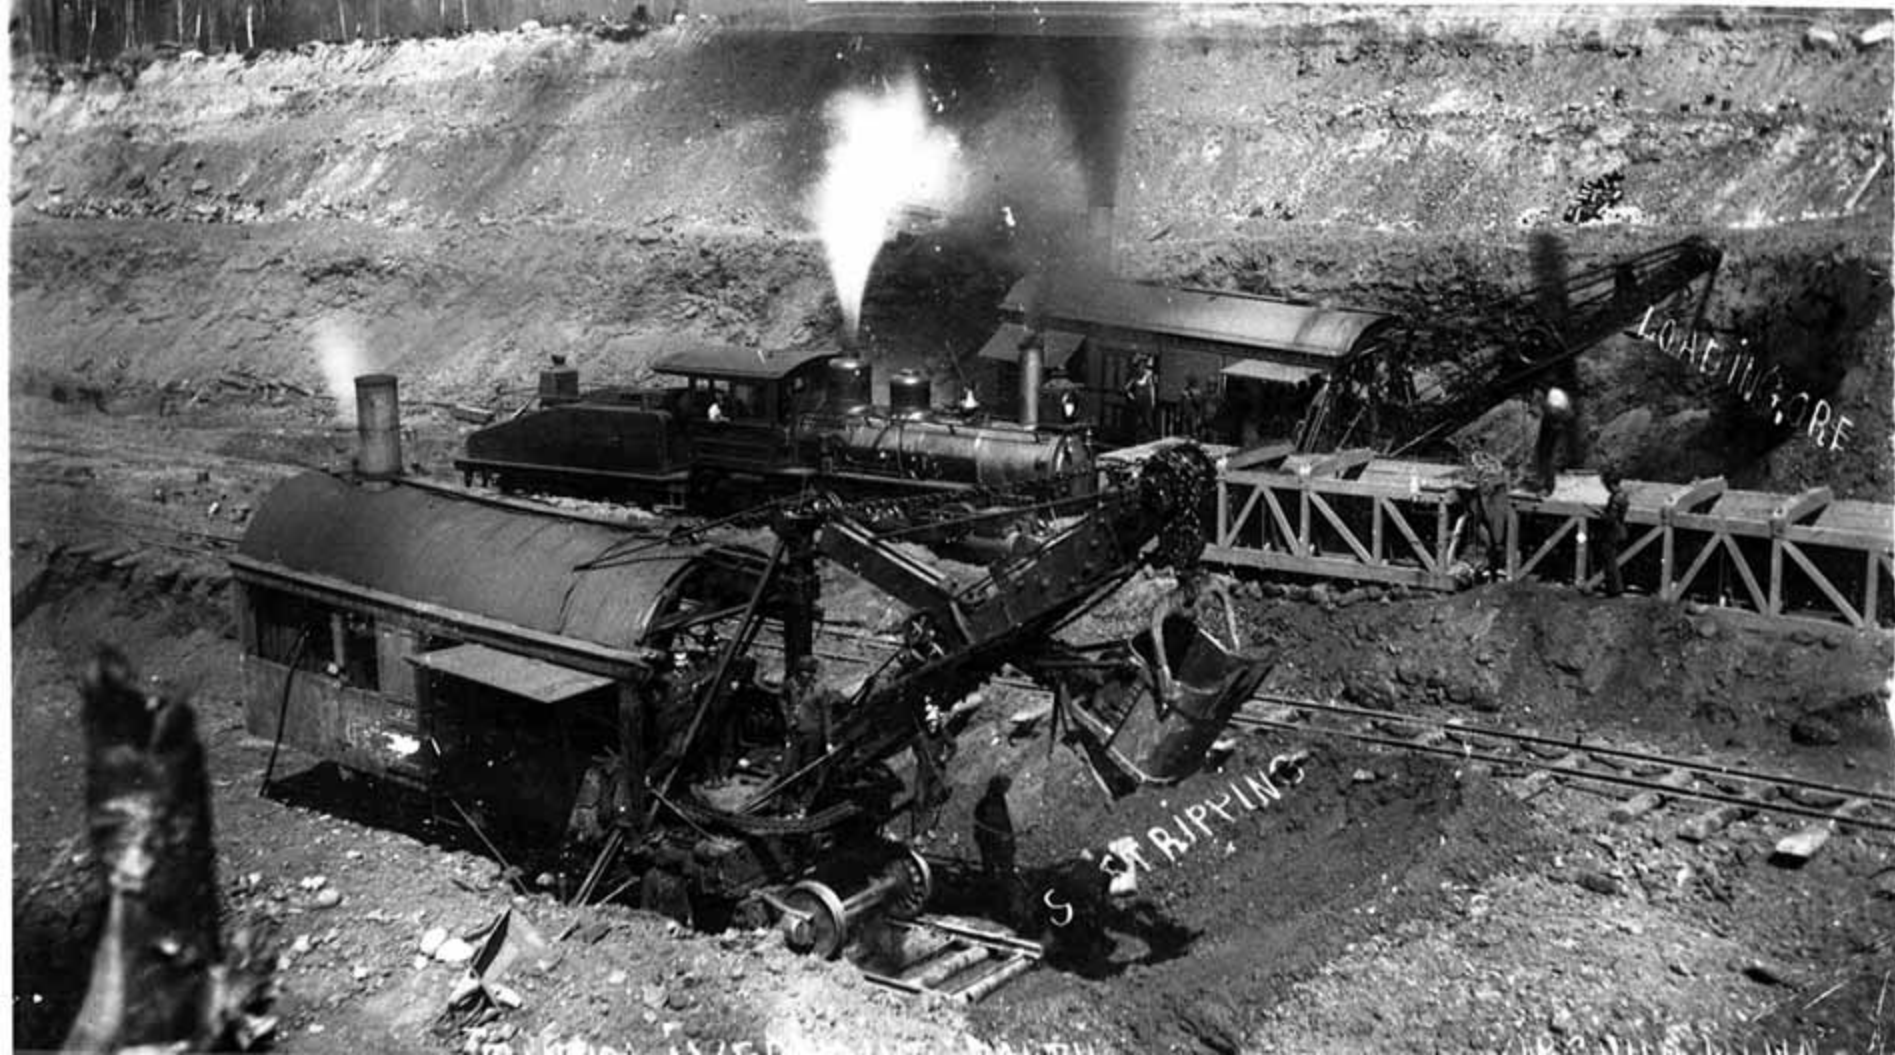
Mesabi Mountain Mine 1894, owned
by the Oliver Mining Co. Drake &
Stratton stripped the mine in 1893.
2.5 Ton Cars are being filled by the
steam-shovel

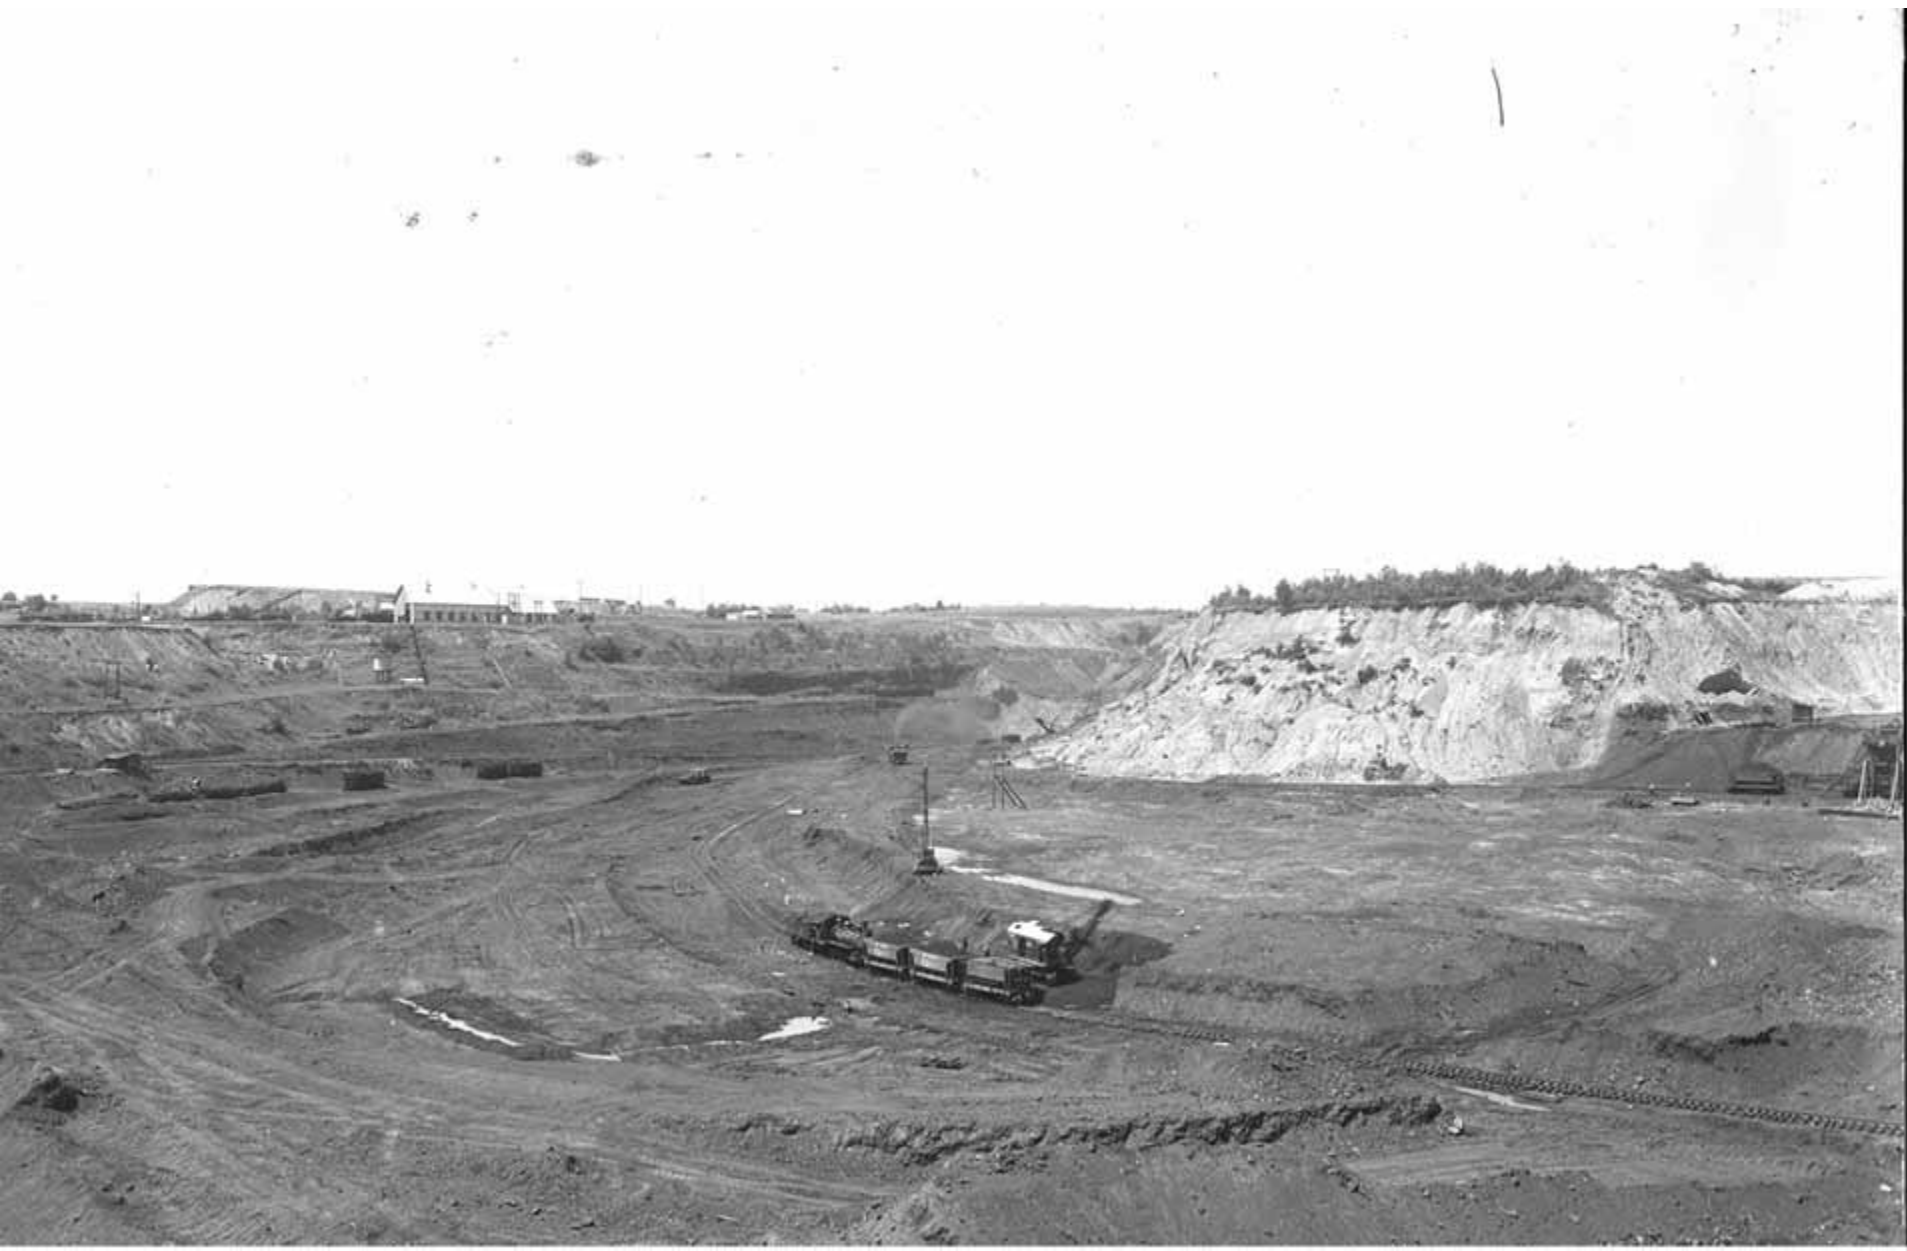
MISSABE PIT
" VIRGINIA MINN.

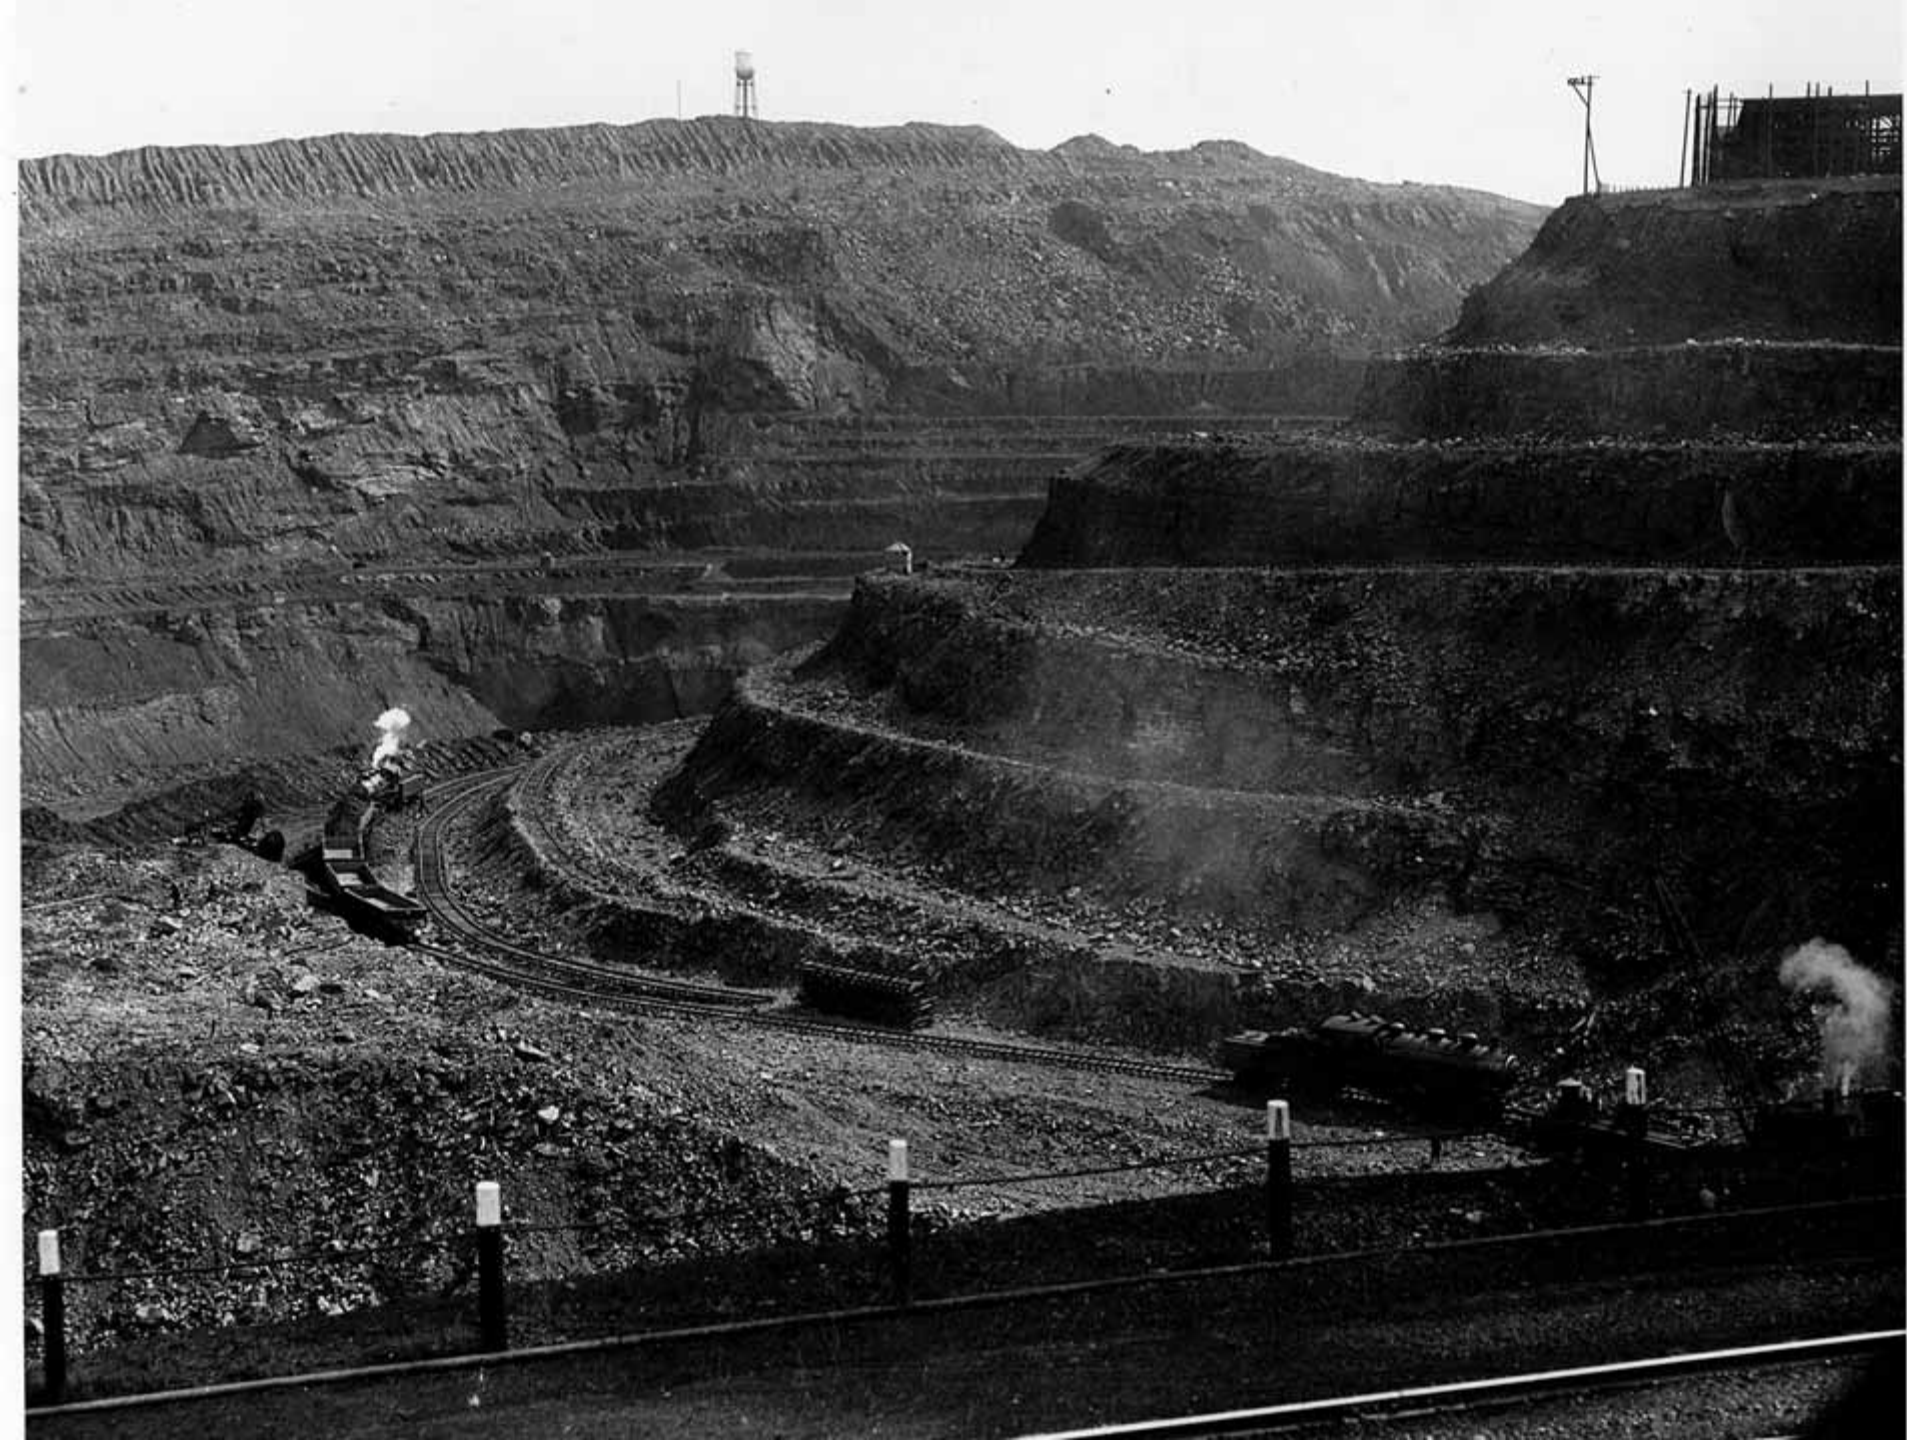
This property has been operated by open pit method, and being of somewhat restricted area, the track grades became so steep as to reach the economical limits of standard steam locomotives. A modified milling system was adopted in which the ore is loaded by the electric shovels into small cars, which are in turn hauled through tunnels to a shaft and hoisted to surface in skips, where it is transferred to railroad cars.

The following description covers briefly the principal features of the installation for the milling system

Five compartment, designed to handle two eight ton skips, cage, counterweight, and ladder road. Ultimate depth approximately 410 feet.

Three tunnels will be driven at 290 feet, 350 feet and 410 feet.

Three 120 B Bucyrus Erie electric. All machines equipped with direct current motors, operated from Motor Generator set, and having Ward Leonard system of control. Power supply carried at 2200 volts, 3 phase, 60 cycles, on pole lines in pit and conveyed to shovels by flexible cables.

This consists of four locomotive cars, and twenty-eight trailer cars, all with capacity of $4\frac{1}{2}$ cu. yds. water level. Gauge 4'8 $\frac{1}{2}$ " Trolley voltage 600 volts D.C. All rolling stock equipped with Timken bearings, and air brakes throughout. This equipment built by The Differential Car Company.

Wire installed at side of tracks in pit a distance of 8 feet from center of track, and 8 feet above top of rail. In tunnels wire installed 2 feet from center of track and 8 ft. 0 in. above top of rail.

This consists of a cage hoist driven by 150 H.P. motor, and ore hoist with cylindro conical drum driven by 500 H.P. motor. Both hoists furnished by the Ottumwa Iron Works, and motors by General Electric Company.

Steel structure with four pockets. Distribution of material from skips to pockets by automatic transfer car. Shaking screen in headframe for screen ore. Headframe designed by H.C. Felver, and fabricated and erected by Worden-Allen Company.

Power purchased from Minnesota Power & Light Company at 20,000 volts, 3 phase, 60 cycles, and stepped down 2200 volts for use of hoists, electric shovels, pumps and air compressors. An additional bank of transformers steps down voltage for 300 K.W. Rotary converter supplying 600 volts D.C. power to haulage system.

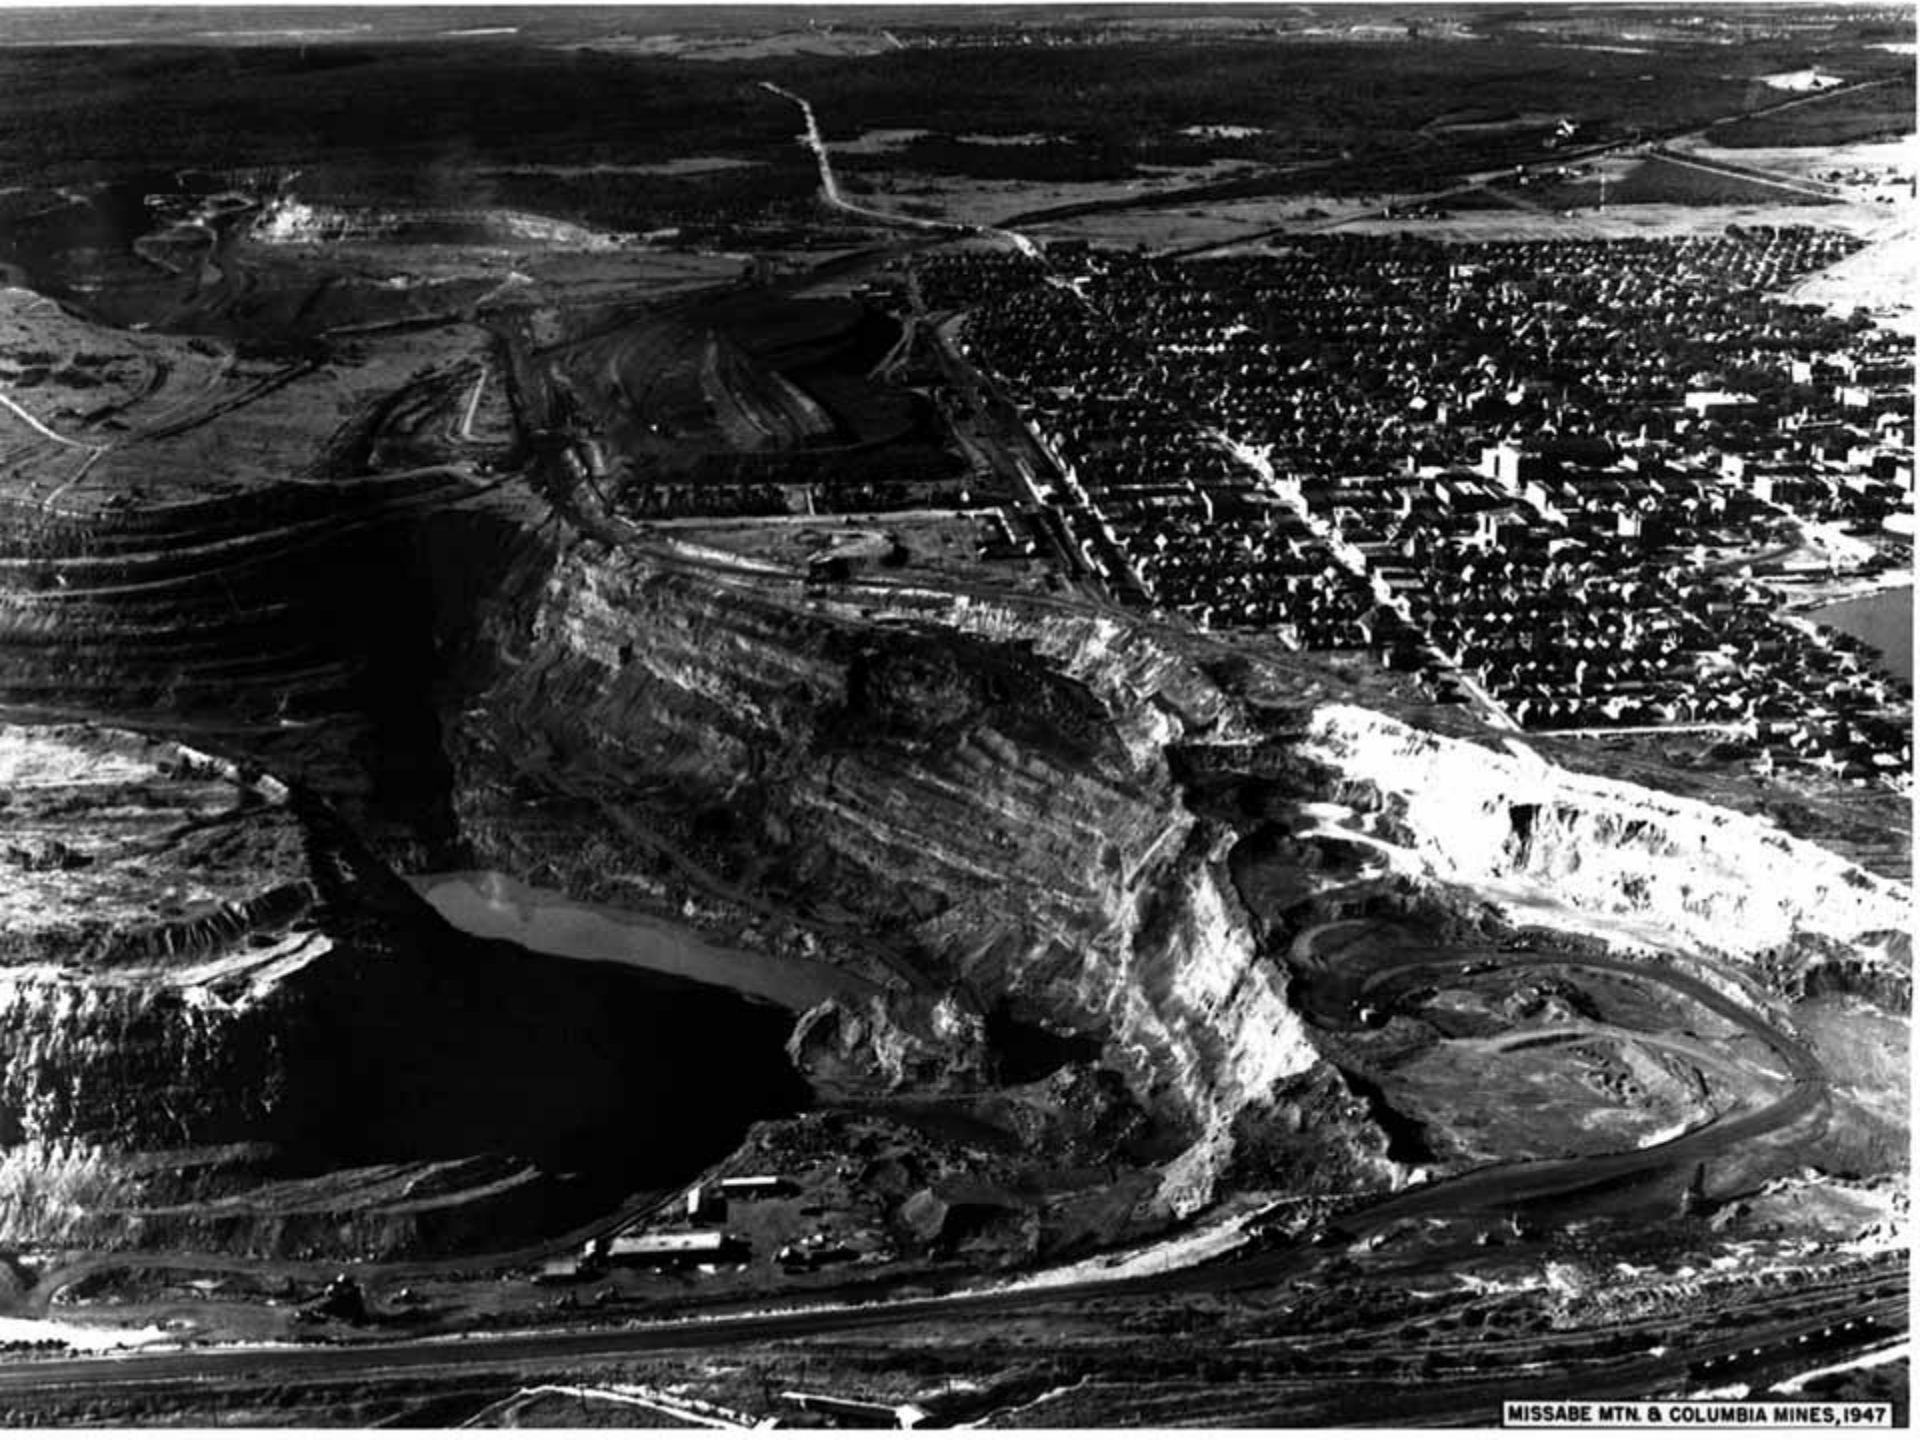
MISSABE MTN. & COLUMBIA MINES, 1947

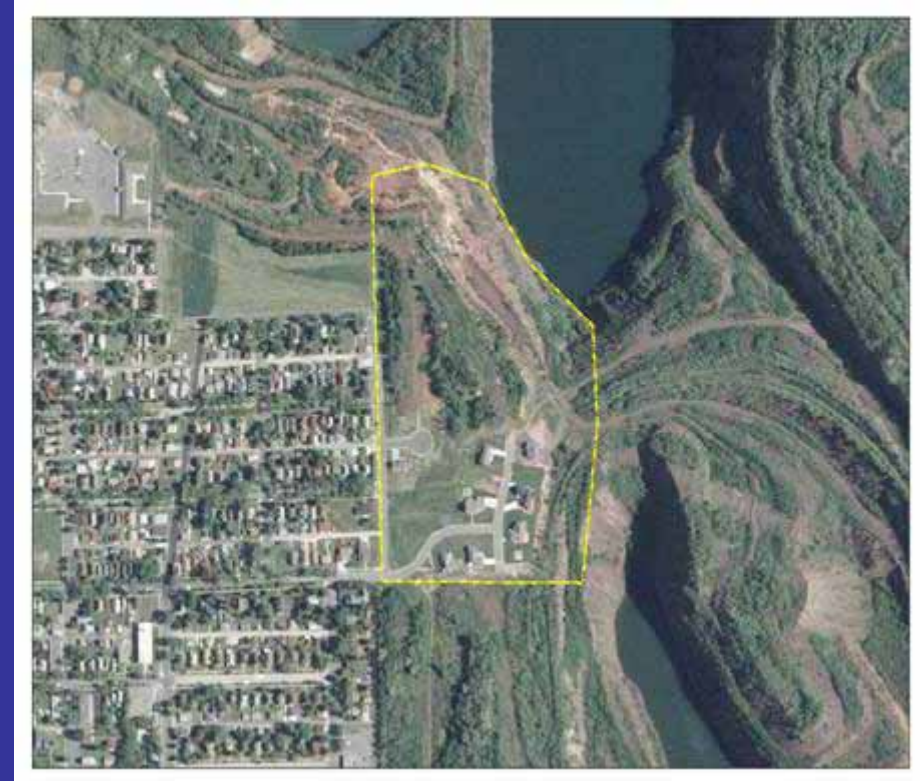
- Phase I ESA included a typical historical search which discussed the proximity to the pit rim
- The only historical uses which were located by the Phase I were employee gardens and a city plat with utility extensions
- The REC were
 - former RR corridor and
 - unknown fill

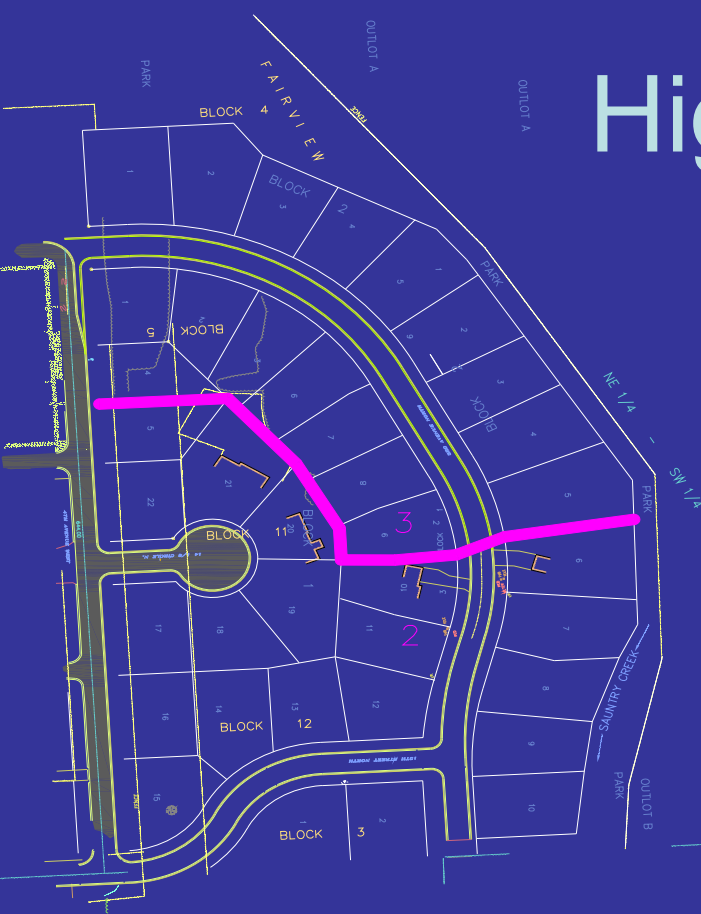
- Historical “Data Gaps” were researched
 - Virginia Historical Society archives
 - Iron World archives
 - Mine inspector records
 - Oliver Mining (US Steel) archives
 - City archives
 - Old Timer interviews
- The REC were still the RR and fill

- About 800 Yd³ soil (DRO/TCB/DBCP) were excavated
- A Certificate of Completion incorporated a CP which required sampling and analysis during
 - future grading
 - utility construction and
 - each building excavation

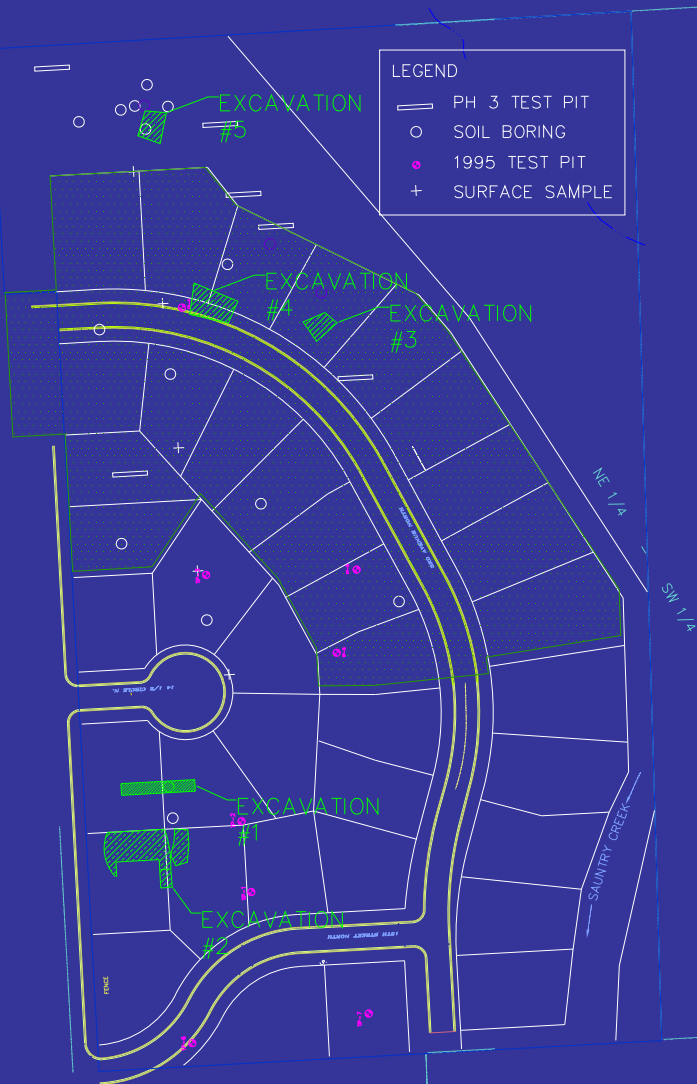
Release Summary

Exc	Date	Volume	COC
Exc #1	1995	20	DRO
Exc#2	1998	800	DRO/TCB/ DBCP/PCB
Exc #3	2007	1940	DRO/TCB/ PCB
Exc#4	2007	84	As
Exc#5	2007	800	DRO/GRO
Exc#6	2007	100	DRO
