Assessment Report of Selected Lakes within the Sauk River Watershed

Minnesota Pollution Control Agency

Water Monitoring Section
Lakes and Streams Monitoring Unit
July 2010

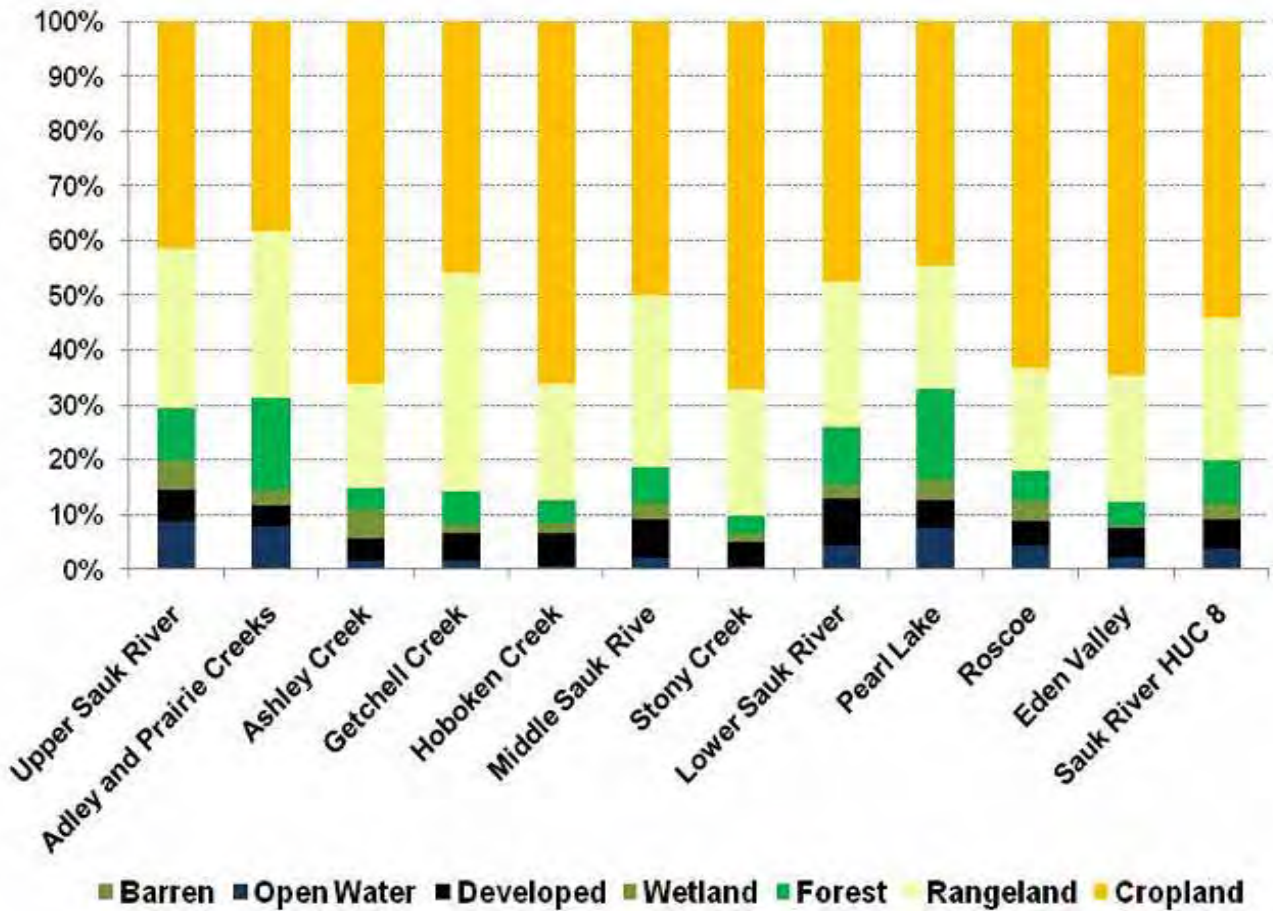
Figure 2 Land use the Sauk River HUC 11 watersheds

The Sauk River Watershed is dominated by crop and rangeland with few patches of forest and wetland areas (Figure 2). The eleven digit HUC's have a similar land use composition. Since runoff from cultivated and pastureland is more nutrient-rich than forest or wetland runoff, nutrient loads to rivers and lakes in many of the 11 digit HUCs may be high. A more detailed assessment of land in Sauk River Watershed including: relief, ownership, soil published by the National Resource Conservation Service (NRCS) can be found at <http://www.mn.nrcs.usda.gov/technical/rwa/assessments/reports/sauk.pdf>.

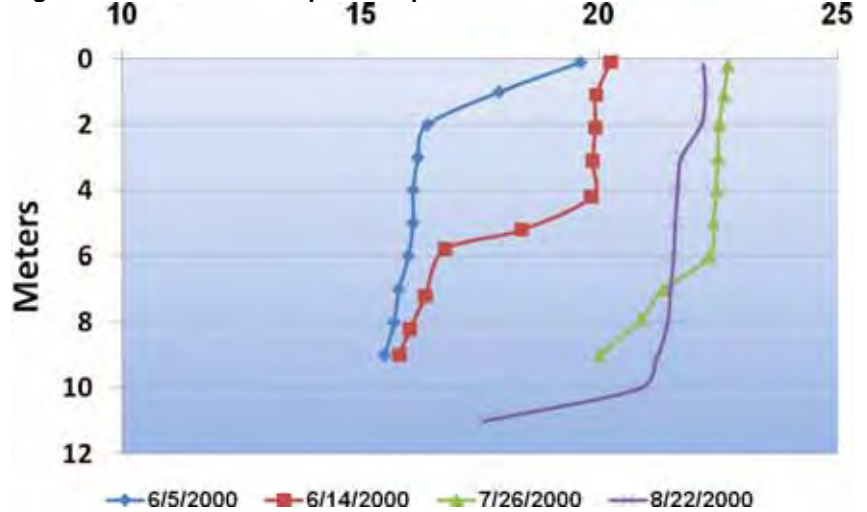
Figure 12. Smith Lake temperature profiles

Weak thermal stratification was evident in most 2000 profiles. A thermocline was evident in mid-June at four to six meters (Figure 12). DO values in the upper 6 M remained above 5mg/L. Hypoxic (DO <2.0 mg/L) conditions were present in the lower depth throughout the 2000 monitoring. These periods of low or no-DO near the sediments allow for internal recycling of phosphorus (P) from the sediments, which can contribute to elevate TP in the upper waters upon wind mixing.

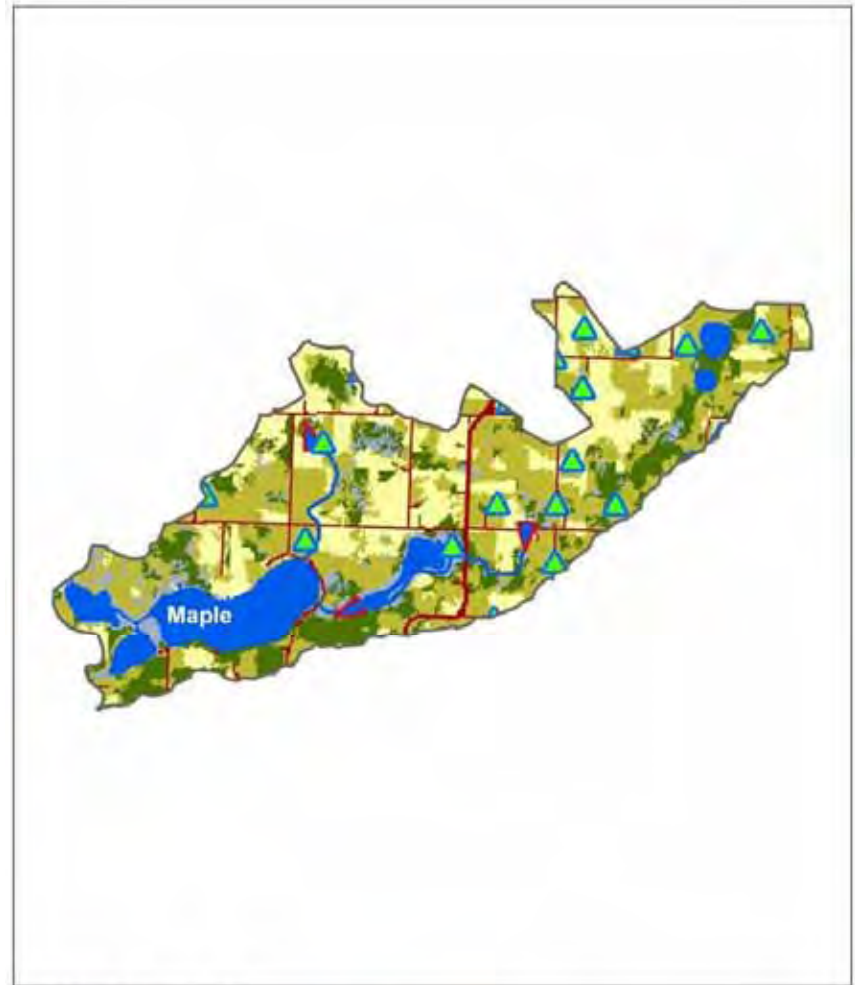
Figure 23. Maple Lake catchment and landuse map

Maple Lake is moderate-sized lake (376 acres) with typical basin bathymetry. The lake drains to the east eventually reaching Lake Osakis. The majority of the catchment is comprised of crop and range land with a fair amount of forested land (Figure 23).

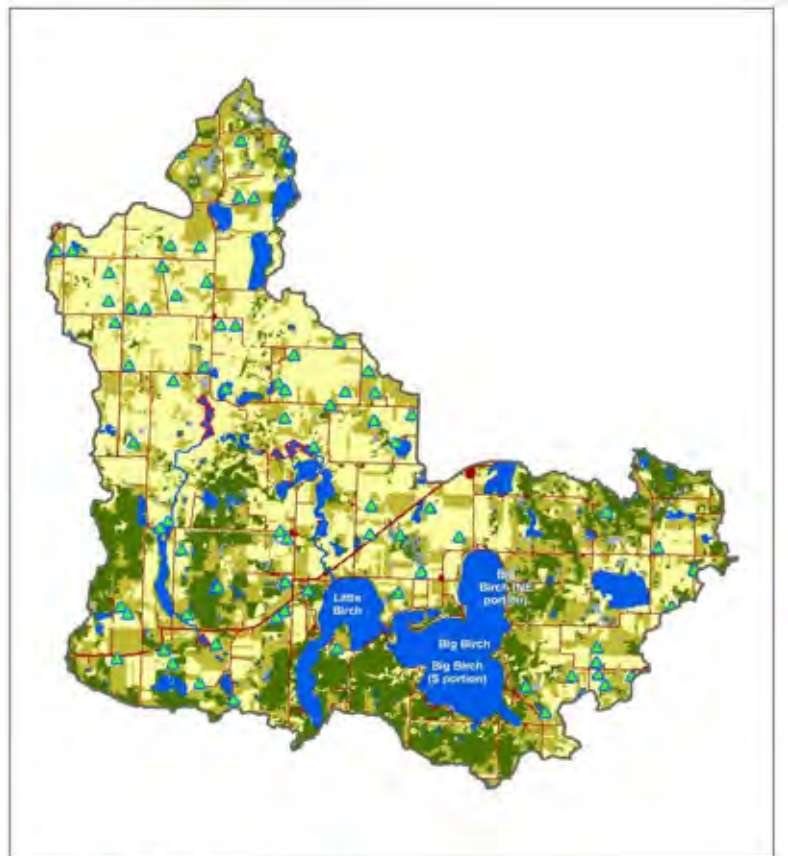
Figure 72. Lake catchment and landuse map

Little Birch Lake is deep at 27 meters (89 feet) with only 31% littoral depth. The lake has a larger watershed that includes Big Birch Lake as well as a fair amount of forested area and small lakes (Figure 72).

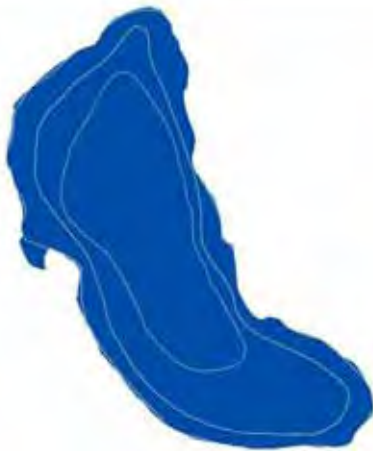
Figure 78. Sand Lake catchment and landuse map

Sand Lake is a small (210 acres) shallow (100% littoral) lake located three miles southwest of Albany. The lake has a very small closed basin watershed. A feedlot facility is located on the west edge of the lake.

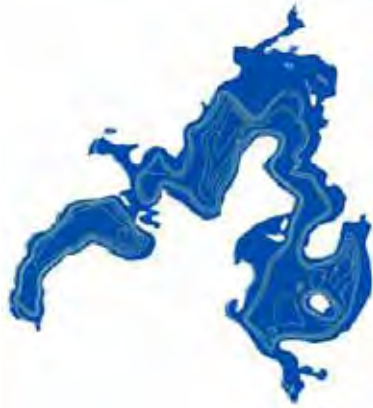
Figure 87. Horseshoe Lake catchment and landuse map

Horseshoe is a 241 Hectare lake with a maximum depth of 17.3 (87 feet) located near Richmond Minnesota. The Eden Valley HUC 11 as well as Sauk River drains into Horseshoe lake Water quality reports written by them MPCA with local partners were published in 1985 and 1995. These reports can be found at <http://www.pca.state.mn.us/water/lakereport.html>

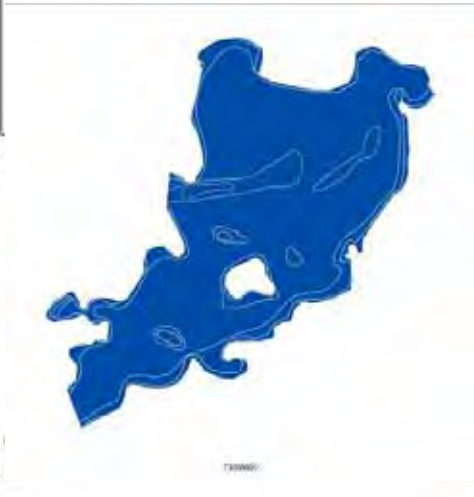
Figure 104. Knaus Lake catchment and landuse map

Knaus Lake is located on the east on of the Horseshow chain of lakes, (just east of Great Northern Lake). The lake is a riverine lake with a maximum depth of five meters (Figure 104). The lake has very large watershed, consisting of many upstream HUC 11's.

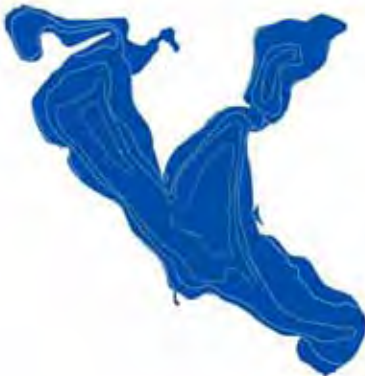
Figure 137. Lake catchment and landuse map

Big Lake is located in south central Stearns County, three miles southwest of Richmond. The lake has a moderate depth and a medium sized watershed with many feedlots (Figure 137).
