Effects of Liquid Manure Storage Systems on Ground Water Quality

April 2001

Minnesota Pollution Control Agency
Ground Water and Toxics Monitoring Unit
Environmental Monitoring and Analysis Section
Environmental Outcomes Division
520 Lafayette Road
St. Paul, Minnesota 55155-4194
(651) 296-6300 or (800) 657-3864

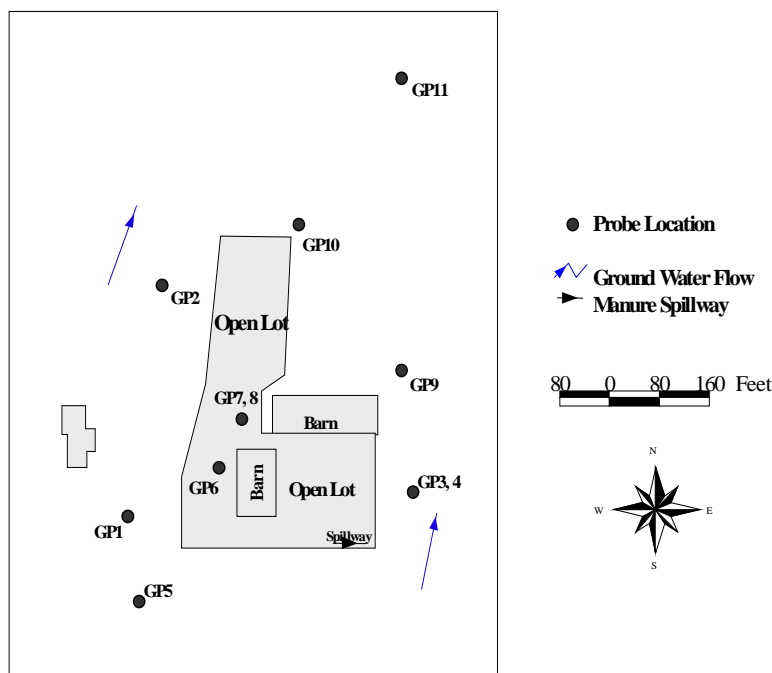
Figure 2 illustrates the location of temporary wells at Site O1. Ground water flow is to the north-northeast. Table 3 summarizes water quality data for each of the wells.

Figure 2: Location of temporary wells and direction of ground water flow at Site O1.

Well 10 was impacted by the feedlot, with concentrations of Kjeldahl nitrogen, ammonia, and organic carbon more than ten times greater than concentrations in up-gradient wells. Nitrate-reducing conditions occurred in this well, and nitrate was below the reporting limit of 0.020 mg/L. Well 11 had chloride and organic carbon concentrations that were more than double the concentrations in up-gradient wells, but the overall rank of 5.1 was low. We estimated a plume length of approximately 425 feet from the center of the feedlot to Well 11 (see Section 2.4 for a description of methods used in estimating plume length).

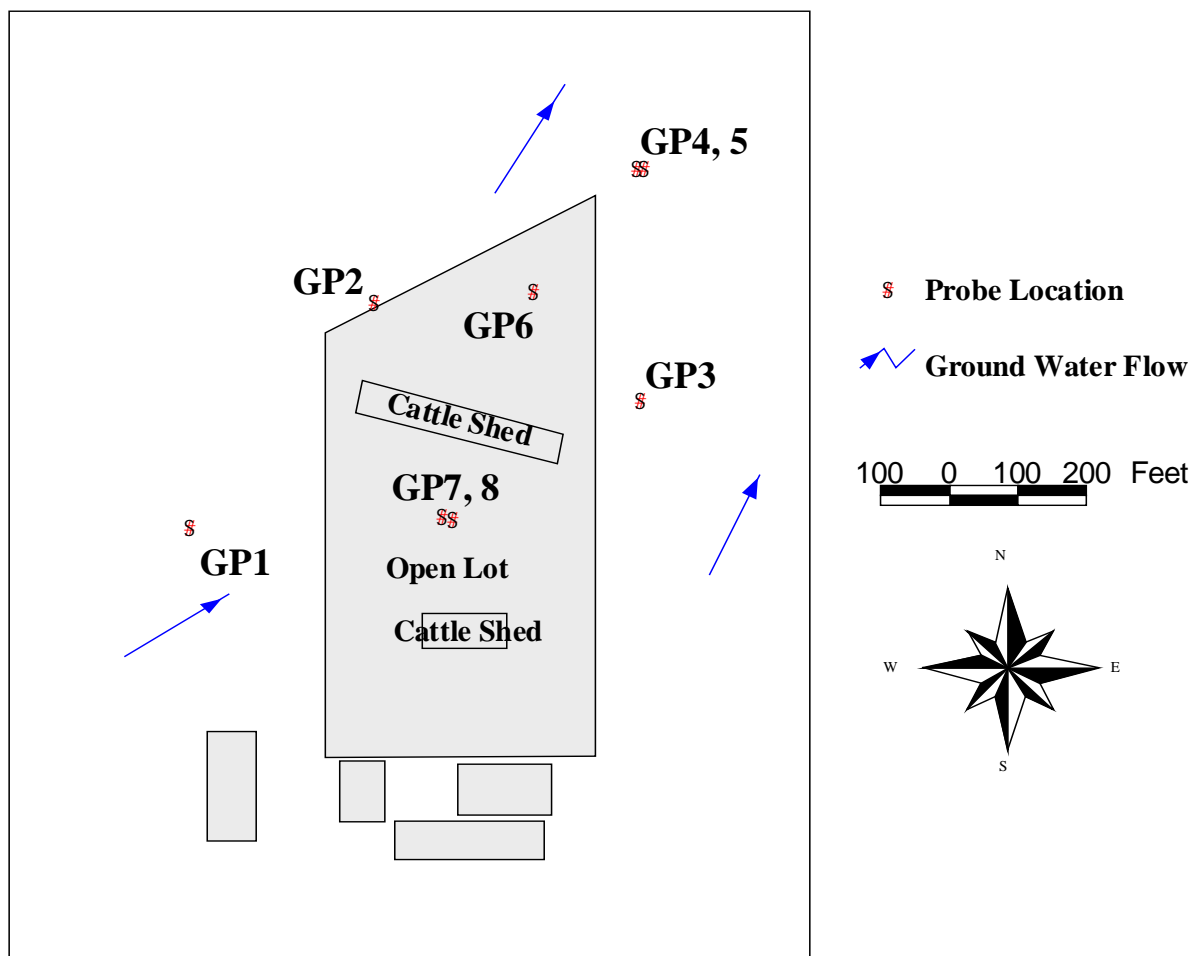
Figure 3 illustrates the location of temporary wells at Site O2. Ground water flow is to the northeast. Table 4 summarizes water quality data for each of the wells.

Figure 3: Location of temporary wells and direction of ground water flow at Site O2.

found at most other sites. Second, Site O2 operates as a temporary feedlot, where animals are removed on a periodic basis and manure and soil are scraped and removed. Because of the intermittent animal activity and the deep water table, soils at the site may not be excessively compacted and water leaching through the soil may be oxidized. Nitrogen therefore leaches as nitrate. Total nitrogen concentrations at Wells 4 and 5, located about 220 feet down-gradient of the feedlot, were about an order of magnitude greater than in Well 1. A nitrate plume therefore extends at least 220 feet from the feedlot.

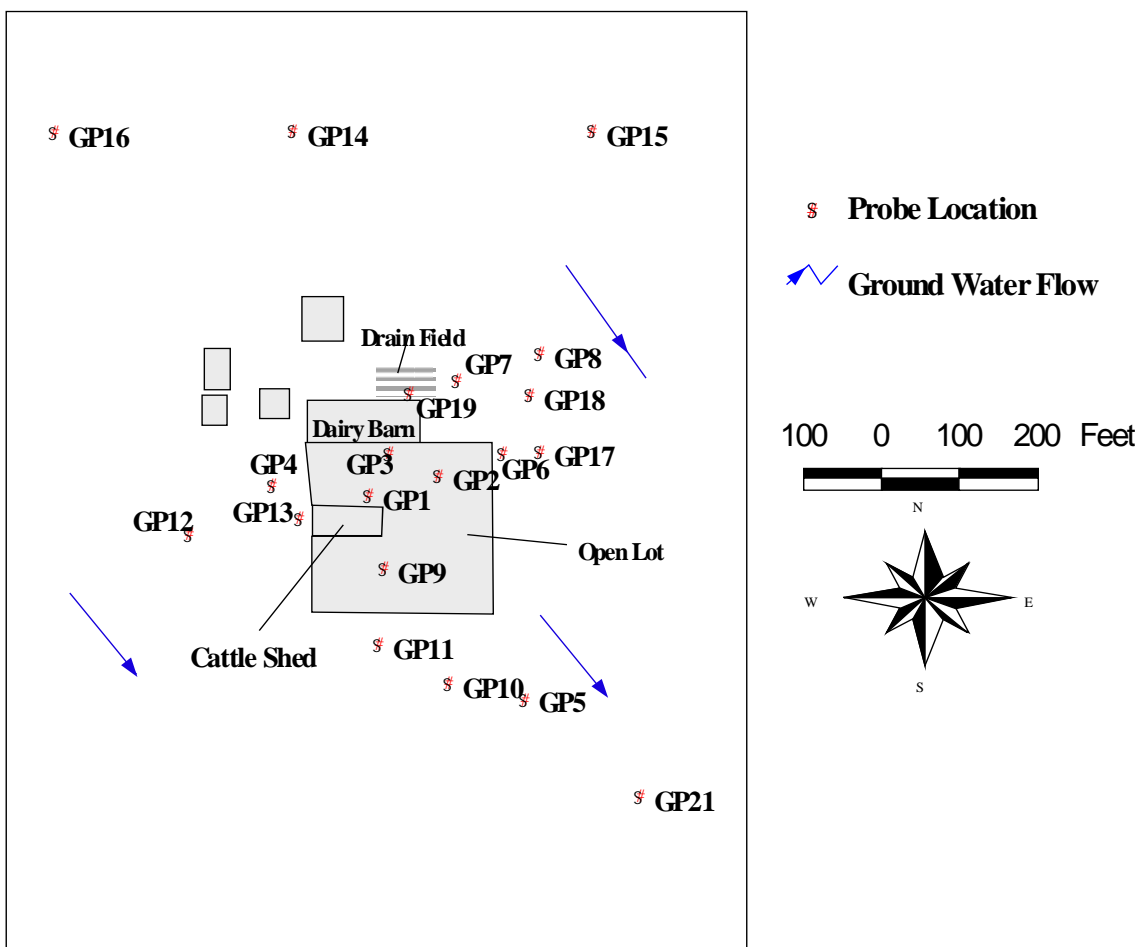
Figure 4 illustrates the location of temporary wells at Site O3. Ground water flow is to the southeast. Table 5 summarizes water quality data for each of the wells.

Figure 4: Location of temporary wells and direction of ground water flow at Site O3.

Wells 1, 3, and 9, located in or just down-gradient of the feedlot, are impacted by the feedlot. Average ranks in these wells exceeded 14, compared to 6.4 in Well 12. We observed ammonia concentrations as high as 35.9 mg/L and total nitrogen concentrations as high as 41.4 mg/L down-gradient of the feedlot. Concentrations of nitrate in up-gradient wells were more than 35 mg/L, except for Well 12. Well 12 is located in an area where crops are not grown, and it appears to be less affected by agricultural activities than Wells 4, 13, and 14. Concentrations of phosphorus, chloride, and iron were much higher beneath and just down-gradient of the feedlot compared to other locations. A plume appears to extend to Well 5, as indicated by elevated concentration of chloride compared to up-gradient wells. The average rank in Well 5 was 8.6. The average rank in Well 21, located about 600 feet down-gradient of the feedlot, was 4.6. A plume, therefore, extends somewhere between Well 5 and Well 21. We estimated a distance of 400 feet.

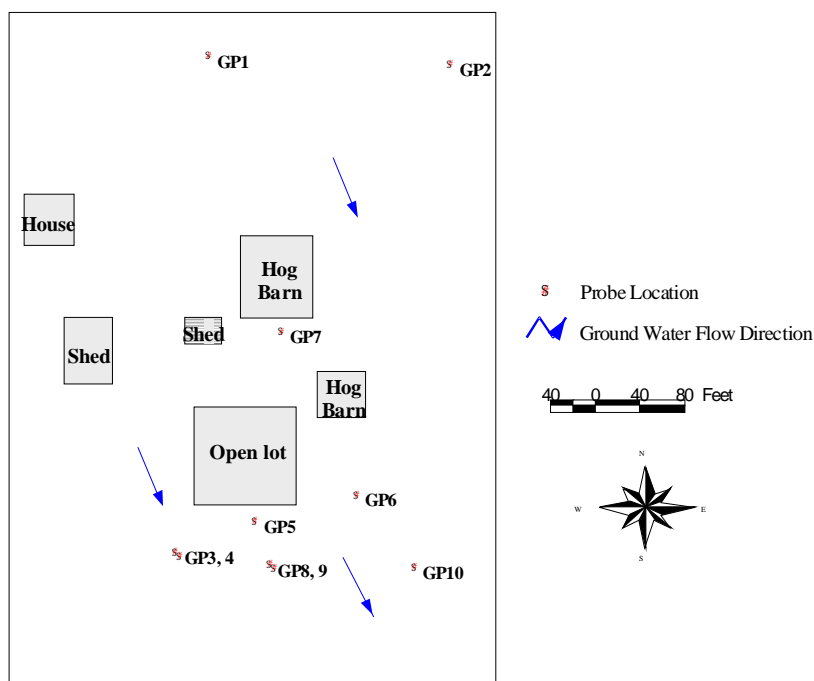
Figure 5 illustrates the location of temporary wells at Site O4. Ground water flow is to the southeast. Table 6 summarizes water quality data for each of the wells.

Figure 5: Location of temporary wells and direction of ground water flow at Site O4.

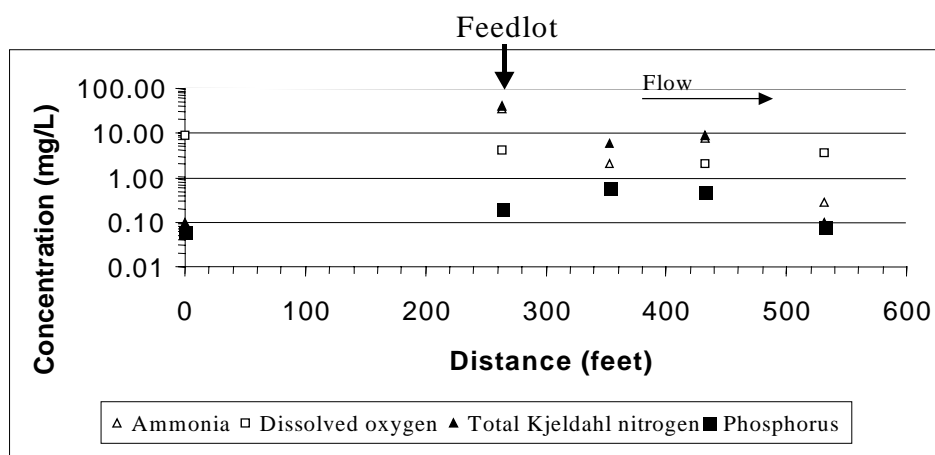
Figure 6: Distribution of chemicals along a ground water flow path passing beneath the open feedlot at Site O3. Concentrations are in mg/L.

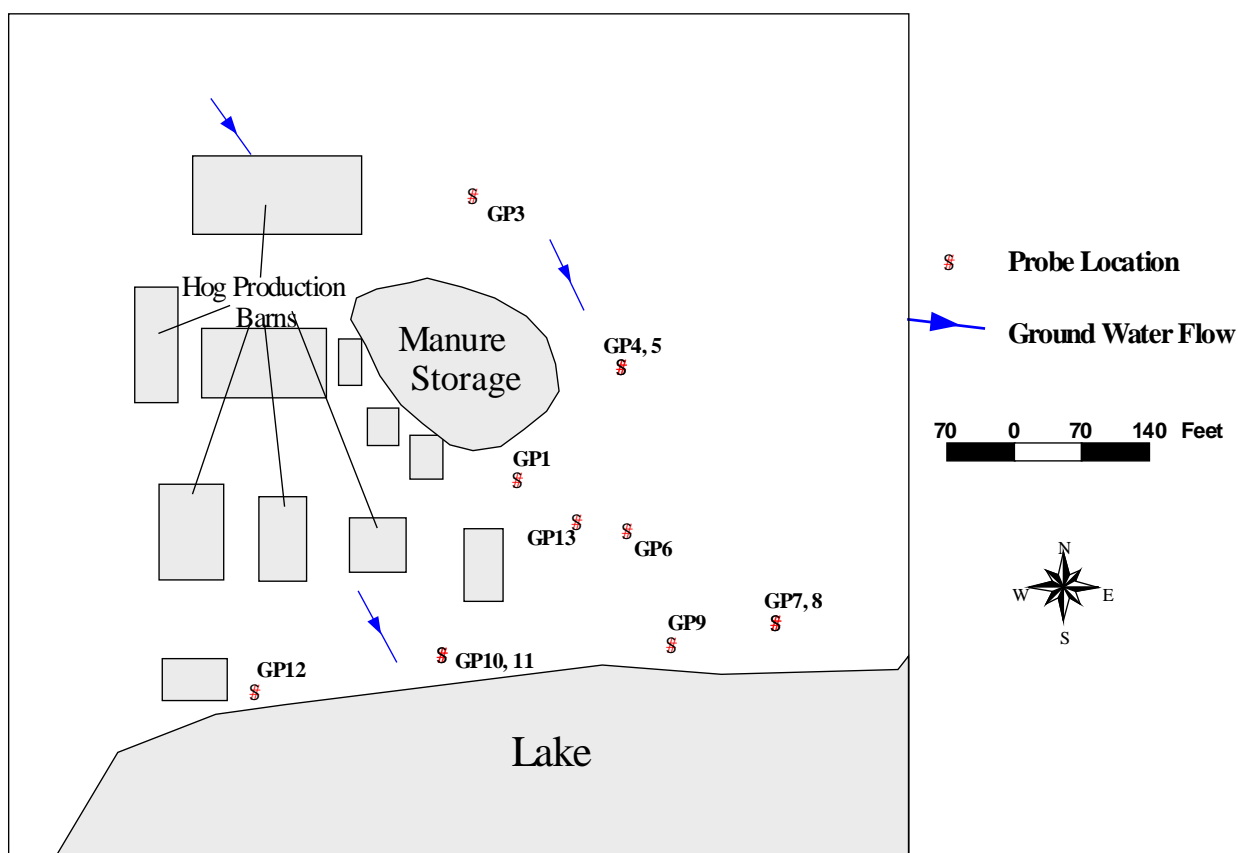
Figure 8: Location of temporary wells and ground water flow direction at Site U1.

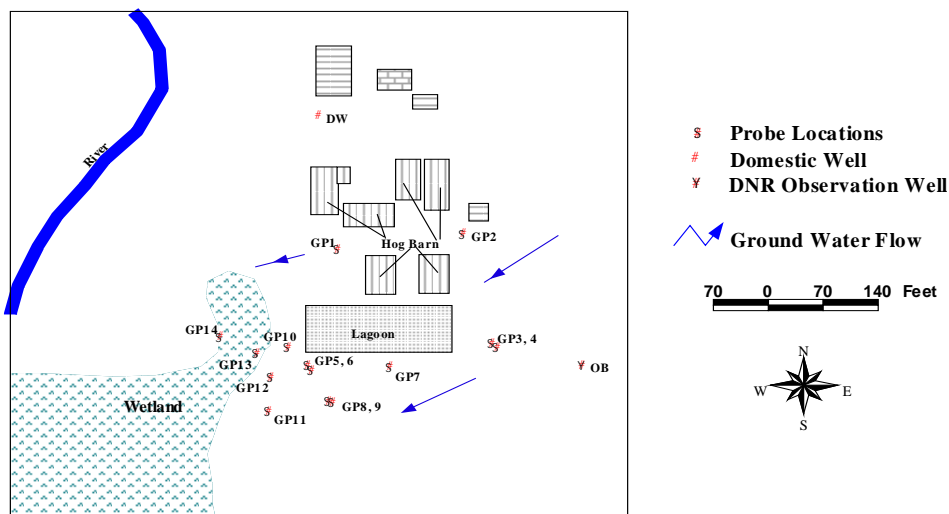
Figure 10 illustrates the location of temporary wells at Site U3. Ground water flow is to the southwest. Table 11 summarizes water quality data for each of the wells.

Figure 10: Location of temporary wells and ground water flow direction at Site U3.

Concentrations of *E. coli* bacteria do not correlate with the location of the unlined basin. Bacteria were found in Wells 3 and 4, which are up-gradient of the basin, and in Wells 10, 13, and 14, which are the furthest down-gradient wells. No bacteria were found in wells closest to the basin. Bacteria in up-gradient wells may be associated with spreading of manure, although we do not have information on the cropping history of fields adjacent to the manure storage

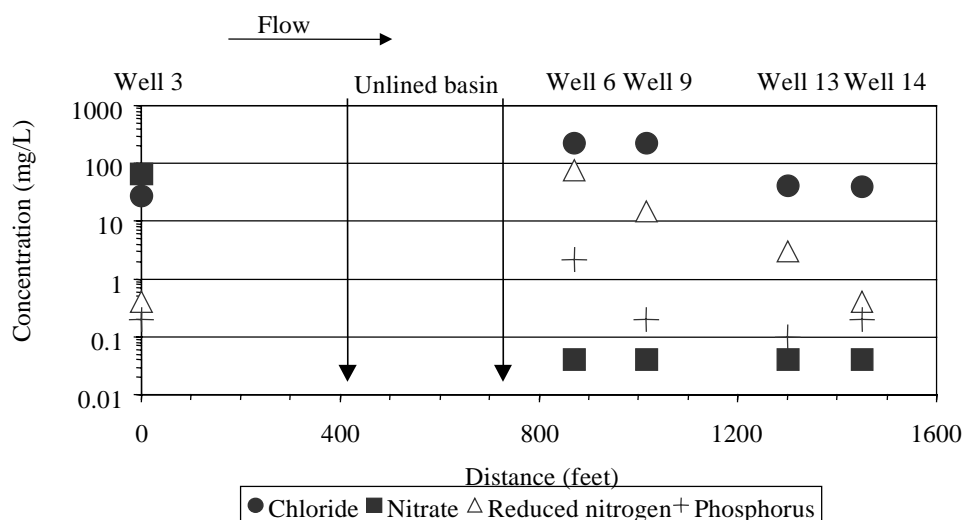
Figure 11: Distribution of chloride, reduced nitrogen, nitrate, and phosphorus along a ground water flow path passing beneath the unlined manure basin at Site U2.

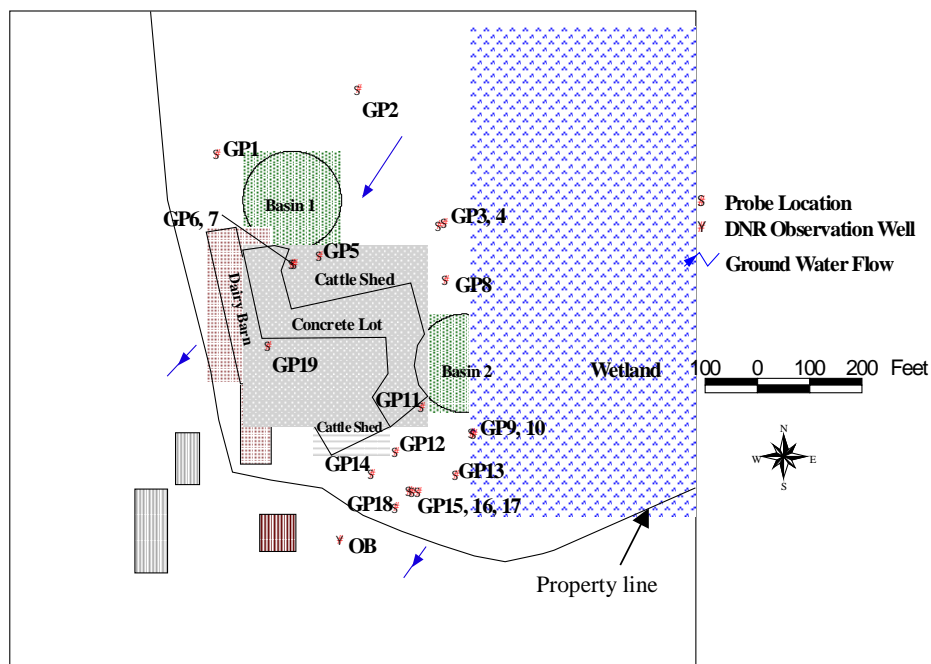
Figure 13: Location of temporary wells and ground water flow direction at Site E1.

Well 7, located immediately down-gradient of Basin 1, showed impacts from manure storage. Concentrations of ammonia, chloride, dissolved organic carbon, phosphorus, and Kjeldahl nitrogen were 66, 94, 39, 0.55, and 77 mg/L, respectively. This compares with concentrations of 0.05, 8.1, 1.0, 0.04, and 0.3, respectively, in Well 2, which was up-gradient of the feedlot. The Eh in Well 7 was very low (73 mV), while iron concentrations were high (22.4 mg/L), reflecting nitrate-reducing conditions. Well 6, which formed a nest with Well 7, was drilled five feet deeper than Well 7. No water quality impacts were evident in Well 6. A plume extends to Well 19, since concentrations of ammonia in this well were 8.78 mg/L. Well 19 was located about 275 feet from the center of Basin 1.

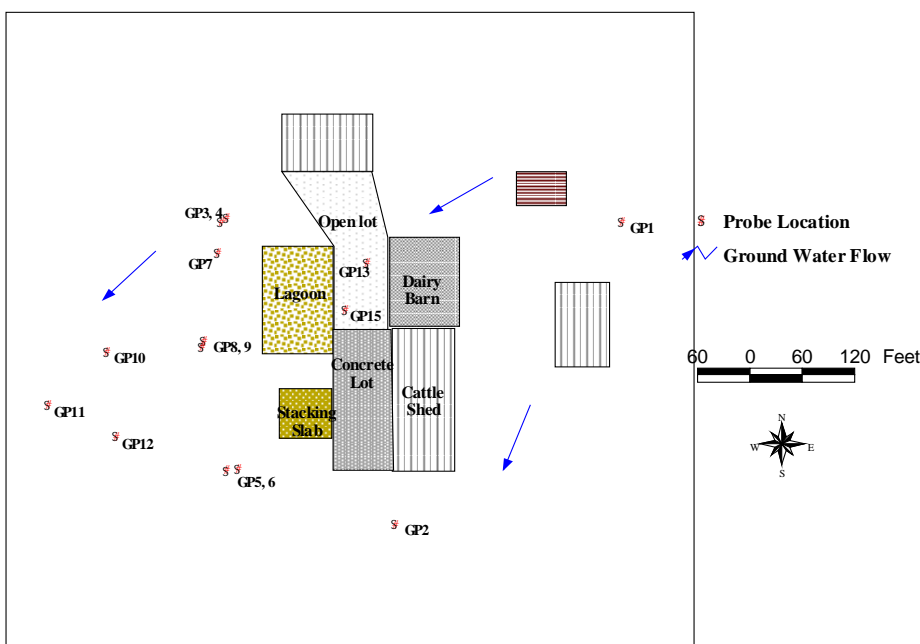
Figure 14 illustrates the location of temporary wells at Site E2. Ground water flow is to the southwest. Table 15 summarizes water quality data for each of the wells.

Figure 14: Location of temporary wells and ground water flow direction at Site E2.

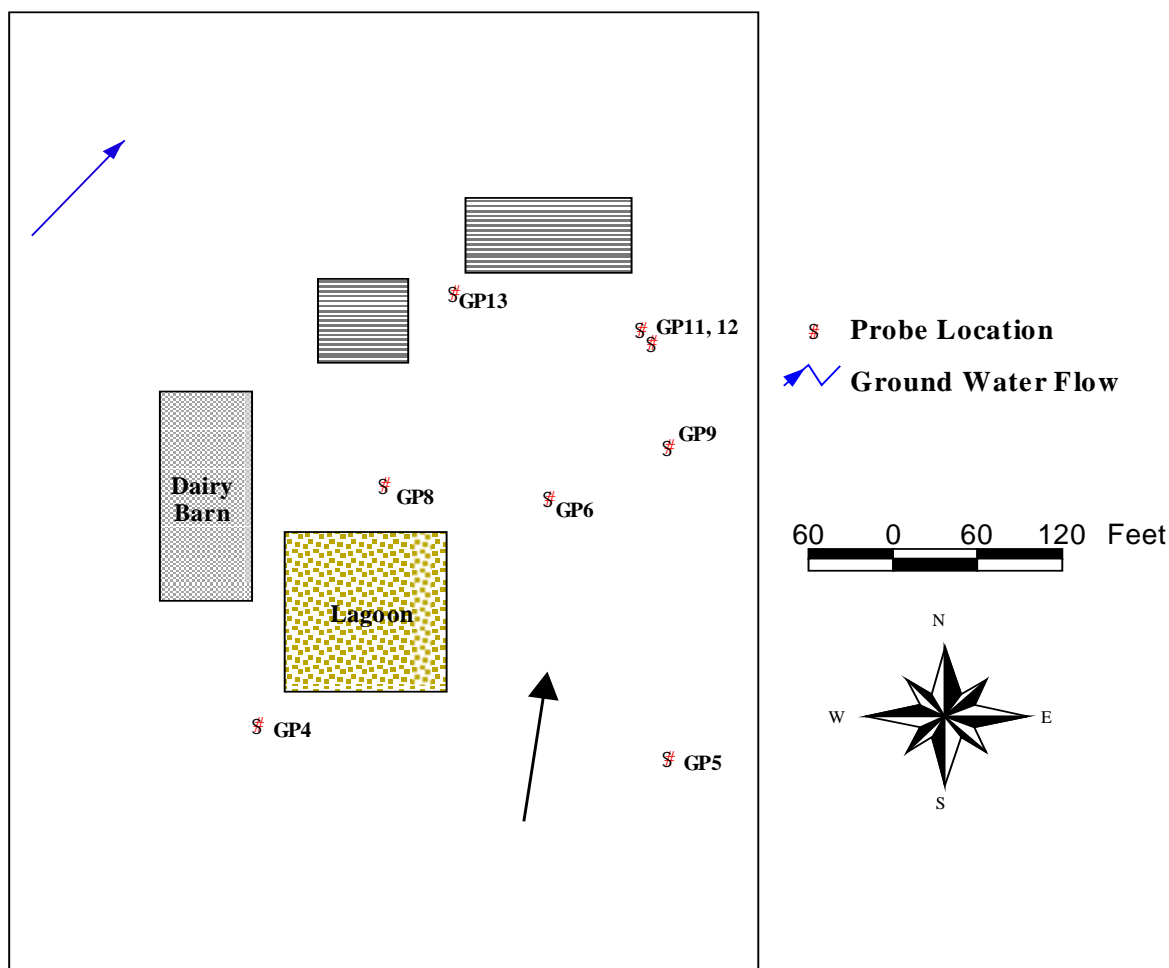
Figure 15 illustrates the location of temporary wells at Site E3. Ground water flow is to the northeast. Table 16 summarizes water quality data for each of the wells.

Figure 15: Location of temporary wells and ground water flow direction at Site E3.

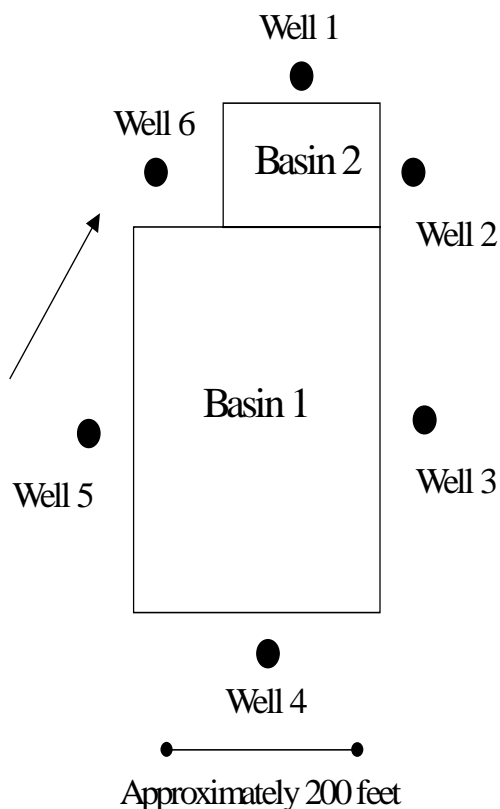
Figure 17: Location of monitoring wells, storage basins, and ground water flow direction (arrow) at Site EM1.

correlations with sampling event were observed in Well 2 for sulfate and nitrate, and in Well 1 for sulfate and chloride. Positive correlations with sampling event were observed in Wells 1 and 2 for specific conductance.

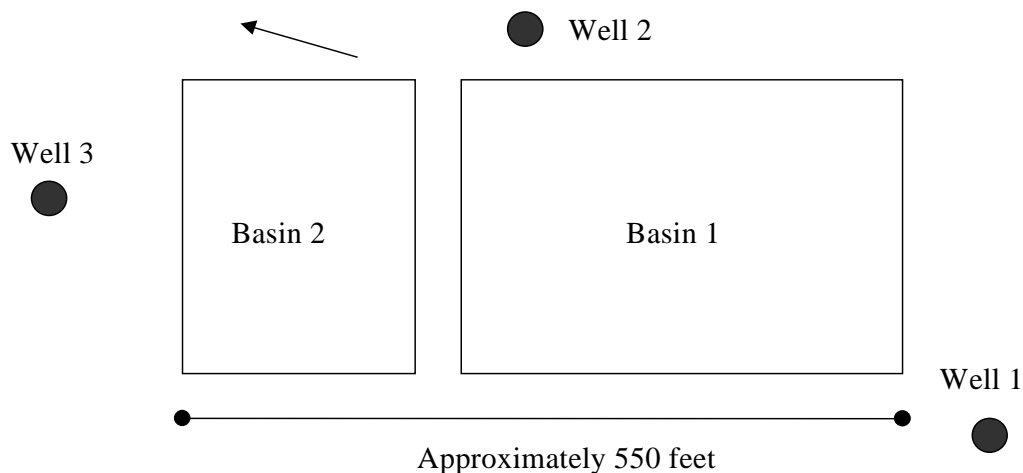
Figure 18: Location of manure storage basins, monitoring wells, and ground water flow direction (arrow) at Site EM2.

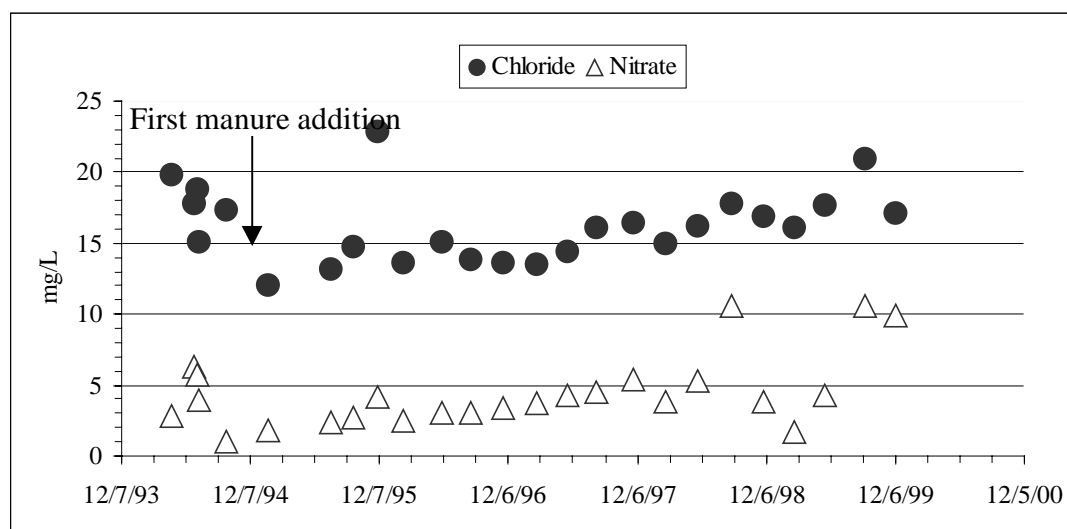
Figure 19: Concentrations of chloride and nitrate as a function of sampling date in Well 3 at Site EM2.

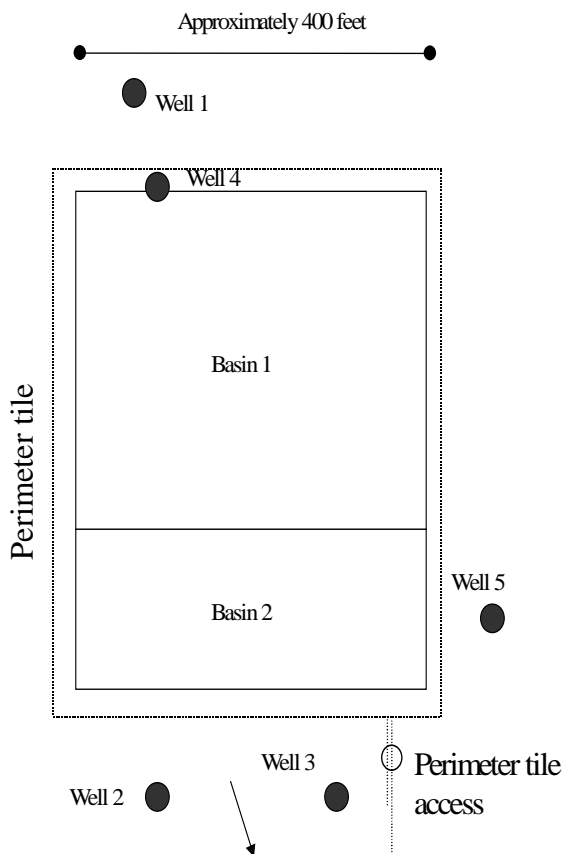
Figure 20: Location of monitoring wells, tile lines, storage basins, and ground water flow direction (arrow) at Site EM3.

To further explore potential impacts from the basins, we calculated nonparametric correlation coefficients between sampling parameters and sampling event (Table 21). There was a negative correlation between sampling event and concentrations of ammonia and nitrate in Well 3. Well 5, which is down-gradient of the manure basin, showed a strong negative correlation (-0.925) between sampling event and chloride concentration.

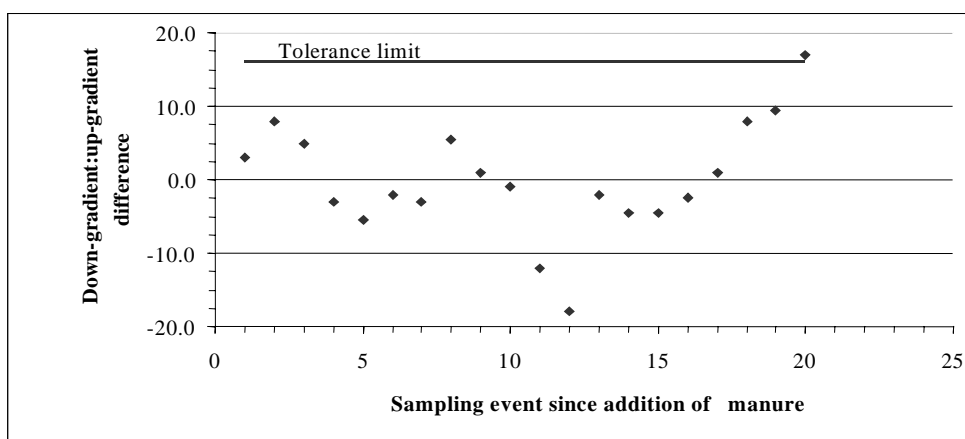
Figure 21: Difference between down-gradient (Wells 3 and 5) and up-gradient (Well 1) ranked concentrations of chloride at site EM3 since addition of manure. The 90 percent tolerance limit is included in the plot.

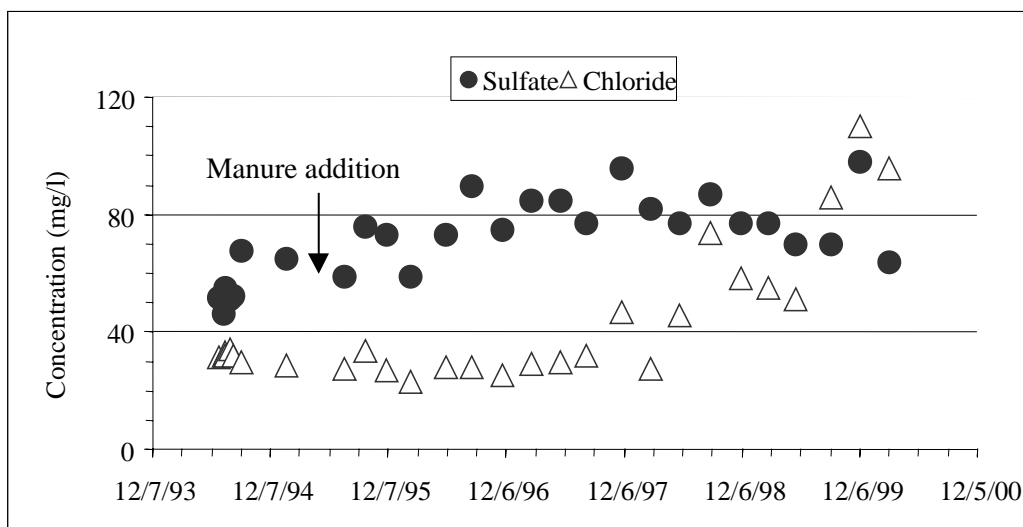
Figure 22: Concentrations of chloride and sulfate in the perimeter tile at Site EM3.

Concentrations of sulfate and chloride in the tile line were positively correlated ($R^2 = 0.664$ for sulfate and 0.514 for chloride) with sampling event, indicating increasing concentrations during the sampling period. Flow information was not available for the tile line. There were no seasonal differences in concentrations of chloride and sulfate. Figure 22 indicates the concentration of chloride has increased steadily since July 1997. The results suggest that the tile line may be intercepting ground water from the storage basin.

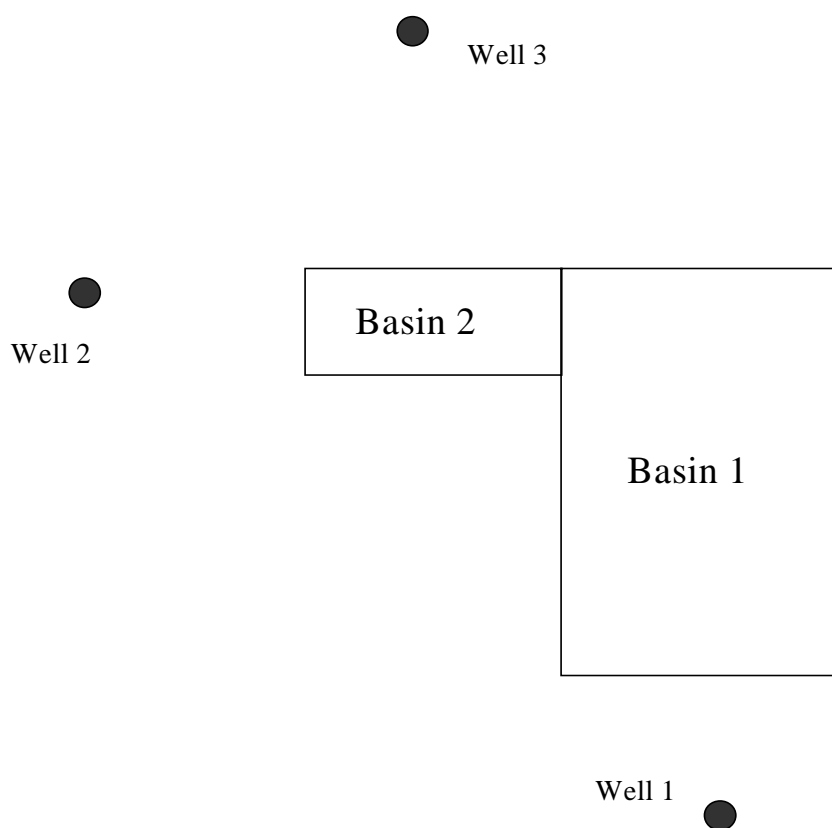
Figure 23: Location of wells and manure basins at Site EM4. Ground water flow direction is unknown.

Ground water flow direction has not been consistent at the site, making it difficult to determine which wells are up-gradient and down-gradient of the manure basin. Only one to three samples were collected each year since sampling began in 1996. There was no correlation between sampling event and chemical concentrations in wells.

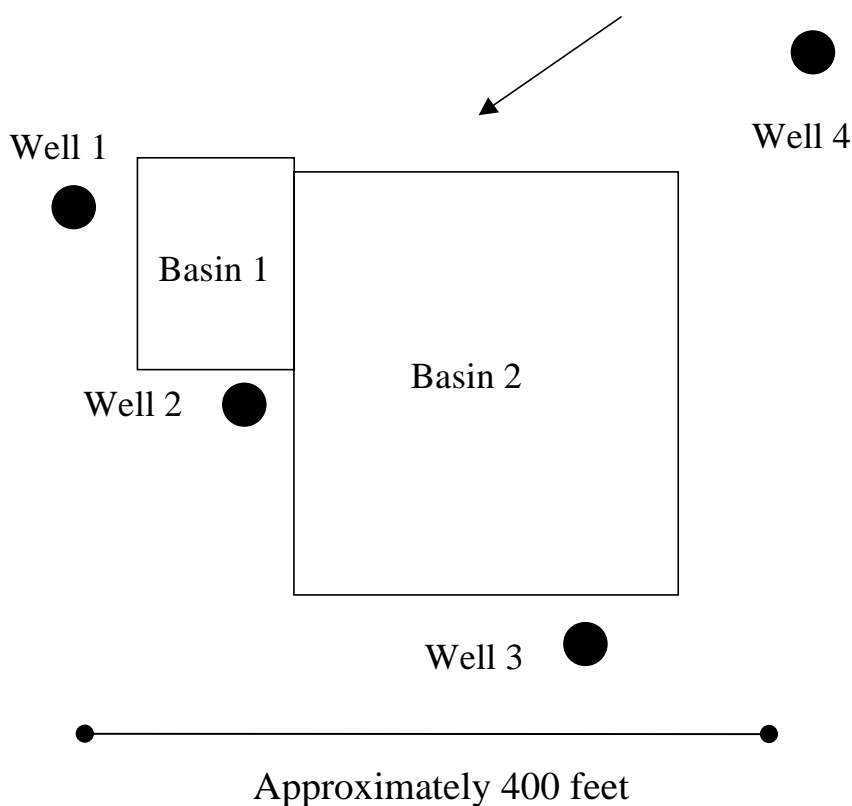
Figure 24: Location of monitoring wells, manure basins, and ground water flow direction (arrow) at site EM5.

We calculated nonparametric correlation coefficients between sampling event and chemical concentration. Table 22 summarizes results of this analysis. The data reveal no significant correlations between sampling event and chemical concentrations in the down-gradient well (Well 2).

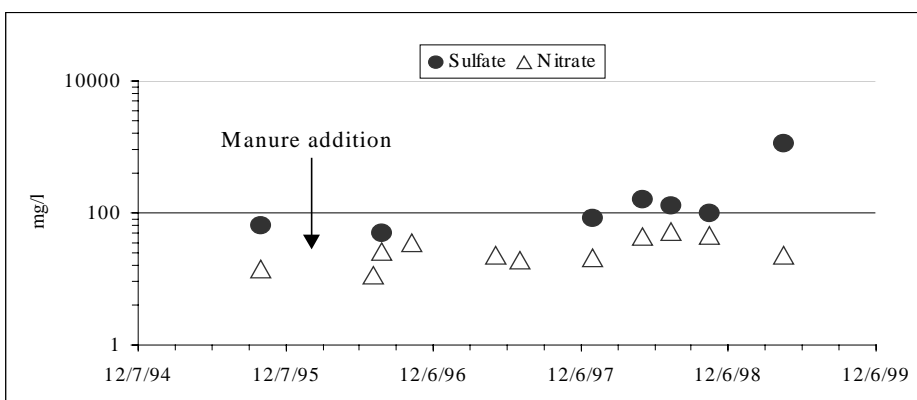
Figure 25: Concentrations of sulfate and nitrate in the perimeter tile at Site EM5.

Several sampling events for the tile line have been missed because of logistical reasons or no flow in the tile. Concentrations of sulfate and nitrate increased during the sampling period ($R^2 = 0.573$ for nitrate, and 0.821 for sulfate)(Figure 25). The correlation between sampling date and sulfate is partly due to a very high concentration of 1160 mg/L in April of 1999, although the nonparametric method tends to smooth out the effect of this value.

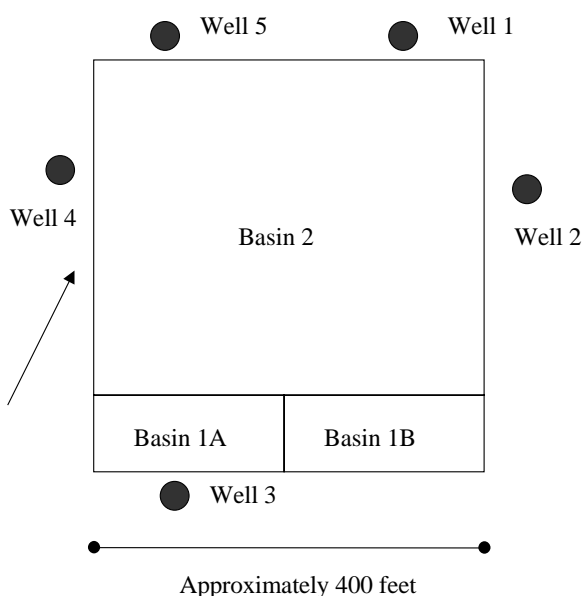
Figure 26: Location of monitoring wells, manure basins, and ground water flow direction (arrow) at site EM6.

We calculated nonparametric correlation coefficients between sampling event and chemical concentration. Table 23 summarizes results of this analysis. The data reveal no significant correlations between sampling event and chemical concentrations in down-gradient wells. Ground water impacts from the manure storage system were not evident at Site EM6.

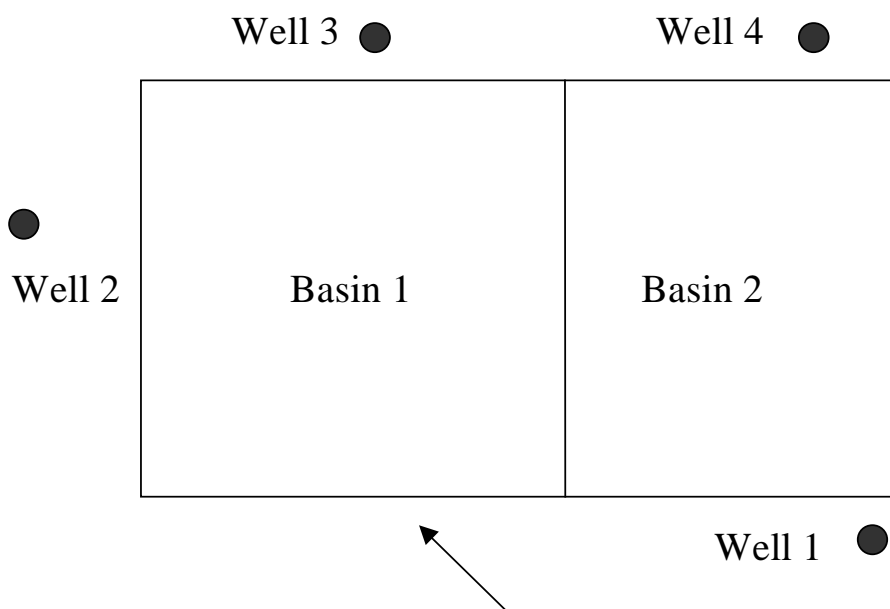
Figure 27: Location of monitoring wells, manure storage basins, and ground water flow direction (arrow) at Site EM7.

We calculated nonparametric correlation coefficients between sampling event and chemical concentrations (Table 24). Nitrate concentrations were positively correlated with sampling event in Well 1 (Figure 28). The source of nitrate is unclear but may be agricultural fields up-gradient of Well 1. Nitrate concentrations were not correlated with sampling event in down-gradient wells.

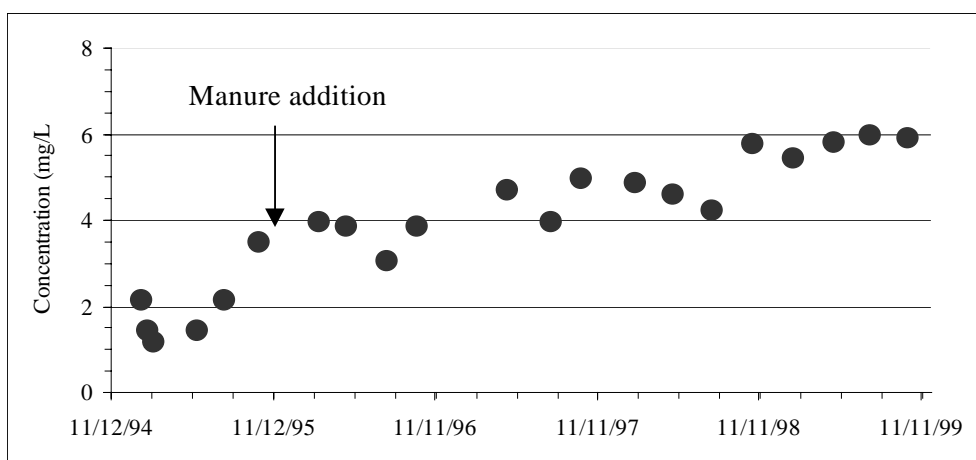
Figure 28: Nitrate concentrations and sampling date in Well 1 at Site EM7.

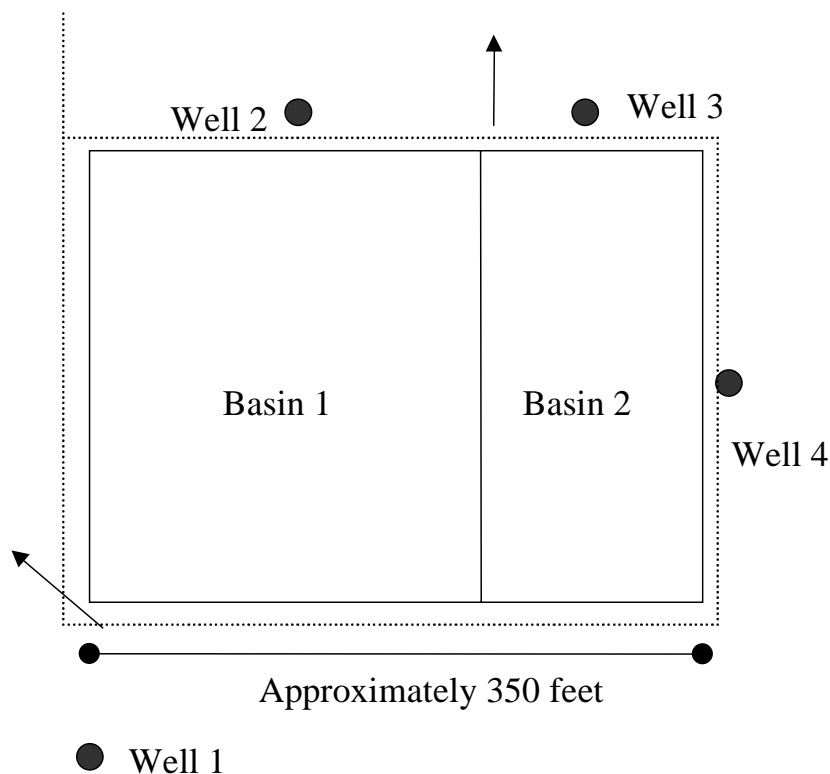
Figure 29: Location of manure storage basins, monitoring wells, and ground water flow direction (arrow) at site EM8. The dashed line illustrates the location of the tile lines.

Well 1 is up-gradient of the basins, while Well 2 is down-gradient. Using nonparametric methods, we calculated 90 percent confidence tolerance limits. We observed no significant differences between Wells 1 and 2 in concentrations of sulfate, chloride, nitrate, specific conductance, total Kjeldahl nitrogen, and ammonia. We observed significant negative correlations between sampling event and specific conductance and concentrations of sulfate and nitrate in Wells 1 and 2 (Table 25).

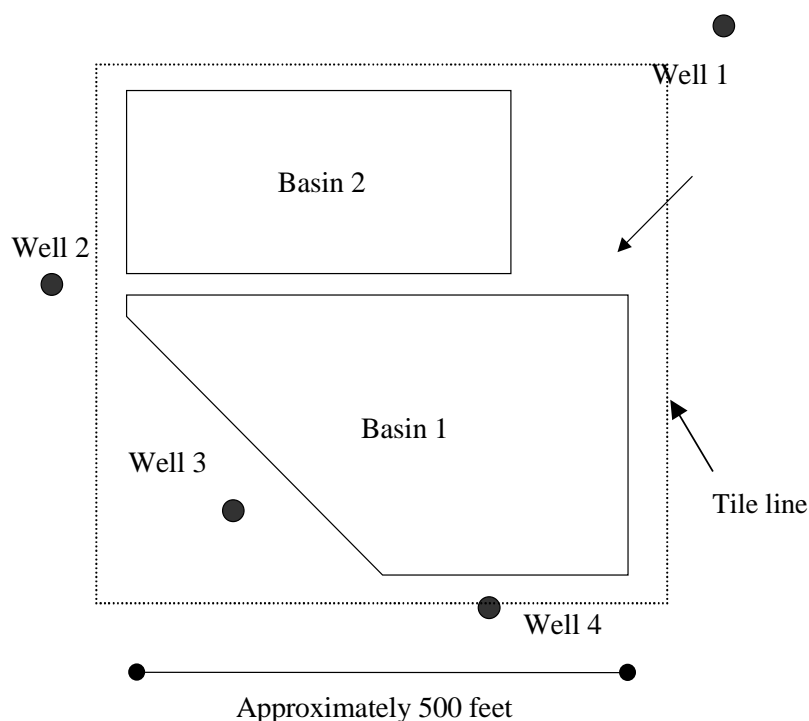
Figure 30: Location of monitoring wells, manure basins, and ground water flow (arrow) at Site EM9.

Well 1 is up-gradient of the manure basins and Well 3 is down-gradient. Comparing down- and up-gradient wells, we calculated 90 percent tolerance intervals for sulfate, chloride, nitrate, specific conductance, and ammonia. No concentrations exceeded the tolerance limit, indicating that concentrations are similar in up- and down-gradient wells. Sulfate concentrations were negatively correlated with sampling event in Well 1 ($R^2 = -0.622$), Well 3 ($R^2 = -0.765$), and Well 4 ($R^2 = -0.842$). Concentrations of Kjeldahl nitrogen and ammonia were higher in Wells 3 and 4 than in Wells 1 and 2, but these high concentrations existed prior to addition of manure in 1995.

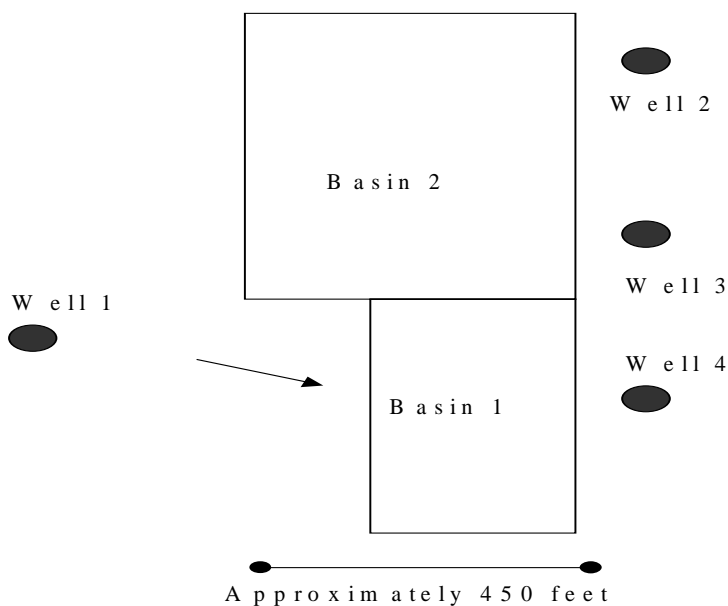
Figure 31: Location of monitoring wells, manure basins, and ground water flow direction (arrow) at Site EM10.

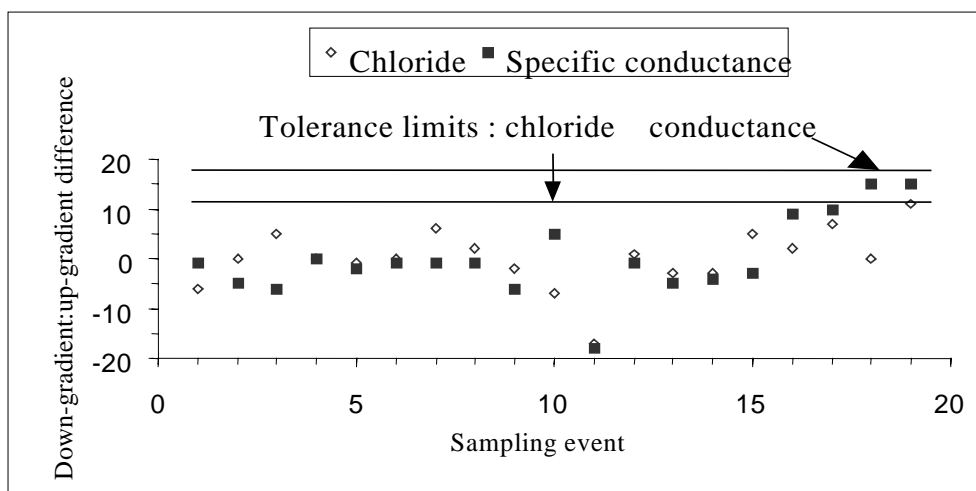
Figure 32: Tolerance limits for chloride and specific conductance at Site EM10. Well 1 is the up-gradient well and Wells 3 and 4 are the down-gradient wells.

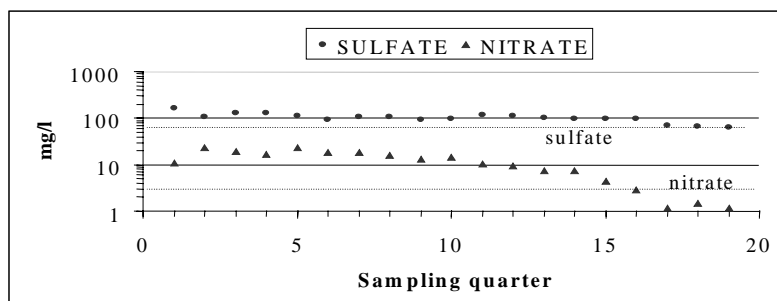
Figure 33: Distribution of sulfate and nitrate in Well 2 at Site EM10, as a function of sampling event. Lower 95% confidence intervals are used because chemical concentrations decreased with sampling event.

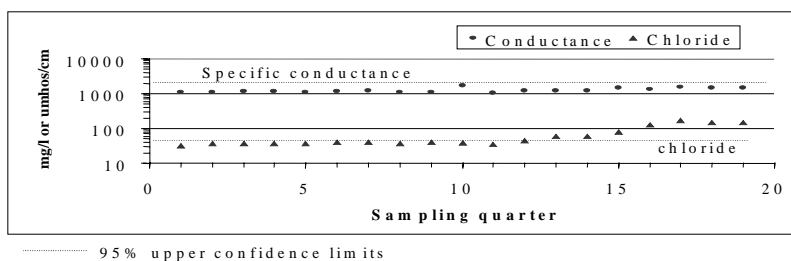
Figure 34: Distribution of chloride and specific conductance in Well 2 at Site EM10, as a function of sampling event. Upper 95% confidence intervals are used because chemical concentrations increased with sampling event.

The strongest correlations between chemical concentration and sampling event were for Well 2, which is side-gradient to the manure basins (Table 27). Concentrations of sulfate and nitrate were negatively correlated with sampling event in Well 2 ($R^2 = -0.736$ for sulfate and -0.884 for nitrate) (Figure 33). Sampling event was positively correlated with specific conductance ($R^2 = 0.692$) and chloride concentration ($R^2 = 0.849$) (Figure 34).

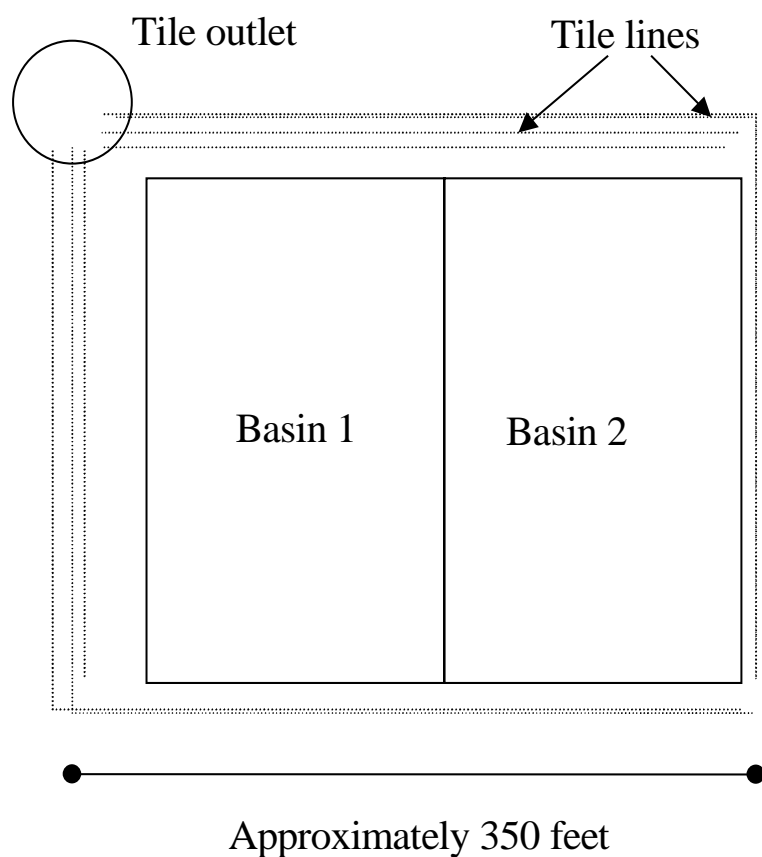
Figure 35: Location of manure basins, tile lines, and tile outlet at Site EM11.

and for chloride in the north and east tiles. There were positive correlations between sampling event and concentrations of sulfate in the north and west tiles. Typically, increasing concentrations of chloride, increasing values for specific conductance, and decreasing concentrations of nitrate are evidence of impacts from manure storage systems. Other indicators may include increasing concentrations of Kjeldahl nitrogen, and phosphorus, and decreasing concentrations of sulfate. The chemistry of water entering the tile lines may provide evidence of a transition in water quality. Additional sampling of redox parameters, such as redox potential, dissolved oxygen, and reduced iron, may provide additional information about the redox status of water entering the tile lines.

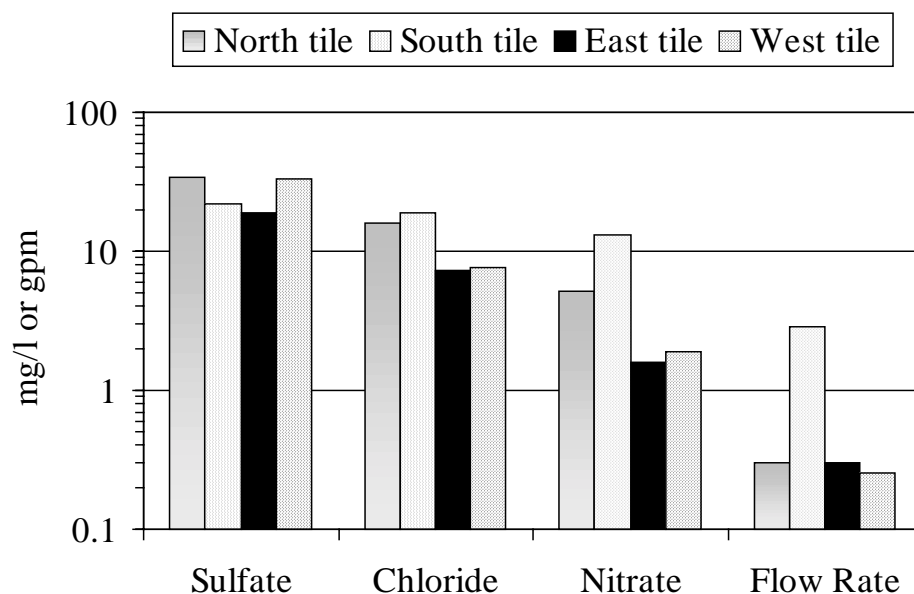
Figure 36: Flow rate and concentrations of sulfate, chloride, and nitrate in tile lines at Site EM11.

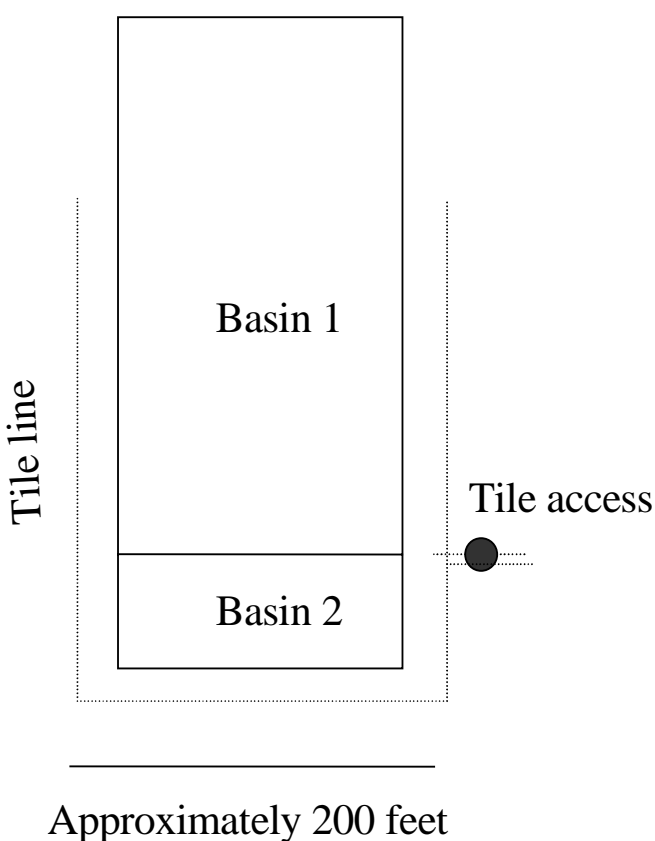
Figure 37: Location of manure storage basins and perimeter tile at Site EM15.

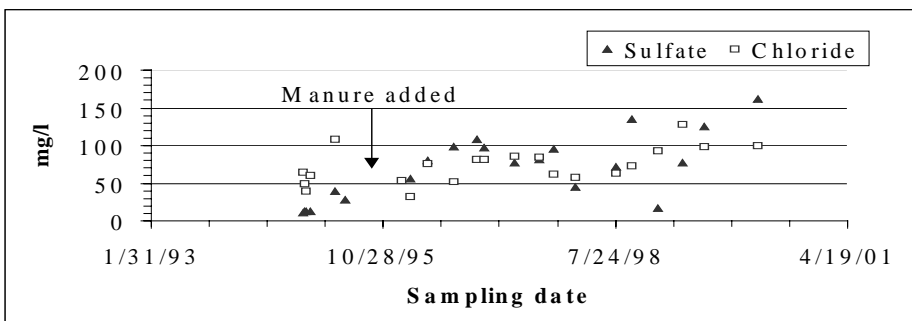
Figure 38: Concentrations of chloride and sulfate in the perimeter tile at Site EM15.
