Effects of Liquid Manure Storage Systems on Ground Water Quality

April 2001

Minnesota Pollution Control Agency
Ground Water and Toxics Monitoring Unit
Environmental Monitoring and Analysis Section
Environmental Outcomes Division
520 Lafayette Road
St. Paul, Minnesota 55155-4194
(651) 296-6300 or (800) 657-3864

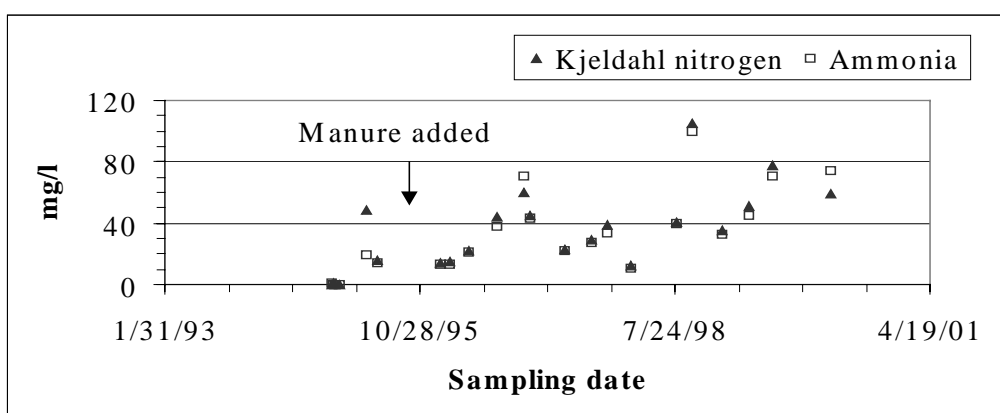
Figure 39: Concentrations of Kjeldahl nitrogen and ammonia in the perimeter tile at Site EM15.

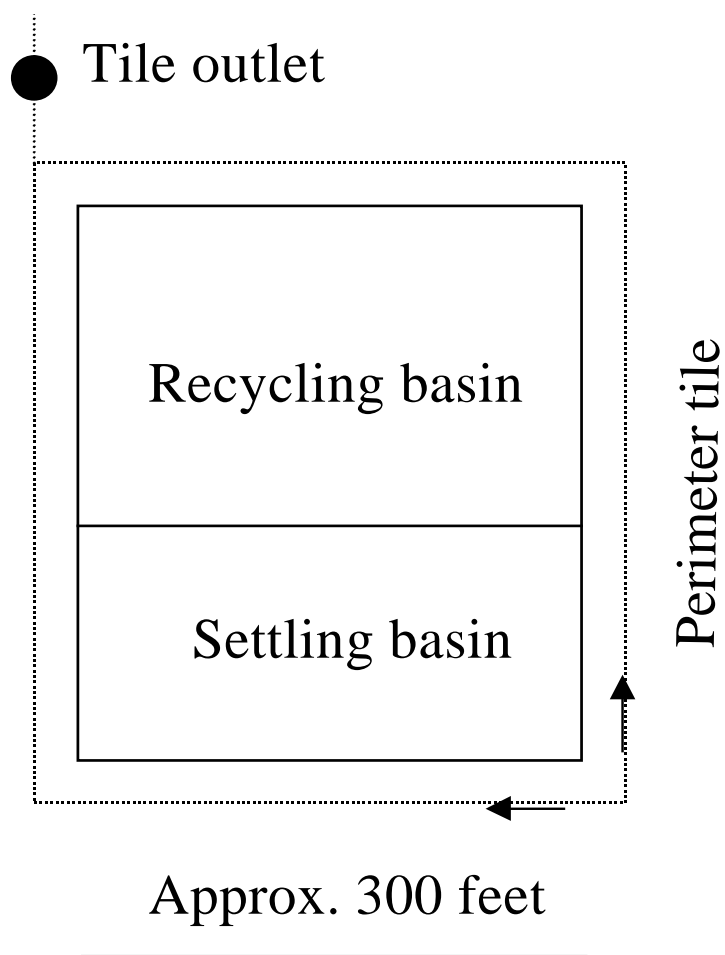
Figure 40: Location of manure storage basins and tile lies at Site EM16.

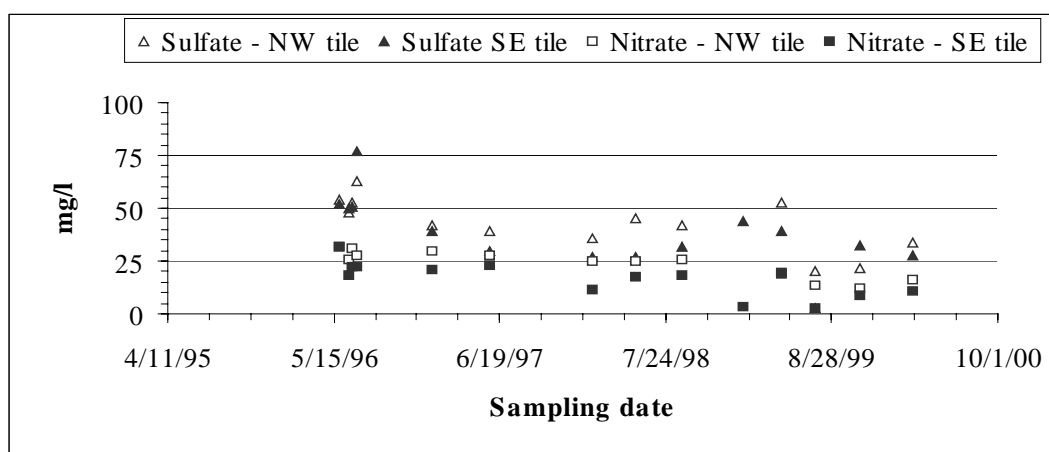
Figure 41: Concentrations of nitrate and sulfate in tile lines at Site EM16, as a function of sampling date.

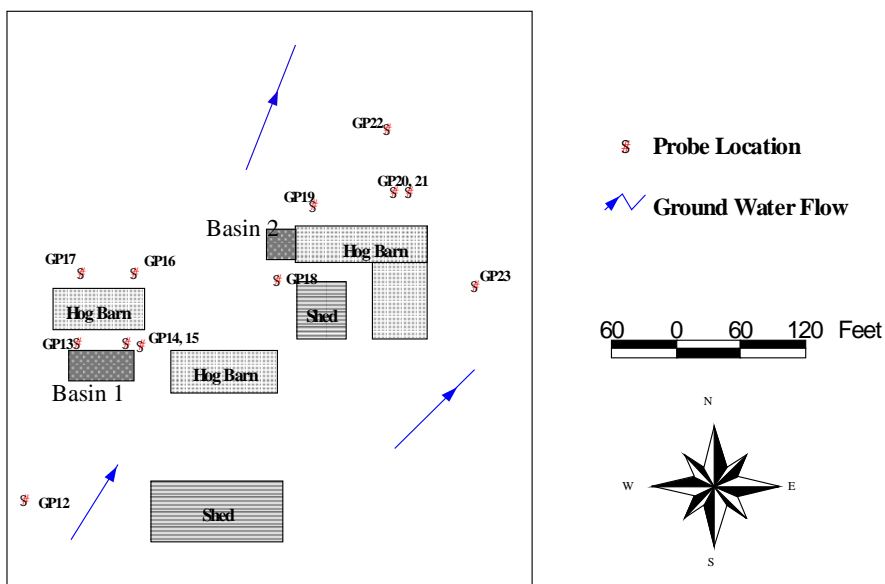
Figure 44: Location of temporary wells and ground water flow direction at Site C1.

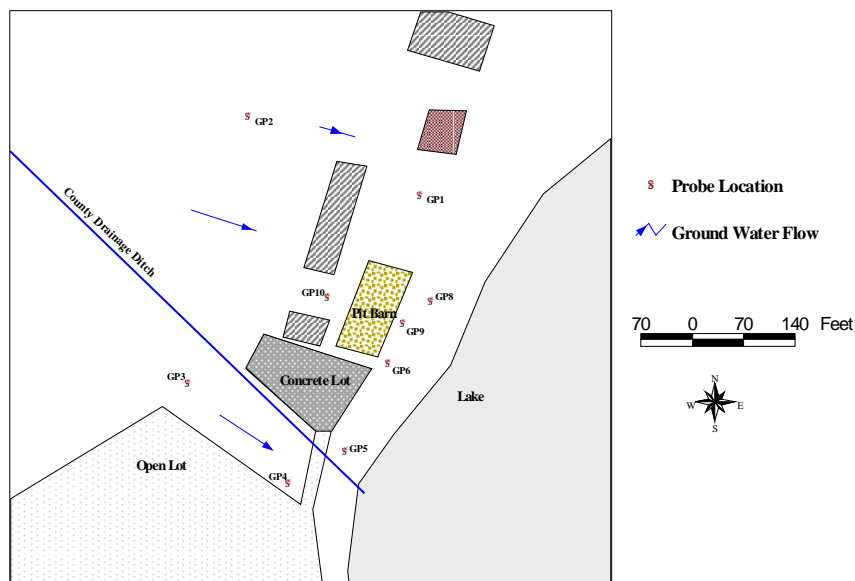
Figure 45: Location of wells and ground water flow direction at Site C2.

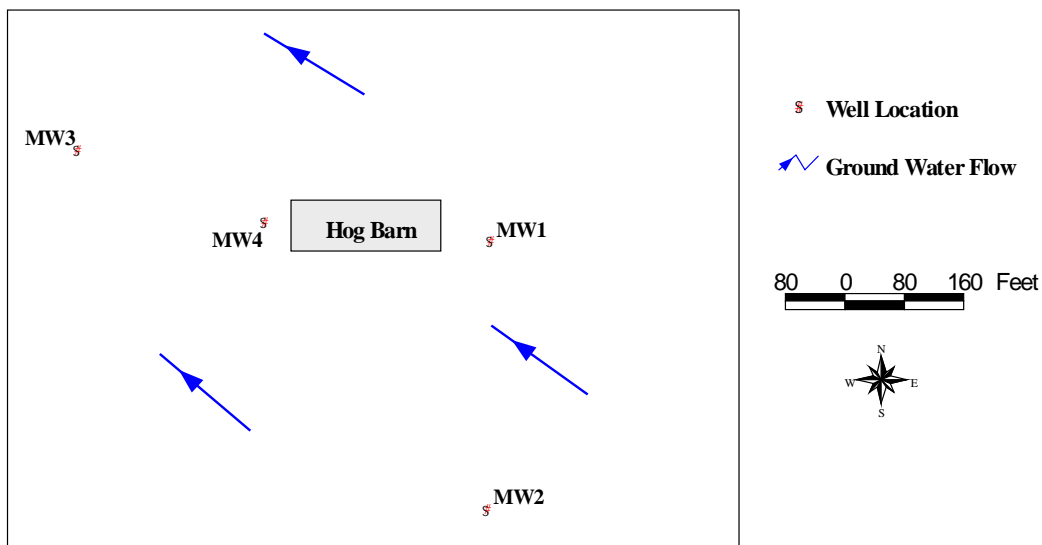
Figure 47: Location of monitoring wells at Site CM4. Manure is collected in a concrete basin beneath the hog barn.

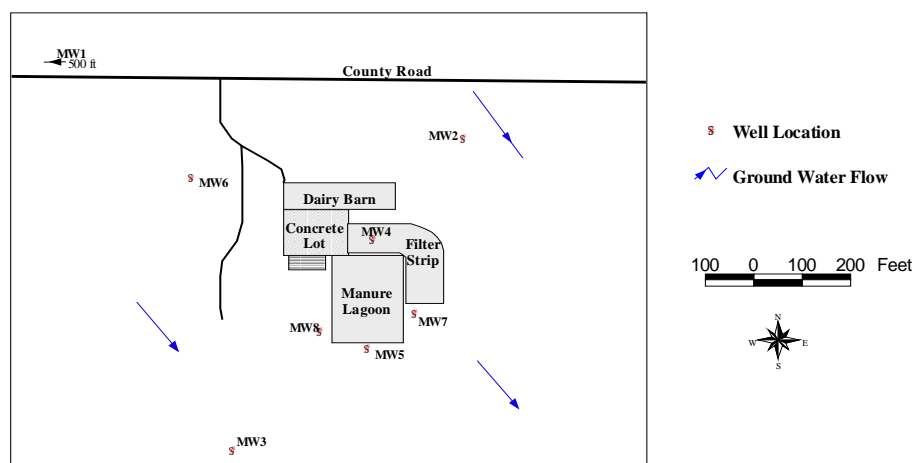
Figure 48: Location of monitoring wells and ground water flow at the site with a geosynthetic liner. Note that wells shown in Figure 48 represent permanent wells drilled after our initial investigation with temporary wells. The well locations in Figure 4 therefore differ from those shown in Figure 48.

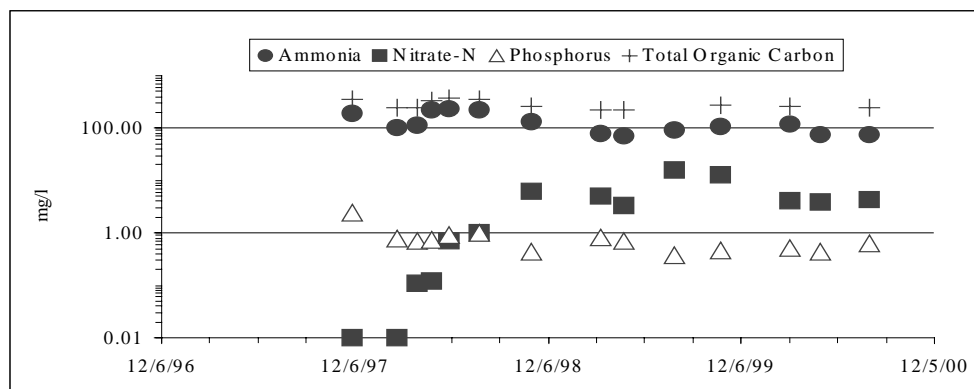
Figure 49: Concentrations of ammonia, nitrate, phosphorus, and organic carbon in Well MW4, located beneath the feedlot at the site with a geosynthetic liner.

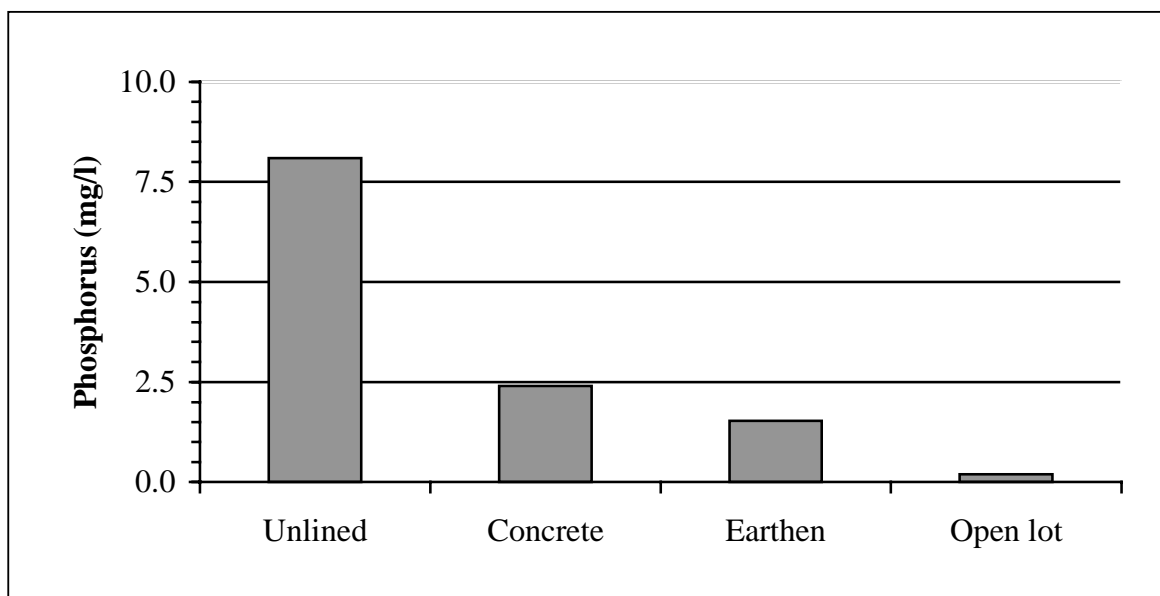
Figure 50: Median phosphorus concentrations for different manure storage systems.

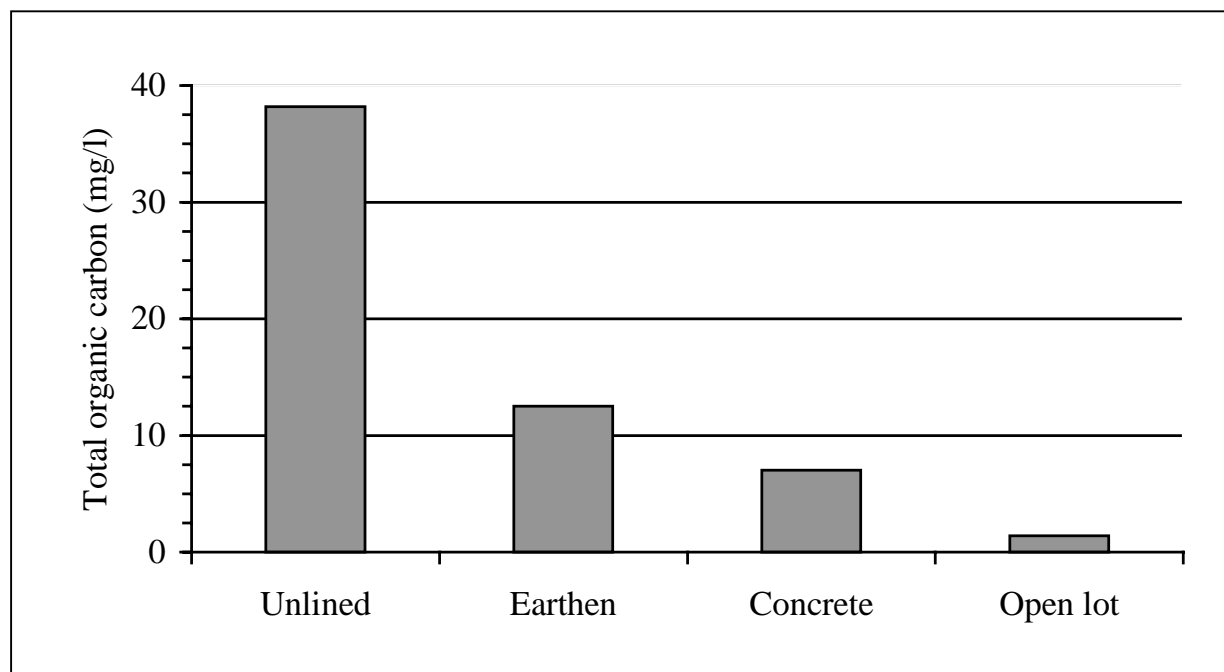
Figure 51: Average concentrations of total organic carbon under four different manure management systems.
