Shingle and Bass Creeks Biota and Dissolved Oxygen TMDL Implementation Plan

**SHINGLE CREEK
WATERSHED MANAGEMENT
COMMISSION**

**MINNESOTA
POLLUTION CONTROL AGENCY**

January 2012

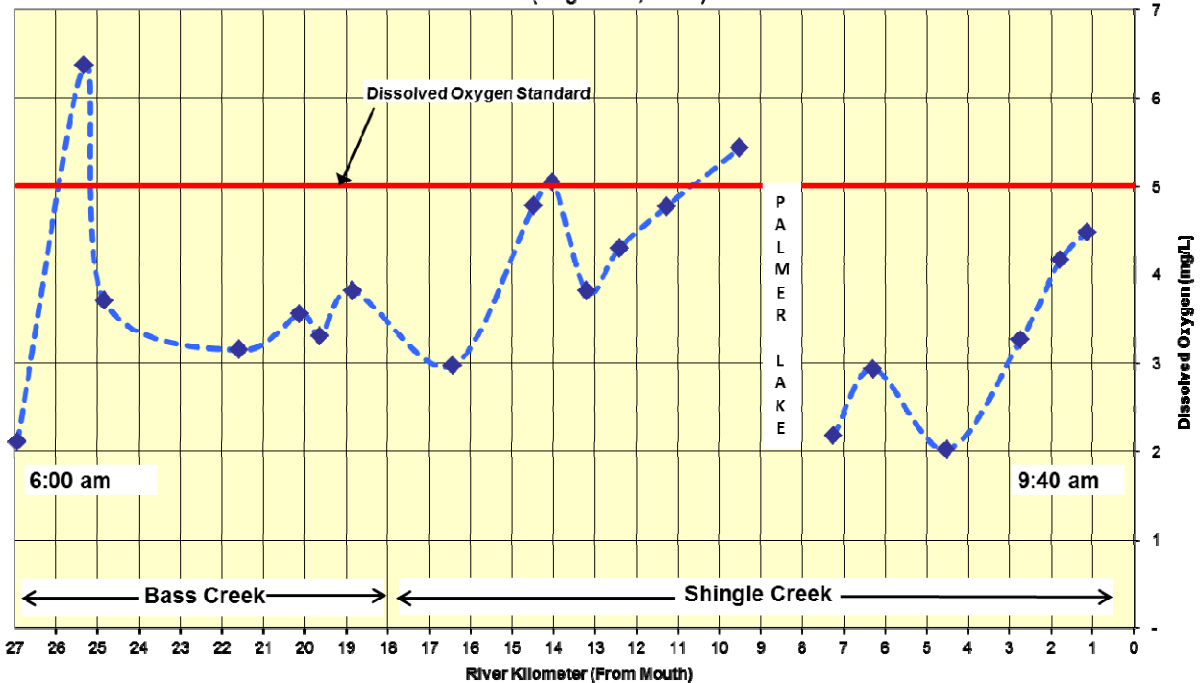
Figure 2.1. Dissolved oxygen in Bass and Shingle Creeks in August 2007.

Longitudinal Dissolved Oxygen Survey Bass Creek and Shingle Creek (August 16, 2007)

Palmer Lake is located between River Kilometer 7.25 and 9.5
River Kilometers 27-18 are Bass Creek; 18-0 are Shingle Creek.

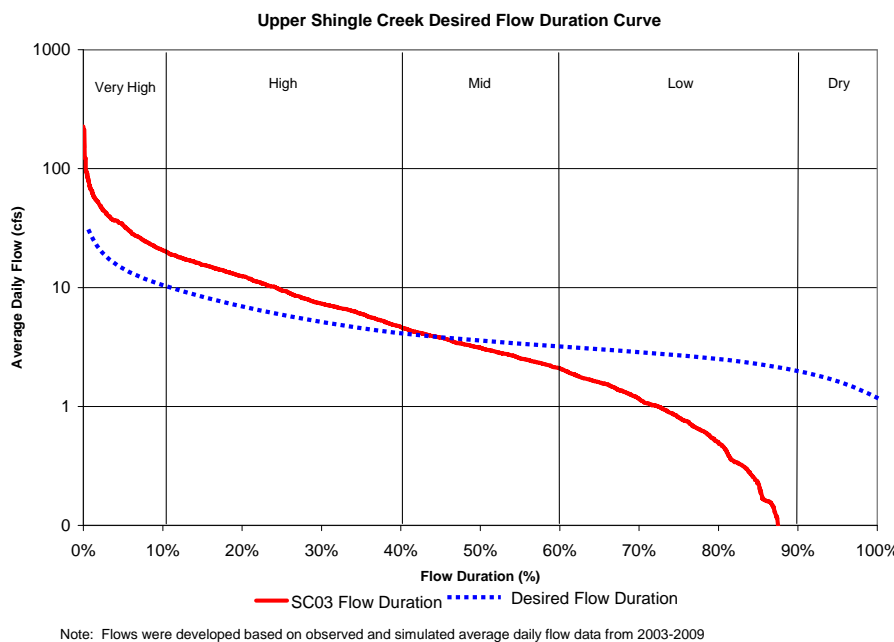
Figure 2.2. Current and desirable flow duration curve for Upper Shingle Creek.

Urbanization in the Shingle Creek watershed has both increased peak flows and reduced base flows. This is most dramatically seen in Upper Shingle Creek where stream flow is 1 cubic foot per second (cfs) or less more than 25 percent of the time. Figure 2.2 presents a generalized desirable flow duration curve for Upper Shingle Creek. A desirable flow regime would reduce peak flows from the current peaks, maintain a stable flow, and sustain a base-flow that would never fall below a desired “ecological base-flow.” Generally, the stable flow that would characterize most of the regime would be defined as a flow rate and velocity that would 1) provide sufficient reaeration to keep DO levels above 5.0 mg/L; 2) adequately mobilize and flush sediment; and 3) be tolerated by desirable fish and macroinvertebrate organisms.

Specific strategies for achieving the desirable flow duration curve will be developed as part of the Shingle Creek WMC’s Third Generation Management Plan in development in 2011-2012. Strategies that would likely be most effective include:

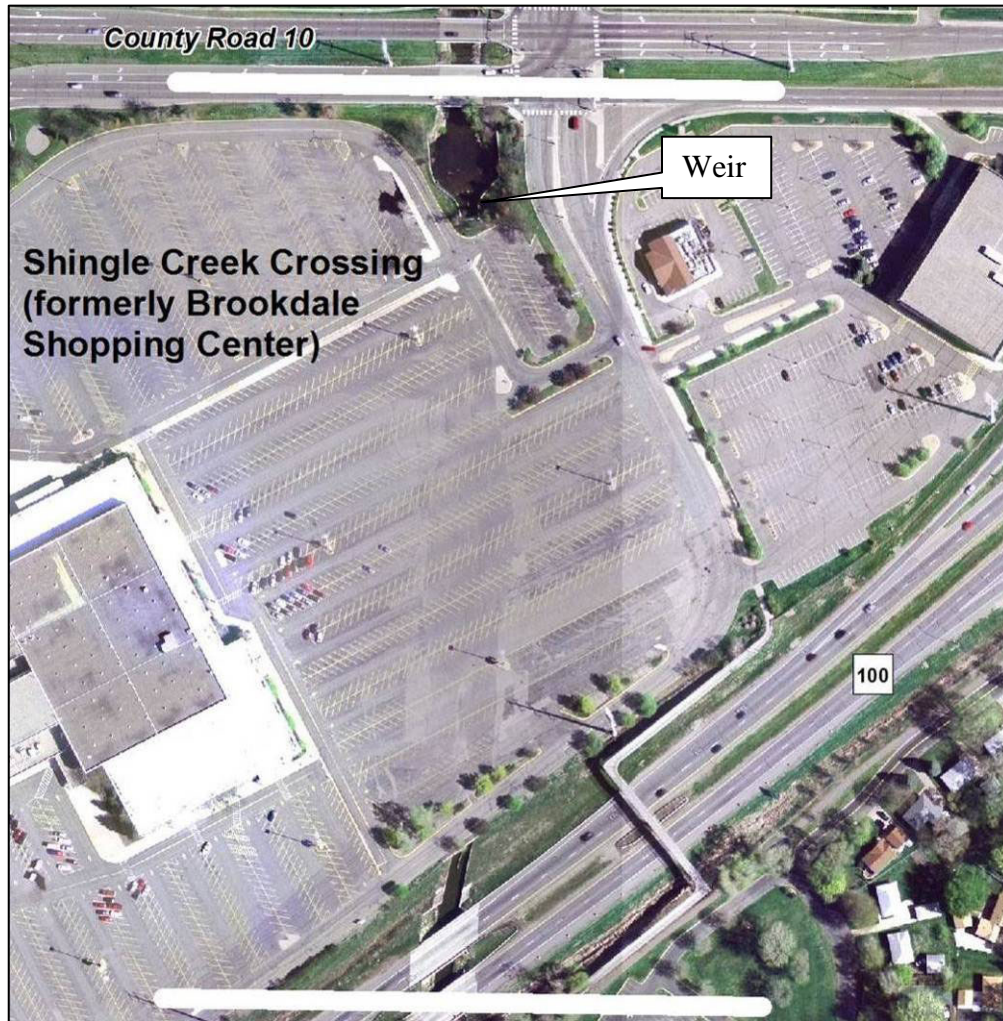
Figure 4.5. Lower Shingle Creek Reaches 4 and 5.

Reach	Description	Length (Mi)	SOD Load Allocation (kg-SOD/day)		Reduction
			Current	TMDL	
4	Weir	.006	1.2	1	16.7%
5	Weir to Highway 100 (box culverts)	0.17	17.6	14.1	19.9%

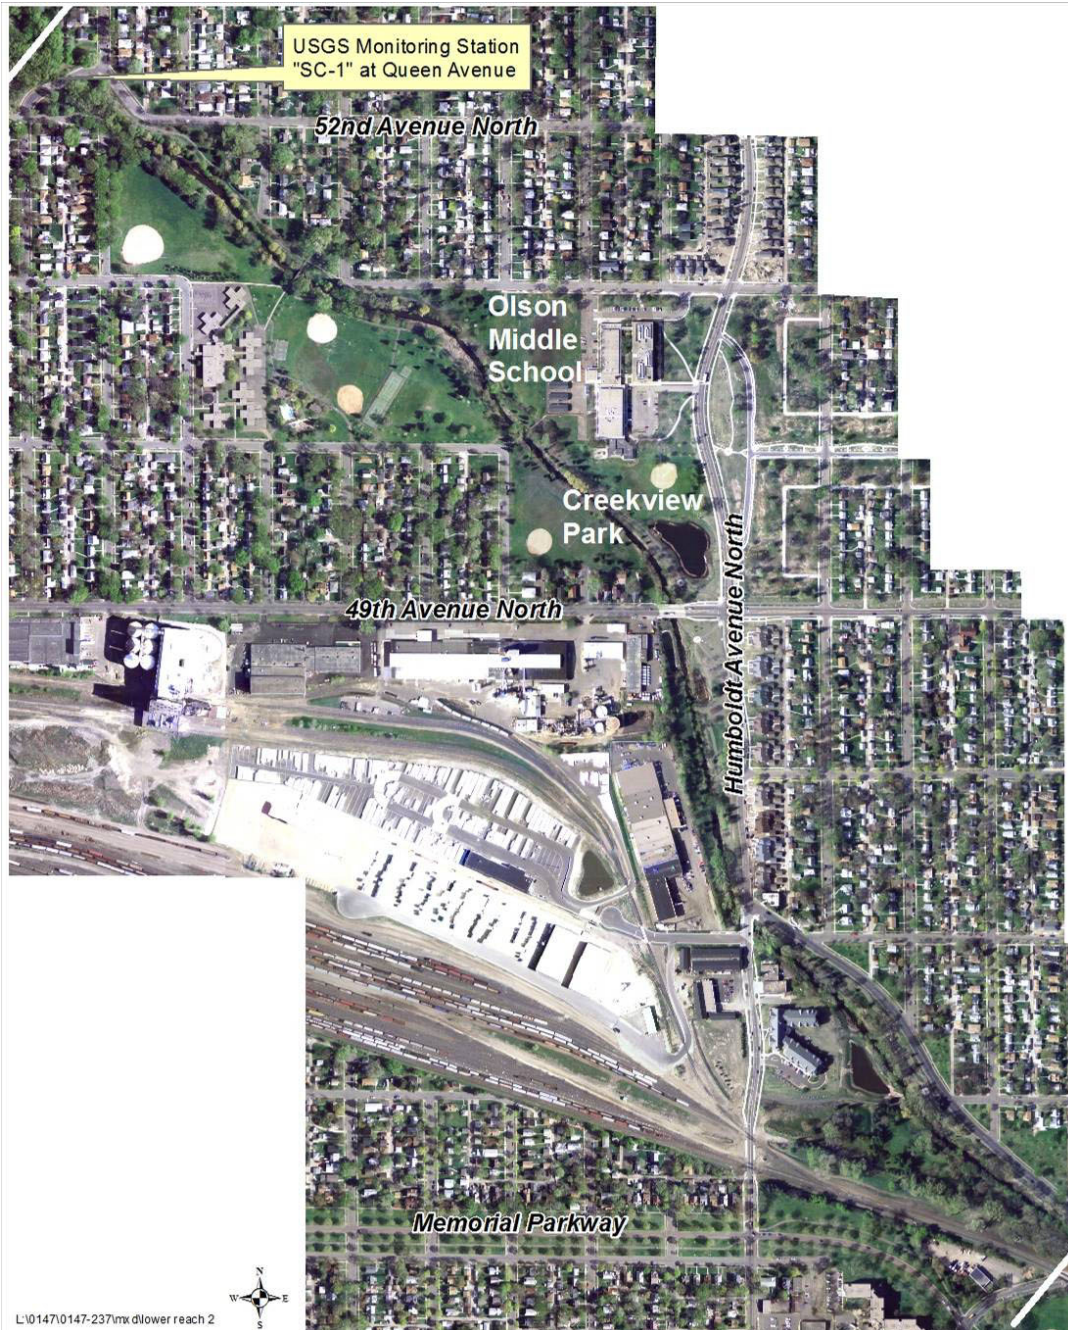
Figure 4.8. Lower Shingle Creek Reach 7.

Reach	Description	Length (Mi)	SOD Load Allocation (kg-SOD/day)		Reduction
			Current	TMDL	
7	USGS monitoring station at Queen Avenue north to Webber Park monitoring station	1.29	71.5	15.5	78.3%

Streambanks in this reach are relatively stable. Thinning the dense tree canopy will allow sunlight to penetrate to the streambank and allow an herbaceous buffer to establish, further stabilizing the banks (Table 4.10). Some riffles were added to the stream in Creekview Park and downstream of Humboldt Avenue as part of the development of the Humboldt Greenway. Additional wood substrate would be valuable, such as root wads and tree pins harvested from tree removals on site.

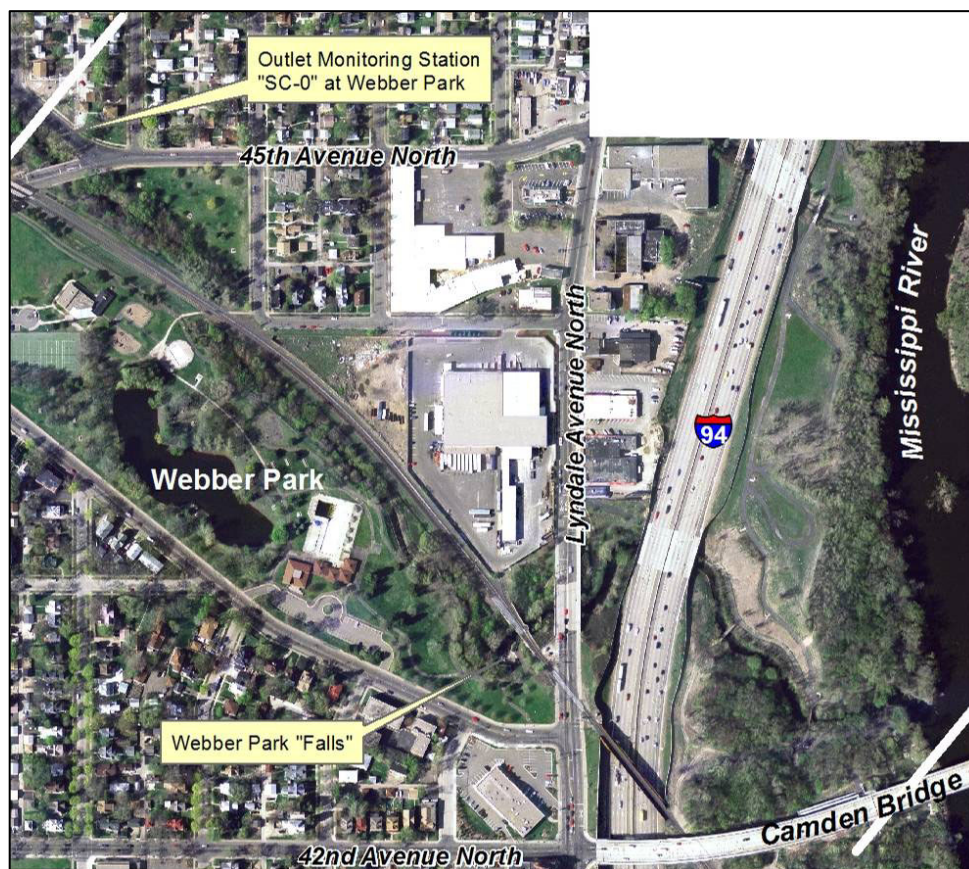
Figure 4.9. Lower Shingle Creek Reach 8.

This reach extends from the Shingle Creek WMC monitoring station SC-0 in Webber Park in Minneapolis (Table 4.11 and Figure 4.9) to the Mississippi River. A seven foot drop structure in Webber Park was added in the 1980s as part of the construction of I-94 and is a significant fish barrier that disconnects Shingle Creek from the Mississippi River ecosystem. Downstream of I-94 the stream passes through North Mississippi Regional Park before discharging into the Mississippi River just upstream of the Camden Bridge in Minneapolis.

Issue	Action	Expected Outcome	Estimated Cost
Lack of habitat	Install in-stream woody habitat features such as root wads, tree pins, riffles and rock vanes	Improved habitat, varied substrate	
“Webber Park Falls,” a seven foot drop structure, is a significant fish and aquatic organism barrier	Provide a fish passage around the structure	Increased connectivity.	\$50,000

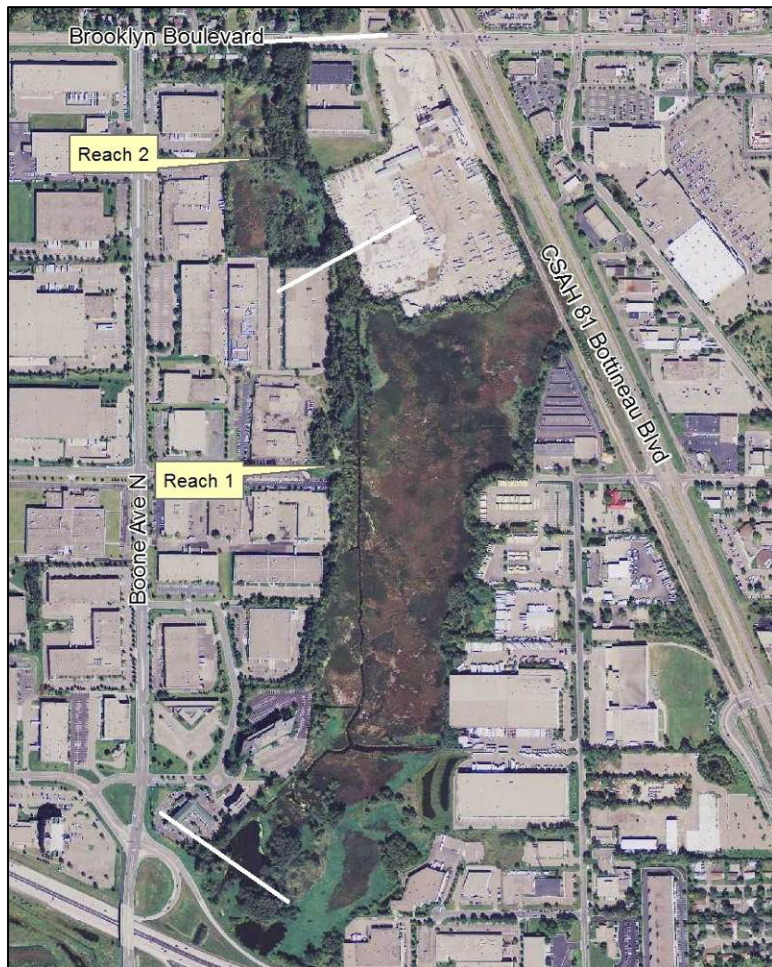
Figure 4.11. Upper Shingle Creek Reaches 1 and 2.

Reach	Description	Length (Mi)	SOD Load Allocation (kg-SOD/day)		Reduction
			Current	TMDL	
1	I-94 to wetland outlet	0.6	69.5	1.1	98.4%
2	Wetland outlet to Brooklyn Boulevard	0.29	13.1	0.2	98.5%

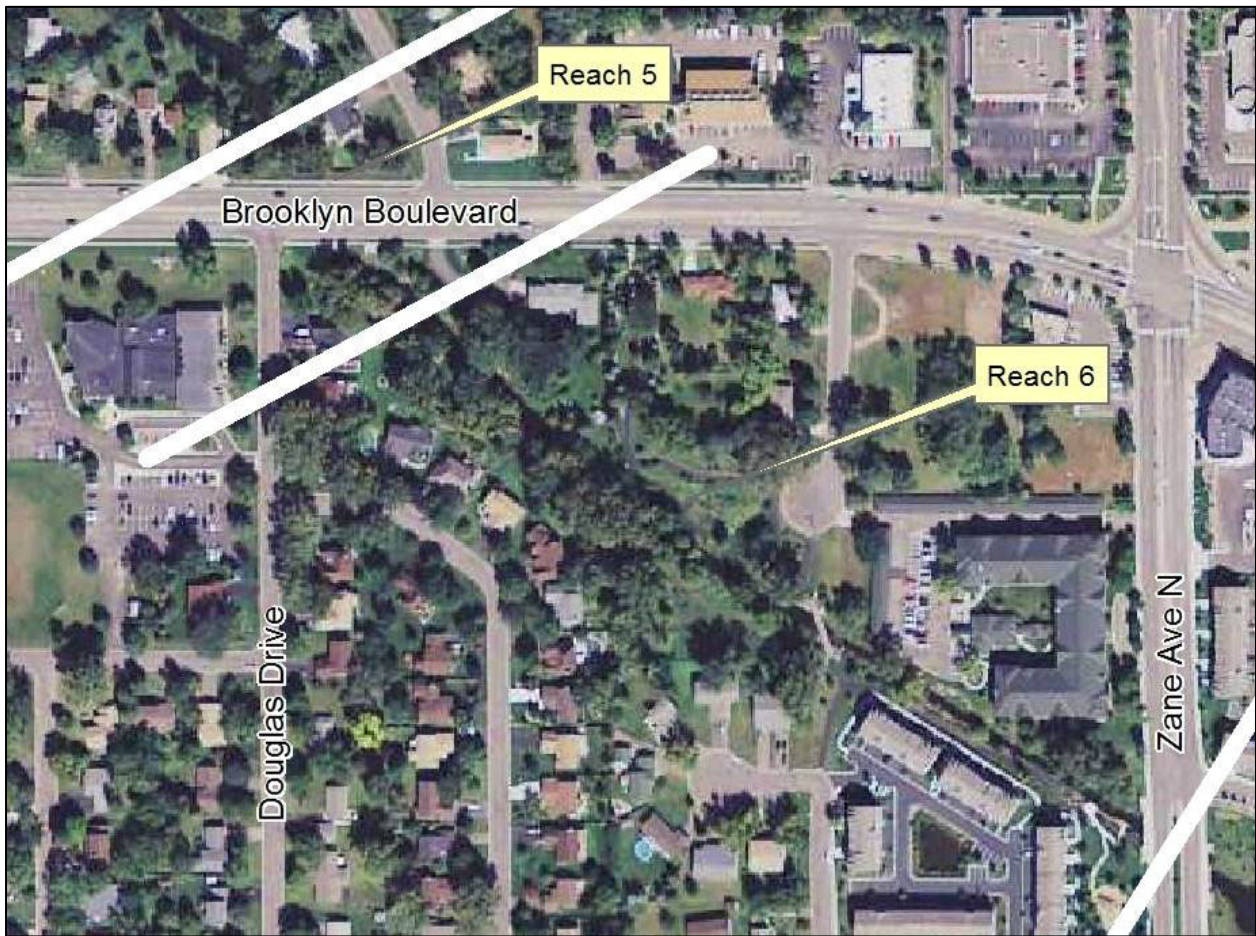
Figure 4.14. Upper Shingle Creek Reaches 5 and 6.

Reach 5 is the rock cascade upstream of Brooklyn Boulevard that replaced an old sheet pile dam and Reach 6 extends from that cascade to Zane Avenue downstream in Brooklyn Park (Table 4.19 and Figure 4.14). In the early 2000’s the City of Brooklyn Park undertook a stream stabilization project on this segment that added a boulder toe and a vegetated buffer.

Reach	Description	Length (Mi)	SOD Load Allocation (kg-SOD/day)		Reduction
			Current	TMDL	
5	Rock Cascade #1 to Brooklyn Boulevard	0.1	4.8	0.9	81.3%
6	Brooklyn Boulevard to Zane Avenue	0.26	6.8	0.4	94.1%

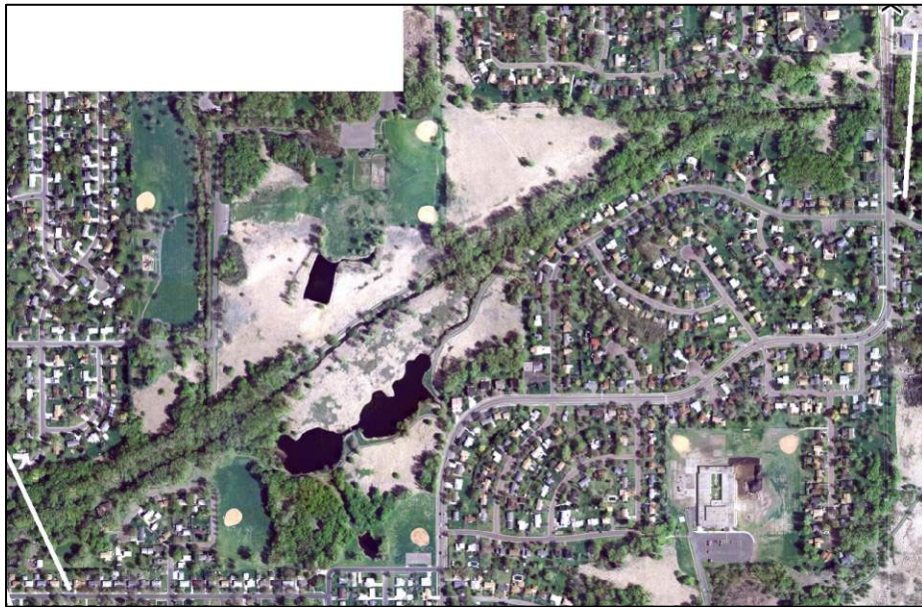
Figure 4.18. Upper Shingle Creek Reach 11.

Reach	Description	Length (Mi)	SOD Load Allocation (kg-SOD/day)		Reduction
			Current	TMDL	
11	Drop Structure in Park to Xerxes Avenue	0.98	35.5	2.4	93.2%

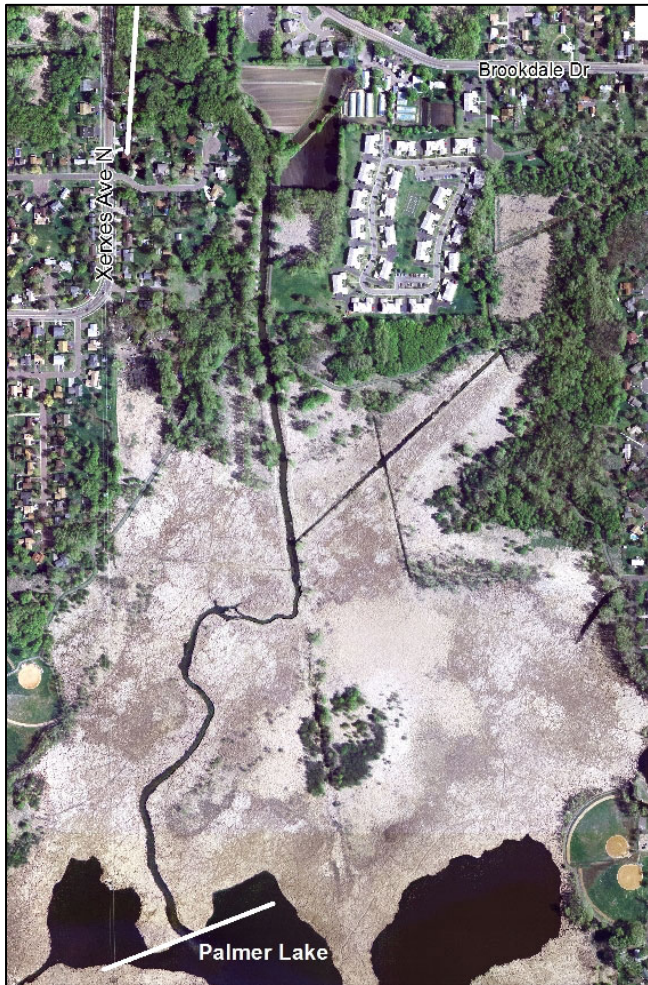
Figure 4.19. Upper Shingle Creek Reach 12.

Upper Shingle Creek Reach 12 extends from Xerxes Avenue North in Brooklyn Park to Palmer Lake (Table 4.27 and Figure 4.19). Xerxes Avenue is the upstream terminus of County Ditch #13. Just downstream of Xerxes Avenue on the right side is a small, shallow backwater area that serves as a high-flow refuge for aquatic organisms. There are two subreaches: from Xerxes to the wetland basin and from the wetland basin to Palmer Lake. Within the wetland basin the stream has remeandered a channel from the original ditch alignment.

Issue	Action	Expected Outcome	Estimated Cost
Dense tree canopy, areas of bank instability, lack of buffer	Restore 1,000 feet of stream: thin trees, stabilize banks as necessary, plant buffer	Stabilized banks and buffer will reduce sediment loss and filter runoff	\$75,000
Lack of habitat	Install in-stream habitat features such as root wads, tree pins, and additional riffles	Improved habitat, varied substrate	
Lack of aeration	Narrow the channel with tree pins and other structures to provide a low-flow channel; install rock riffles	Increased aeration, increased velocity at low flows, increased species diversity and abundance

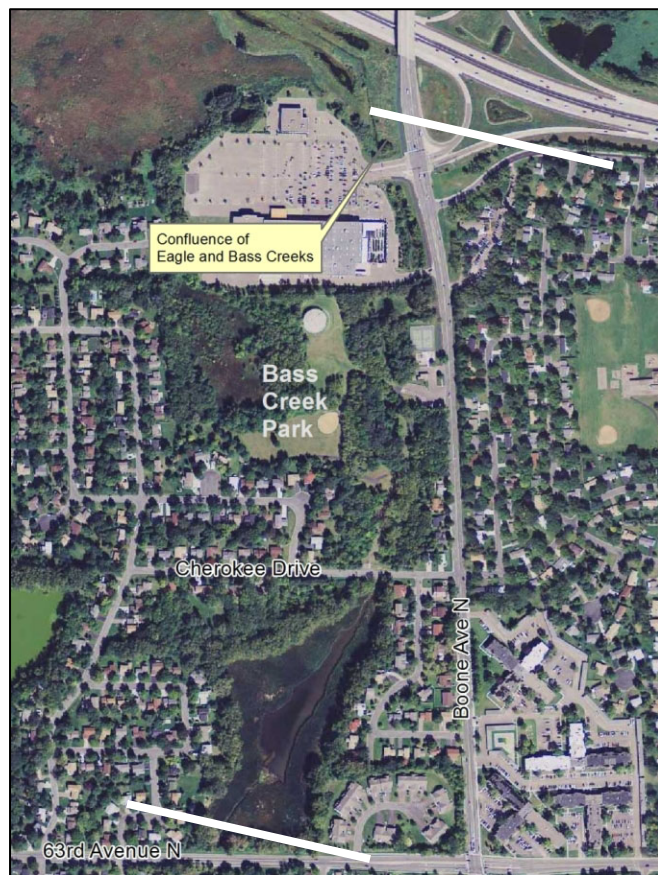
Figure 4.21. Bass Creek Reach 1.

Reach	Description	Length (Mi)	SOD Load Allocation (kg-SOD/day)		Reduction
			Current	TMDL	
1	63rd Avenue to Eagle/Shingle Creeks	0.7	Not modeled	Not modeled	Not modeled

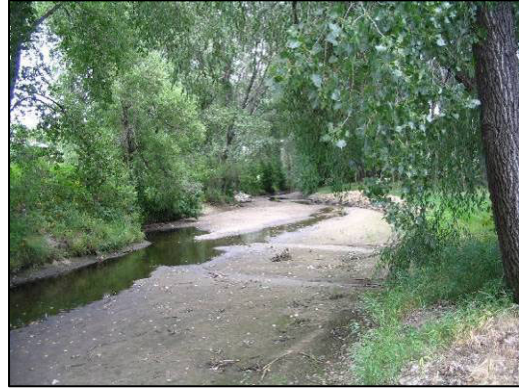
Shingle Creek has naturally created a narrow channel to carry low flows and base flow here downstream of Candlewood Drive in Brooklyn Park.

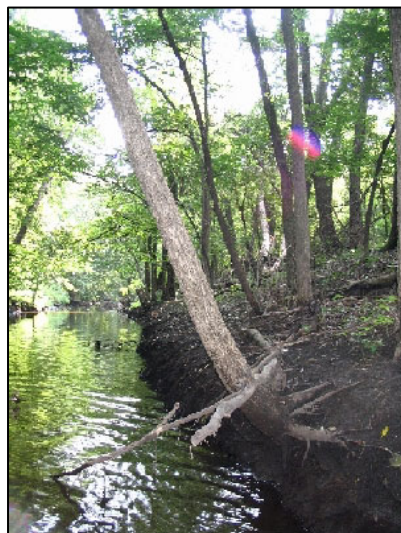
Remove leaning and undercut trees

Leaning and undercut trees should be removed either through routine maintenance or as a part of any streambank project. Because their root system is often exposed, they provide little bank stability and are at greater risk of falling. Falling can result in streambank failure and increased erosion. The debris can also block flow and cause debris and sediment to accumulate.

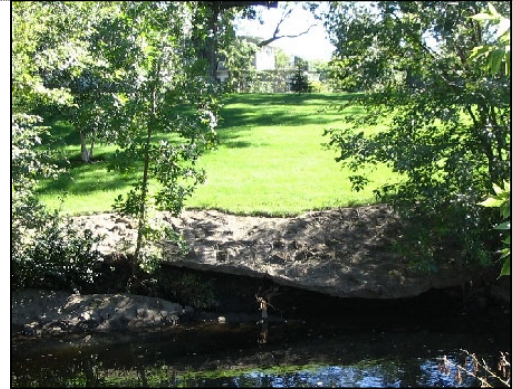
This streambank in Brooklyn Park is armored with riprap covered with concrete. Other reaches include placed riprap, wood shoring walls, and concrete block walls.

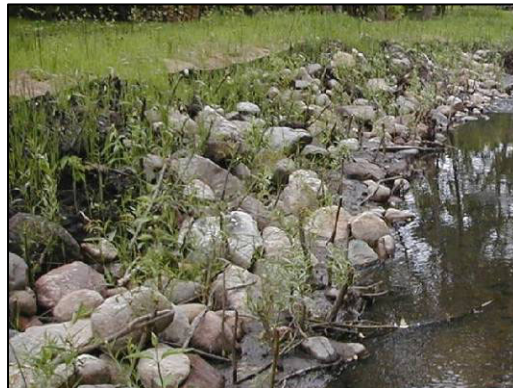
Fill voids in rip rap with soil and plant native vegetation between the rocks

This technique provides more streambank stability, promotes infiltration, and softens the appearance of the riprap. Here on Pike Creek in Maple Grove, live willow stakes were planted between the riprap.

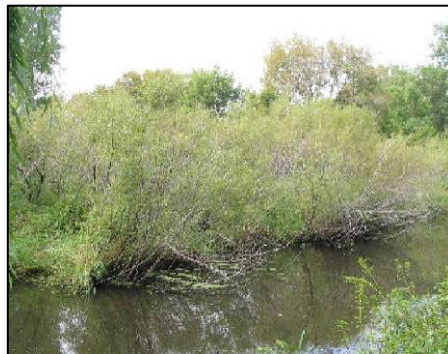
Restore native vegetation in riparian zone to improve habitat

Remove the invasive and cultivated vegetation in the riparian zone and replace with native, long-rooted herbaceous vegetation, a shrub layer, and tree species appropriate for and native to the vegetative community. Overhanging vegetation provides habitat for fish and invertebrates, and leaves and small woody detritus are an important source of organic carbon.

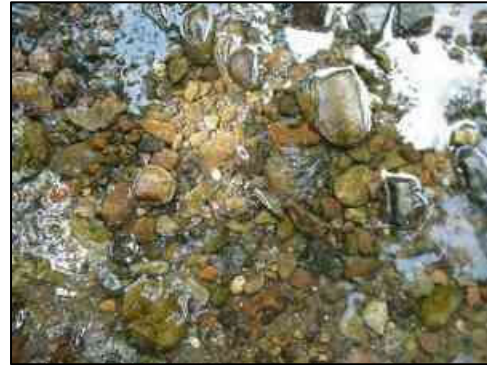
Increase Substrate Diversity

Increasing substrate diversity leads to areas readily colonized by macroinvertebrate communities. An important design feature is to ensure that good stream substrates such as cobble do not become embedded by sediment deposited as a result of reduced channel velocities. The diversity of habitat should include cobble, boulders, and sands as well as woody debris such as submerged logs, fine woody debris, and leaf packs.

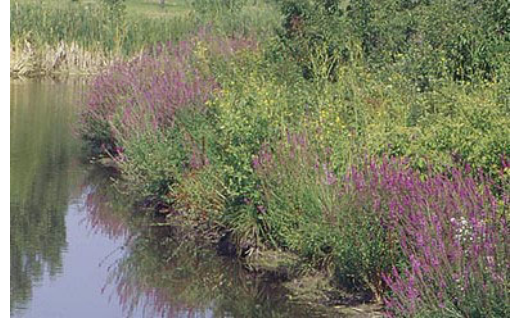
Buffer areas should be inspected regularly for invasive vegetation, and any found should be removed promptly. Many invasive species are hardy and adventitious, and can quickly crowd out more beneficial species. A healthy riparian zone requires a variety of plant species.

Purple loosestrife, an invasive plant. (North Dakota)
