Groundhouse River Total Maximum Daily Loads for Fecal Coliform and Biota (Sediment) Impairments

Final TMDL Report

March 2009

**Submitted by:
Tetra Tech**

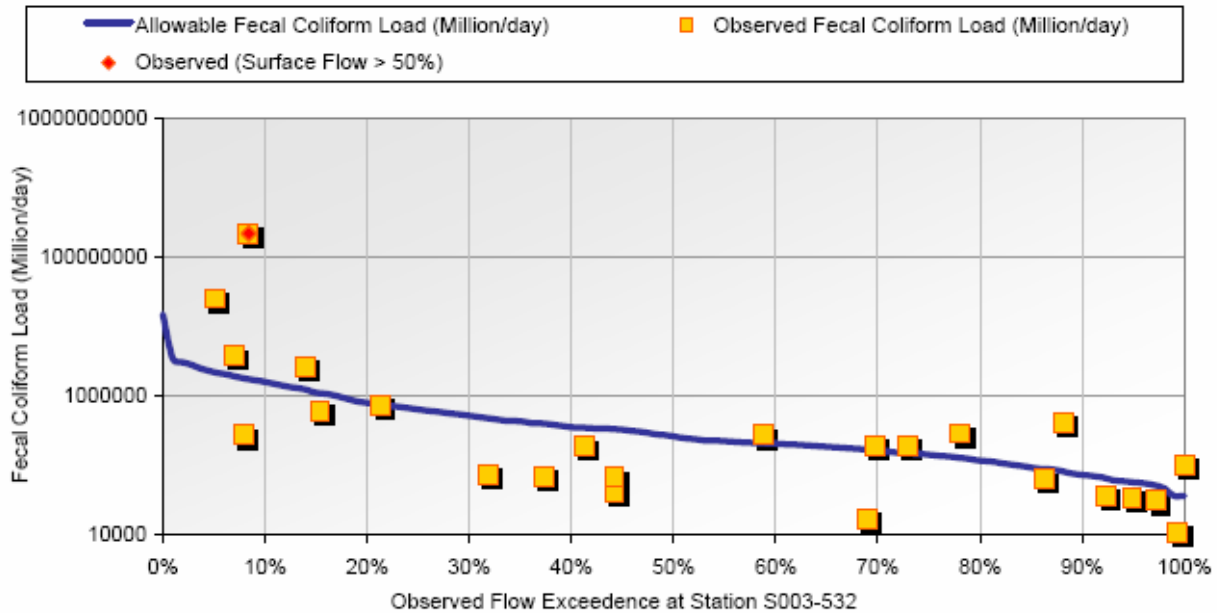
Figure 25. Fecal Coliform Load Duration Curve Example for the S003-532 Sampling Station Located on the Groundhouse River

An example load duration curve is presented in Figure 25 and illustrates that observed fecal coliform loads exceed allowable loads across all of the flow regimes. The figure indicates that excessive loads occur during high flow events and also when subsurface flows exceed surface flows. The proportion of surface versus subsurface flows was determined using the sliding-interval method for streamflow hydrograph separation contained in the USGS HYSEP program (Sloto and Crouse, 1996). Algorithms from HYSEP were incorporated into the load duration analysis to determine the proportion of daily mean discharge that was overland runoff (surface) or groundwater discharge (subsurface) components. A surface flow threshold value of 50 percent was used to identify water quality samples that were collected during primarily surface runoff events.

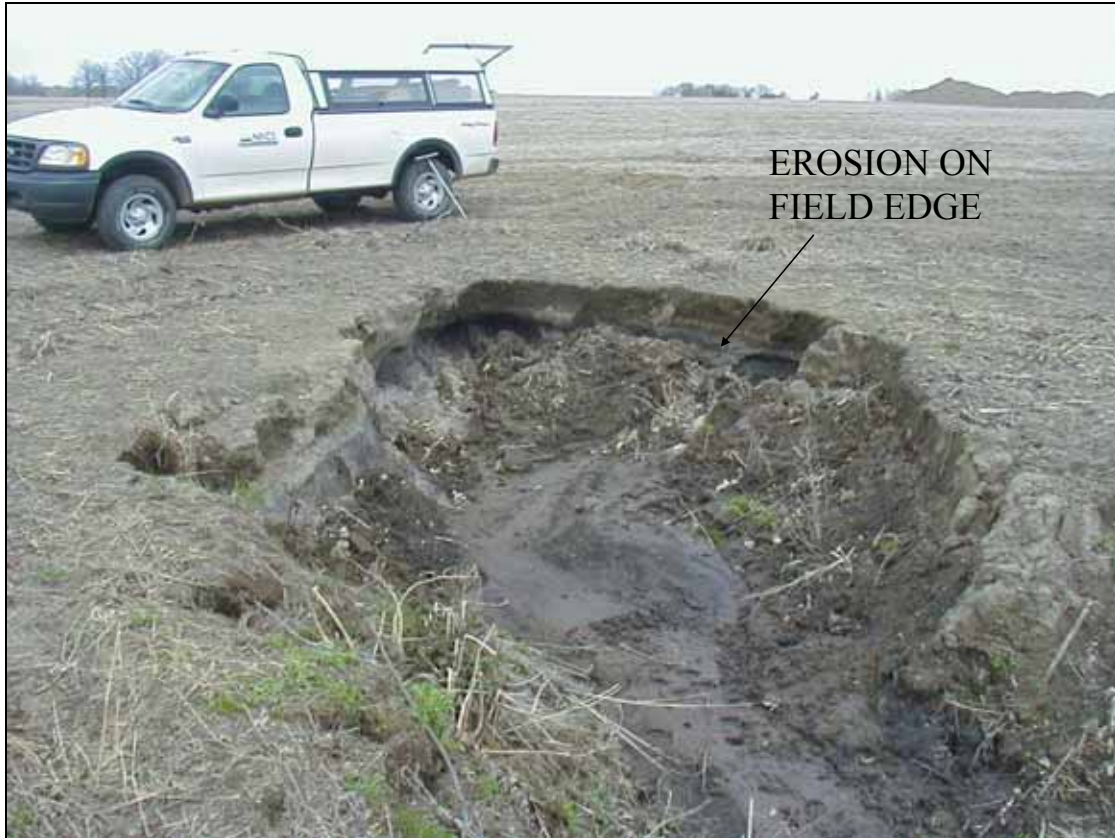
Figure 29. Gully Erosion from Agricultural Field

Lands used for crop production contribute sediment to the impaired waters and result in reduced macroinvertebrate scores. Figure 29 shows an example of gully erosion from an agricultural field in the watershed. In addition, application of fertilizers and pesticides may contribute excess nutrients and toxic chemicals to nearby waterbodies. Table 41 summarizes the crop production BMPs that will most efficiently reduce sediment loads from this source.

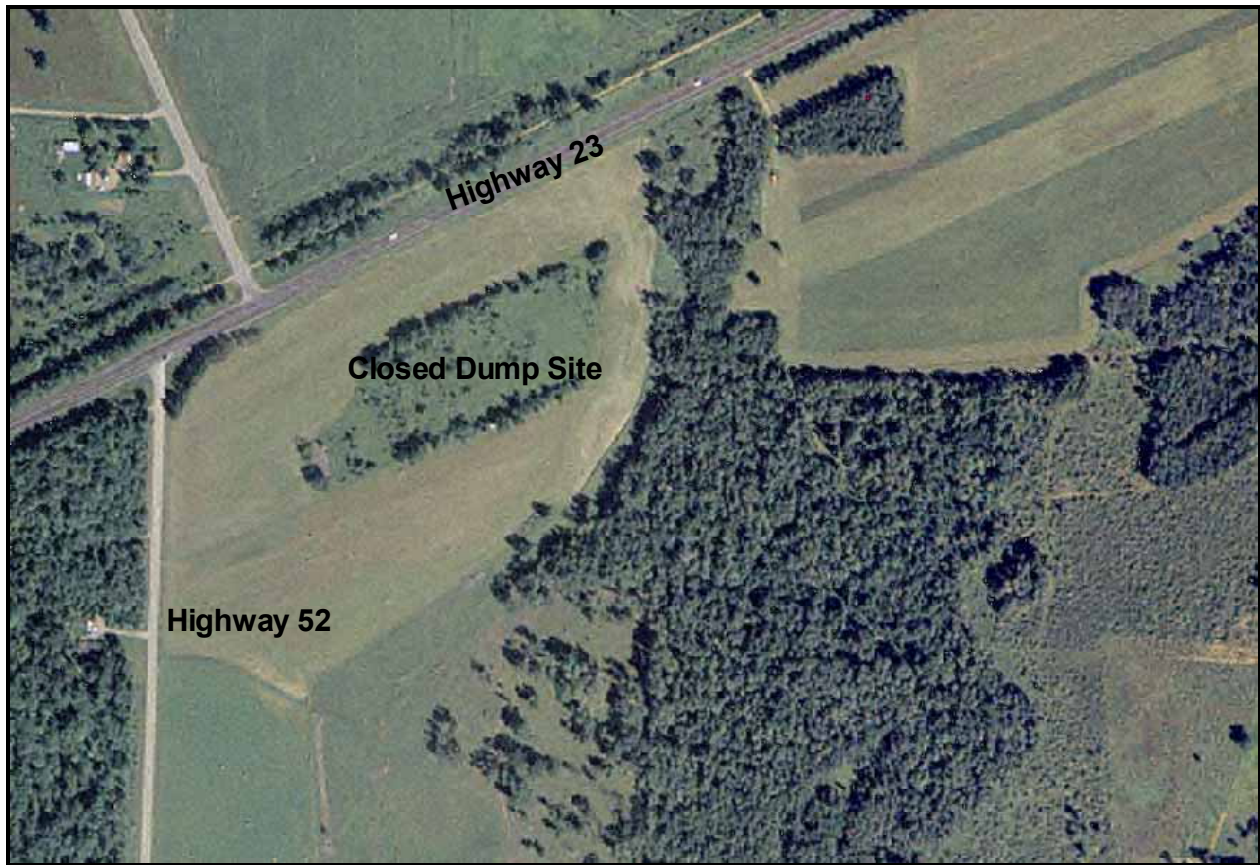
Figure B-4. 2003 Aerial Photograph of the Closed Ogilvie Town Dump

Based on information provided by MPCA and stakeholder input, there are two closed dumps in the Groundhouse Watershed. The Ogilvie town dump located near the intersection of Highway 23 and Highway 52 southwest of Ogilvie was closed and covered in 1975. In May of 1980 the site was inspected and determined appropriately closed in accordance with Minnesota Rule SW-12. The 1980 inspection report states that the site “has been very well covered and revegetation is excellent.” The site was entirely fenced though the gate was broken and a small amount of recent dumping had occurred. An aerial view of the Ogilvie town dump taken in 2003 by USDA is shown in Figure B-4.

Based on the 1980 inspection report it is unlikely that the Ogilvie town dump is contributing significant sediment or fecal coliform loading to the waterbodies of the Groundhouse watershed.

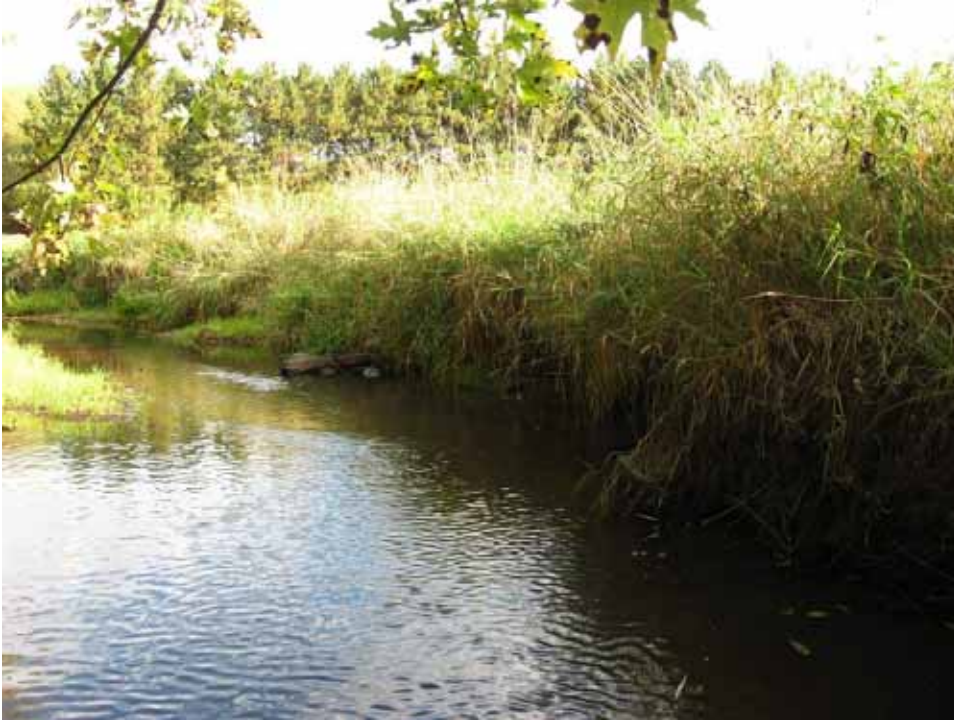
Upstream view of Groundhouse River immediately upstream of the Hwy 23 crossing. This is the downstream limit of the reach listed for impacted aquatic communities. The streambed substrate was firm sand and gravel.

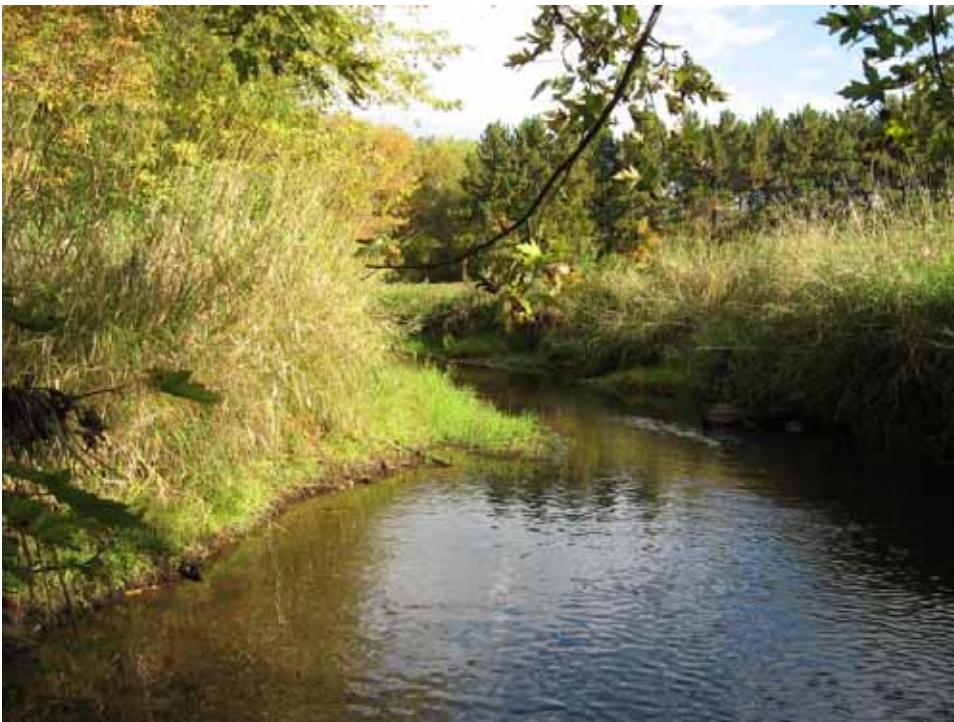
Upstream view from same vantage as previous photo. Note small point bar along right bank. Due to the drought conditions, the vegetation does not necessarily indicate a stable bar.

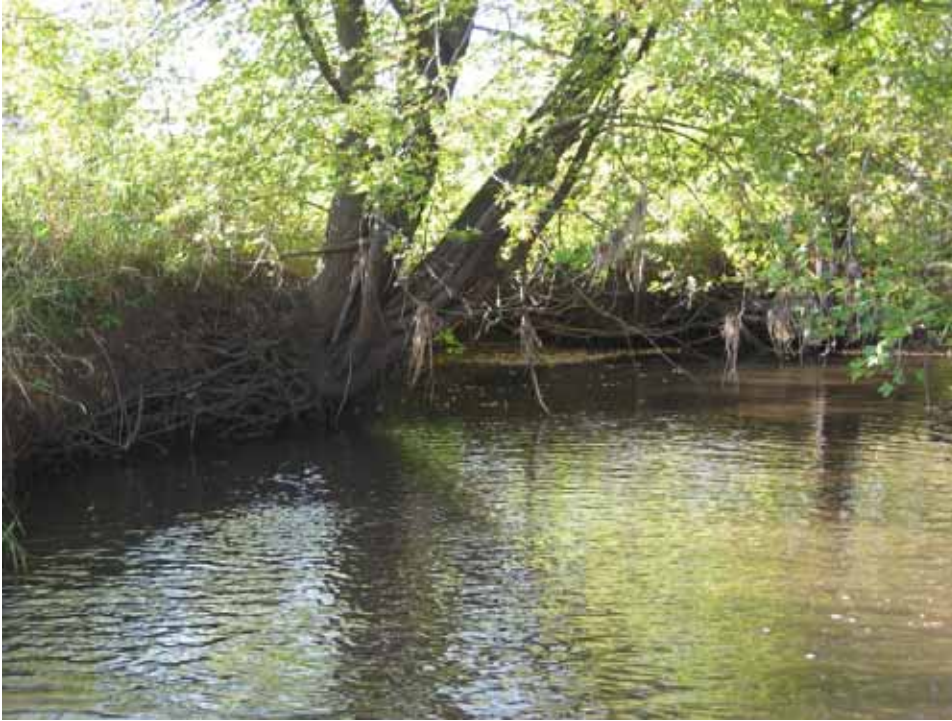
Downstream view at same location as previous photos. Toe scour was observed at the base of the tree, but the size (e.g., age) of the tree indicates the erosion is a long-term process. Debris in the tree was approximately 6-feet above the elevation of the thalweg.

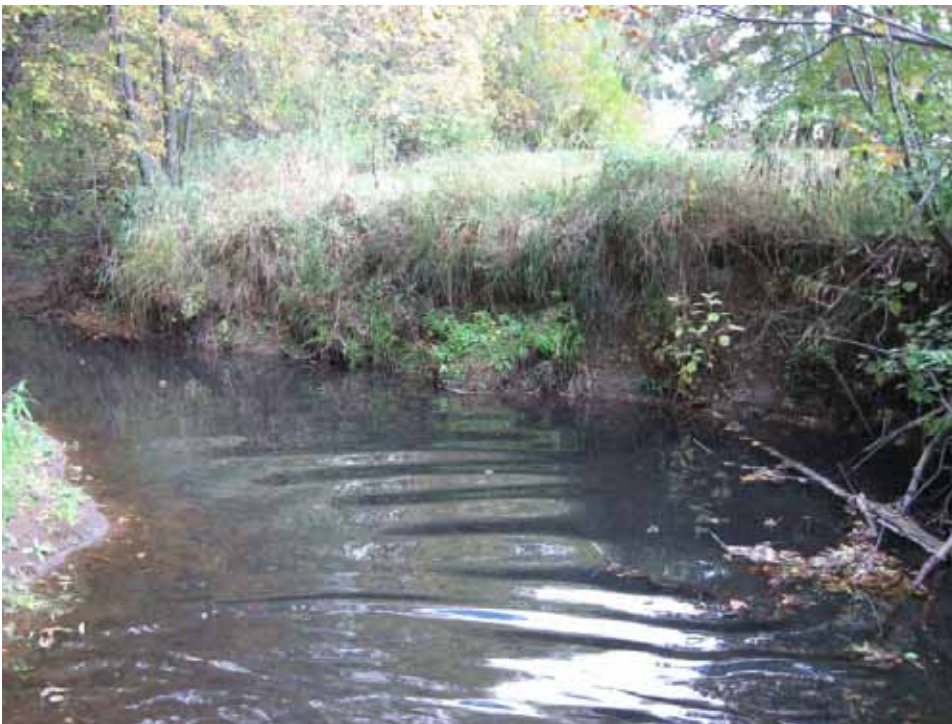
Upstream view slightly farther upstream from previous photos. This streambank is nearly vertical, approximately 6-feet high, supports little woody vegetation (the reed canary grass has only shallow roots), and shows block failures at the toe. While a pool is still present, the substrate here is less firm.

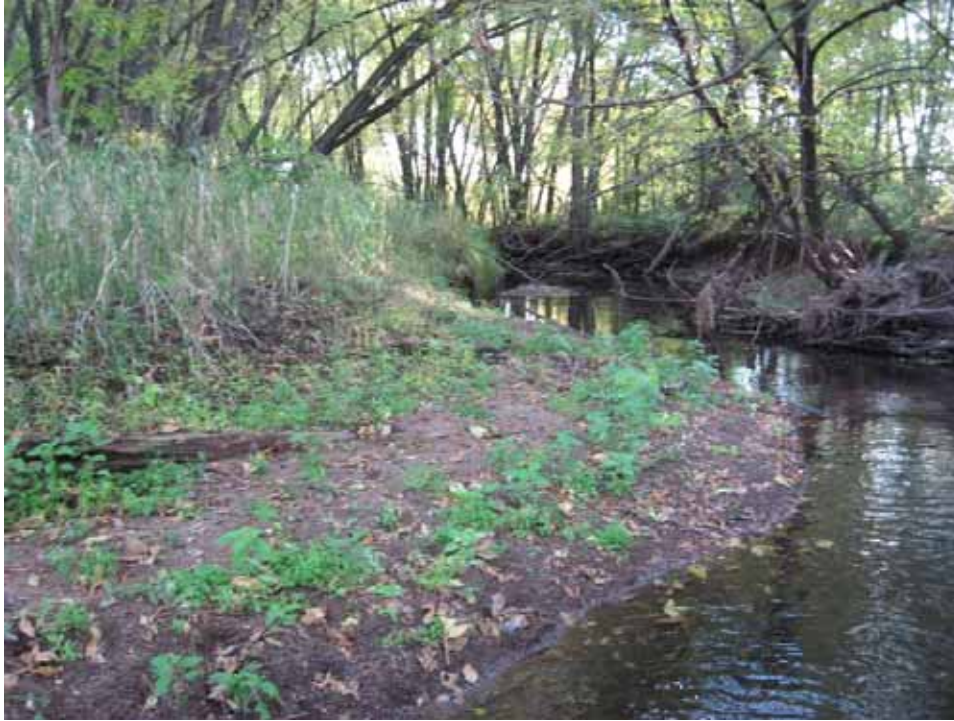
Upstream view of point bar opposite the unstable streambank shown in the previous photo. The depositional material primarily consisted of coarse sand.

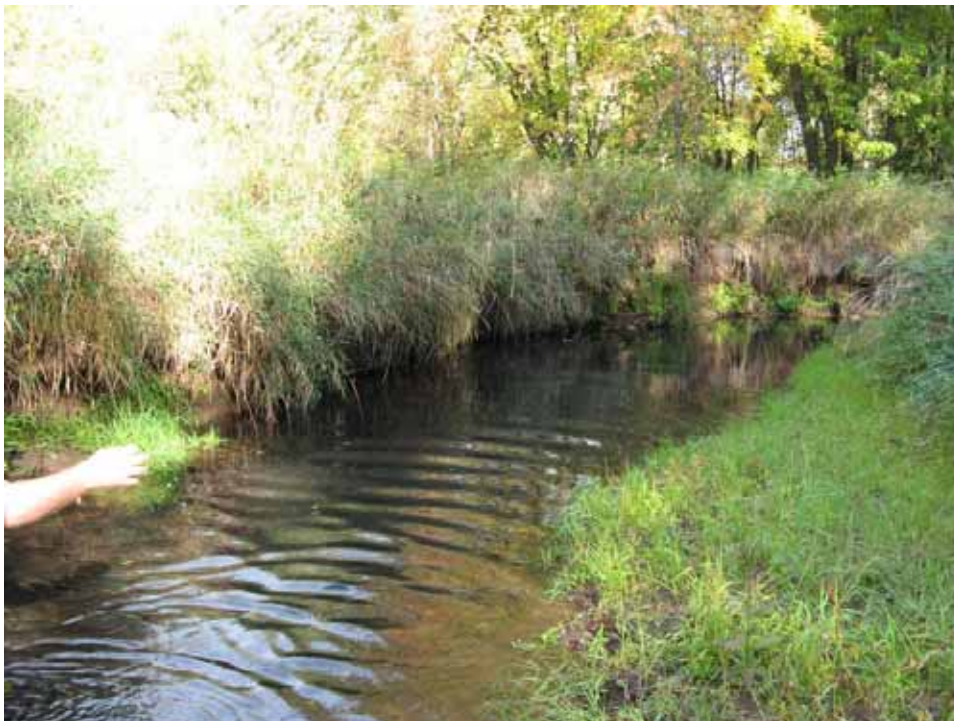
Upstream view beneath through the power line corridor. The taller streambanks (5-6' high) and eroding bank material are likely attributed to the lack of woody vegetation. The corridor runs along one side of the meander belt such that approximately half the bends are located in this cleared corridor.

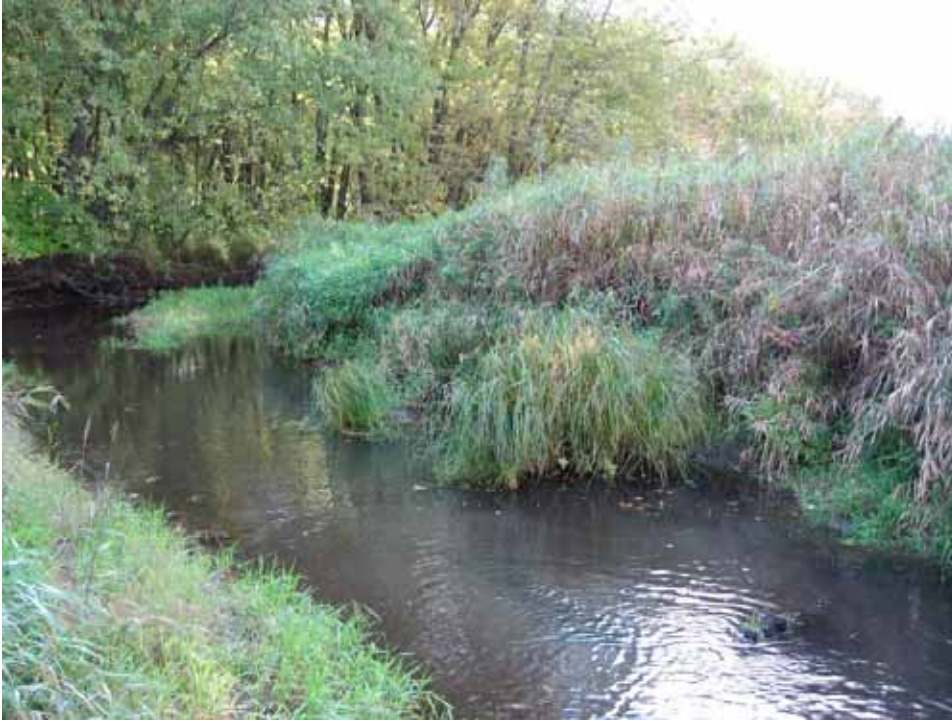
Downstream view of streambank in the power line corridor. Note the lower streambank height as the stream flows back into naturally wooded area. Streambank material is sandy loam/silt loam.

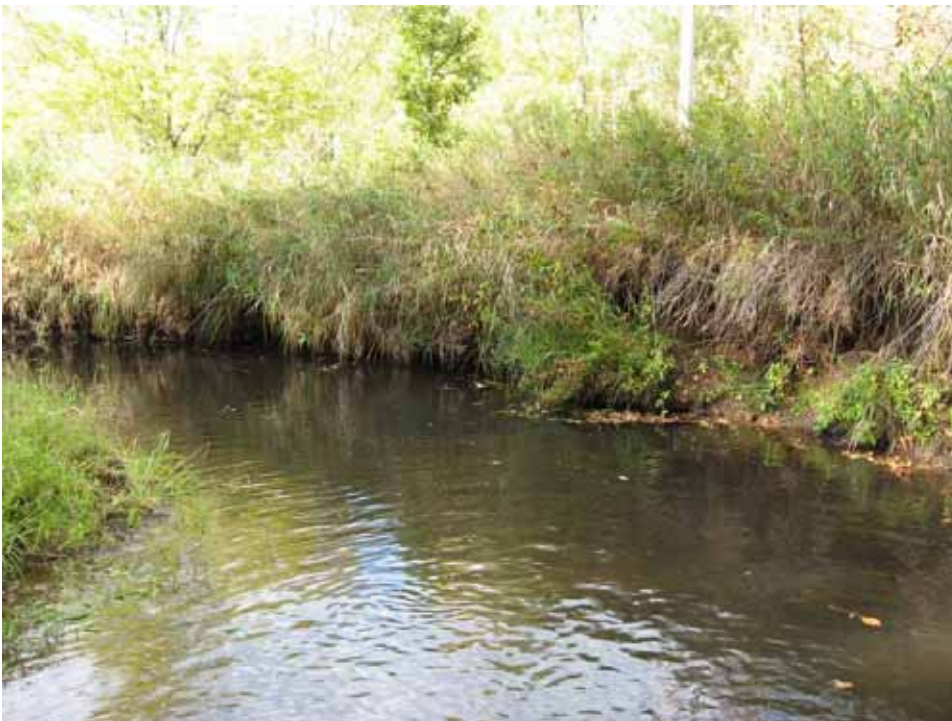
Downstream view of streambank shown in the previous photo. Scour at the toe of the bank leads to undercutting and slumping of the upper bank. This was the primary mechanism for streambank sediment input observed along this reach of the Groundhouse River.

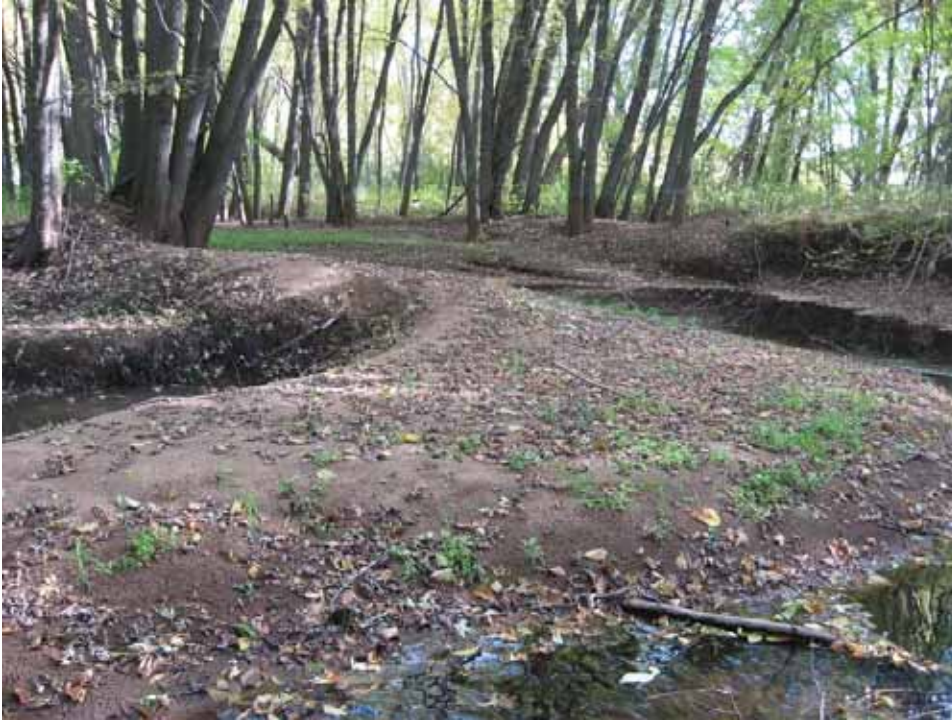
Upstream view of large depositional (point) bar in the wooded area just upstream of the previous two photos. The material is mostly coarse sand – representative of streambank material. Note the wider channel and lower streambank heights where the woody vegetation has not been cleared.

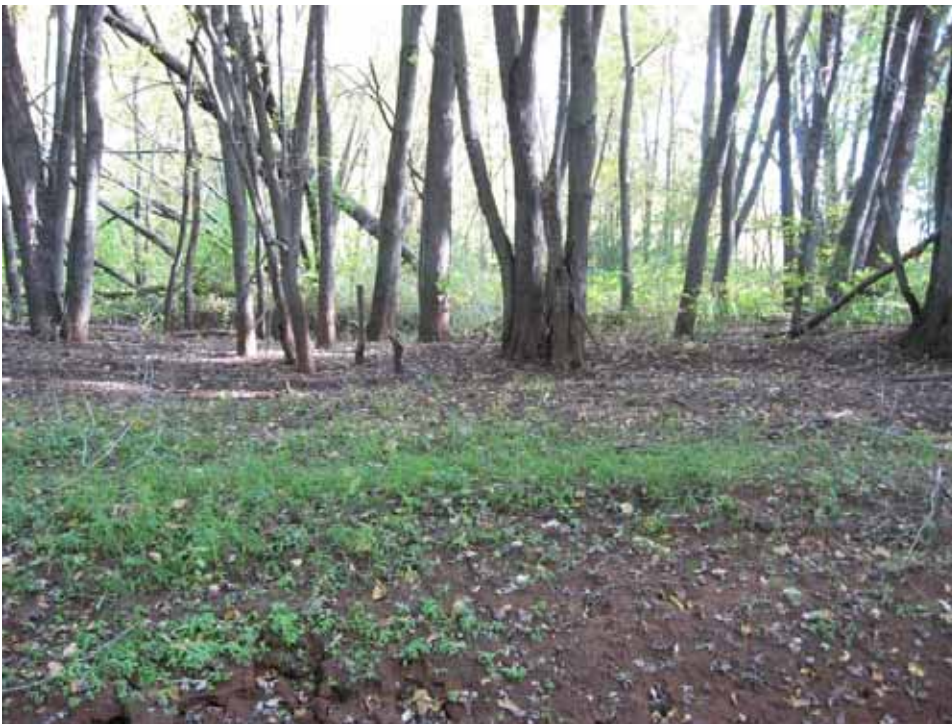
Close-up of the overbank area shown in the previous photo. Note the staining on the tree trunks likely indicating inundation during certain times. If flood waters draw down relatively rapidly, pore water pressure in the streambanks could contribute to mass wasting.

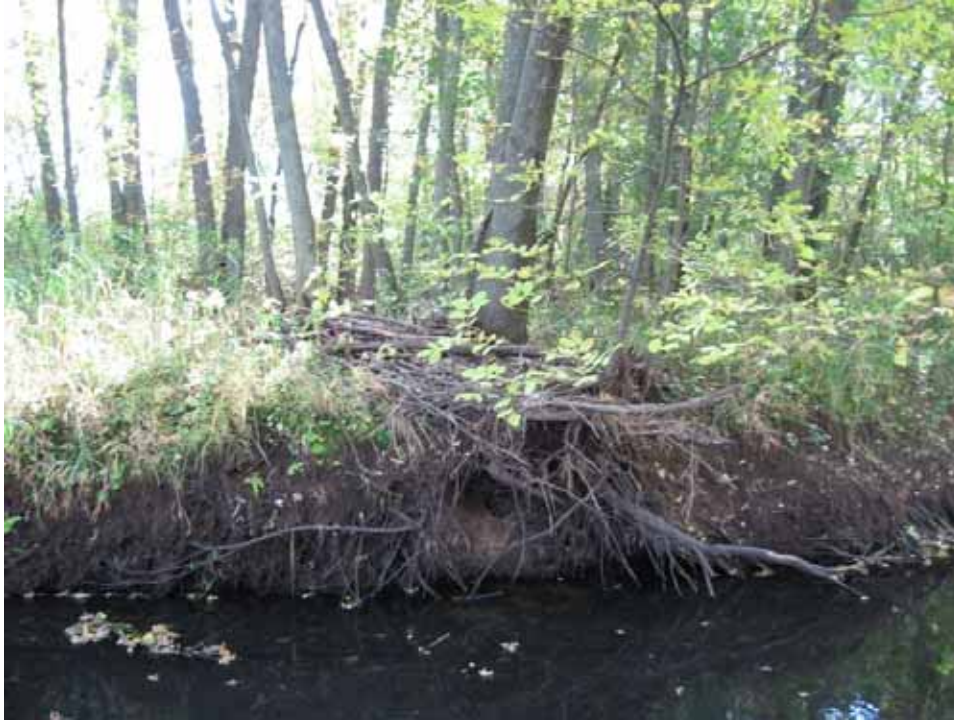
Fluvially transported woody debris along the right bank. This debris indicates that hydraulic stresses, particularly on the toe of the streambank are sufficient to erode and transport streambank material.

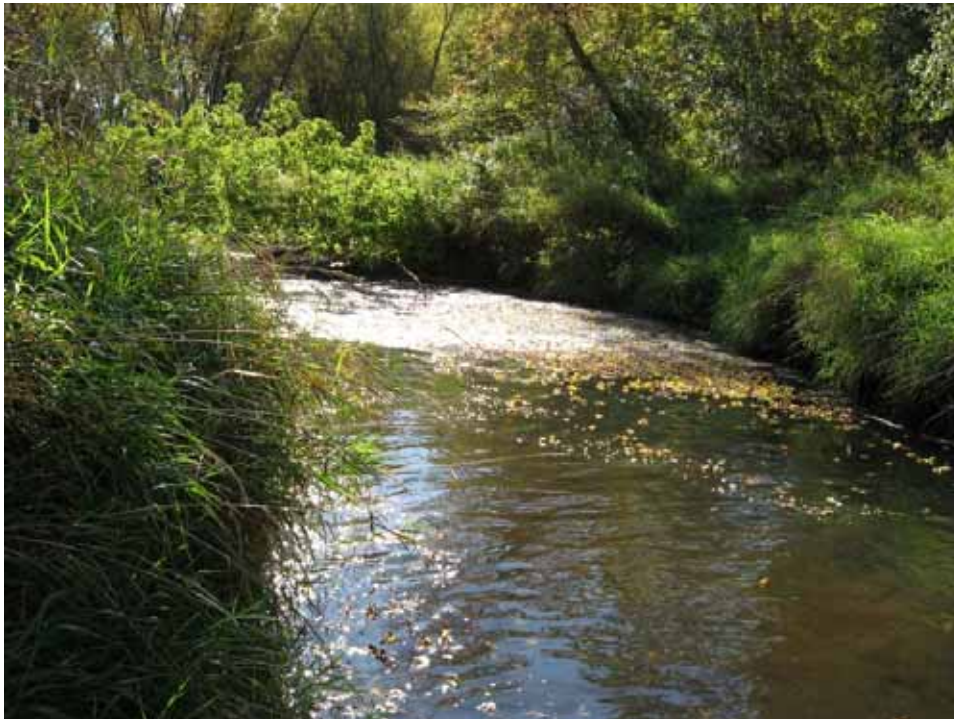
Downstream view toward another crossing of the power line corridor. A debris jam has created a backwater area with excessive green algal growth. The algae is likely due to the open canopy, slow moving water, and nutrient load provided by upstream sources.

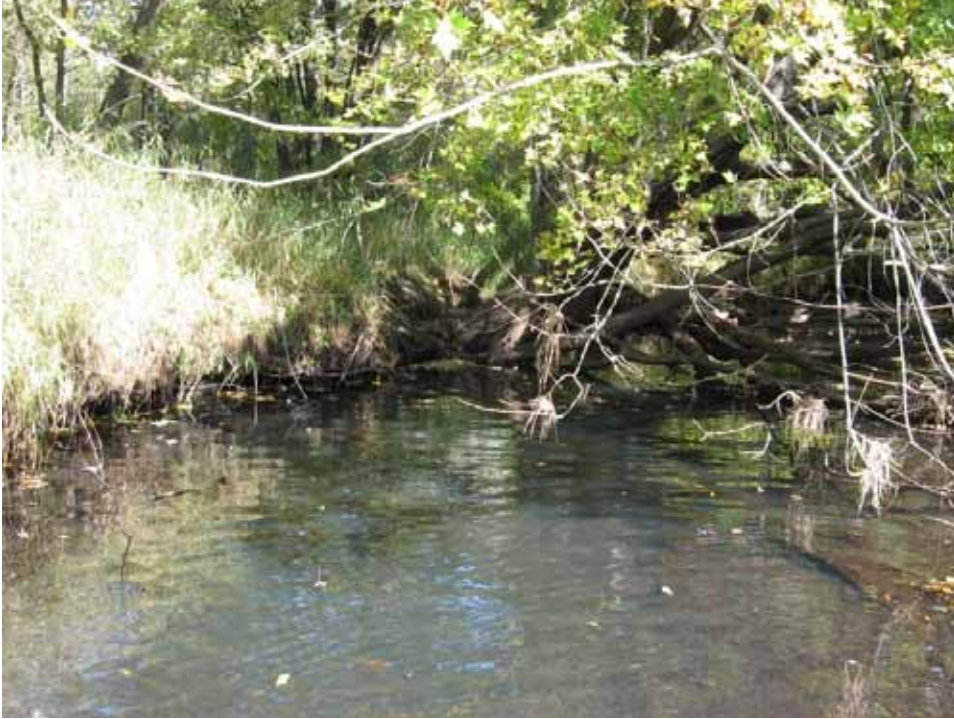
First cobble riffle encountered upstream of the Hwy 23 crossing. Noted stoneflies and mayflies on substrate. Only minor embeddedness of surface substrates was observed.

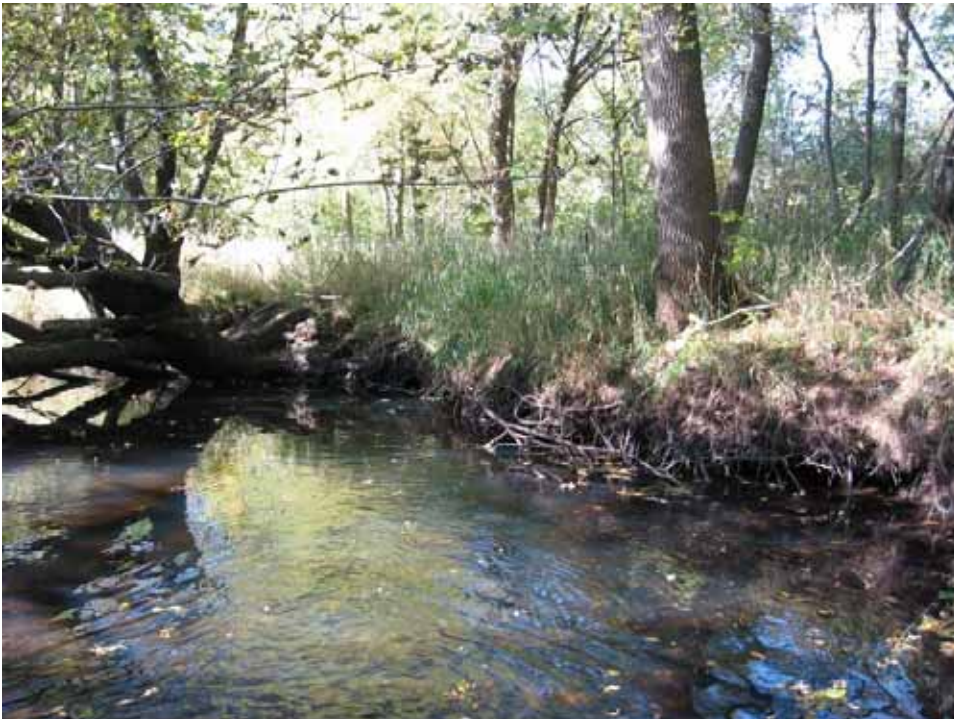
Right bank along cobble riffle shown in previous photo. Note the lower streambank height and the influence of woody roots. The tree at the left of the photo appears to have been recently undercut. Channel response is likely widening due to the more erosion resistant substrate in this reach.

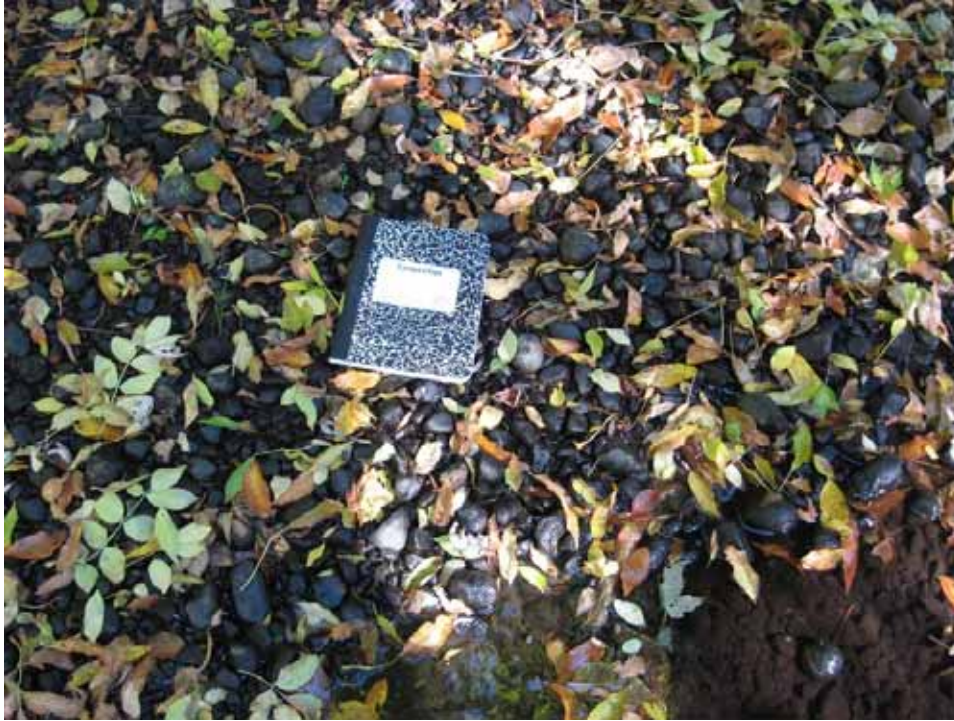
Depositional bar substrate just upstream of the cobble riffle shown in the previous photos. The substrate shape is sub-rounded.

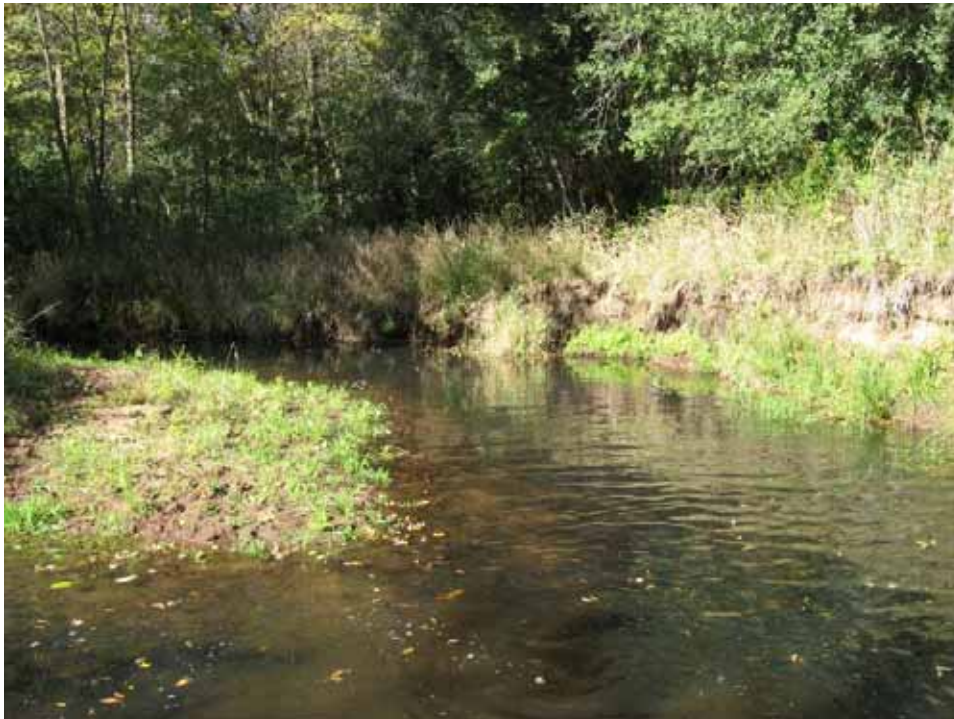
Downstream view of right bank under power line crossing upstream of the cobble riffle shown in the previous photos. The depositional bar on the left bank appears to be storing some of the sediment generated by the erosion of the right bank.

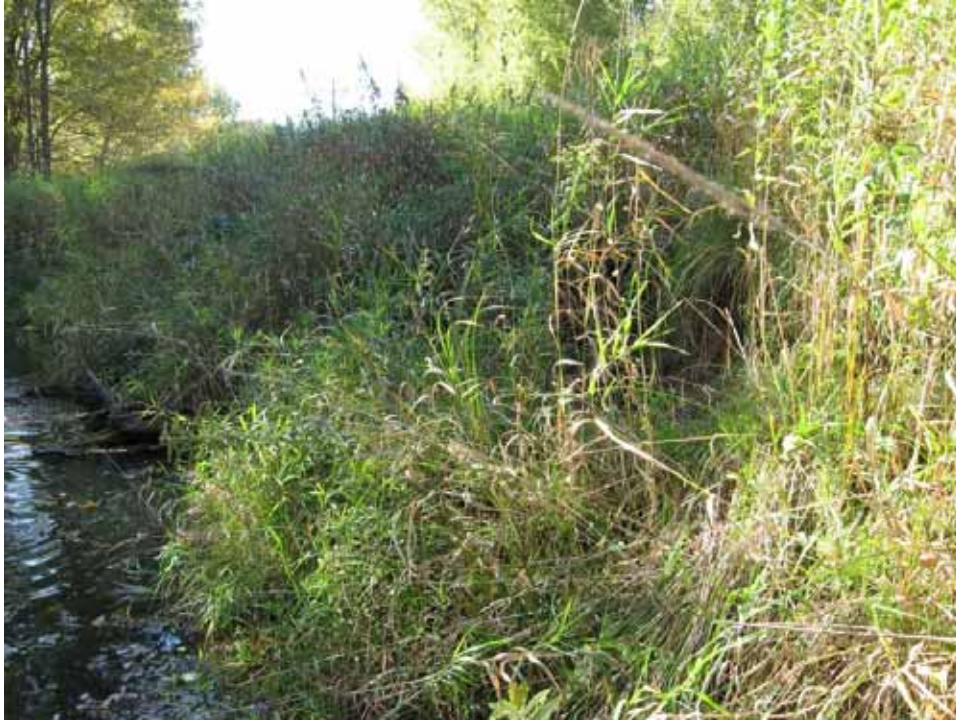
Close up view of large block of streambank material detached from the streambank. The location along the power line corridor indicates the lack of woody vegetation contributes to the susceptibility of the streambanks to destabilizing forces.

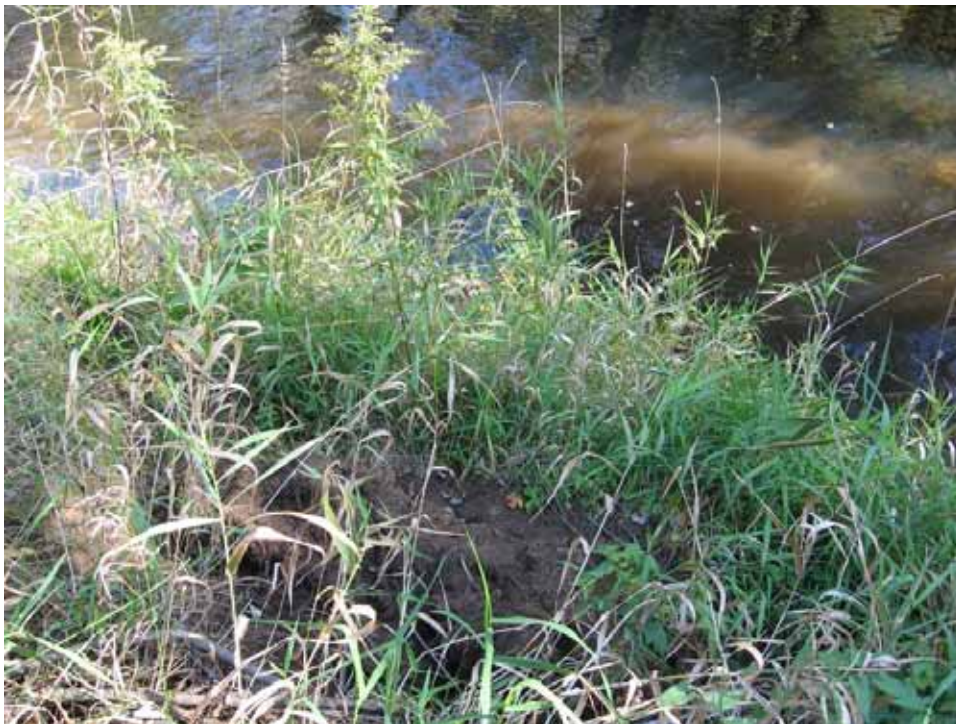
Separation of sediment block from the streambank as seen from the top of the bank.

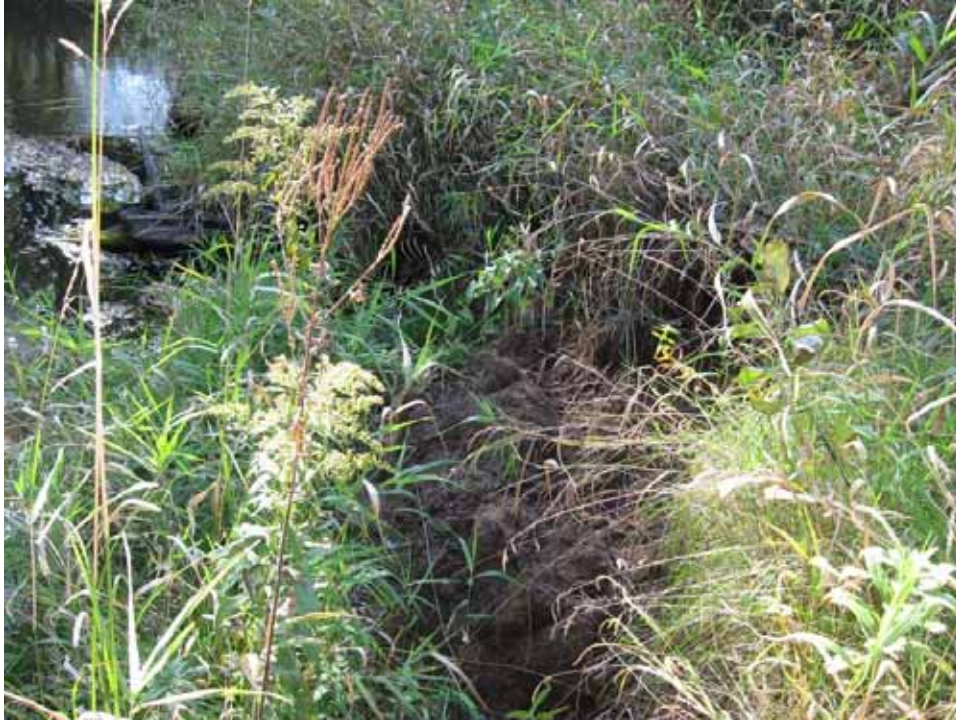
View of the block failure shown in previous photos as seen from the top of the bank.

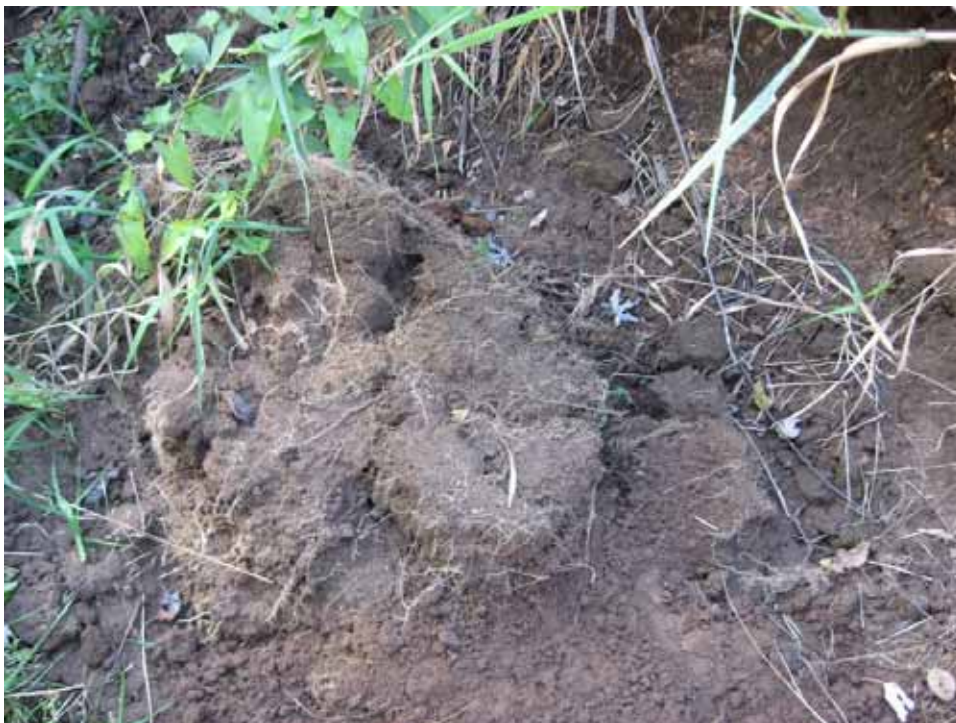
Close-up view of the streambank material where the failure block is separating as shown in the previous two photos.

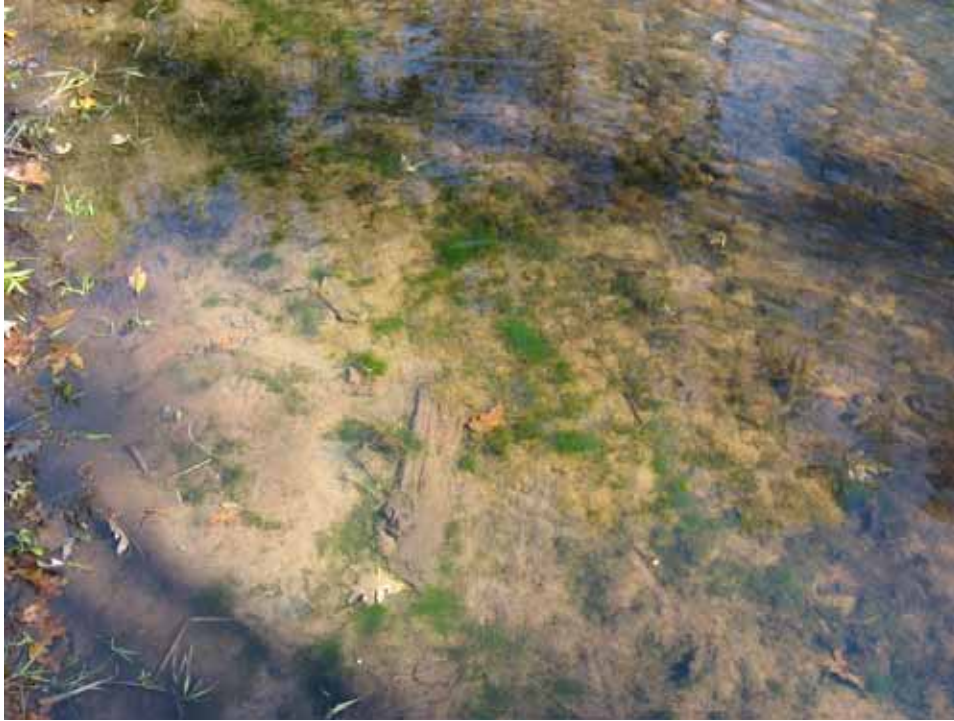
Growth of green algae on a depositional bar. The presence of soft, fine depositional material indicates this is a slower flowing region of the channel.

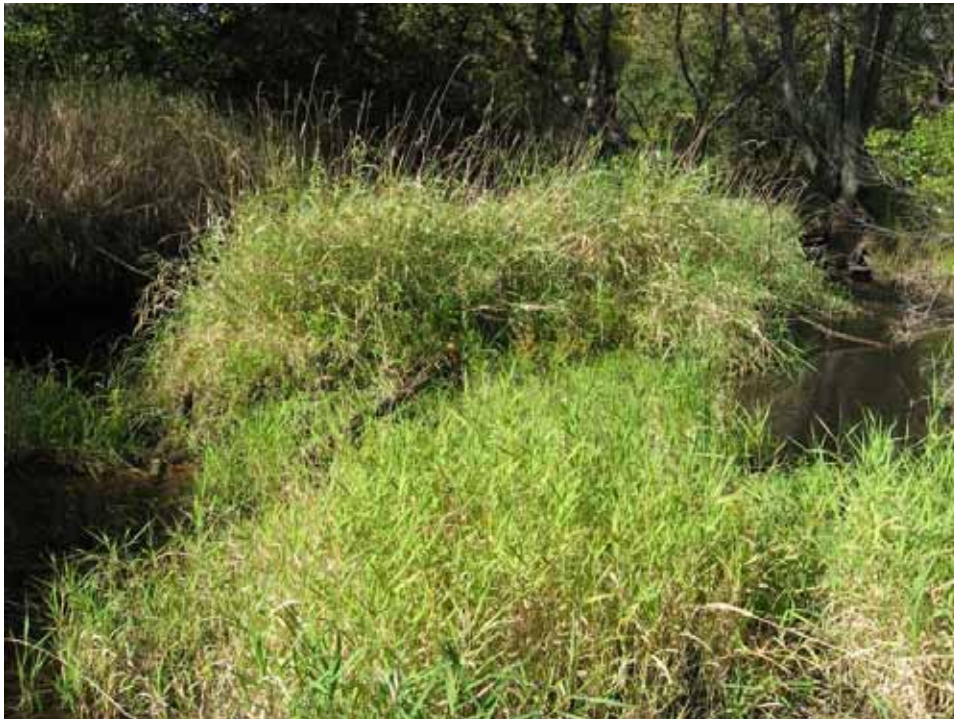
Upstream view of the upper limit of the reach walked from the Hwy 23 crossing. The grassy depositional bars are located where the power line crossing is located. More large woody debris was observed in the channel upstream of this point.

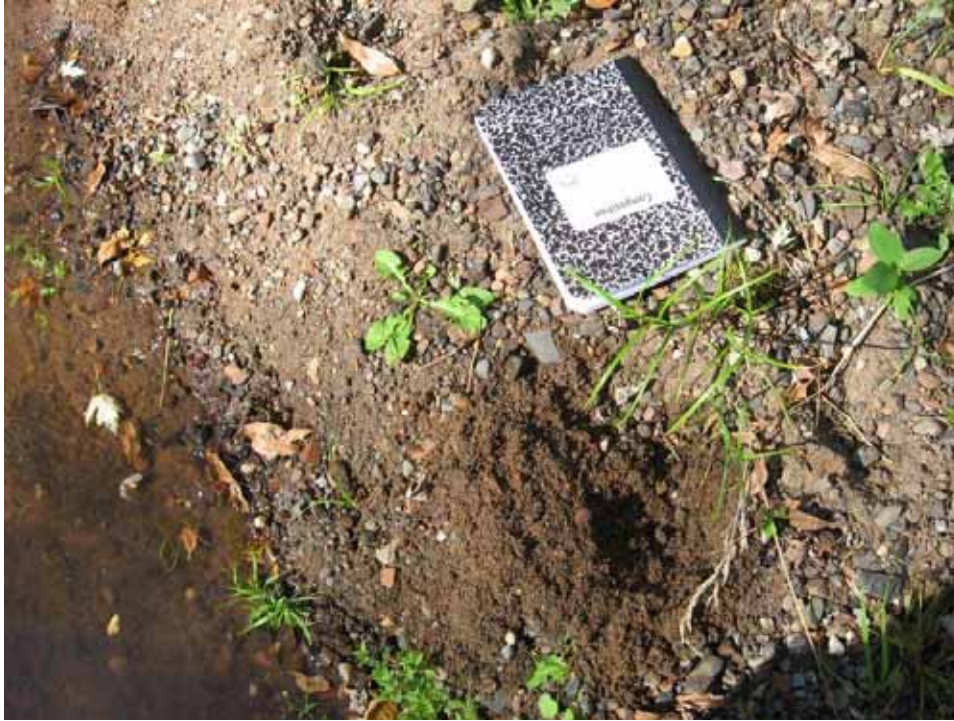
Depositional material at the downstream end of one of the depositional bars shown in the previous photo.

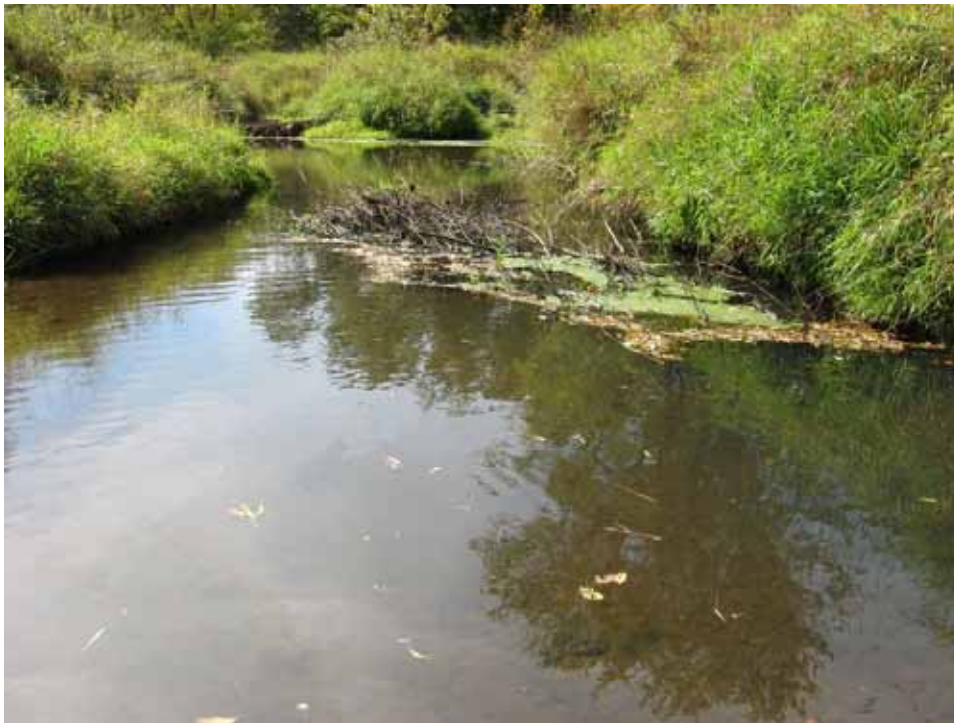
Downstream view downstream of the Hwy 23 crossing. This was the downstream limit of the reach walked from Hwy 23. Bottom substrate was considerably less consolidated than the upper section.

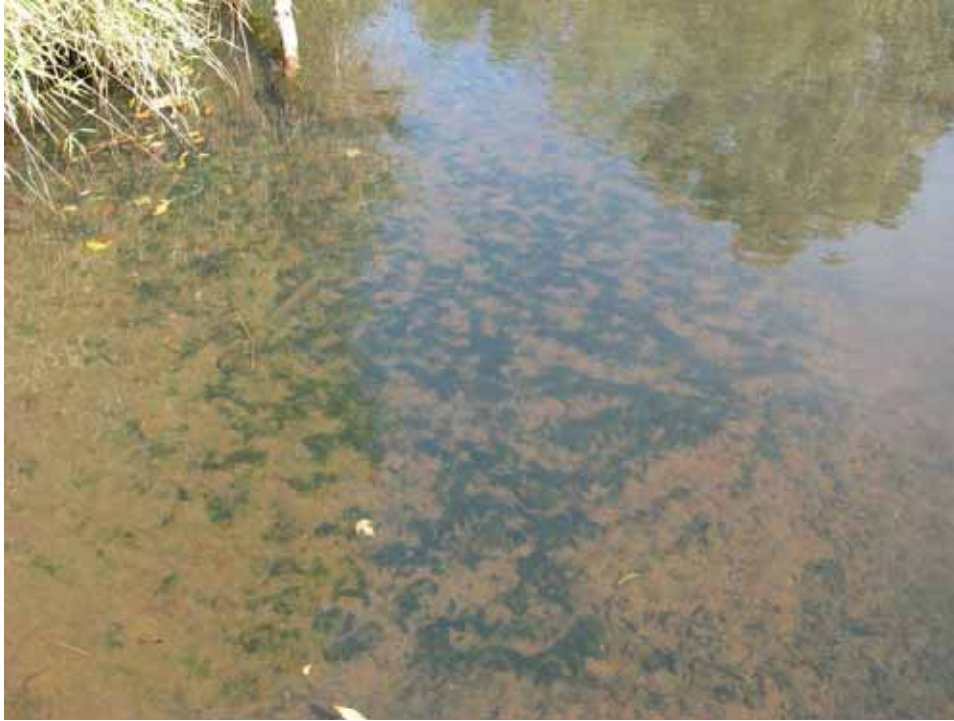
Growth of green algae on bottom substrate in the reach shown in the previous photo.

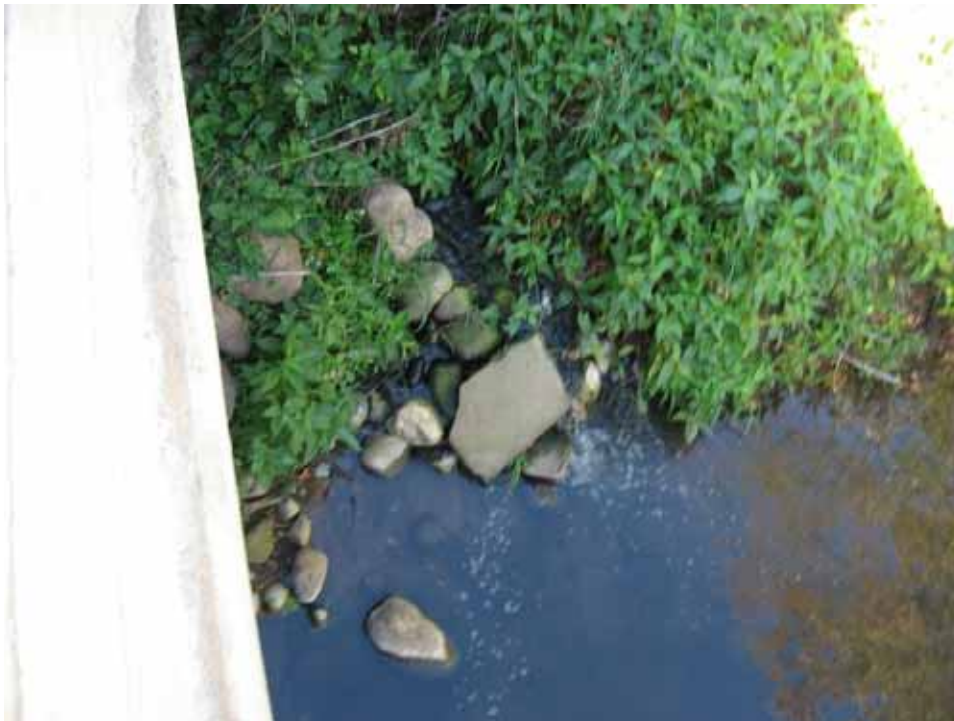
Outfall from the Ogilvie publicly owned wastewater treatment works (POTW) located on the right streambank immediately upstream of the Hwy 23 crossing. No changes in water quality were observed downstream of the outfall.
