Groundhouse River Total Maximum Daily Loads for Fecal Coliform and Biota (Sediment) Impairments

Final TMDL Report

March 2009

**Submitted by:
Tetra Tech**

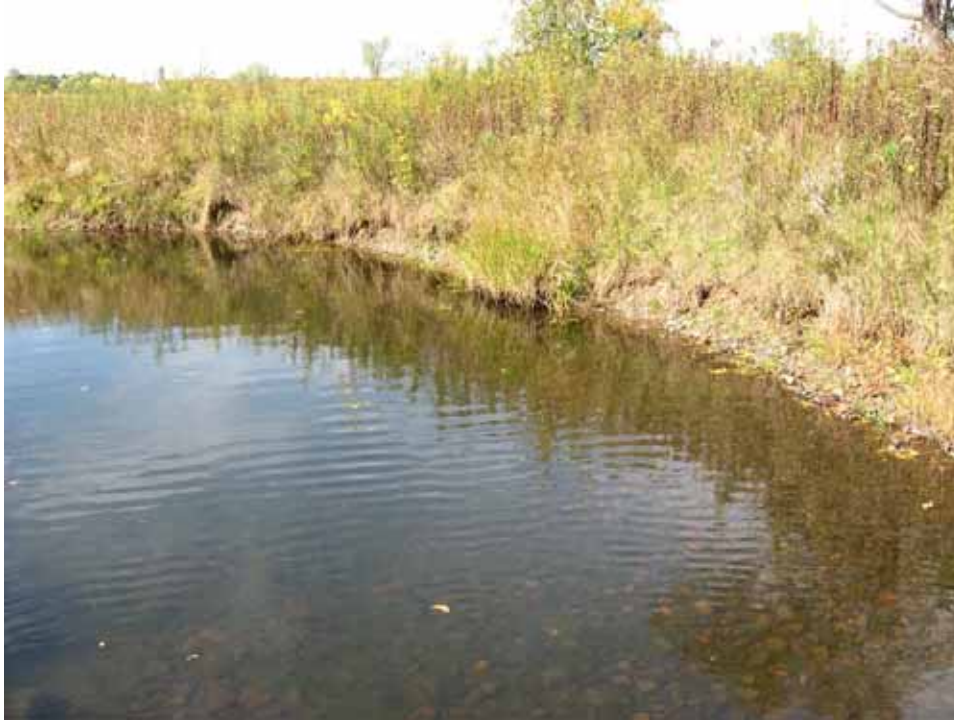
Upstream view of the left bank of the Groundhouse River at a site off of Dill Road (located upstream of the previous site). Note the cobble substrate and the more stable morphology of the bank – particularly along the outside of a meander bend.

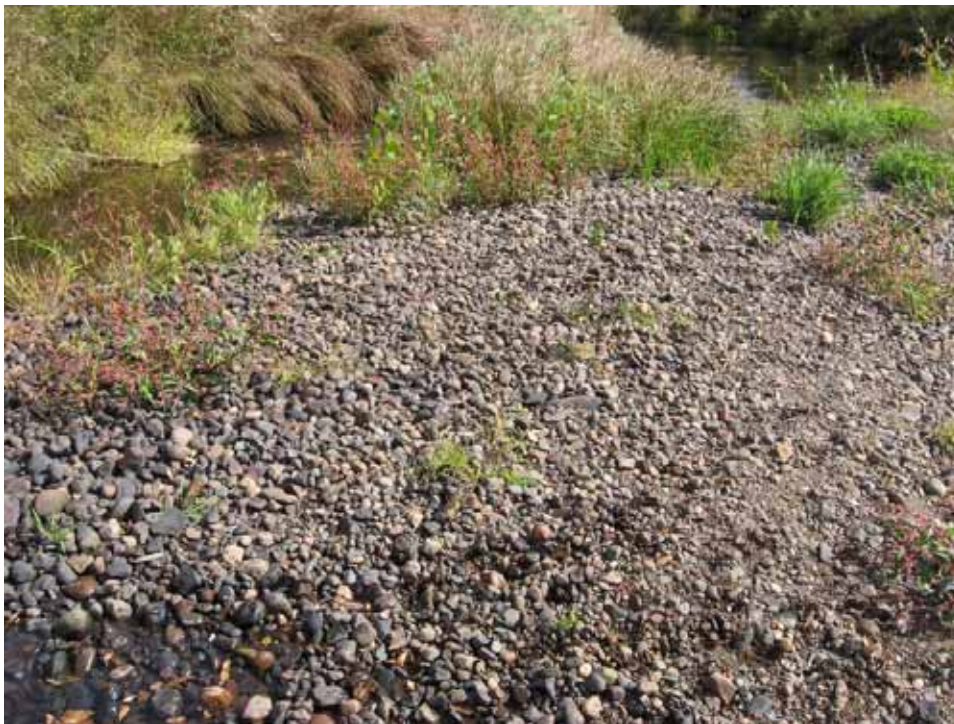
Mid-channel depositional bar formed of gravel and cobble. Both submerged and emergent vegetation were observed in this reach. The reach is located in a meadow with little woody vegetation or canopy cover, the streambanks were generally low and not sources of excess sediment to the reach.

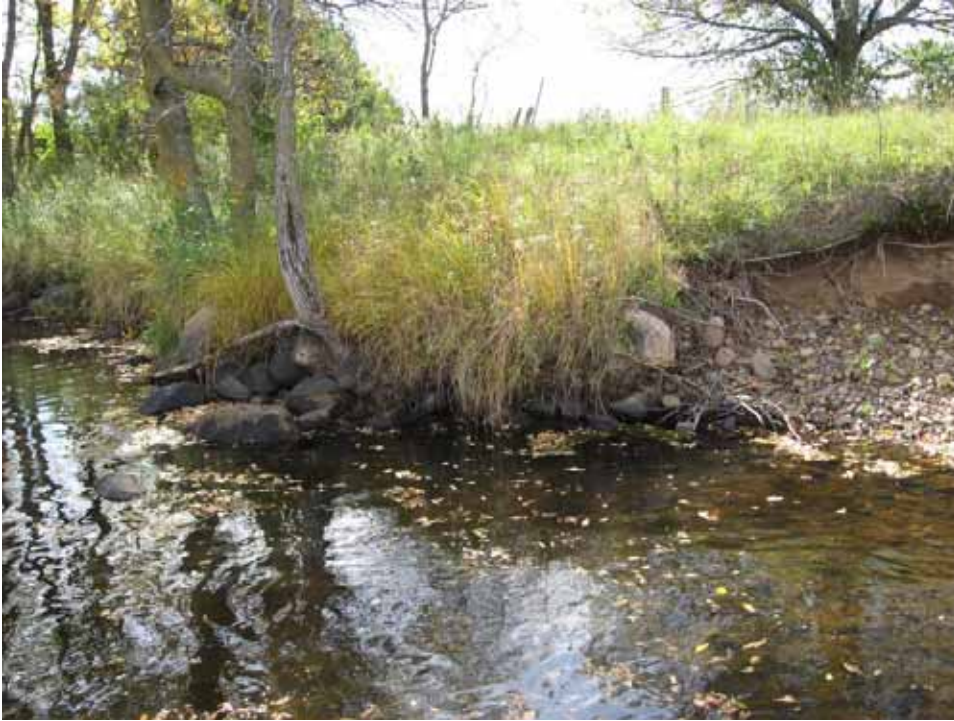
Downstream view of right bank at the head of a bend. The boulders to the left of the photo were likely placed by the adjacent landowner to minimize streambank erosion. Note the contrast with the upstream conditions where no boulders were installed.

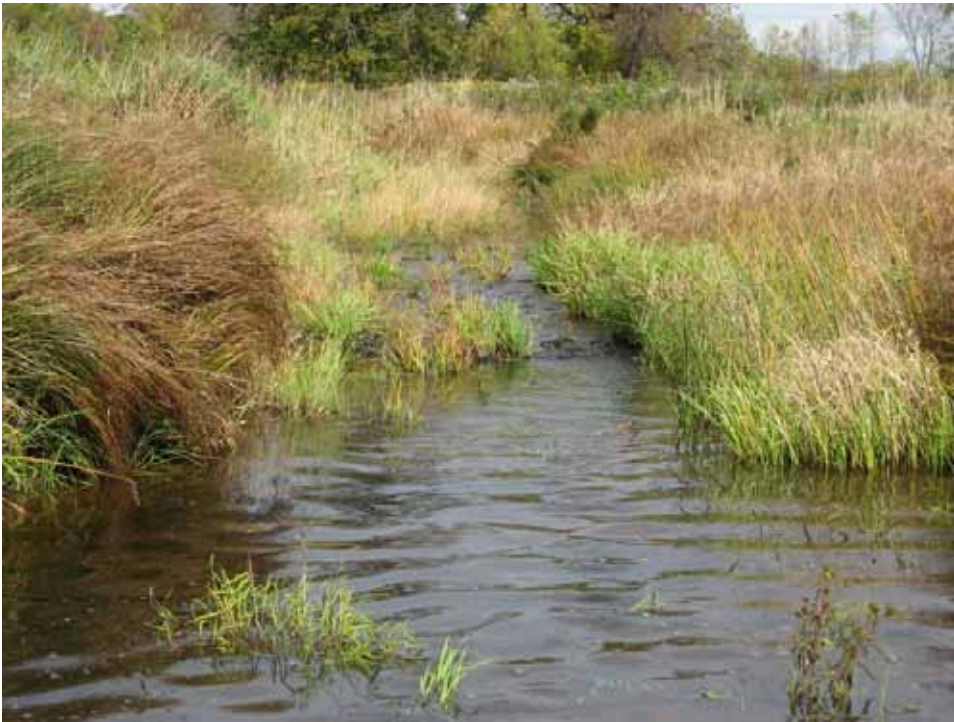
Upstream view of a cobble riffle at the upstream end of the reach walked off of Dill Road. Approximately 0.5'-feet of fall occurs over this riffle – the third observed in this reach.

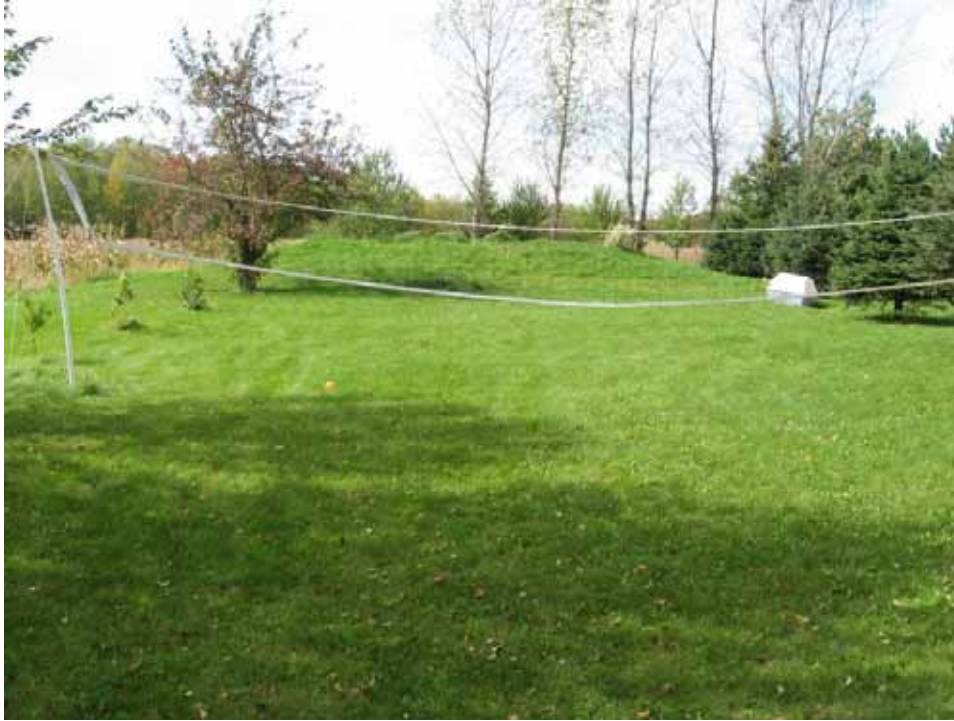
Example of mound-type septic systems commonly used in the watershed. This mound was located approximately 250-feet from the Groundhouse River (other mounds were observed closer).

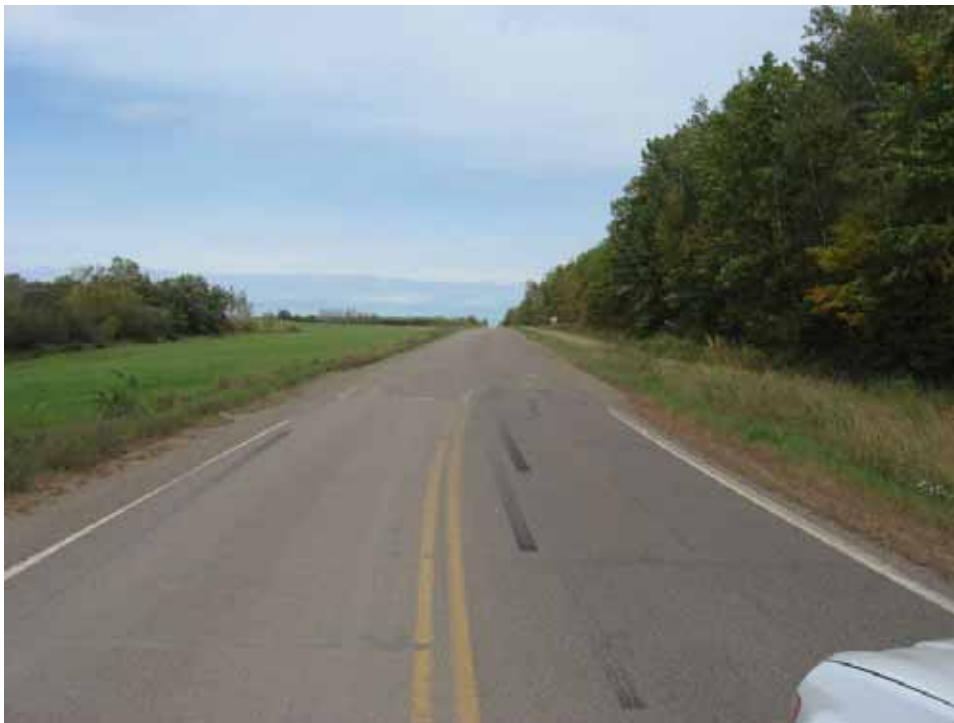
Transition from asphalt paved road to graveled road near the intersection of Hwy 10 and 170th Avenue. In general the gravel roads were very well maintained and no evidence of sediment input at stream crossings was observed. Roadside ditches were not common.

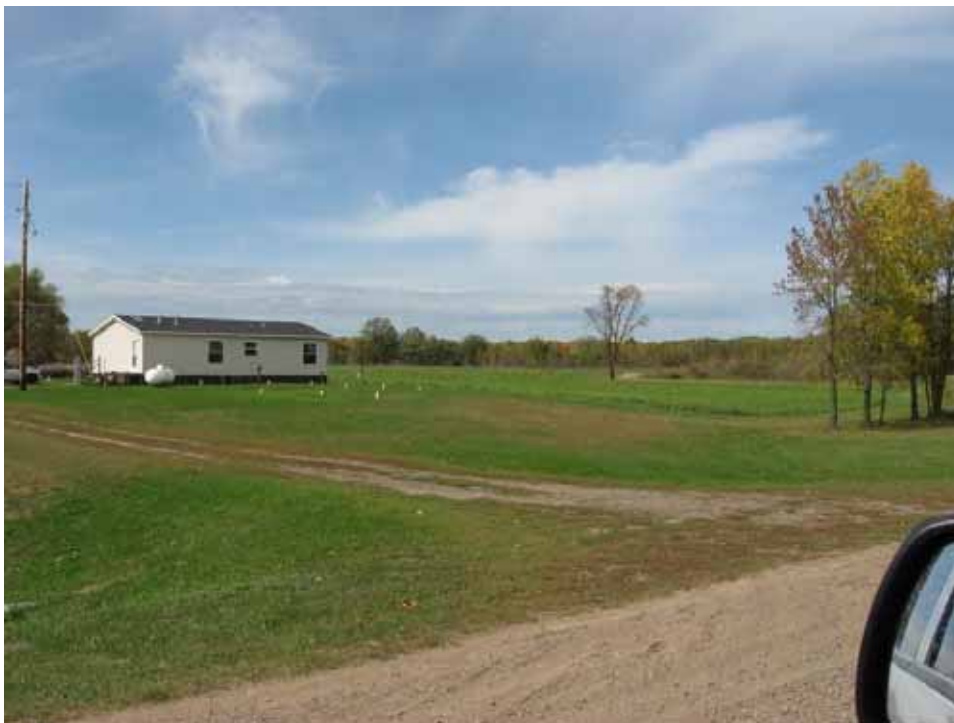
An example of a mound septic system (note the white pipes in the foreground of the house) within 100 feet of the Groundhouse. This site is just upstream of the Hwy 10 crossing.

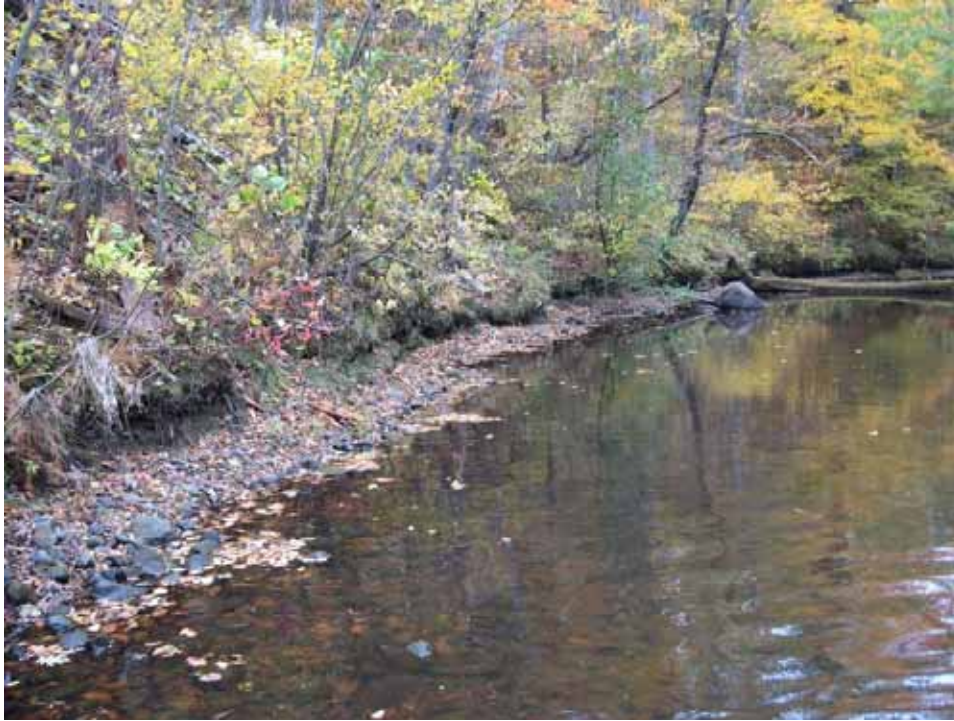
Third site visited where Apple Road crosses the Groundhouse River in the Rum River State Forest. This location is immediately upstream of the crossing (which is reported to have been washed out multiple times over the previous 5 years). Note the confinement by the valley wall along the right bank. The woody vegetation and cobble/boulder substrate limit the sediment generated in this reach.

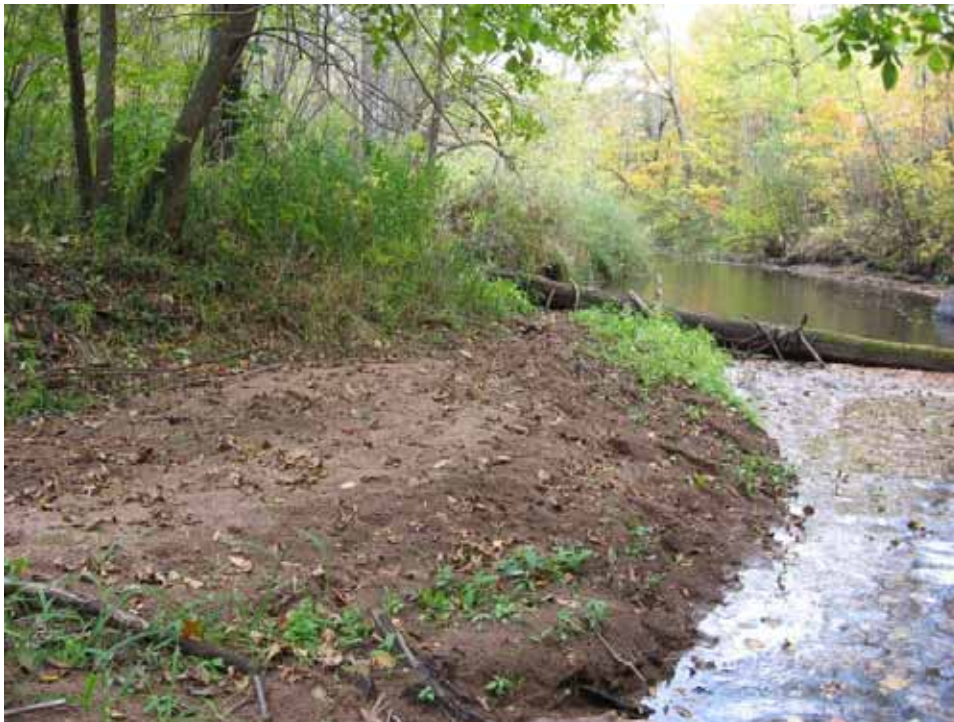
Sandy deposition on a point bar along the left bank. More sand was observed under the surface substrate layer in this reach than in downstream reaches.

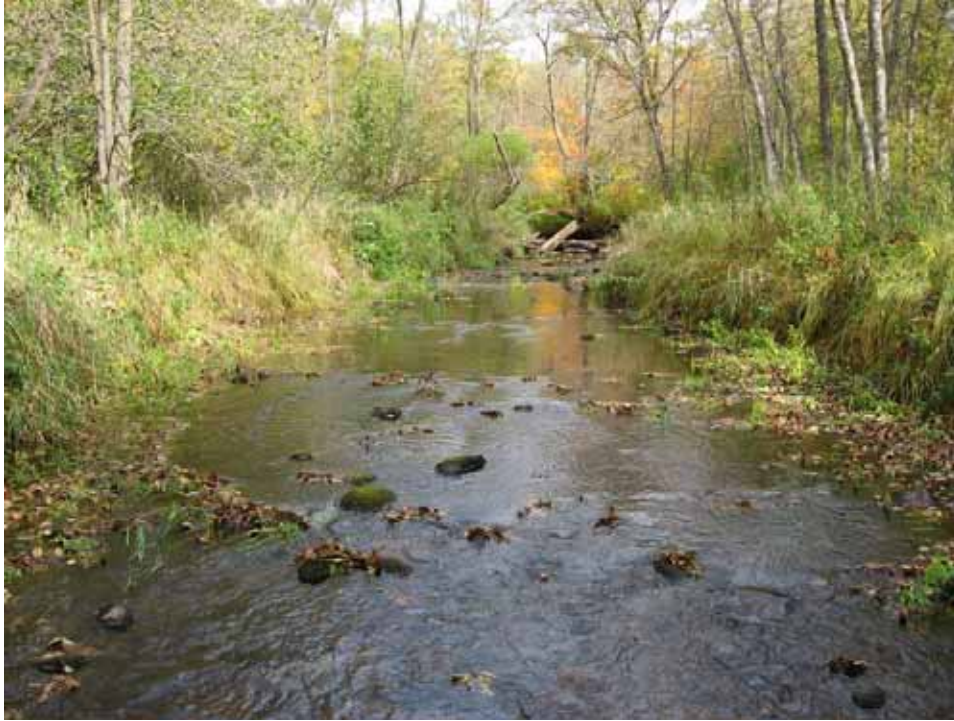
Upstream view of a cobble riffle. The cobbles were between 50 – 75 percent embedded with sand. The source of the sandy material was not evident.

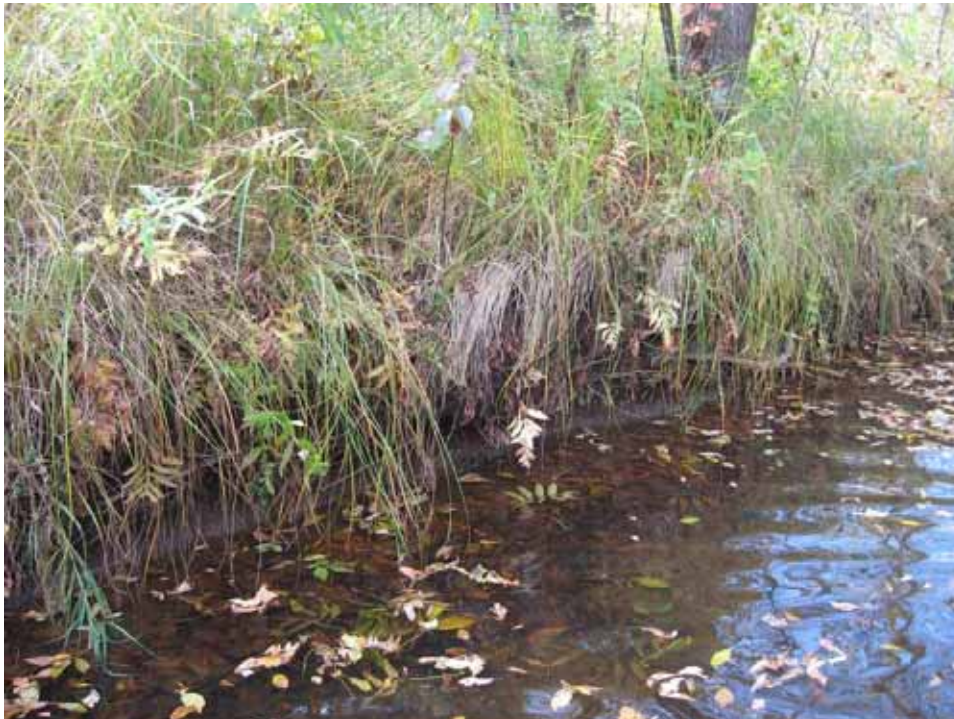
Upstream view of left bank upstream of riffle shown in previous photograph. Minor undercutting of the bank is shown – but this does not appear to be significant enough to be the sources of the sediment deposited in this reach.

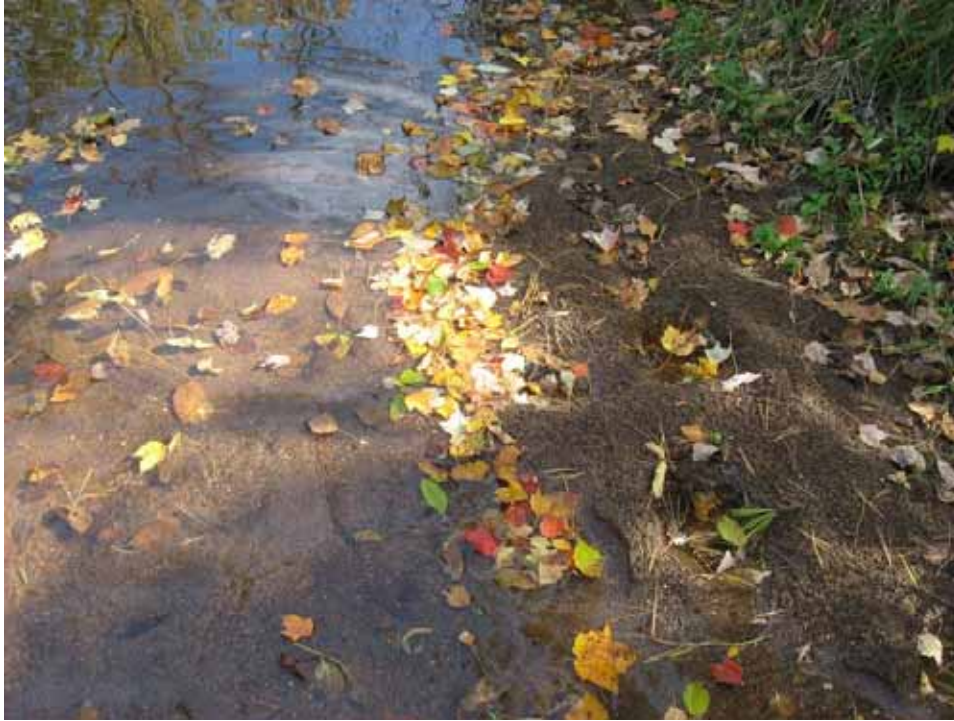
Another sandy depositional bar observed in this reach. In places, sand was the predominant material on the streambed.

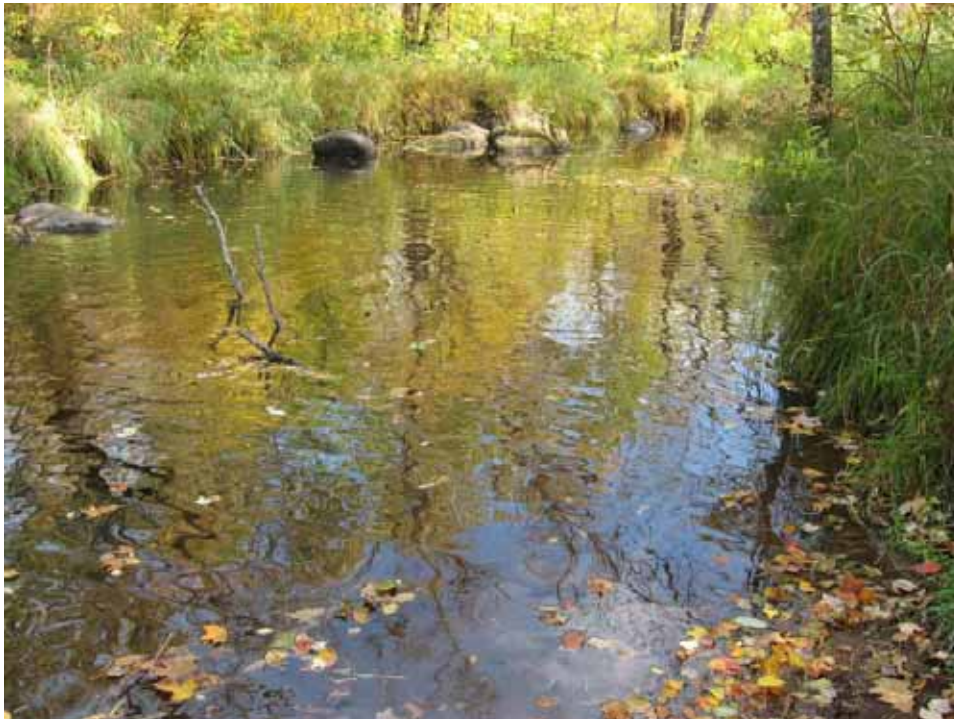
Downstream view at the upstream end of this reach. Note the boulders along the left bank. Due to the presence of the large substrate clasts, the sandy material observed in this reach is likely transported from upstream sources and not indicative of underlying geology.

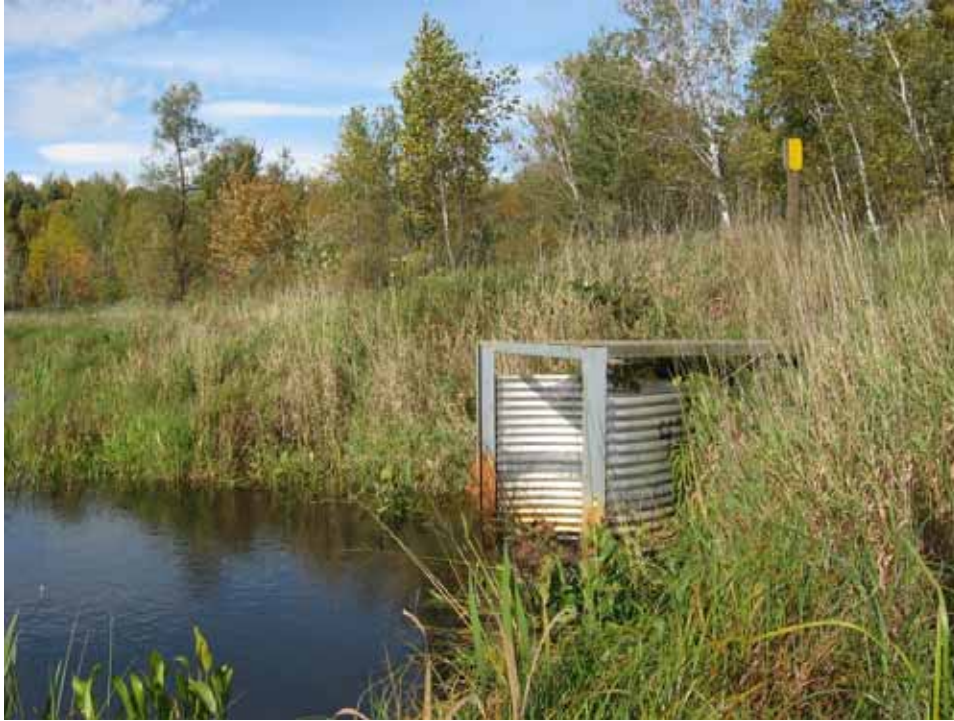
Flashboard riser structure to control flows from a large lake/wetland to a small tributary to the Groundhouse that enters just downstream of the site visited off of Apple Road.

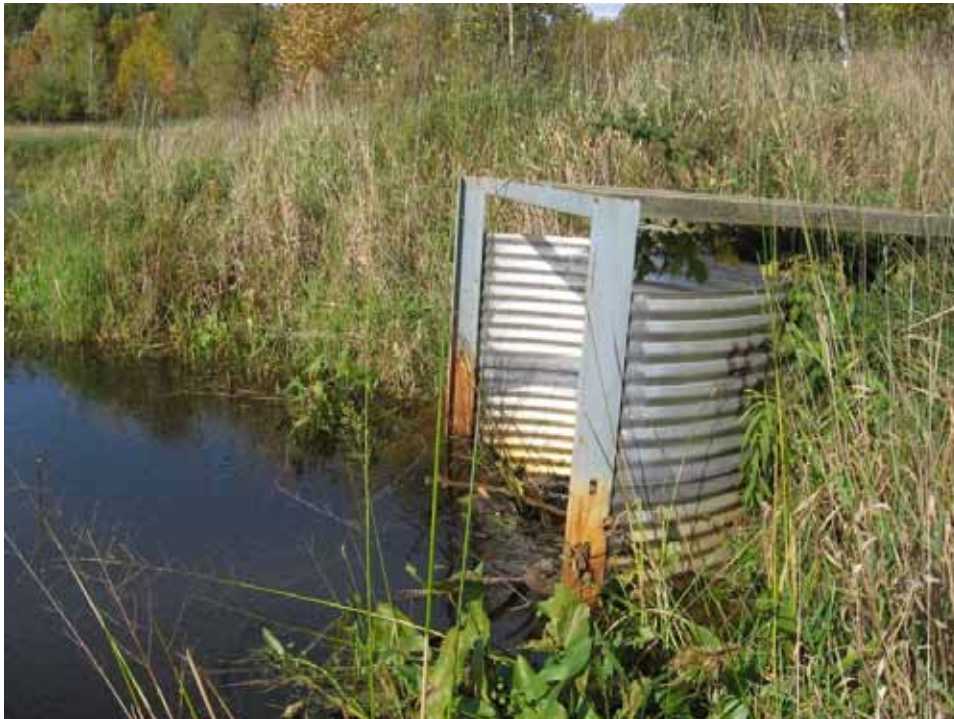
Another view of the outlet structure.

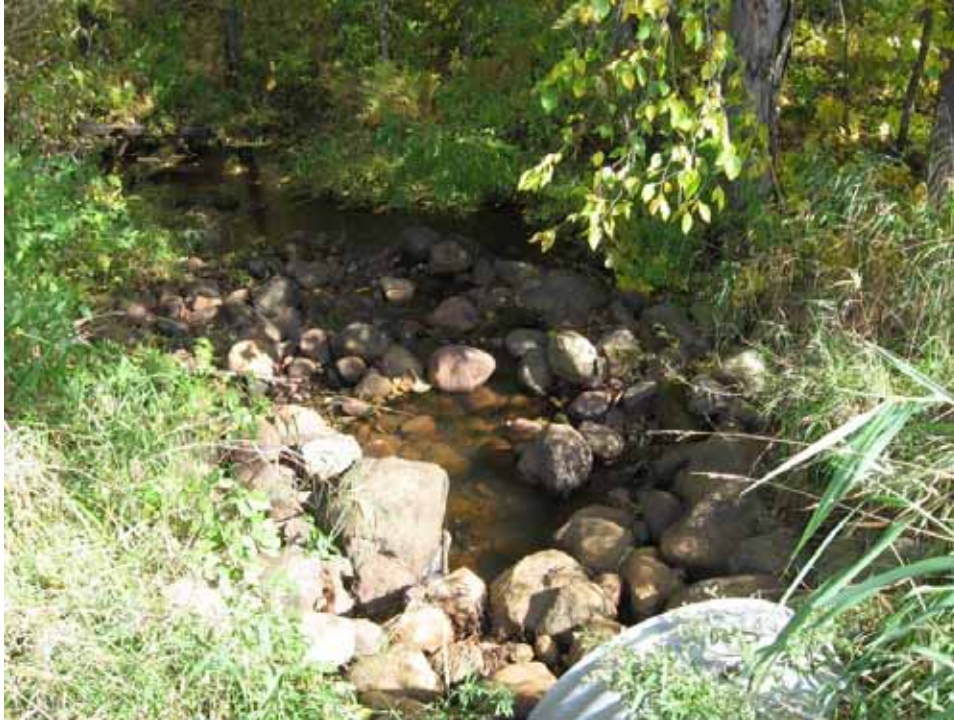
Downstream end of the culvert from the outlet structure shown in the previous photographs. The 36-inch CMP discharges to placed riprap before entering the small tributary.

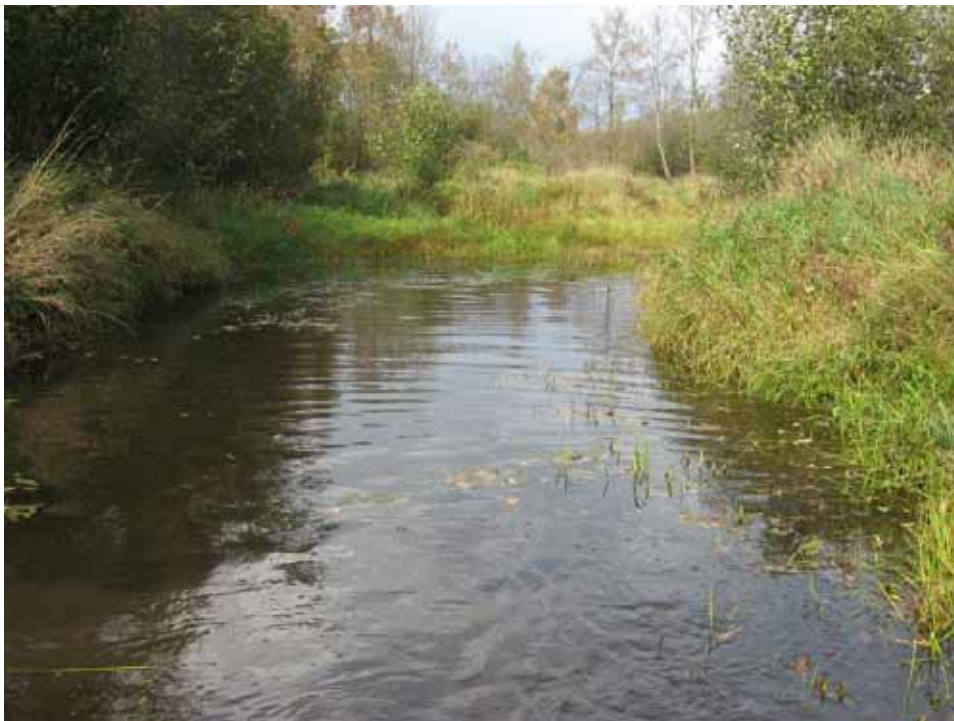
Upstream view of “wetland flowage” near, but downstream, of the confluence of the West Fork of the Groundhouse and the Groundhouse. This reach exhibited a very low gradient, and no erosion was observed.

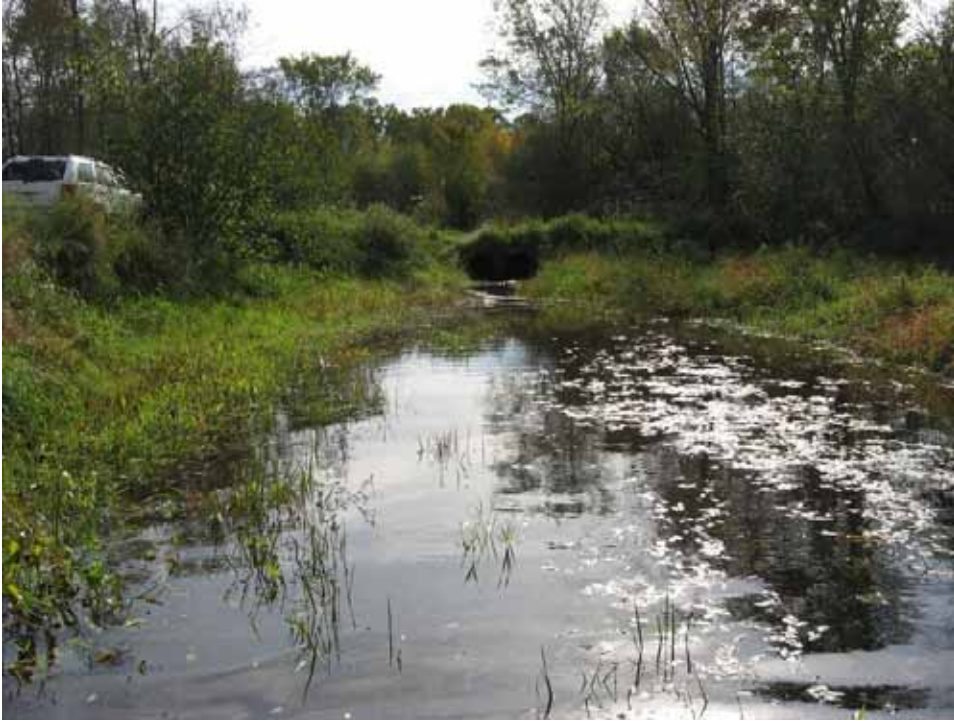
Downstream view from of the “wetland flowage” shown in the previous photo. A culvert crossing is located near the vehicle on the left bank.

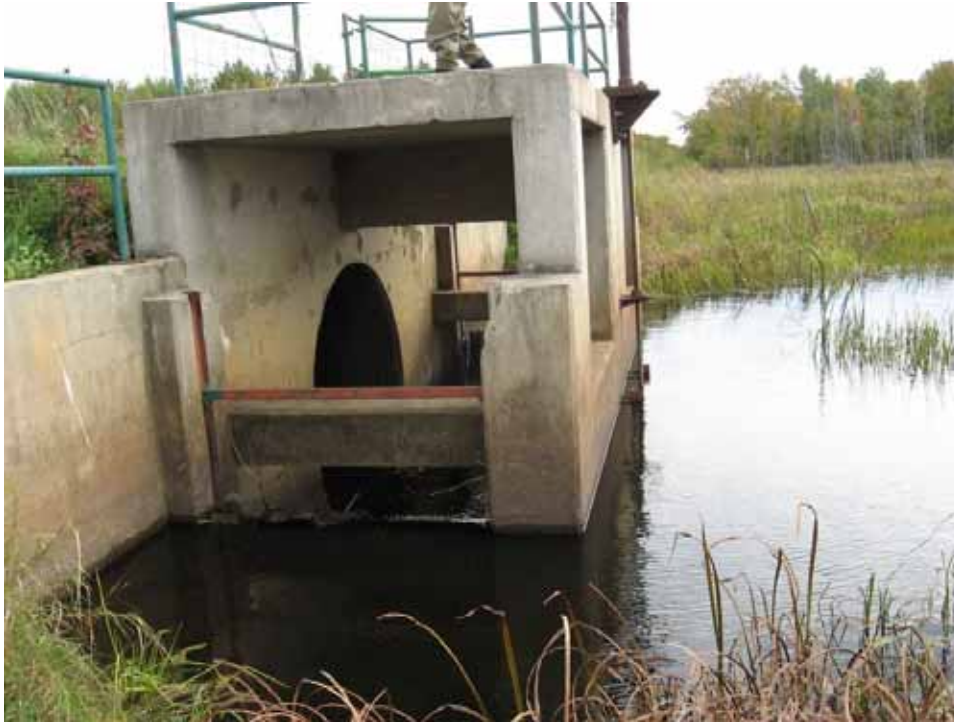
Control structure used to maintain the water surface elevation of the impounded area shown in the previous photograph. The culvert barrel is a CMP 8-feet in diameter.

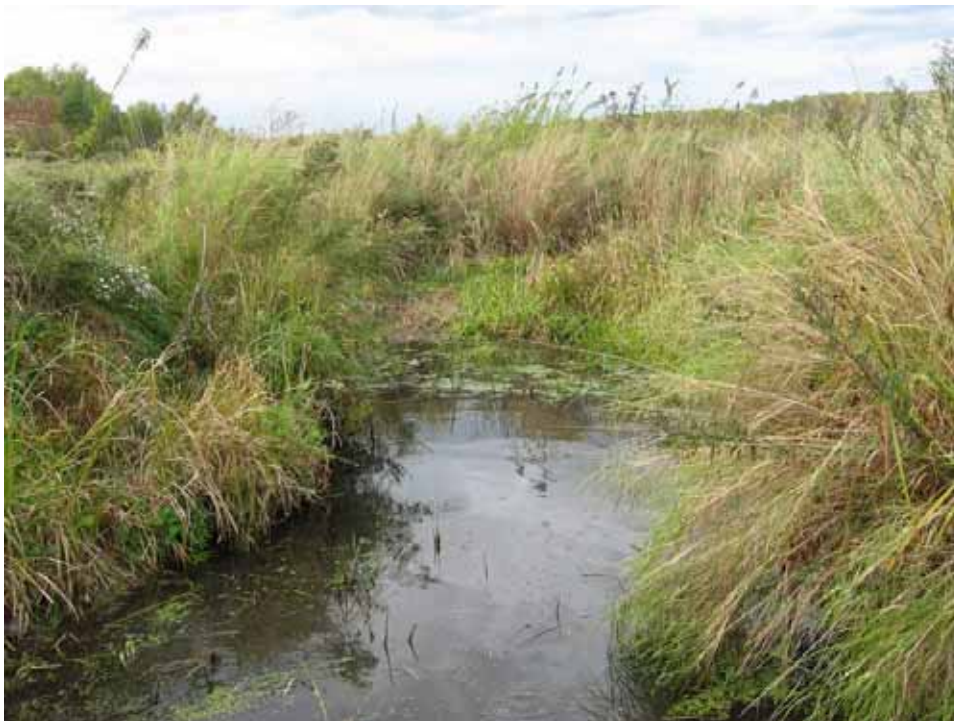
Upstream view of the Groundhouse River upstream of the Hwy 26 crossing. This site is upstream of the confluence with the West Fork. The channel is approximately 6-feet wide and 2-3-feet deep. Little active erosion was noted, but the streambed was soft sand and gravel. The reach is located in a broad wetland.

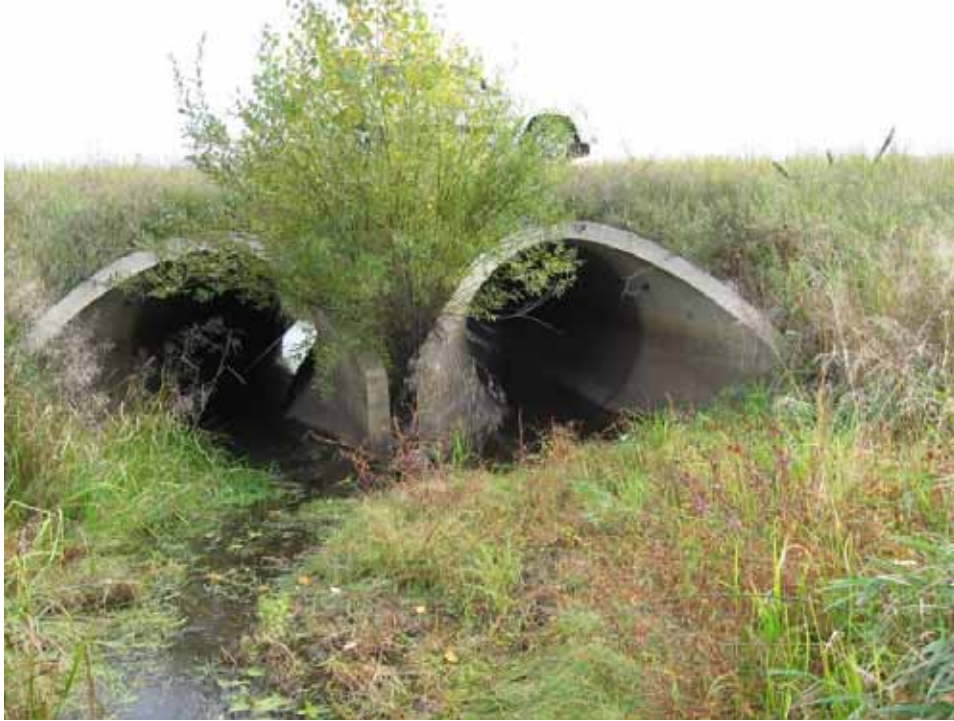
Downstream view from previous photo vantage point. The dual 60-inch diameter RCP culverts clearly show a high water mark approximately 3-feet above the thalweg elevation. Downstream of this culvert, lots of organic material and much was located on the streambed. Ongoing decomposition was observed by the methane bubbles released by disturbing the sediment. Likely low dissolved oxygen.

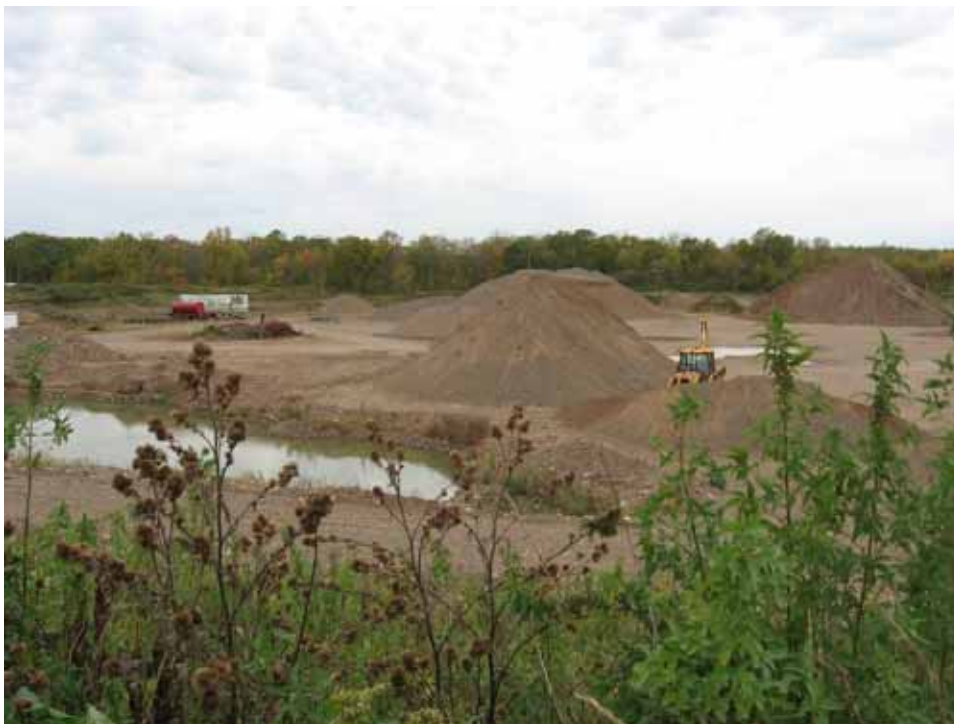
Surface gravel mining operation observed along Hwy 10. This operation was not noted on the DOT maps.

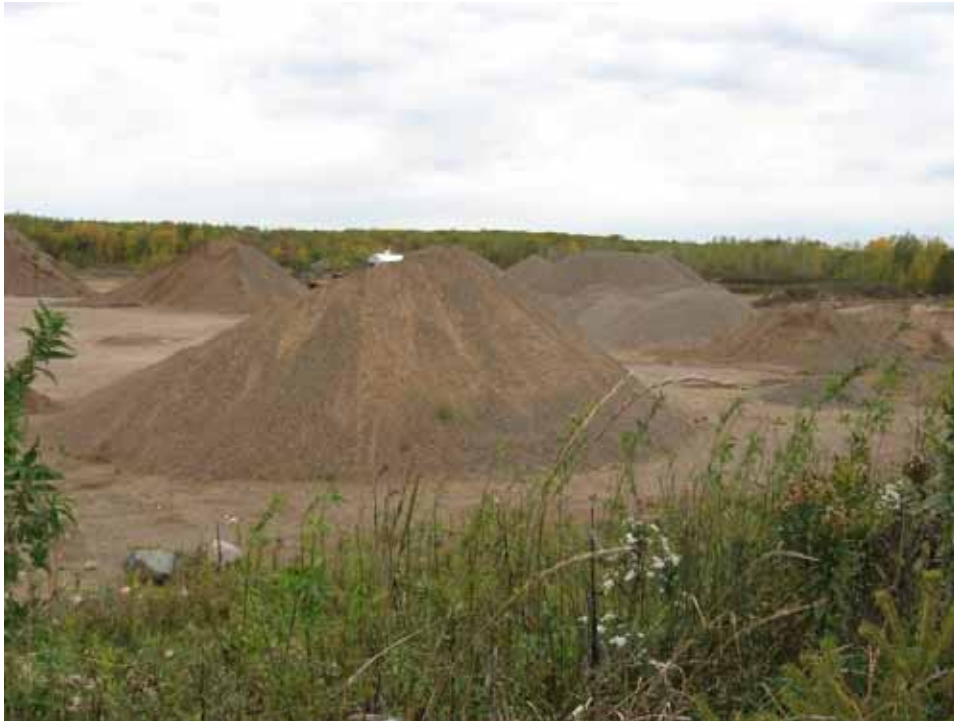
Stockpiles of aggregate in the same operation as shown in the previous photo. The operation is approximately 6-acres in size. The western edge abuts the riparian area along the North Fork of the Groundhouse. The confluence with the Groundhouse River is downstream of the site in the Rum River State Forest – thus, this is not the source of the sandy material noted in that reach.

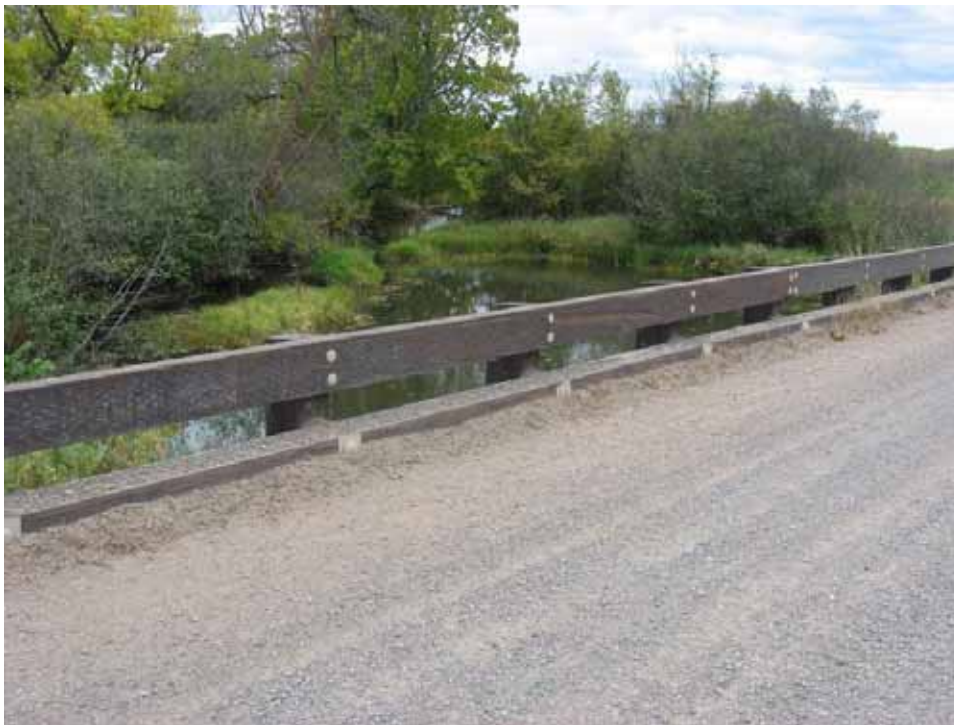
Highway 10 crossing of the Groundhouse. Despite the gravel road surface, even across the bridge, no evidence of excessive input to the river was observed.

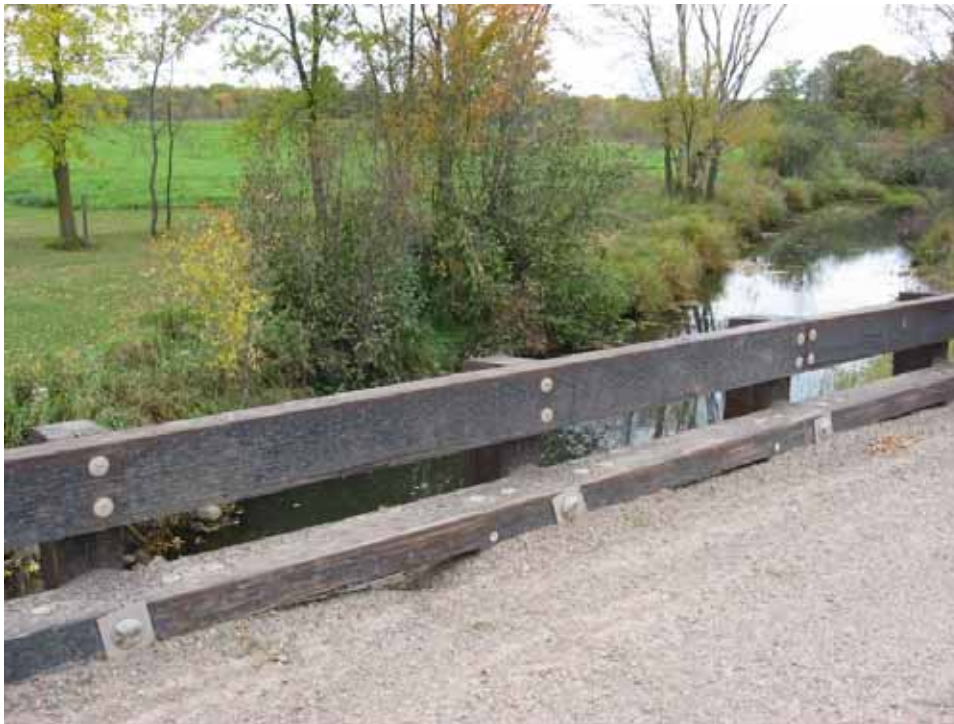
A point where road runoff can directly enter and transport sediment to the Groundhouse River.

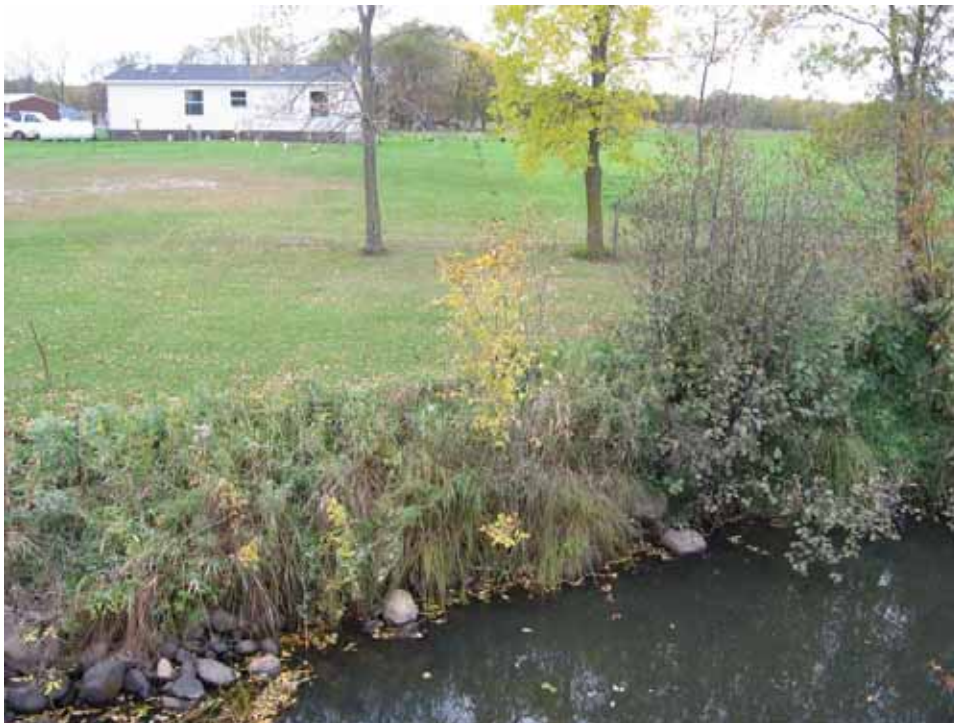
A second view of the mound septic system at the Hwy 10 crossing showing the proximity to the River.

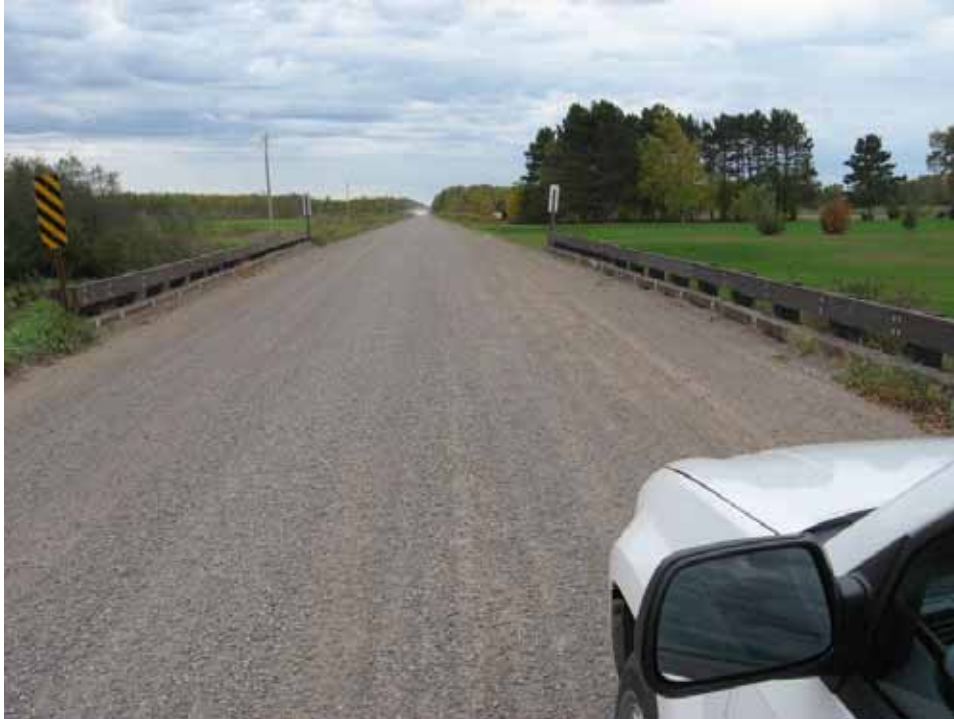
View facing south along Hwy 10 at the Groundhouse crossing. Note the well maintained condition of the road surface. The grade of the road is sloping away from the River.

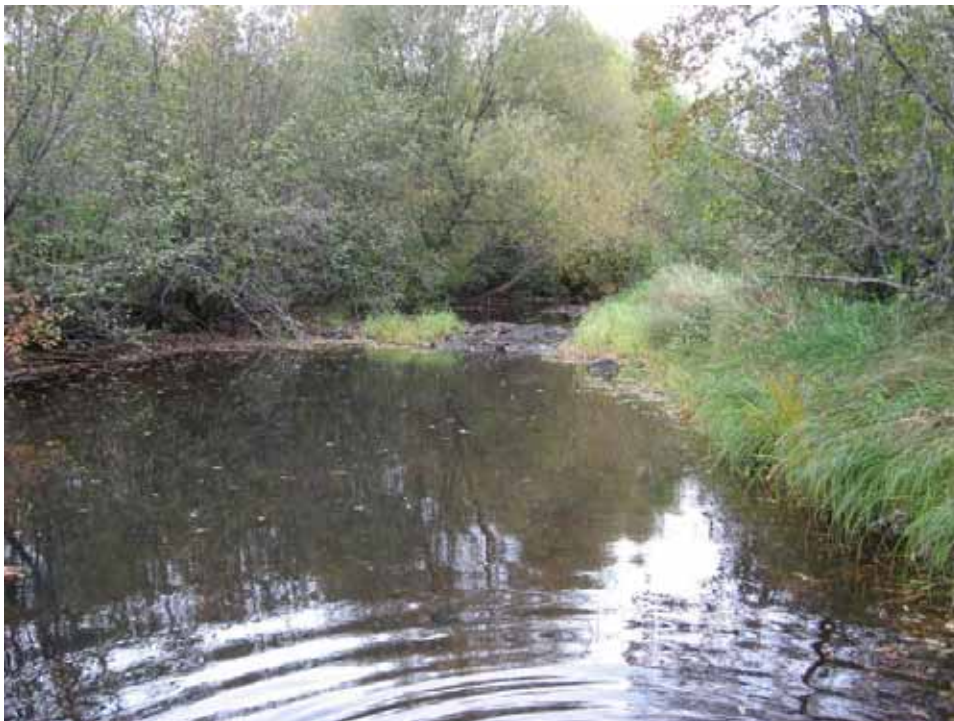
Upstream view of the Groundhouse upstream of the Highway 57 crossing. The substrate in this reach consisted of cobbles and boulders, as indicated by the riffle in the center of the photo. An abundance of algae was observed on the substrate.

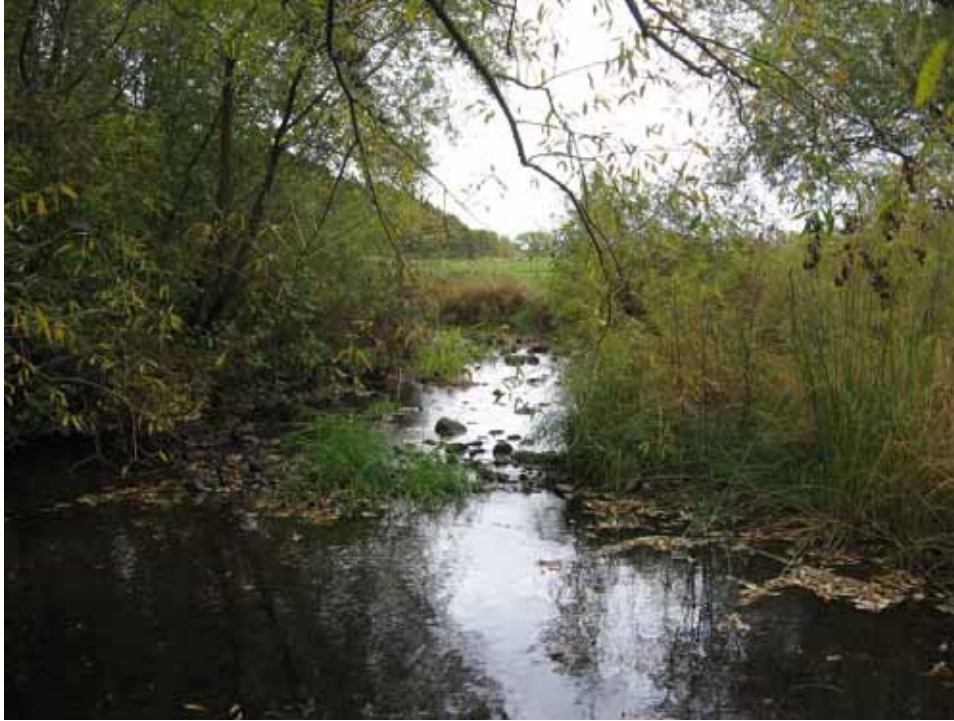
Upstream view of a second riffle observed upstream of the previous photo.

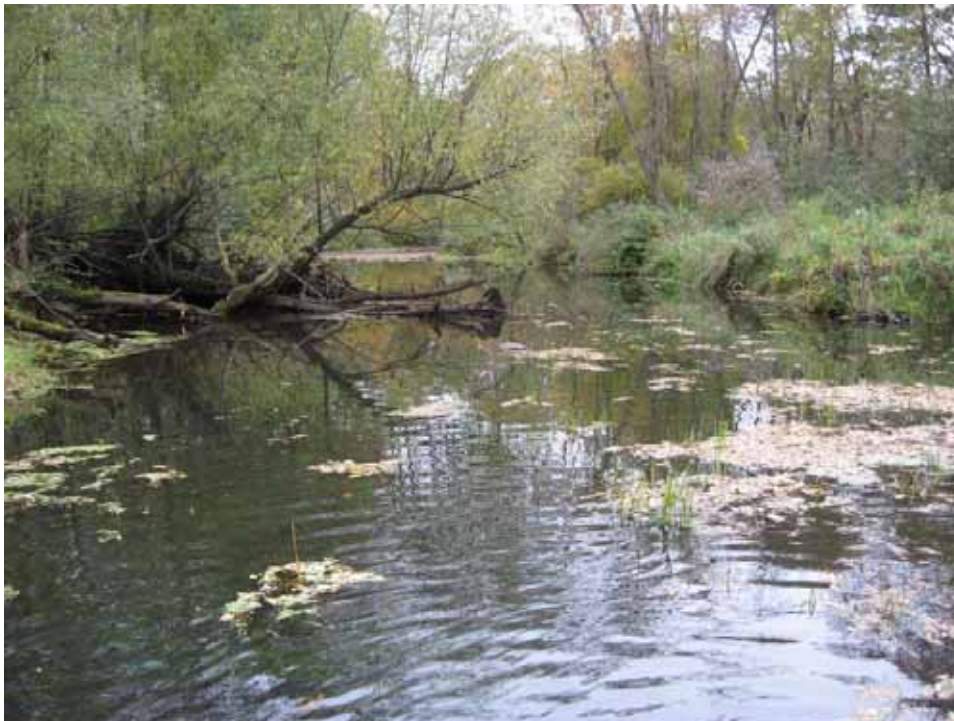
Upstream view at the upper end of the reach upstream of the Hwy 57 crossing. Note the wide channel with low streambanks. The shape is likely the result of the larger, more erosion resistant streambed substrate.

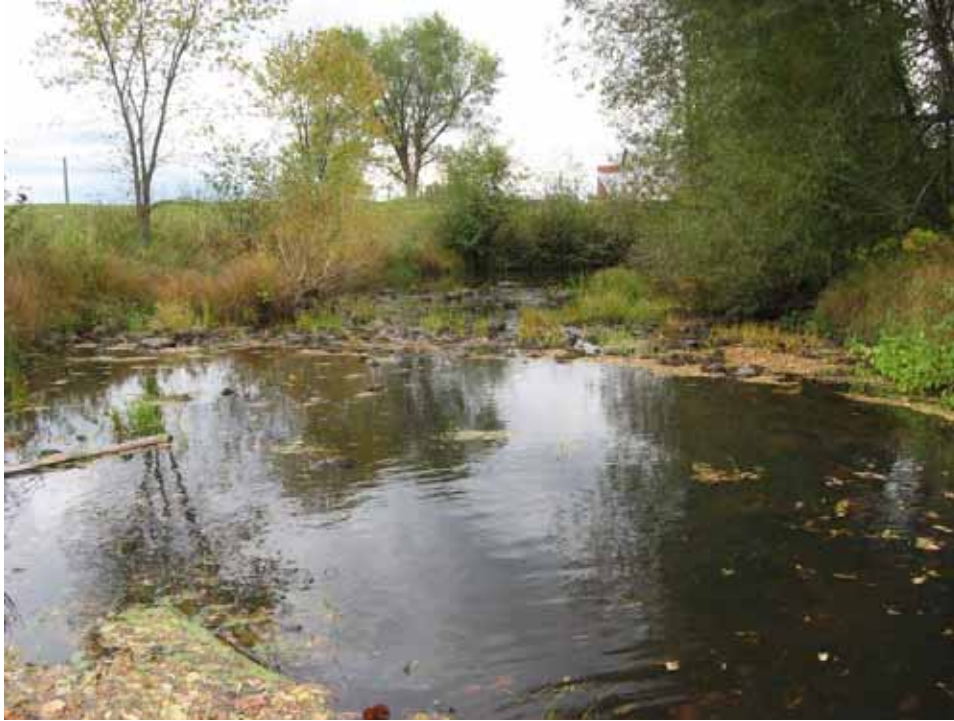
Downstream view from vantage point of previous photo. A cobble/boulder riffle spans the entire width of the channel. Sand was noted in interstitial spaces indicating deposition of finer material over the coarse material – not the presence of an armor layer over finer material.
