Groundhouse River Total Maximum Daily Loads for Fecal Coliform and Biota (Sediment) Impairments

Final TMDL Report

March 2009

**Submitted by:
Tetra Tech**

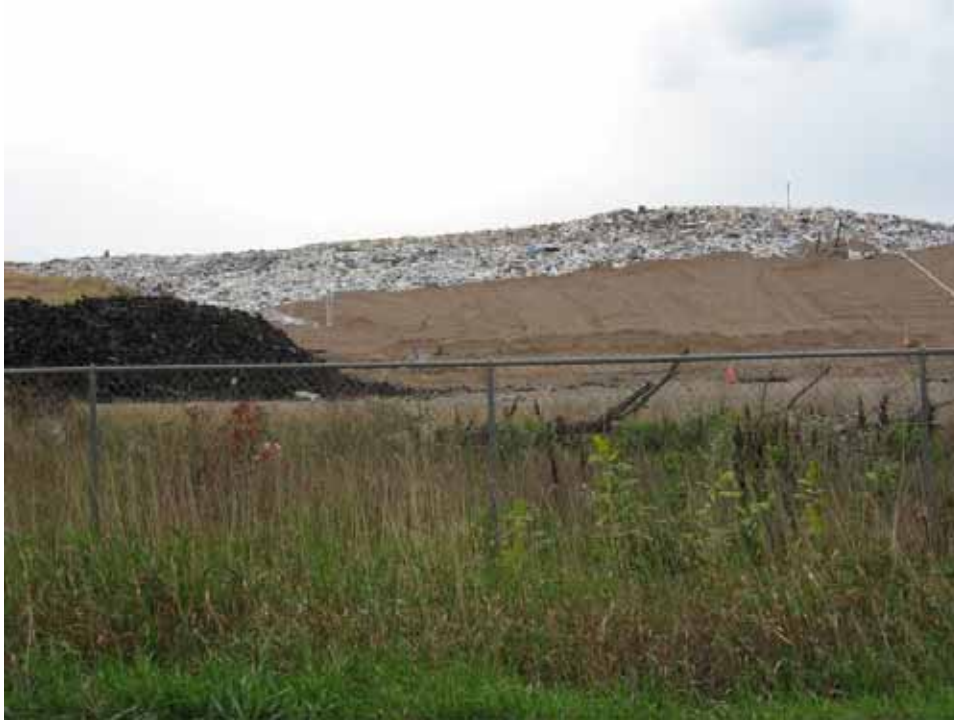
Solid waste in the landfill left uncovered after the facility closed for the day.

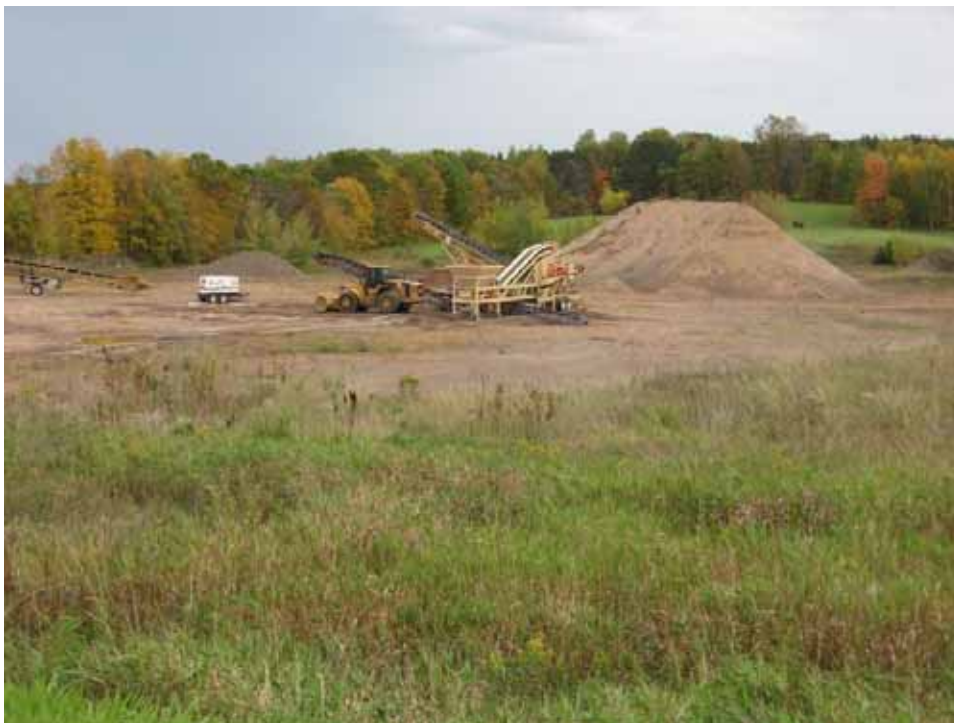
Surface mining operation adjacent to the solid waste facility – this site also turned out to be outside of the watershed boundary.

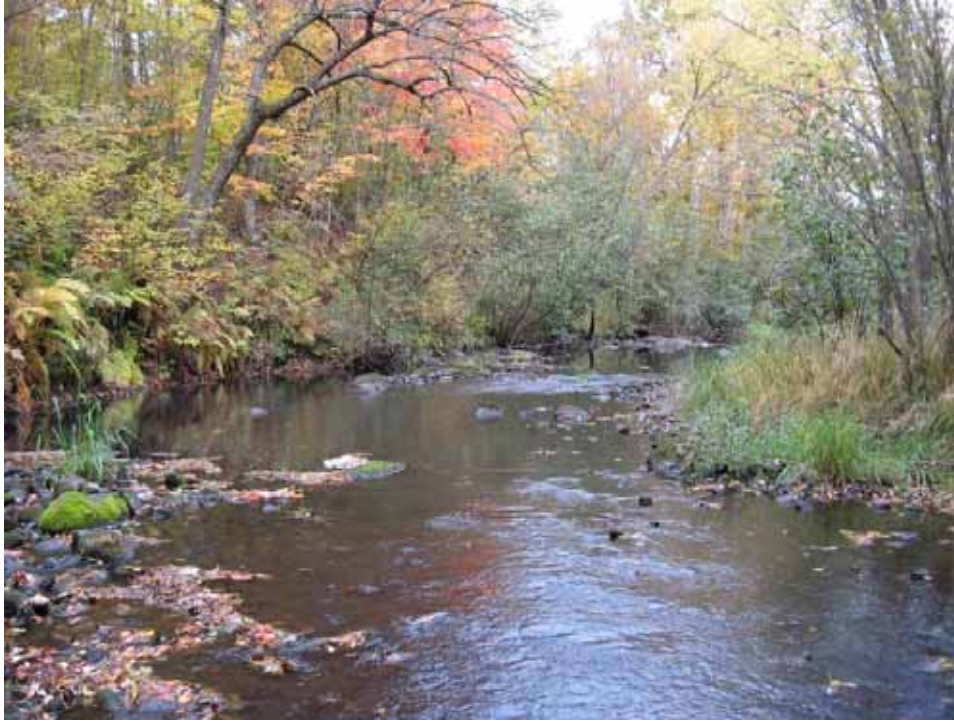
Downstream view of the Groundhouse downstream of the 150th Avenue crossing (first site visited south of Ogilvie). Despite the eroding streambanks observed at the next upstream site (at the Hwy 23 crossing), this wide reach (25 – 50 feet) contained cobble/boulder substrates with only minor sandy deposition.

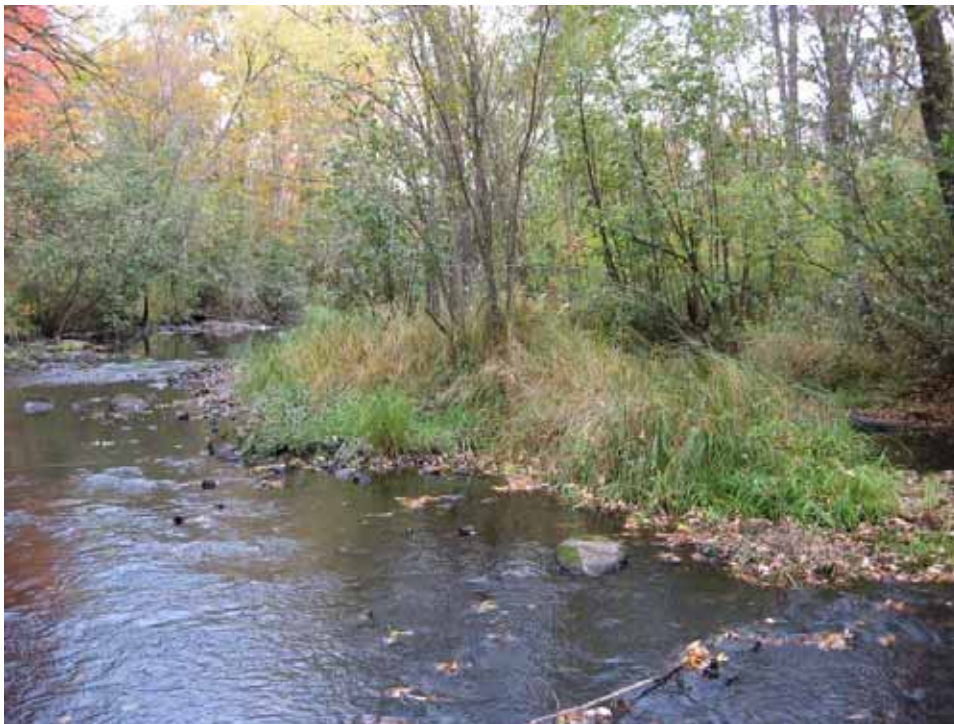
Upstream view of a depositional bar along the inside of a bend. The vegetated bar consisted primarily of gravels.

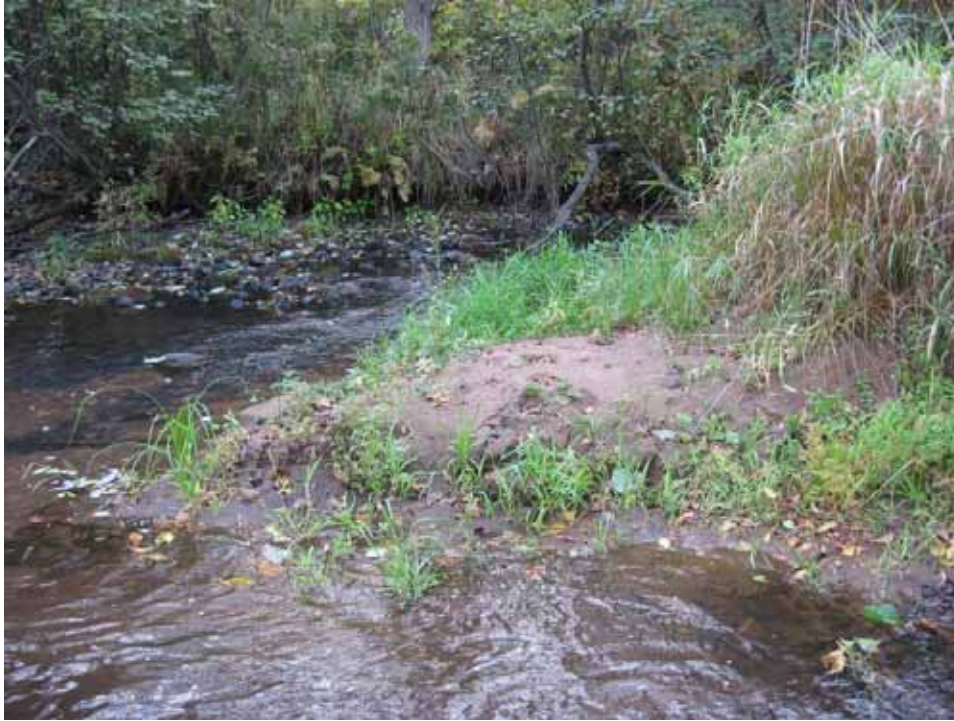
Downstream toe of a mid-channel bar showing 18 – 24 inches of deposition. The finest material is deposited at the toe of the bar – in this case clean, coarse sand with little if any silt or clay. The finer size fractions are likely transported through this reach.

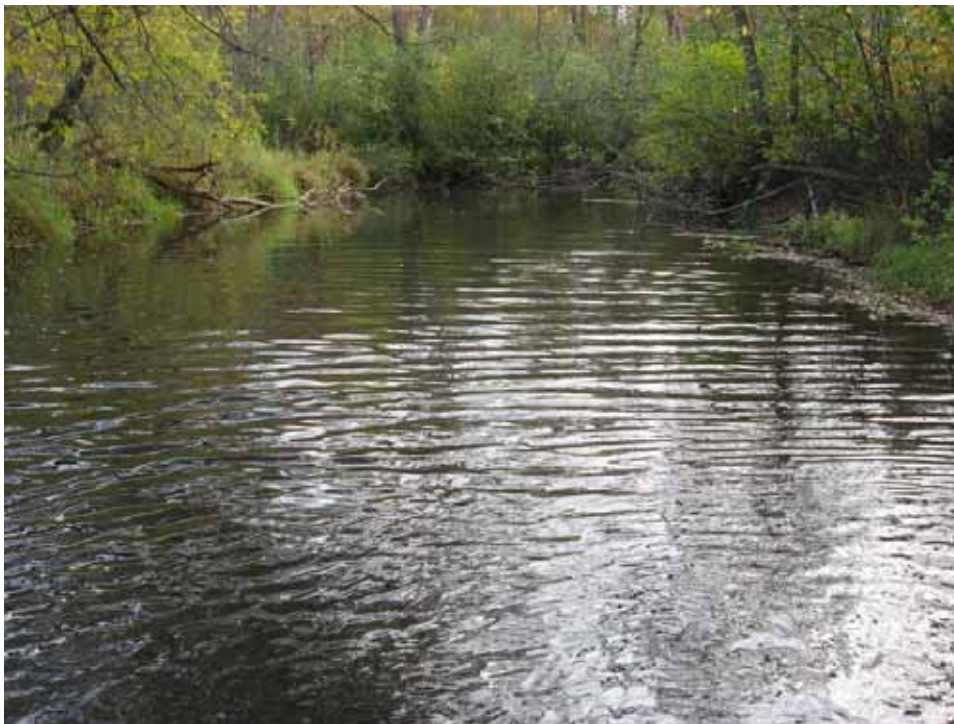
Downstream view of a run typical of this reach. The average depth was approximately 18 inches. A thin coating of fines was observed over the coarse gravel/cobble substrate, but this is likely indicative of the drought conditions throughout the summer; not of excessive deposition and infilling.

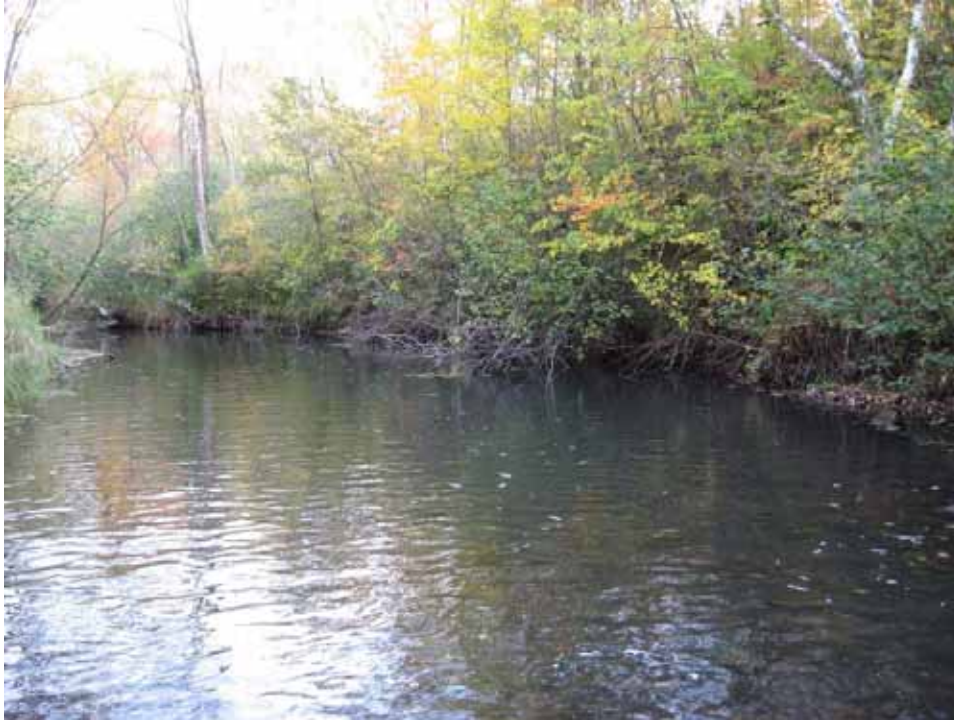
Upstream view of a pool along the toe of the left bank. A submerged depositional bar along the toe of the right bank was observed, but it is likely that the material is generated from upstream sources and not changes in the morphology of this reach. The pool depth was greater than 3 feet.

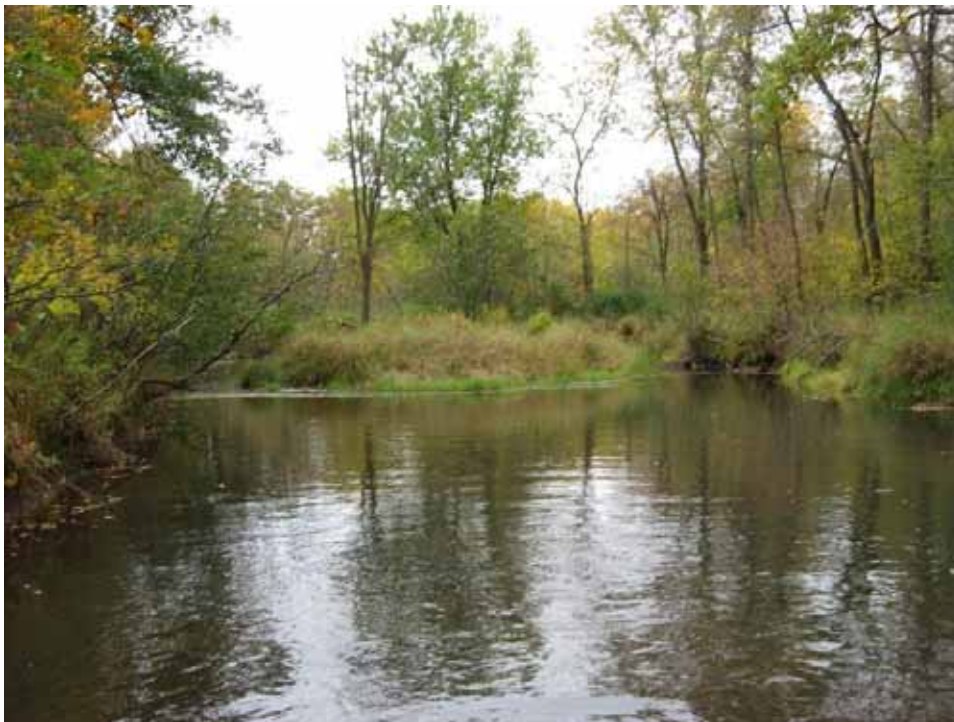
Downstream view of a large mid-channel depositional bar. The reach primarily consisted of long, low gradient runs interspaced with short, deep riffles. Finer depositional material was observed at the tail of each run, typically leading vegetated mid channel bar at the head of each riffle.

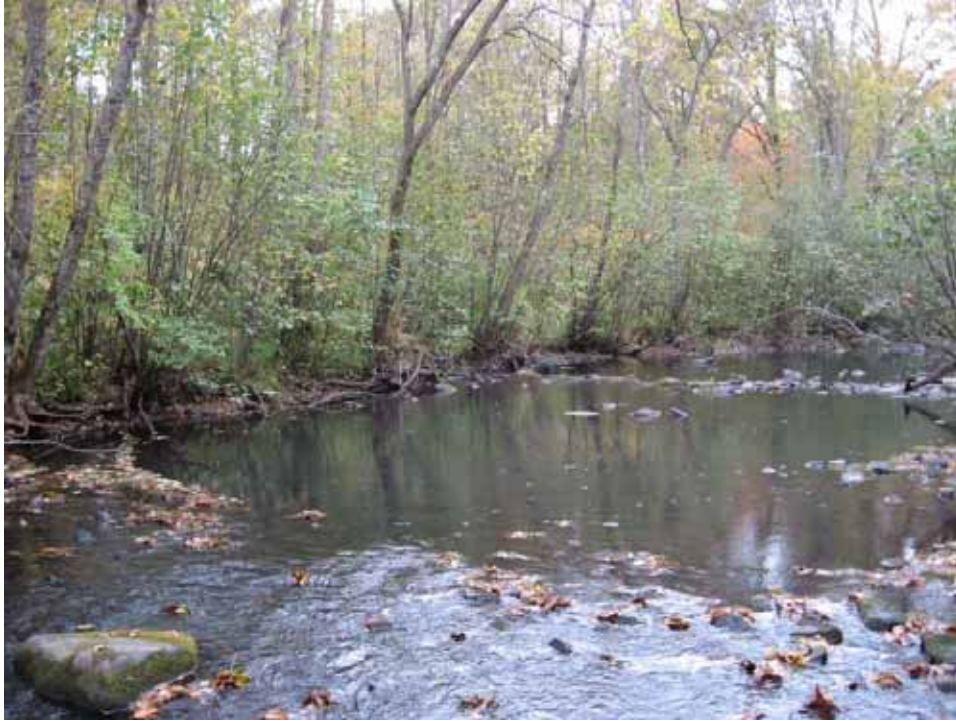
Upstream view the right bank showing the influence of understory vegetation (alder) on bank stability along the outside of a meander bend. This type of vegetation could be an appropriate means for reducing sediment generation along the cleared sections of the power line corridor at the next upstream site.

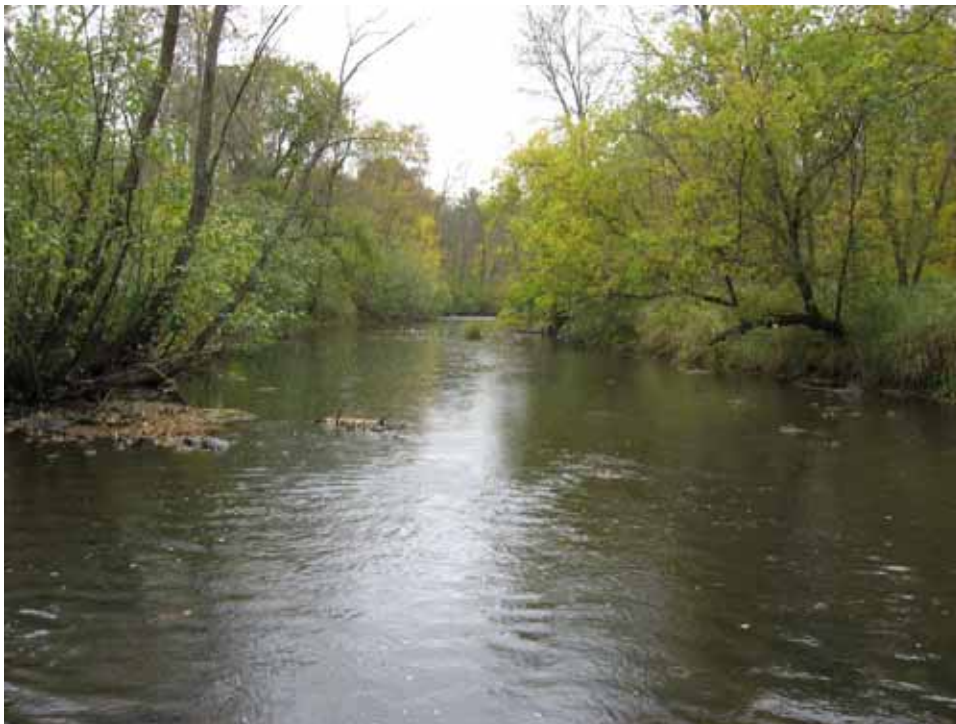
Upstream view of most downstream reach visited on the Groundhouse River (located off Hickory Street near intersection of Hwy 2 and 145th Avenue). The reach was approximately 60-feet wide with deep riffles and cobble substrate. The cobbles were partially embedded with sand-sized depositional material.

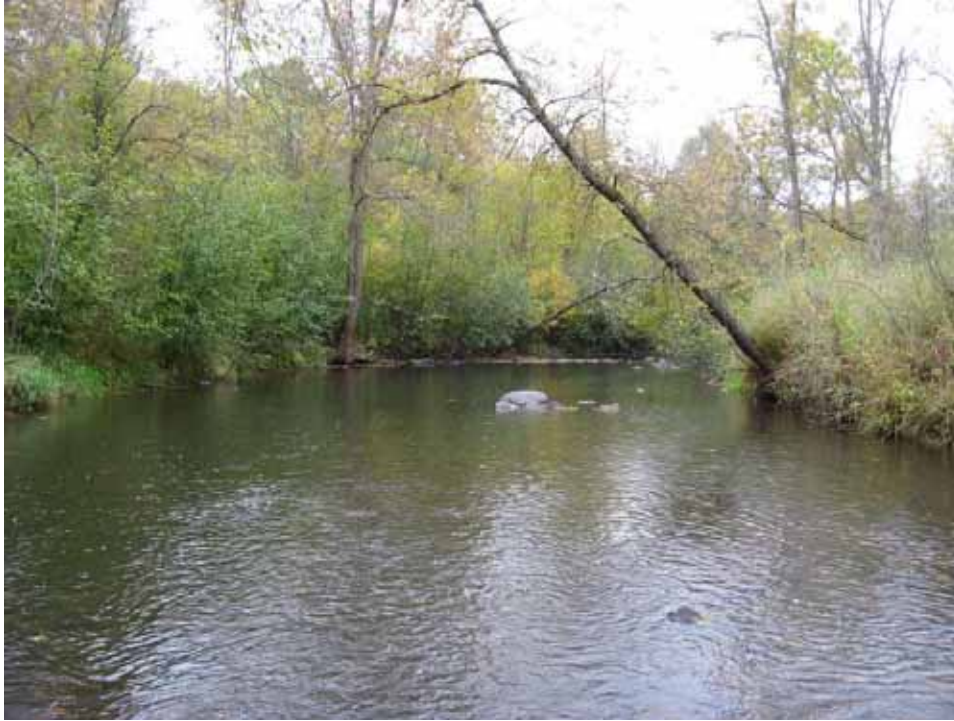
Downstream view showing long, low gradient runs. Broad floodplains were observed along both sides of the reach.

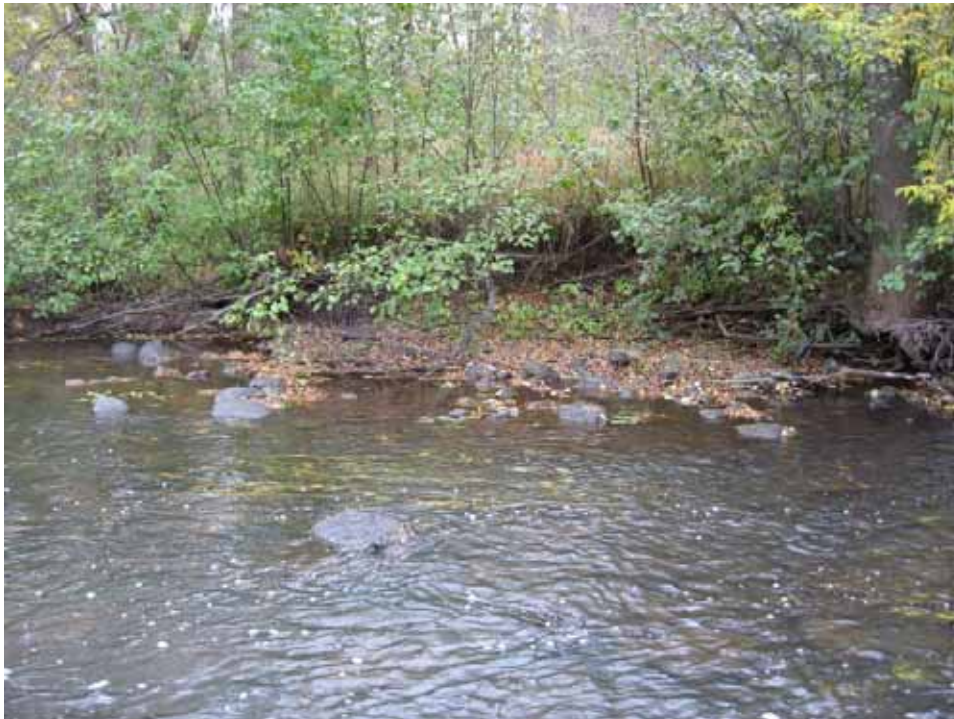
Example of a riffle in this reach. The riffles were relatively short and flow depth was deep. The water surface did not exhibit the turbulence typical of riffles. Boulder sized material was observed in the riffles.

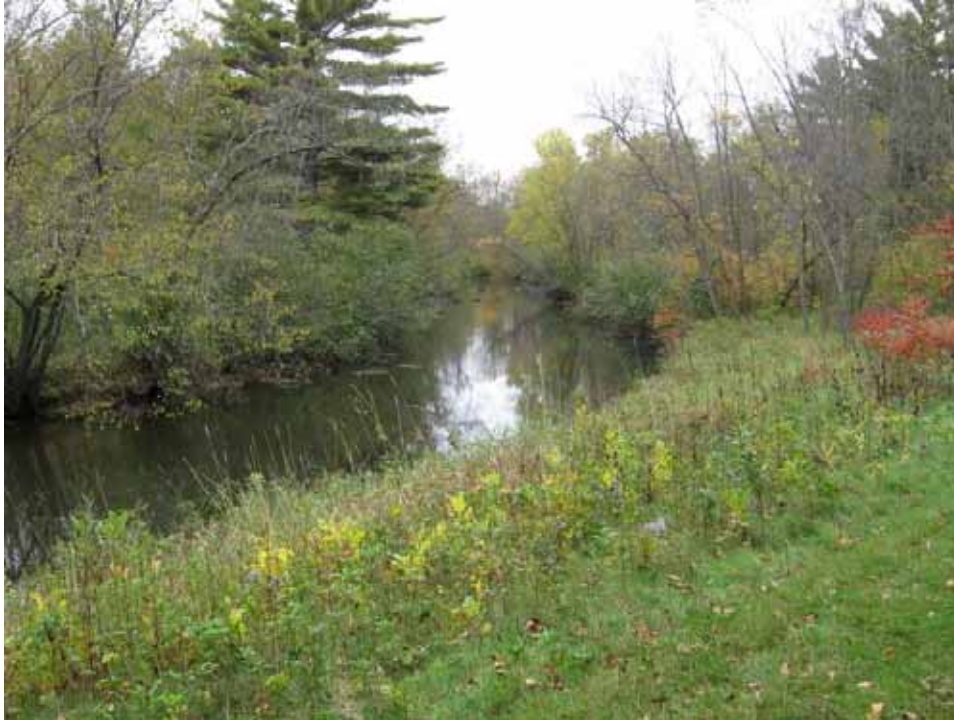
Upstream view at the upstream end of the reach – just upstream of the riffle shown in the previous photo. Another long run is shown. Active deposition of sandy material was noted along the top of both streambanks (both of which were approximately 5 feet above the thalweg elevation).

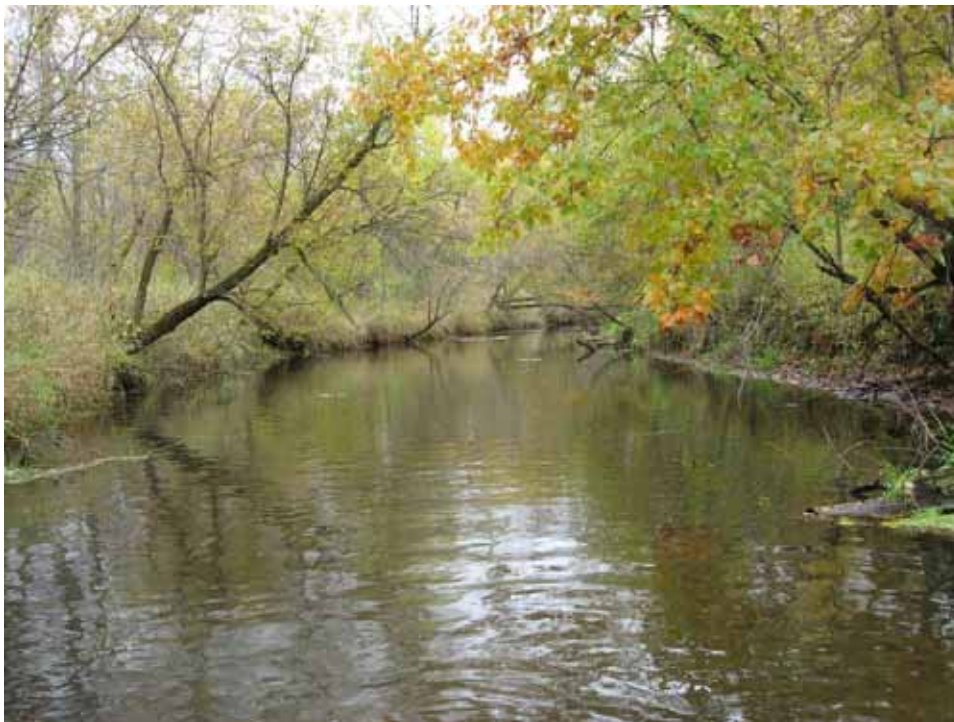
Downstream view of most downstream site (off of 140th Avenue) on the South Fork Groundhouse River, just upstream of the confluence with the mainstem. The geometry was prismatic (approx. 50-ft wide, 2-ft deep, 7-8-ft bank heights), likely indicating historic channelization.

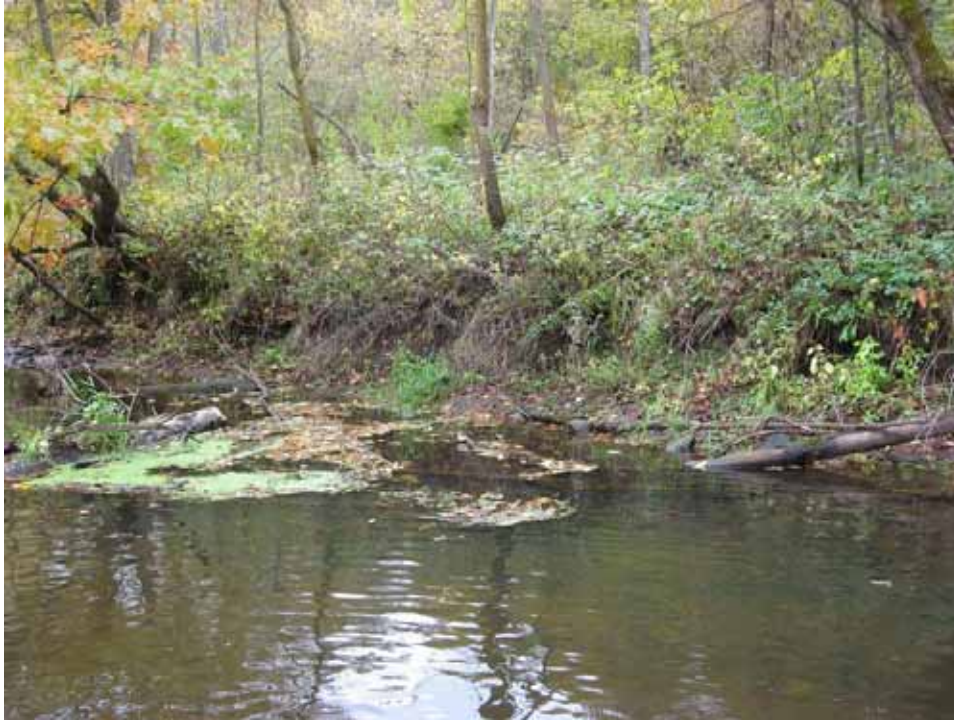
View of nearly vertical right bank. Deposition was evident at the toe of the bank. The valley wall confined the right overbank area, but a broad, accessible floodplain was observed on the left bank.

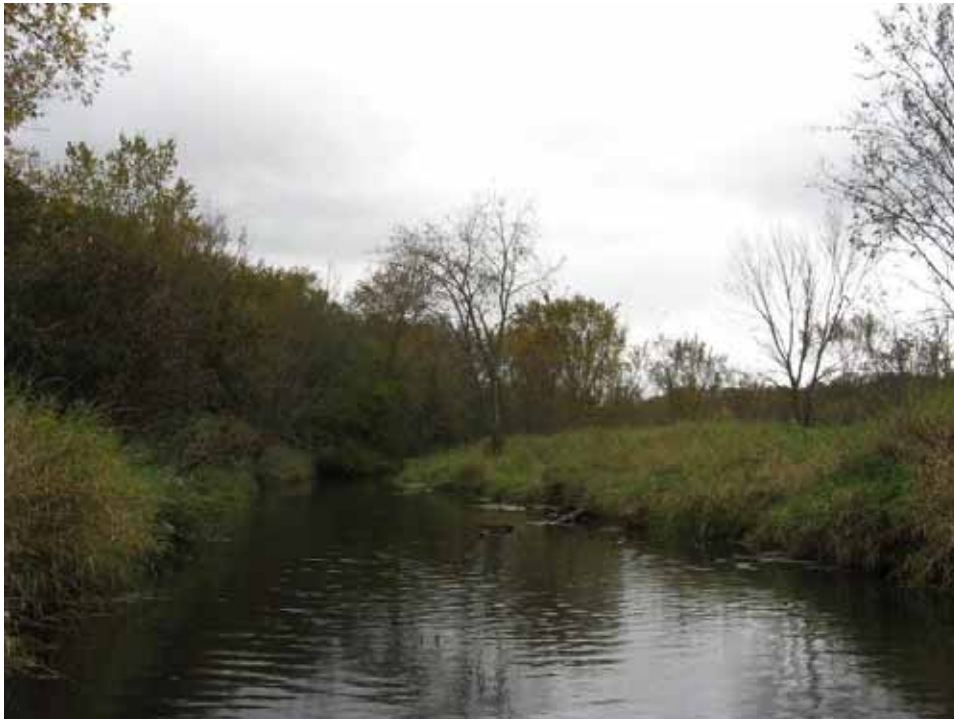
Upstream view of channelized reach. Spoil piles line both banks, although trees are established on the right bank spoil pile. The substrate was primarily sand. No cobbles or boulders were observed, nor were any riffles or pools (other than small scour pools).

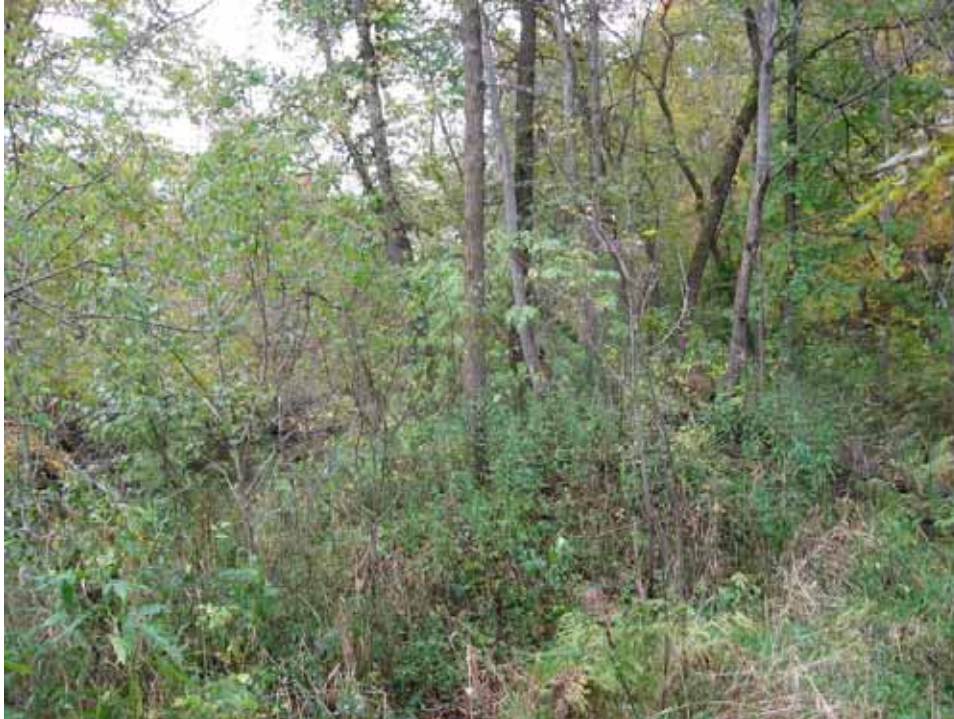
Downstream view of the spoil pile along the right bank. Based on the size of the largest trees growing on the spoil pile, it was estimated that the channelization occurred no sooner than 50 years ago.

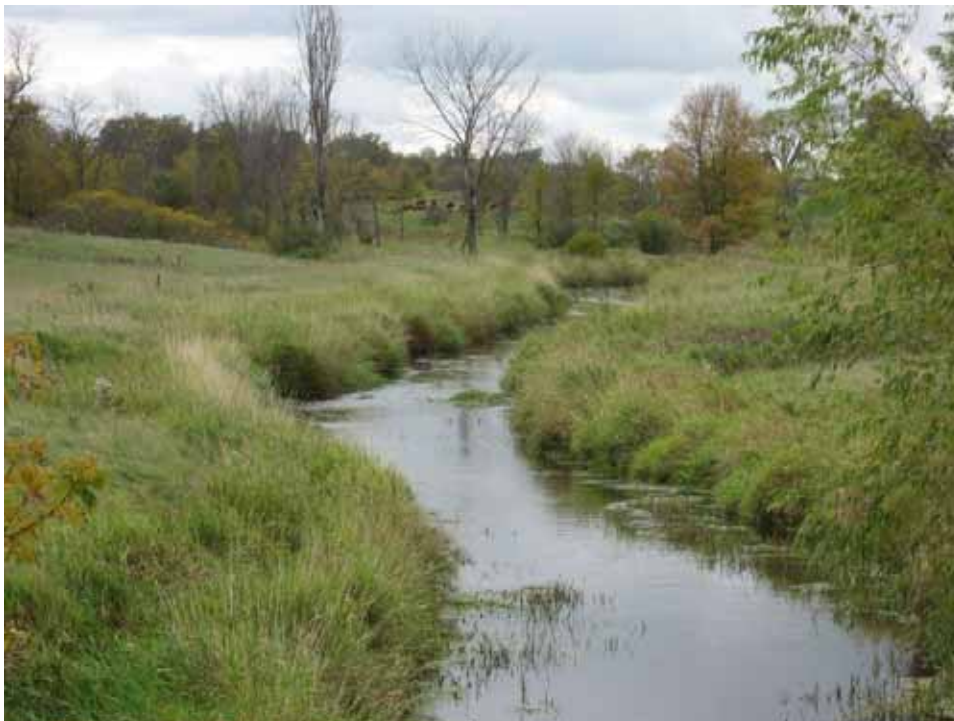
Upstream view of the South Fork at the 140th Street crossing. Note the herd of cattle on the hill in the background of the photo – the river smelled strongly of cow manure.

The reach of the South Fork located near 140th Avenue (approximately 3,500 feet upstream of the confluence with the Groundhouse River) was noted to have a very strong manure odor. A cattle pasture was observed a short distance upstream, but the condition of a buffer, if any, could not be seen. The odor was strong enough that it was obvious just standing on the culvert crossing at the creek.

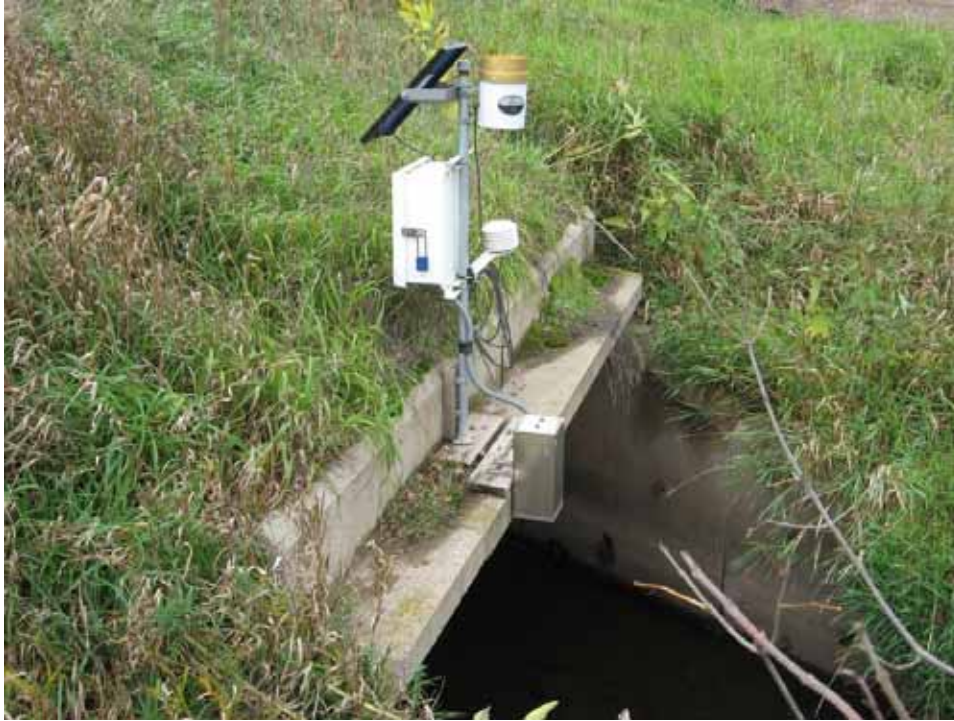
Rain gage and acoustic Doppler velocity (ADV) meter on the left of three culverts under the 140th Street crossing of the Groundhouse. No information was posted as to the owners of the equipment.

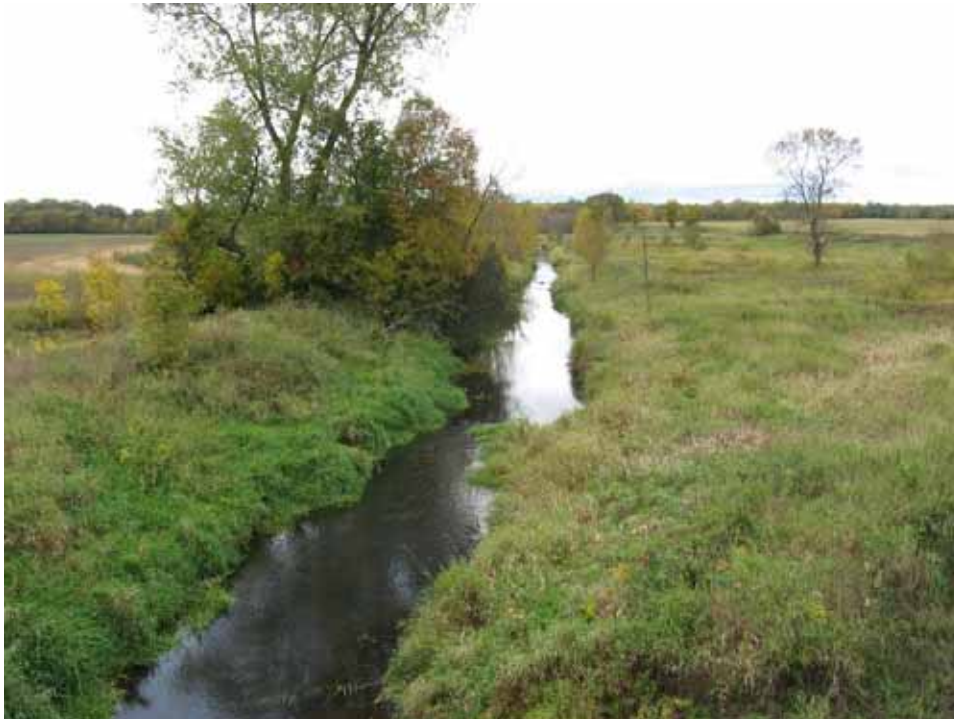
Upstream view of South Fork Groundhouse River from the Hwy 47 crossing. The historic channelization noted downstream is still evident at this reach – although the size of the channel is considerably smaller.

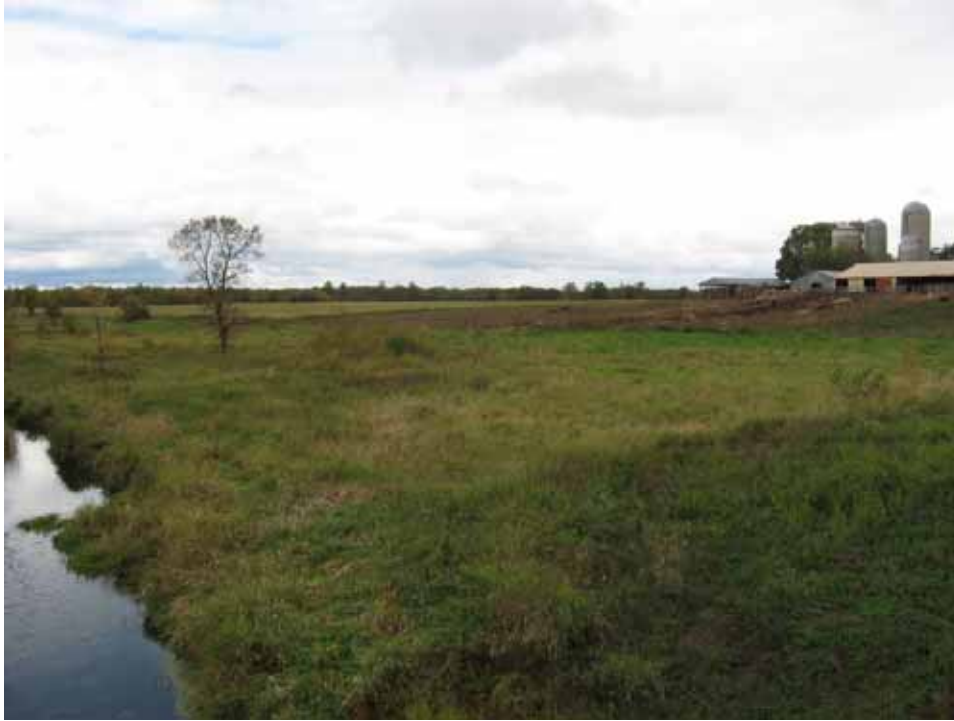
Animal operation along the left bank of the South Fork. The cattle were fed approximately 250-300 feet from the channel; however, a vegetated buffer was located between the two.

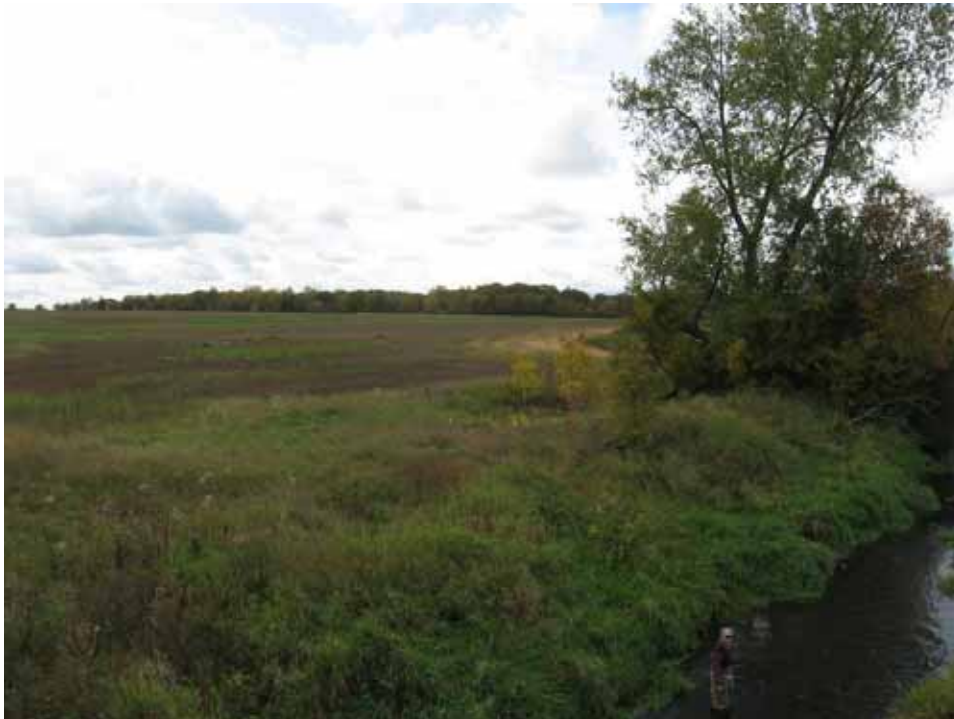
Row crop agriculture along the right bank. Again, note the presence of a vegetated buffer strip between the row crops and the channel.

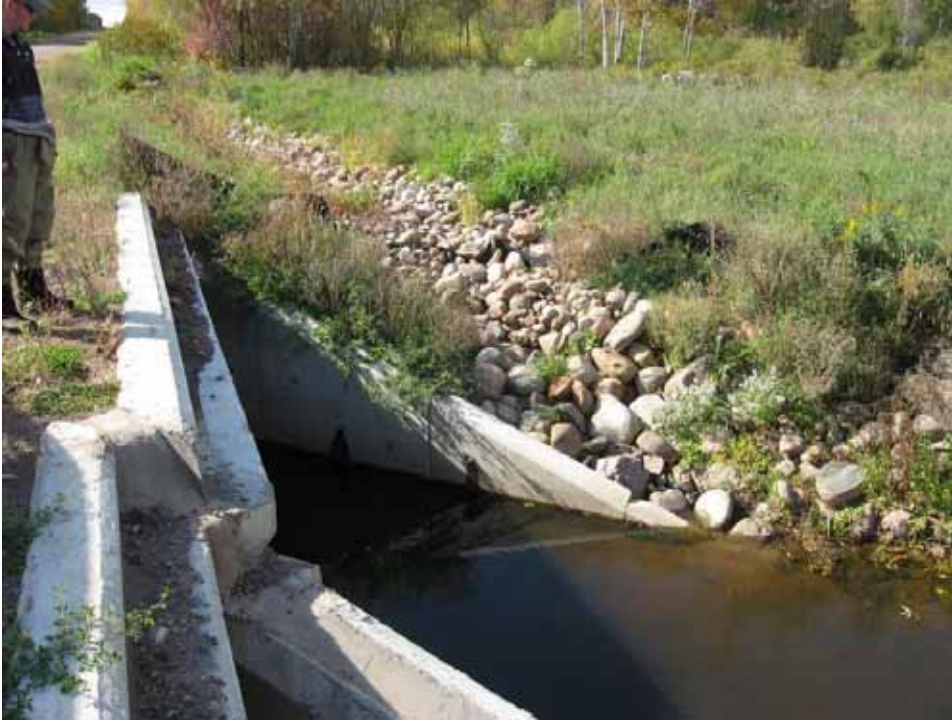
View of roadside drainage ditch entering the South Fork from CR-49. The depositional fan at the toe of the riprap ditch indicates the graveled road surface does contribute some fine material to the system.

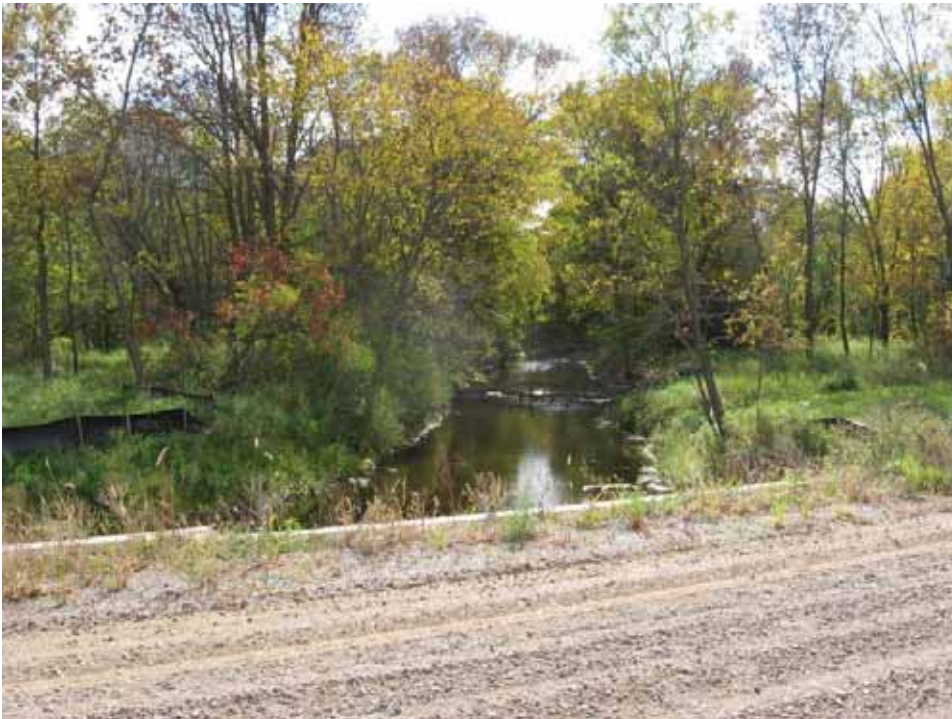
Upstream view of CR-49 crossing of the South Fork. The prismatic shape still indicates historic channelization of this reach.

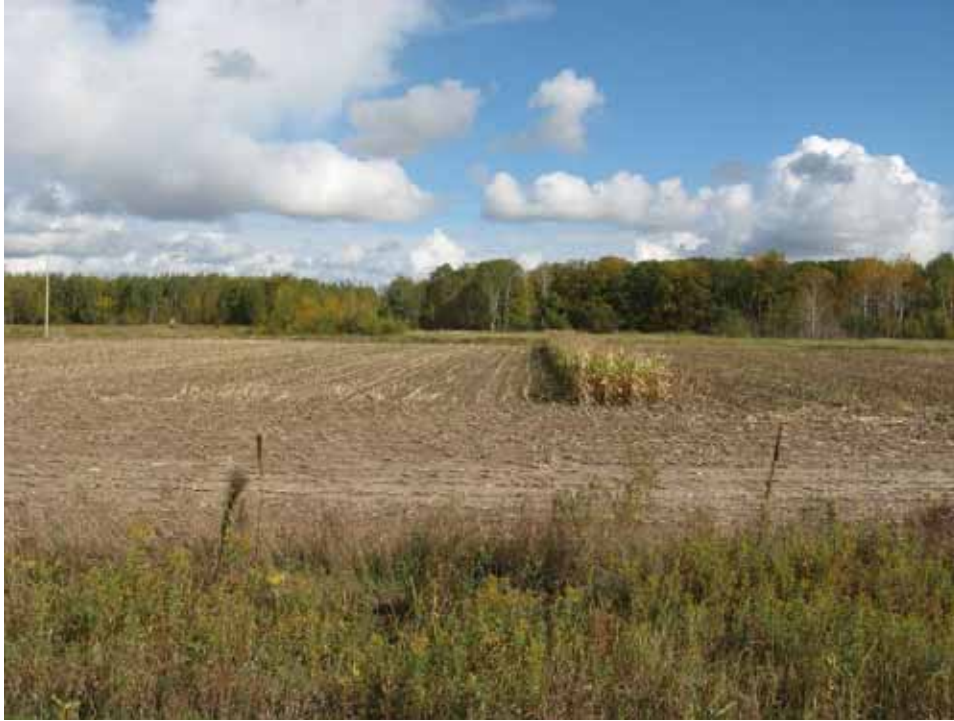
Southeast corner of the intersection of CR-49 and CR-50 illustrating the influence of corn on ground cover.

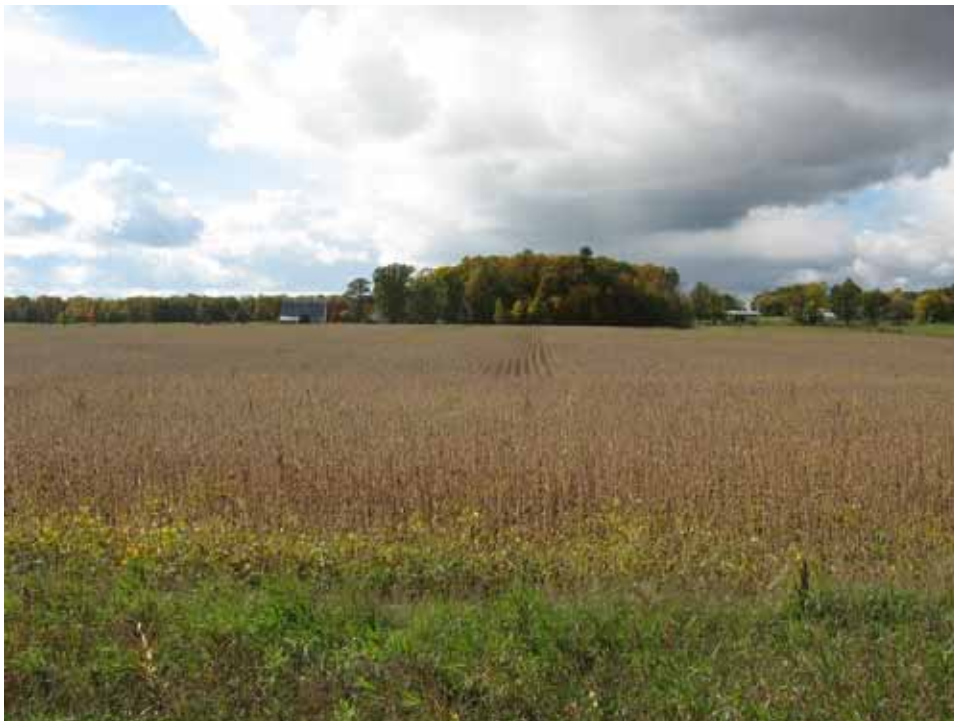
Southwest corner of the intersection of CR-49 and CR-50 illustrating the influence of soy beans on ground cover.

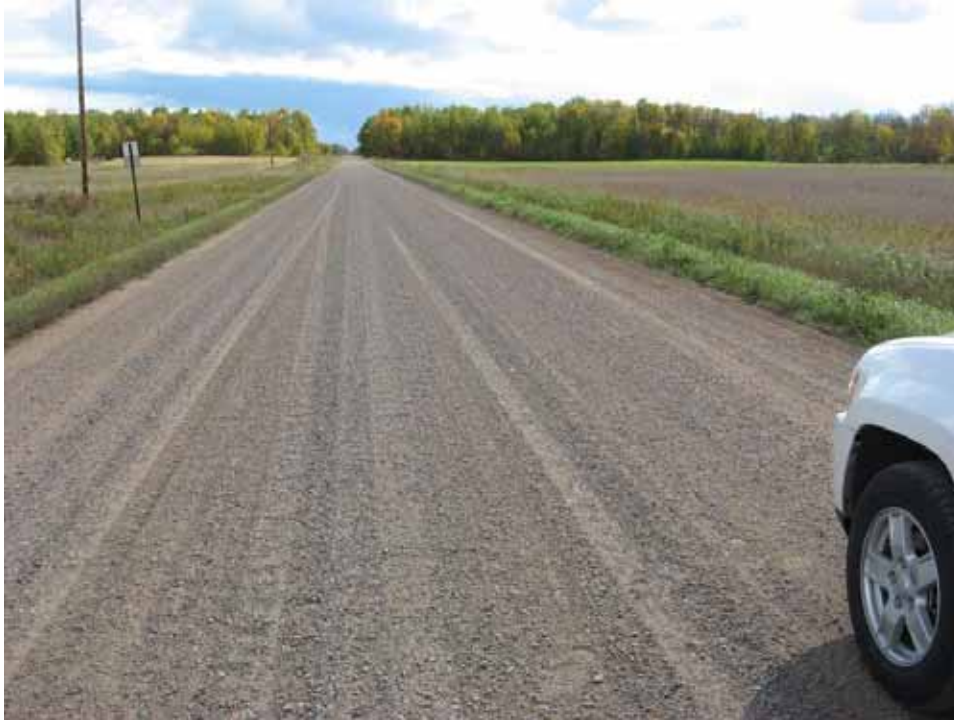
Another example of graveled road cover, approximately 25-feet wide, crowned, and bladed in the previous few days – possibly move picture.

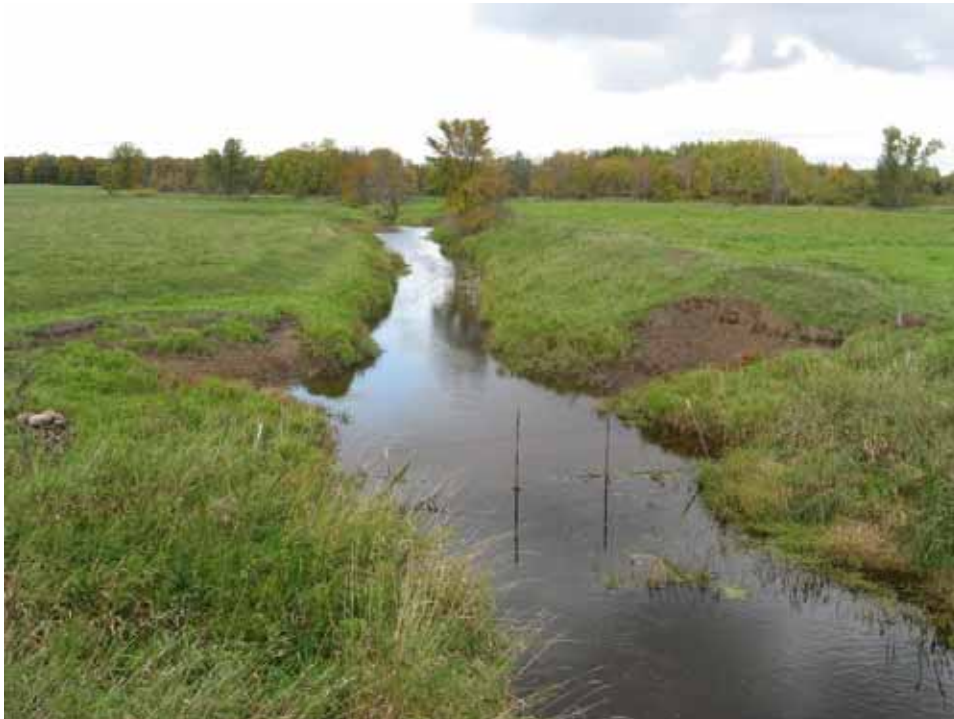
Downstream view of the South Fork at the CR-49 crossing. Note the influence of cattle on the streambanks where no riparian exclusion measures are in place. No cattle were observed in this reach.

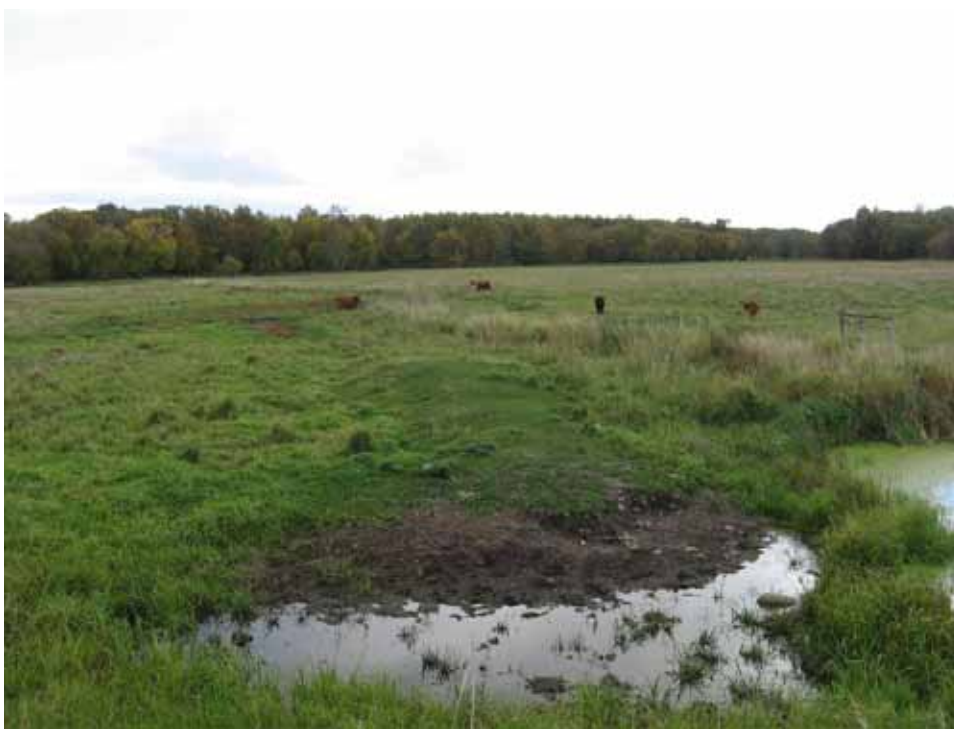
Downstream view of CR-4 crossing the South Fork. Note the influence of cattle on the channel morphology as well as the green algae in the pool at the right of the photo.

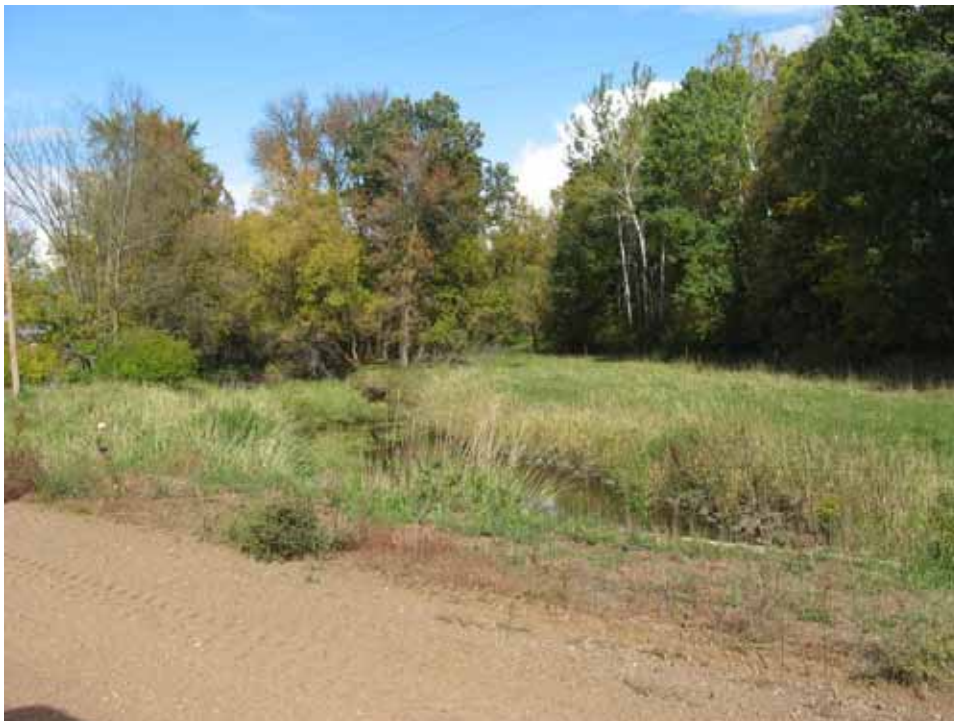
Downstream view of Delta Street crossing of the South Fork Groundhouse. At this point, the channel did not exhibit any indicators of historic channelization.

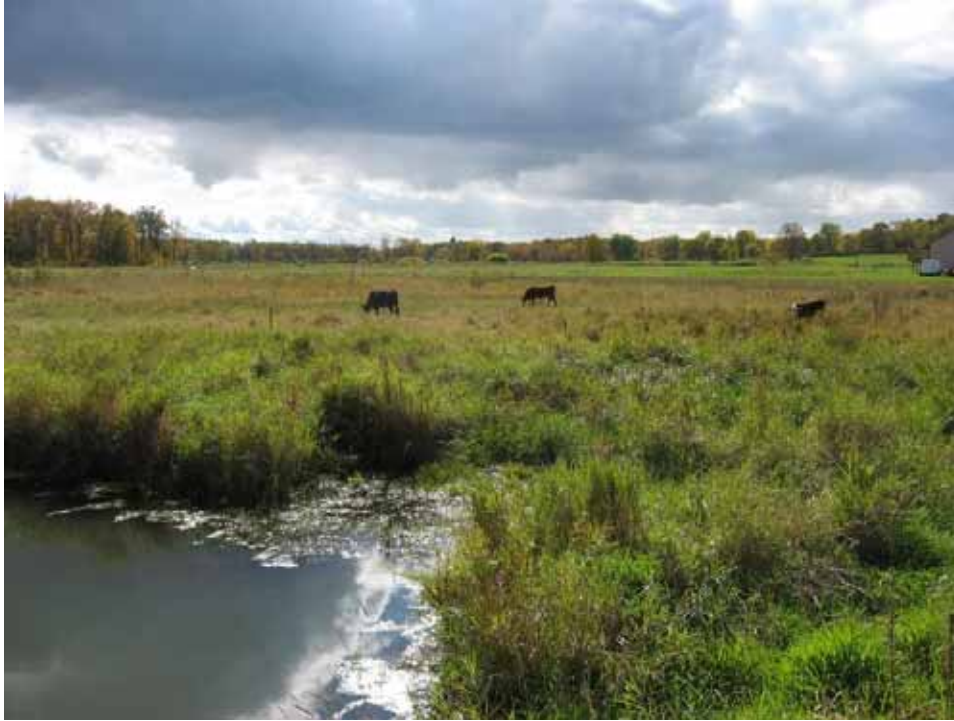
Downstream view of CR-4 crossing. Fencing is installed to prevent cattle access to the channel; however, abundant filamentous, green algae was observed in the pool.
