Groundhouse River Total Maximum Daily Loads for Fecal Coliform and Biota (Sediment) Impairments

Final TMDL Report

March 2009

**Submitted by:
Tetra Tech**

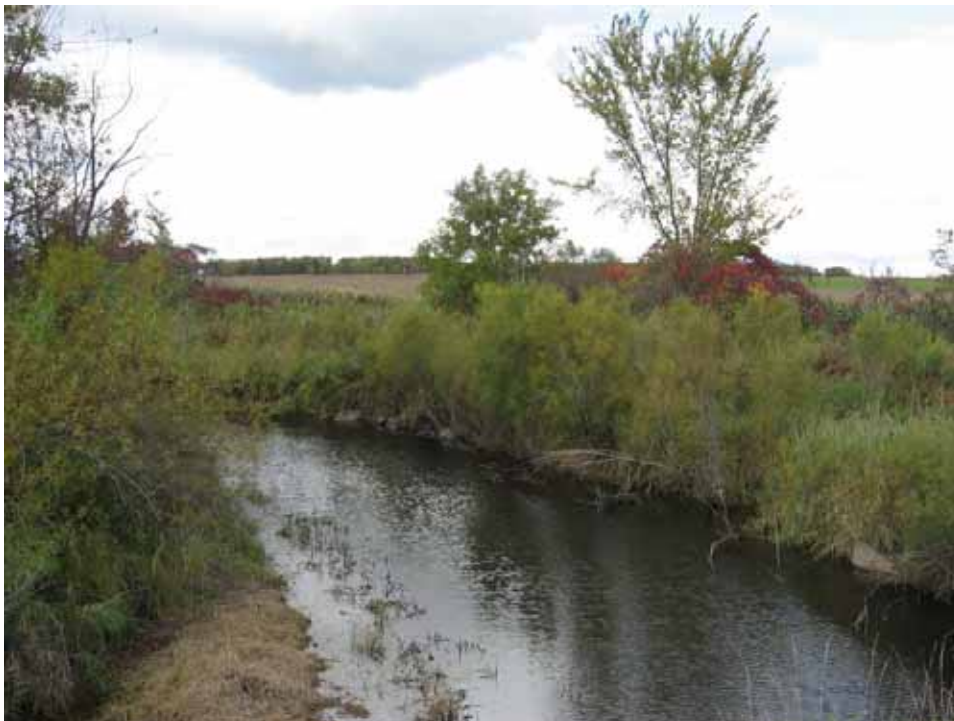
Upstream view of the South Fork at the CR-4 crossing. Boulders or possibly rip rap placed at the toe of the streambank along with the willows effectively control erosion along the toe of the bank. Row crop (corn) is visible in the background of the photo.

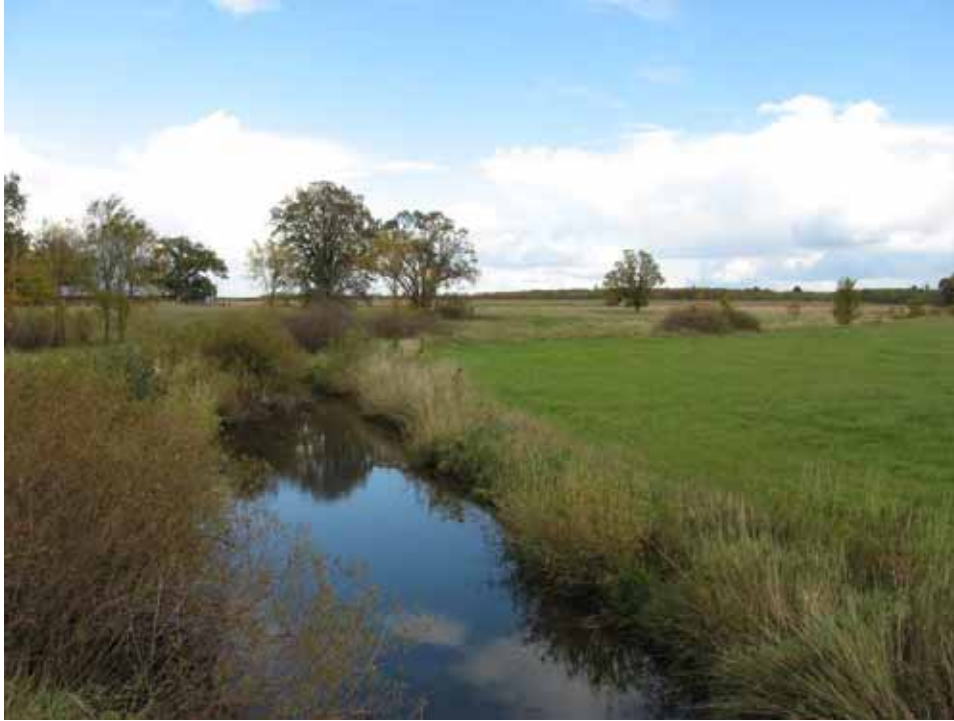
Downstream view of the South Fork at the CR-9 crossing. The channel curves toward the top-right corner of the photo (as indicated by the vegetation line).

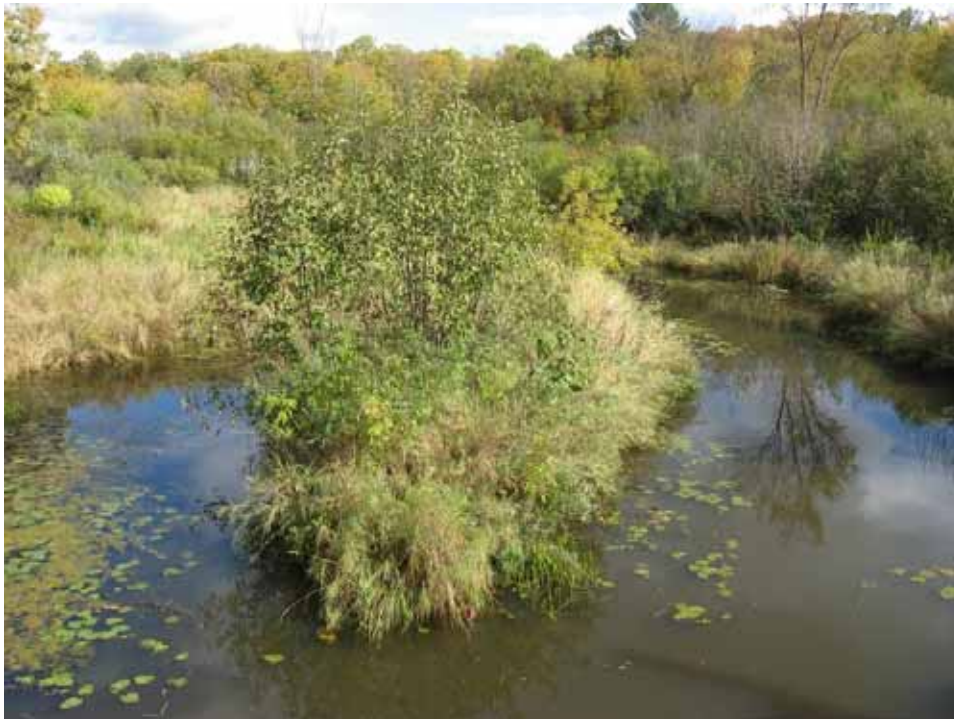
Upstream view of turbid slow moving water in the South Fork at the CR-9 crossing between 130th and 140th Avenues. It is likely that this reach exhibits higher water temperatures and lower dissolved oxygen.

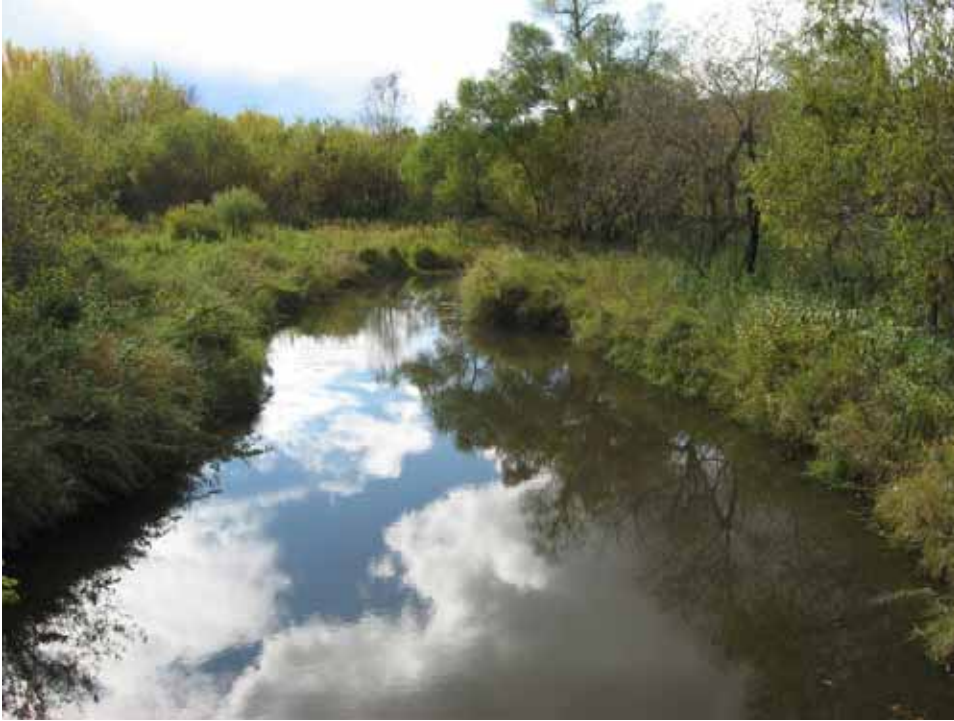
Downstream view of the South Fork at the same crossing as the previous photo. Note the turbid water and undisturbed water surface.

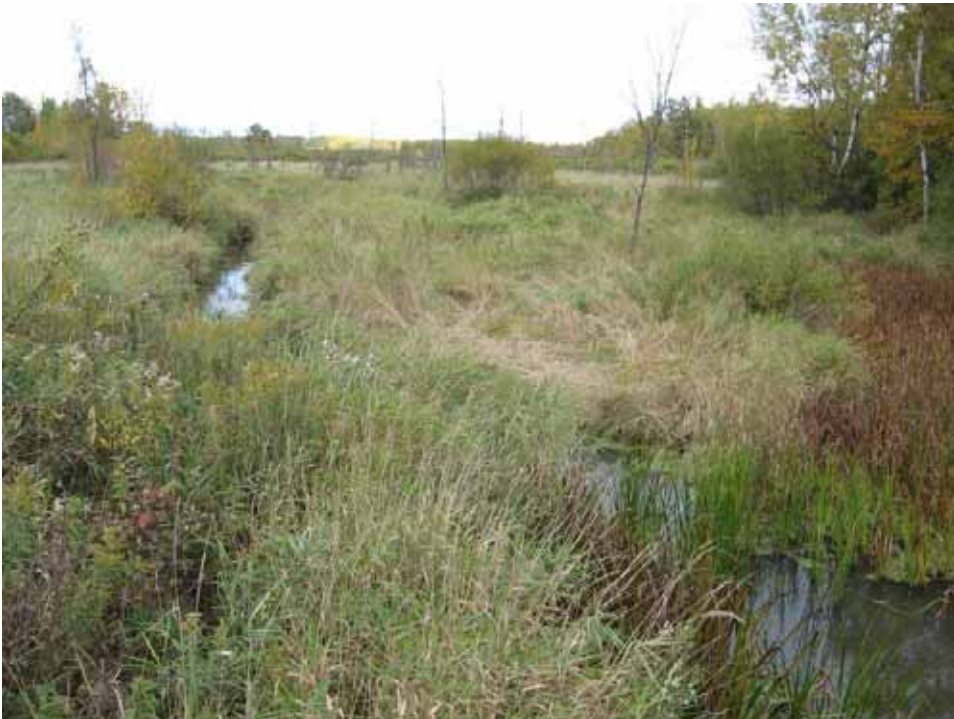
Upstream view of the South Fork at the CR-9 crossing (north of Hwy 23). The South Fork flows through a broad wetland at this point.

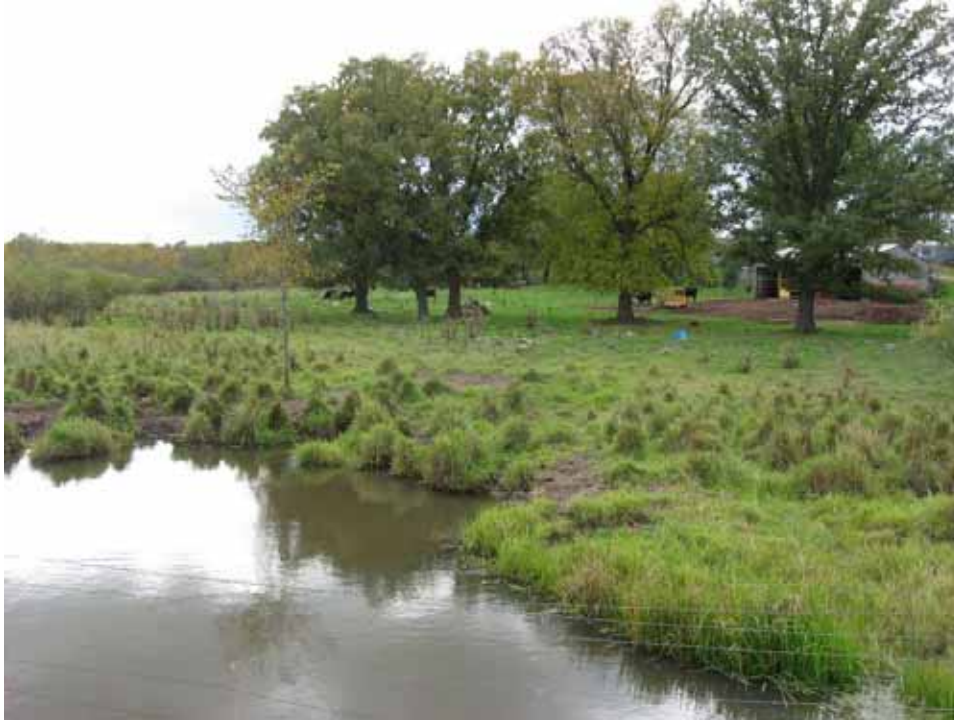
Downstream view of the South Fork from the same vantage point as the previous photo. About one dozen cattle were observed along this reach. The cattle have open access to the channel, as indicated by the trampled streambanks.

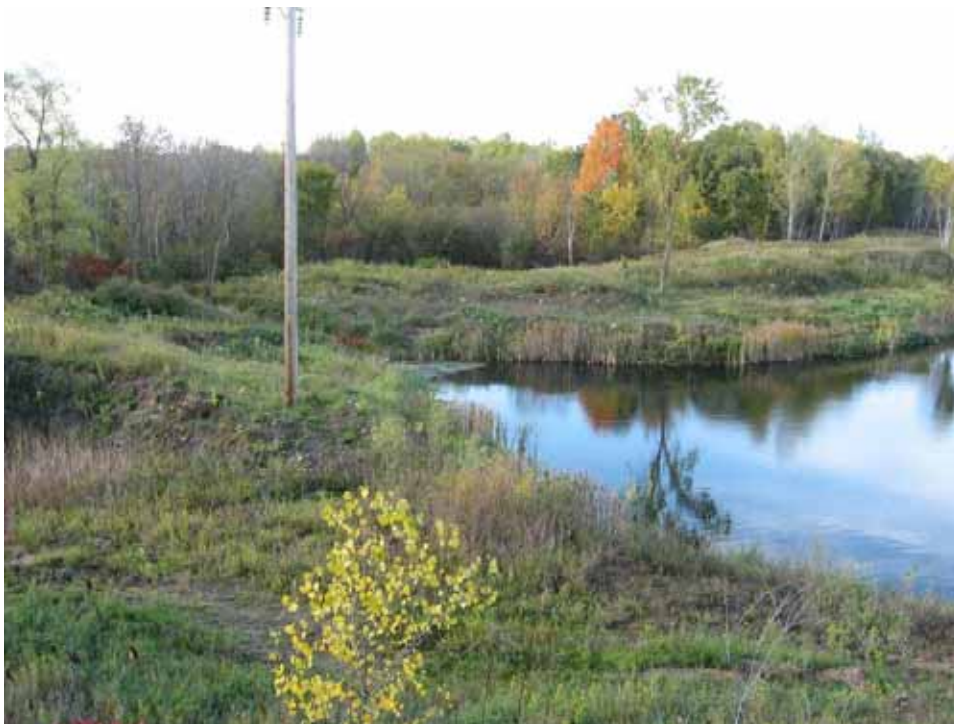
Gravel pit (#33062) off of Hwy 23 where a reported drainage ditch is connected to the South Fork of Groundhouse River. The gravel pit no longer appears active, and the water in the pond was crystal clear.

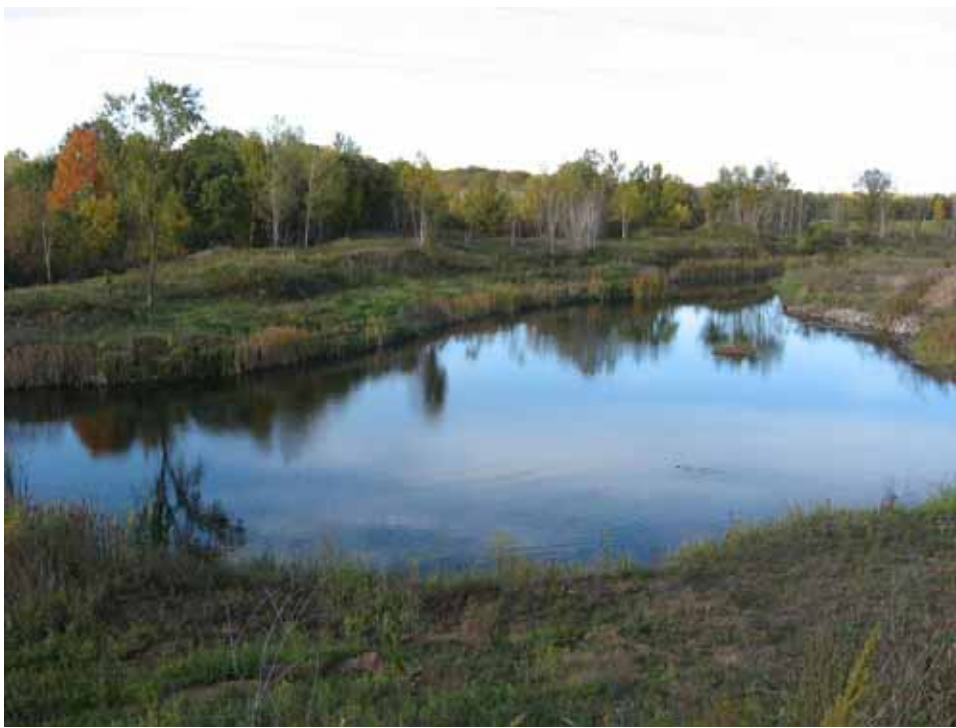
View of the same pond as shown in the previous photo.

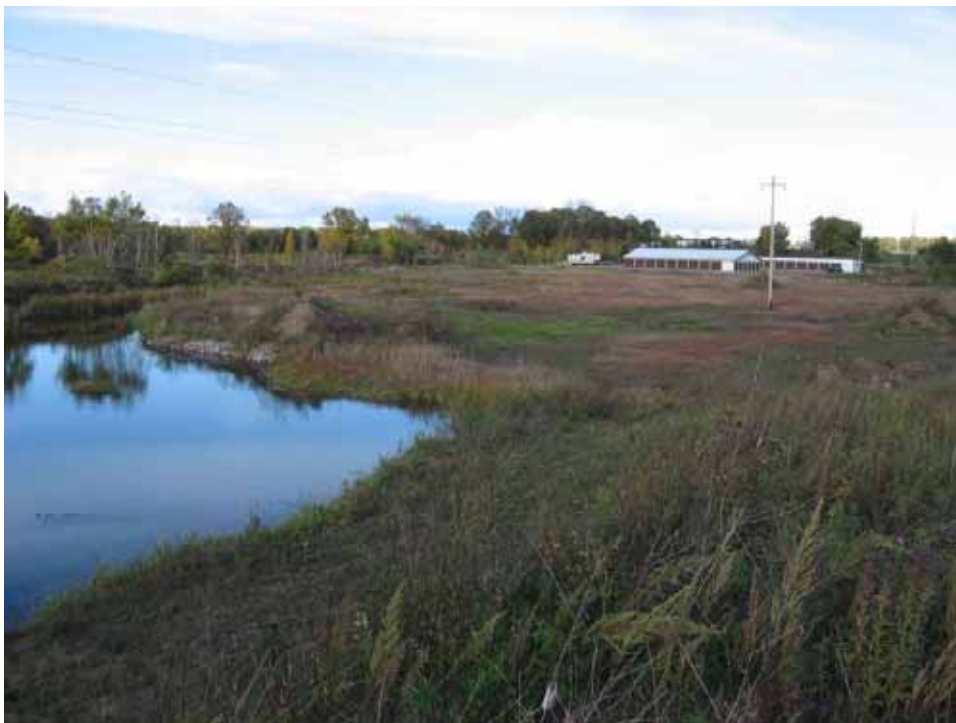
View of the gravel pit showing the contributing drainage area to the pond. The vegetation limits the potential for erosion of surface soils.

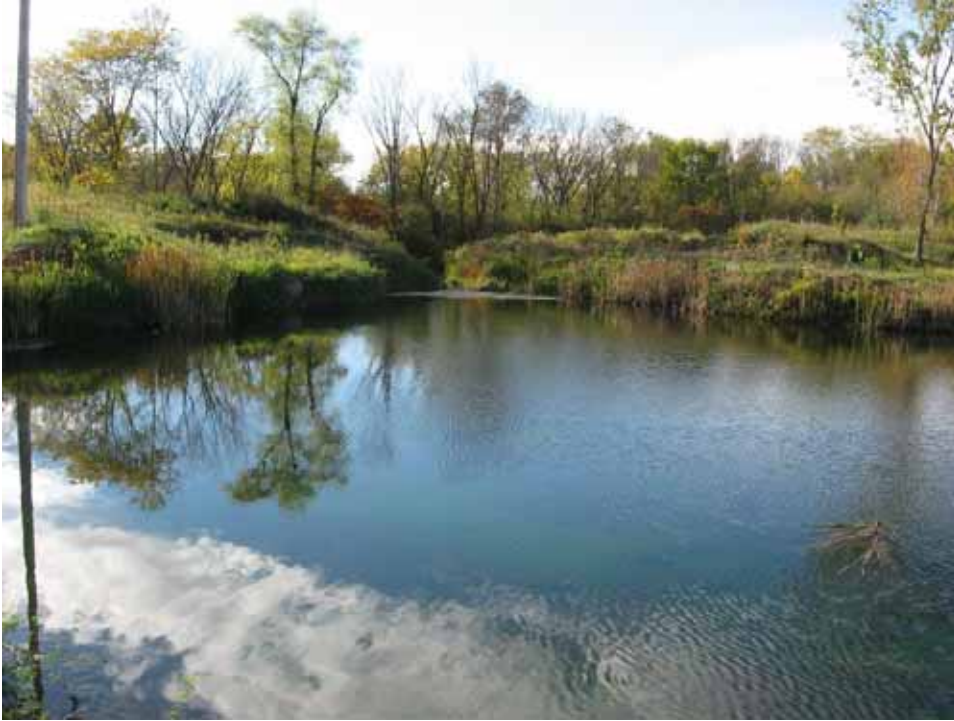
Another view across the pond toward the ditch to the South Fork.

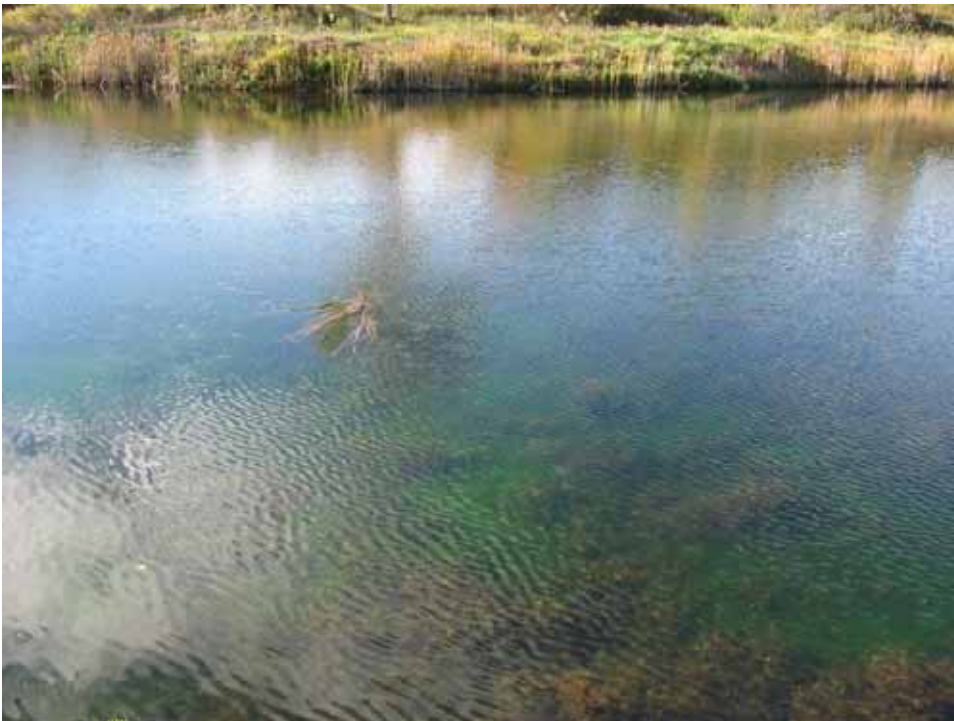
View of the water clarity in the pond – note the submerged aquatic vegetation thriving in the clear water.

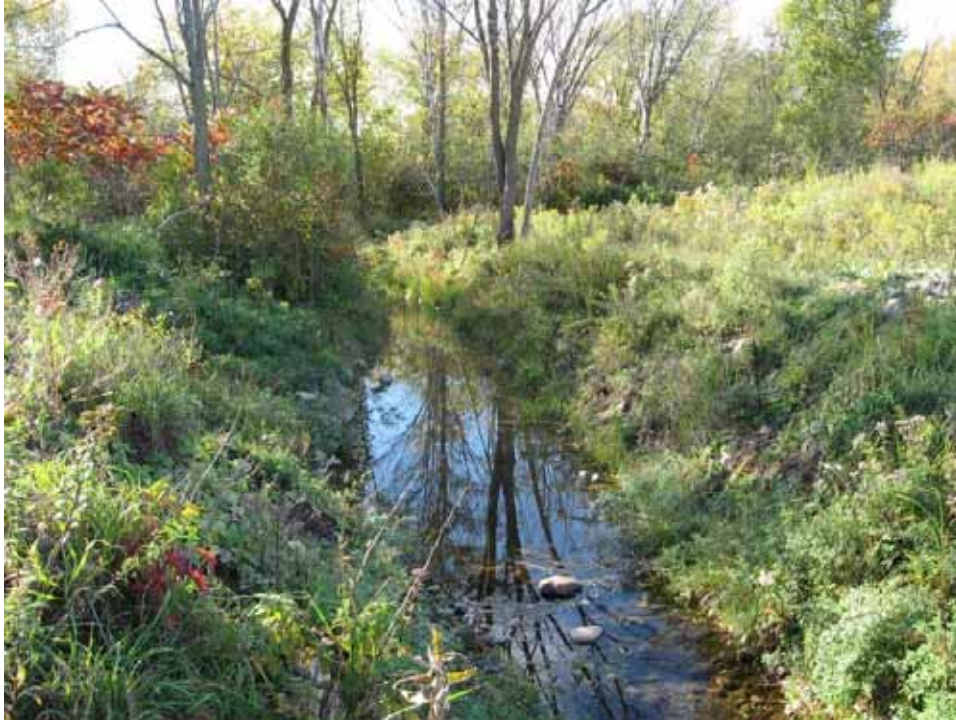
View of drainage ditch from pond toward the Groundhouse. No evidence of sediment input from this ditch was observed.

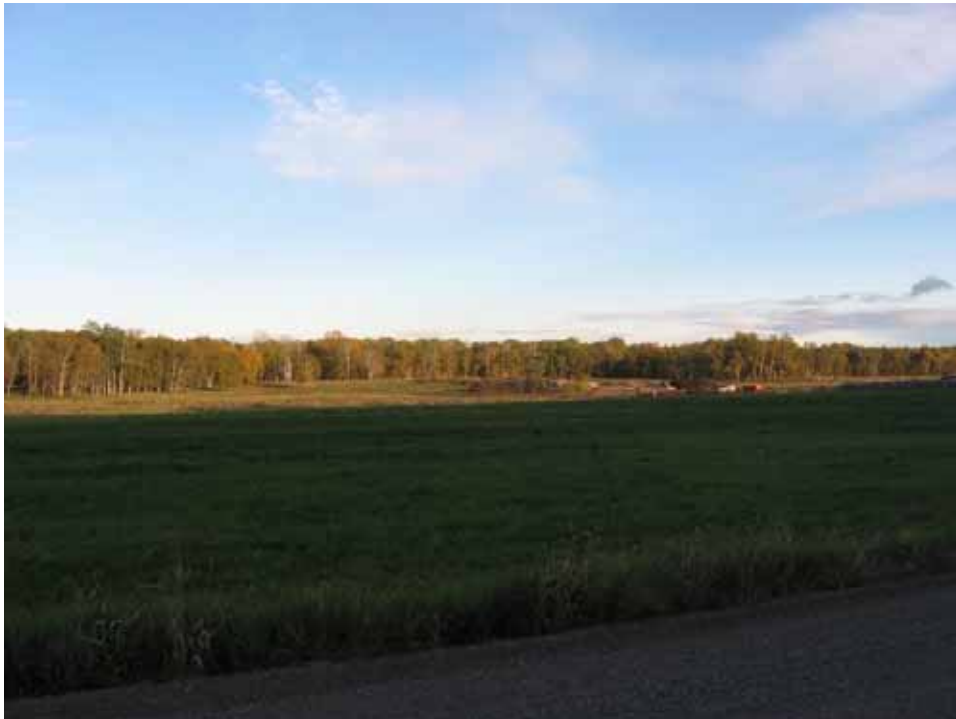
A view of gravel pit #33038 just east of CR-52. While a small drainage ditch runs through this property, the gravel pit does not appear to be a source of sediment to the South Fork of the Groundhouse River.

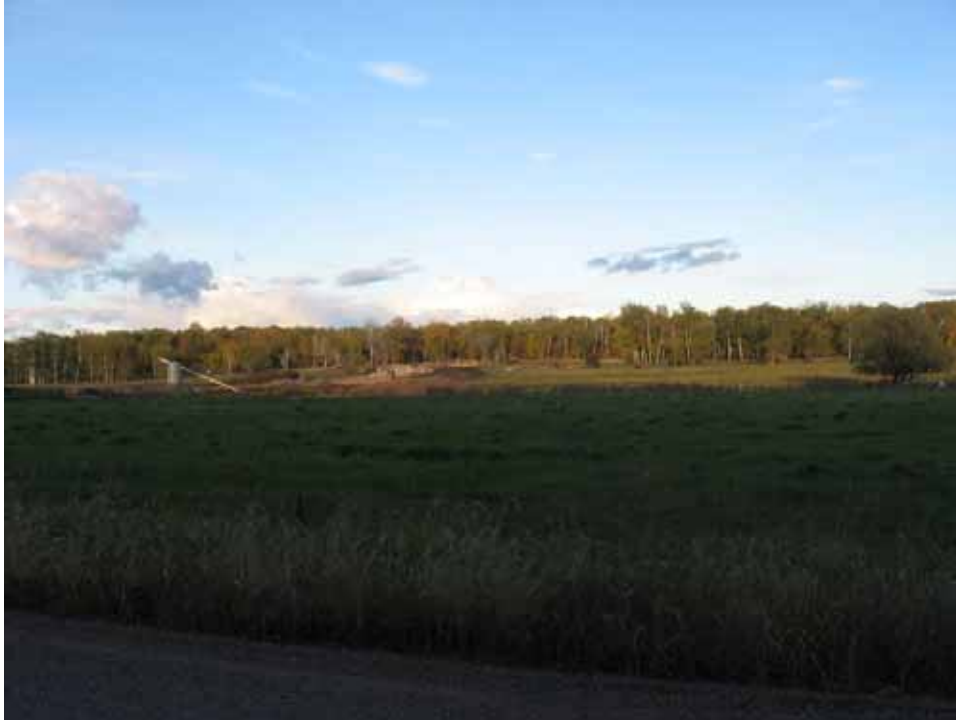
Another view of gravel pit #33038. Gravel pit #33039 was not found.

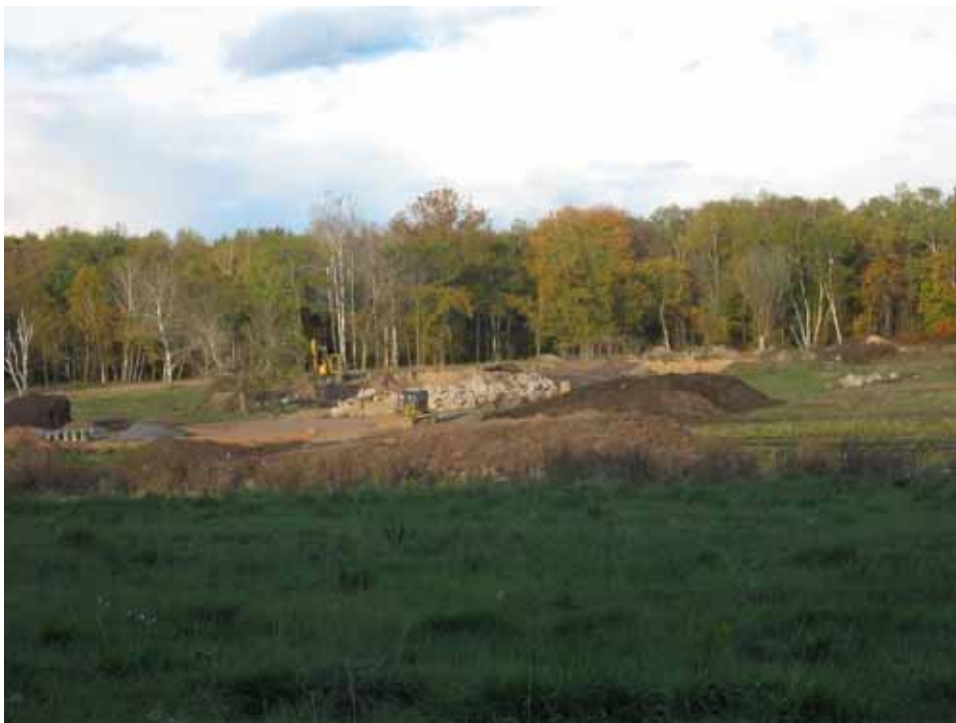
Close up view of gravel pit #33038. It appears that a paving company is now using the pit as a disposal site for asphalt and concrete waste – not as a source of gravel aggregate.

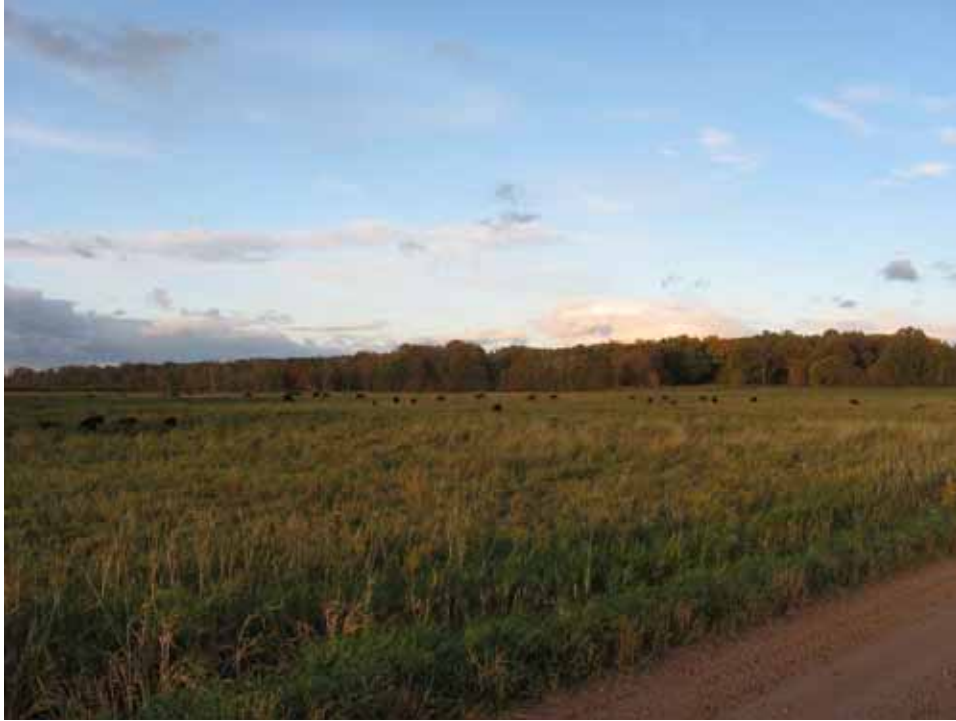
Example of a cattle pasture. A few dozen cattle were observed in this pasture.

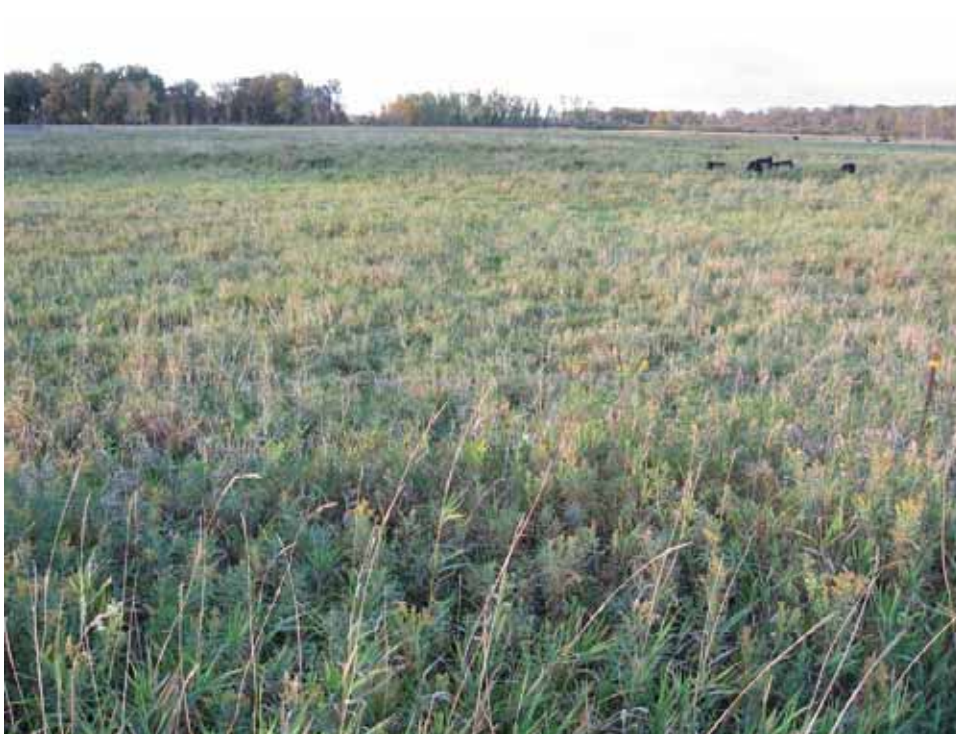
Close up view of ground cover in the pasture shown in the previous photo.

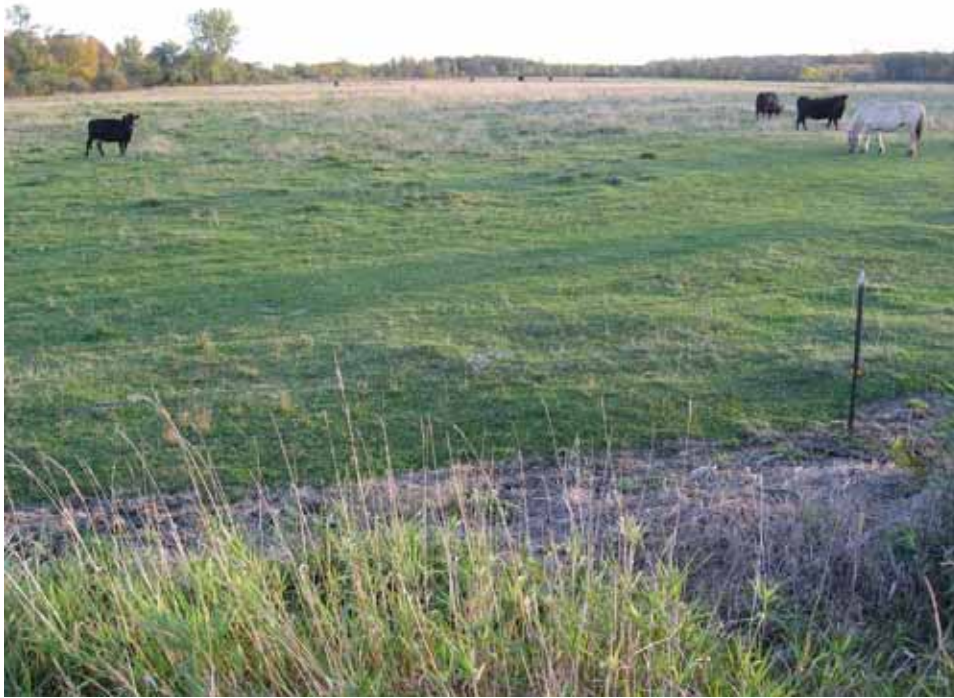
Another example of ground cover observed in the cattle pasture shown two photos previous.

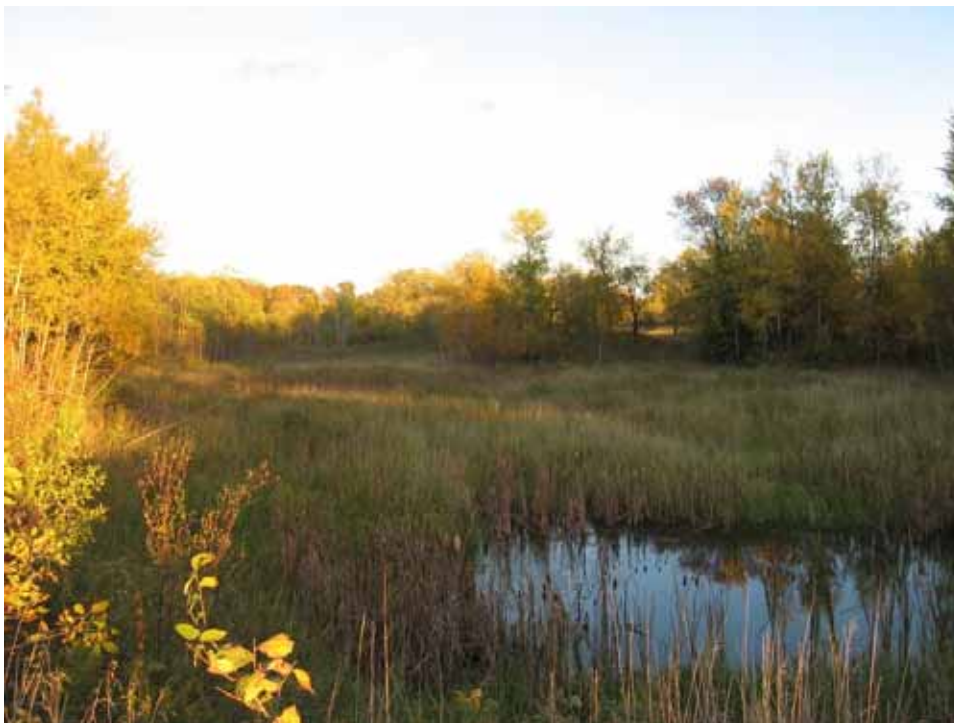
Gravel pit #33055 and or #33056 at the intersection of Hwy 47 and 110th Avenue. While marked as an active pit on the 2003 MNDOT map, this pit does not exhibit any signs of recent activity. As there is no outflow, it is unlikely that it is, or was, a source of sediment to the South Fork.

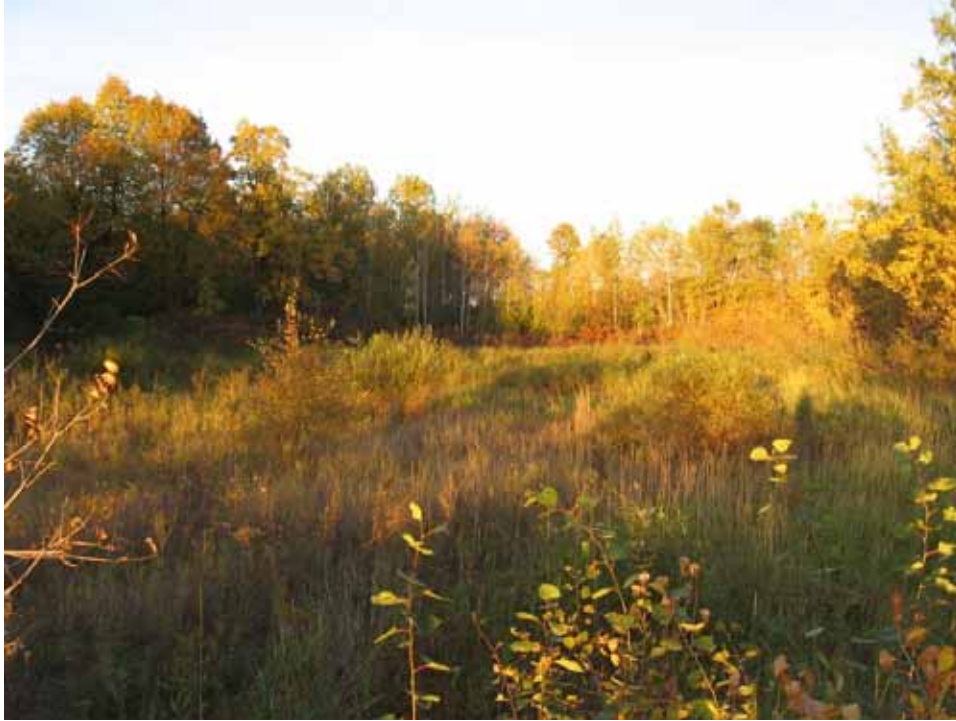
Gravel pit #33054 on the northeast side of the intersection shown in the previous photo. While the 2003 MNDOT map indicates this is an active pit, the vegetation indicates otherwise.

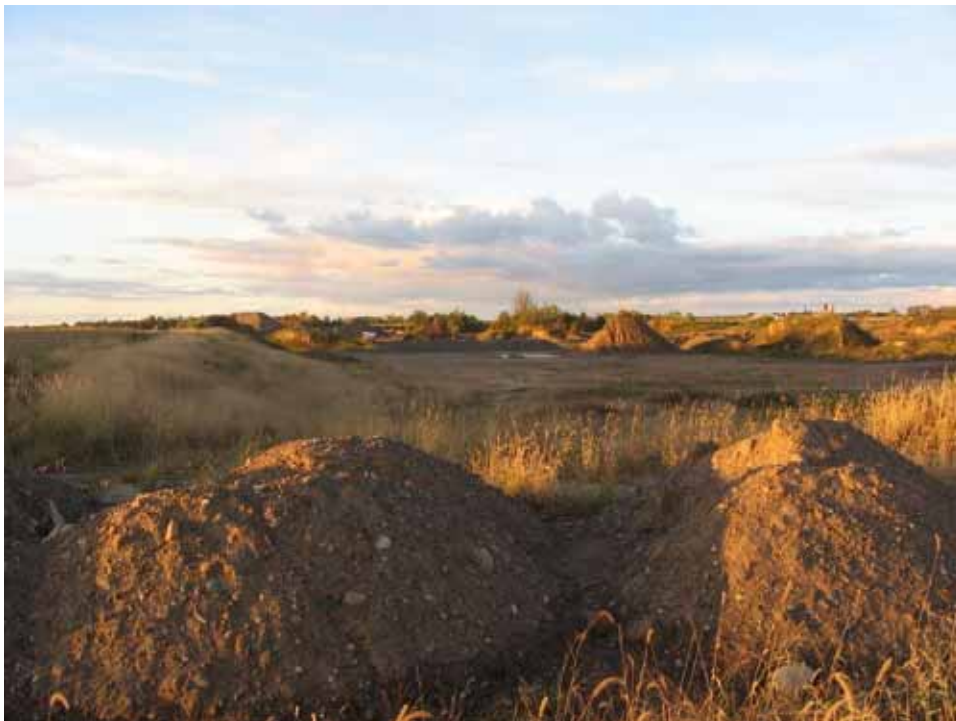
A view toward the North from 110th Avenue at commercial aggregate site #33087. The portion of the pit in the foreground does not appear active; the stockpiles in the background indicate where excavation activities were ongoing during the visit.

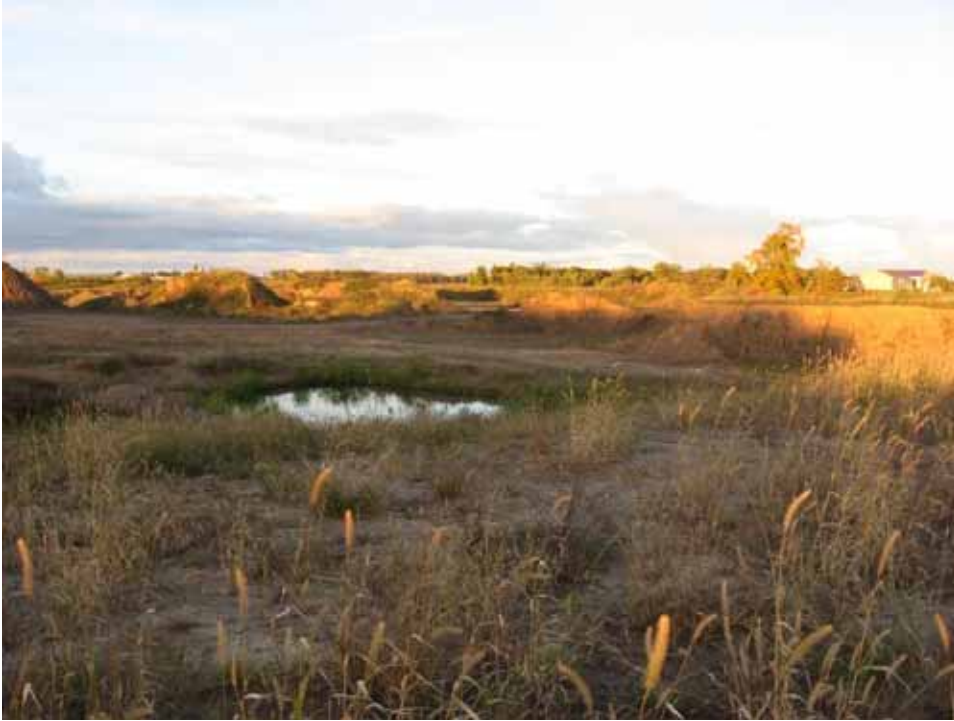
Inactive portion of aggregate pit #33087.

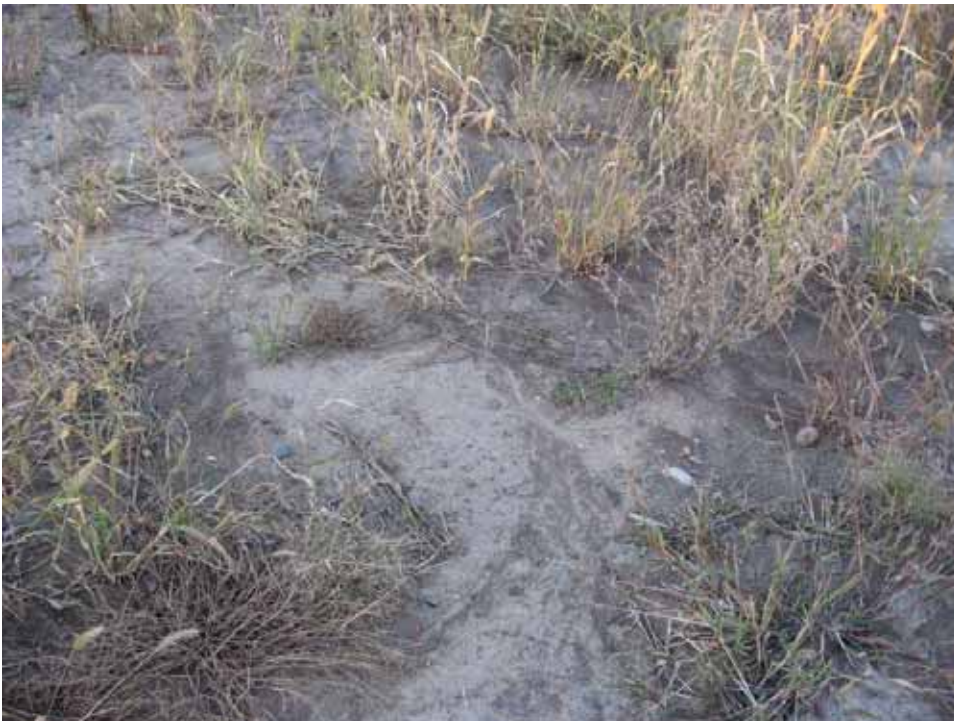
Close-up of groundcover in inactive portion of pit #33087.

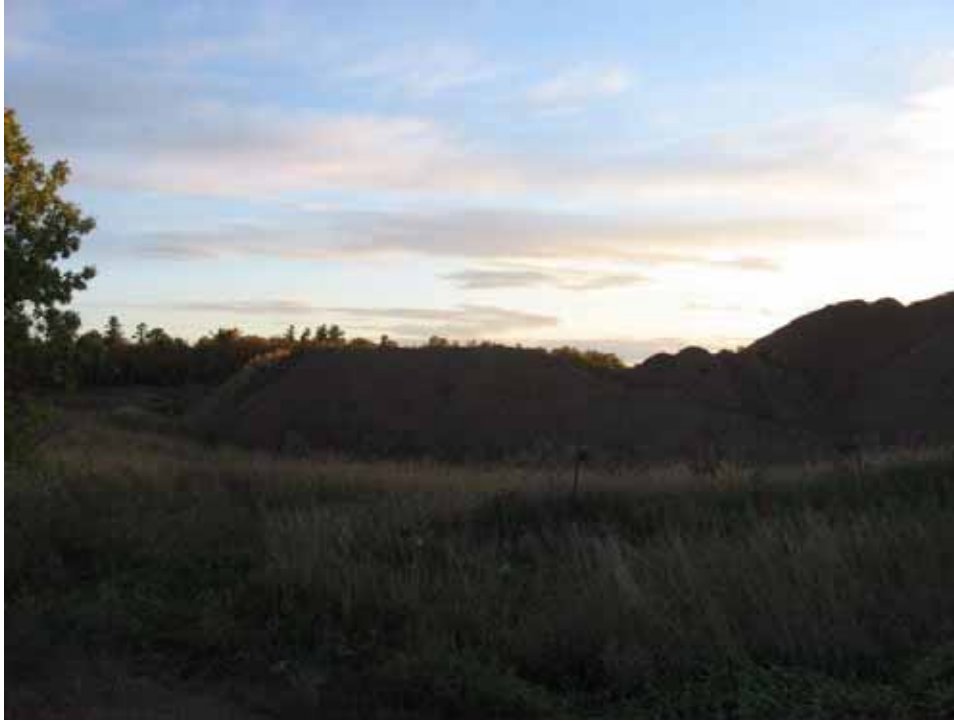
Aggregate stockpiles at the eastern side of commercial aggregate pit #33093. As with pit #33087, the commercial operations are large-scale pits that disturb tens of acres. However, as precipitation is likely trapped in the pit, it is not expected that these operations are sources of sediment to the South Fork.

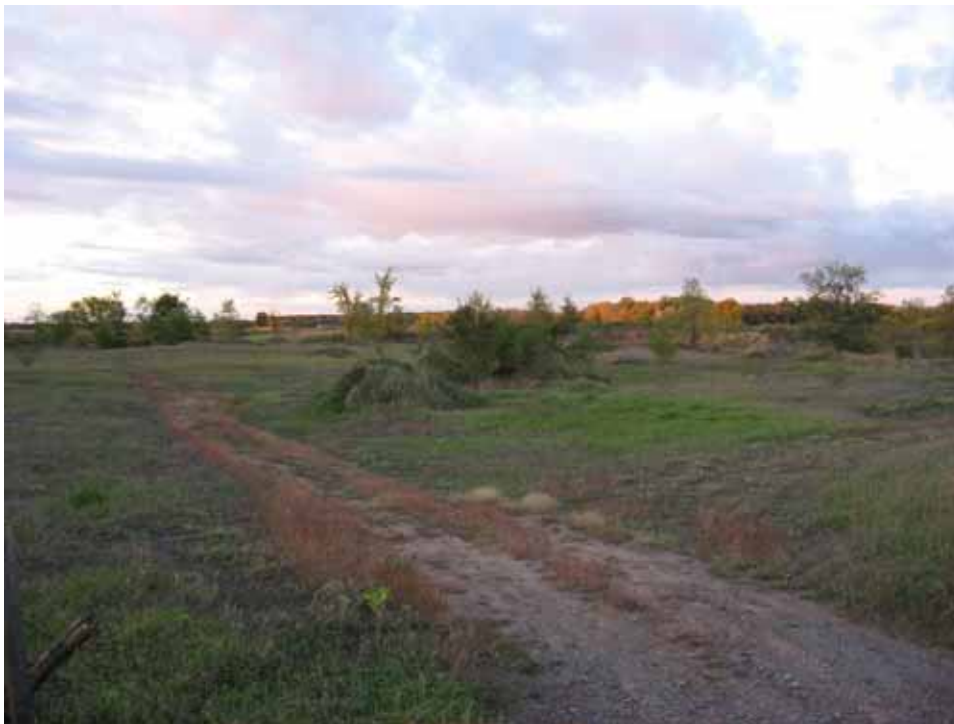
Gravel pit #33041 indicated as active on the 2003 MNDOT map no longer appeared active.

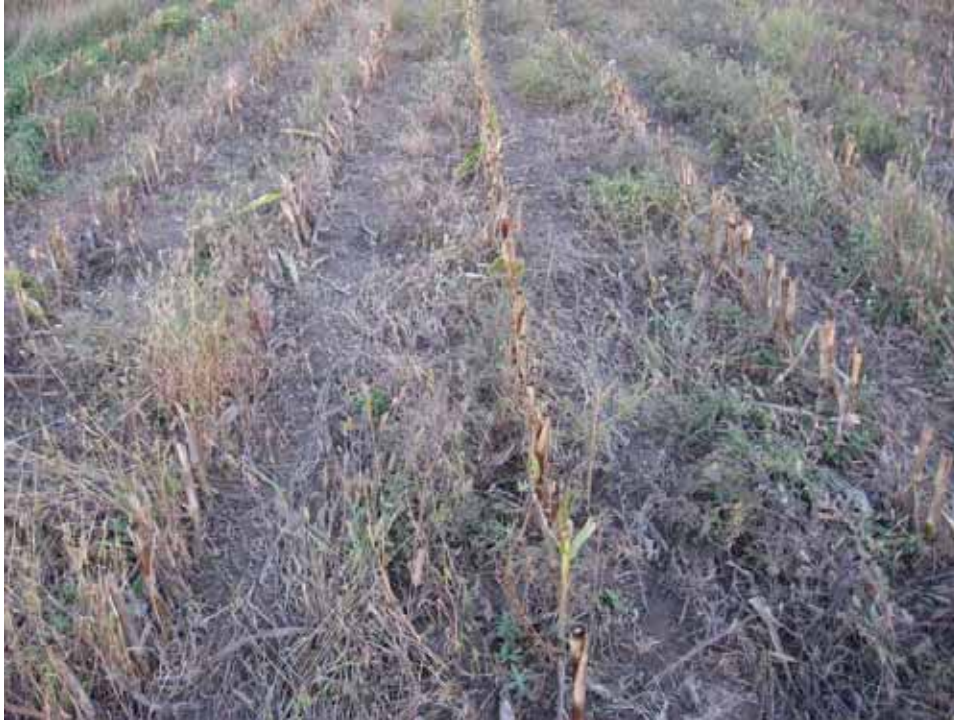
Close-up view of groundcover where row crops have been harvested.

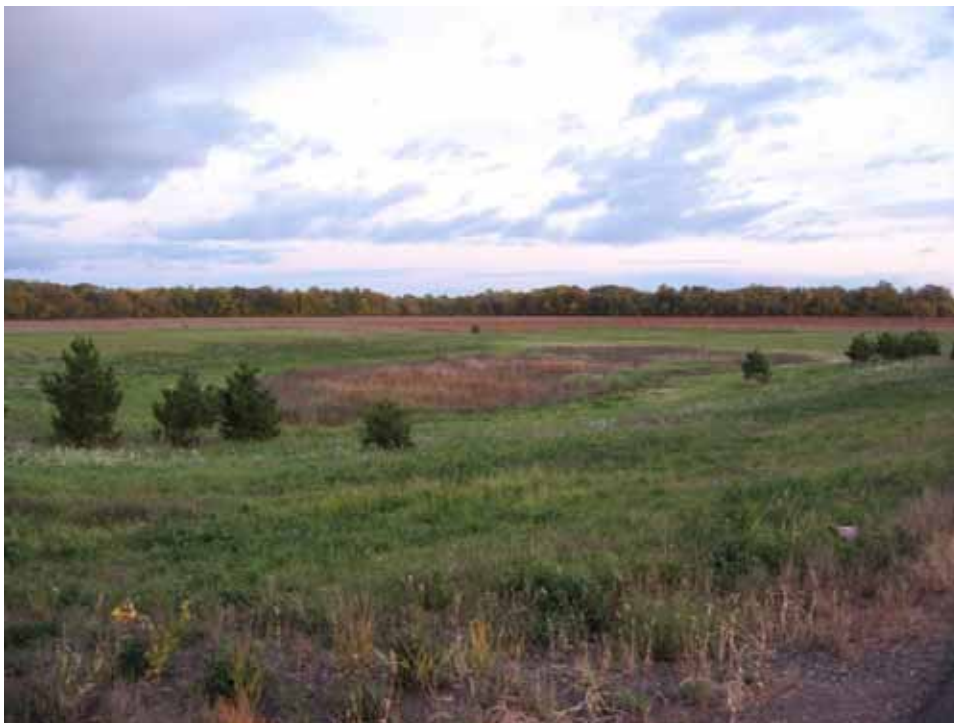
Gravel pit #33057 along Hwy 47 just south of Ogilvie. While clearly no longer an active pit, it appears this area may now function as a wetland.

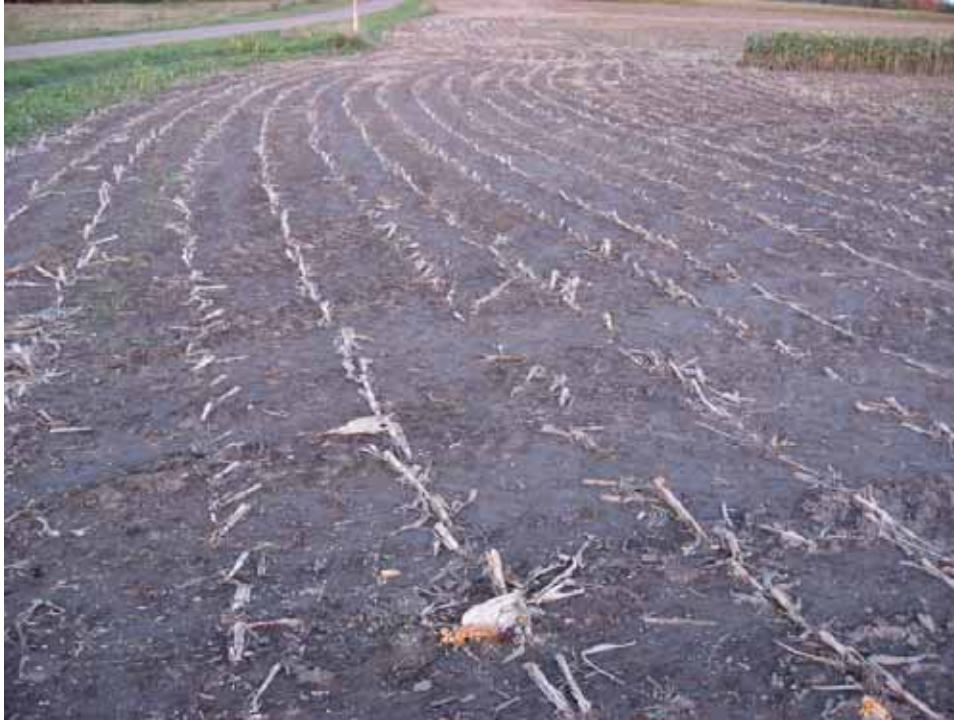
Another close-up of groundcover where row crops (corn) had recently been harvested. Note the patch of corn still standing in the top right corner of the photo.

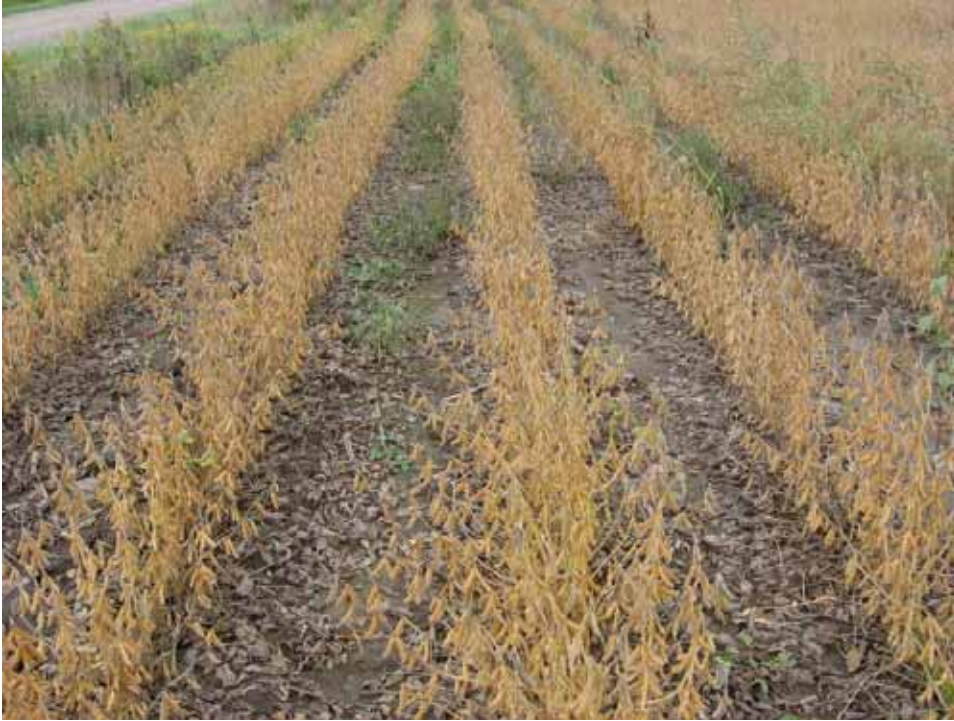
Close-up example of soybean cover.

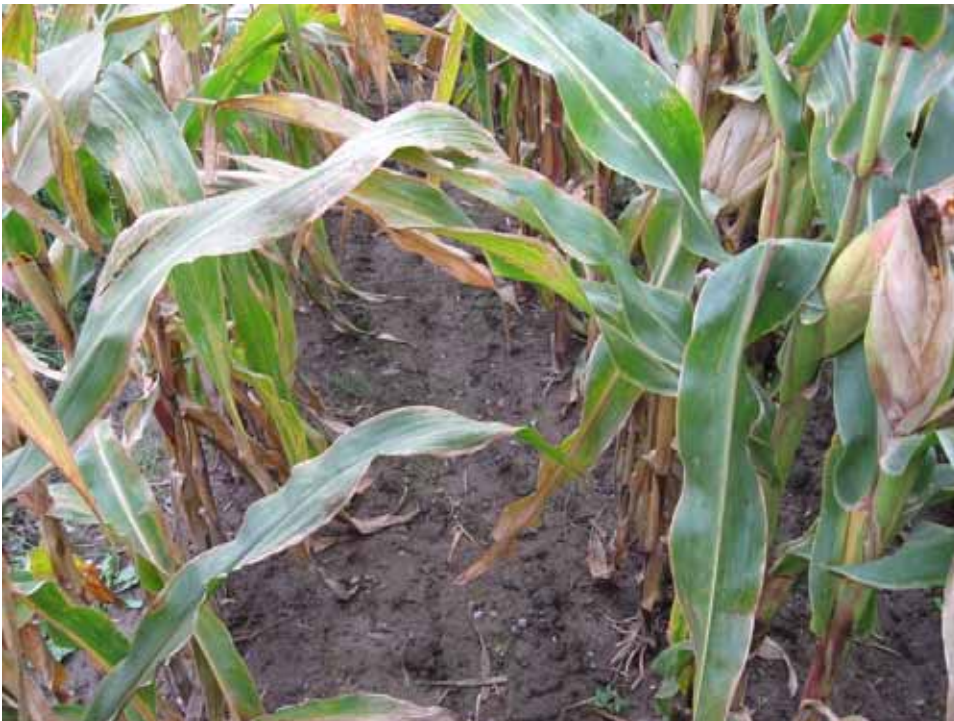
Close-up example of groundcover between rows of corn.

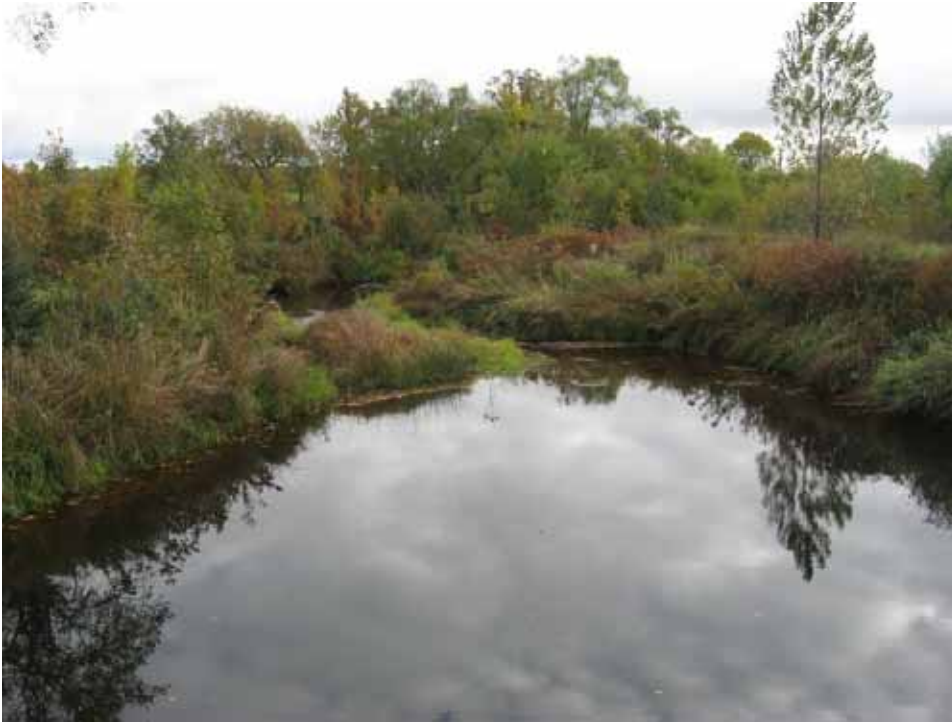
Downstream view of the Groundhouse River at CR-53 crossing (north of CR-55). The channel appeared to be under a backwater, possibly from the influence of a beaver impoundment.

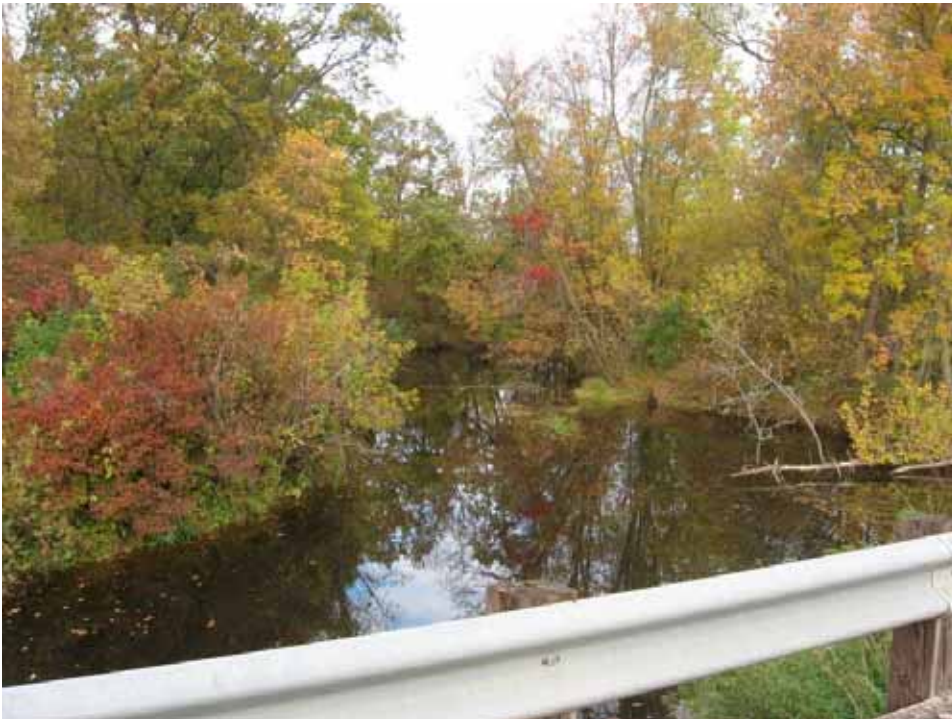
Upstream view of the Groundhouse River from the same vantage as the previous photo. The water was too dark to assess the size of the streambed substrate.
