Groundhouse River Total Maximum Daily Loads for Fecal Coliform and Biota (Sediment) Impairments

Final TMDL Report

March 2009

**Submitted by:
Tetra Tech**

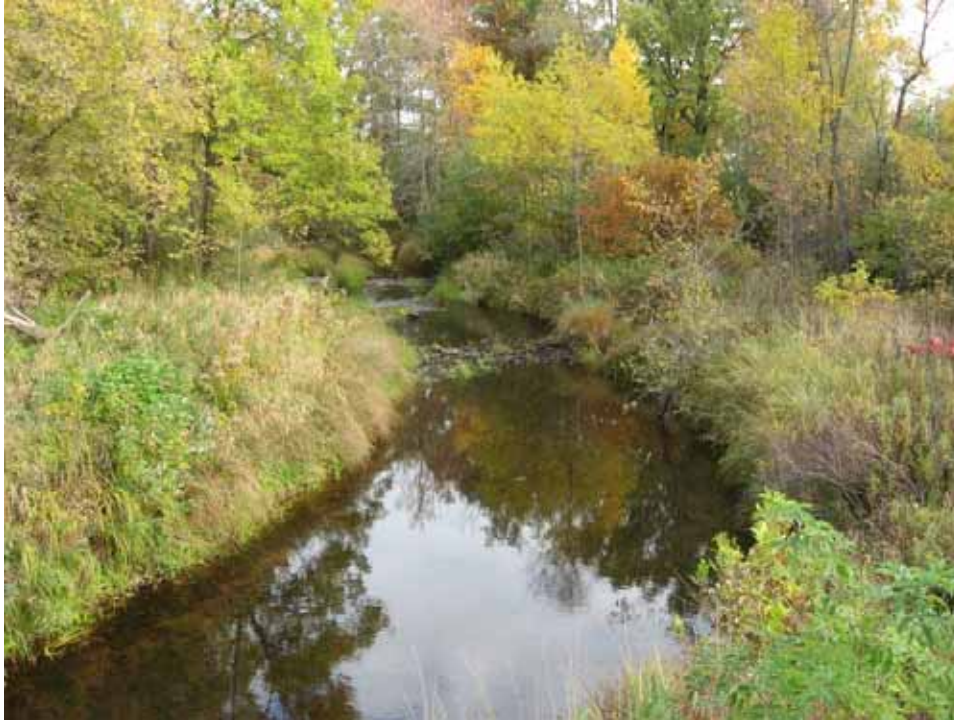
Upstream view of the Groundhouse River at the CR-55 crossing (east of CR-53). At this point (downstream of the previous photos), the channel no longer appears to be impounded. The two cobble riffles shown in this reach indicate a free flowing system.

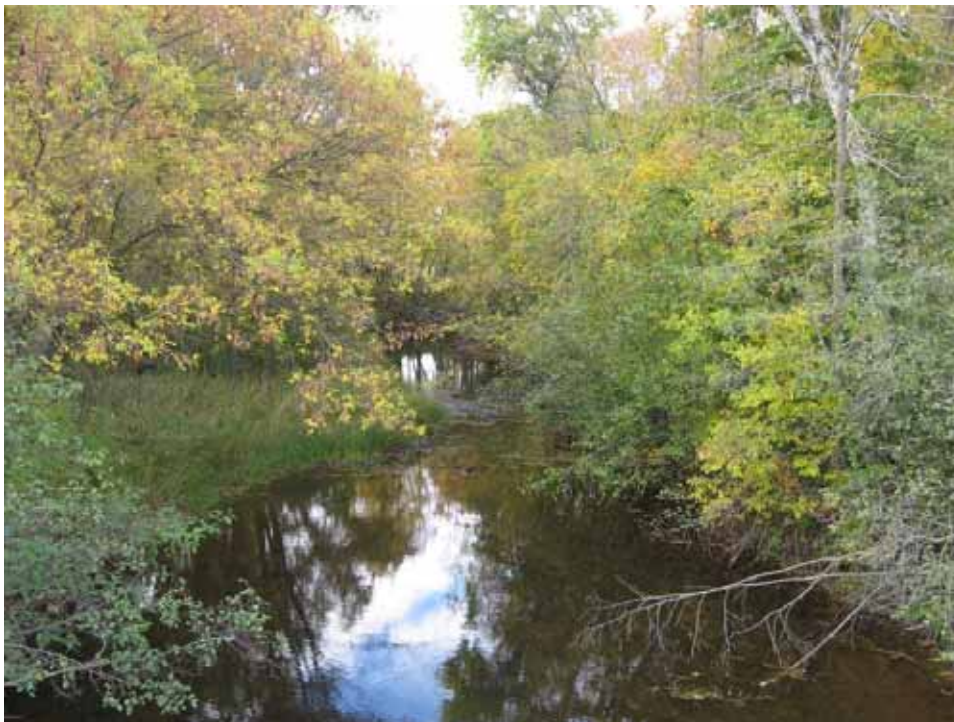
Downstream view of the Groundhouse from the same vantage point as the previous photo. Another cobble riffle was observed. The morphology of the channel did not appear to be an active source of sediment to downstream reaches.

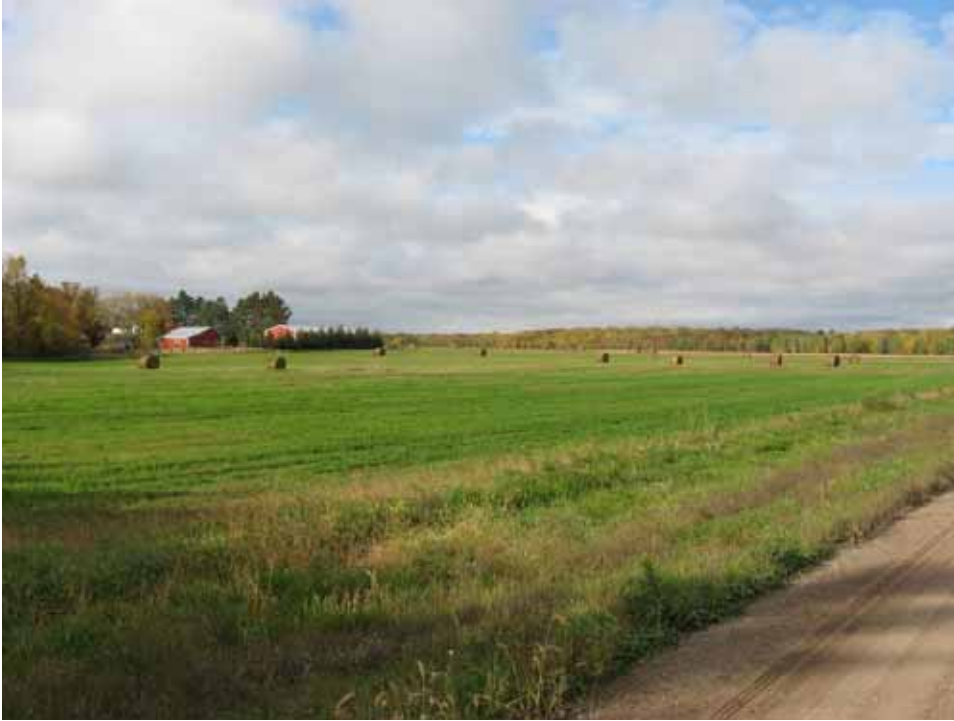
Hay or clover (?) field in the Groundhouse watershed after a recent harvest.

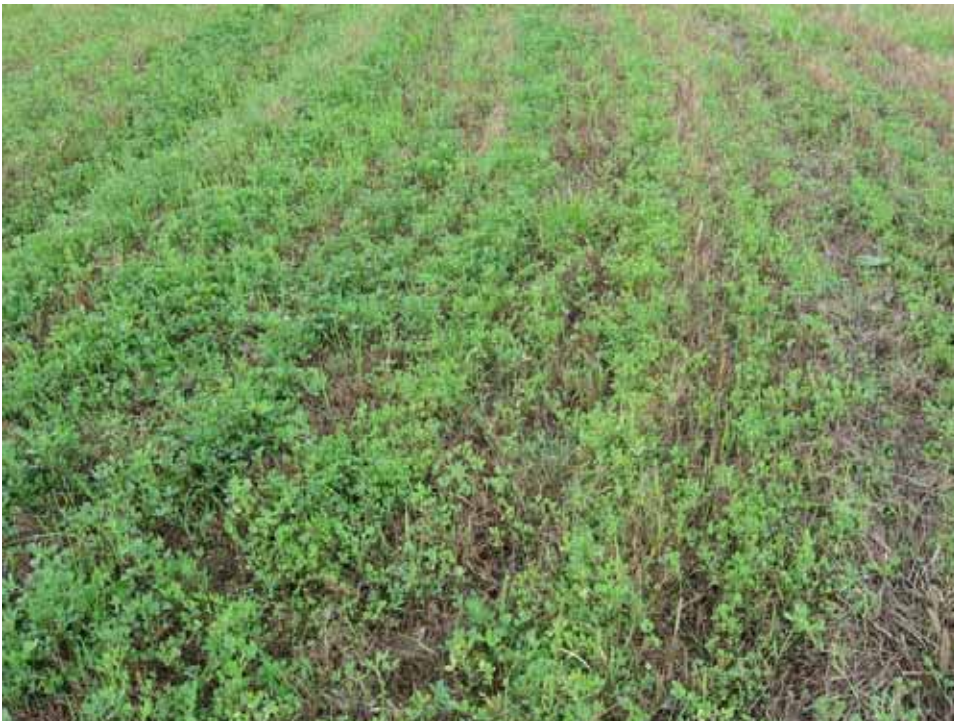
Close-up of groundcover (hay or clover?) shown in the previous photo.

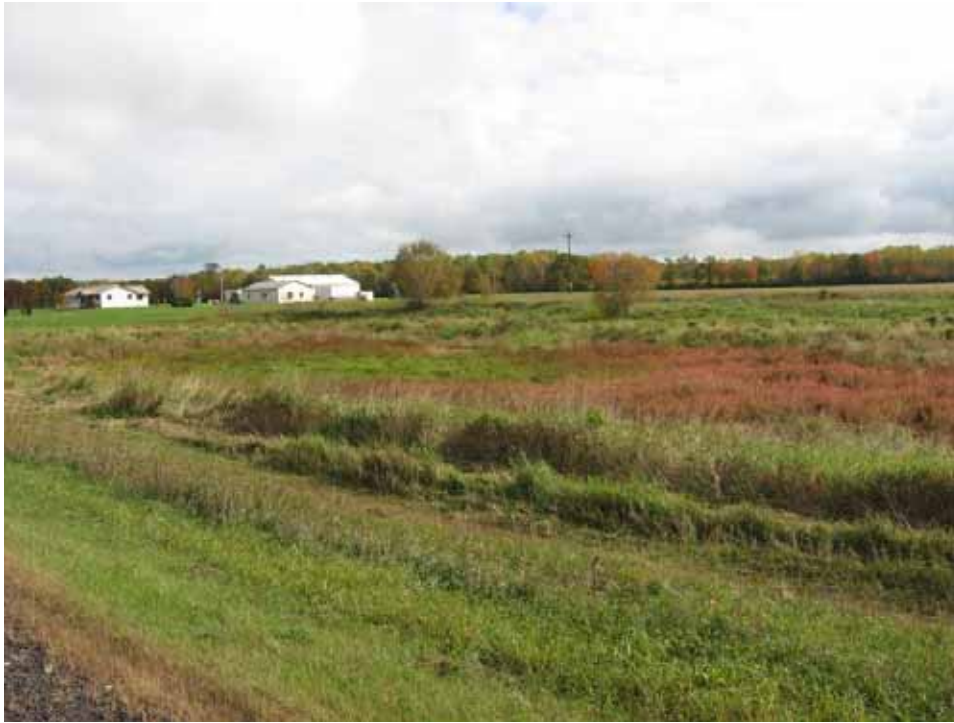
Inactive gravel pit #33048 on the eastern side of Hwy 47 just north of Ogilvie.

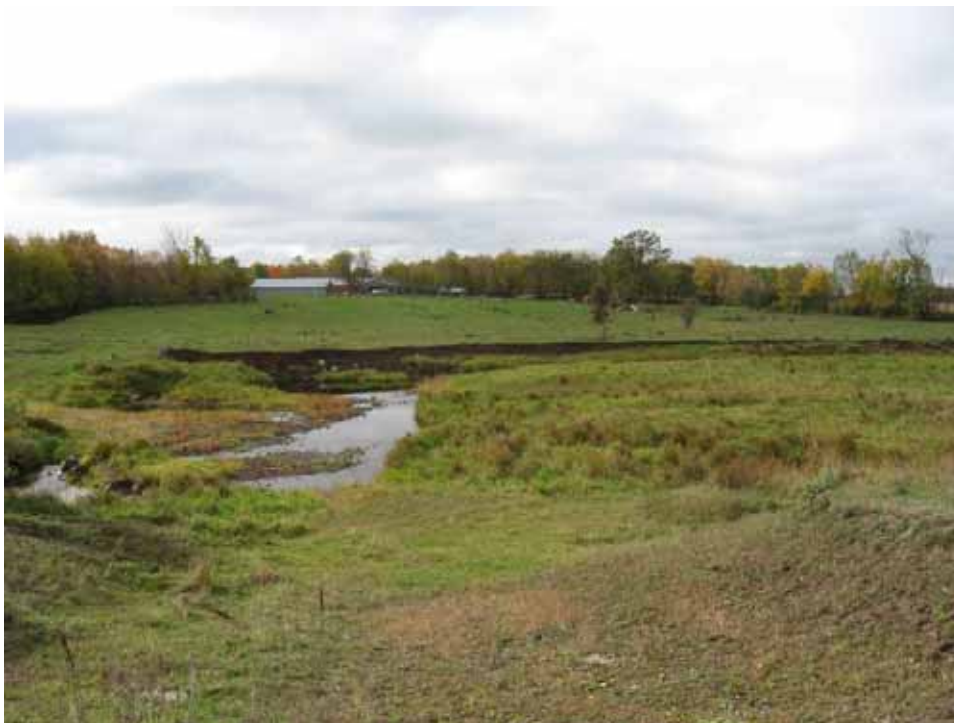
Extensive streambank erosion along the Groundhouse River off of 172nd Avenue to the west of Hwy 47 (just north of Ogilvie). Note the mid-channel bar in the foreground. While cattle were not observed, it is obvious that animal have access to the river throughout this pasture.

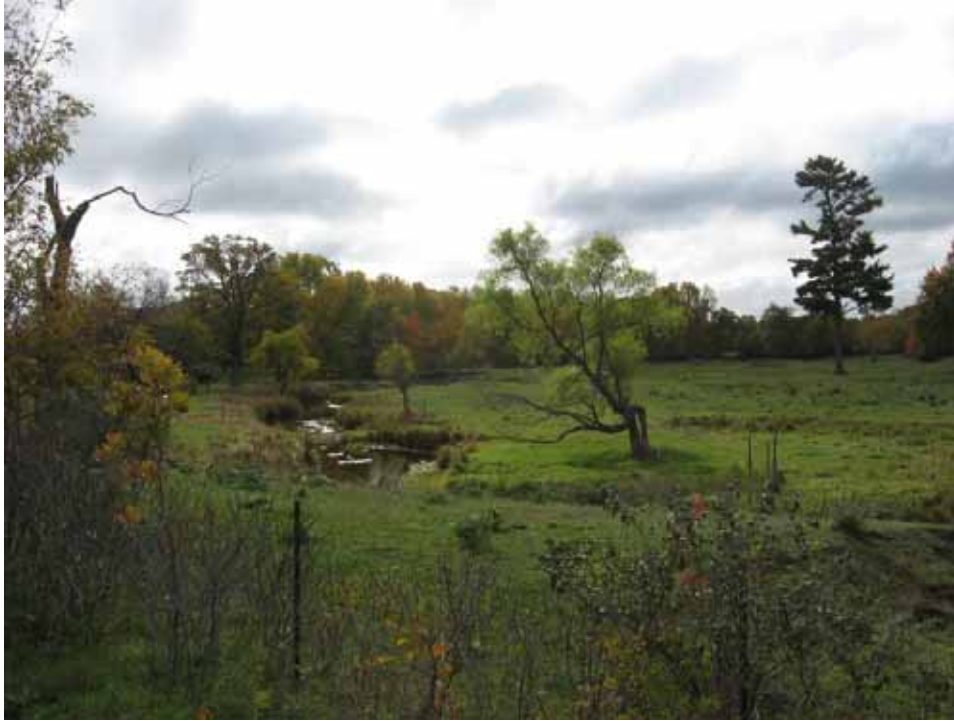
Downstream view of the Groundhouse River from the same vantage point as previous photo. Streambank erosion continues through this reach.

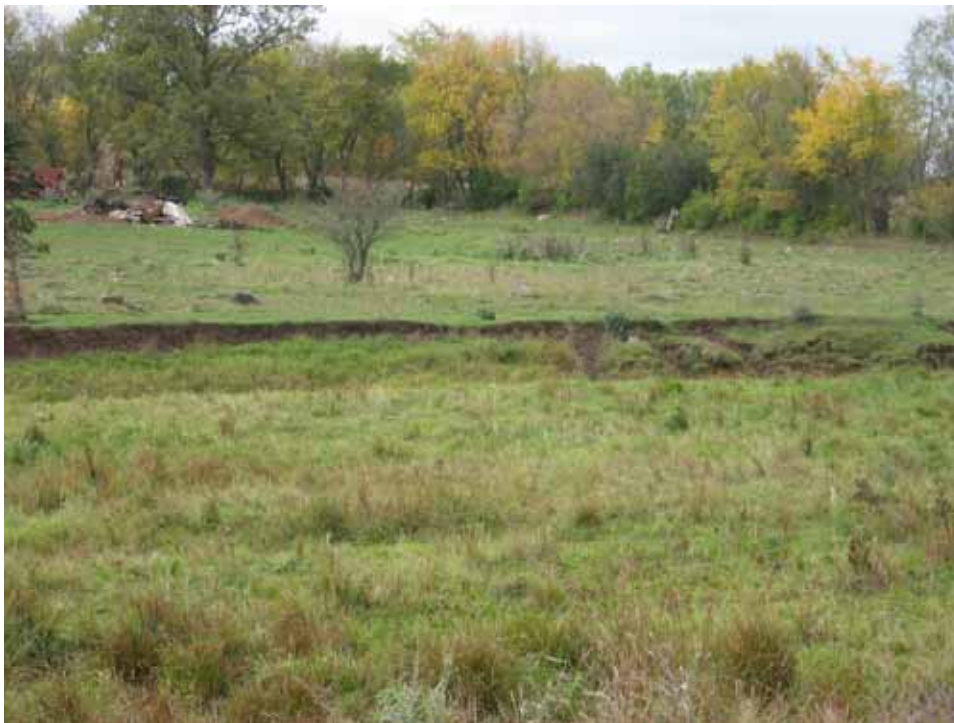
Close-up of streambank slumping. Based on the knickpoint at the top of the streambank and the grass on the streambank, it is clear the toe of the streambank is being eroded and the upper bank slumps into the river.

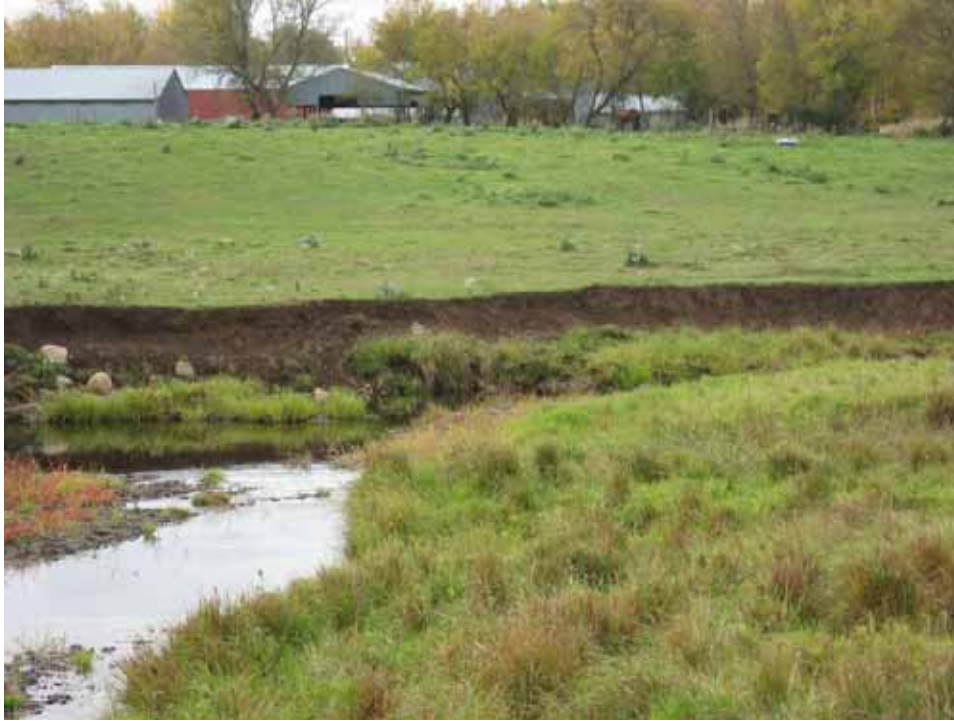
Another close-up view of the streambank erosion. This reach of the river is located in glacial outwash sands that afford little resistance to hydraulic stresses – particularly when no woody vegetation is present and livestock can trample the banks.

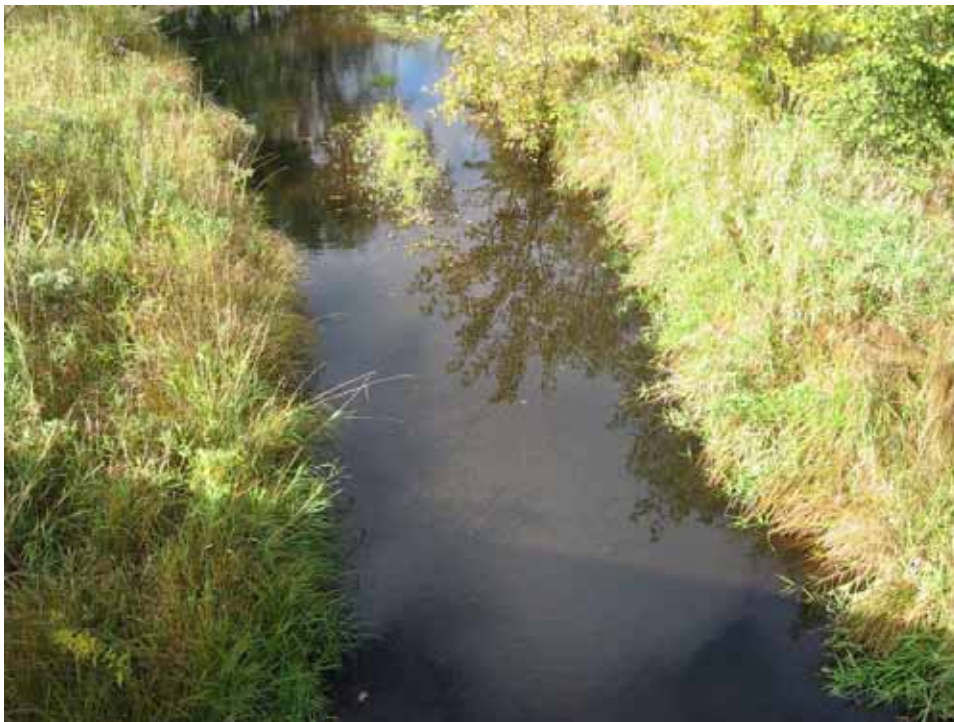
Upstream view of the Groundhouse from the Hwy 47 crossing – approximately 2,000 feet downstream from the previous photos. Note the gravel cobble substrate on the streambed and the stable streambanks.

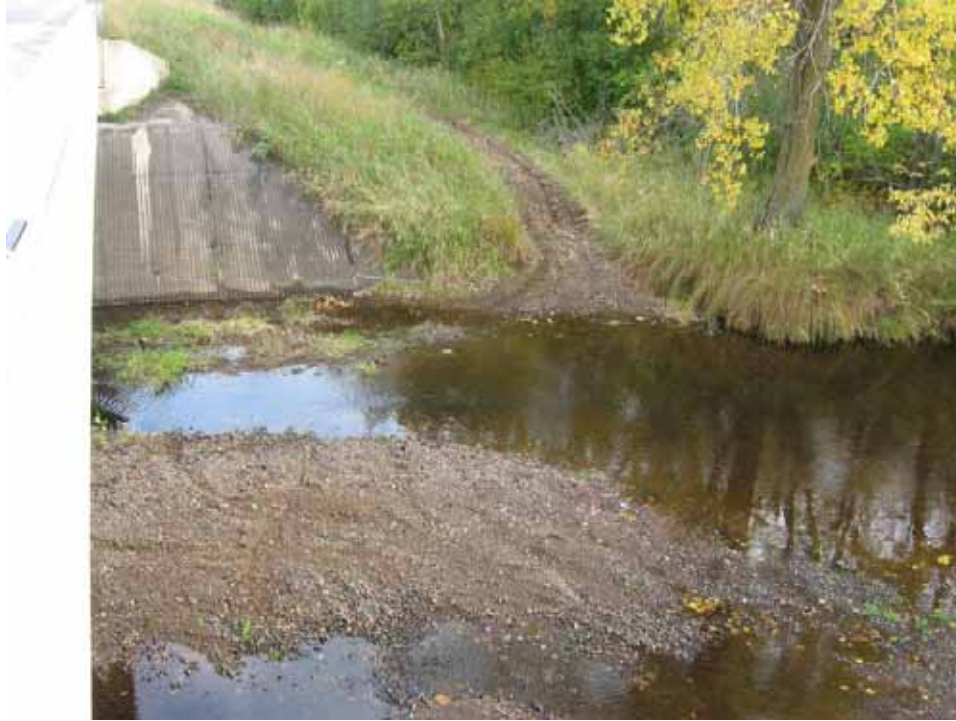
Downstream view of the Groundhouse from the Hwy 47 crossing. Where the channel is overly wide due to the road crossing, a gravel mid-channel bar has formed. Note the ATV access trail and tire tracks on the bar.

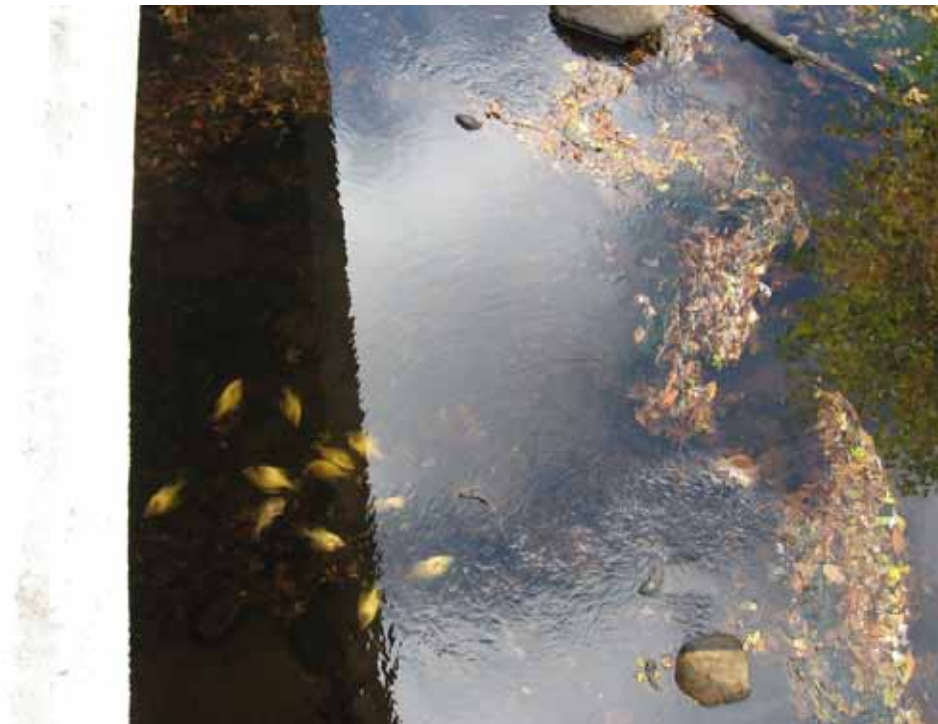
View of dead fish in the Groundhouse at the upstream side of the CR-60 (Hill Ave) crossing in Ogilvie. It is likely the fish were dumped into the river. Also note the large cobbles and boulders in the channel.

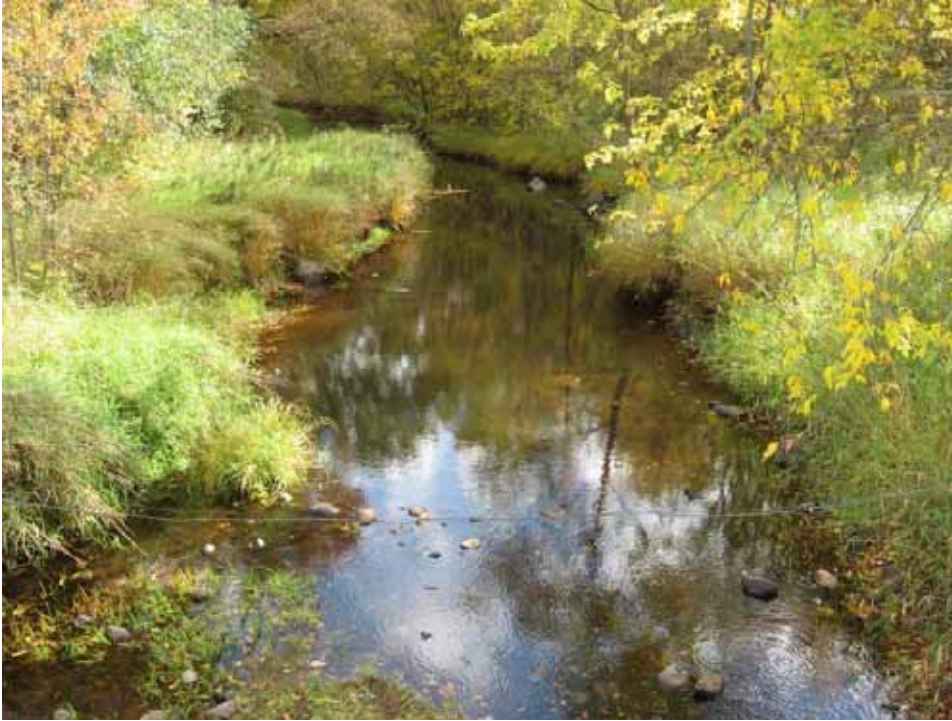
Downstream view of the Groundhouse from the CR-60 crossing. The streambanks appear stable with accessible floodplain on both streambanks. Coarse substrate is again prevalent in the streambed.

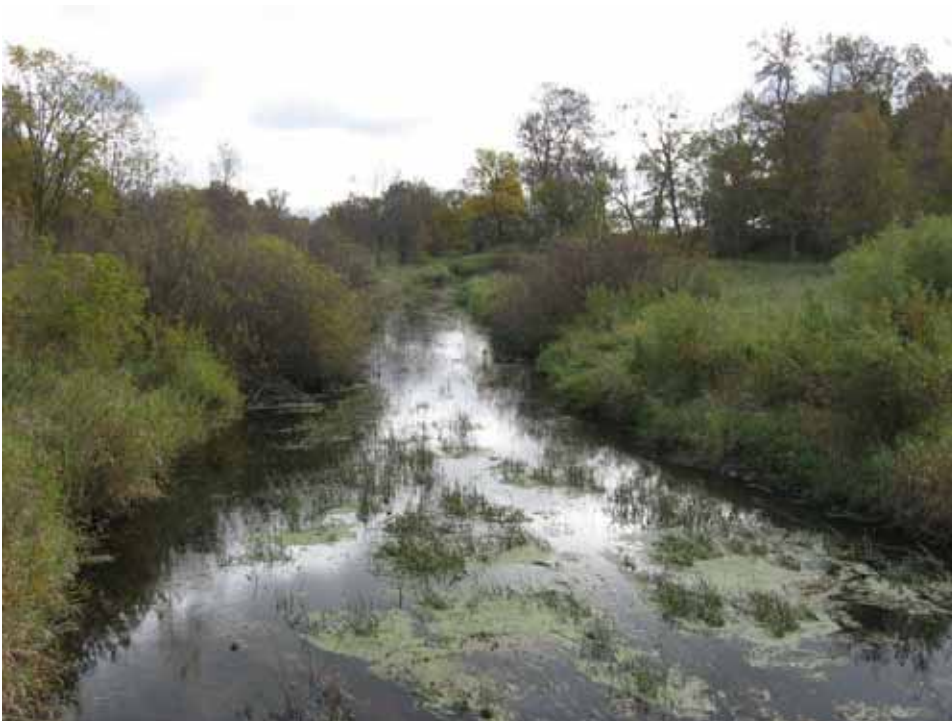
Downstream view of the South Fork at the CR-50 crossing. This reach appeared to have experienced historic channelization. Due to the open canopy and high nutrient load, filamentous green algae was abundant.

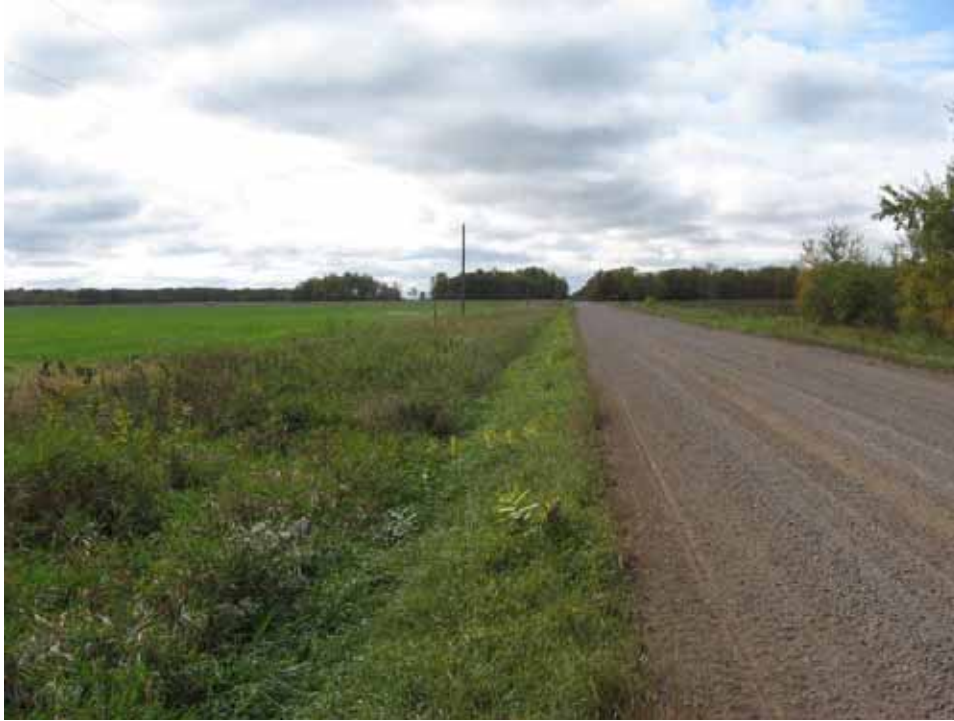
Upstream view of drainage ditch along CR-50 (facing south). Due to the well maintained road surface and the vegetation in the ditch, most eroded sediment is likely trapped in the ditch before being transported to the river.

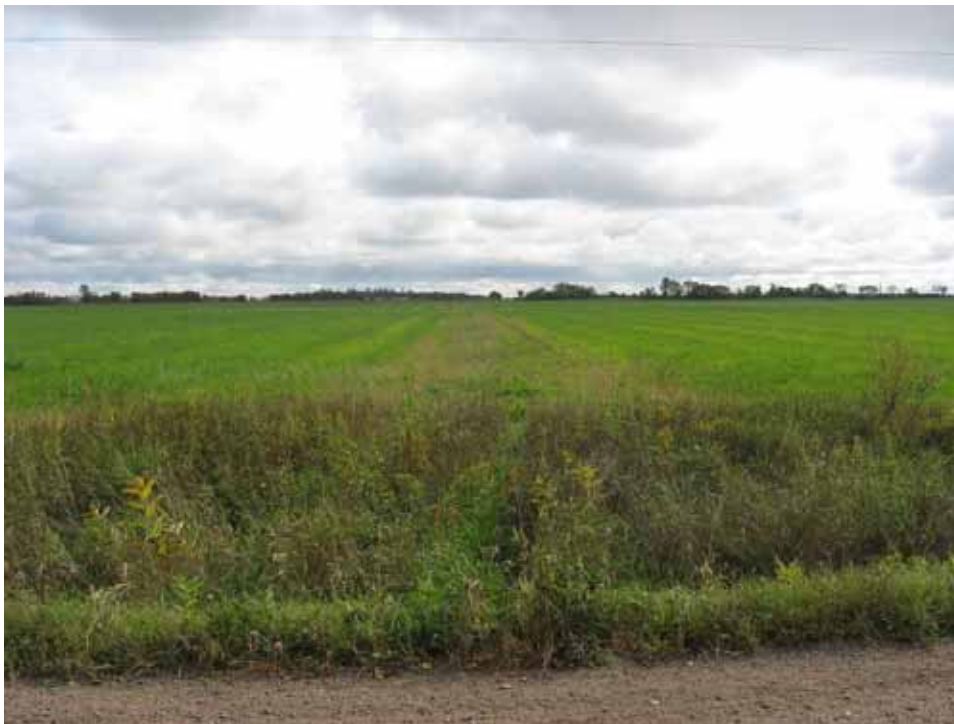
View to the east of a lateral ditch into an agricultural field. The lateral ditch connects to the drainage ditch that runs along CR-50.

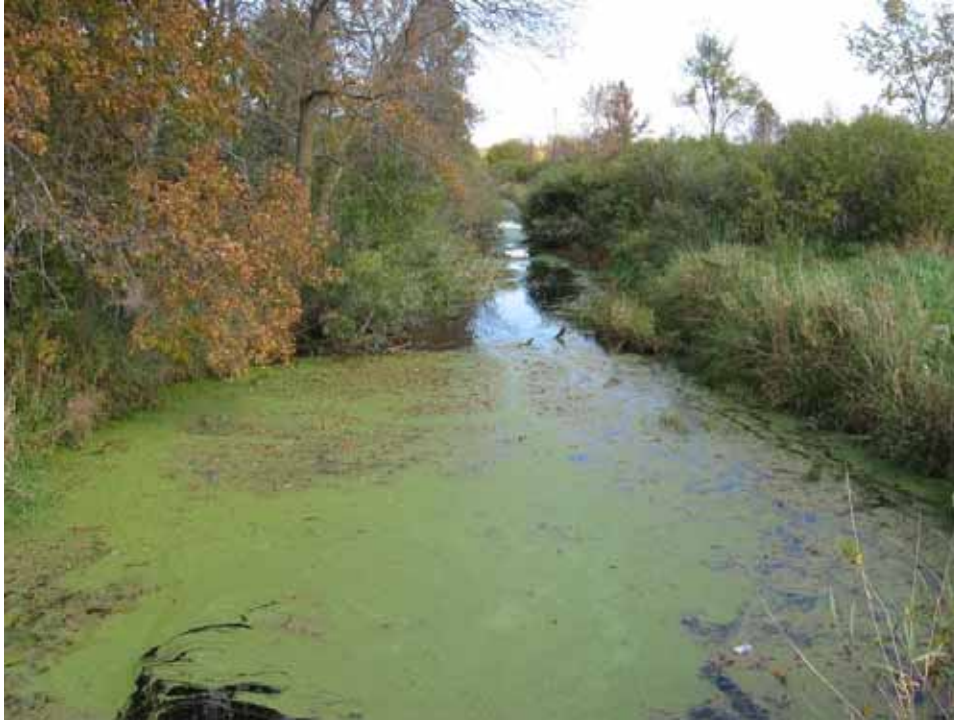
Downstream view of drainage ditch in the South Fork watershed as seen from 110th Avenue. The ditch drains agricultural areas. An animal, resembling a beaver, was observed swimming in this ditch. Possibly a beaver impoundment is backing up flow and enhancing algal growth.

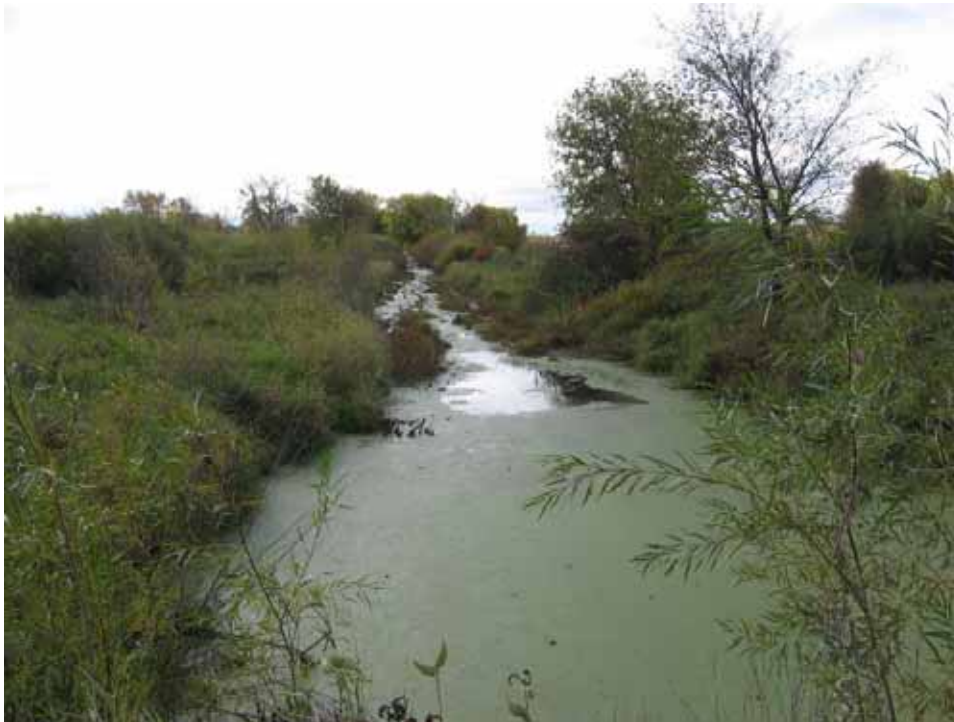
Upstream view of drainage ditch as seen from previous vantage point. Again, note the abundance of green algae.

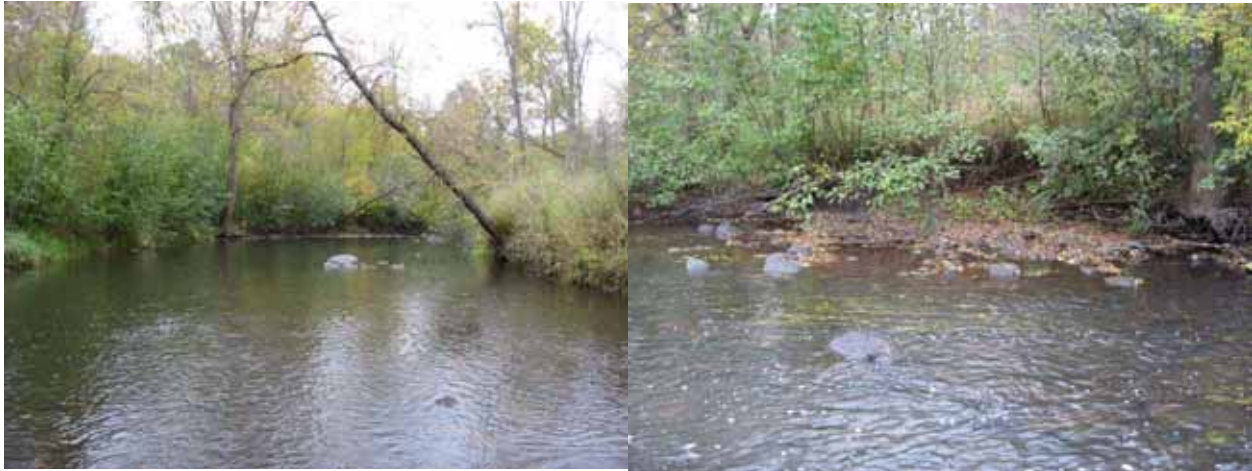
The lowermost site on the Mainstem Groundhouse River (06SC061) had one of the highest biological condition scores despite trends at other sites showing biological impairment with high nutrient levels and percent fines. Site 06SC061 is a larger stream channel with a complex riparian structure and instream substrate structure that provides a variety of physical refugia (Figure D-20). The cumulative impacts from pollutants on the biological community in large rivers do not appear to be as severe as individual effects from each pollutant on biological communities in smaller streams. Biota appear to be able to escape pollution impacts at the lowermost portion of the Groundhouse River (site 06SC061) despite the influence of these stressors in other portions of this drainage.

Figure D-20. Lower Mainstem of the Groundhouse River near site 06SC061 showing riparian condition and instream structure.

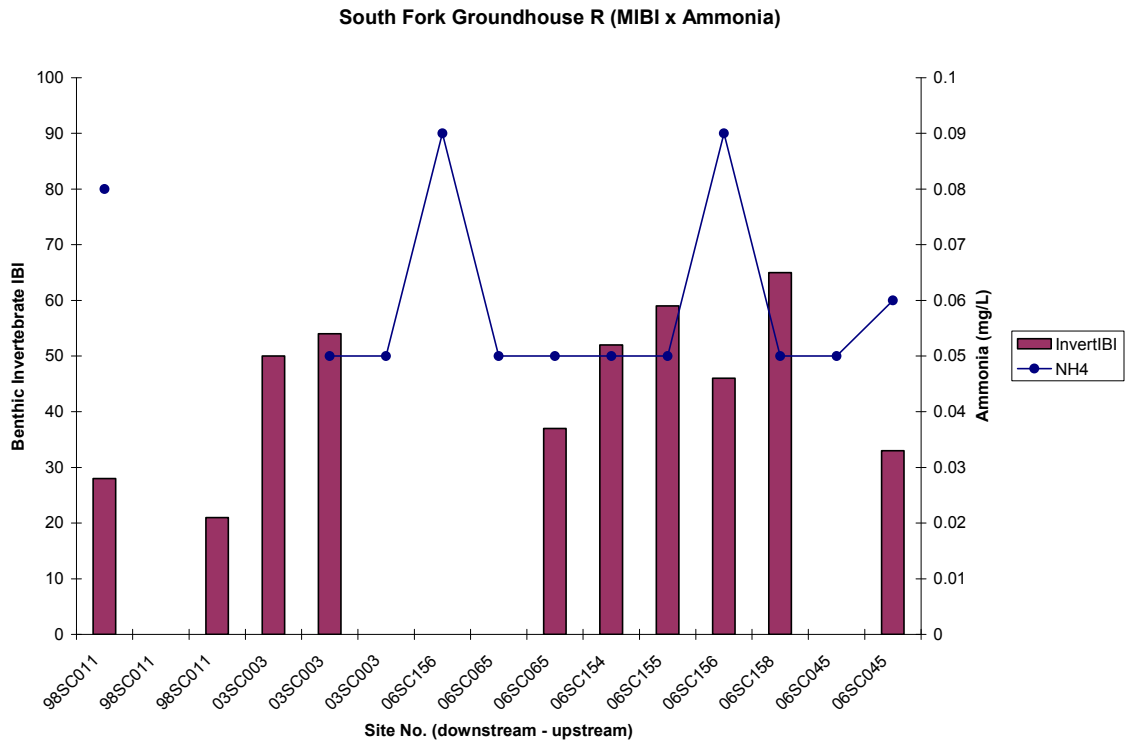
Figure D-21. Ammonia concentrations and MIBI scores along the Groundhouse River.

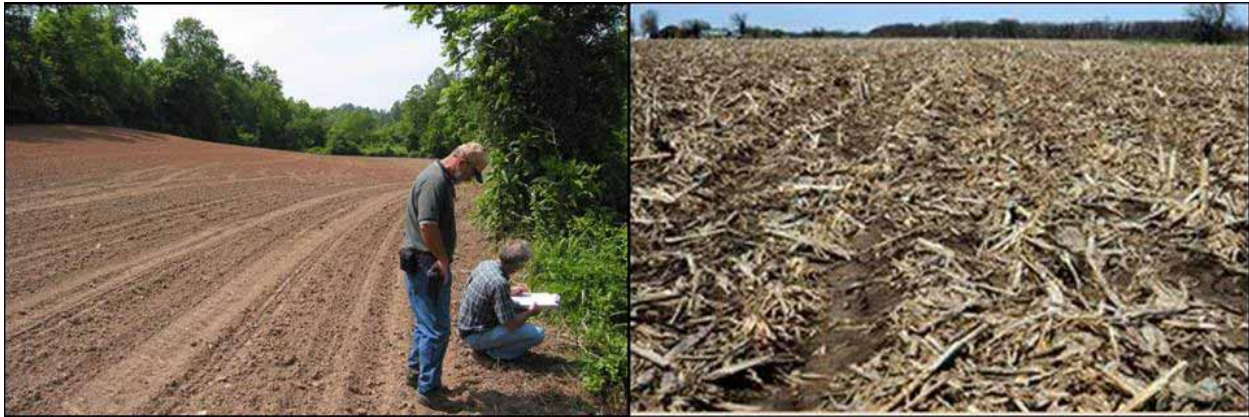
Corn residues are more durable and capable of sustaining the required 30 percent cover required for conservation tillage. Soybeans generate less residue, the residue degrades more quickly, and supplemental measures or special care may be necessary to meet the 30 percent cover requirement (UME, 1996). Figure 1 shows a comparison of ground cover under conventional and conservation tillage practices.

Figure 1. Comparison of Conventional (left) and Conservation (right) Tillage Practices

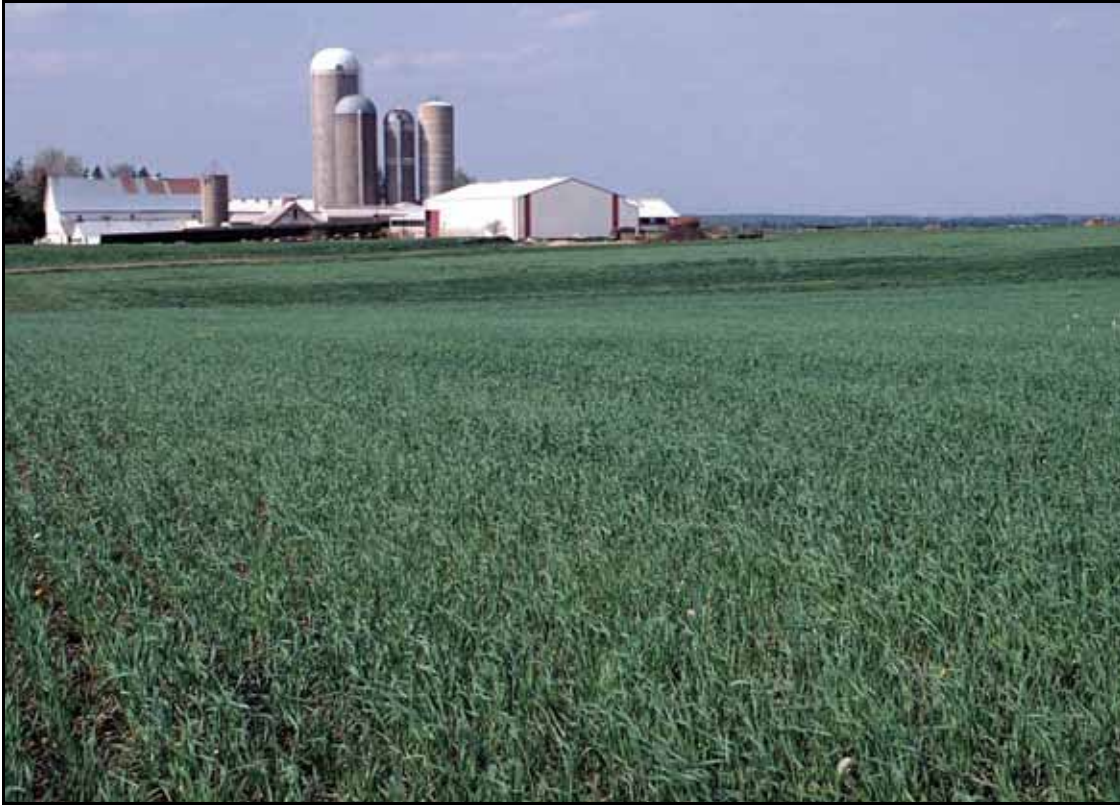
Grasses and legumes may be used as winter cover crops to reduce soil erosion and improve soil quality (IAH, 2002). These crops also contribute nitrogen to the following crop, reducing fertilizer requirements. Grasses tend to have low seed costs and establish relatively quickly, but can impede cash crop development by drying out the soil surface or releasing chemicals during decomposition that may inhibit the growth of a following cash crop. Legumes take longer to establish, but are capable of fixing nitrogen from the atmosphere, thus reducing nitrogen fertilization required for the next cash crop. Legumes, however, are more susceptible to harsh winter environments and may not have adequate survival to offer sufficient erosion protection. Planting the cash crop in wet soil that is covered by heavy surface residue from the cover crop may impede emergence by prolonging wet, cool soil conditions. Cover crops should be killed off two or three weeks prior to planting the cash crop either by application of herbicide or mowing and incorporation, depending on the tillage practices used. Use of cover crops is illustrated in Figure 2.

Figure 2. Use of Cover Crops

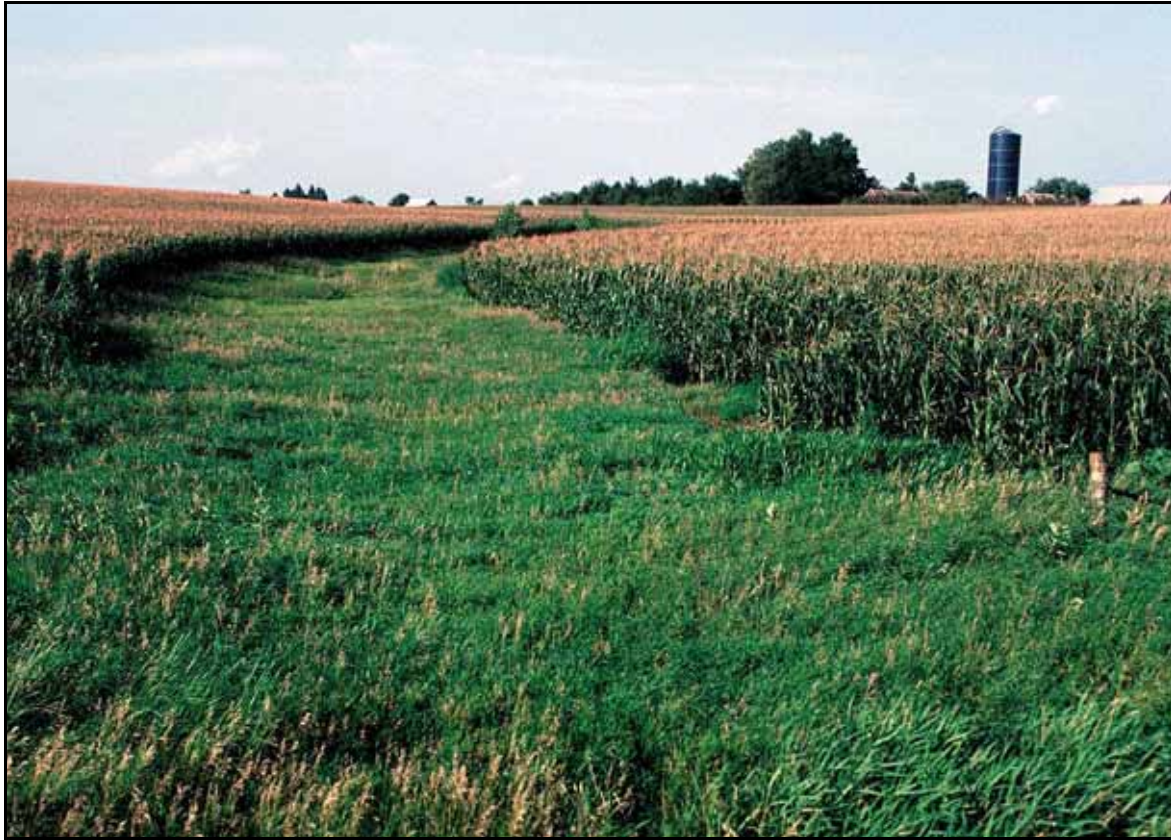
storage areas (NRCS, 2003). In addition, the grassed channel reduces runoff velocities, allows for some infiltration, and filters out some particulate pollutants. A grassed waterway providing surface drainage for a corn field is shown in Figure 4.

Figure 4. Grassed Waterway

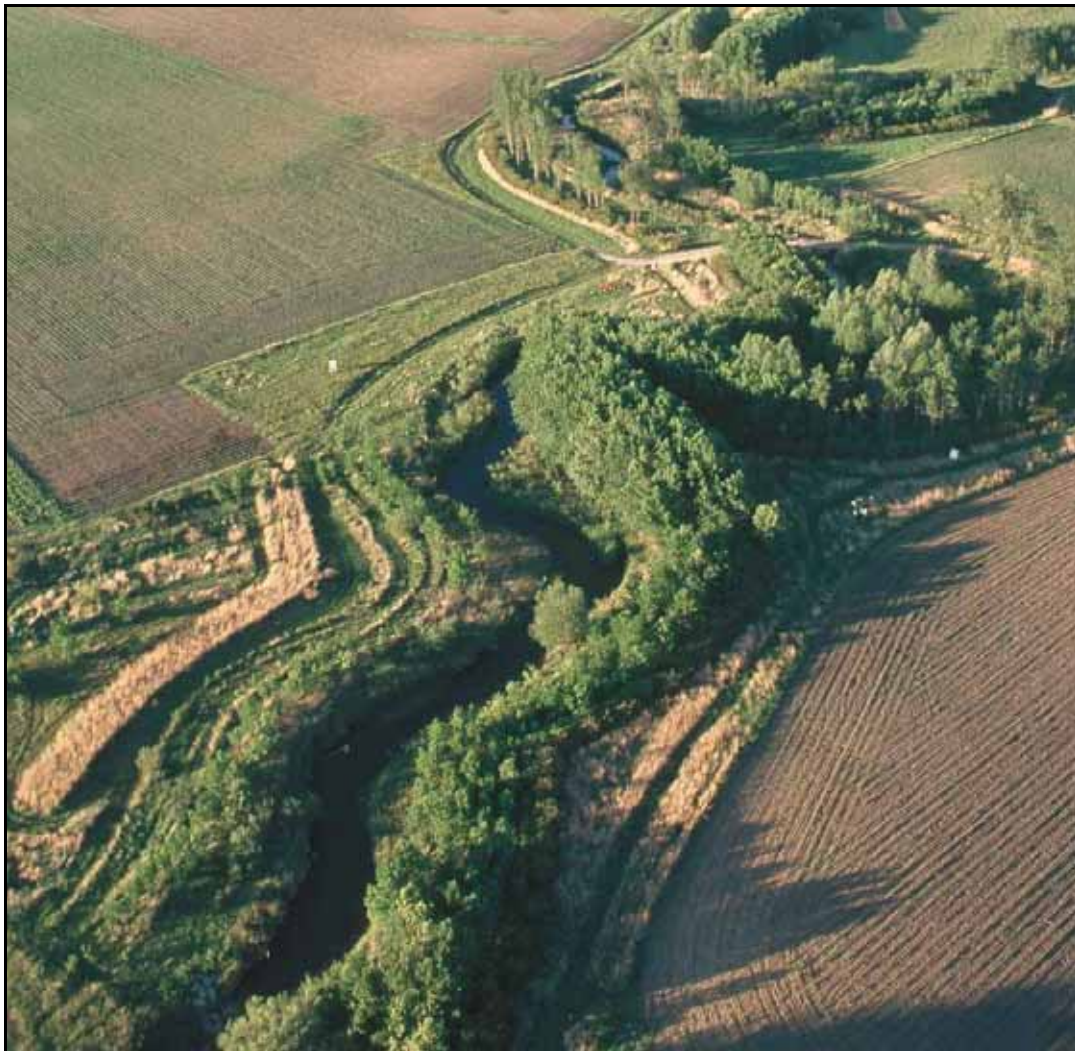
Even more important than the filtering capacity of the buffers is the protection they provide to streambanks. The rooting systems of the vegetation serve as reinforcements in streambank soils, which help to hold streambank material in place and minimize erosion. Riparian buffers also prevent cattle access to streams, reducing streambank trampling and defecation in the stream. Due to the increase in stormwater runoff volume and peak rates of runoff associated with agriculture and development, stream channels are subject to greater erosive forces during stormflow events. Thus, preserving natural vegetation along stream channels minimizes the potential for water quality and habitat degradation due to streambank erosion and enhances the pollutant removal of sheet flow runoff from developed areas that pass through the buffer. A riparian buffer protecting the stream corridor from adjacent agricultural areas is shown in Figure 5.

Figure 5. Riparian Buffer Between Stream Channel and Agricultural Areas

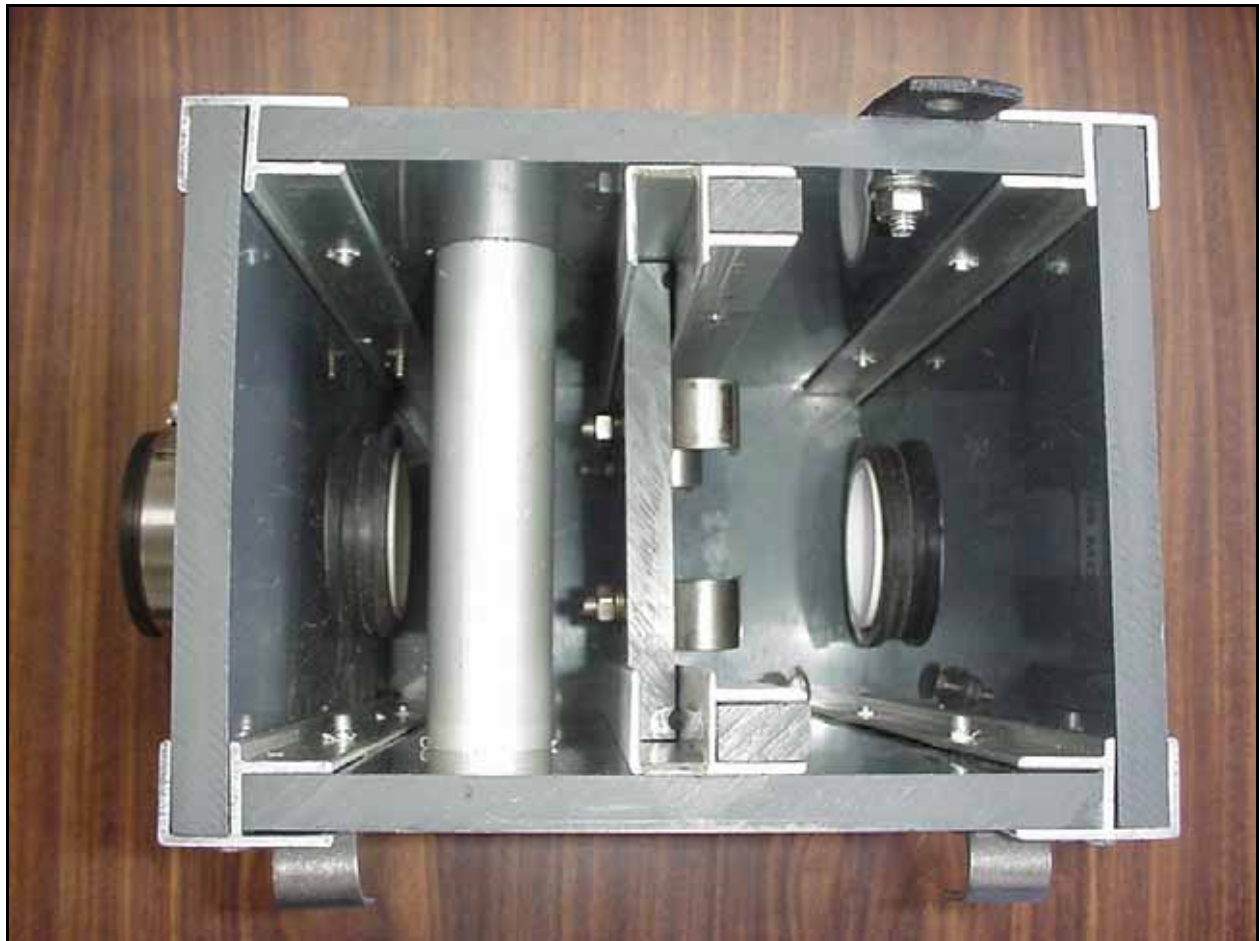
A conventional tile drain system collects infiltrated water below the root zone and transports the water quickly to a down-gradient surface outlet. Placement of a water-level control structure at the outlet (Figure 6 and Figure 7) allows for storage of the collected water to a predefined elevation. The stored water becomes a source of moisture for plants during dry conditions and undergoes biological, chemical, and physical processes that result in lower nutrient concentrations in the final effluent. Installation of outlet control structures can also be used to plug old farm ditches and restore wetland areas.

Figure 7. Interior View of a Drainage Control Structure with Adjustable Baffle Height

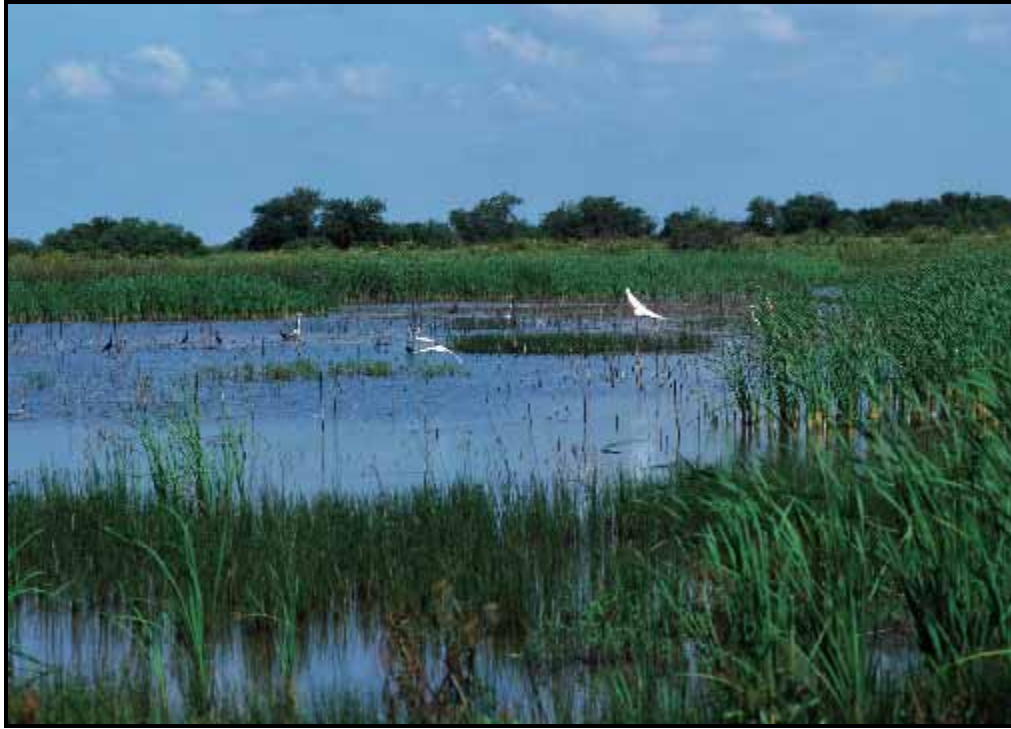
Wetland restoration is appropriate for areas that were historically functioning as a wetland environment, but were altered to accommodate other land uses, such as agriculture. Because wetlands are typically located between upland areas and receiving streams or rivers, they serve as natural filters for pollutants such as sediment and nutrients. They also provide habitat for wildlife and reduce peak flows in stream channels by storing flood waters. Natural or restored wetland areas should not be used to treat point or nonpoint pollution (USEPA, 2003); constructed wetlands may be created for this purpose, as discussed in Section 1.1.7 of the Groundhouse River TMDL Report. Figure 8 shows a restored wetland supporting wildlife in Iowa.

Figure 8. Restored Wetland Providing Wildlife Habitat

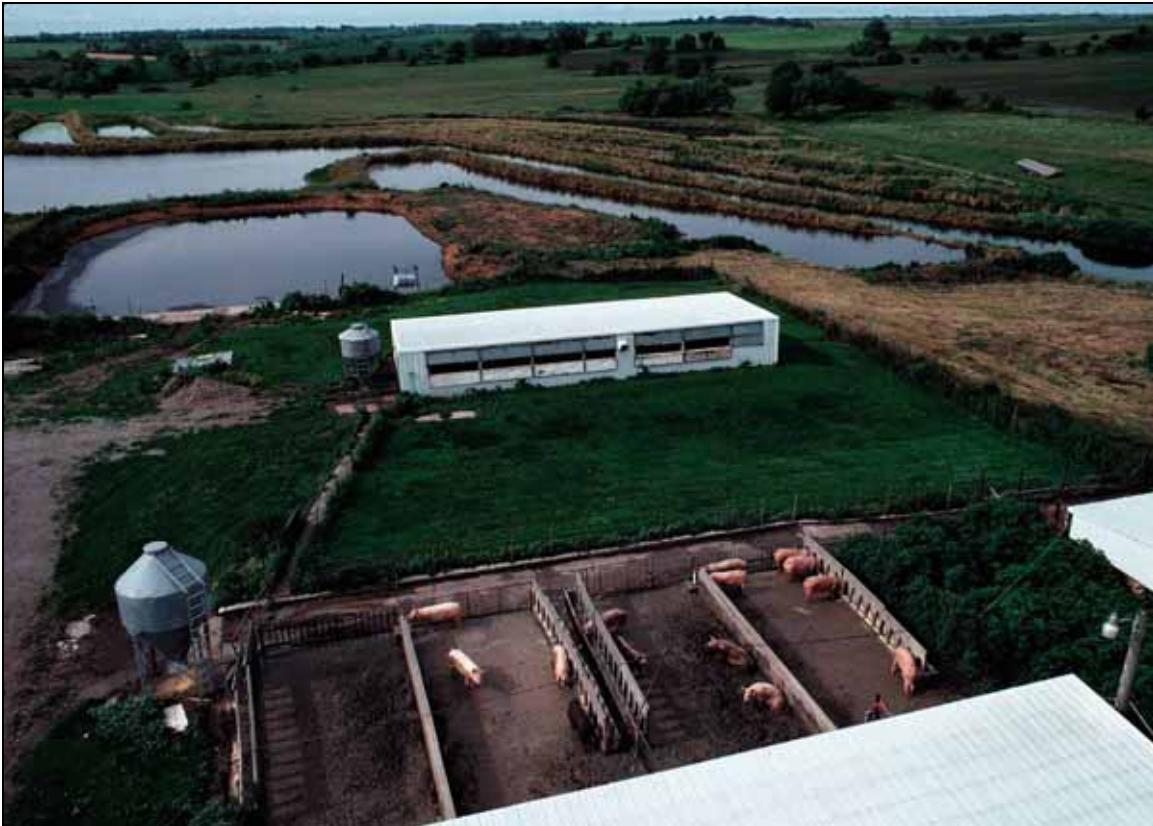
Constructed wetlands used to treat animal wastes are typically surface flowing systems comprised of cattails, bulrush, and reed plants. Prior to treating animal waste in a constructed wetland, storage in a lagoon or pond is required to protect the wetland from high pollutant loads that may kill the vegetation or clog pore spaces. After treatment in the wetland, the effluent is typically held in another storage lagoon and then land applied (USEPA, 2002a). Alternatively, the stored effluent can be used to supplement flows to the wetland during dry periods. Constructed wetlands that ultimately discharge to a surface waterbody will require a permit, and the receiving stream must be capable of assimilating the effluent during low flow conditions (NRCS, 2002). Figure 9 shows an example of a lagoon-wetland system.

Figure 9. Constructed Wetland System for Animal Waste Treatment
