Groundhouse River Total Maximum Daily Loads for Fecal Coliform and Biota (Sediment) Impairments

Final TMDL Report

March 2009

**Submitted by:
Tetra Tech**

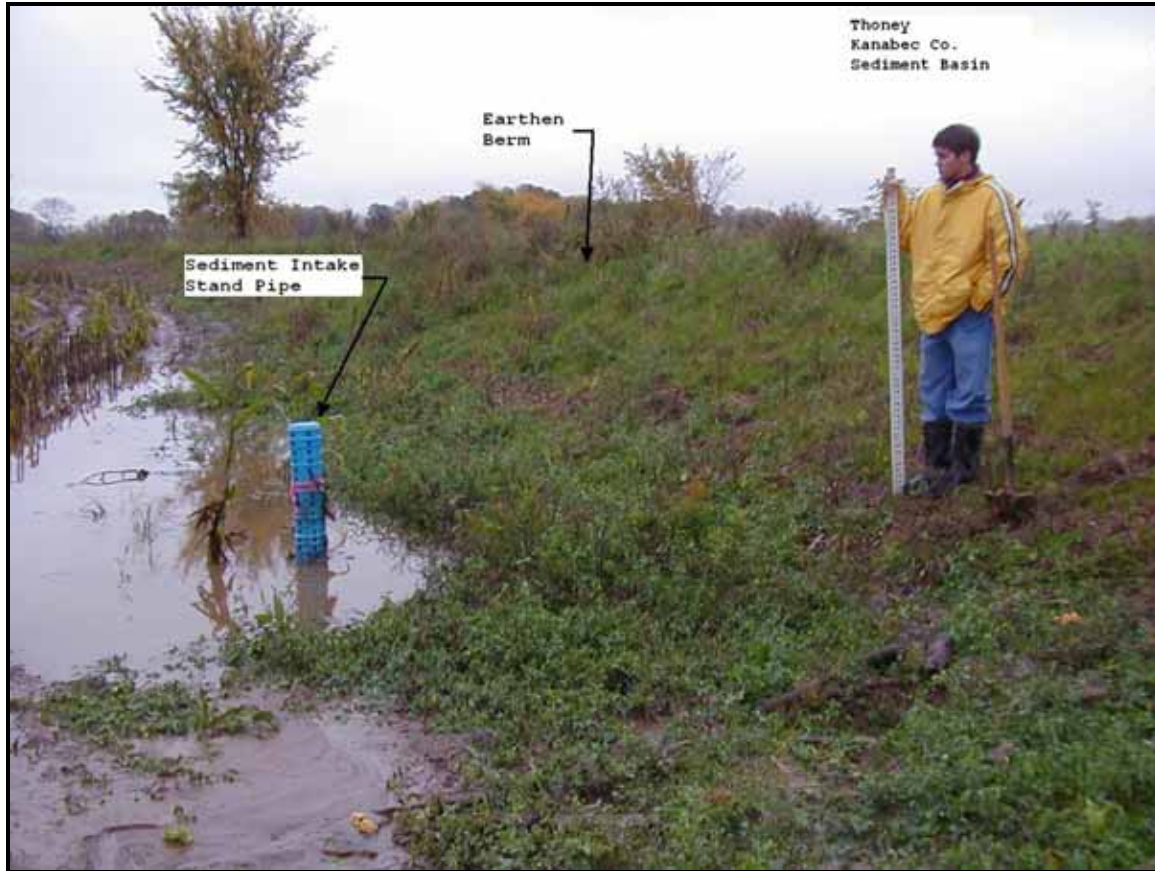
Sedimentation basins are used to settle out sediment and any attached pollutants before runoff leaves the field. They can also be used to protect wetlands from high levels of pollutant loading that may disturb the flow and water quality functions of the system. Basins need to be dredged periodically when the sediment storage capacity is full. A sedimentation basin constructed in Kanabec County is shown in Figure 10.

Figure 10. Sedimentation Basin

Not many studies report the costs of constructing and maintaining sedimentation basins draining agricultural areas. Data from a study in Indiana (Richardson, 2003) indicate that the annual costs of constructing and maintaining sedimentation basins is \$33.50 per acre of agriculture per year. The local project shown in Figure 10 was constructed for \$10,850 and treats 23 acres of crop land. Assuming a system life of 20 years, the annualized construction costs are approximately \$24/ac/yr (this does not include maintenance costs).

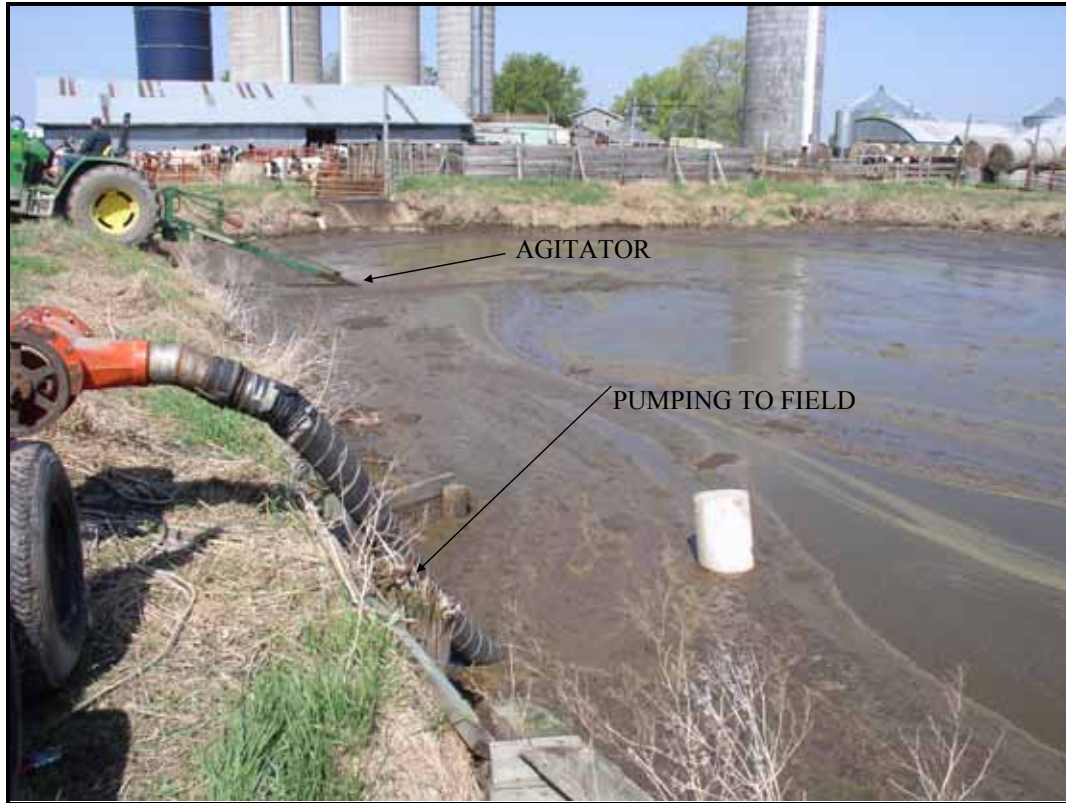
A photo of an earthen manure storage pit taken by the Kanabec County Soil and Water Conservation District is shown in Figure 11.

Figure 11. Earthen Manure Storage Pit

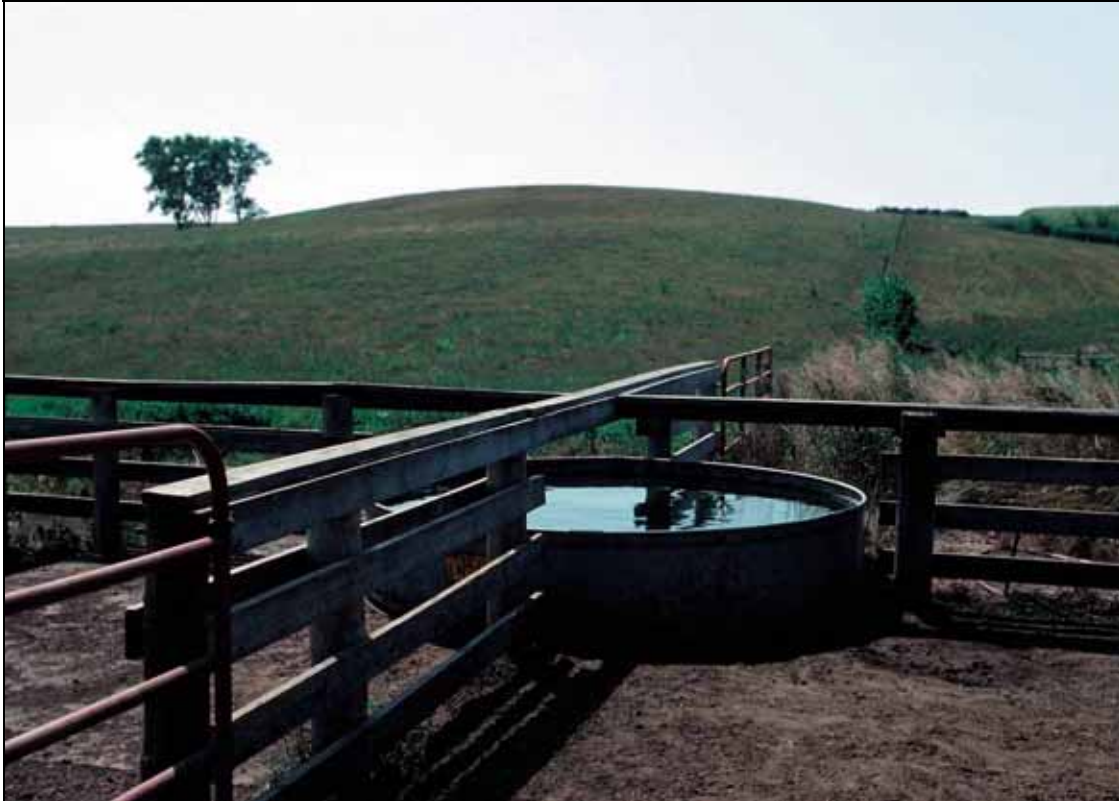
exclude cattle from streams and riparian areas. One method of providing an alternative water source is the development of off-stream watering using wells with tank or trough systems. These systems are often highly successful, as cattle often prefer spring or well water to surface water sources. Figure 13 shows a centralized watering tank allowing access from rotated grazing plots and a barn area.

Figure 13. Centralized Watering Tank

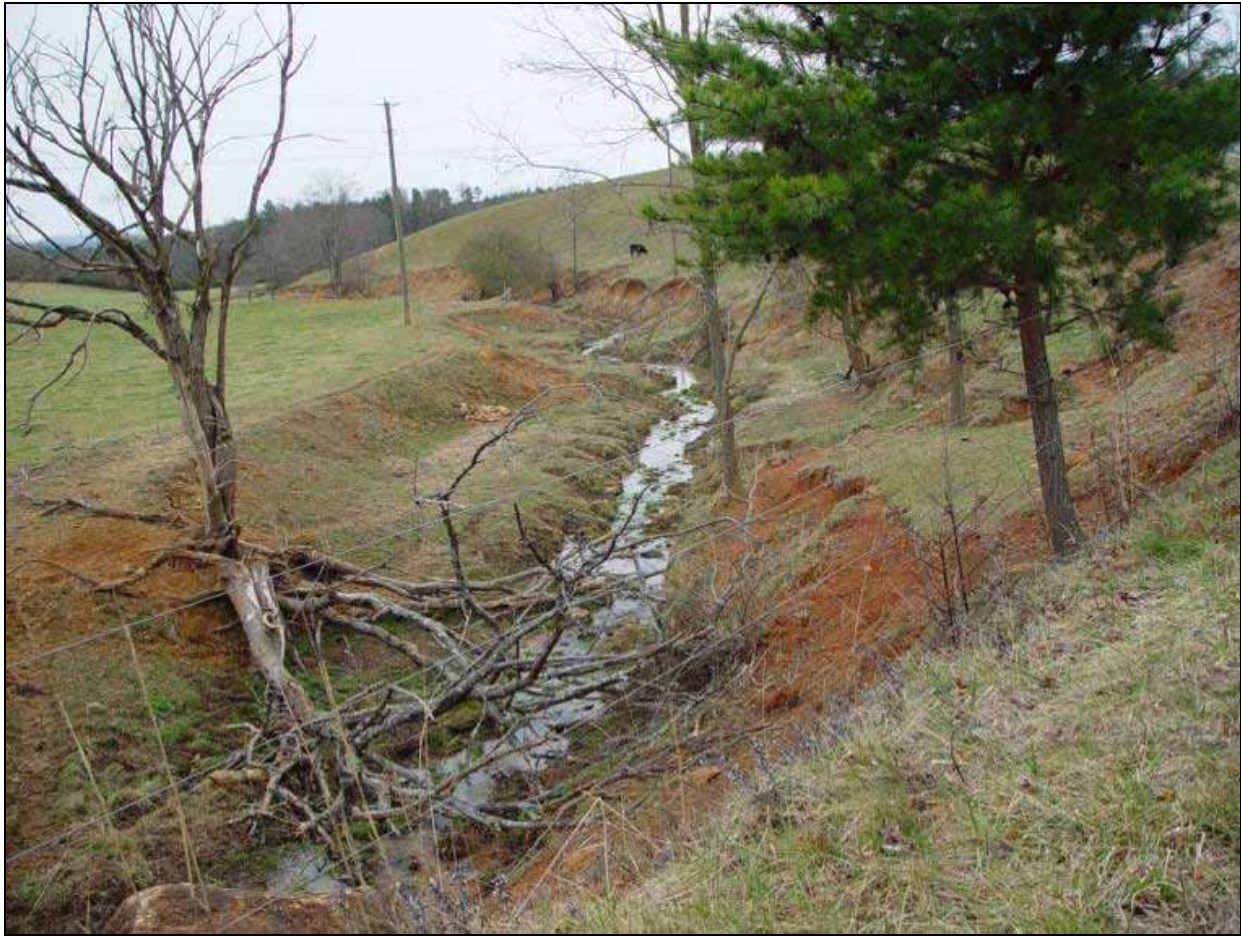
Cattle manure is a substantial source of nutrient and fecal coliform loading to streams, particularly where direct access is not restricted and/or where cattle feeding structures are located adjacent to riparian areas. Direct deposition of feces into streams may be a primary mechanism of pollutant loading during baseflow periods. During storm events, overbank and overland flow may entrain manure accumulated in riparian areas resulting in pulsed loads of nutrients, total organic carbon (TOC), biological oxygen demand (BOD), and fecal coliform bacteria into streams. In addition, cattle with unrestrained stream access typically cause severe streambank erosion. The impacts of cattle on stream ecosystems are shown in Figure 14 and Figure 15.

Figure 14. Typical Stream Bank Erosion in Pastures with Cattle Access to Stream

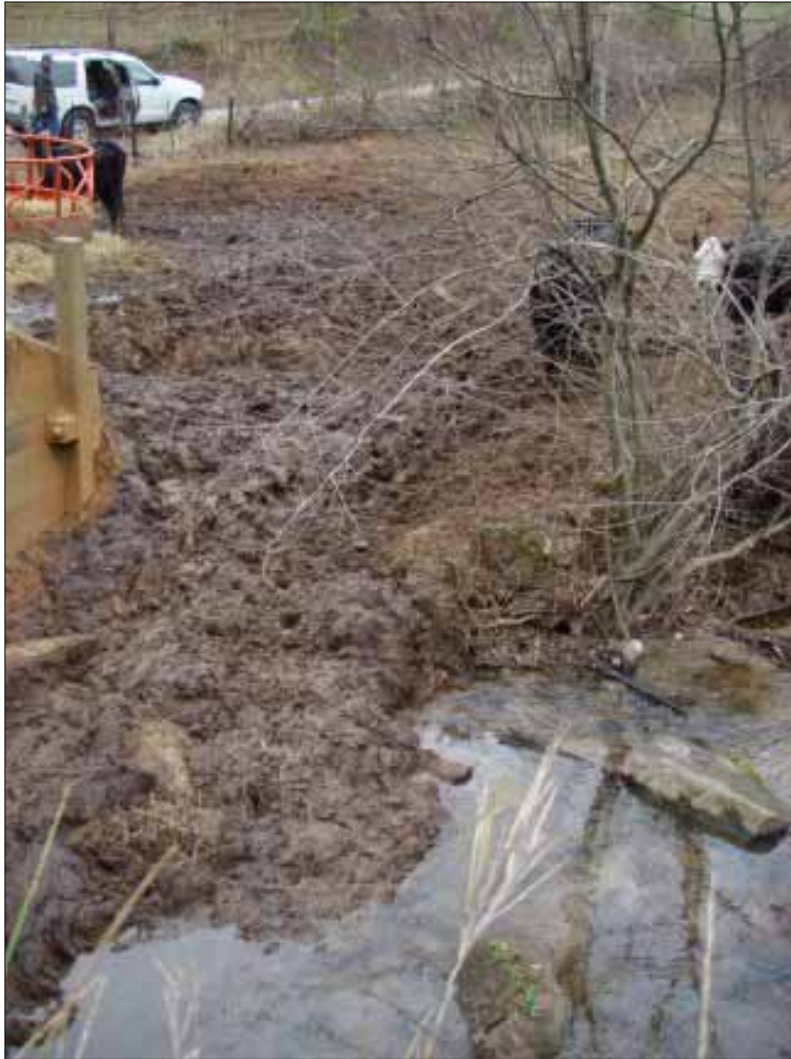
Figure 15. Cattle-Induced Streambank Mass Wasting and Deposition of Manure into Stream

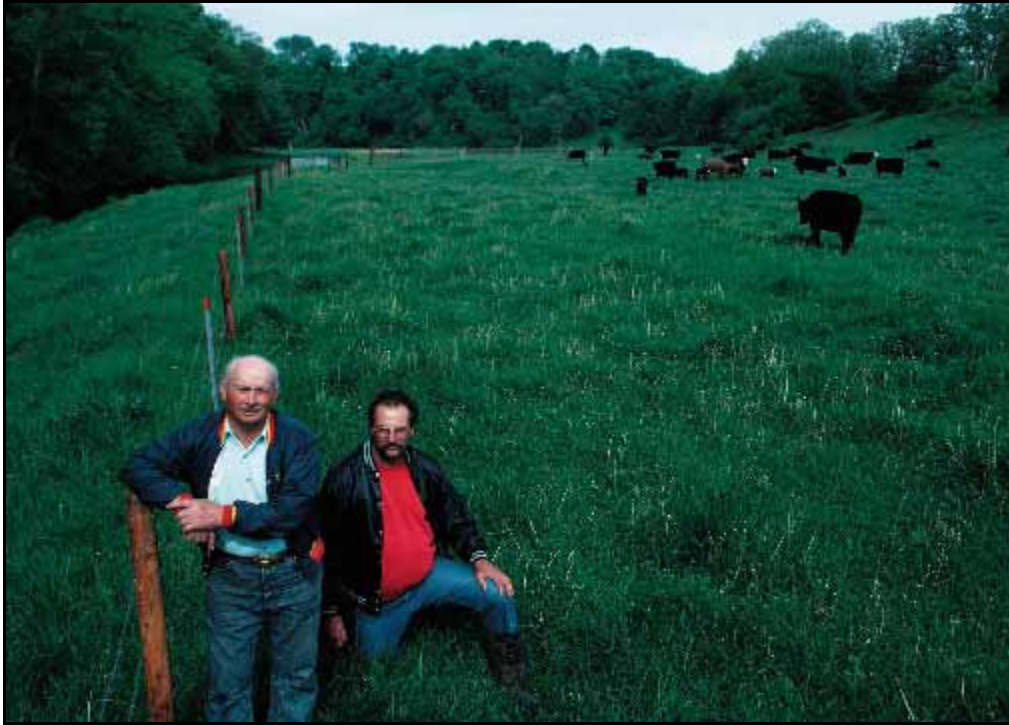
An example of proper exclusion and the positive impacts on the stream channel are shown in Figure 16.

Figure 16. Stream Protected from Cattle by Fencing

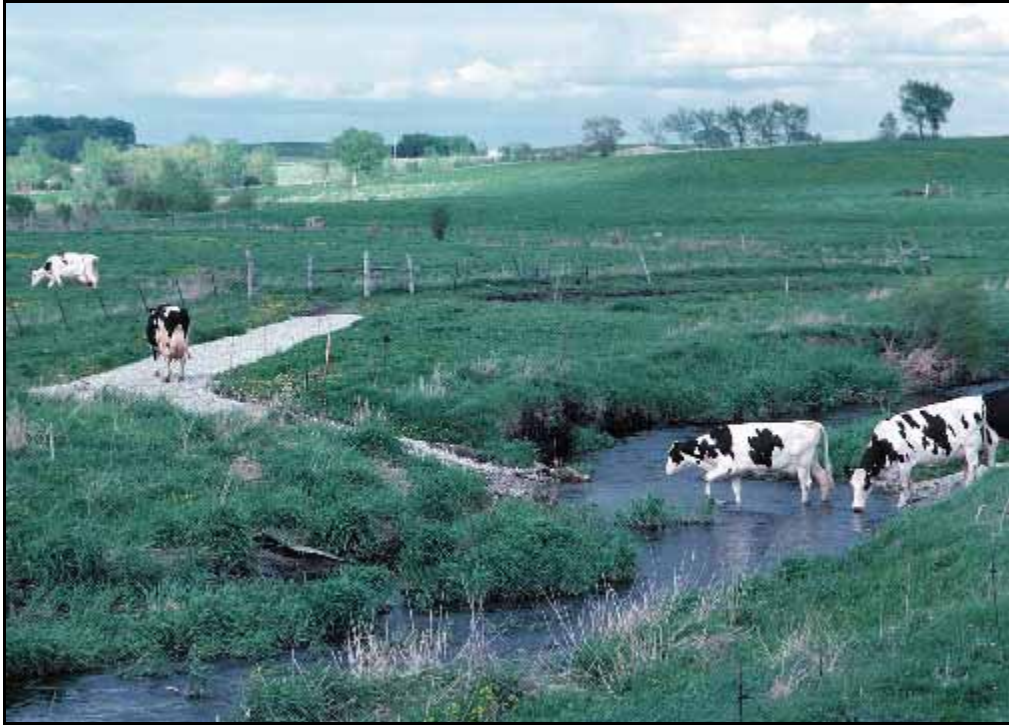
Allowing limited or no animal access to streams will provide the greatest water quality protection. On properties where cattle need to cross streams to have access to pasture, stream crossings should be built so that cattle can travel across streams without degrading streambanks and contaminating streams with manure. Figure 17 shows an example of a reinforced cattle access point to minimize time spent in the stream and mass wasting of streambanks.

Figure 17. Restricted Cattle Access Point

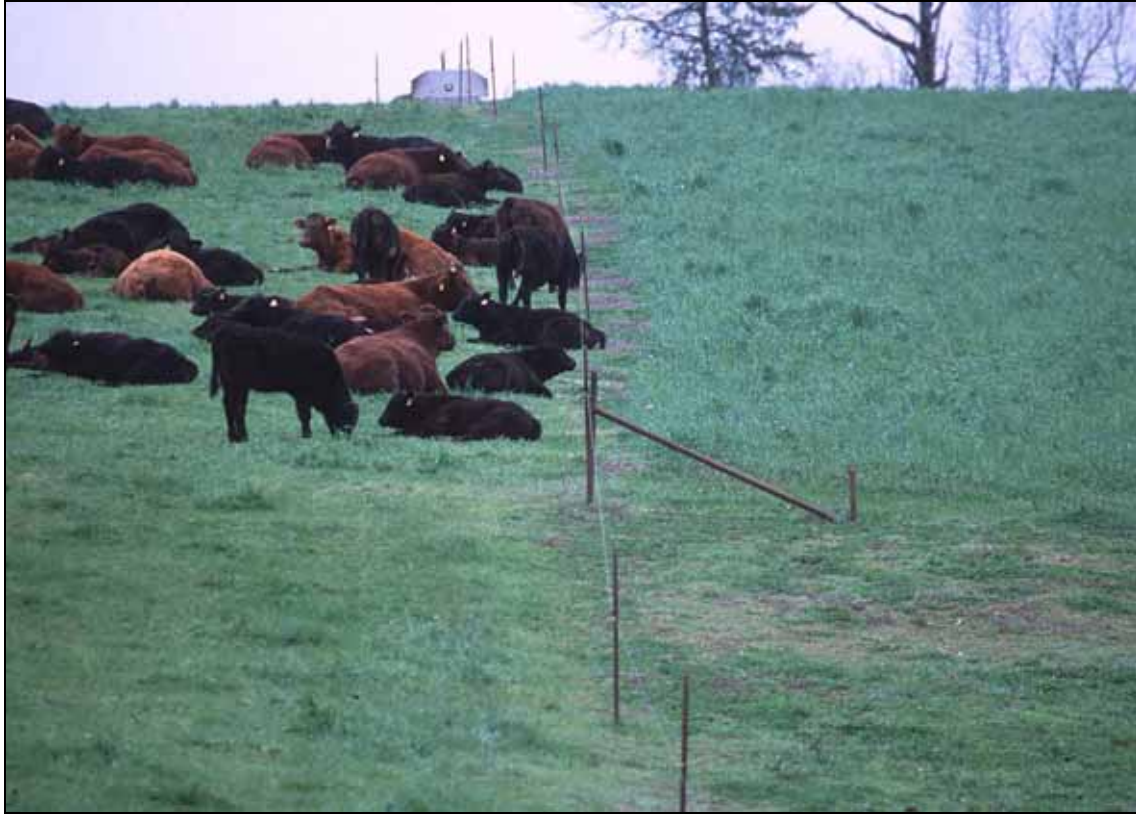
While erosion rates from pasture areas are generally lower than those from row-crop areas, a poorly managed pasture can approach or exceed a well-managed row-crop area in terms of erosion rates. Grazing land protection is intended to maximize ground cover on pasture, reduce soil compaction resulting from overuse, reduce runoff concentrations of nutrients and fecal coliform, and protect streambanks and riparian areas from erosion and fecal deposition. Figure 18 shows an example of a pasture managed for land protection. Cows graze the left lot while the right lot is allowed a resting period to revegetate.

Figure 18. Example of a Well Managed Grazing System
