Bluff Creek Watershed

Total Maximum Daily Load Implementation Plan: Turbidity and Fish Bioassessment Impairments

**Submitted by:
Barr Engineering Company**

Final Report—July, 2013

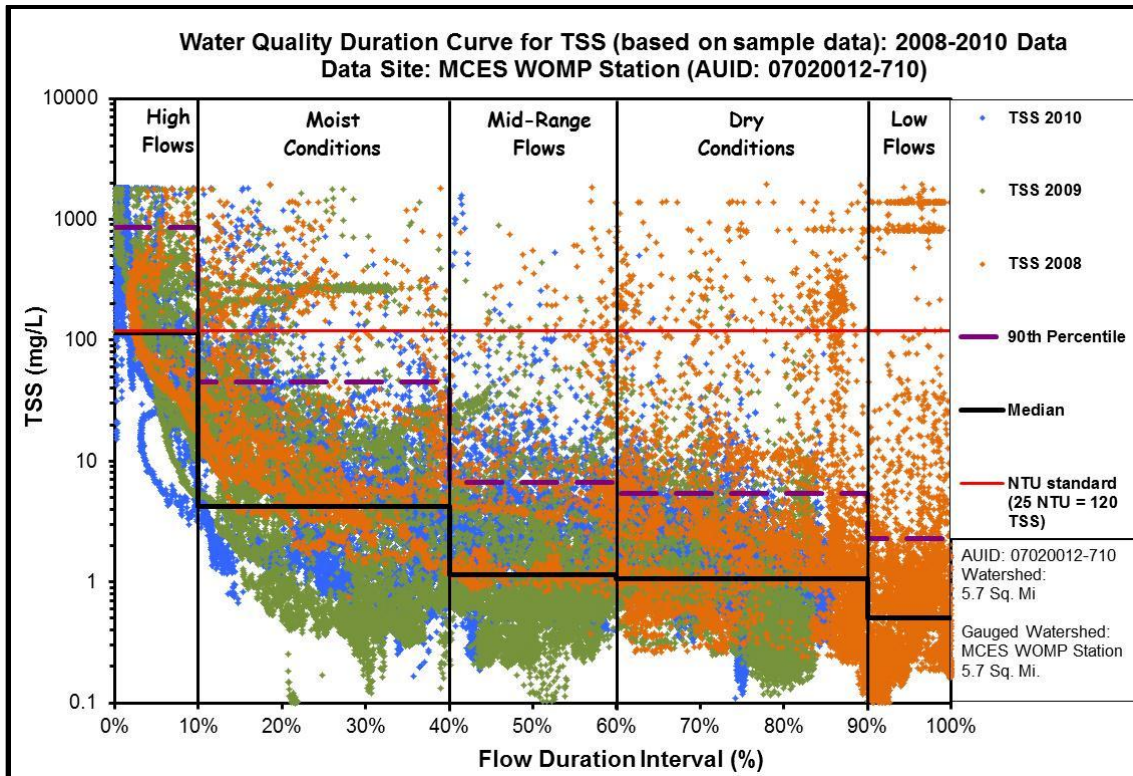
Figure 2.2 Water quality duration curve 2008-2010 (AUID: 07020012-710)

As indicated in [Figures 2.1 and 2.2](#), the monitored 90th percentile TSS loading is above the NTU standard for all of the combined years under the high flow conditions, while the moist conditions, mid-range, dry and low flows are below the standard in all years. As a result, the high flow condition is the only flow for which a TMDL must be developed and this indicates that loading reductions are only needed under the high flow condition to meet the turbidity standard. No reductions would be required under the other four flow conditions. As discussed in [Section 2.3.1](#), the total daily load capacity for the entire Bluff Creek reach was 8.22 tons/day for the high flow condition and was allocated to each of the individual TSS sources in [Table 2.1](#). Since the 90th percentile TSS concentration over the three year monitoring period ([Figure 2.2](#)) was 892 mg/L for the high flow condition, this translates to a loading rate of 61.1 tons/day and would require an approximately 87%

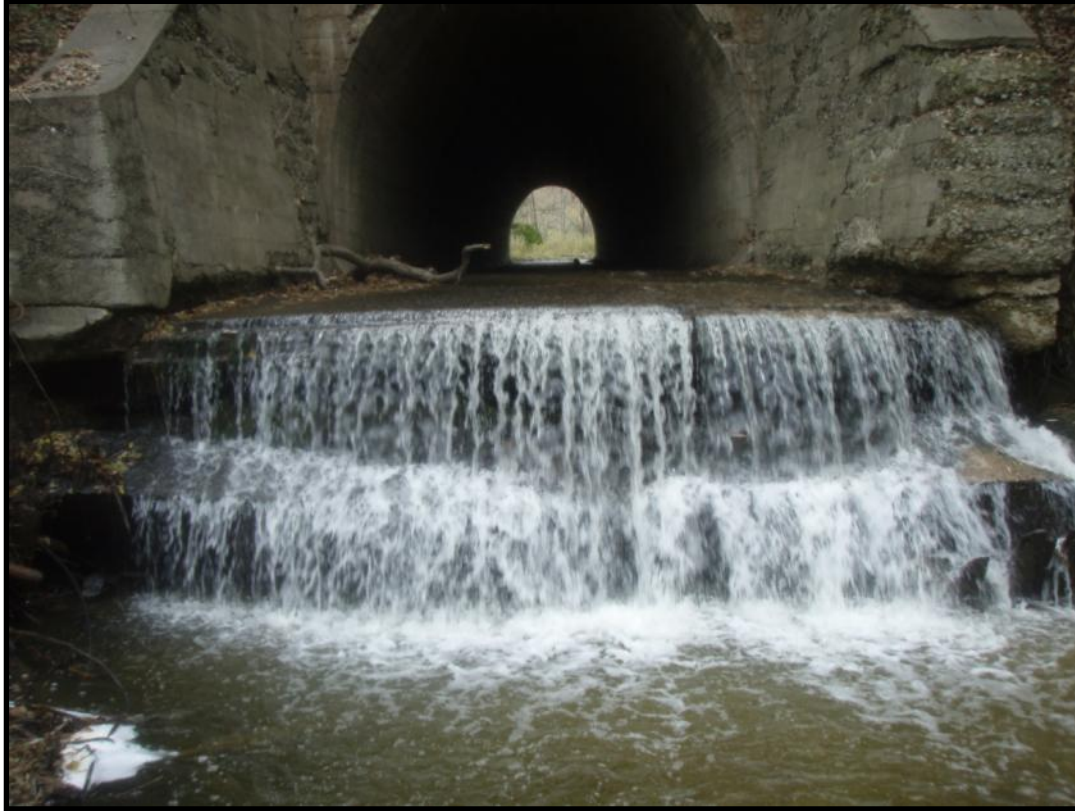
Habitat fragmentation is considered a possible stressor because a large drop at the downstream end of the regional trail culvert ([Figure 3.1](#)) interrupts the connectivity of Bluff Creek. This interruption of connectivity prevents passage of fish between upstream and downstream reaches of Bluff Creek. Such isolation may increase mortality due to separation from food sources and prevent replenishment of the species when disease or other stressors reduce the population. Isolation may lead to the demise of a fishery, including extinction (Letcher et al., 2007). Evaluation of Bluff Creek stream reaches upstream and downstream of the culvert indicates upstream reaches were impaired while a downstream reach was not impaired. The data indicate habitat fragmentation has adversely impacted Bluff Creek's fishery and has resulted in impairment of stream reaches located upstream of the culvert (Barr Engineering Company, 2010).

Figure 3.1 Large drop at downstream end of regional trail culvert (looking upstream)

Design and construction of a ramp structure at the culvert outlet is recommended to provide fish passage, thus removing the habitat fragmentation stressor in Bluff Creek. Further details on the design and construction of this fish passage are given in [Section 4.1.1.1](#).

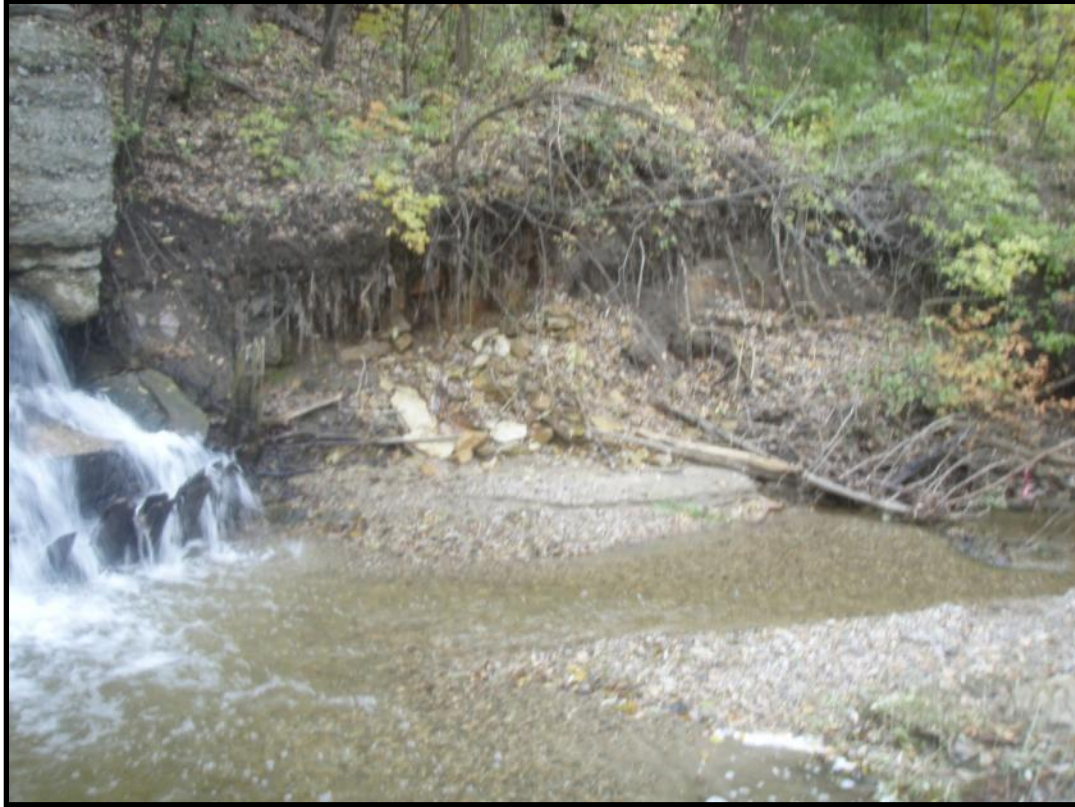
High flows were identified as a stressor to the stream's biological community because of its interaction with sediment, metals, and habitat fragmentation. High flows not only increase sediment and metals loading to Bluff Creek, but also exacerbate the stress to the biological community caused by habitat fragmentation. High flows move fish downstream from the regional trail culvert and habitat fragmentation prevents the fish from returning to the upstream location and replenishing the fish community. To prevent the current problem from worsening with future development, it was recommended that management measures to prevent anthropogenic flow increases should be employed now and in the future (Barr Engineering Company, 2010).

Figure 3.2 Eroding left stream bank immediately downstream of culvert outlet

Problems with high flow could be addressed by achieving the same goals discussed previously: sediment TMDL wasteload and load reductions through this TMDL and designing and constructing a ramp structure at the culvert outlet. Sediment load reduction would remove both sediment and metals as stressors to Bluff Creek. Fish passage at the culvert outlet would remove habitat fragmentation as a stressor. Because flow is only a problem when high flows interact with these stressors, removal of the stressors would also eliminate high flows as a stressor to Bluff Creek. Reductions in anthropogenic high flow rates could also be achieved through general stormwater practices. Placement of detention/infiltration BMPs to manage stormwater runoff would decrease the peak flow rates reducing high flow as a stressor.

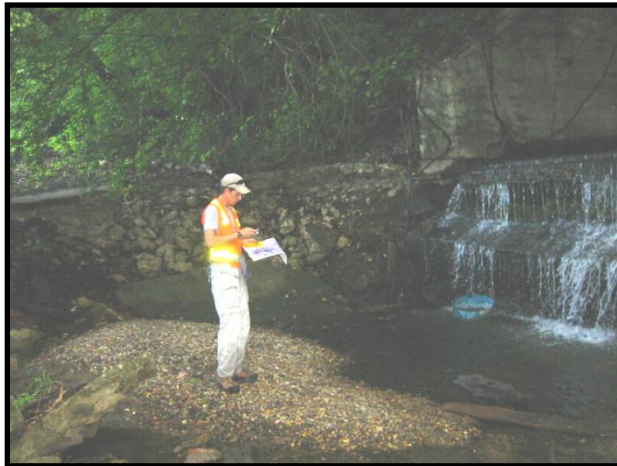
This site includes the downstream end of the regional trail crossing culvert and an eroded bank immediately downstream of the culvert. The stream channel has downcut significantly below the culvert, and the culvert is being undermined. Left unchecked, the culvert may begin to fail. The large drop at the downstream end of the culvert prevents fish passage to upstream reaches (see [Figure 4.2](#) and [Figure 4.3](#)).

Figure 4.2 Large drop and undermining at downstream end of regional trail culvert (Site 1)

Evaluate the structural condition of the culvert and make necessary repairs to prevent further undermining, including a rock energy dissipation structure. Evaluate existing vegetation and thin trees where possible to provide greater sunlight to ground vegetation. Grade eroded banks, add toe protection to prevent further undercutting and plant with native plantings.

Habitat fragmentation should be addressed at the downstream end of the regional trail crossing culvert by designing and constructing a ramp structure to provide fish passage. The ramp could be constructed of either concrete or natural rock material. Natural rock material is recommended as it would offer greater flexibility, be less susceptible to scour or undercutting, and would be more aesthetically appealing. The first step in the fish passage project is completion of a concept level design of the ramp, which would include the collection of existing site information, detailed site topographical survey, structural evaluation of the culvert, development of design sketches and a conceptual-level cost estimate. This phase would include initial discussion with agency representatives.

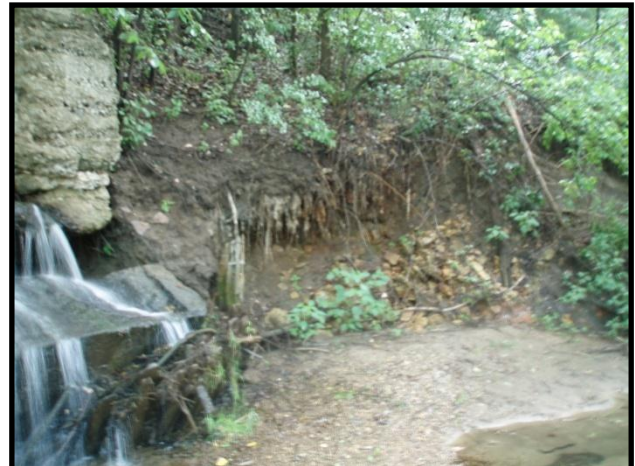
Figure 4.3 Large bank failure downstream of culvert outlet on left bank (Site 1)

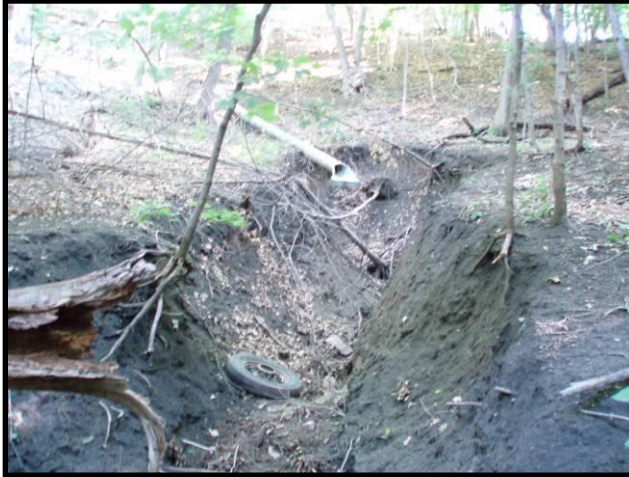
Site 2 consists of an approximately 1,000-foot long main ravine with a 600-foot long side ravine on the north side of the valley. The main ravine receives drainage via a corrugated metal pipe from Mandan Circle, with severe erosion below the discharge point. A large sand deposit exists about halfway down the main ravine. The tributary ravine receives drainage from MN TH 101 and has numerous sub-tributary ravines (see [Figure 4.4](#) and [Figure 4.5](#)).

Figure 4.4 Large Headcut in Main Ravine Below Pipe Outlet from Mandan Circle (Site 2)

Review condition and design of storm sewer pipe from Mandan Circle, and, at a minimum, provide energy dissipation (such as riprap) at pipe outlet. Provide grade control stabilization of main ravine and tributary ravine after watershed flows have been controlled. Evaluate existing vegetation and thin trees where possible to provide greater sunlight to ground vegetation. Grade steep banks and plant with native plantings.

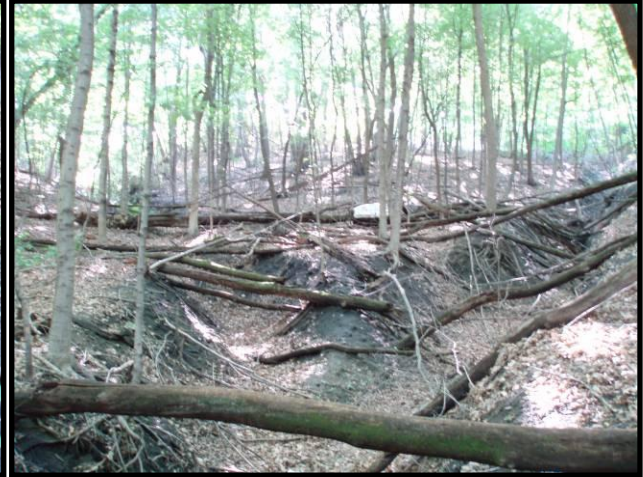
Figure 4.5 Tributary Ravine with Exposed Tree Roots (Site 2)

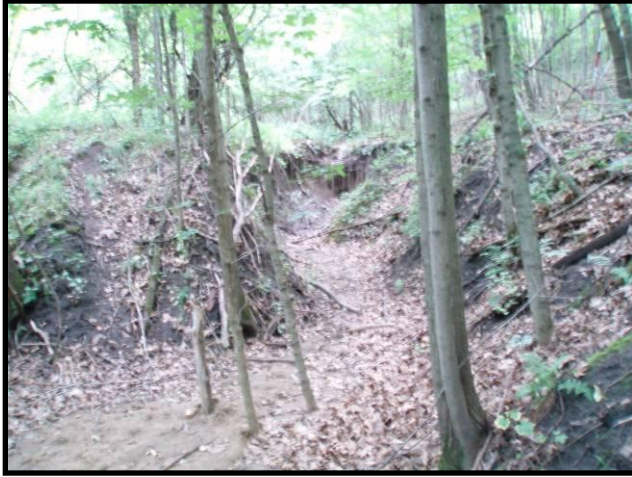
Site 3 consists of an approximately 850-foot long main ravine on the north side of the valley with moderate erosion. The ravine receives drainage from an 18-inch corrugated metal pipe from Creekwood Drive. The pipe conveys discharge from a pond on the north side of Creekwood Drive. There are several headcuts along the ravine, but no severe slope failures. A sand deposit is present at the bottom of the ravine (see [Figure 4.6](#) and [Figure 4.7](#)).

Figure 4.6 Headcut Followed by Sand Deposit in Lower Part of Ravine (Site 3)

Review condition and design of storm sewer pipe from Creekwood Drive. Review design of pond outlet and provide extended detention outlet to reduce the frequency and magnitude of the high flows, if necessary. Provide energy dissipation at pipe outlet and grade control stabilization in the eroded ravine. Evaluate existing vegetation and thin trees where possible to provide greater sunlight to ground vegetation.

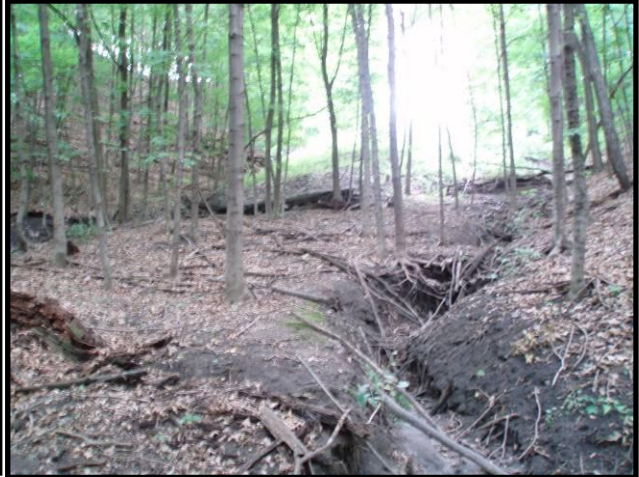
Figure 4.7 Headcutting in the Upper Part of the Ravine (Site 3)

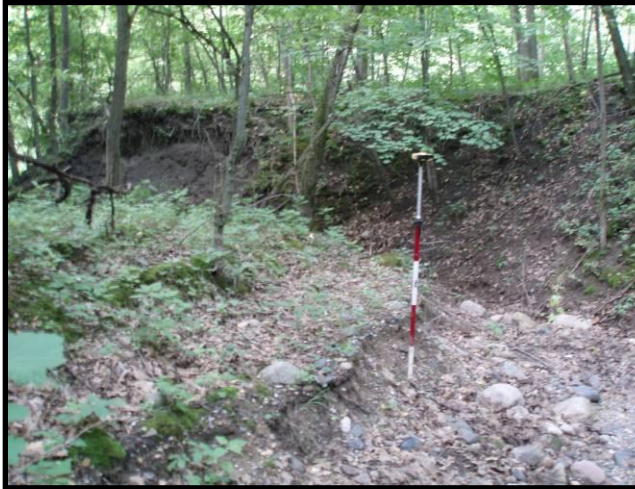
Site 4 has an approximately 750-foot long main ravine with a 600-foot secondary ravine on the north side of the valley. Main ravine has moderate erosion, while the secondary ravine requires additional investigation. The main ravine receives drainage from a 24-inch above-ground corrugated metal pipe that originates from the east end of the Bluff Creek Golf Course parking lot. The ravine bottom is well armored and fairly broad, with occasional slope failures along the banks (see [Figure 4.8](#) and [Figure 4.9](#)).

Figure 4.8 Well-armored channel bottom with occasional slope failures at lower part of ravine (Site 4)

Review condition and design of storm sewer pipe from adjoining property owner. Provide energy dissipation at pipe outlet and grade control stabilization in the eroded ravine. Evaluate existing vegetation and thin trees where possible to provide greater sunlight to ground vegetation.

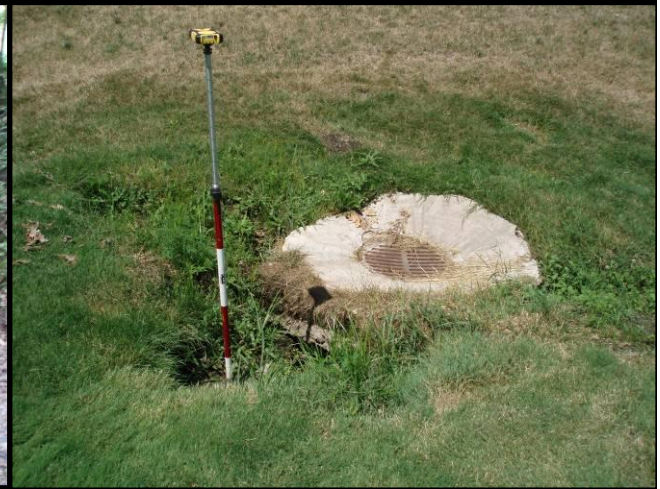
Figure 4.9 Pipe inlet in poor condition from east end of golf course parking lot (Site 4)

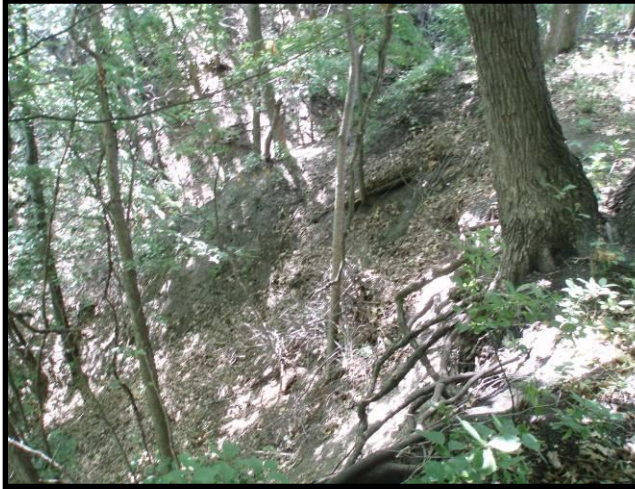
Site 5 consists of an approximately 500-foot long, steep ravine on the south side of the valley with minor erosion. This ravine has a small watershed, with Hesse Valley Road at the head of the ravine (see [Figure 4.10](#) and [Figure 4.11](#)).

Figure 4.10 Above view of short, steep ravine (Site 5)

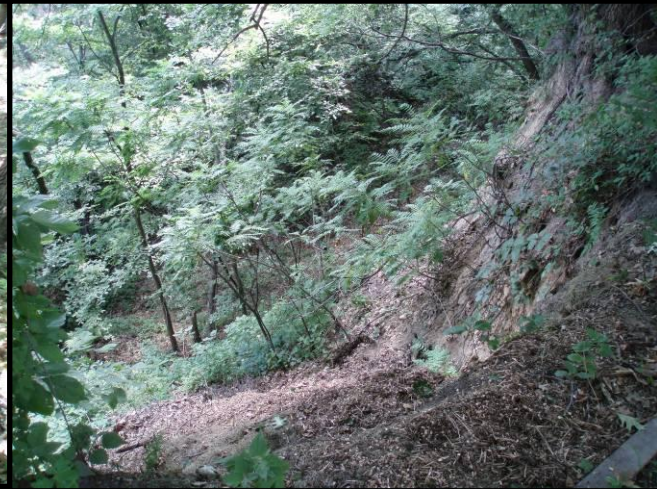
Figure 4.11 Yard waste dumping onto failed slope (Site 5)

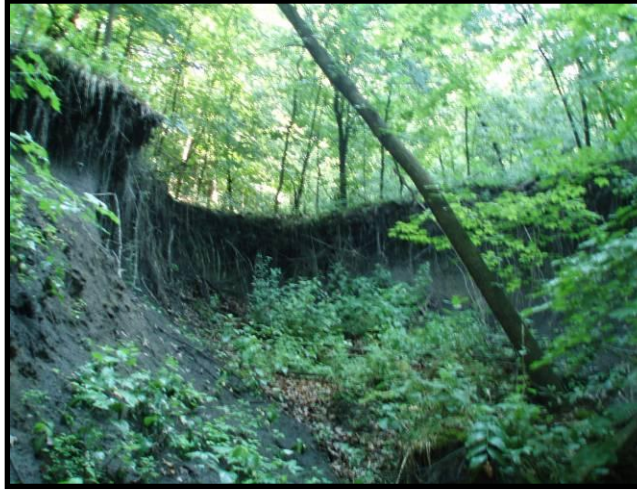
Site 6 consists of an approximately 600-foot long ravine on the north side of the valley with severe erosion. The ravine originates from a point approximately 150-feet south of the Bluff Creek golf course parking lot. The ravine is narrow and incised, with a significant headcut approximately 1/3 distance from the bottom. Ravine terminates in a steep gully leading to the creek, with an adjacent failure on the creek bank (see [Figure 4.12](#) and [Figure 4.13](#)).

Figure 4.12 Large headcut in lower part of ravine (Site 6)

Review drainage and groundwater seepage of ravine to determine cause of erosion. Evaluate existing vegetation and thin trees where possible to provide greater sunlight to ground vegetation. Provide grade control and energy dissipation in ravine and provide better transition to Bluff Creek. Grade eroding banks and revegetate with native vegetation.

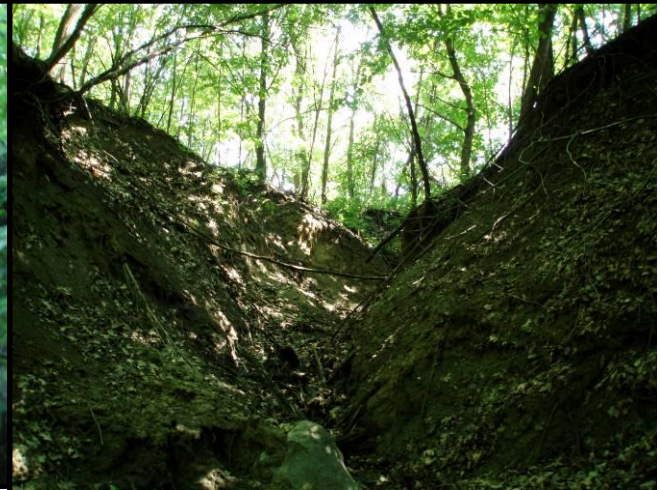
Figure 4.13 View of ravine (Site 6)

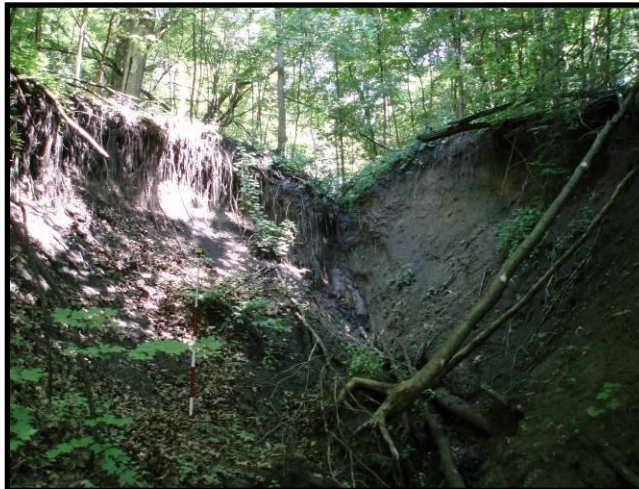
Site 7 consists of an approximately 700-foot long ravine on the north side of the valley with severe erosion. The mouth of the ravine is near that of Ravine 6, while the head of the ravine is approximately 300-feet west of the Bluff Creek golf course parking lot. The ravine is narrow and incised, with several significant headcuts. A 12-inch pipe drains to this ravine from the golf course. A trickle of surface water flow was observed, but groundwater seepage may also be a contributing factor. A sand deposit was observed at the bottom of the ravine near the creek (see [Figure 4.14](#) and [Figure 4.15](#)).

Figure 4.14 Large headcut in middle part of ravine (Site 7)

Review drainage and groundwater seepage of ravine to determine cause of erosion. Determine source of pipe drainage and possible stormwater detention options. Evaluate existing vegetation and thin trees where possible to provide greater sunlight to ground vegetation. Provide grade control and energy dissipation in ravine and groundwater control, in the form of horizontal or toe drains, as needed. Grade eroding banks and revegetate with native vegetation.

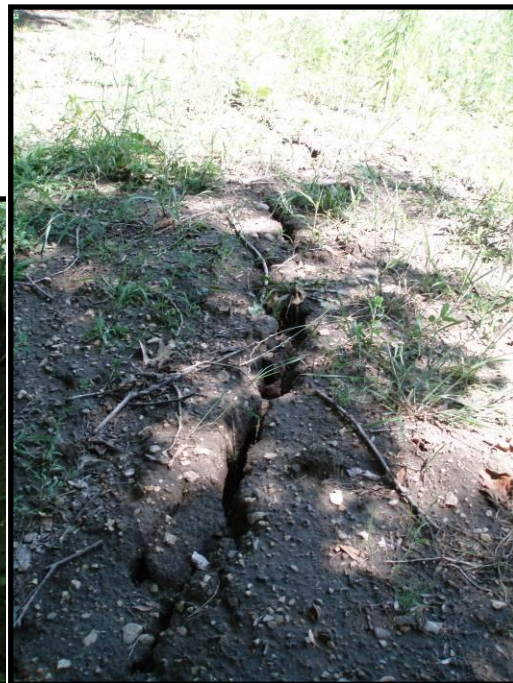
Figure 4.15 Crack foretelling impending slope failure (Site 7)

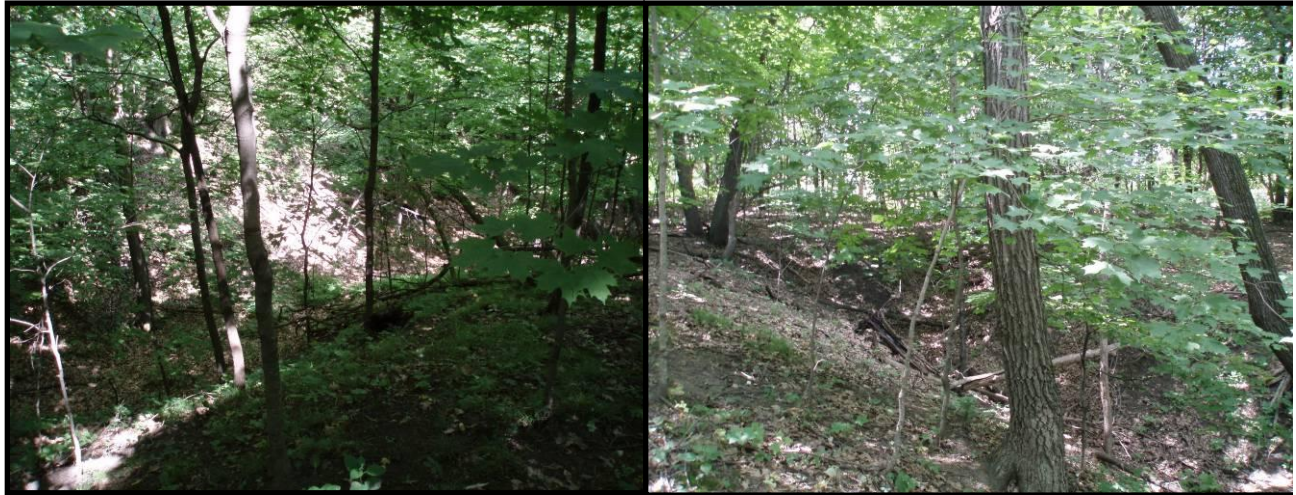
Site 8 consists of an approximately 500-foot long ravine on the south side of the valley with minor erosion. The ravine originates near Hesse Farm Road and has a small tributary watershed. Although it is steep, there is only minor erosion evident in this ravine (see [Figure 4.16](#) and [Figure 4.17](#)).

Figure 4.16 Above view of ravine (Site 8)

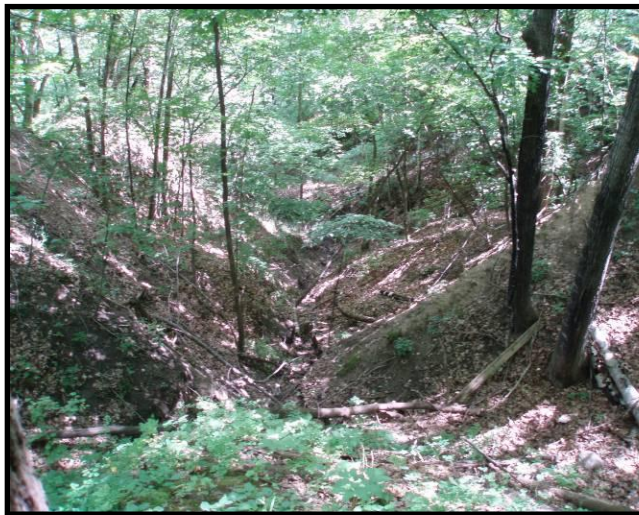
Site 9 consists of an approximately 400-foot long ravine on the south side of the valley with minor erosion. The ravine originates about 30-feet north of Hesse Farm Road and has a small tributary watershed. Although it is very steep, there is only minor erosion evident in this ravine (see [Figure 4.18](#) and [Figure 4.19](#)).

Figure 4.18 Above view of ravine (Site 9)

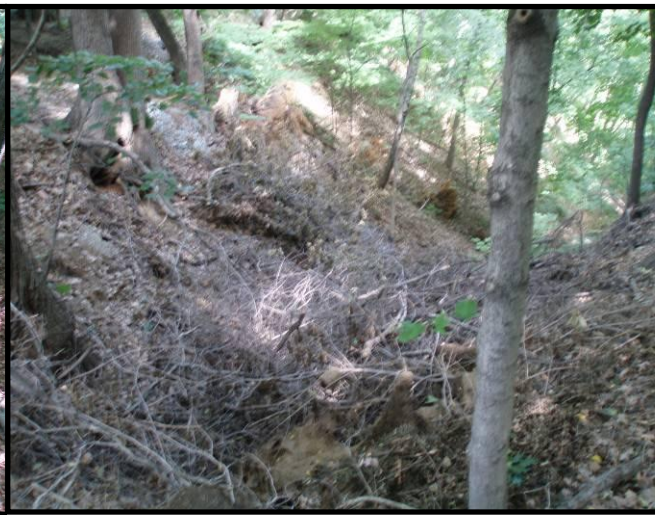
Figure 4.19 Yard waste dumping in ravine (Site 9)

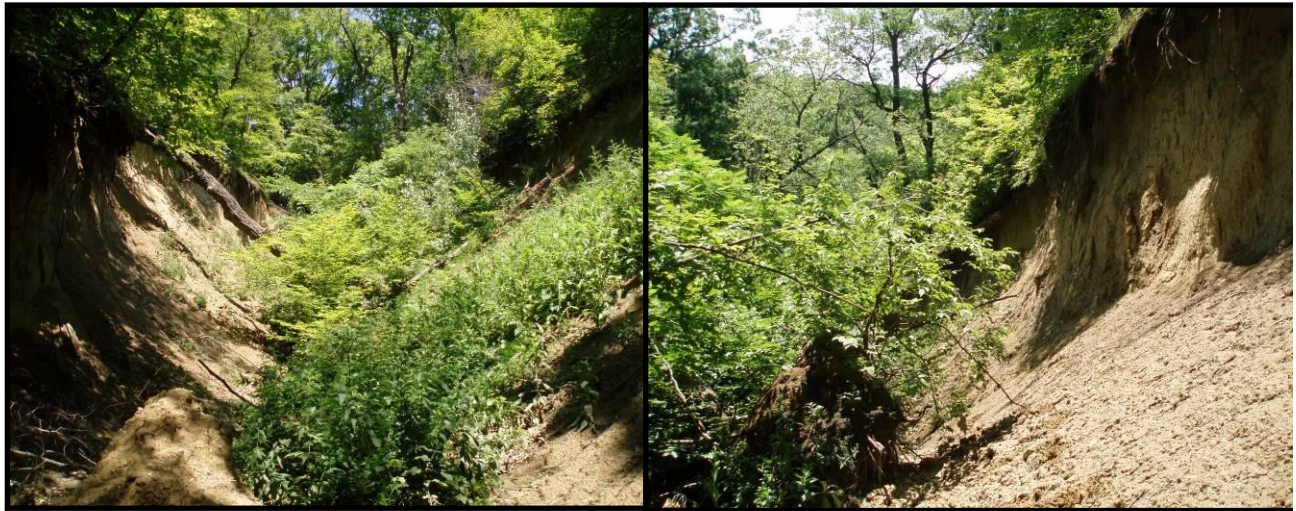
Site 10 consists of an approximately 450-foot long ravine on the north side of the valley with severe erosion. The head of the ravine originates at a path from the golf course. It is unclear what the purpose of the path is, and it may be abandoned. Lower half of the ravine is deeply eroded and has been for some time, with vegetation re-established on portions of the eroded slopes. Exposed soils are dense sandy clay, with some strata resembling sandstone (see [Figure 4.20](#) and [Figure 4.21](#)).

Figure 4.20 30-foot deep slope failure area (Site 10)

Figure 4.21 Failed sidewall (Site 10)

Review drainage and groundwater seepage of ravine to determine cause of erosion. Determine purpose of golf course path and drainage from golf course. Evaluate existing vegetation and thin trees where necessary to provide greater sunlight to ground vegetation. Provide grade control and energy dissipation in ravine and provide better transition to Bluff Creek. Grade eroding banks and revegetate with native vegetation.

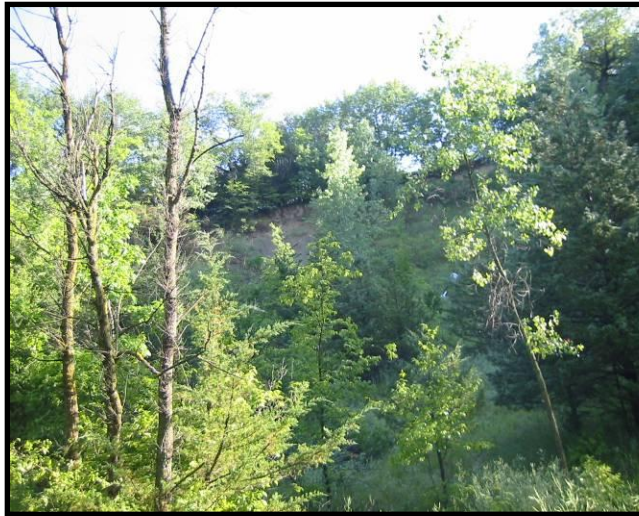
This site consists of a very large slope failure on the north valley wall. A much smaller slope failure is nearby immediately adjacent to the creek. The larger slope failure has been present for over 80 years, and the lower embankment has largely revegetated with grasses and small trees. The upper, more vertical banks continue to slowly erode. The original failure may have been induced by groundwater seepage or streambank erosion, but the upper vertical bank is probably no longer influenced by these factors (see [Figure 4.22](#) and [Figure 4.23](#)).

Figure 4.22 Large slope failure with Revegetated lower bank (Site 11)

Review drainage patterns of failure area and store and/or redirect local drainage around eroding slopes as needed to reduce concentrated flow over the bank. Grade the vertical upper banks and revegetate with native vegetation. Stabilize slope failure adjacent to creek and redirect creek away from the bank toe. Revegetate stabilized bank and provide erosion control.

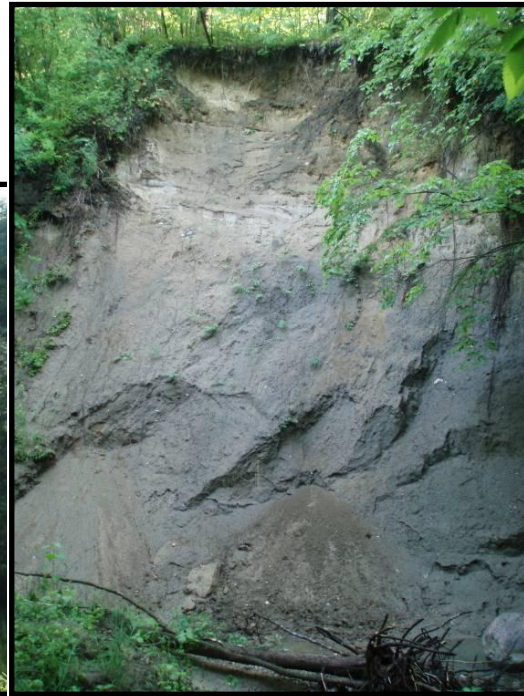
Figure 4.23 Bank failure on creek (Site 11)

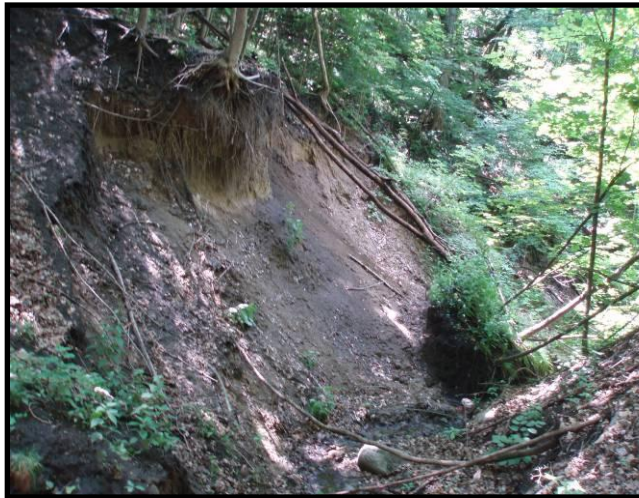
Site 12 consists of an approximately 1,000-foot long ravine on the north side of the valley with a 225-foot tributary ravine, both having severe erosion. The lower 350 feet of the ravine is relatively stable, indicating that the ravine may be the result of a headcut that has been slowly migrating up the valley wall. The heads of both the main ravine and the tributary ravine are at the south perimeter of the golf course (see [Figure 4.24](#) and [Figure 4.25](#)).

Figure 4.24 Severe erosion in upper part of main ravine (Site 12)

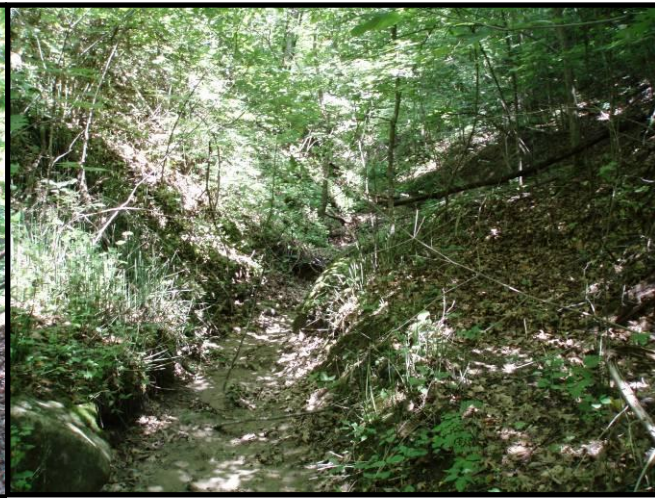
Figure 4.25 Stable lower extent of ravine with a sandy channel (Site 12)

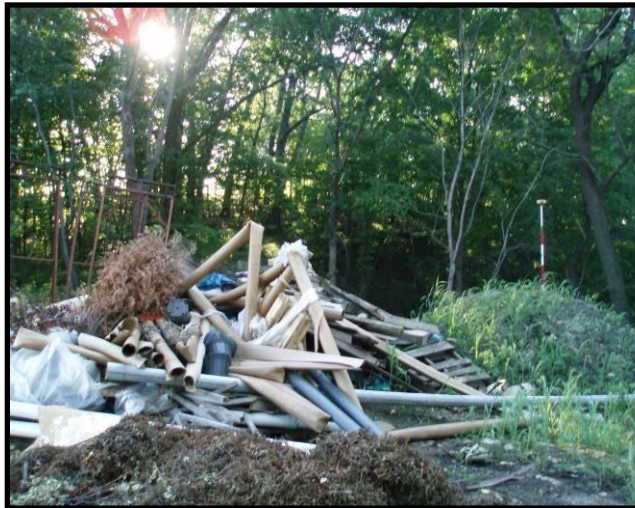
Site 13 consists of an approximately 650-foot long ravine on the west side of the valley with moderate erosion. The head of the ravine is at a hobby farm. A promiscuous dump is present on the site. Materials present consisted primarily of yard wastes and general building materials. Soils and historic aerial photographs indicate that a wetland existed upstream of this channel at one time. The wetland site currently has a surface tile intake and is being used as cropland. A minor bank failure is present near the mouth of the ravine at Bluff Creek, but does not appear likely to develop into a more severe erosion problem (see [Figure 4.26](#) and [Figure 4.27](#)).

Figure 4.26 Yard waste and building materials at the head of the ravine (Site 13)

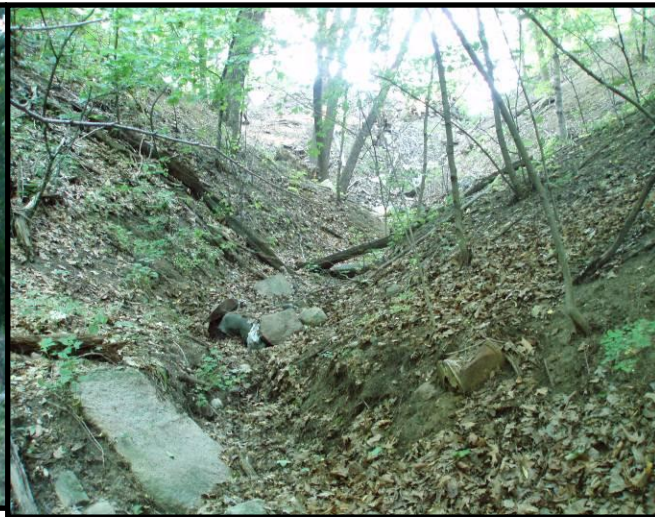
Figure 4.27 Debris present at midpoint of ravine (Site 13)

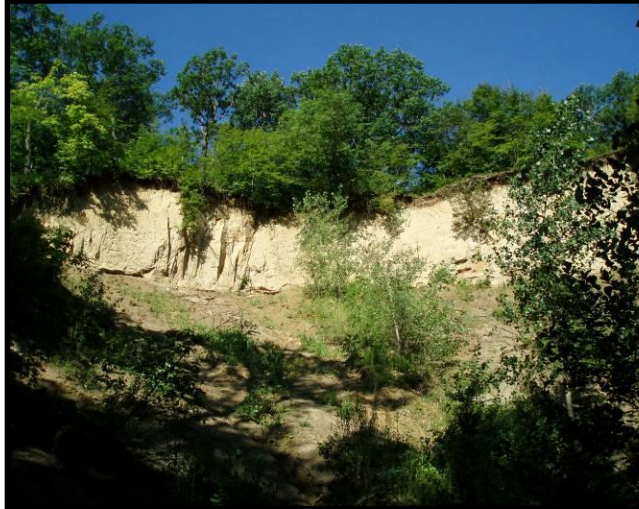
This site consists of a very large slope failure on the west valley wall, directly north of Site 13. The failure is approximately 300-feet across. Wet soils on the lower part of the failure indicate that groundwater probably plays a role in this failure. The upper vertical bank is comprised of very dense sandy clay. Timber debris and sand from the failure has accumulated at a bend in Bluff Creek (see [Figure 4.28](#) and [Figure 4.29](#)).

Figure 4.28 Large slope failure with wet soils on lower area and dense sandy clay soils on upper bank (Site 14)

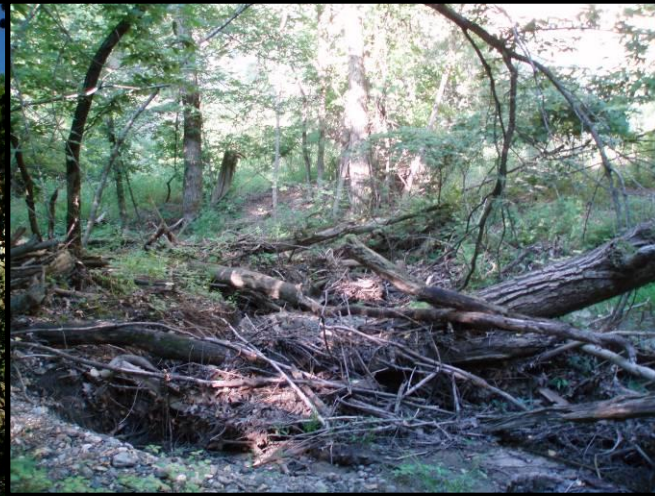
Figure 4.29 Timber debris and sand deposit at channel bend (Site 14)

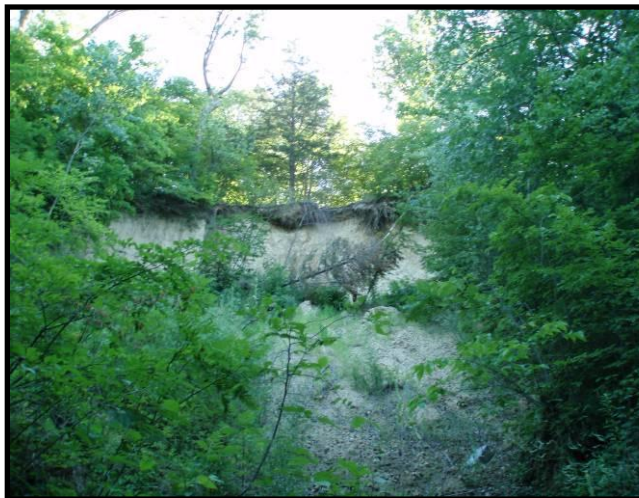
This site consists of a large slope failure on the east valley wall. The failure is approximately 200-feet across and 80-feet high. Groundwater probably plays a role in this failure. The upper vertical bank is comprised of very dense sandy clay. This site is near the west perimeter of the golf course, and an abandoned drain pipe is evident at the top of the ravine (see [Figure 4.32](#) and [Figure 4.33](#)).

Figure 4.32 Large slope failure with wet Soils on Lower Area and dense sandy clay soils on upper bank. (Site 16)

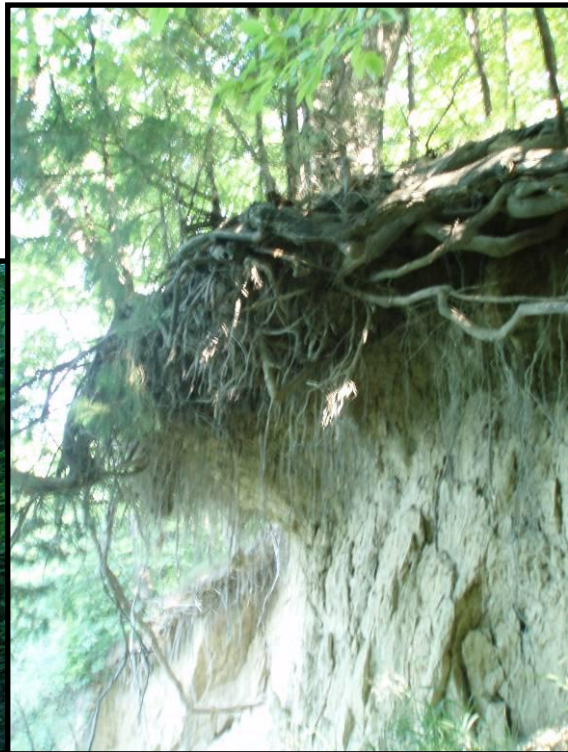
Figure 4.33 Upper vertical bank with dense clayey sand or soft sandstone (Site 16)

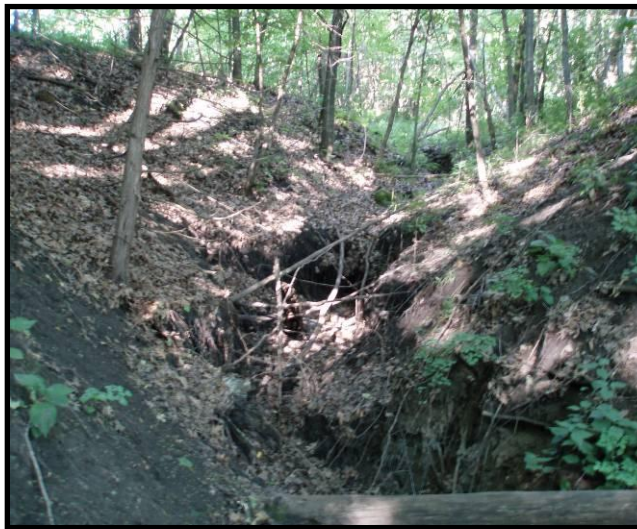
Site 17 consists of an approximately 380-foot long ravine on the east side of the valley with moderate erosion. The head of the ravine originates at the same hobby farm as site 13, with yard waste present. Some headcutting is evident, especially near the top and bottom of the ravine. The middle portion is relatively stable (see [Figure 4.34](#) and [Figure 4.35](#)).

Figure 4.34 Some headcutting present at the head of the ravine (Site 17)

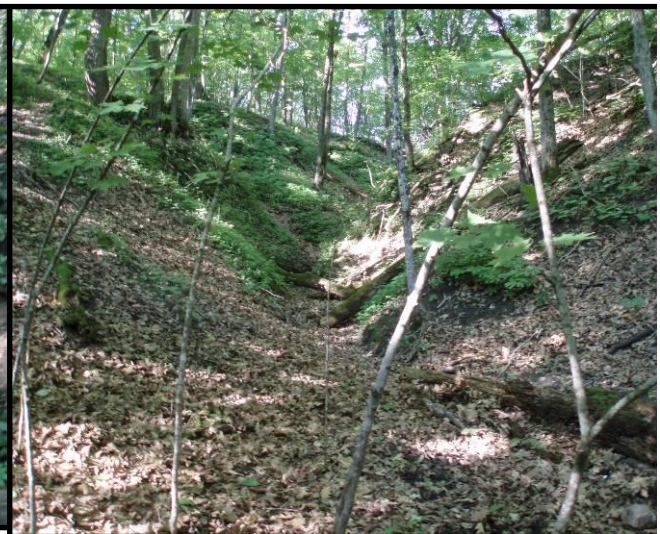
Figure 4.35 Stable middle portion of ravine (Site 17)

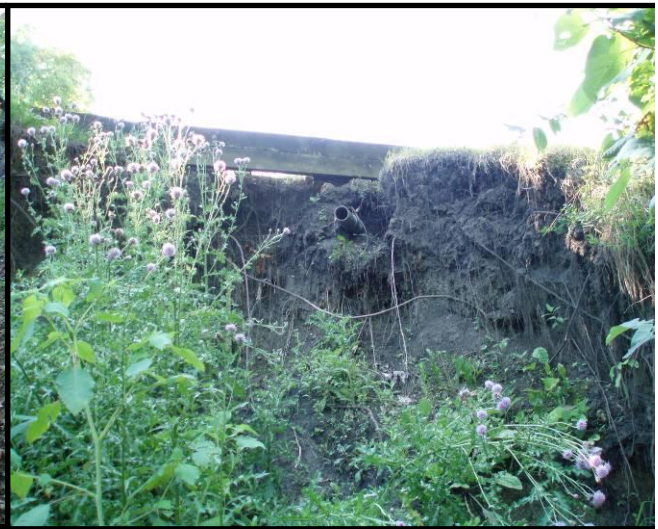
Site 18 consists of an approximately 1,000-foot long ravine on the east side of the valley with severe erosion in the form of slope failures and a 10 to 15-foot deep headcut approximately 40 yards up the ravine from Bluff Creek. The ravine originates at the west side of the Bluff Creek golf course and conveys local drainage. Portions of the ravine are older, with vegetation present on the bottom and side slopes. Groundwater seepage may play a role in the frequent slope failures, or they may occur following significant flood events. There is another nearby slope failure about 150 feet north of this ravine. Stabilization of this failure could be accomplished at the same time (see [Figure 4.36](#) and [Figure 4.37](#)).

Figure 4.37 Pipe outlet from golf course (Site 18)

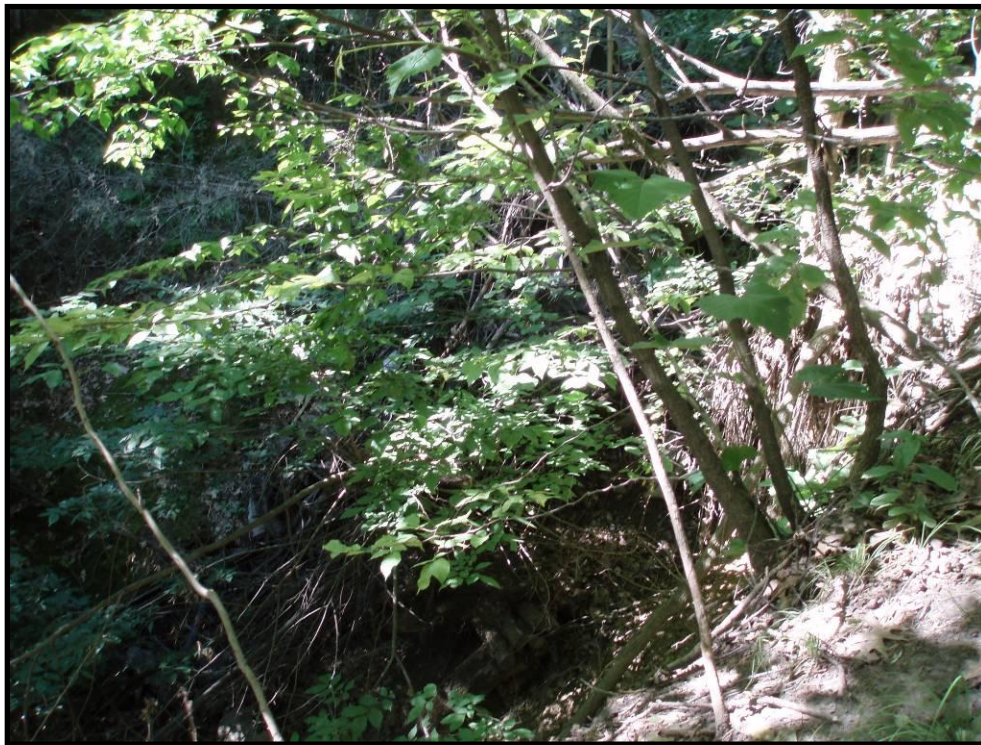
Site 19 consists of an approximately 250-foot long ravine on the west side of the valley with moderate erosion. The head of the ravine originates at the same hobby farm as site 13, with brushy debris at the head of the ravine. A slope failure also exists near the head of the ravine (see [Figure 4.38](#)).

Figure 4.38 Slope failure near head of ravine (Site 19)

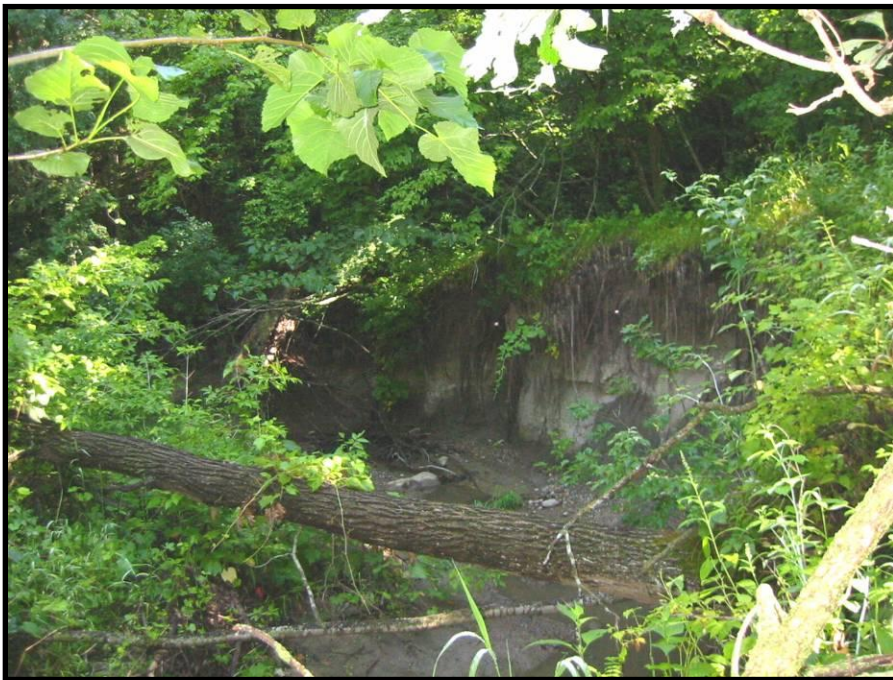
This site consists of an approximately 400-foot long reach of Bluff Creek having severe bank erosion. The erosion is occurring primarily on the east side of the valley wall where the stream abuts it. The stream is highly meandering in this reach, with some downed timber which tends to exacerbate the problem (see [Figure 4.39](#)).

Figure 4.39 Bank erosion on outside of bend (Site 20)

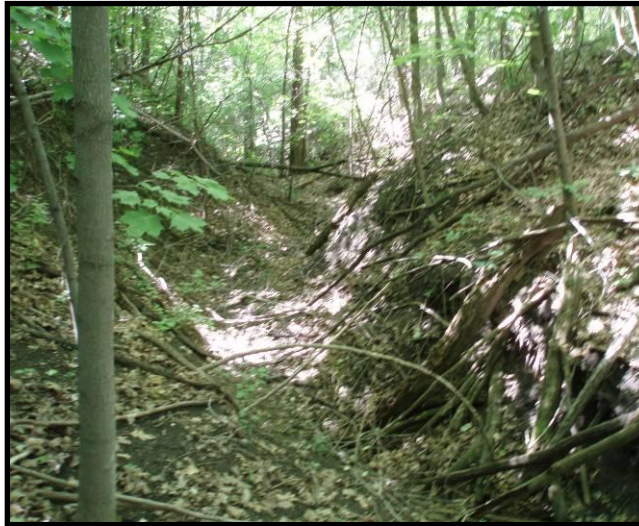
Site 21 consists of an approximately 725-foot long ravine on the west side of the valley with minor to moderate erosion. The lower half of the ravine has moderate erosion, while the upper half has minor erosion. Highway 212 construction altered the natural drainage to the head of the ravine. Some headcutting and bank erosion is evident throughout the ravine (see [Figure 4.40](#) and [Figure 4.41](#)).

Figure 4.40 Headcutting and slope erosion at head of ravine (Site 21)

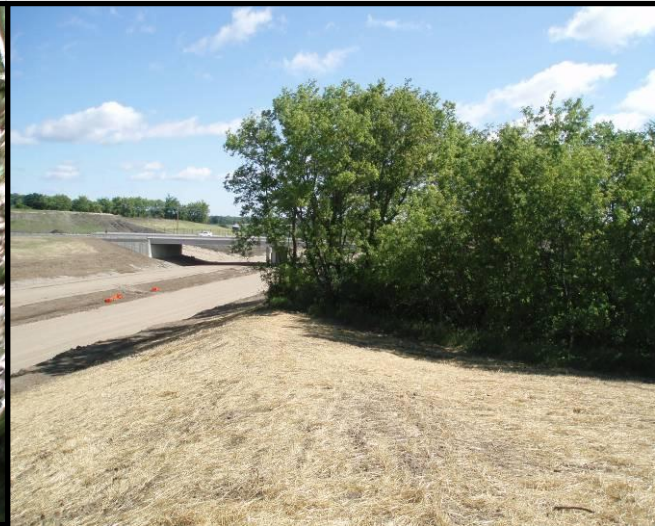
Figure 4.41 Highway 212 construction at head of ravine (Site 21)

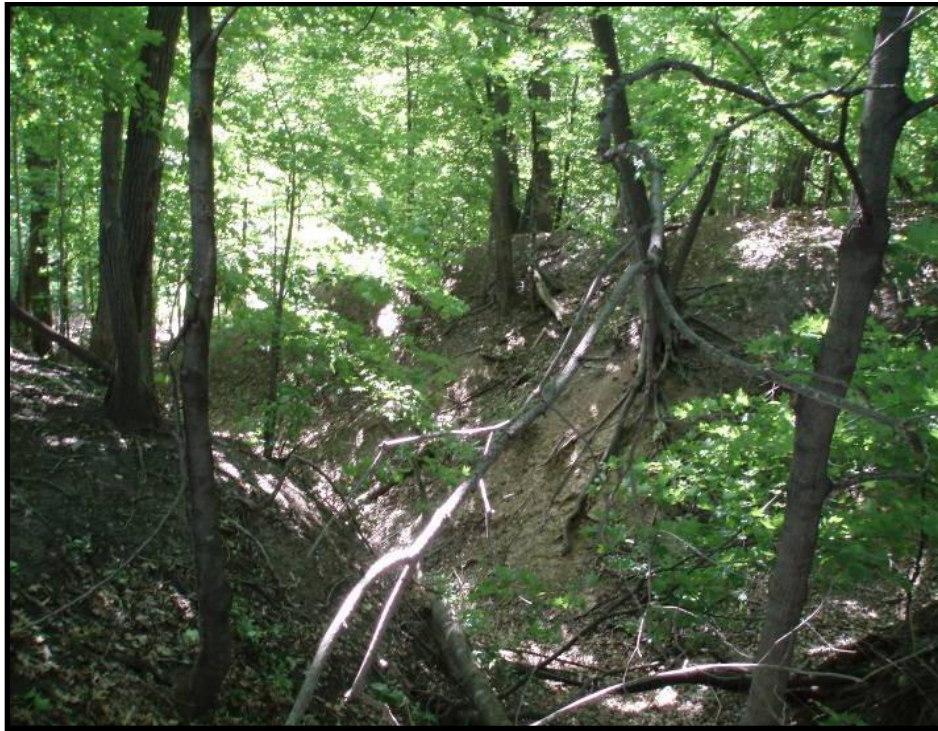
Site consists of two parallel 350-foot long ravines on the west side of the valley near the new Highway 212 construction. The southern ravine has minor erosion (see [Figure 4.42](#)) while the northern ravine has moderate erosion. Highway 212 construction reduced the natural drainage area to the ravines, but construction runoff had previously resulted in a gully forming at the head of the north ravine in the summer of 2007.

Figure 4.42 Minor erosion at southern ravine (Site 22)
