**Bluff Creek Watershed**

**Total Maximum Daily Load Report:  
Turbidity and Fish Bioassessment Impairments**

**Submitted by:**  
**Minnesota Pollution Control Agency**

**June, 2013**

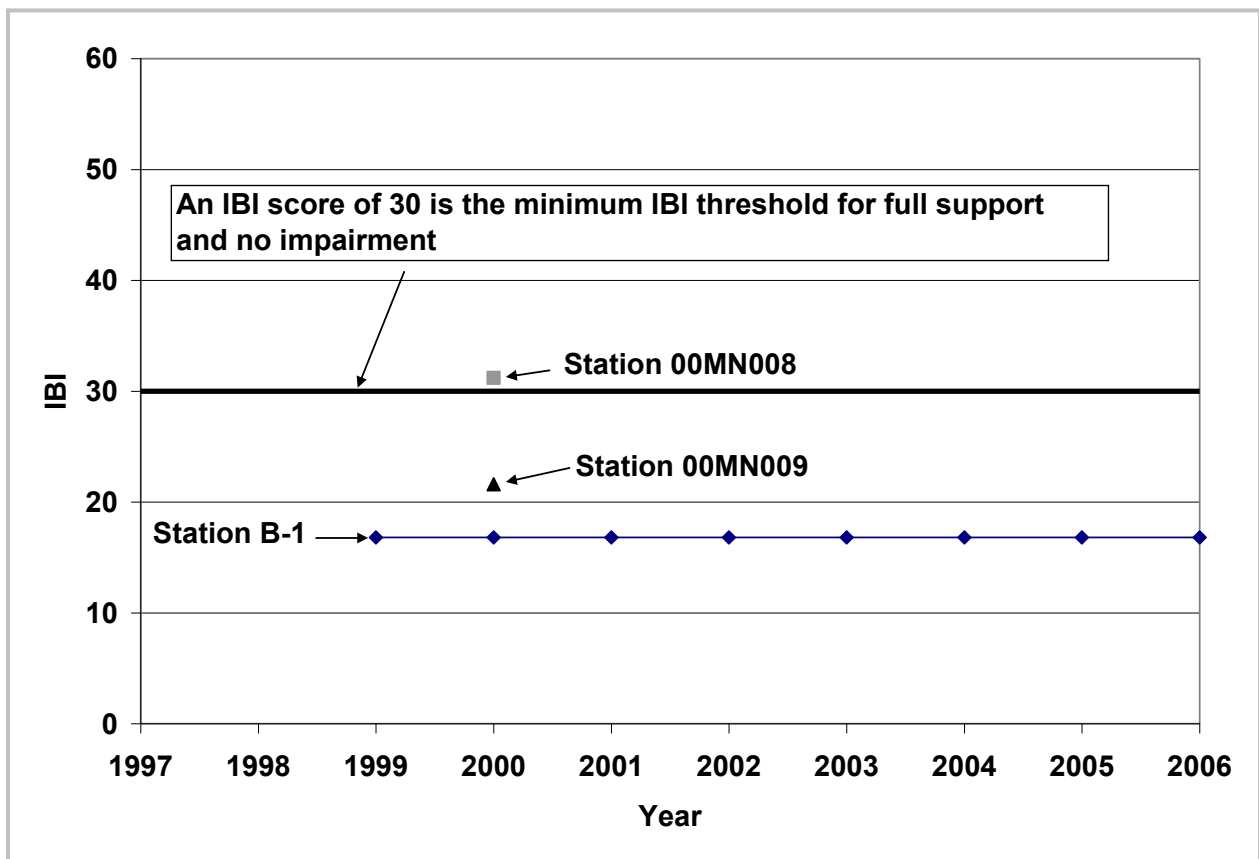
Figure 2.1 1999-2006 Bluff Creek IBI Summary—Stations B-1, 00MN008, and 00MN009

indicate environmental degradation has occurred in the impaired reach. The absence of darters and simple lithophilic spawners indicate the impaired stream reach may have habitat deficiencies due to siltation of coarse substrates and excessive sedimentation or due to cold water temperatures. The absence of darters may also indicate a loss of channel complexity from channelization. Because the downstream unimpaired location noted darters, the data either indicate siltation of coarse substrates is not problematic at the downstream location, the downstream channel is more complex, or that another stressor (e.g., habitat fragmentation between the two locations) is the driving force in the fish assemblage.

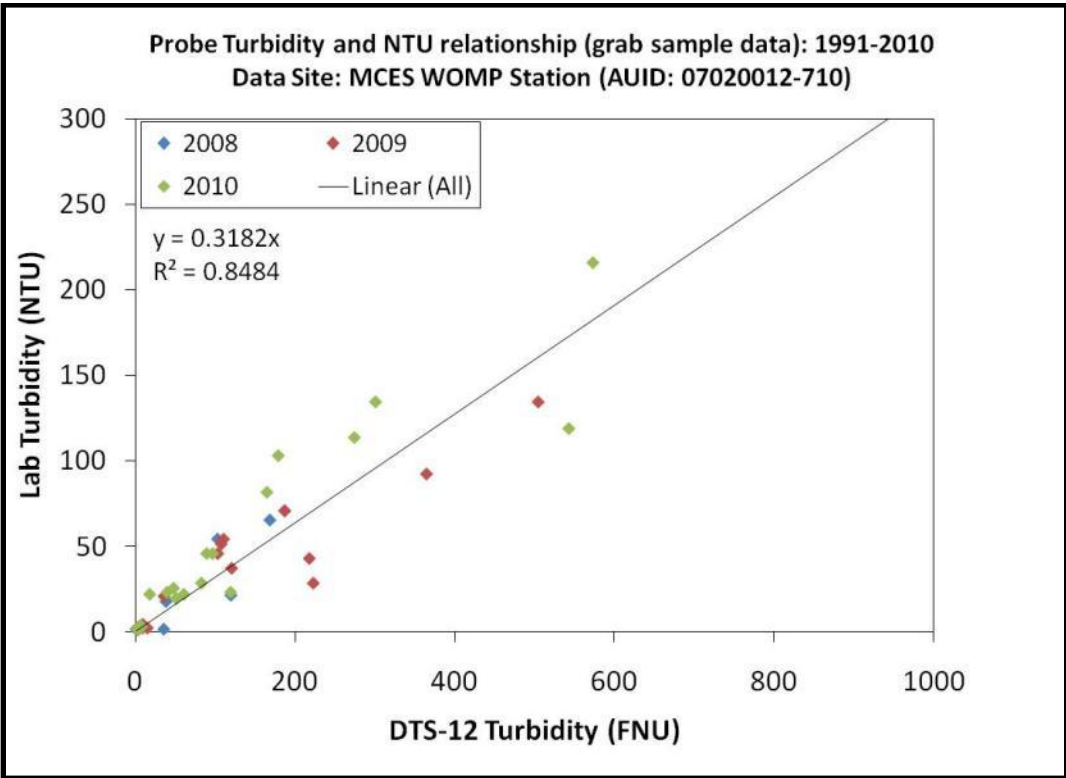
**Figure 3.2 Bluff Creek WOMP (MCES BL 3.5) FNU to NTU relationship**

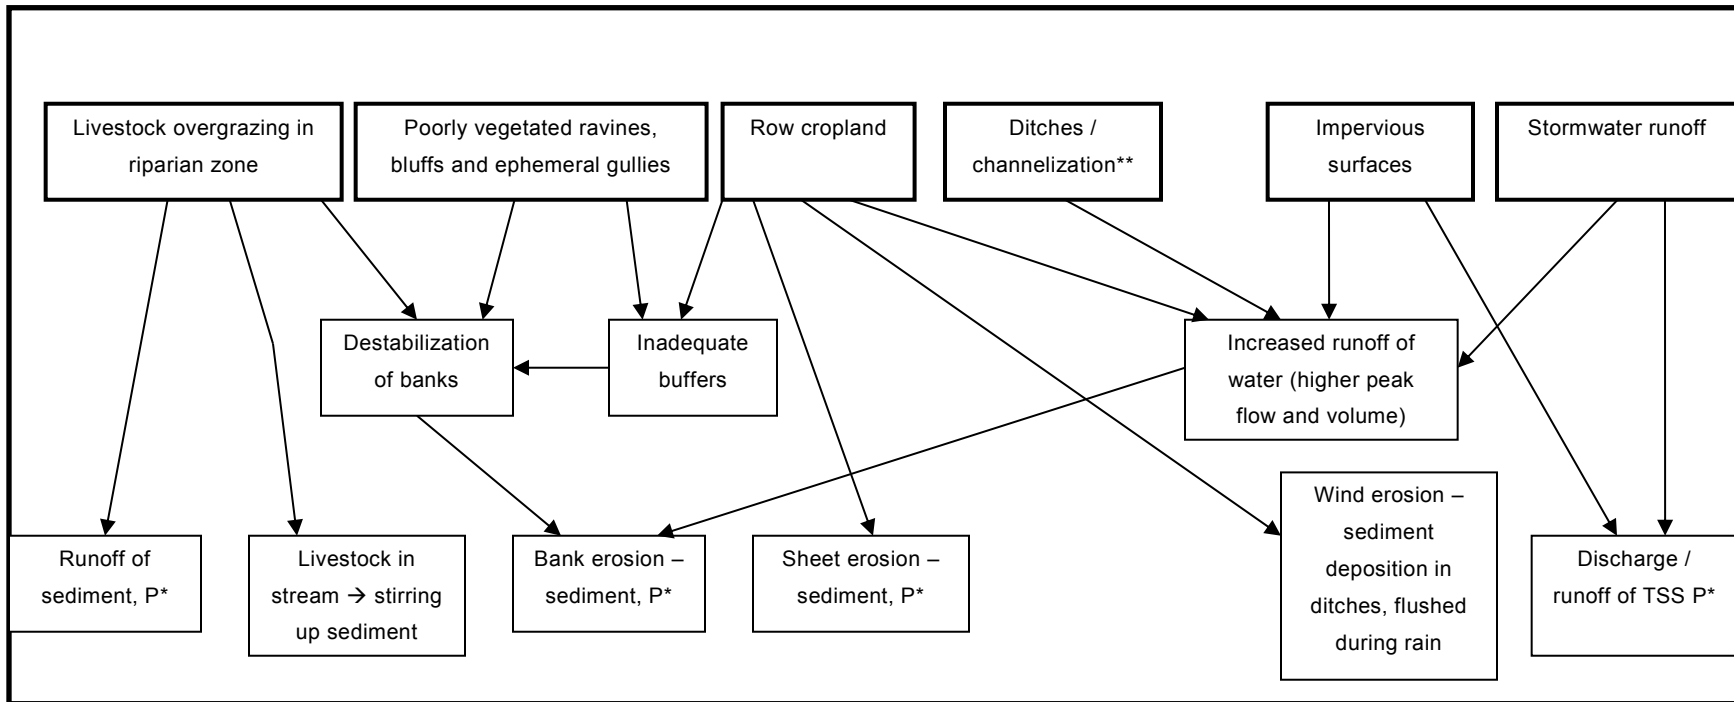
**Figure 3.5 Simplified turbidity conceptual model of candidate sources and potential pathways**

\* Phosphorus (P) can contribute to turbidity through production of algal blooms during lower flow periods or in low-gradient/low-velocity portions of stream.

\*\* Ditches / channelization also can cause sediment delivery via:

- bank erosion as watercourses revert to original meandering
- scour erosion at side-inlets
- steeper gradient can cause headward erosion and downcutting (nickpoints may form; channel erodes nickpoint resulting in upstream scour)
- ditch cleaning / dredging

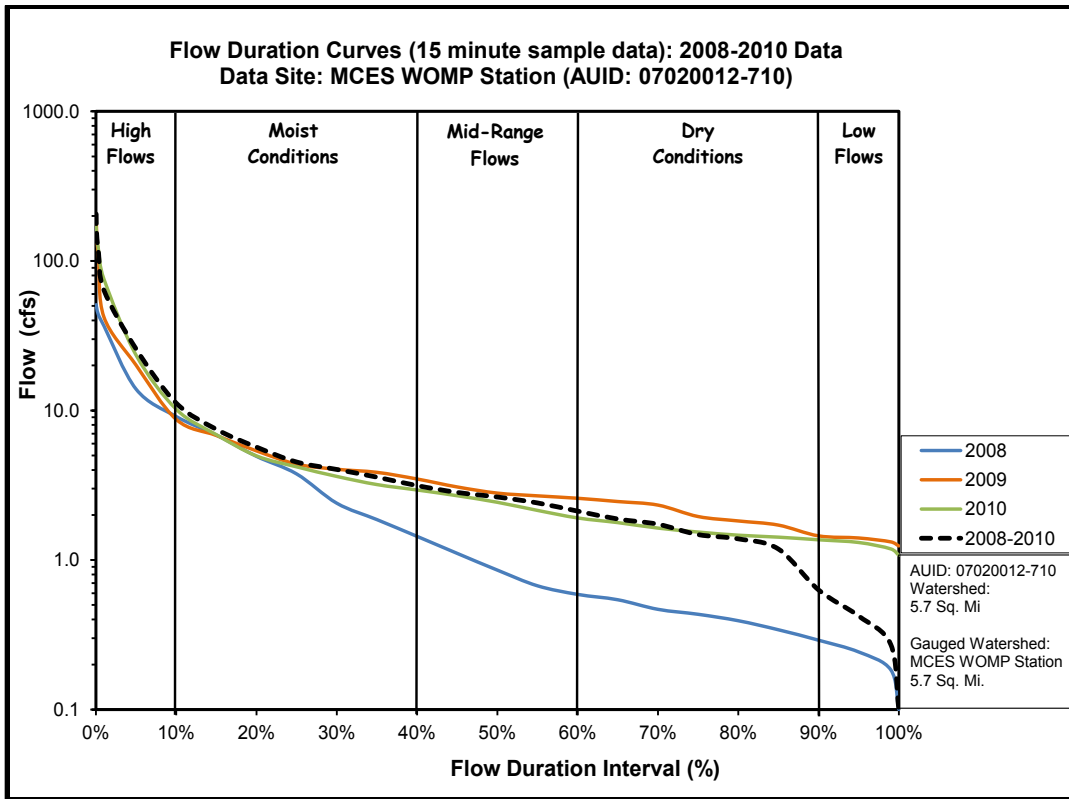
**Figure 3.8** Flow duration curve 2008-2010 using 15 minutes flow data (AUID: 07020012-710)

Flow duration curves were developed at the WOMP station (BL 3.5) for the last three years (2008, 2009 and 2010) along with a combined data set representing all three years (2008-2010). The flow duration curves rank each flow based on its percent rank. A flow duration interval of 10% represents a value where only 10% of the flow rates are higher. A 90% interval represents a low flow rate where 90% of measurements are higher. The results show 2008 as a low flow year when compared to both 2009 and 2010 ([Figure 3.8](#)). A further comparison looking at daily average flow rates for 2008, 2009 and 2010 and comparing them to historical values for the past 9 years (2002-2010) shows the same results ([Figure 3.9](#)) with 2008 having lower flow rates throughout the flow regime.

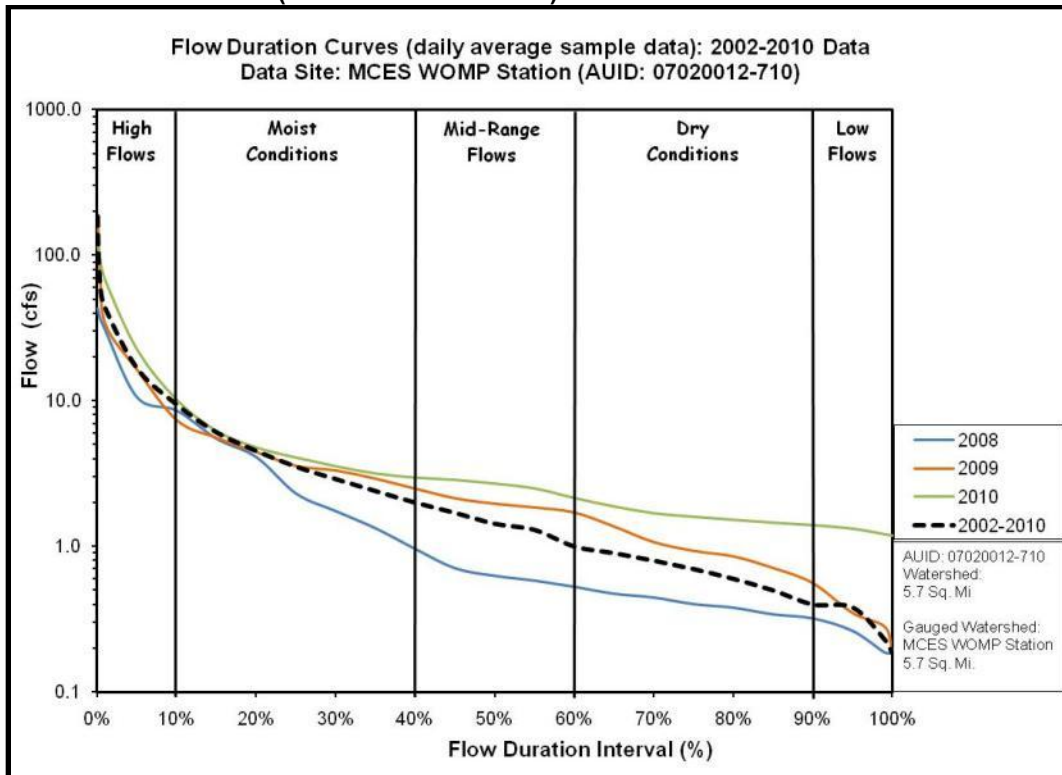
**Figure 3.9** Flow duration curve 2002-2010 using daily average flow data (AUID: 07020012-710)

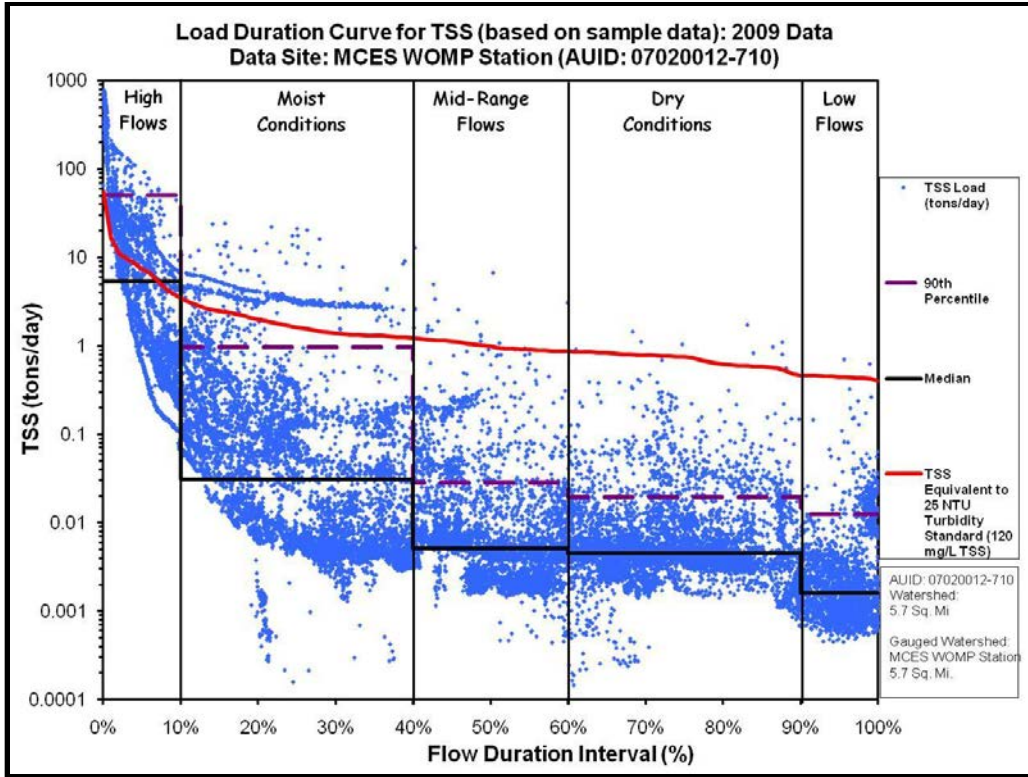
Figure 3.11 Load duration curve 2009 (AUID: 07020012-710)

Load duration curves were created for each of the three years individually and all three years combined (2008-2010) at the Bluff Creek WOMP station (Figures 3.10 through 3.13). Load duration curves plot the corresponding TSS load (tons/day) calculated using the 15 minute interval flow rate (cfs) and TSS concentration (mg/L), converted from the NTU turbidity measurement, against the flow percent rank (%) for each measurement. At the Bluff Creek WOMP station the highest TSS loads occurred during the high and moist flow zones. Median loads over the three year period (Figure 3.13) were calculated as 8.9, 0.0575, 0.0085, 0.0045, and 0.0006 tons/day for the high, moist, mid, dry and low flow zones respectively. The higher loads occurring under high and moist flow conditions is a result of combining the higher flows with the highest TSS concentrations observed within the high and moist flow zones due to poorly vegetated ravines, bluffs, gullies and stream channels (Figure 3.14). Median concentrations for the three year period were recorded as 118.8, 4.4, 1.2, 1.1 and 0.5 mg/L for the high moist, mid, dry and low flow zones respectively. The 90 percentile concentrations were 892, 47, 6.9, 5.7 and 2.4 mg/L for the high moist, mid, dry and low flow zones respectively.

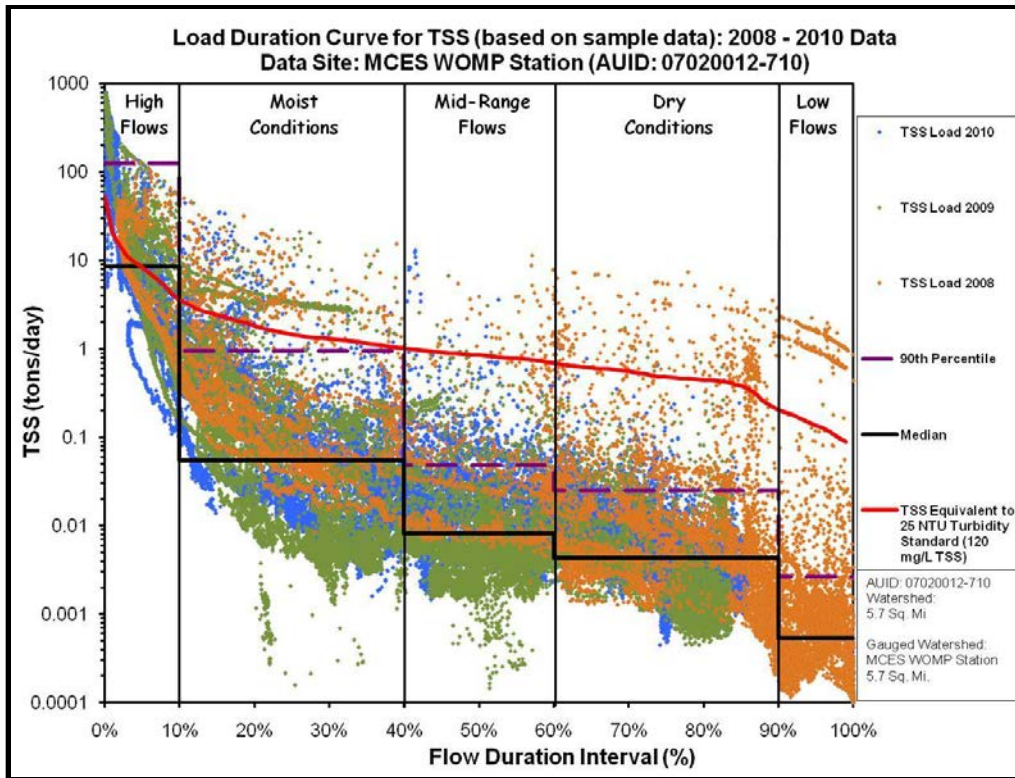
Figure 3.13 Load duration curve 2008-2010 (AUID: 07020012-710)

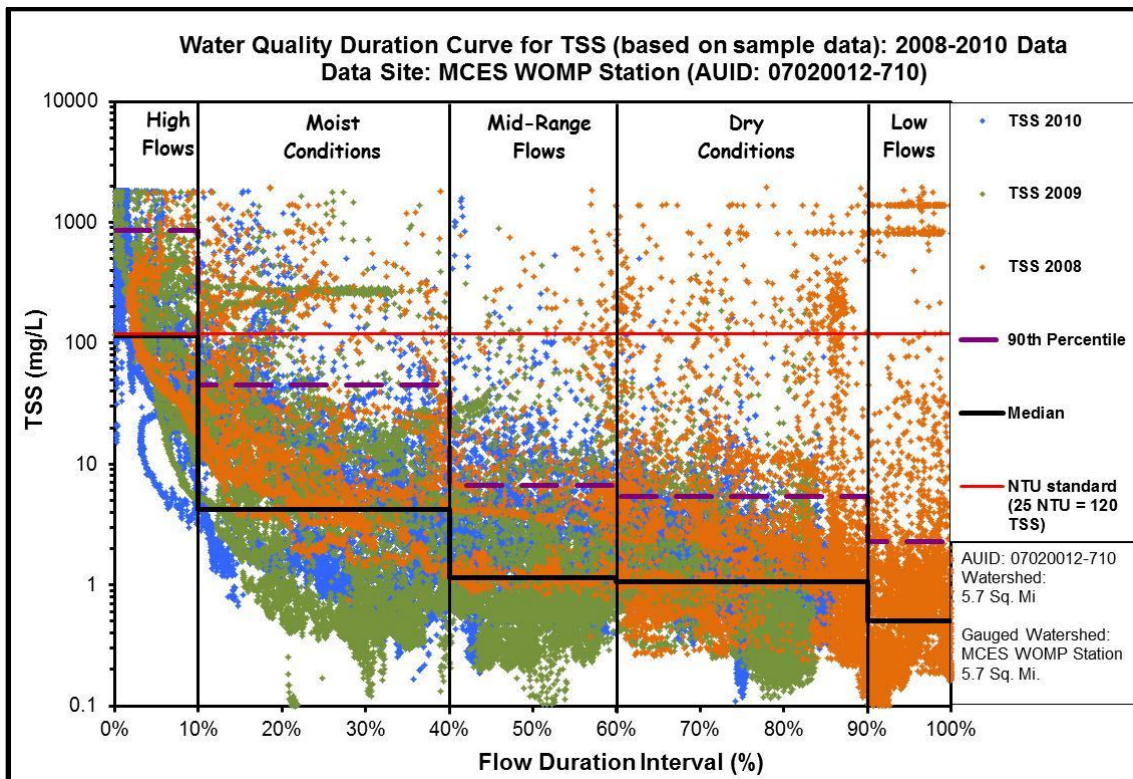
Figure 3.14 Water quality duration curve 2008-2010 (AUID: 07020012-710)

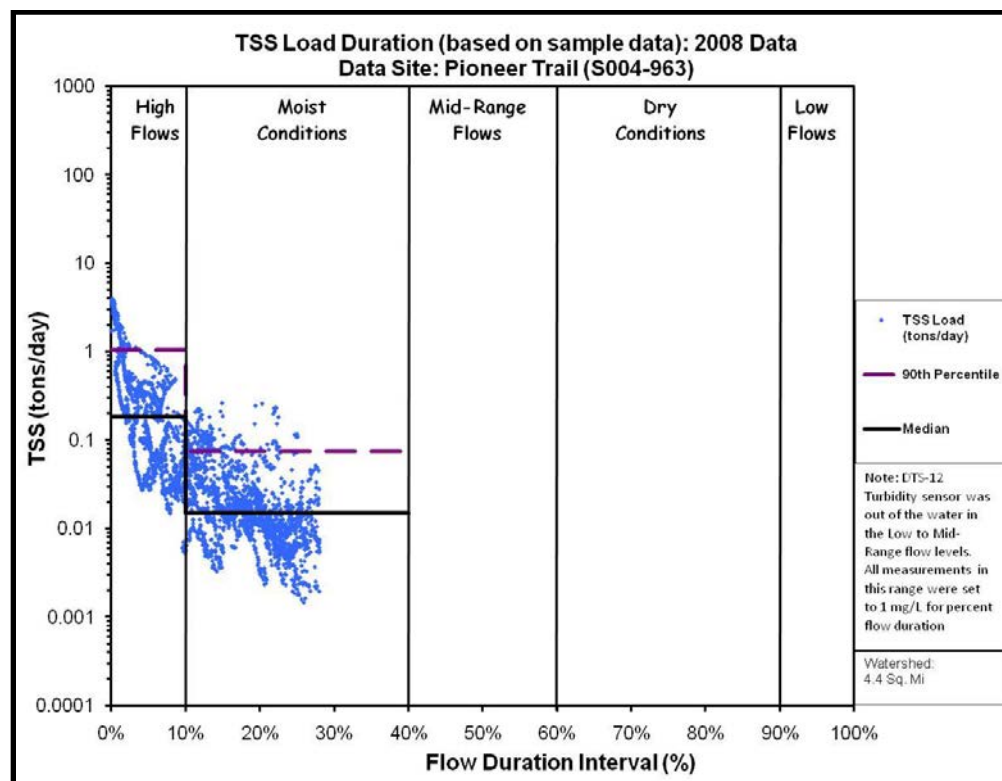
Figure 3.15 Load duration curve 2008 (Pioneer Trail)

TSS concentrations and loads were also calculated at the upstream Pioneer Trail temporary sampling station (Figures 3.15 and 3.16). The station was set up for the year 2008 only. Samples were collected every 15 minutes. During low to mid-range flow levels the water level in the stream receded below the bottom of the DTS-12 turbidity probe. During late summer no flow was present at this station. In order to compensate for the lack of data, flow percentages were calculated for the entire year, but only the corresponding loads with a corresponding NTU measurement were plotted. The median TSS loads from Pioneer Trail were 0.1825 tons/day for high flows and 0.0151 tons/day for moist conditions. No data was available for the mid-range, dry range and low flows. The median concentrations were recorded at 15.0 mg/L for the high ranges and 4.7 mg/L for the moist conditions. The data shown in Figure 3.15 was not used in setting the TMDL, but was compared with the data collected at the WOMP station (see Figure 3.10) to evaluate the relative importance of the gullies/ravines, bluffs and streambank erosion sources of turbidity that enter the stream in the lower valley of the watershed between Pioneer Trail and the WOMP monitoring stations. The results of this data comparison indicate that the TSS load measured at the WOMP station was one to two orders of magnitude higher than the load observed at Pioneer Trail during high flow conditions in 2008.

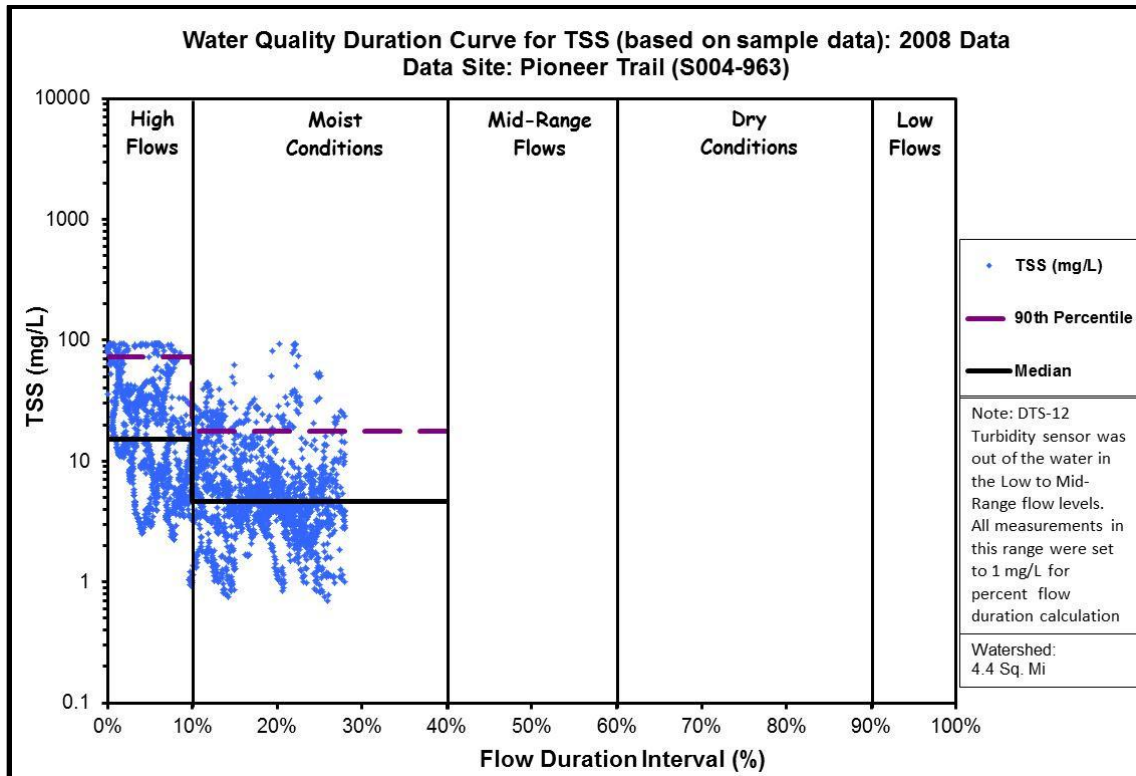
Figure 3.16 Water quality duration curve 2008 (Pioneer Trail)

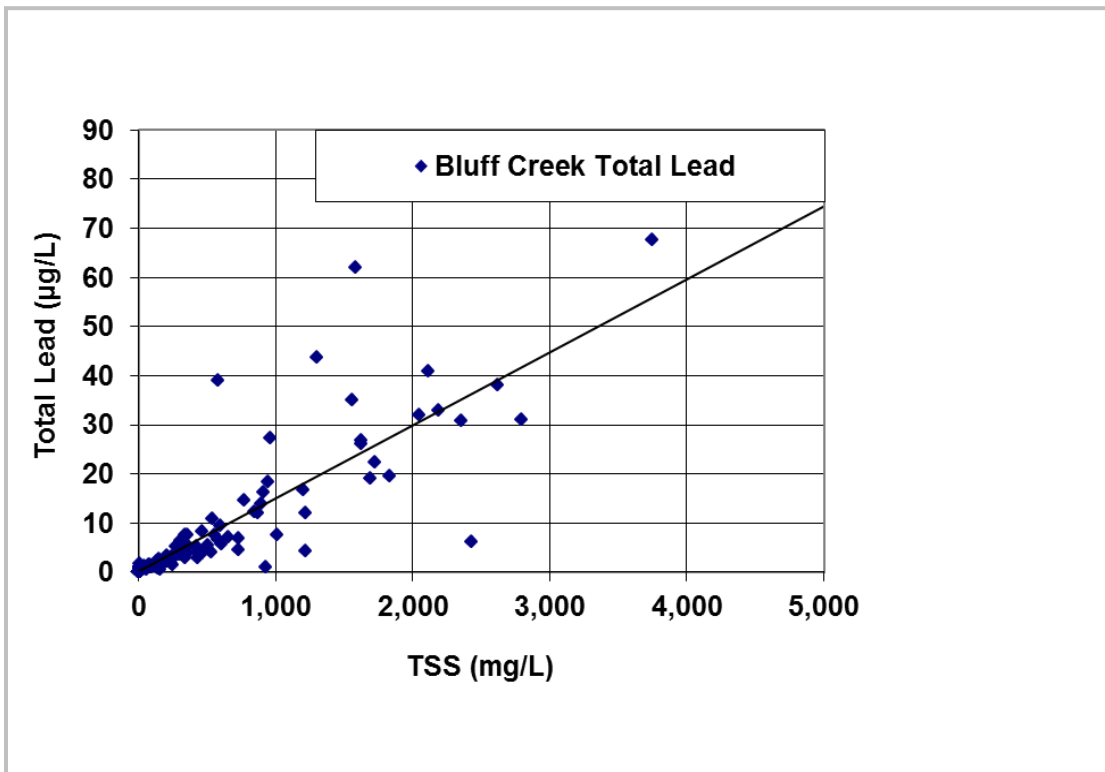
Figure 4.1 Lead versus suspended solids for Bluff Creek WOMP site

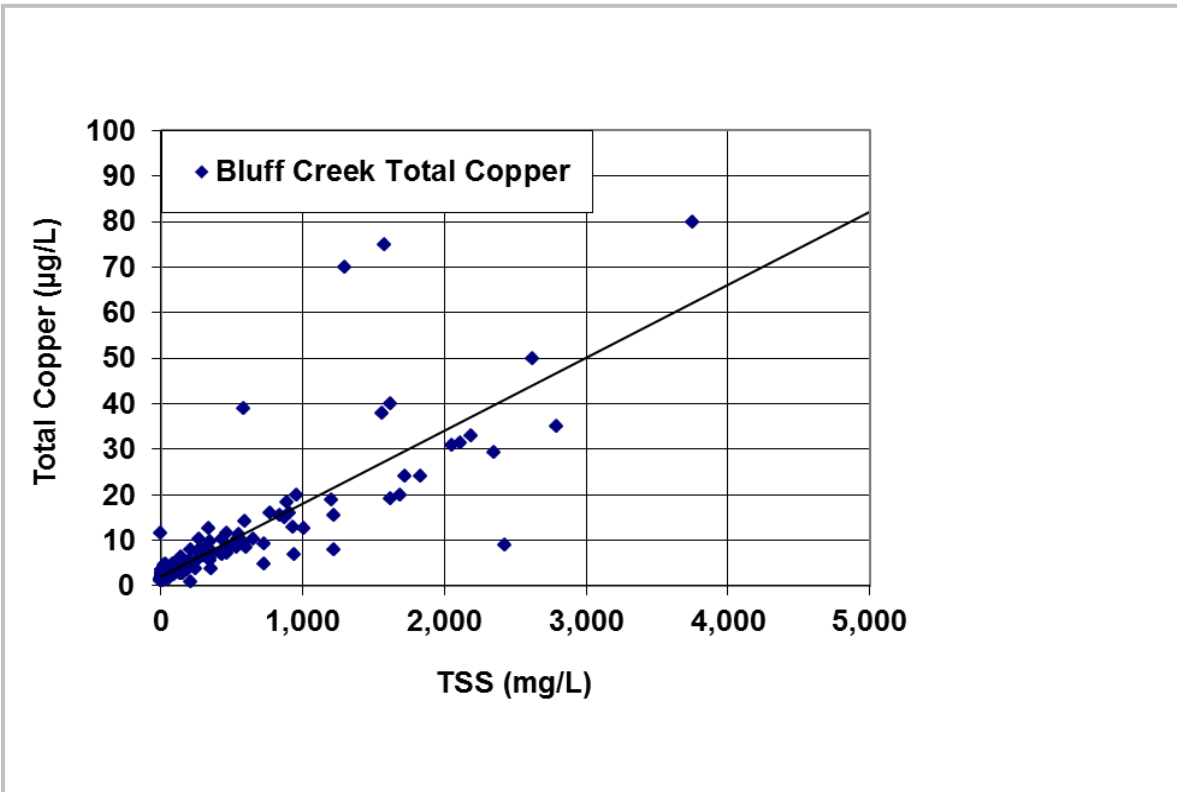
Figure 4.3 Copper versus suspended solids for Bluff Creek WOMP site

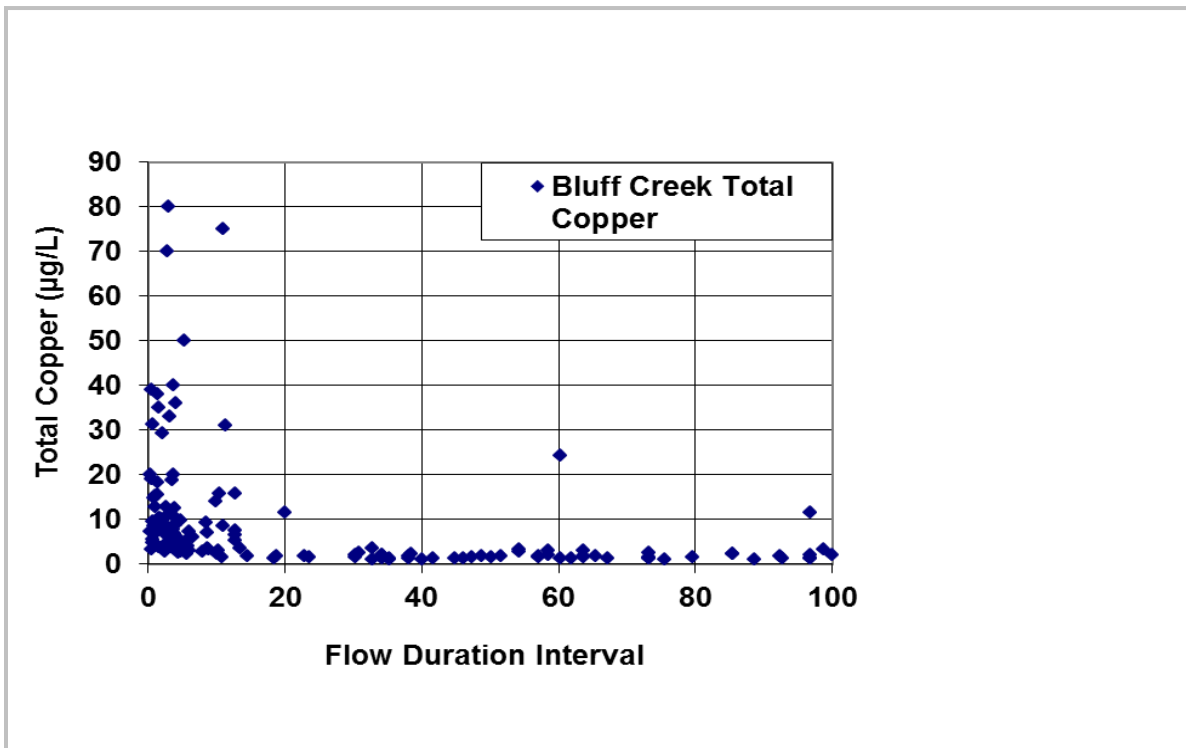
Figure 4.4 Copper water quality duration curve for bluff creek WOMP site

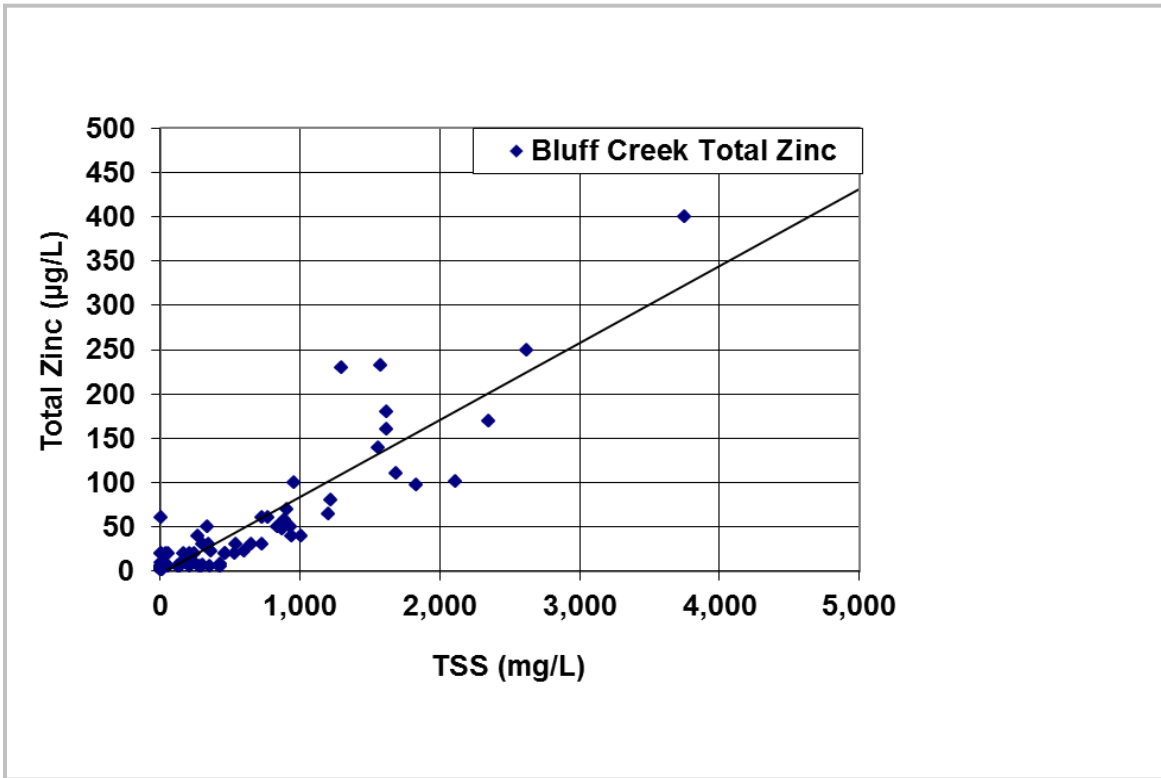
Figure 4.5 Zinc versus suspended solids for Bluff Creek WOMP site

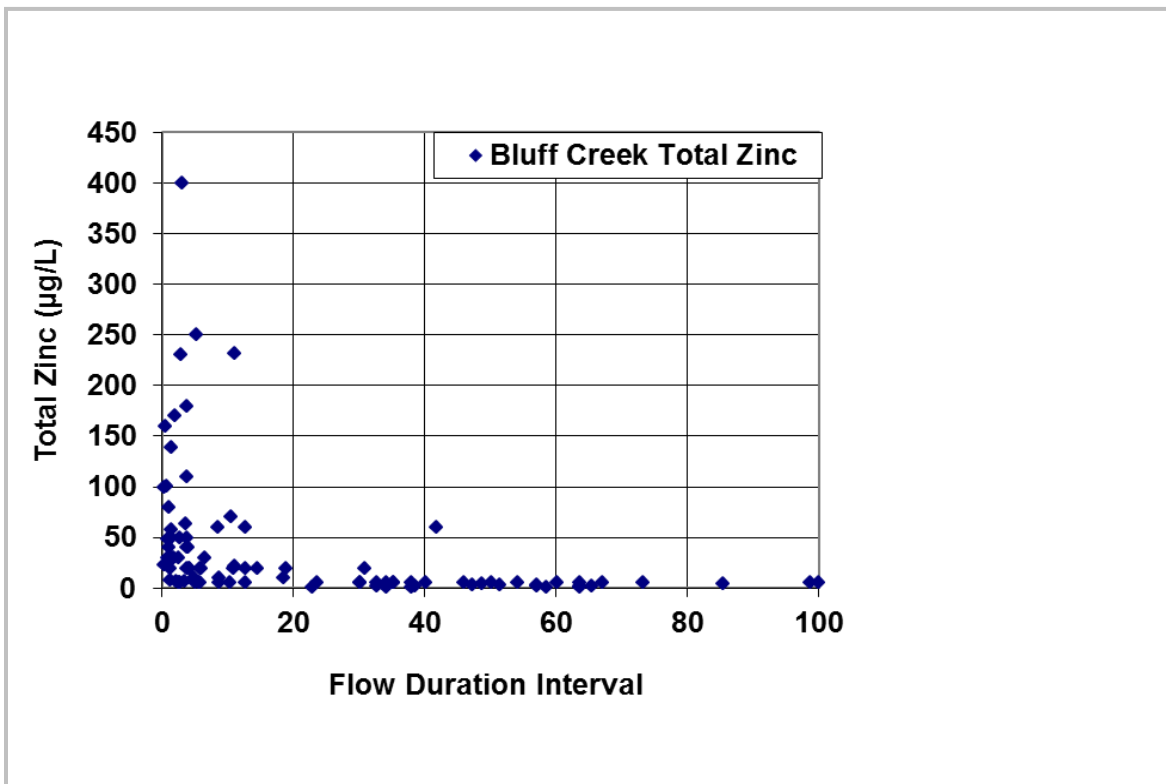
Figure 4.6 Zinc water quality duration curve for Bluff Creek WOMP site

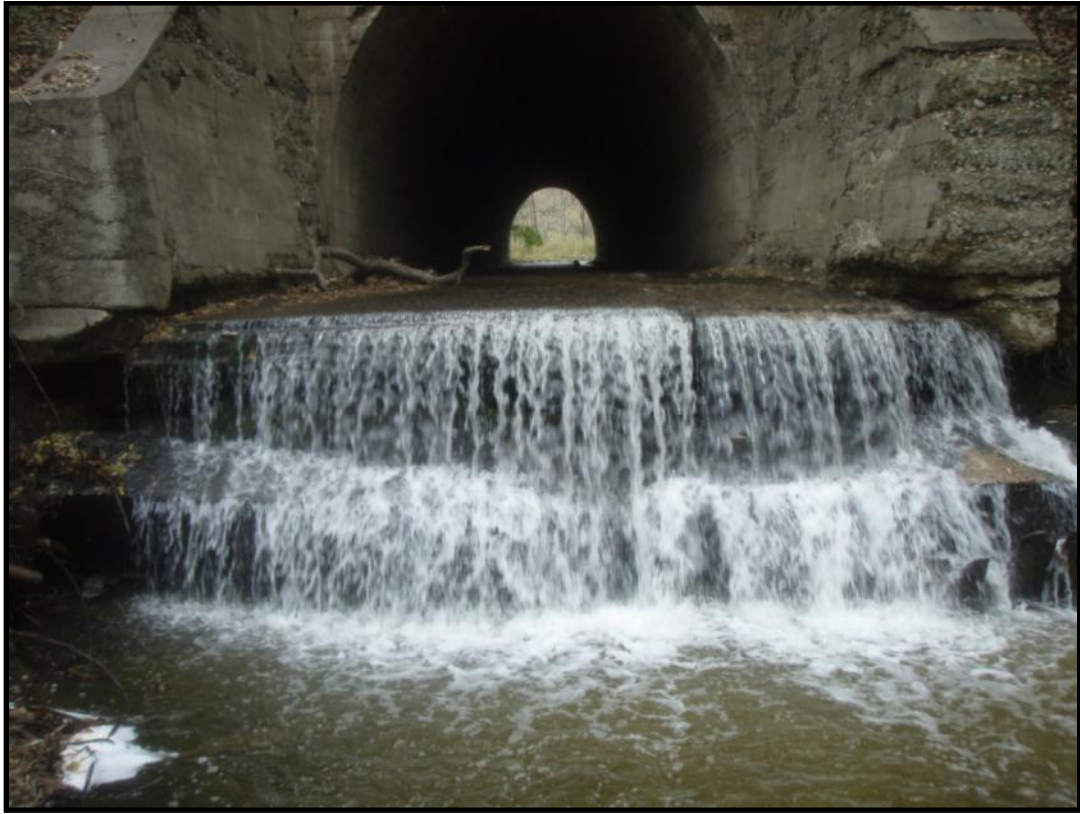
**Figure 4.7** Large drop at downstream end of regional trail culvert (looking upstream)

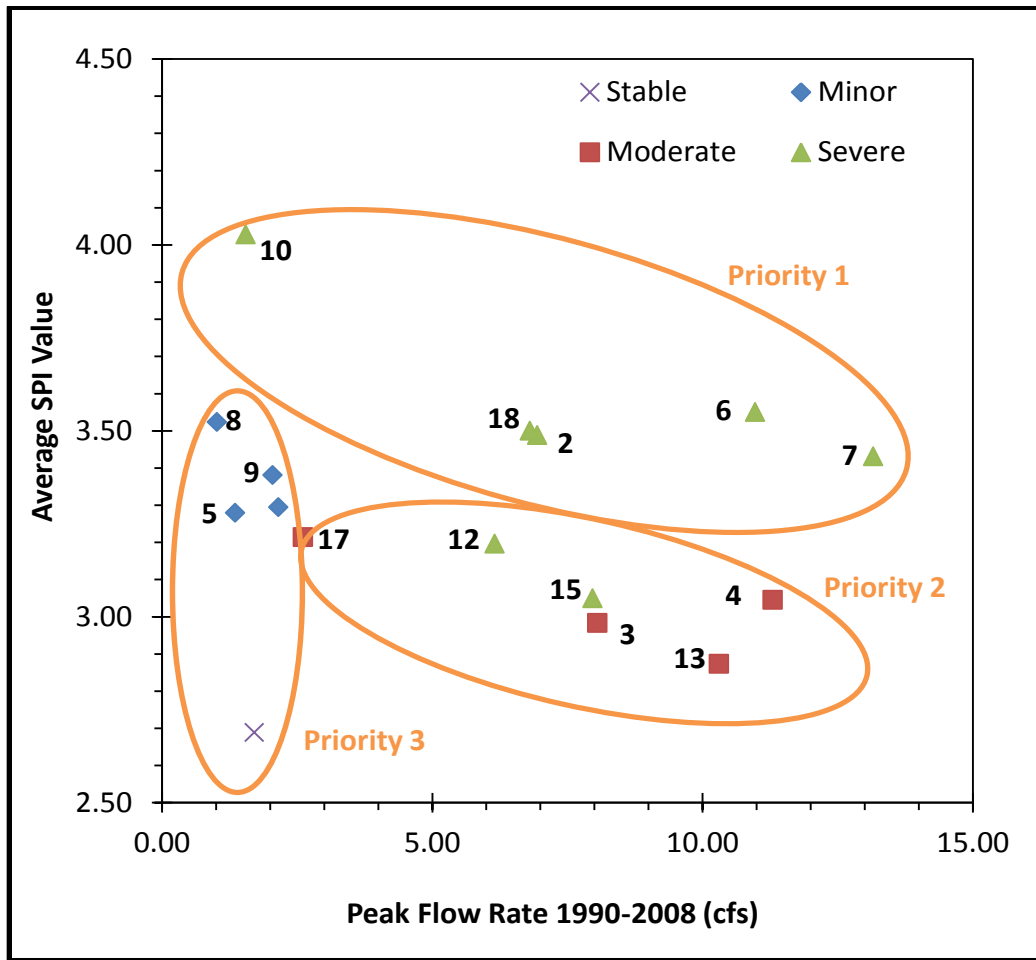
Figure 7.3 Ravine stability comparison

modeled peak flow rates with comparable SPI values than both ravines with minor or stable erosion. On average, ravines surveyed as having severe erosion had both higher SPI values and modeled peak flow rates than the ravines surveyed with minor or stable erosion and higher SPI values than those surveyed as having moderate erosion.

Using the results from Figure 7.3 and the severity rankings from the erosion survey implementation sites were group into three priority rankings. Priority 1 sites include the five ravines located in the severe grouping in Figure 7.3 plus a site with severe slope failure and the bank erosion downstream of the Bluff Creek culvert crossing of the Hennepin County Regional Trail Corridor. Priority 2 sites include four moderate erosion ravines and two severe erosion ravines located in the moderate

grouping in [Figure 7.3](#), as well as the three moderate erosion slope failure and bank erosion sites listed along with stream stabilization measures along with entire lower reach. The remaining sites listed as having minor erosion were listed as priority 3. [Table 7.2](#) lists all of the erosion sites grouped by priority and includes cost information in 2007 dollars for each sites. Implementation of all feasible options for reducing nonpoint sources of sediment to the stream and design and construction of a ramp to allow fish passage at the regional trail culvert crossing is estimated to cost approximately \$4.5 million. The implementation of only priority 1 sites would cost \$2.0 million, priority 2 sites would cost \$2.35 million and priority 3 sites would cost \$110,000.

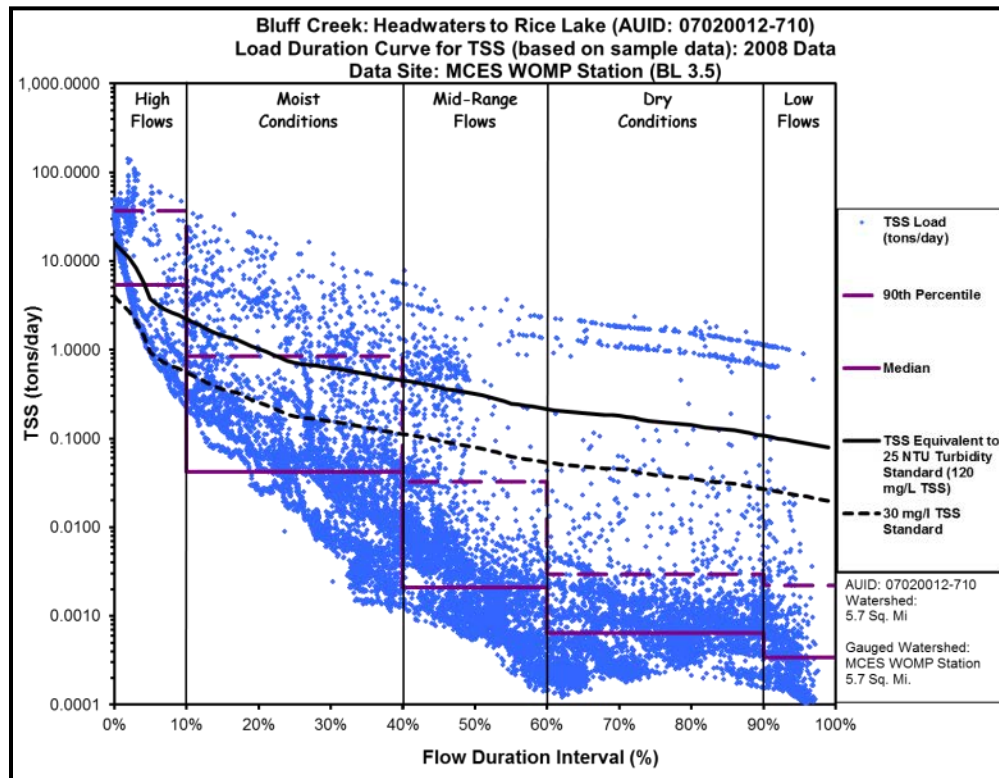
Figure A.1 Load Duration Curve 2008 (Bluff Creek WOMP)

Load duration curves were developed showing the existing 25 NTU standard and the proposed 30 mg/L TSS standard for the three sample years (Figure A.1-A.3) and all three years combined (Figure A.4). The 90<sup>th</sup> percentile and mean values for each flow zone are also shown and are discussed in section 3.4 of the report. The 90<sup>th</sup> percentile value for both the high flow and moist conditions zones are above the 30 mg/L standard for all years and do not meet the standard requirements. The midrange flows, dry conditions and low flows all meet the standard requirements. The midrange flows, dry conditions and low flows all meet the standard requirements.

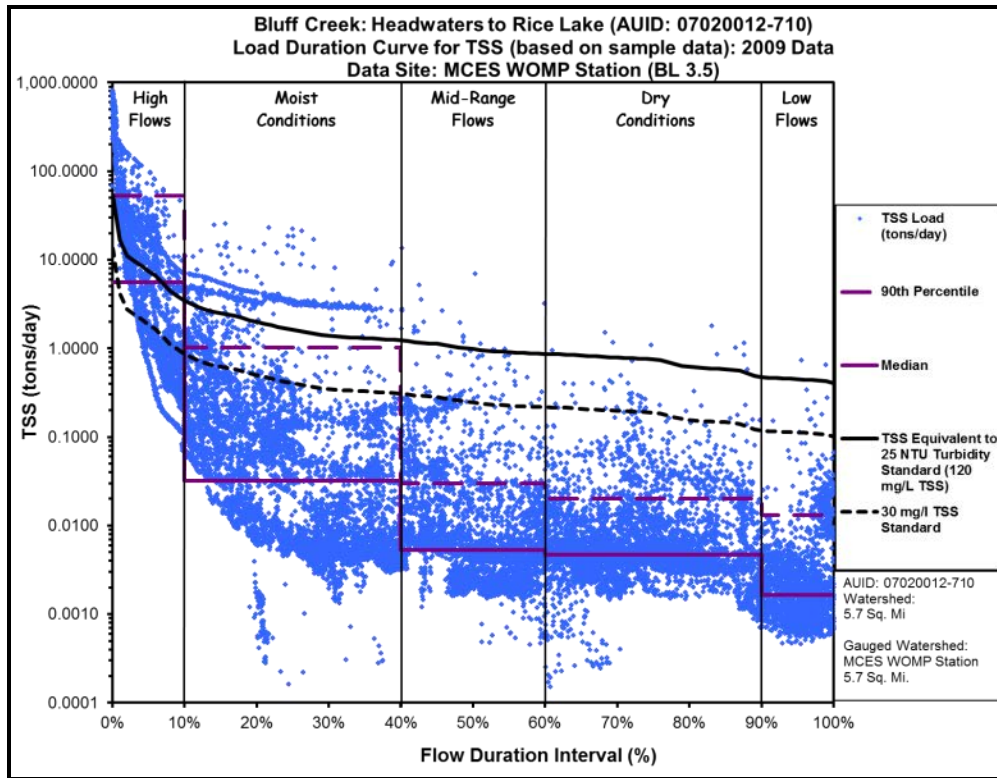
Figure A.2 Load Duration Curve 2009 (Bluff Creek WOMP)

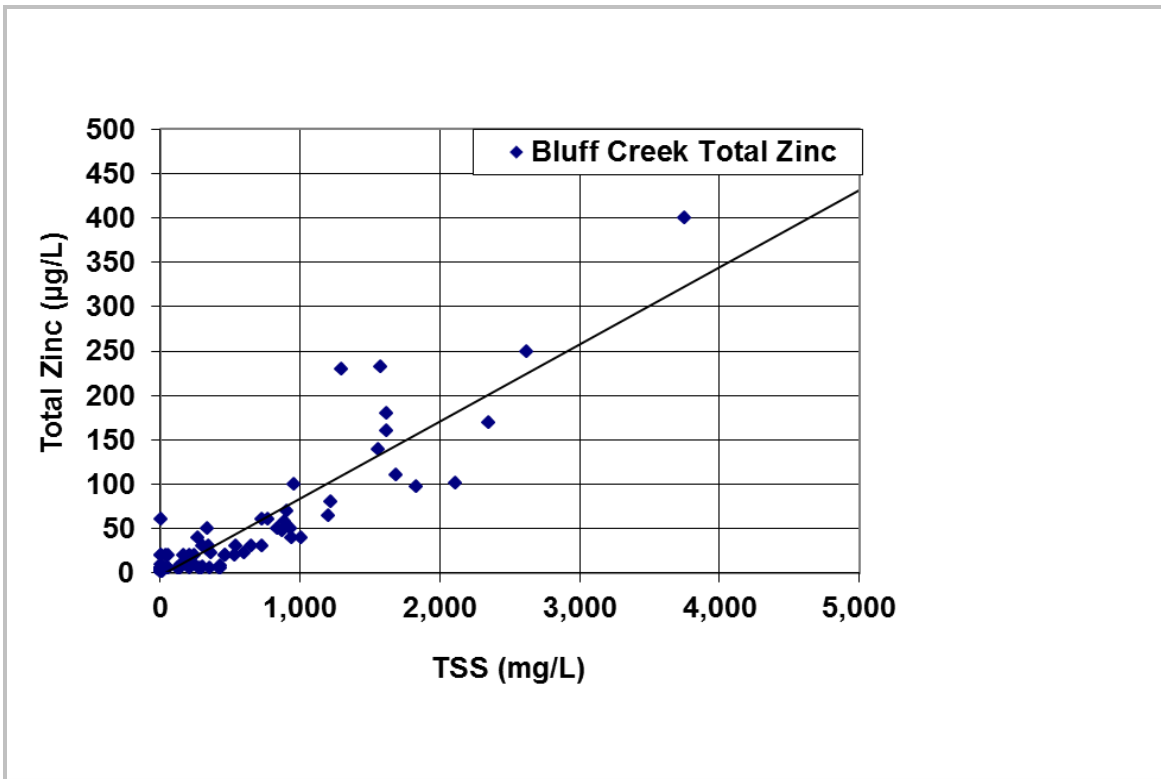
Figure D.5 Zinc versus suspended solids for Bluff Creek WOMP site

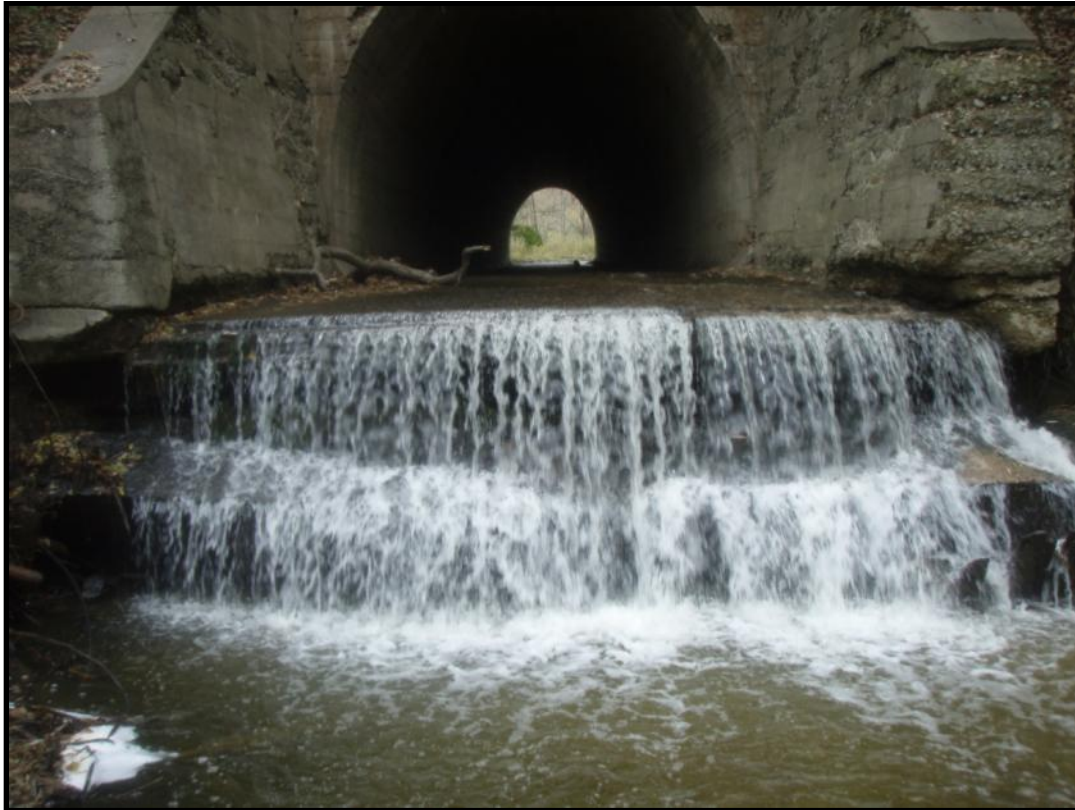
of the species when disease or other stressors reduce the population. Isolation may lead to the demise of a fishery, including extinction (Letcher et al., 2007). Evaluation of Bluff Creek stream reaches upstream and downstream of the culvert indicates upstream reaches were impaired while a downstream reach was not impaired. The data indicate habitat fragmentation has adversely impacted Bluff Creek's fishery and has resulted in impairment of stream reaches located upstream of the culvert (Barr Engineering Company, 2010).

**Figure D.7 Large drop at downstream end of regional trail culvert (looking upstream)**

Design and construction of a ramp structure at the culvert outlet is recommended to provide fish passage, thus removing the habitat fragmentation stressor in Bluff Creek. The ramp could be constructed of either concrete or natural rock material. Natural rock material is recommended as it would offer greater flexibility, be less susceptible to scour or undercutting, and would be more aesthetically appealing. The eroding left stream bank (looking downstream) immediately downstream of the culvert outlet (Figure D.8) should be stabilized at the time of ramp construction, likely with vegetated reinforced soil slope (VRSS), which is a bio-engineering approach that is well suited to steep banks. In addition, the culvert should be inspected to identify needed repairs and any repairs

identified during inspection should be made. The first step in the fish passage project is completion of a concept level design of the ramp, which would include the collection of existing site information, detailed site topographical survey, structural evaluation of the culvert, development of design sketches and a conceptual-level cost estimate. This phase would include initial discussion with agency representatives.
