Notice of Termination photo guidance

NPDES/SDS Construction Stormwater Permit Requirements

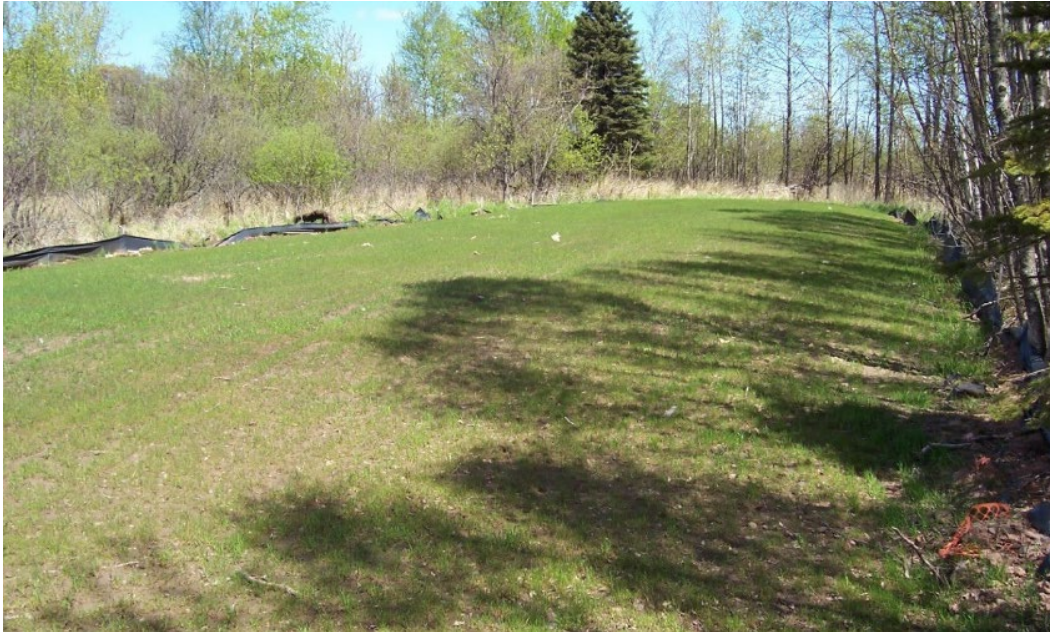
This image shows an acceptable vegetative cover, as it appears to be 70% or greater. However, permittees must remove all temporary synthetic erosion prevention and sediment control BMPs prior to submitting the NOT. The silt fence shown above should be removed.

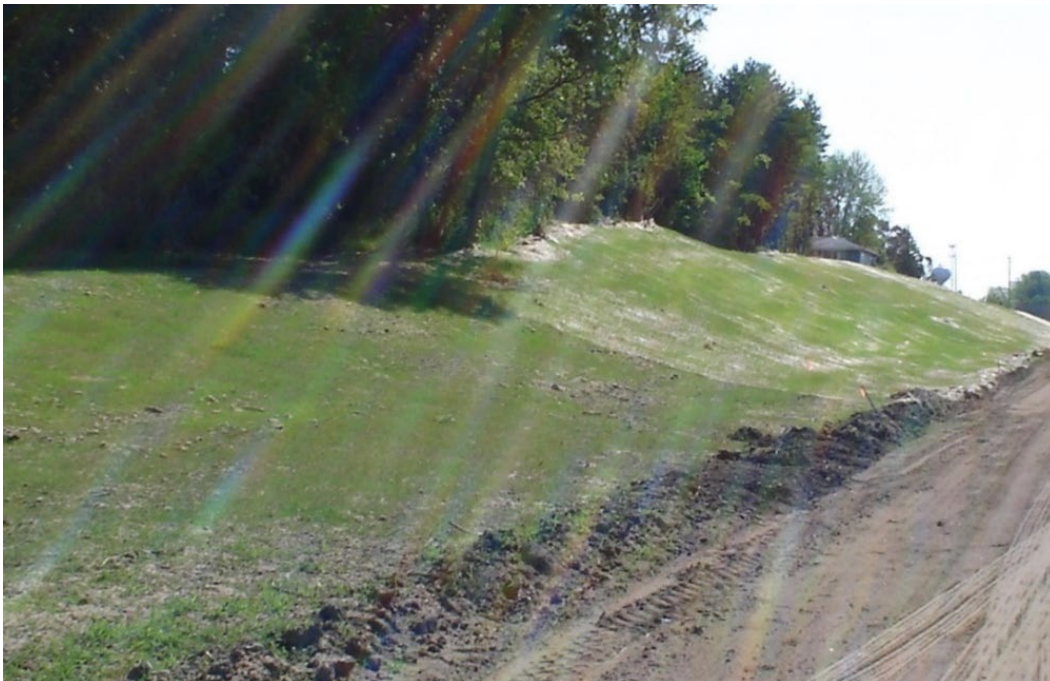
While the vegetative coverage in this image would be acceptable, as it appears to be 70% or above, permit termination would not be allowed. There is ongoing construction. Permanent cover has not been installed outside the vegetated area.

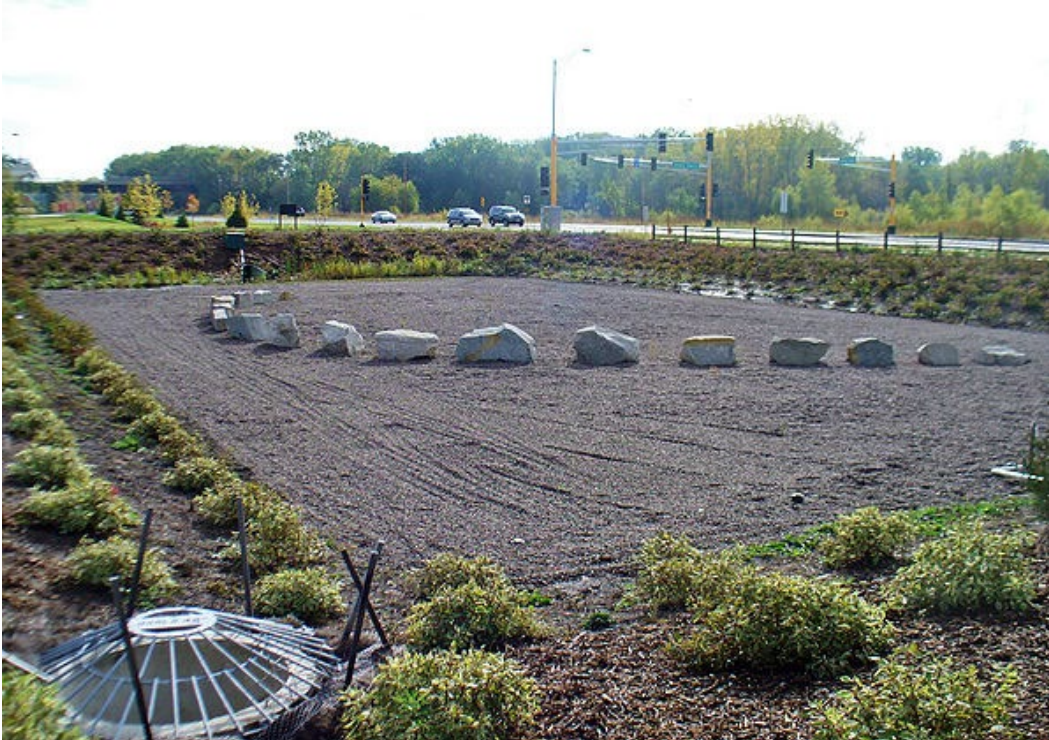
Vegetation is not required where it would interfere with the function of a specific area, such as impervious surfaces or the base of a sand filter. This sand filter system is intended to have a non-vegetated surface. Photo courtesy of [Ramsey-Washington Metro Watershed District](#).

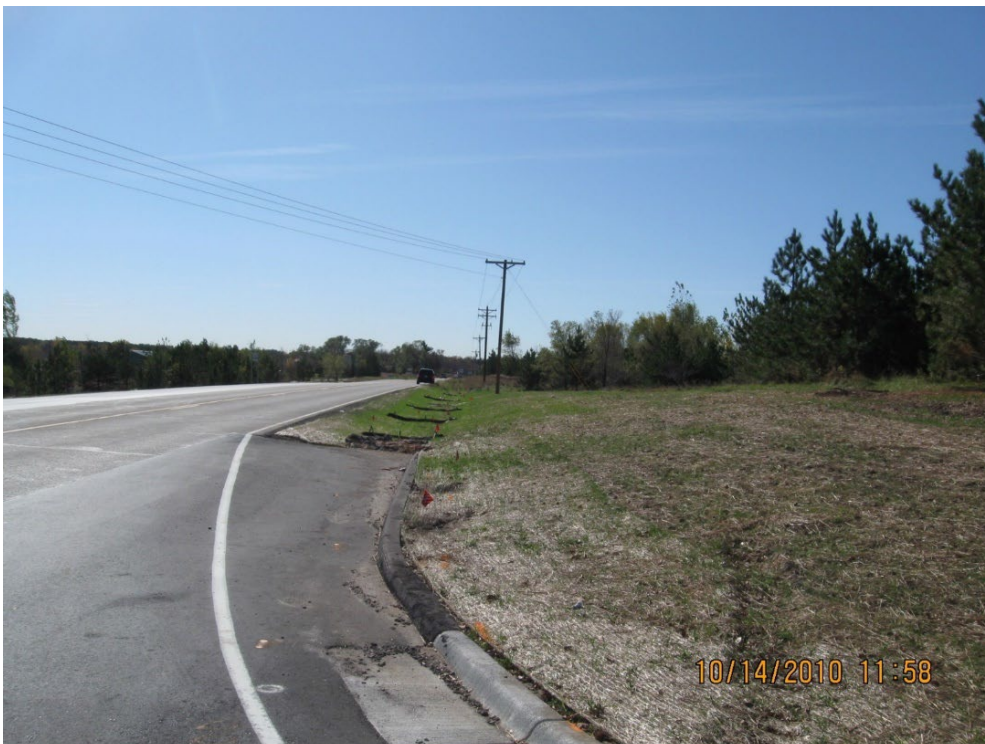
This image shows around 50% vegetative cover and would not be acceptable.

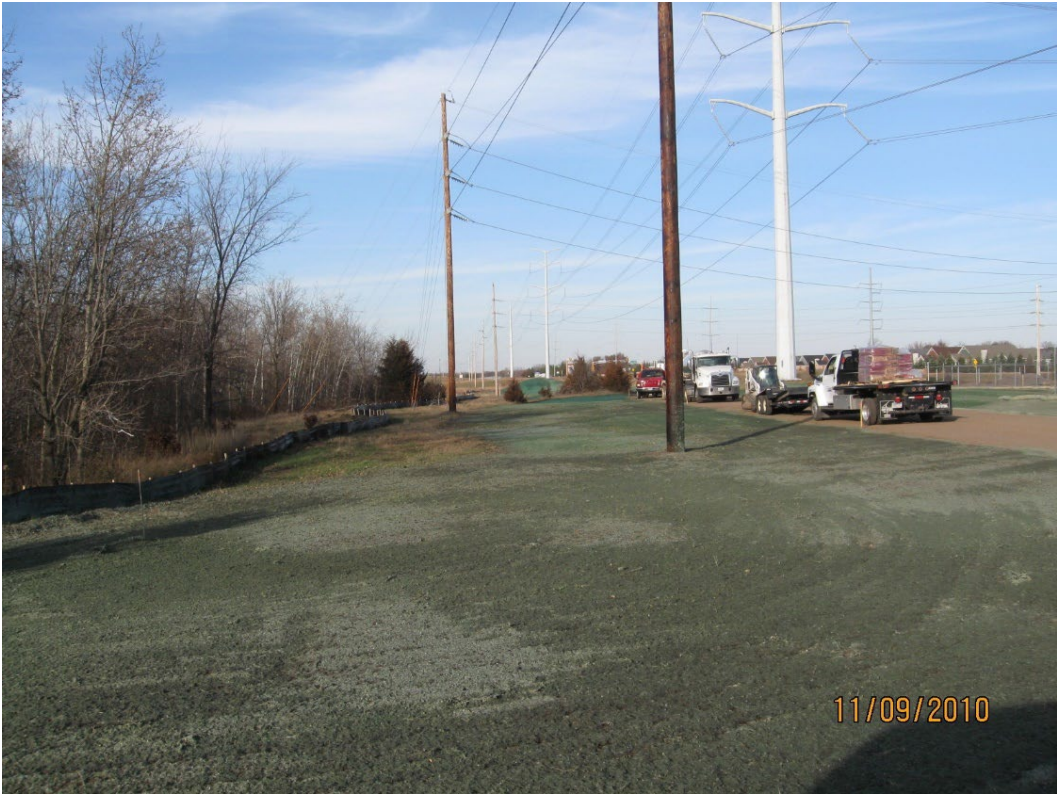
This image shows ground that has been disturbed and then stabilized with temporary hydraulically applied erosion control. This is not permanent vegetative cover and would not be acceptable.

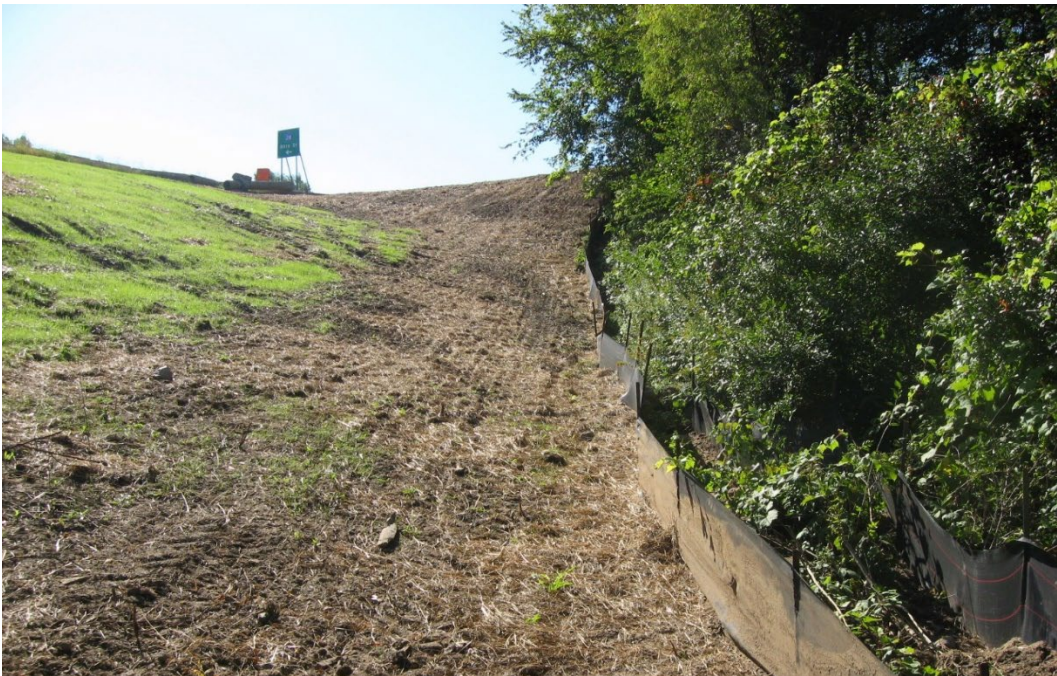
This image shows around 10% cover and would not be acceptable.

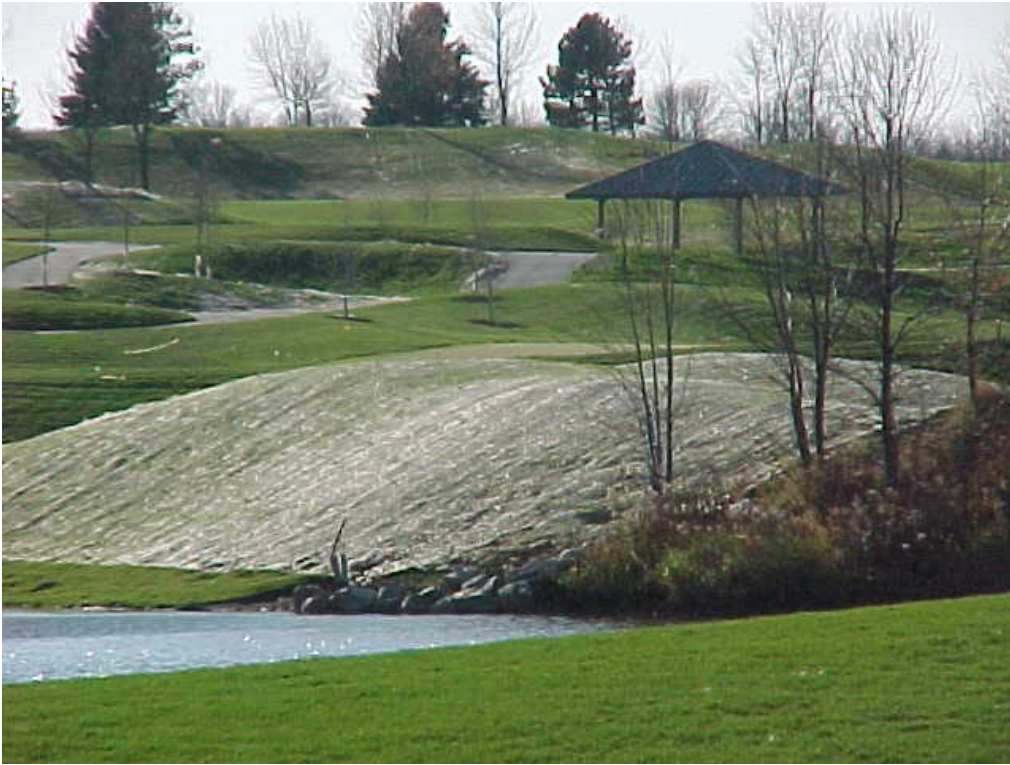
While the surrounding areas have plenty of vegetative cover, the area with erosion control blankets has around 10% vegetative cover and would not be acceptable.

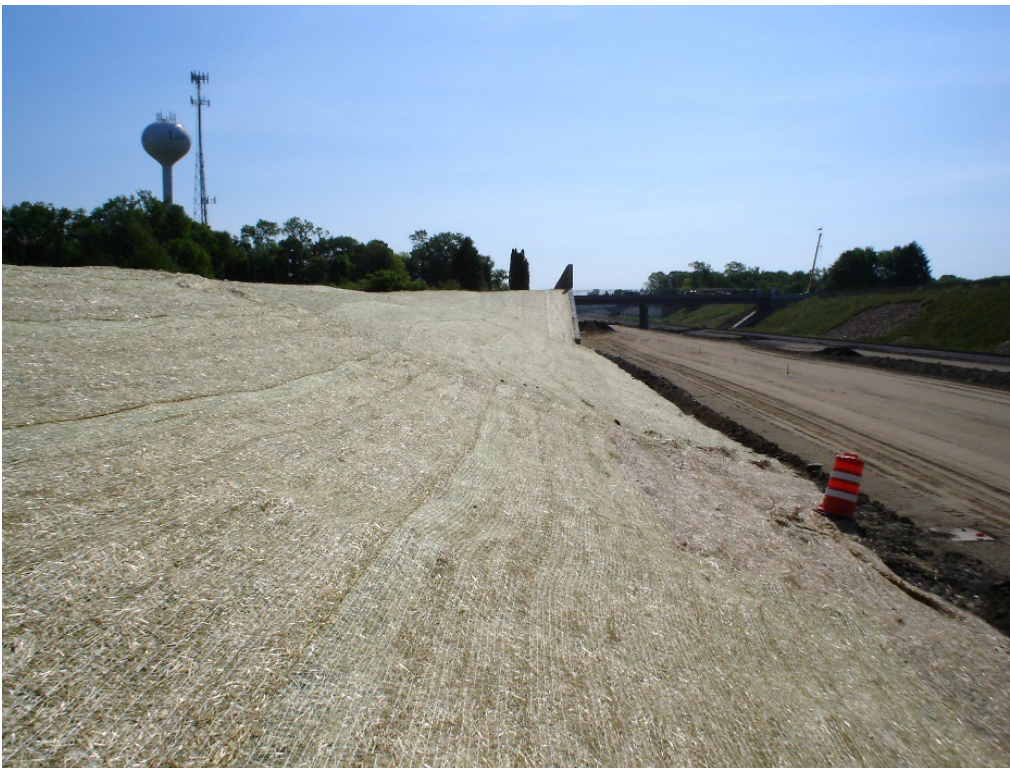
This slope appears to have no vegetative cover, as well as adjacent ongoing construction, and would not be acceptable.

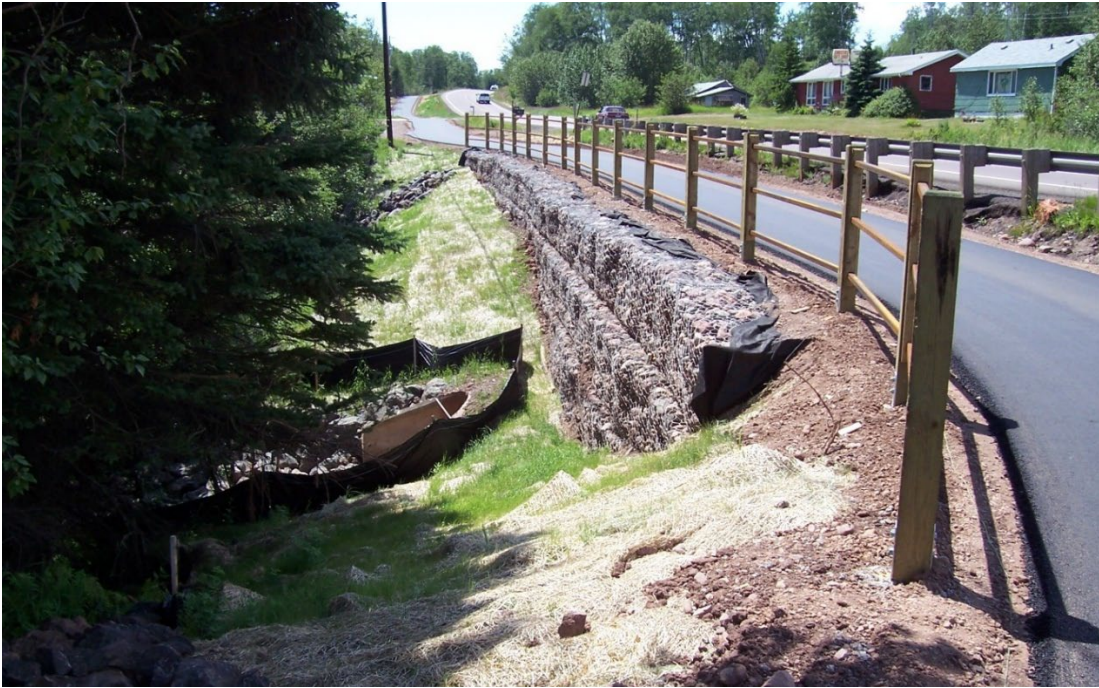
This image shows vegetative coverage of around 50% and would not be acceptable.

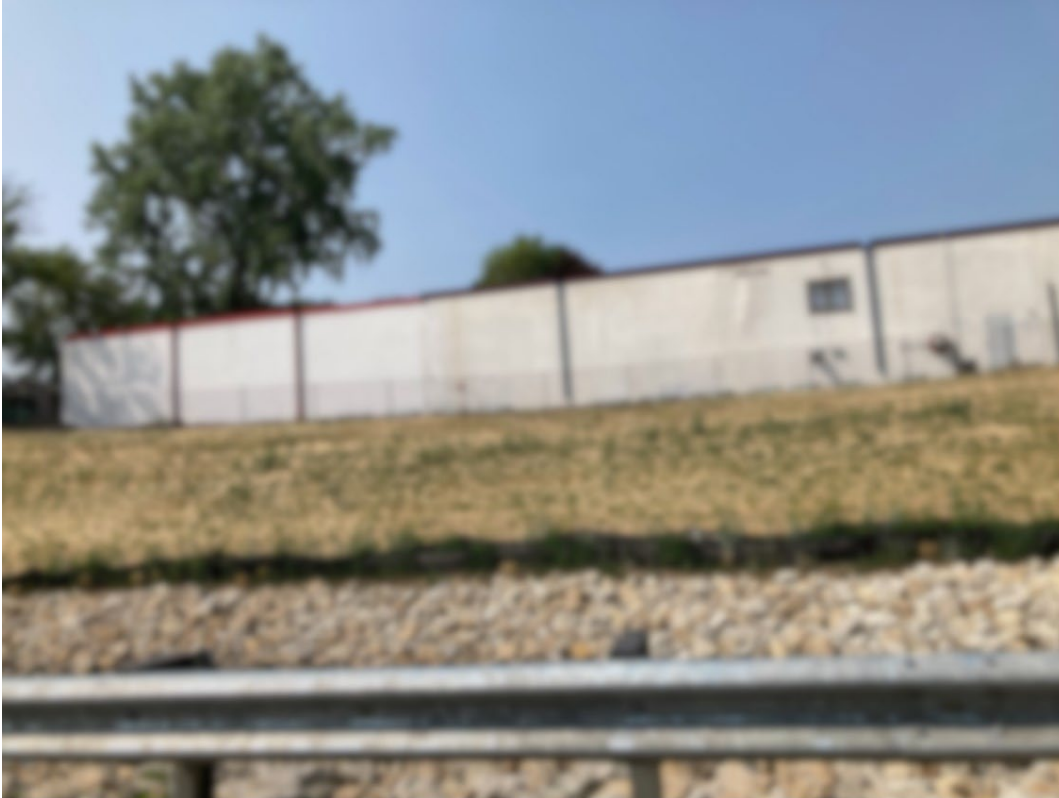
This photo is out of focus.

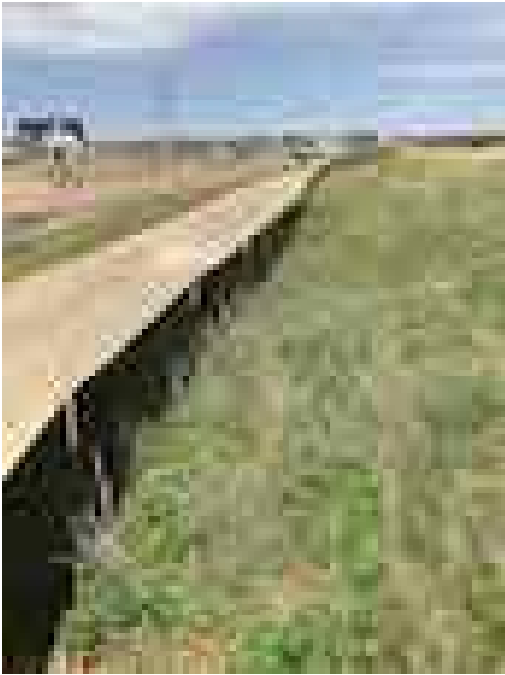
This photo is low resolution.

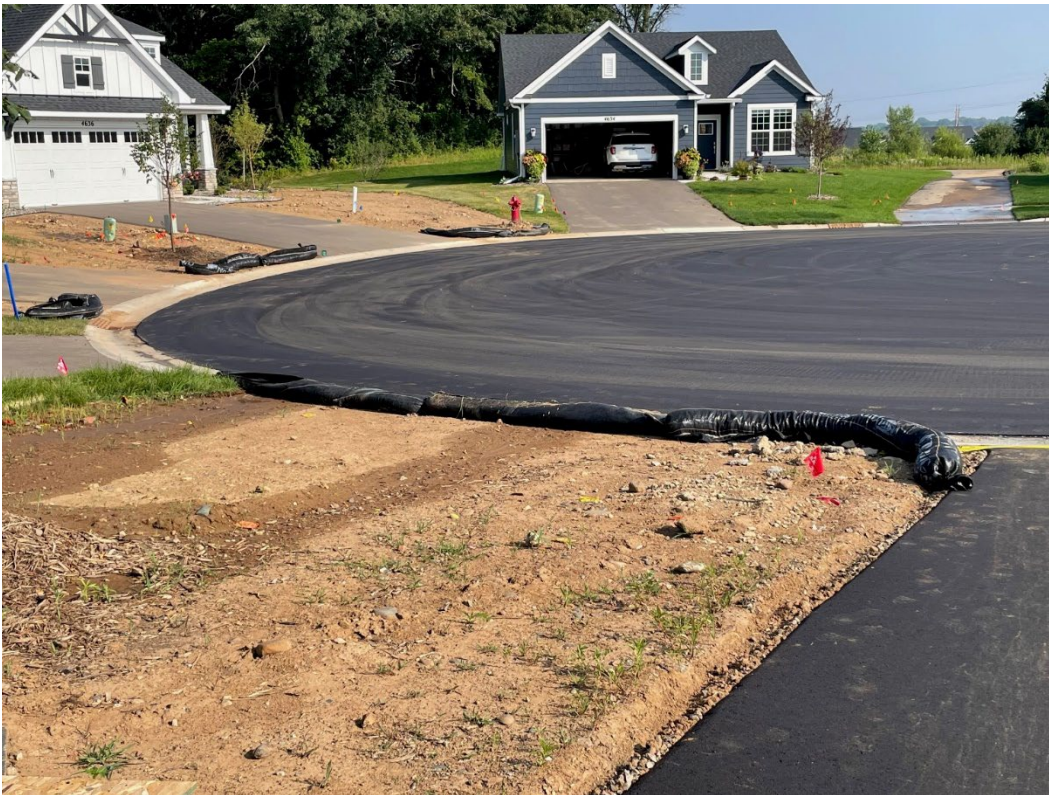
It isn't clear which lot in this residential development is being terminated. The lot in the foreground is not ready for termination.

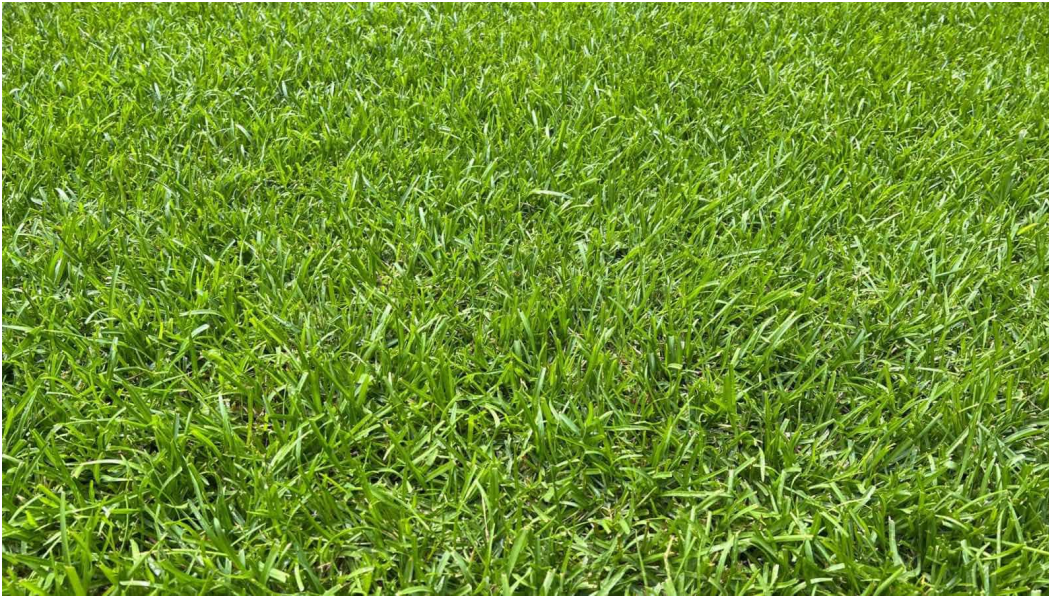
This photo is zoomed in too close to be identifiable.
