Chippewa River Watershed

Minnesota River Basin

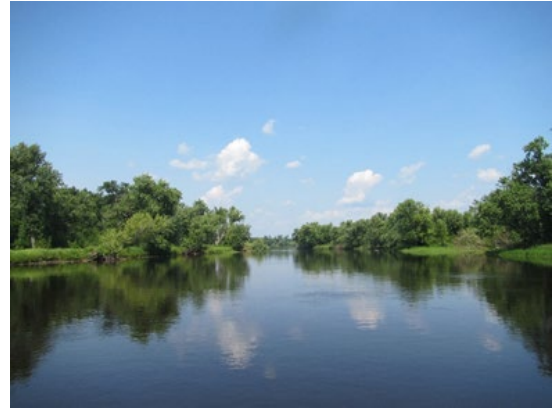
Figure 1. Chippewa watershed western Minnesota.

The Chippewa River Watershed is a heavily farmed area with most of the native prairie grassland and wetlands converted to row crops. Surface waters in the Chippewa River Watershed have been drastically altered with the installation of subsurface drain tiles and channelization of streams.

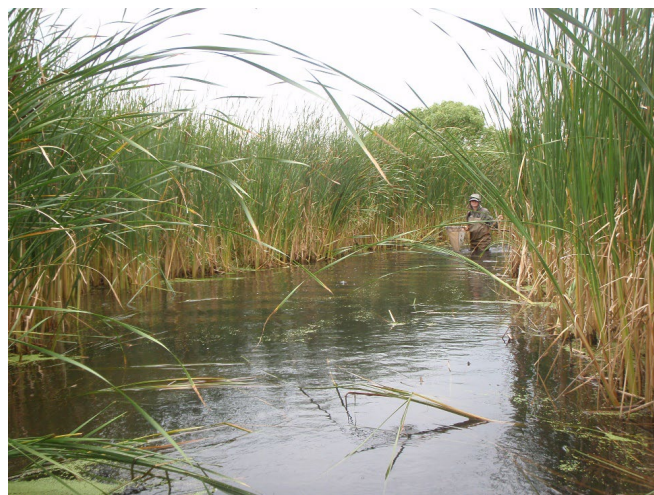
Picture 1. Outlet Creek in the Chippewa River watershed.

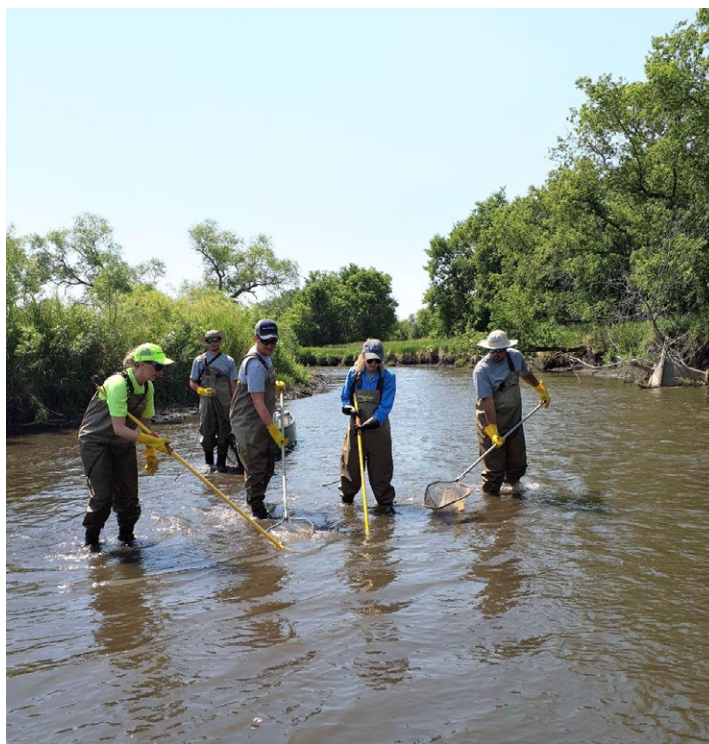
Picture 2. Biologist electrofishing on the Chippewa River.

Sampling fish in the watershed’s rivers and streams experienced challenges due to high water levels and COVID-19. Monitoring fish communities was scheduled to happen in 2019, but biologist were only able to sample 18 sites out of 51 due to increased precipitation. The remaining sites were scheduled to be sampled in 2020, but those activities were postponed due to the pandemic. Therefore, 24 stream sites were sampled for fish in 2021 to account for these disruptions.

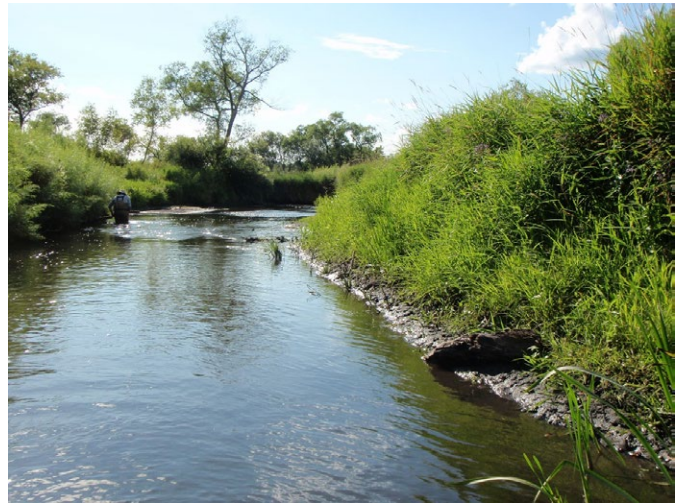
Picture 3. Outlet Creek

Outlet Creek, which begins at the outlet of Lake Minnewaska and flows into Lake Emily, was found to be impaired for aquatic macroinvertebrates based on 2009 monitoring. The 2015 Chippewa Stressor Identification Report noted that Outlet Creek biology was impacted by a number of stressors including high turbidity, high phosphorus, and low dissolved oxygen.

Stream monitoring has not been done to determine the effect these efforts had on water chemistry levels. Biological samples collected at station 09MN065 (Figure 2.) in 2019 and 2020 indicate that macroinvertebrates are now healthy. Ultimately, the influence of climatic differences between these two time periods can't be ruled out (see Trends section), none the less, the improvement is encouraging and highlights the potential for achieving water quality goals in a short amount of time.

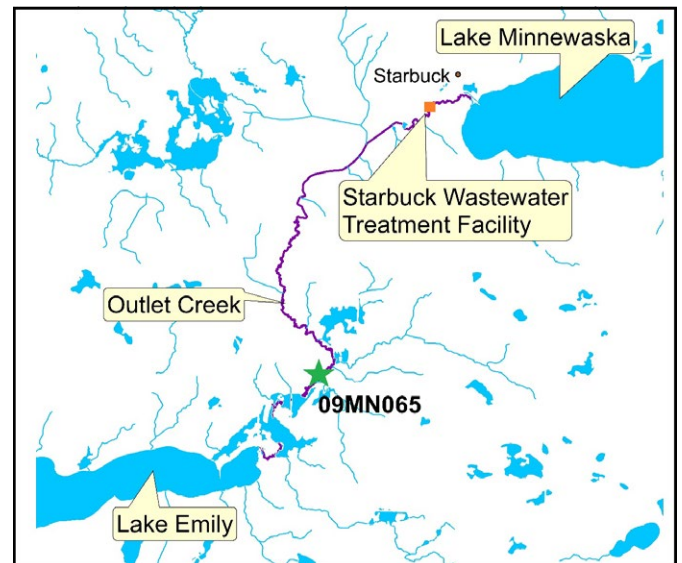
Figure 2. Starbuck Wastewater Treatment Facility discharged to Outlet Creek

The Starbuck Wastewater Treatment Facility was issued a new discharge permit in 2018 putting daily and annual limits on the amount of phosphorus it can discharge in to Outlet Creek (Figure 2.). The facility already had a State Discharge Restriction (SDR) limit of 1.0 milligrams per liter (mg/L), calendar month average, January-December, set in 2011 to protect Lake Emily. Lake Emily was listed as impaired for nutrients in 2002, but is now fully supporting aquatic life.

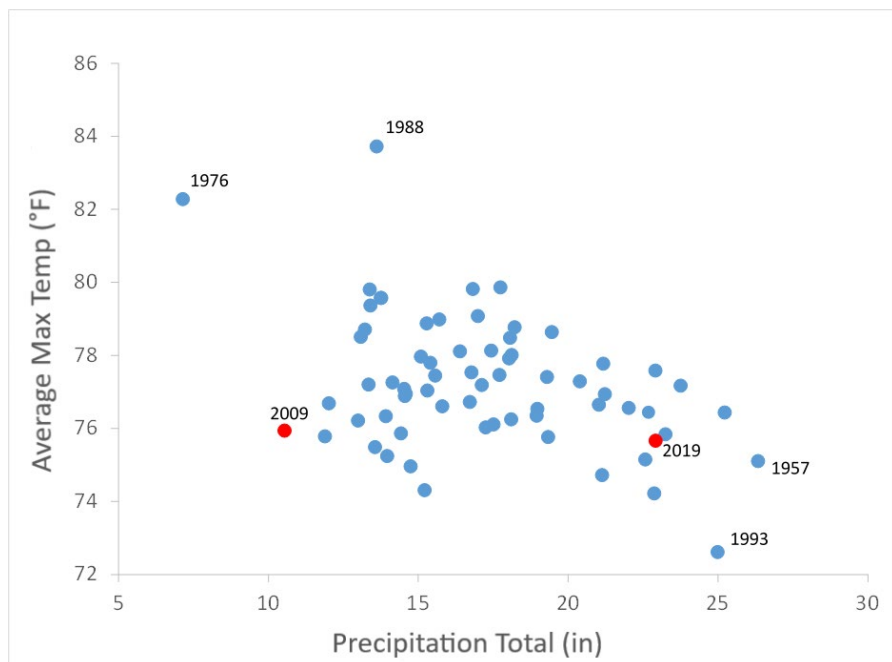
Figure 8. Characterization of air temperature and rainfall conditions for May-September period (1953-2019) for the Chippewa River watershed.

Context for these results is provided by a characterization of the climatic conditions that occurred during biological monitoring in 2009 and 2019. In 2009, the Chippewa River Watershed experienced an extreme drought (-7.0 in) and was near normal in terms of air temperature (-0.9 ° F) during the May to September time period (Figure 8.). Conversely, the watershed had above-normal rainfall (+5.4 in) and was abnormally cool (-1.2 ° F) in 2019 over the May to September time period. It is also worth pointing out that there were rainfall deficits during the three summers prior to 2009 monitoring activities and above-normal rainfall during the five summers prior to 2019; potentially exacerbating the observed differences between those monitoring years. Overall, given the dry conditions affecting the watershed in 2009 and the wetter-than-average and cooler conditions present in 2019, there is a high likelihood the observed changes in biological condition at either the watershed or individual site scale are at least partially due to differences in climatic conditions between the two periods.
