Watonwan River Watershed Hydrology, Connectivity, and Geomorphology Assessment Report

MINNESOTA DEPARTMENT OF NATURAL RESOURCES
DIVISION OF ECOLOGICAL AND WATER RESOURCES

2014

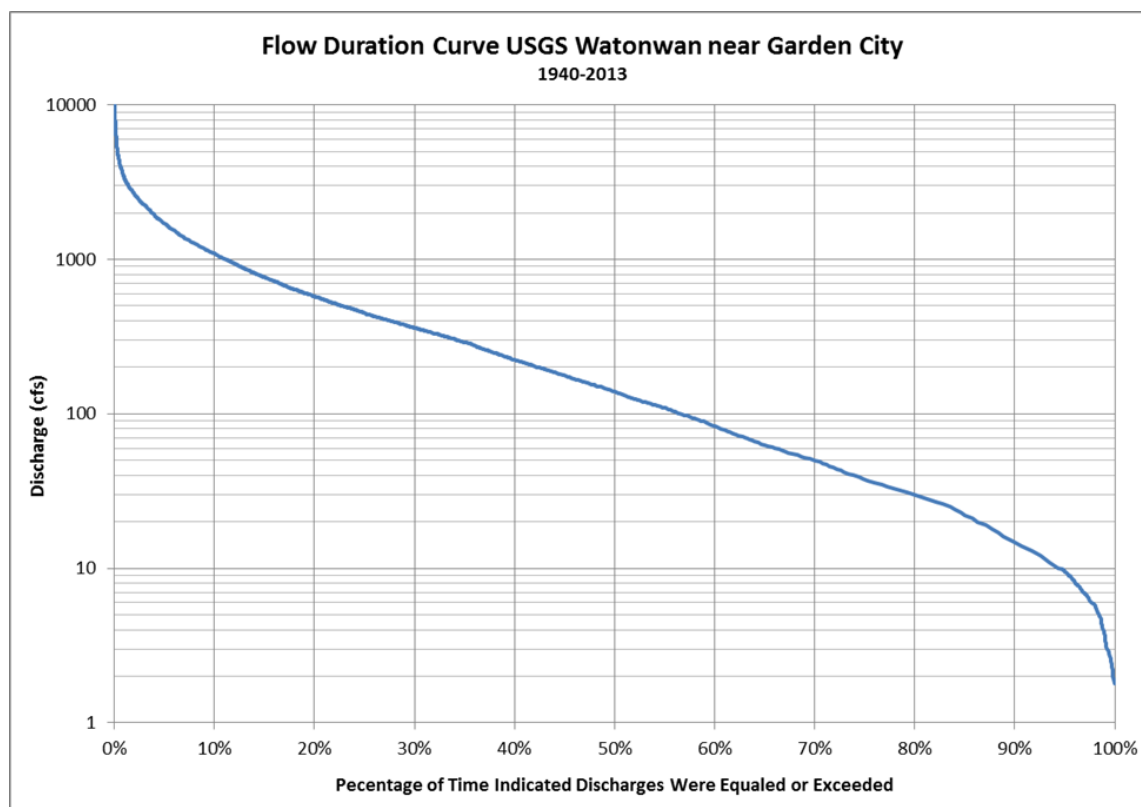
Figure 9. Flow duration curve of Watonwan monthly discharge values.

Discharge data are also used to create a duration curve (Figure 9). Duration curves are used to examine the discharges and determine when a specific flow volume was exceeded or equaled in a given period, such as how often the flow volume exceeds high (*i.e.* 10th percentile) and low (*i.e.* 90th percentile) flow conditions for the watershed.

A curve with a steep slope throughout indicates a highly variable stream whose discharge is derived from direct runoff. A flat slope indicates the potential presence of surface or ground-water storage, which can help meter out the flow at a slower rate. The curve for the Watonwan is steeper, indicating variability within the system. This is likely related to the “flashiness” or rapid response to rain events within the watershed. It should be noted, however, that while the low flow conditions (*i.e.* < Q90) do have a high slope, no zero flow conditions are recorded. This indicates that while a negligible amount of perennial storage exists within the watershed, there is likely some level of ground water interaction with the river system at low flows.

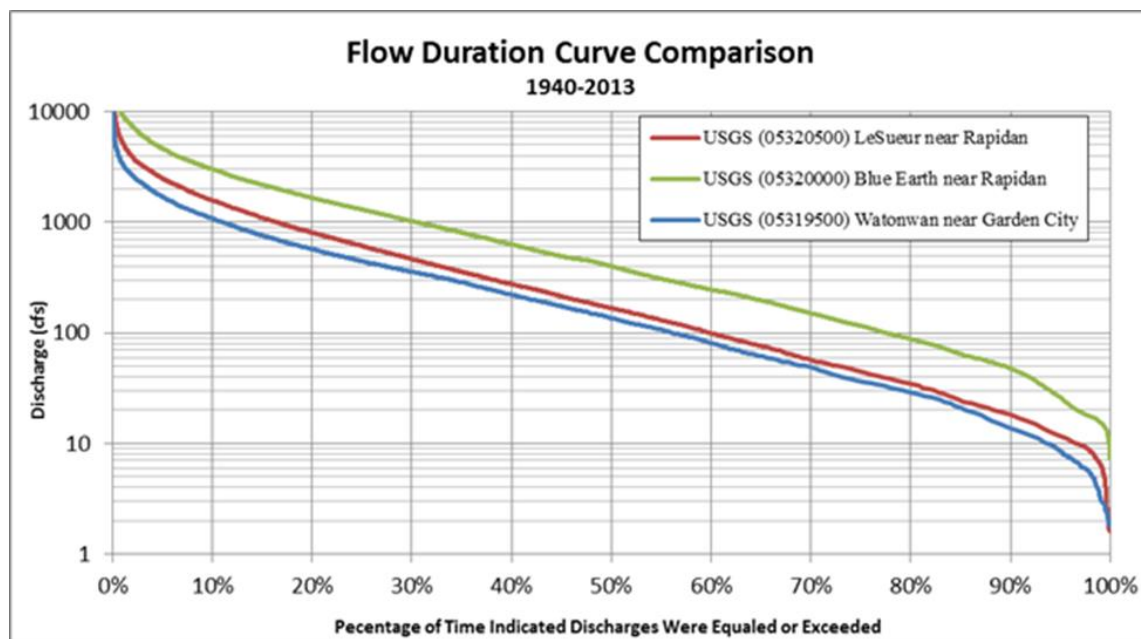
Figure 10. Flow duration curve plotted as discharge over watershed area.

The Greater Blue Earth River watershed is comprised of the Watonwan, Blue Earth, and Le Sueur Rivers. When all three rivers are plotted out as duration curves (Figure 10), some differences in the watersheds can be noted. The slopes of the main body of the curves (*i.e.* Q15 – Q85) are very similar, with the primary difference being the volume of each watershed. However, the upper and lower ends of the curves reflect some significant differences. It should be noted that the Watonwan has the steepest slopes at both ends, indicating that the watershed reacts faster to rain events due to limited storage capacity within the system.

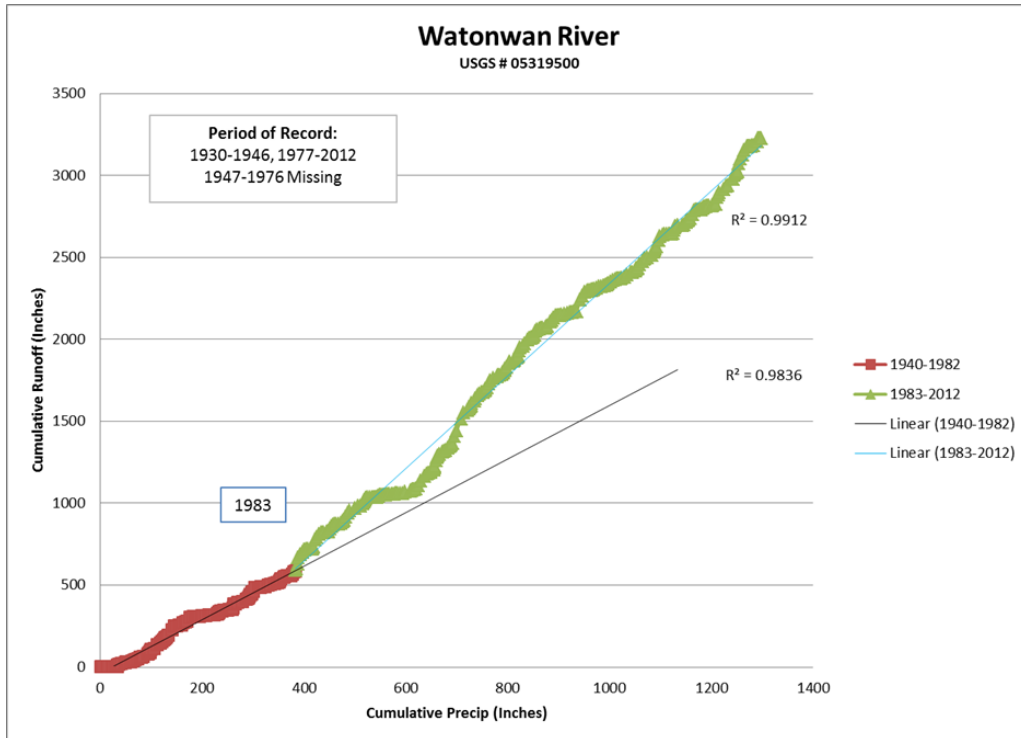
Figure 13. Double mass curve of runoff and precipitation demonstrates an increase in the amount of runoff per inch of precipitation due to a change in the relationship around 1983.

Before the shift in slope at 1983, there is a fairly strong relationship between runoff and precipitation during the 1930 to 1982 period. A strong relationship also occurs from 1983 to 2012 following an increased slope indicating more water is being discharged from the watershed than can be accounted for by the annual precipitation totals. The one downward anomaly depicted within the 1983 to 2012 period is due to the drought conditions of 1988 and 1989. This change in the slope relationship from 1983 to 2012 indicates runoff from the watershed is increasing relative to the amount of rain. Within the entire data set, both low and high annual precipitation volumes were recorded suggesting that a period of wet or dry conditions does not affect this relationship.

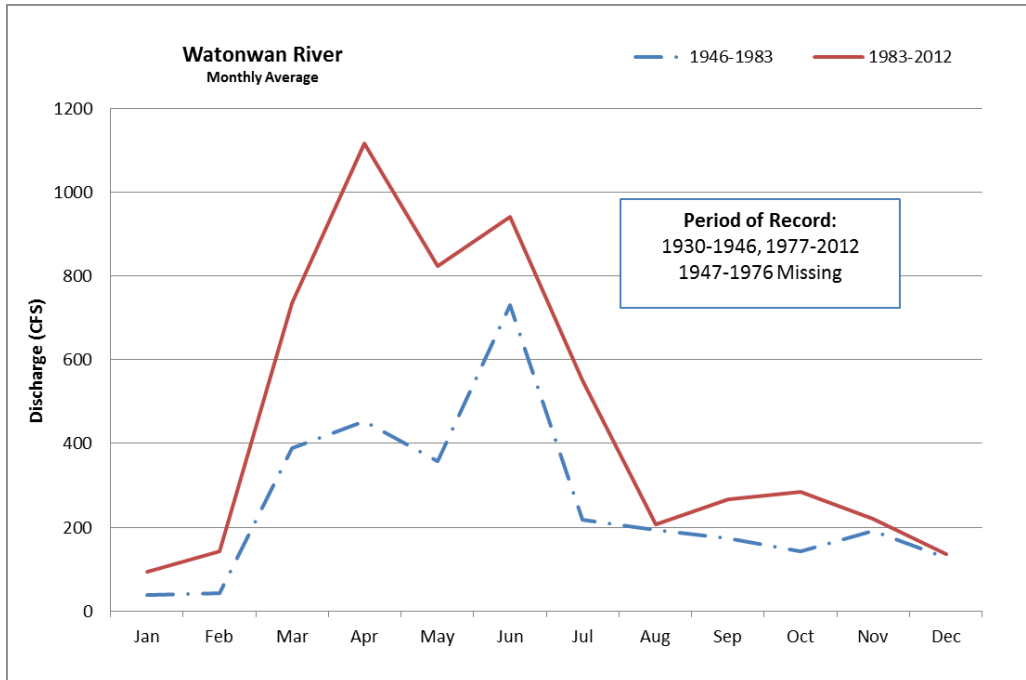
Figure 14. Comparison of average monthly discharge from 1946-1983 and 1983-2012 to demonstrate the degree of change.

The two periods of record can also be plotted out as average annual discharge. While this does condense the data, it is useful to examine the change between the average values. As seen in Figure 14, the average value has changed in both volume and timing. This is a general comparison, as the missing data may increase or decrease the annual average for the 1930-1983 period of record.

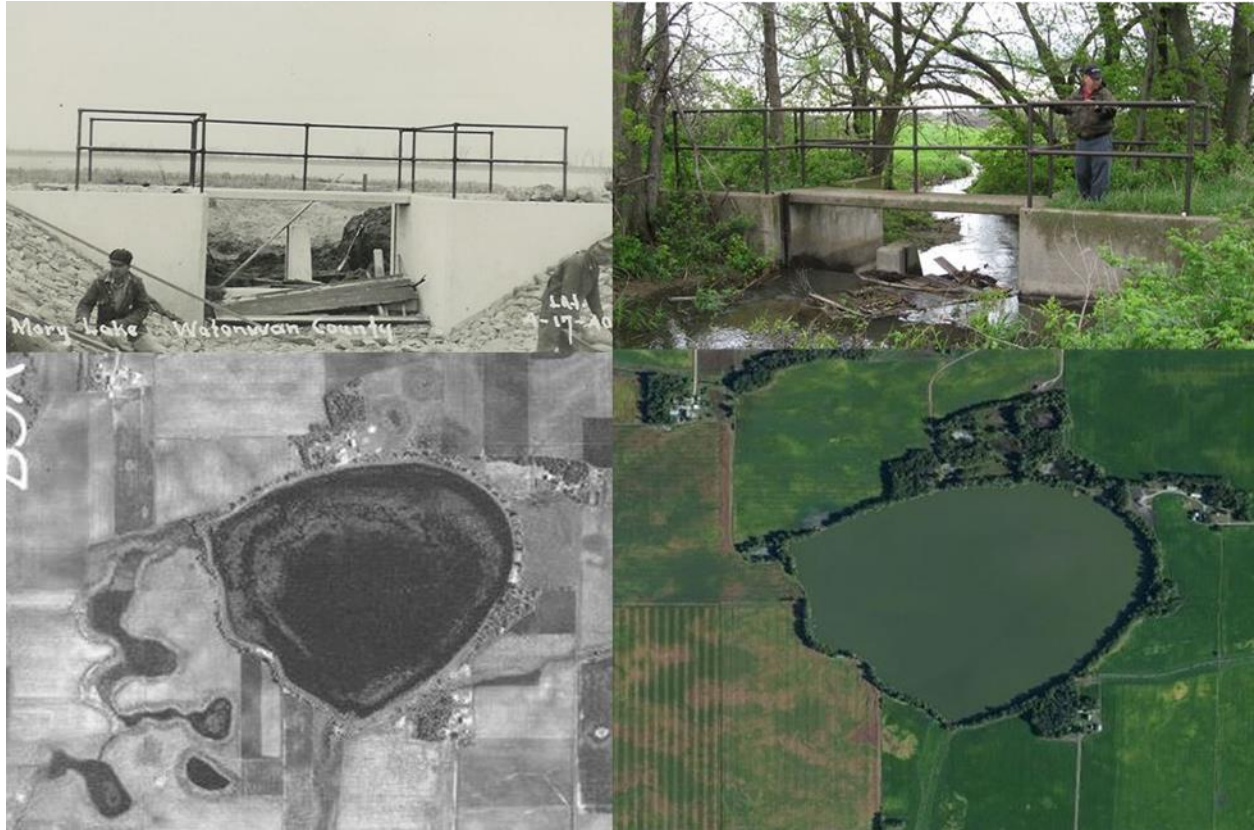
Figure 20. Outlet structure on Mary Lake in central Watonwan River watershed. Structures throughout the watershed such as this likely changed lake and stream stability, affected sediment deposition, emergent aquatic vegetation, and hydrology.

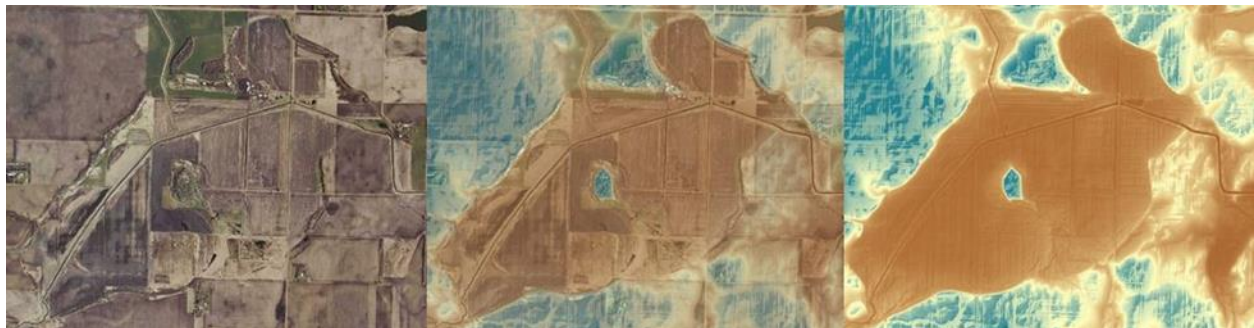
Figure 21. Not all lakes, wetlands, and depressional areas were originally included within the longitudinal connectivity of the Watonwan watershed. Here, the original Mountain Lake can be seen through LiDAR imagery. Mountain Lake was ~900 acres and was drained in 1905-06 as demands for increased agriculture led to the expansion of drainage ditches through south central Minnesota.

After settlement, lakes, wetlands, and depressional areas within the Watonwan watershed were altered (*i.e.* outlet structures) or drained (*i.e.* public drainage system). Drainage and outlet structures have had drastic impacts on the longitudinal connectivity, natural drainage network, and quality of aquatic resources within the Watonwan watershed (Figures 20 and 21).

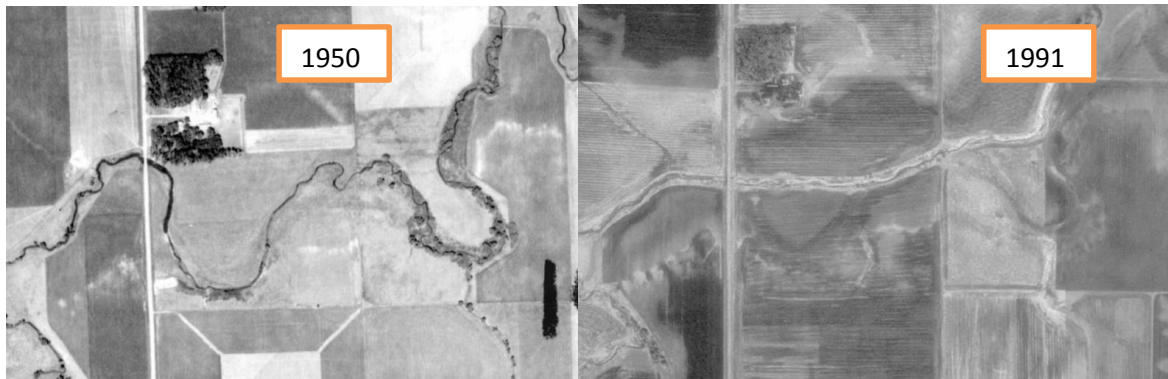
Figure 24. The channel at the North Fork Watonwan geomorphology survey site was straightened at some point between 1950 and 1991.

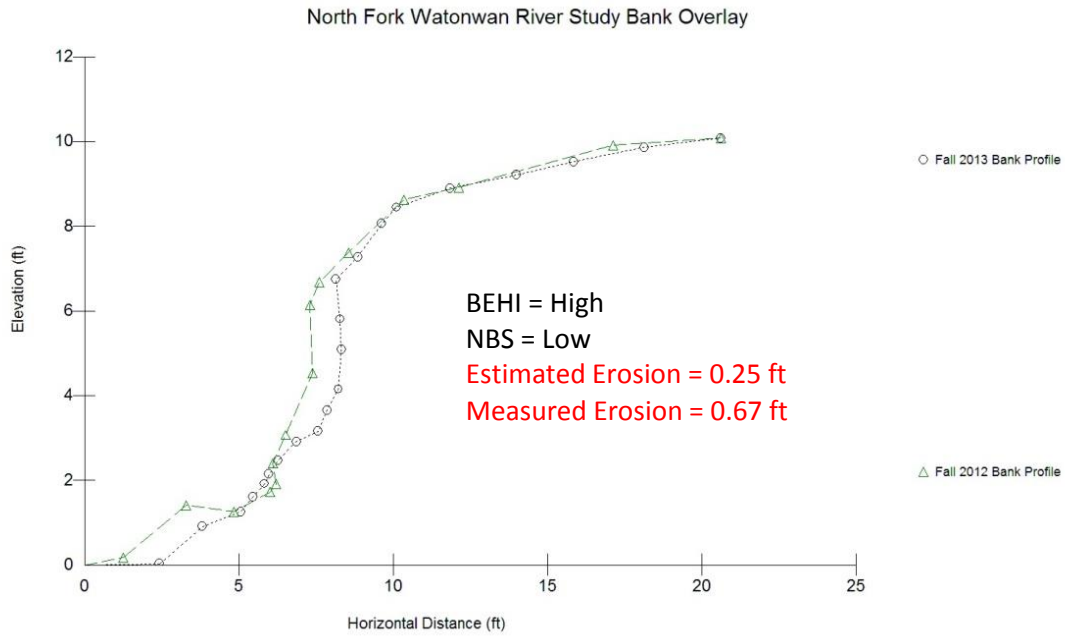
Figure 27. Cross sectional profile of monumented pool study bank from 2012 and 2013 surveys along with BEHI, NBS, estimated, and measured erosional rates.

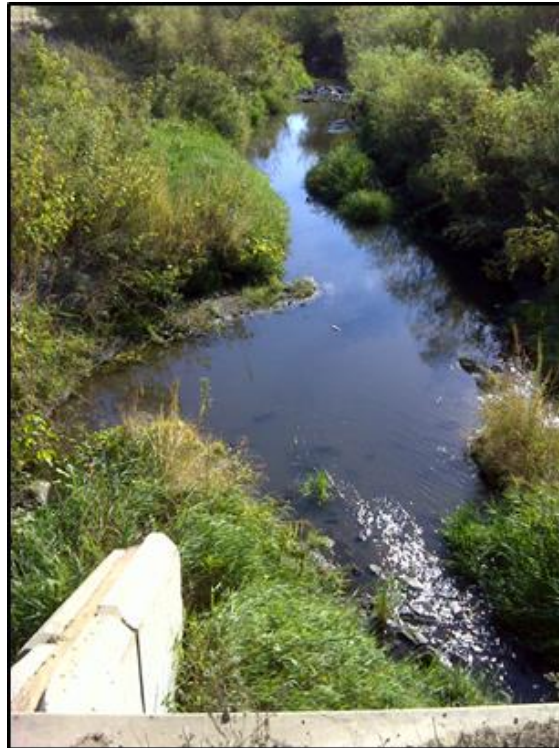
Figure 28. Sediment deposition within the culvert barrels indicate improper sizing.

The road crossing 130 feet upstream from the start of the survey reach provides an example of what happens when road crossings are improperly sized. The amount of sediment deposited in the three barrel culvert relates to the fact that the road crossing was built too wide for the bankfull channel; therefore, sediment is being deposited and developing a floodplain in the other culvert barrels (Figures 28 and 29). In order for a stream to maintain stability, it must transport the water and sediment of its watershed. Ideally, sites like this would have a culvert large enough to handle the bankfull discharge, and then have floodplain relief culverts at the floodplain elevation to allow flood flows to stay on the floodplain and not become bottlenecked (Zytkevich and Murtada 2013). An indirect impact of these culverts stems from the channelization of the stream that directed the flows straight into the culverts. Historically, the North Fork Watonwan River was naturally meandering. In order for this low gradient headwater type channel to be stable, it will continuously work to increase sinuosity. Much of the lateral bank erosion noted in the study reach stems from the channelization that took place historically.

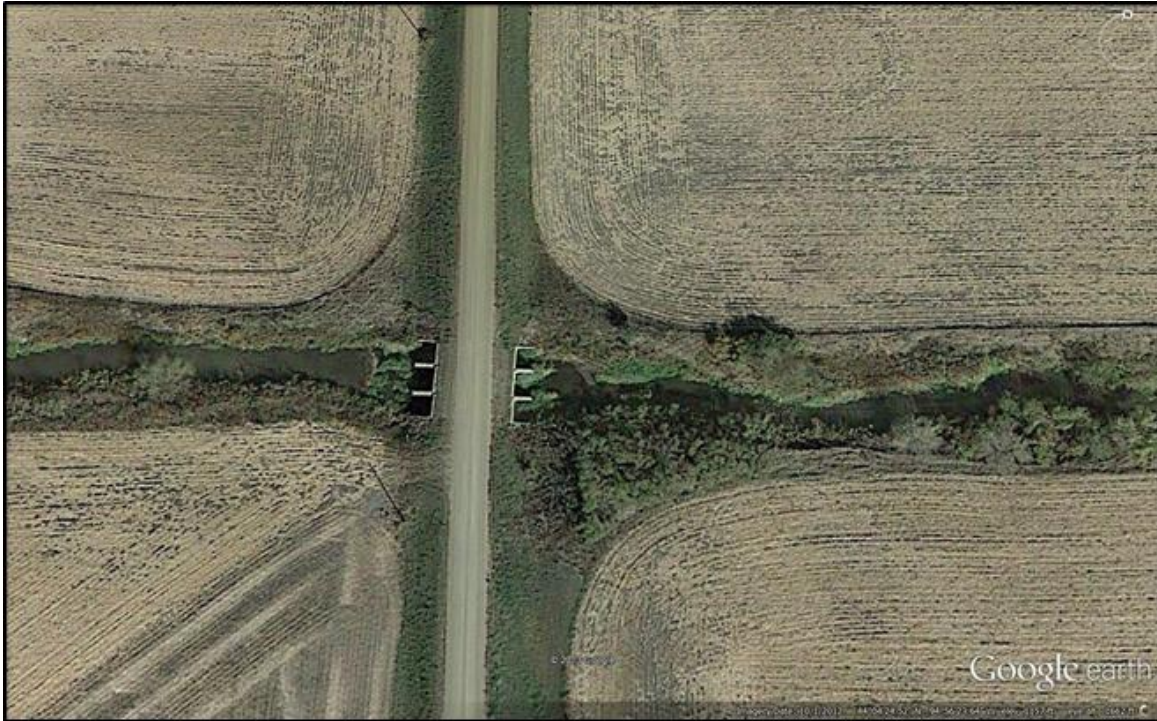
Figure 29. Triple barrel culvert, two barrels filling with sediment and providing flood plain relief during high flows.

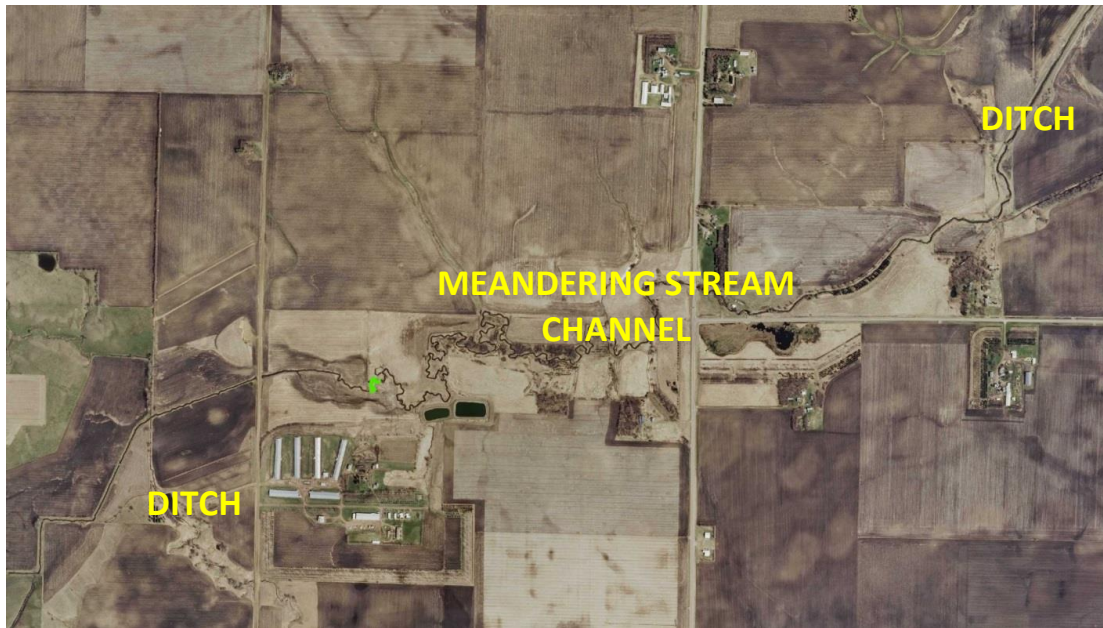
Figure 32. Judicial Ditch #1 was historically channelized both upstream and downstream of the geomorphology survey site (green area) that represents the naturally meandering channel this system once was.

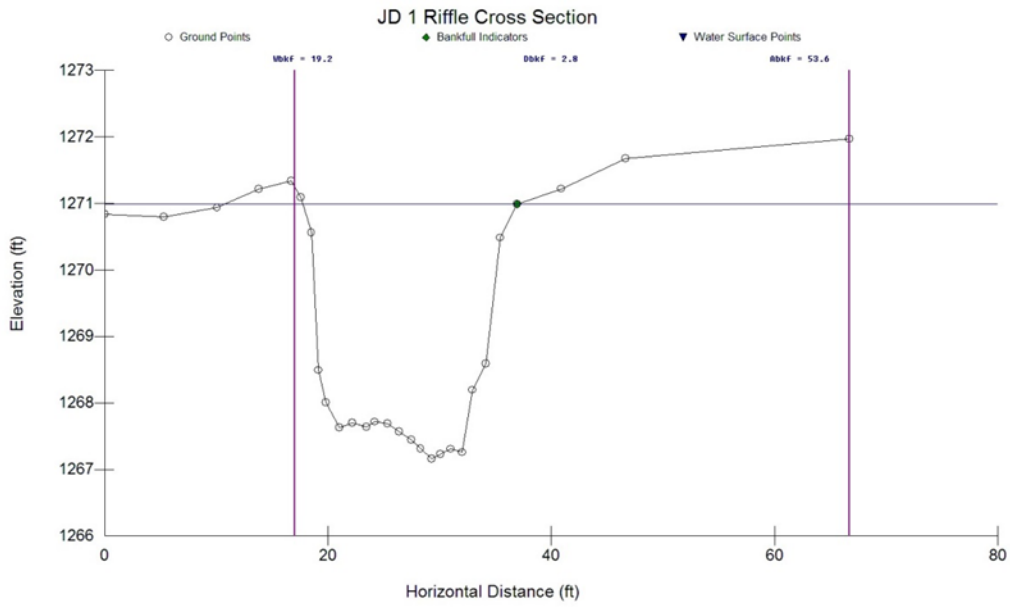
Figure 34. Riffle cross sectional profile that characterizes the deep and narrow nature of “E” channel types.

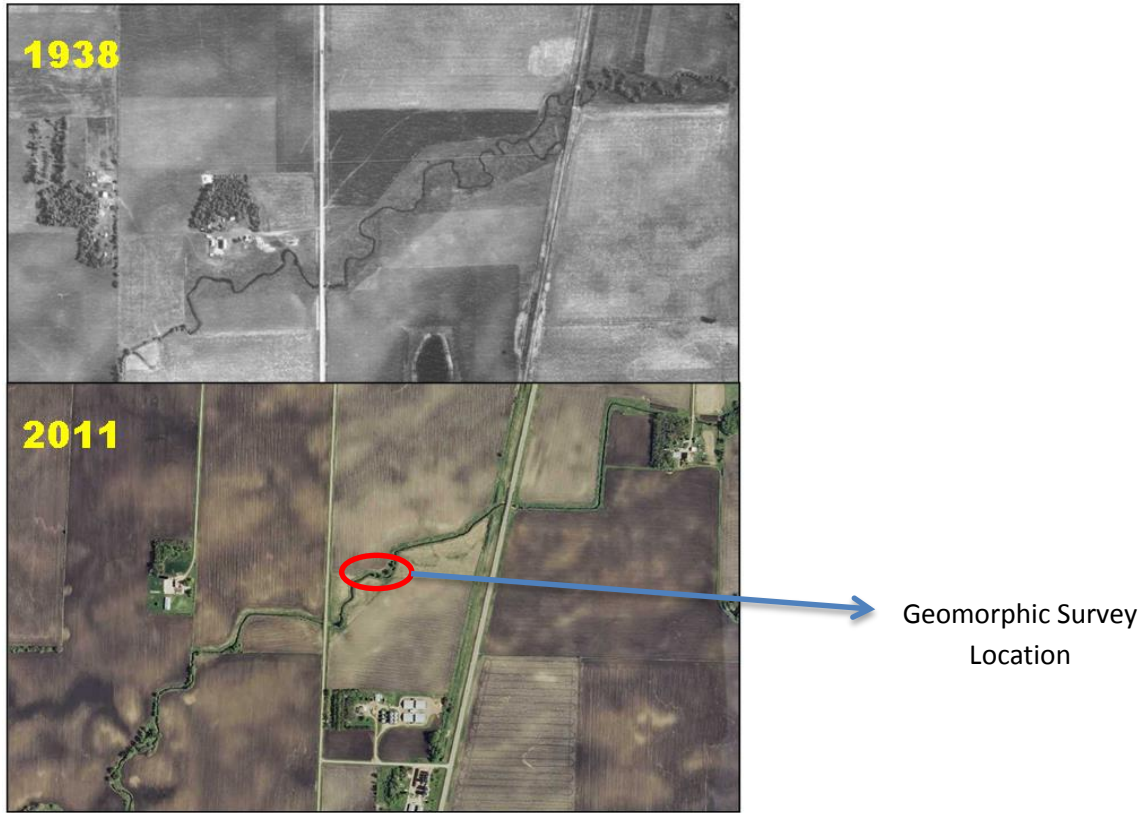
Figure 39. Aerial photography depicts historical channelization of the upper St. James Creek geomorphology survey site.

The upper St. James Creek site is located between Kansas Lake and MN Hwy 4 southwest of the city of St. James. The landuse upstream is primarily cultivated crops 87.5%, with 3.9% perennial cover, 3% water, and 5.6% in other land uses (WHAFF). According to the MPCA, there is currently not enough data available to determine the recreation, aquatic life, or fish consumption condition (*i.e.* no impairments listed). The stream reach was surveyed once in the fall of 2012 with a dry stream bed and resurveyed in the spring 2014 at moderately low flow. A wide perennial buffer (*i.e.* >50ft) borders the stream on both sides of the channel throughout the surveyed reach. Similar to other sites, there is evidence of past stream channelization upstream and downstream (Figure 39).

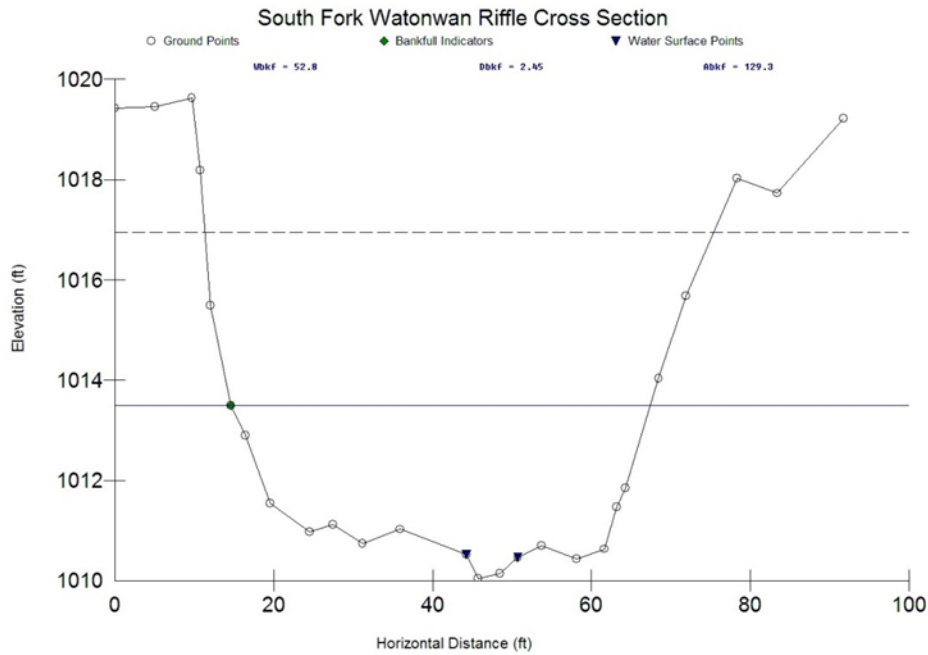
Figure 41. Riffle cross sectional profile indicates that the South Fork of the Watonwan River at Eagle's Nest County Park does not access its floodplain at two times bankfull flows.

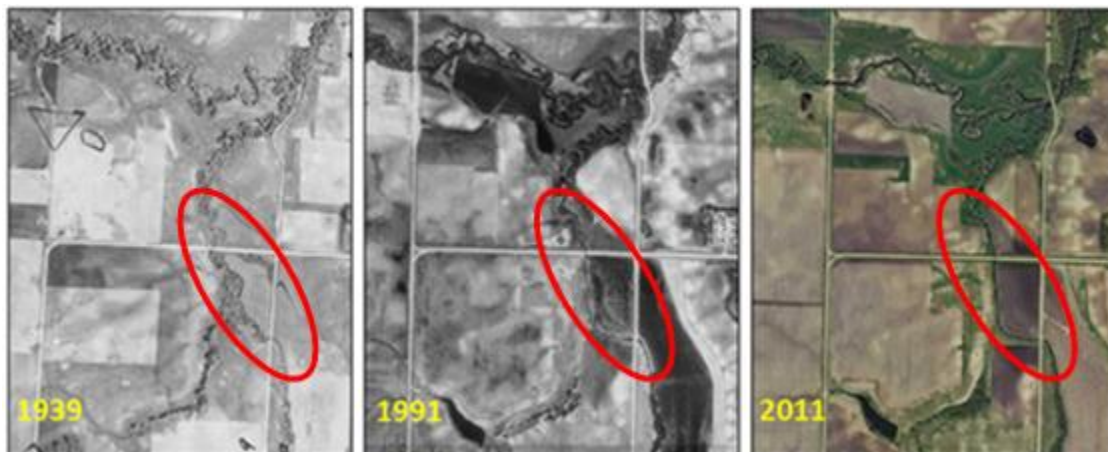
Figure 45. Historical aerial photography depicts past channelization within the Willow Creek subwatershed.

The stream is narrow, deep, and classified as an E channel representing good floodplain connectivity. Streams such as this (*i.e.* E4 stream types) have a very high sensitivity to disturbance, good recovery potential, moderate sediment supply, high streambank erosion potential, and riparian vegetation plays a significant role in maintaining stability (Rosgen 1994; Appendix II). The Willow Creek survey site has a very low water surface slope (*i.e.* 0.00009 ft/ft) and is located in a depression, as shown on the LiDAR image (Figure 44). A low water surface slope is typical of E channels, but approximately 400ft downstream of the surveyed reach a beaver dam was found in both 2012 and 2013 that likely influenced the shallow slope and pebble count during surveys. There is evidence of past channelization on Willow Creek (*i.e.* 50.4% of stream miles have historically been channelized) (Figure 45). The sinuosity is low for what is typically found in E channels (*i.e.* typically >1.5).

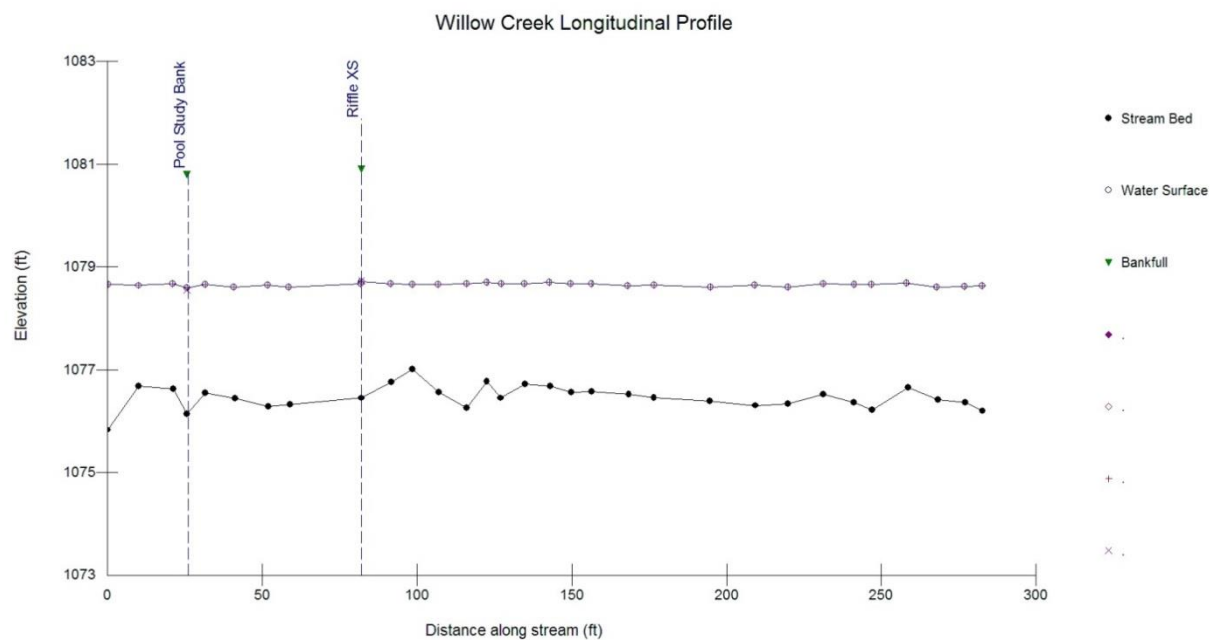
Figure 46. Longitudinal profile of Willow Creek geomorphology survey site depicting minimal undulation in the streambed.

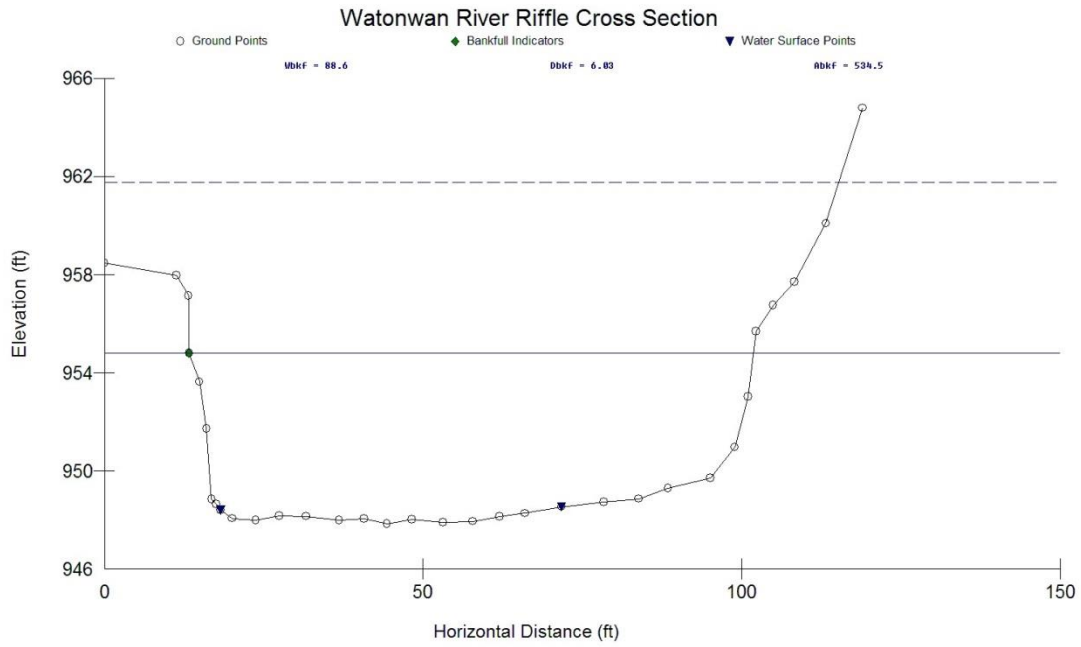
Figure 47. Riffle cross section surveyed in fall 2012.

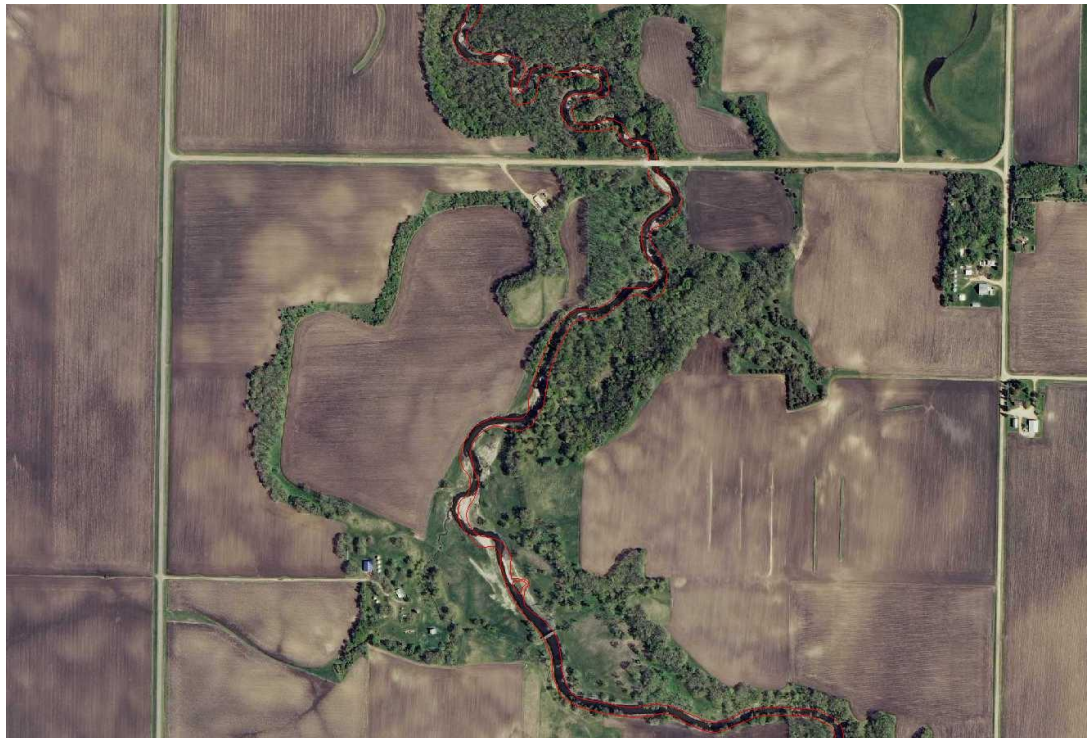
Figure 51. Streamline overlays created from historical aerial photography indicate that the stream reach in which the lower Perch Creek geomorphology site is located within has not seen many significant changes to pattern, profile, or dimension since 1991.

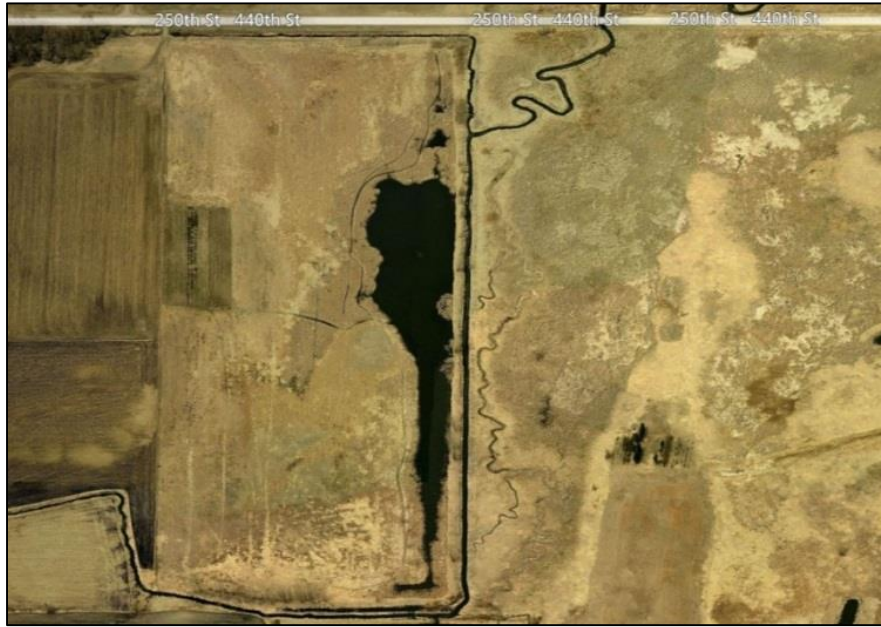
Figure 54. Aerial photography and LiDAR imagery depicts historical channelization within close proximity to the upper Perch Creek geomorphology survey site.

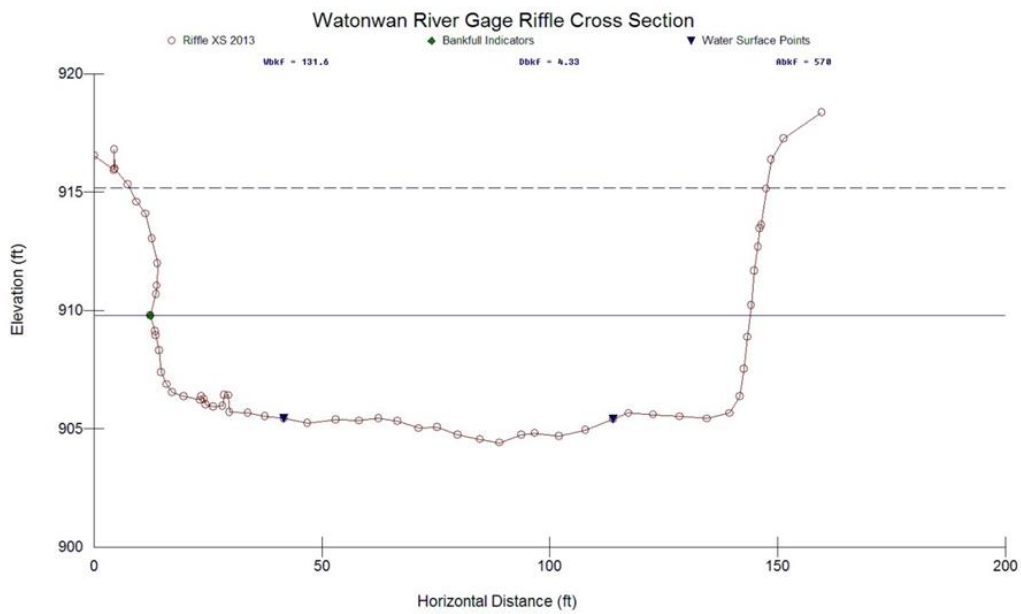
Figure 56. Riffle cross sectional profile at the lower Watonwan River geomorphology survey site indicating that the channel is over wide and does not access its floodplain at 2x bankfull flows.

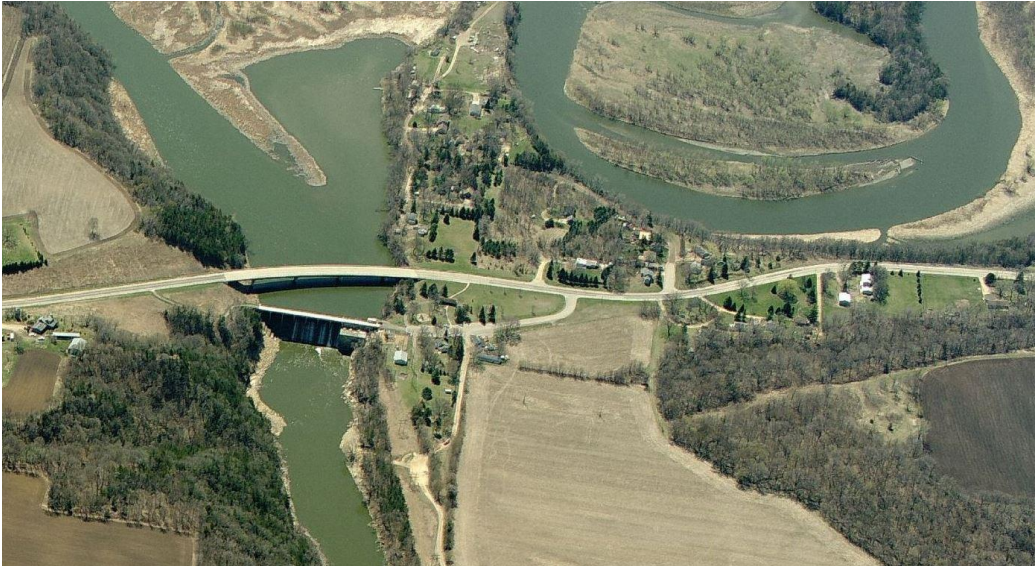
Figure 57. Much of the lower Watonwan River is influenced by the Rapidan Dam on the Blue Earth river; approximately 11 miles downstream of the confluence of the Watonwan and Blue Earth Rivers.

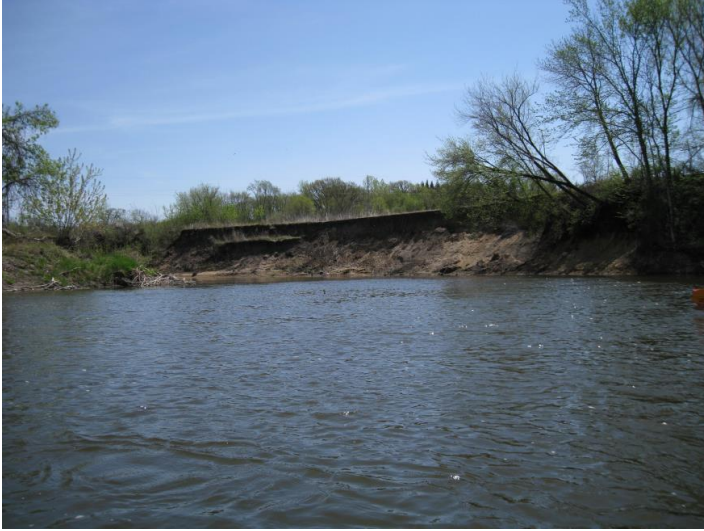
Figure 59. Example of bank erosion and mass wasting found within the lower reaches of the Watonwan watershed.

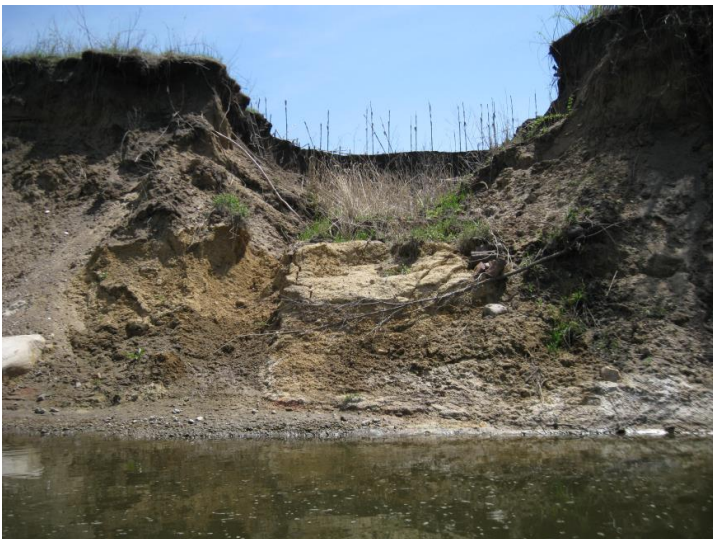
Figure 60. Example of bank erosion and mass wasting found within the lower reaches of the Watonwan watershed.

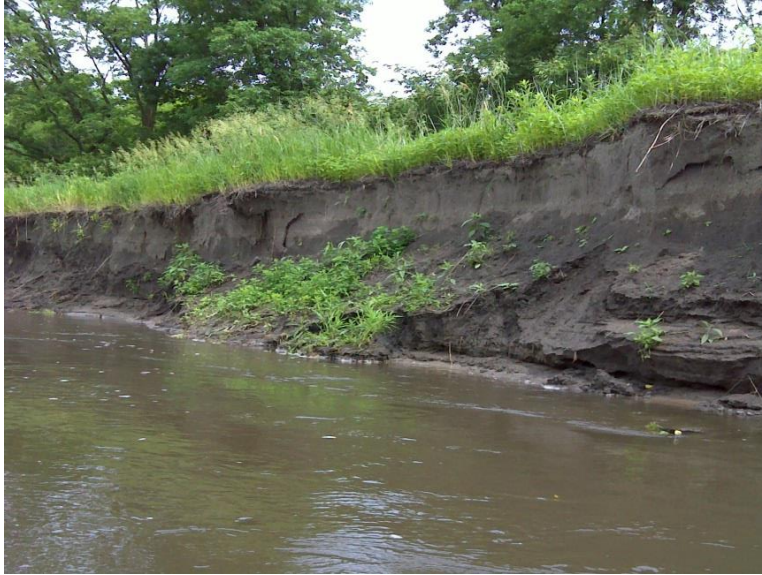
Figure 64. Mass wasting of streambank leading to increased rates of lateral channel migration.

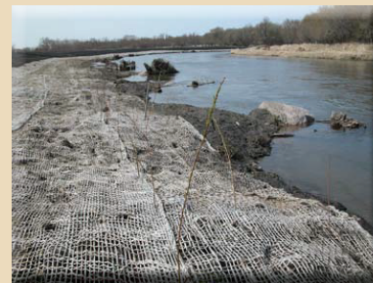
» Biodegradable ECBs are made of: jute (a vegetable fiber) mesh (*in photo*), coconut/coir fiber, straw, or excelsior (fine wood fiber) that are woven into a fiber matrix. ECBs are designed to temporarily provide erosion protection and assist with vegetation establishment as they degrade over 1-3 years leaving a vegetated bank. Products with polypropylene materials are not recommended because they do not degrade and can entangle wildlife in the rigid knitting.
 ✕ ECBs are placed over re-graded and re-seeded streambanks (use more durable netting for steeper banks). Wood stakes or live cuttings are used to secure the fabric in place (instead of metal anchor pins). Blankets should be installed promptly after the restoration to provide immediate erosion protection.

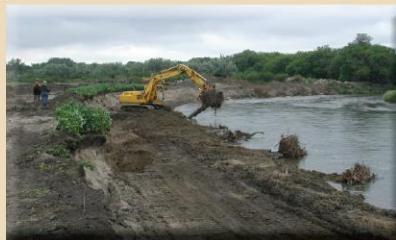
Installation of root wads using an excavator to drive tree trunks into the bankfull bench (looking upstream).

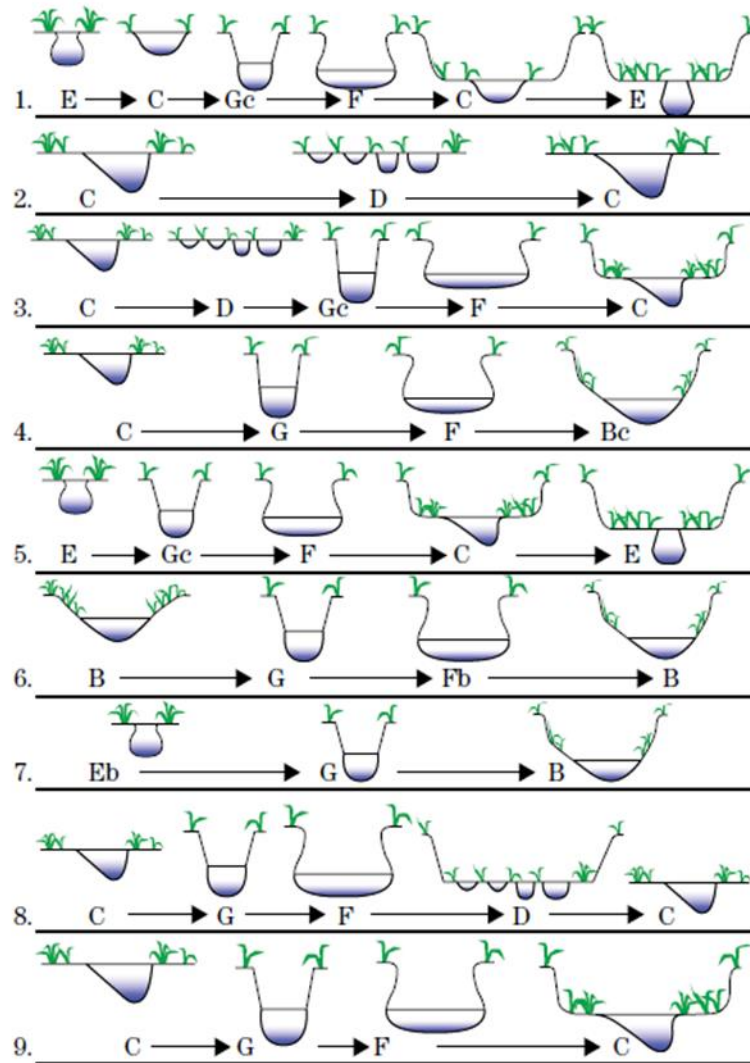
Appendix IV. Various stream type succession scenarios representing actual rivers (Rosgen 2006).

Figure 11-15 Various stream type succession scenarios
