# **North Fork Crow River**

# Watershed Restoration and Protection Strategies (WRAPS) Report Summary

wq-ws4-06b

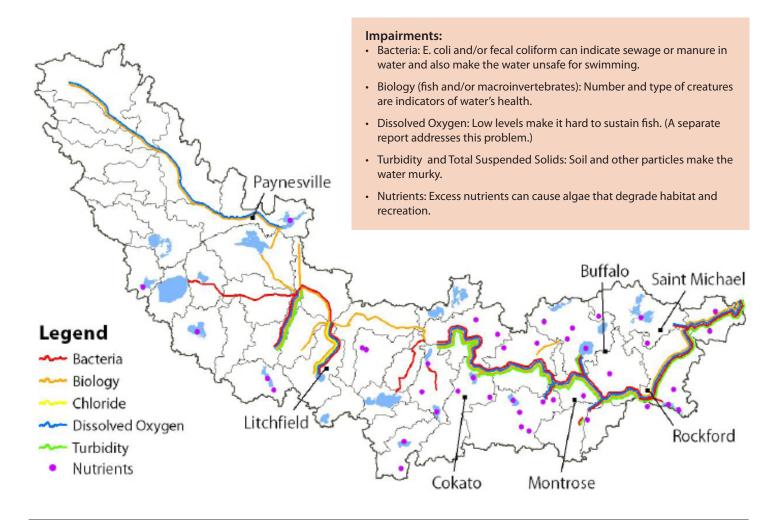
# Impairments in the North Fork Crow River Watershed

Waters are "impaired" if they fail to meet standards. The map on the next page shows the impairments for streams and lakes in the North Fork Crow River watershed. Under federal and state laws, impaired waters must have Total Maximum Daily Load (TMDL) studies to determine reductions of pollutants needed to again meet water quality standards. In this first WRAPS cycle, the MPCA and local partners completed TMDL studies for 34 lakes and 7 stream sections.

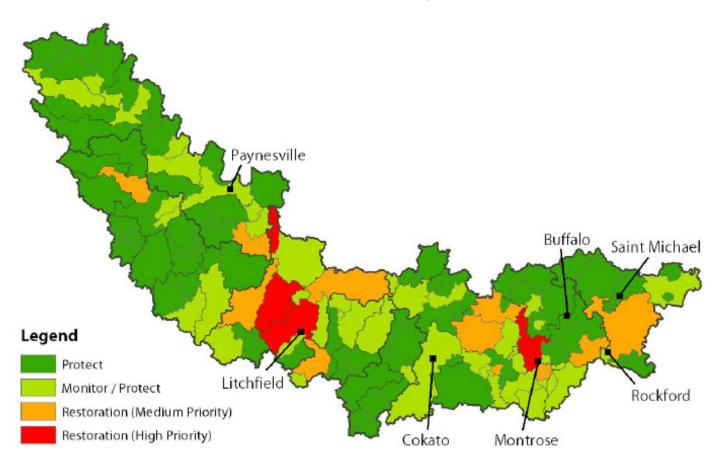
#### North Fork Crow River Watershed: Areas for restoration and protection

The MPCA created the strategy map below for subwatersheds – drainage areas within the larger watershed – to help identify general priority areas for targeting actions to improve water quality. Multiple sources of data, maps and analysis tools were combined to create this map. The colors on the map indicate:

- Red High priority restoration (water is Impaired, needs highest attention)
- · Orange Medium priority restoration (water is Impaired)
- Light green Protection/monitoring (water quality is good but declining or faces threats)
- Dark green Protect (water quality is good)
