Final Duluth Urban Area Watershed Restoration and Protection

October 2020

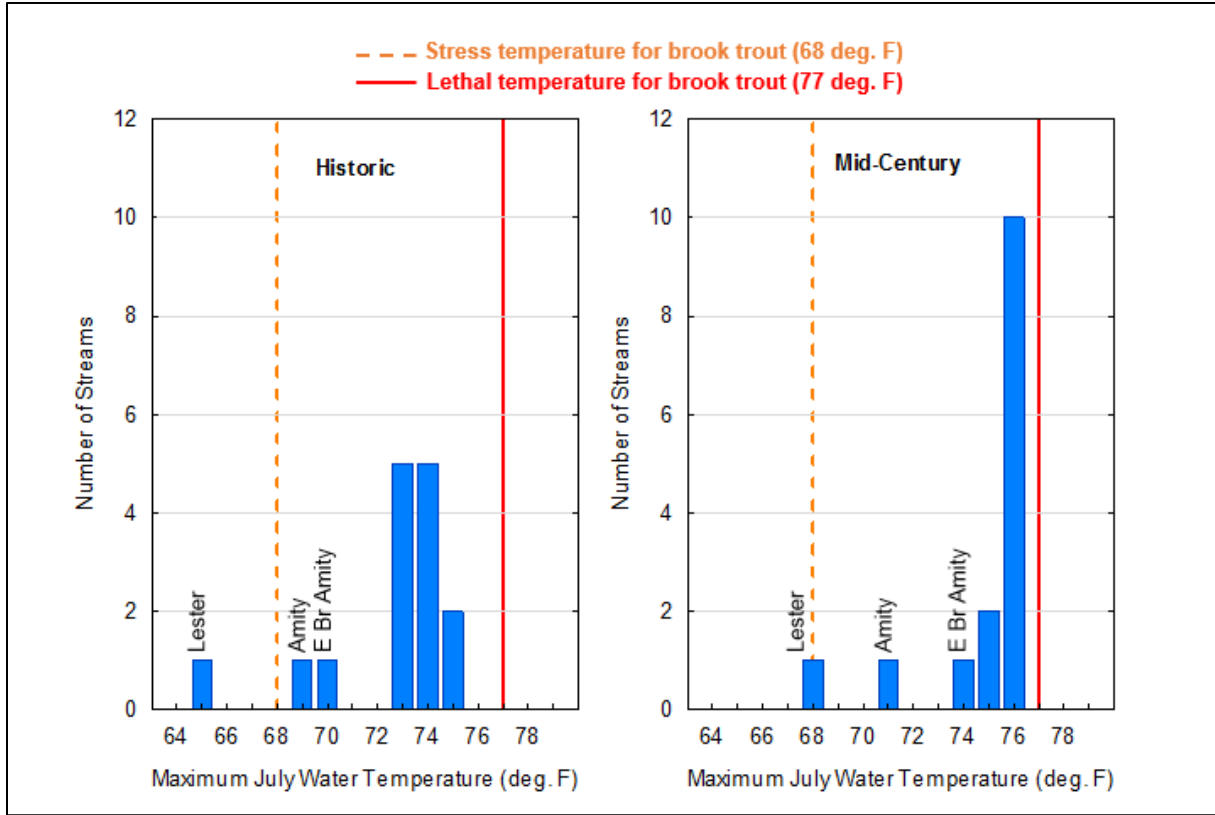
Figure 26. Simulated historic and mid-century average water temperatures of designated trout streams. Temperatures are the average of the simulated maximum July water temperatures for the historic (1995–2015) and mid-century (2025–2055) time periods.

Stream vulnerability to climate change was determined by evaluating projected increases in water temperature by mid-century (i.e., centered around 2040) as a result of climate change. Streams with higher projected temperatures are considered at risk of not being able to support healthy cold water fish communities. A climate change analysis was conducted with the HSPF model application using projected future climate conditions, based on global climate model simulations released by the Intergovernmental Panel on Climate Change (2017). For the stream temperature sensitivity analysis presented here, simulated average maximum July water temperatures were evaluated with respect to the lethal temperature of 77 degrees Fahrenheit (F) and the stress temperature of 68 degrees F for brook trout (MPCA 2017a). Maximum July temperatures were used to represent the worst-case scenario likely to be experienced by stream organisms. Over a 20-year simulation period (1995 through 2015) to represent historical conditions and a 30-year simulation period (2025 through 2055) to represent mid-century conditions, the maximum simulated July temperatures of each stream were averaged to produce one value per stream for historical conditions and one value per stream for mid-century conditions.

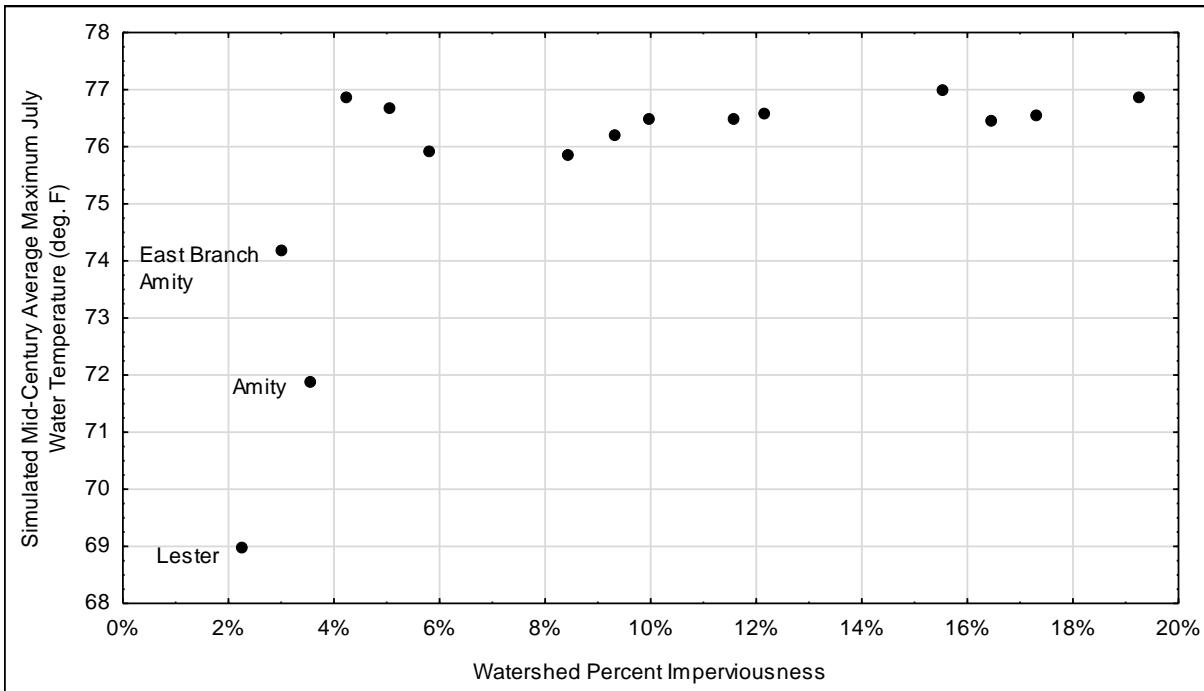
Figure 27. Simulated mid-century average maximum July water temperatures versus subwatershed percent imperviousness. Unlabeled streams include those streams listed in Table 9 excepting Lester River, Amity Creek, and East Branch Amity Creek.
