Two Rivers Watershed

Watershed approach

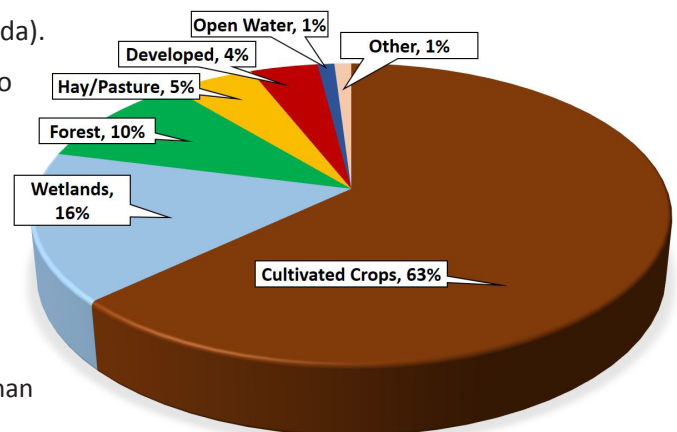
Land Use – Two Rivers Watershed

Cultivated crops is the dominant land use cover, comprising more than 63% of the watershed. The next largest cover is wetlands at 16%.

- The watershed is dominated by agriculture, with more than 64% of the land use in crop production. Approximately 79% of streams have been altered from their original course in an effort to increase drainage rates to better suit the current land use practices of the area. These alterations have resulted in dams, loss of habitat, low flows, and lowered levels of oxygen in many streams, reducing the abundance and diversity in both fish and macroinvertebrate (aquatic insect) communities.

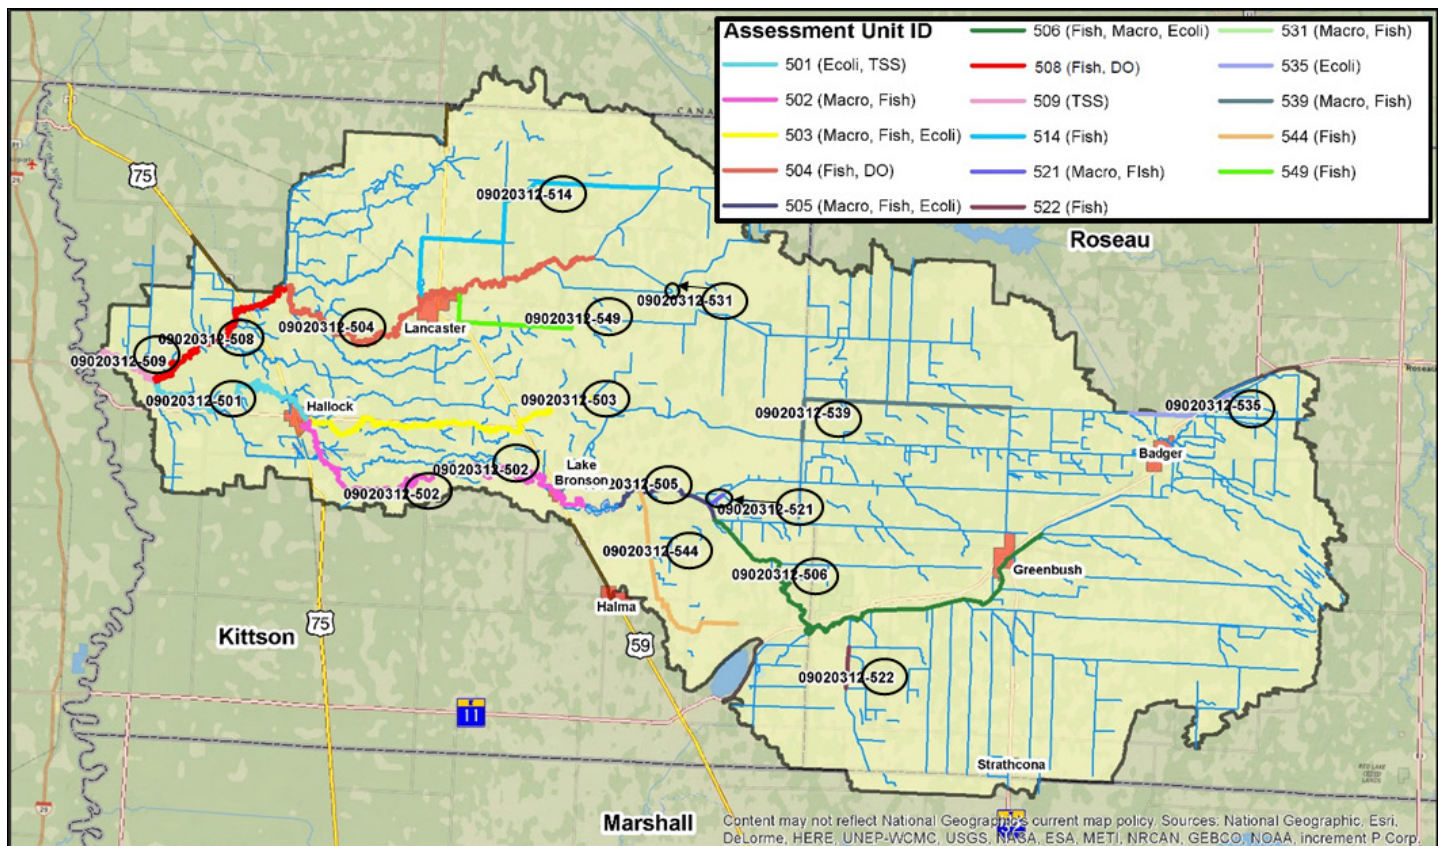
Assessments: Are waters meeting standards?

During the first phase of the watershed approach – intensive watershed monitoring – the MPCA and local partners collect data about biology such as fish populations, chemistry such as pollutant levels, and flow. Waters are “impaired” if they fail to meet standards. The map above shows the aquatic life and recreation impairments in the Two Rivers Watershed.

Using data from these sampling efforts, it was determined that 13 stream reaches were impaired for fish and/or aquatic insects. Five stream reaches were impaired for aquatic recreation (swimming) due to excessive levels of *E. coli* bacteria. Two stream reaches were impaired for low dissolved oxygen levels and two stream reaches were impaired for turbidity/total suspended solids (excessive sediment in the water).

Seven Total Maximum Daily Load (TMDL) studies were developed for six stream reaches; five address high levels of *E. coli* bacteria and two address total suspended solids (TSS). These studies identify known and likely sources of the pollutants and reductions needed to bring these reaches back into compliance with state standards. More information is needed before TMDLs can be done for the other impairments.

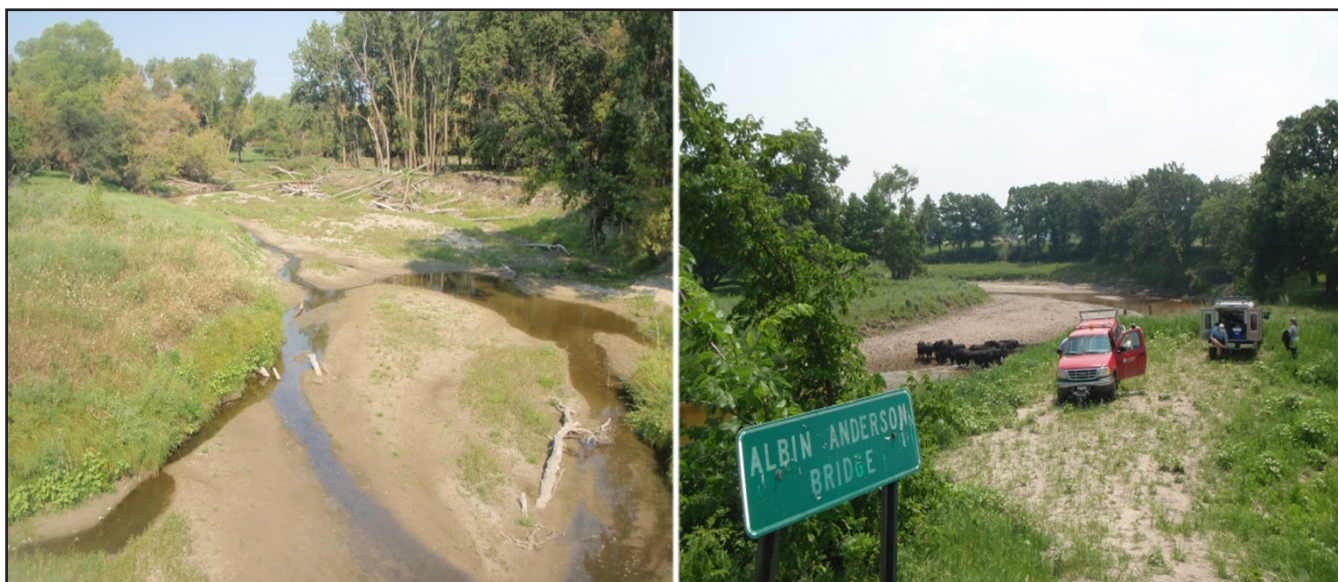
Low flow conditions in the South Branch of the Two Rivers in August 2012 (left) and in July 2013 (right). Low flows can cause low dissolved oxygen levels and other conditions that are harmful to fish and aquatic insect communities.
