Red Lake River Watershed

Watershed approach

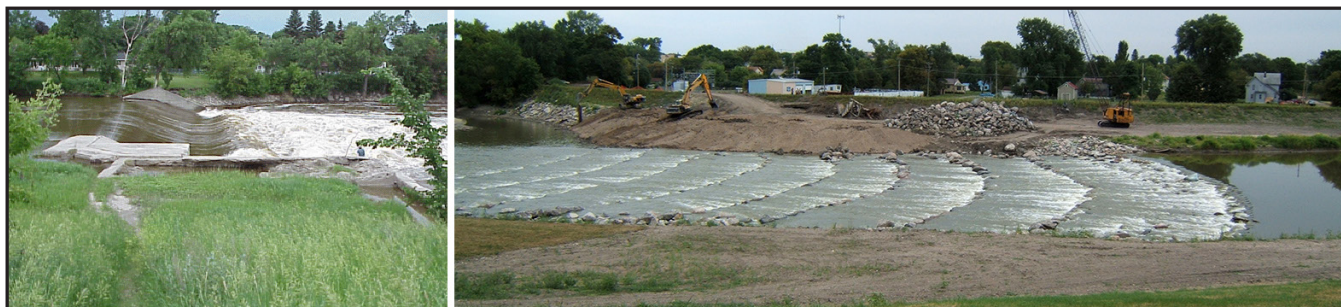
In 2005, a project involving a number of state and local watershed partners removed an old dam in Crookston (left) and replaced it with a series of rapids formed from boulders (pictured from opposite side of river). This project, along with a dam project upstream of town, restored fish passage from the Red River in East Grand Forks to Thief River Falls, a distance of 125 river miles. Fish now have access to better spawning habitat.
