WRAPS report summary Water Restoration and Protection Strategy

Upper Wapsipinicon River Watershed

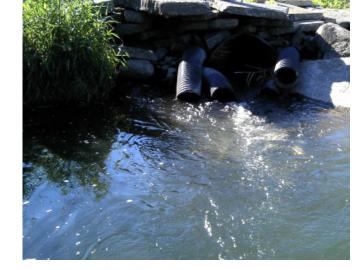
- Altered hydrology: Artificial drainage, such as channelized ditches and field tiling, is driving many of the problems in the watershed. Inadequate flow, caused by rapid drainage, appears to affect aquatic habitat at times. (Photo at right shows extensive tile drainage into a stream.)
- Bacteria: *E. coli* and/or fecal coliform bacteria can indicate sewage or manure in water and also make the water unsafe for swimming.
- Biology (fish and/or macroinvertebrates): There are fewer fish and bugs, and fewer species of them, than expected for this type of streams.
