### **WRAPS report summary** Watershed Restoration and Protection Strategy

# Roseau River Watershed

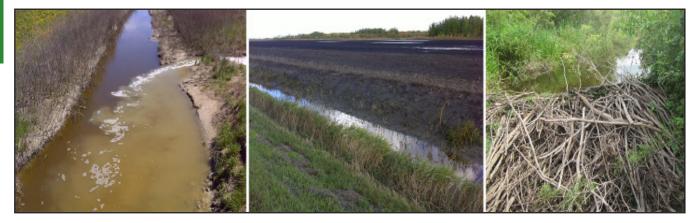
Images taken during stressor identification field work in the watershed in 2017. Sediment laden water entering Hay Creek from adjacent ditch (left); a partially buffered tributary to Hay Creek (center); and a beaver dam on Severson Creek.

- Stressors associated with the biologically impaired reaches in the RRW include loss of longitudinal connectivity (barriers to fish passage such as dams, culverts, etc.), flow regime instability (excessively high flows followed by very low-flow conditions), insufficient physical habitat, high suspended sediment, and low dissolved oxygen (DO). Stressors associated with water quality impaired reaches include historical channel modifications that contribute to altered stream hydrology (e.g., extreme peak flows and periods of minimal flow), streambed and bank erosion, upland soil erosion, historical changes in land cover (e.g., native vegetation to cropland), and lack of riparian buffers. Furthermore, livestock populations and unrestricted livestock access to streams contribute toward elevated levels of *E. coli* in the watershed.
